Reach 1b (Maplecrest Gage to County Bridge #3-30287-0)

Reach 1b begins at the USGS gage station in Maplecrest, and flows parallel with Big Hollow Road for approximately 8,744 feet (1.7 miles) to the county bridge below the L. MacGlashen farm (**Map VI-2**). The stream reach is located within valley zone 5 (**Figure V-11**), with an average valley slope of 2.7%. Valley morphology is characterized by steep side slopes with a narrow, confined valley floor. The drainage area contributing to the reach ranges from 2.03 mi² at the top of the reach to 5.5 mi² at the county bridge. Land cover through the reach is dominated by forest, while other land use in the reach includes limited residential development and some small scale agriculture.

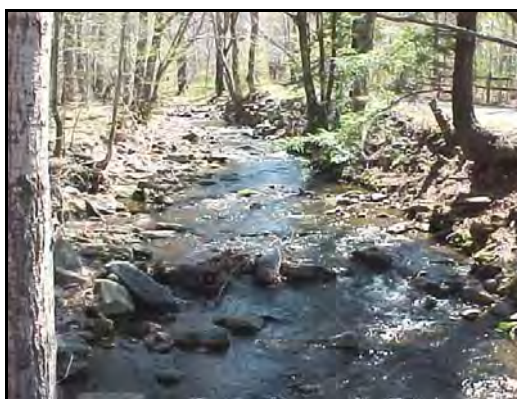
Figure VI-4: Section of segment 1b as it runs along access road to NYSDEC trail head.

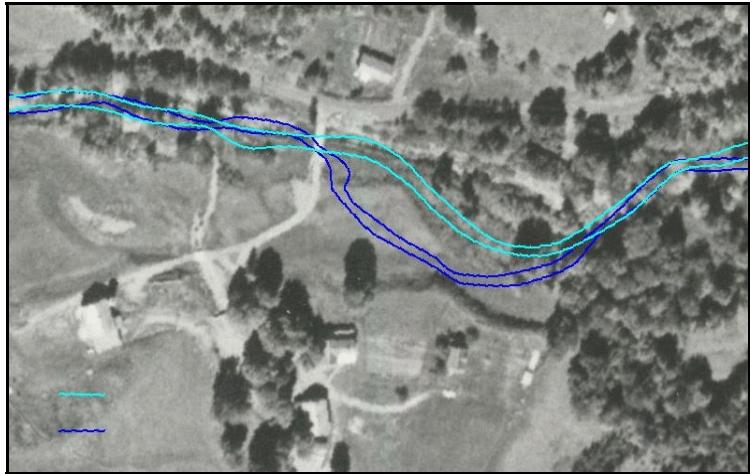
Continuing down the reach, the Batavia Kill has been characterized by adjustments in the stream's planform. The stream channel upstream of the new bridge at the L. MacGlashan farm has migrated toward the south over 150' since 1959, with the largest movement of nearly 50' occurring between 1995 and 2000 (**Figure VI-6**). The largest shifts have occurred during years of large storm events in 1996 and 1999, with an average erosion rate of approximately 1' per year (**Figure VI-5b, photo B**).

Figure VI-6: Aerial overlay of channel migration between 1959 (light blue) and 2000 (dark blue) at L. MacGlashan farmstead.

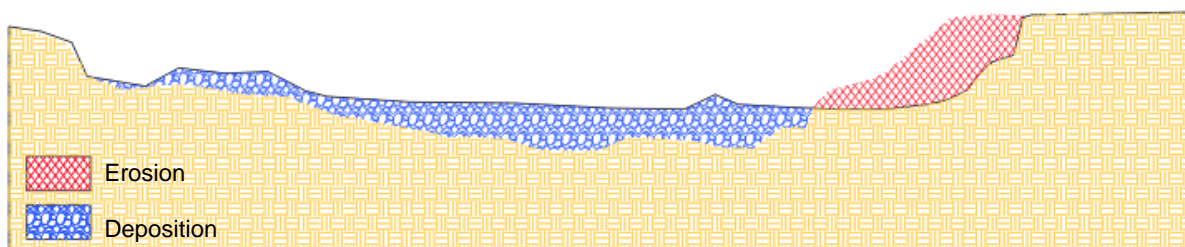
Figure VI-7: Headwaters cross section #5 overlay from 1999-2000 depicting channel aggradation and lateral migration.

The aggradation in the lower segment of reach 1b is most likely attributed to several factors. First, the GCSWCD had inventoried a large beaver dam that was causing a decrease in sediment transport capacity and promoting local aggradation of the channel. A second factor contributing to the aggradation is an increase in overall sediment supply

from the areas of degradation and lateral erosion above. The most significant change was noted after the September 1999 flood event in which the stream discharge in this area exceeded 790 cfs and completely buried the beaver dam with gravel. The result was significant localized flooding and nearly six feet of lateral erosion.

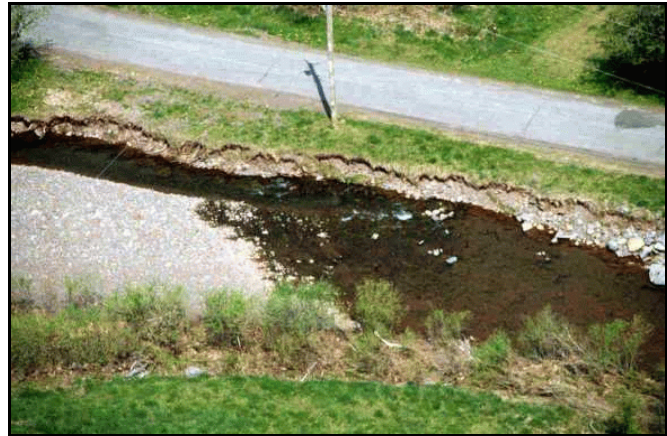
While the upper portion of reach 1b has only minor, localized instability problems, the lower extent of the reach is felt to be heading toward extreme instability. The GCSWCD has observed aggradation, degradation, and lateral meander migrations in this section of the reach, and there is a very low probability that the stream channel will achieve an acceptable state of stability on its own. There is currently a seasonal structure threatened, and several homes are likely to be impacted in the future.

Figure VI-8: Aerial view of lateral migration along County Route 56 in lower section of management segment 1b.

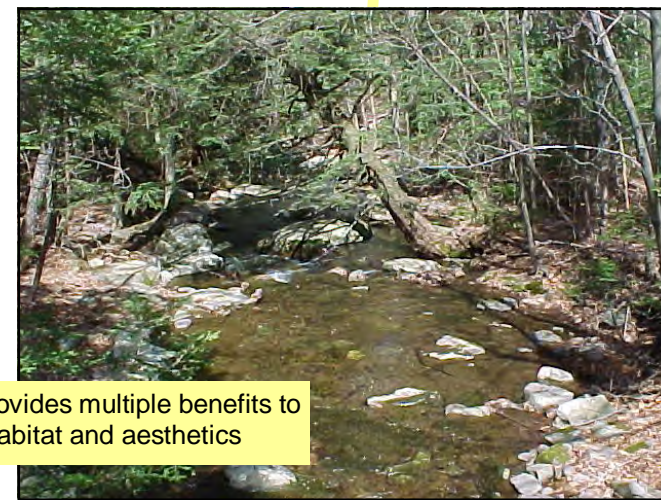
H

Healthy riparian vegetation provides multiple benefits to bank stability, fisheries habitat and aesthetics

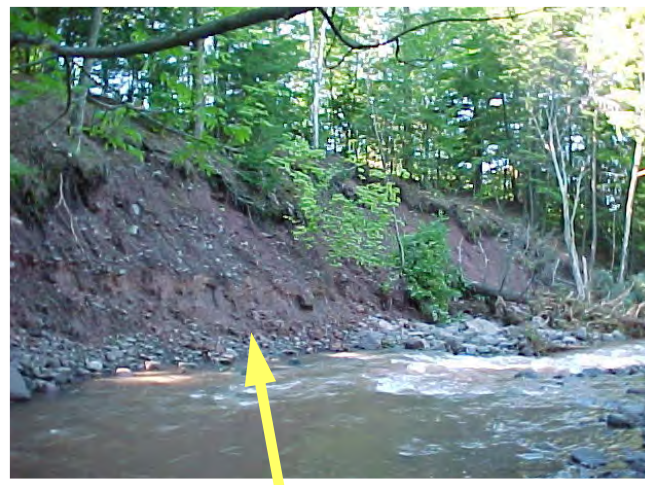
A

While the upper portion of the reach is characterized as being relatively stable, the lower portion of reach 1b was noted as having significant areas of channel erosion (**Figure VI-5b, photos A,B,D,E,F**). The erosion inventoried in 1997 was almost exclusively located in this sub-reach. Instabilities were noted in several areas, with channel aggradation and degradation observed, as well as lateral channel erosion. In August of 1999, three monitoring sections were installed in this section to determine stream type and the current state of instability.

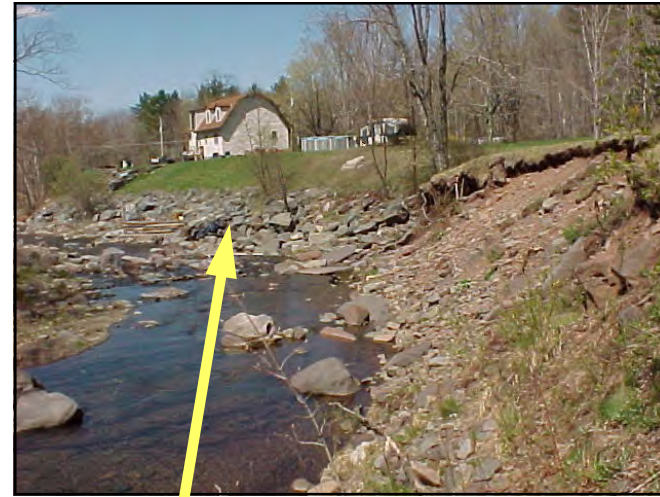
C

In lower reach 1b, it must also be noted that the GCSWCD has also been watching an area of severe streambank failure associated with a large culvert on a small unnamed tributary to the Batavia Kill. The culvert was substantially damaged in the 1987, 1996 and 1999 flood events (**Figure VI-5b, photo C**). While the culvert has been replaced after each storm event, this drainage feature continues to contribute to the instability of this section of the reach. In 1990, the GCSWCD undertook a rip rap project in this area to address erosion at the point where the small tributary meets the main stream, and to protect a small cabin in that area. Rip rap was placed on the right bank of the tributary between the culvert and the Batavia Kill, and continued downstream on the right bank of the Batavia Kill. In the 1999 flood event, this rip rap completely failed, with massive erosion occurring near the cabin (**Figure VI-5b, photo G**). It is unknown to what extent the culvert has contributed to overall instability, but the GCSWCD strongly recommends additional assessment, and appropriate mitigation of this problem.

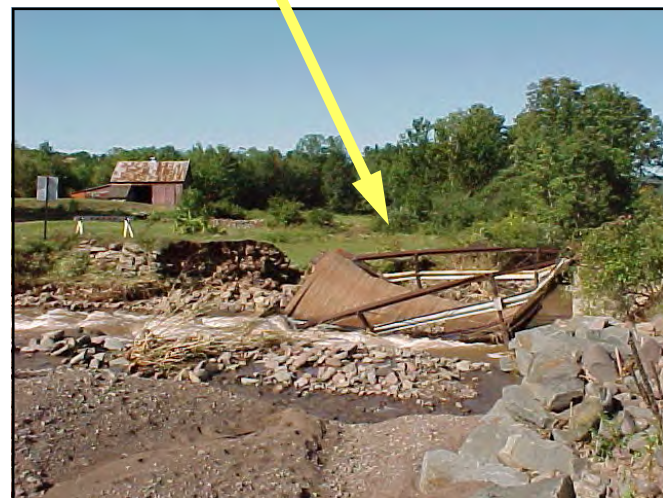
F

In September 1999, the town bridge at the L. Milton MacGlashan farm failed during the Tropical storm Floyd flood event (**Figure VI-5b, photo F**). The cause of the failure was documented as scour of the left bridge abutment, most likely the result of inadequate capacity to pass the storm flow, as well as degradation of the streambed and lateral erosion. The replacement bridge was relocated approximately 150 feet down stream, to a location where the stream planform was straight. The new bridge was built at 60 feet in length, in an area where the GCSWCD has determined the bankfull width to be approximately 35 feet. The combination of the new alignment and the lengthening of the bridge is both highly favorable to reestablishing a stable stream morphology in this reach.

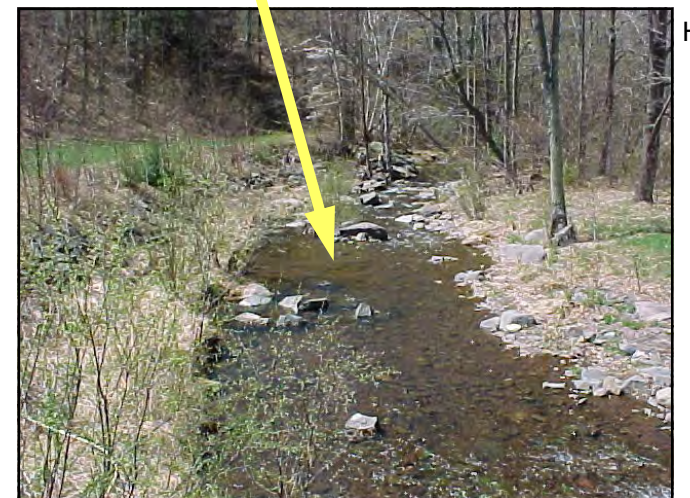
H

Rip-rap installed by the GCSWCD in early 1990's has failed
