Reach 2a (CD Lane Park Flood Control Structure to Intersection CR 40/56)

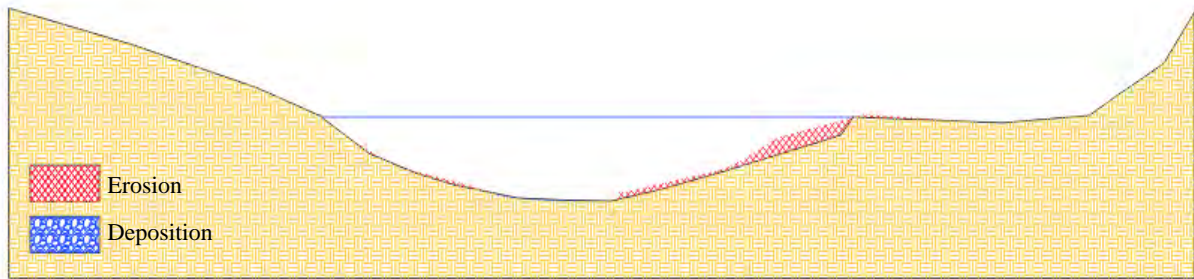
Figure VI-21: Overlay of 1998 and 2000 cross sections taken below CD Lane Park Flood Control Structure.

A single monumented cross section was installed below the CD Lane Park flood control structure for classification purposes in 1998 and was subsequently surveyed again in 2000 to determine if any stream changes had occurred as a result of the September 1999 flood event. (**Figure VI-21**). The cross section monitoring indicated that the channel has achieved a stable morphology that accommodates the modified water and sediment discharges from the flood control structure. Minimal erosion during the monitoring period validated the GCSWCD observation that the reach is highly stable.

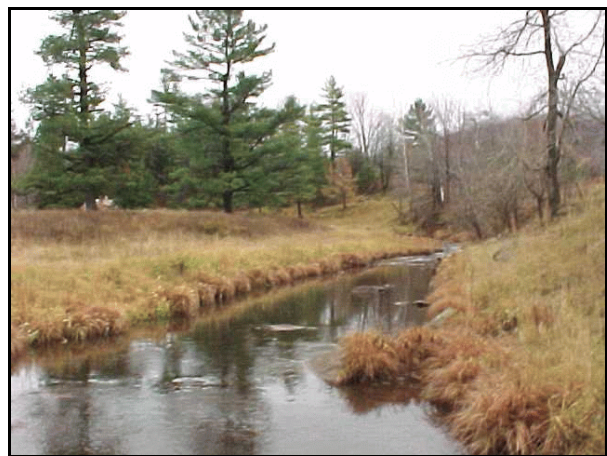
Figure VI-22: While grasses and forbs provide stability, poor overhead cover reduces habitat value.

The riparian community in reach 2a consists of moderate to low-density mixed deciduous/coniferous overstory, with a brush/grass understory. The entire length of the reach is characterized by extensive growth of sedges and other herbaceous plants within the active channel and on the lower streambanks. Several sections of the riparian buffer are regularly mowed, but these activities do not appear to be having an impact on channel stability. The stream riparian community immediately below the dam consists of highly dense grasses and sedges with some low shrub growth (**Figure VI-23a, photos A,B,C,D,E,F,G**). Between the dam and Slater Road, the reach is dominated by herbaceous growth, with limited areas of forest. While the reach has excellent riparian vegetation from a stability standpoint, much of the reach exhibits fair to poor conditions in regard to buffer species that provide stream cover and thermal benefits (**Figure VI-22**). The lower reach transitions to

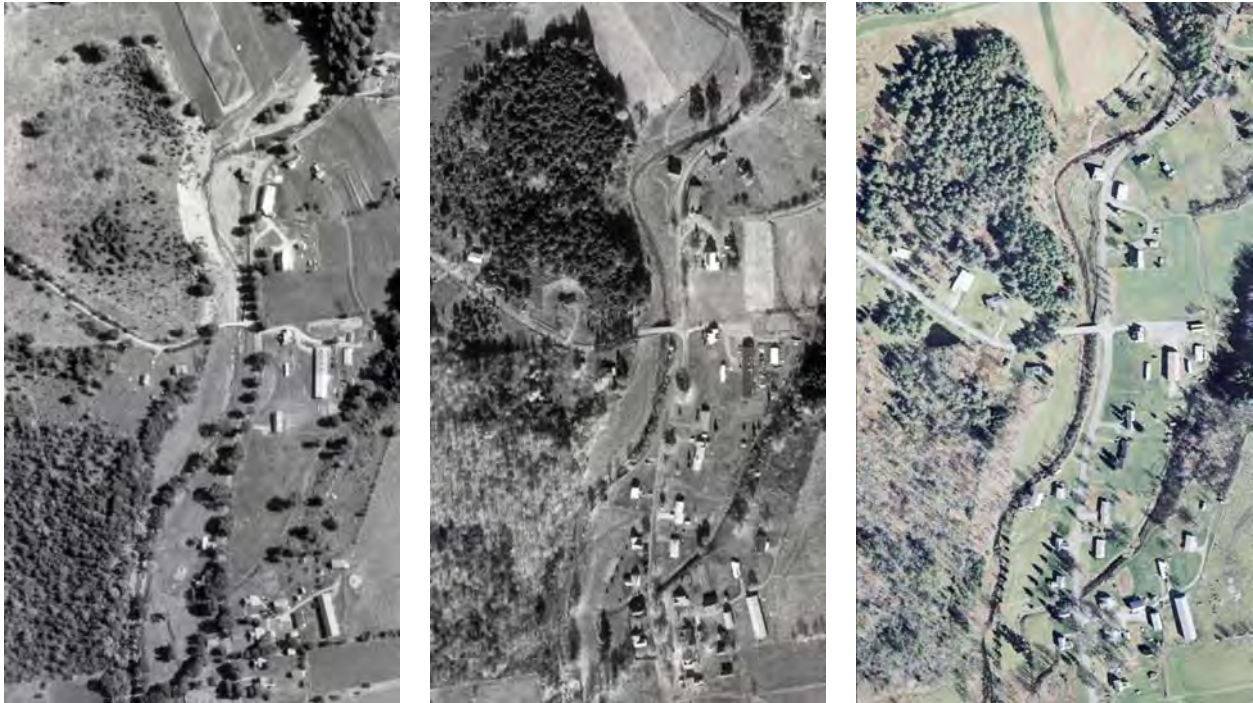
Figure VI-24: Aerial progression from 1959 (left), 1980 (middle) and 2000 (right), note that the riparian condition has essentially remained the same over 40 years.

a higher density of woody growth, with trees and shrubs supplementing the herbaceous communities. During the assessment phase, the GCSWCD compared aerial photographs over a 41 year period from 1959 to 2000 which indicate that the riparian zone has remained essentially the same (**Figure VI-24**).

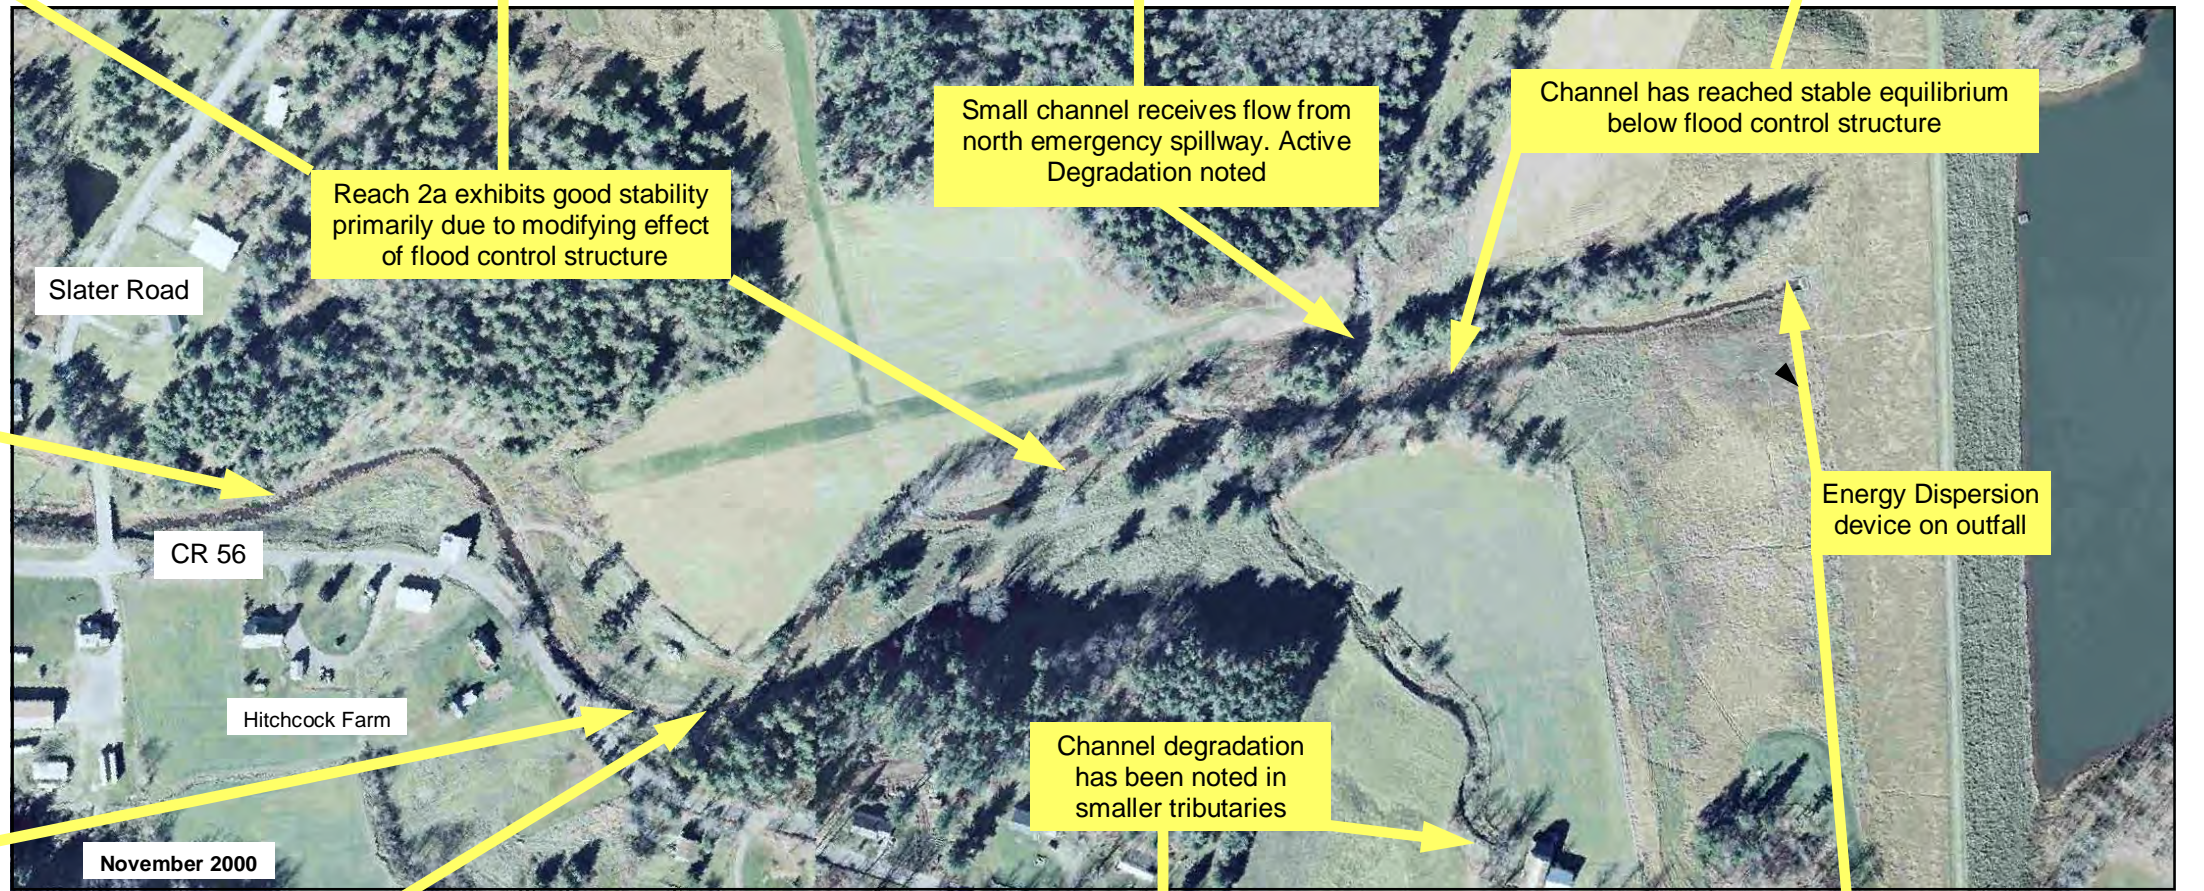
Reach 2a exhibits good stability primarily due to modifying effect of flood control structure

Small channel receives flow from north emergency spillway. Active Degradation noted

Channel has reached stable equilibrium below flood control structure

Energy Dispersion device on outfall

Channel degradation has been noted in smaller tributaries

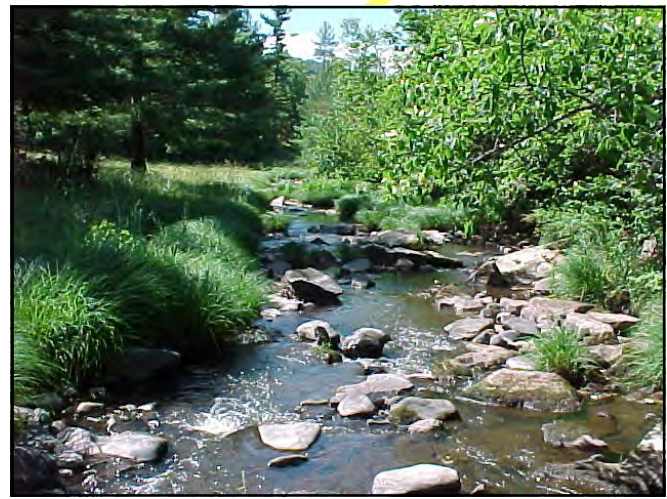
G

During the assessment period, the GCSWCD noted active incisement of several of the smaller tributaries that contribute to the reach; this was not physically measured. The intermittent tributary that enters from the base of Thomas Cole Mountain (**Figure VI-23a, photo G**) and the tributary that enters from the north just below the dam (**Figure VI-23a, photo C**) both are actively degrading (downcutting). The tributary from Thomas Cole is extremely active below County Route 56. The tributary passes through the Hitchcock property where it has incised substantially. The channel's banks have no cover and are mowed to their tops. Monitoring on the main stem Batavia Kill above the confluence has shown no vertical degradation. The vertical instability of the tributary is believed to be confined to the tributary itself.

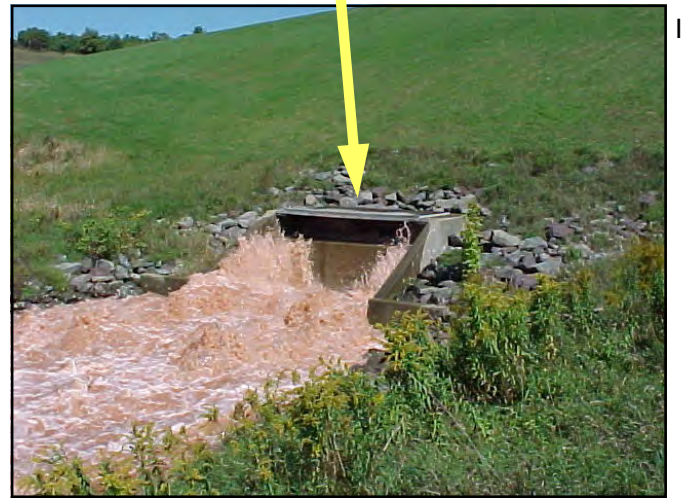
I

The central infrastructure feature within the reach is the outfall for the C.D. Lane flood control structure (**Figure VI-23a, photo I**) In the GCSWCD's initial assessment of the reach, the primary concern was related to the typical "clear water" effects seen below similar dam structures (**see section V-C**). The completion of the flood control structure in 1976 effectively created a large trap for sediment that significantly reduces the stream's sediment supply.

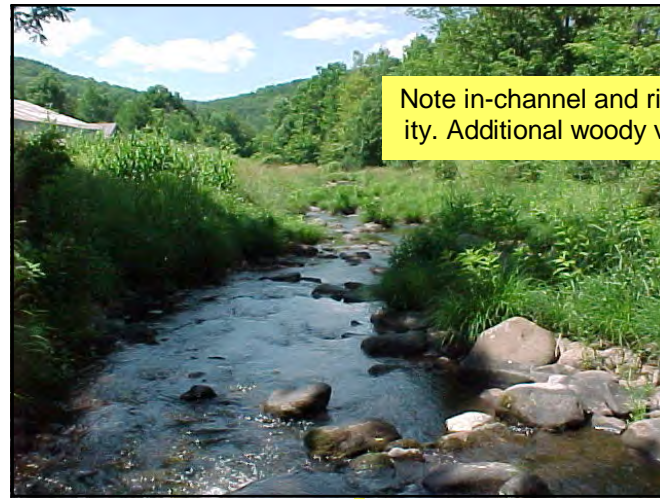
B

Note in-channel and riparian vegetation promote stability. Additional woody vegetation would improve habitat

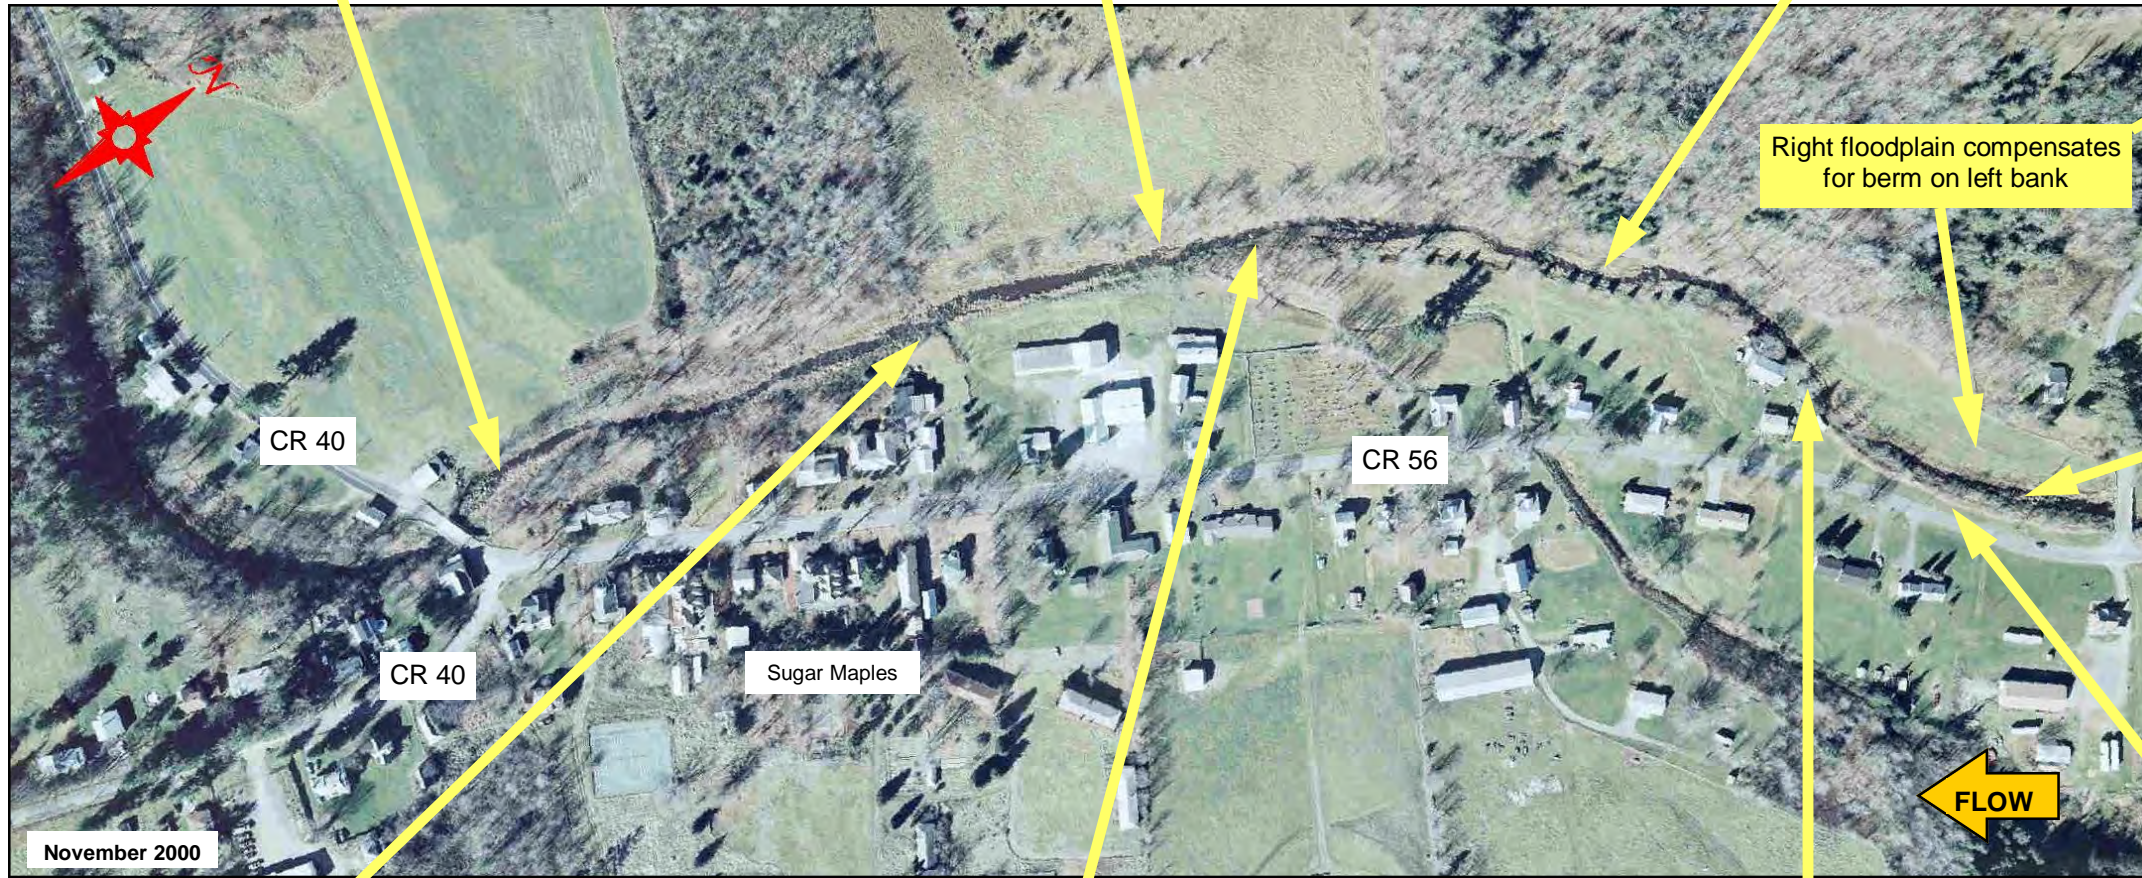
Right floodplain compensates for berm on left bank

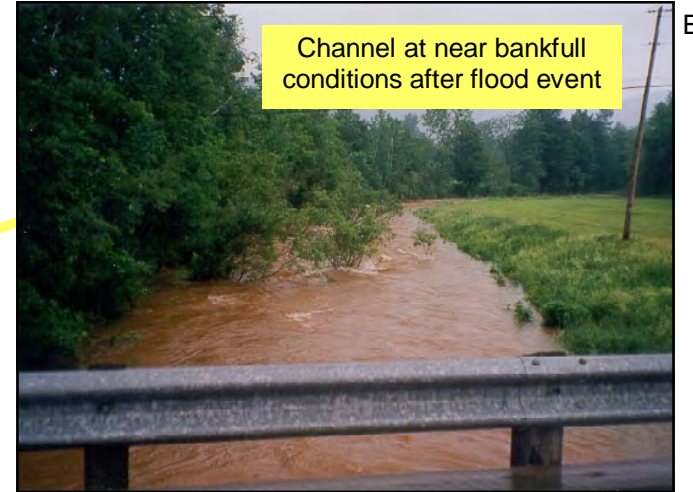
E

Channel at near bankfull conditions after flood event

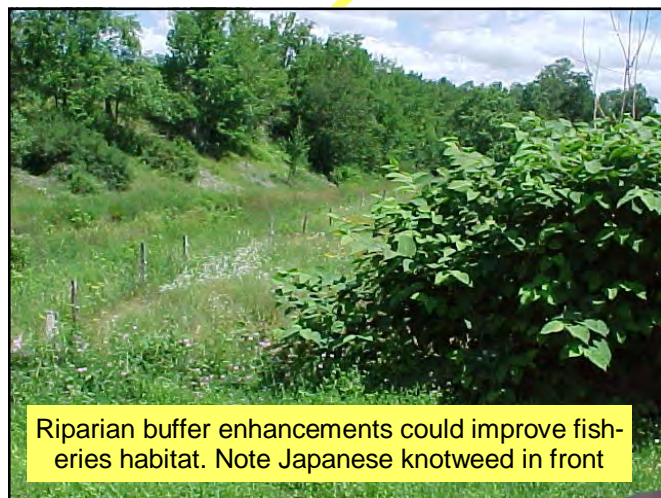
F

Riparian buffer enhancements could improve fisheries habitat. Note Japanese knotweed in front

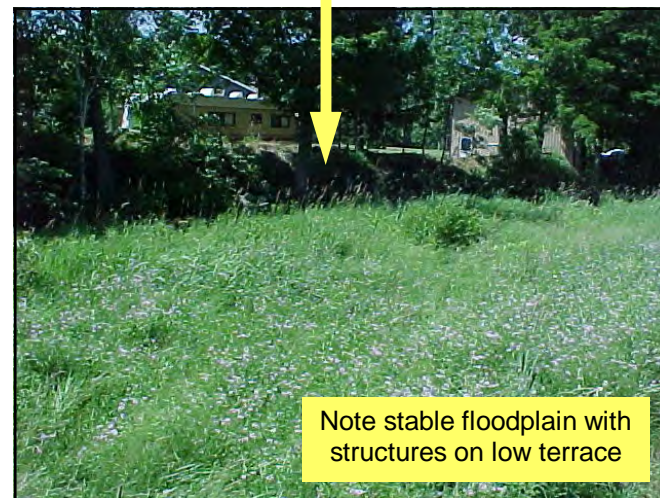
H

Note stable floodplain with structures on low terrace

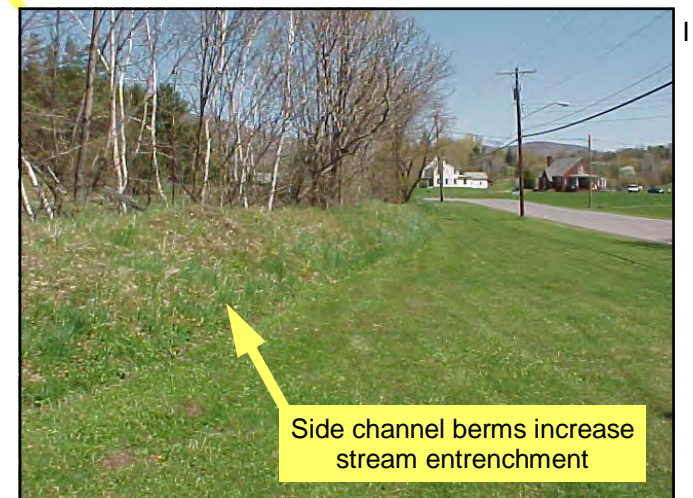
I

Side channel berms increase stream entrenchment
