Reach 2b (Intersection CR 40/ CR 56- Hensonville Market)

Reach 2b includes the section of Batavia Kill beginning at the intersection of County Routes 40 and 56 in Maplecrest, and runs downstream to the area adjacent to the Hensonville Market. The reach is approximately 1.9 miles in length and ranges in drainage area from 11 mi² to 13.4 mi². The channel receives four unnamed seasonal tributaries through reach 2b. The stream reach is located in Valley Zone 3 and has an average valley slope of 1.3% (**Figure V-11**).

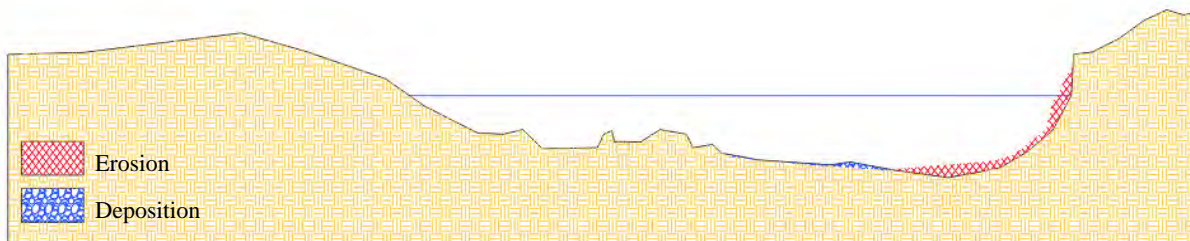
Figure 27: Overlay of 1998 and 2000 monitoring cross section showing erosion and deposition indicating good stability during the monitoring period.

In 1998, a single cross section was measured in this sub-reach behind the Harp and Eagle in Hensonville. The cross section was used to obtain information about the stream's hydraulic geometry (width, depth, cross sectional area). This cross section was resurveyed in 2000 and the GCSWCD determined that it had remained stable over that time period (**Figure VI-27**).

The channel dimensions of width/depth and entrenchment at the cross section have remained essentially unchanged with only minor scour at the cross section. The channel scour is conceivably caused by a slow change in bed feature from a riffle to a pool and potentially results from the September 1999 flood event. The reach was reexamined after the September 1999 flood event and the reach appeared to have maintained its stability.

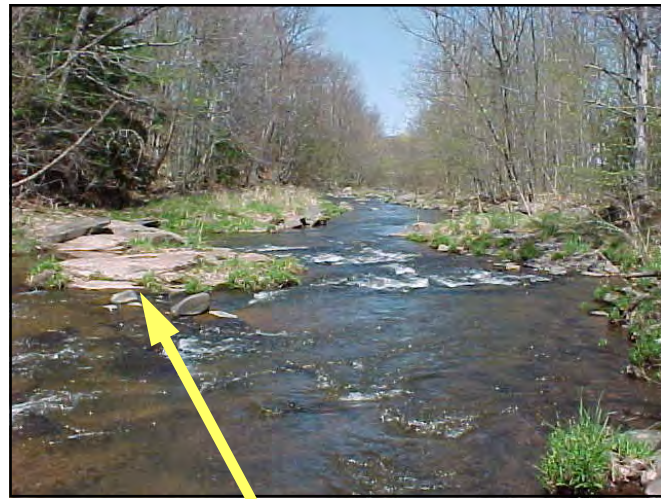
A

The Phase I Inventory and Assessment process characterized the reach as having very low streambank erosion with only 300 feet of stream bank erosion noted on the entire 1.9 mile long reach (**Figure VI-26a, Photo A,B,C,D,E,F**). Stream profile (the slope of the stream bed) is controlled by bedrock exposures at the top of the reach as well as near the bottom, and the remnants of an old K-Dam fisheries structure located near the top of the reach (**Figure VI-26a, photo G**) also appears to exert some control on the profile.

the bridge exhibits no signs of backwater deposition or bridge scour. Immediately upstream of the bridge, approximately 600 feet of channel is influenced by County Route 40 which is a factor in the increased channel entrenchment (**Figure VI-26a, photo A,E**). This entrenchment also extends a short distance below the bridge, but despite this entrenchment the channel appears to be stable under the current flow regime.
