Reach 2c (Hensonville Market to CR 65)

Figure VI-28: Reach 2c

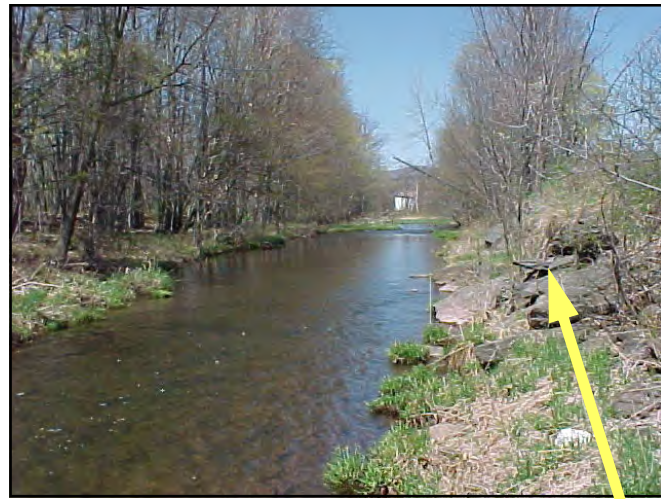
A

The riparian vegetation through the majority of the reach consists of a very thin buffer along County Routes 40 and 65A. The buffer is composed of a mixed population of mature deciduous species, conifers and grasses on the reach's lower banks (**Figure VI-28, photo A,C,D**). Although the forest buffer is thinner than desired in places along CR65A, the canopy cover appears to be providing excellent shading of the stream channel through the reach, and the vegetation is assumed to be a major factor in the stability of the reach. As noted in previous reaches in management segment 2, the stream channel is well vegetated with grasses and sedges (**Figure VI-28, photo D**).

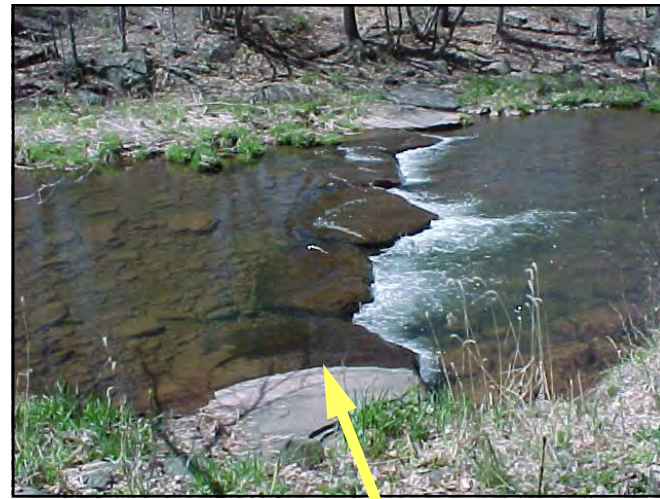
B

exerted by a timber K-dam and a boulder sill (**Figure VI-28, photo B,E**), both located just below the County Route 40 bridge (No. 3-30285-0). The K-dam is in poor to fair condition and has lost much of its scour pool function. These structures are common, having been installed by the NYSDEC, the GCSWCD and others under state and federal conservation programs in the 1960s. The boulder sill was constructed in the early 1990s by the Town of Windham, under the technical assistance of the GCSWCD. The sill was constructed to provide grade control protection for a water service main that runs from the Town's well house to Hensonville under the stream. The rock sill has worked well, and survived the 1996 and 1999 flood events. There are no visual signs that either structure is impacting reach stability.
