Reach 3b (Concrete Dam at Thompson House to CR 79 Church Street)

Reach 3b Summary

Figure: VI-33a Reach 3b-Upper

Figure: VI-33b Reach 3b-Lower

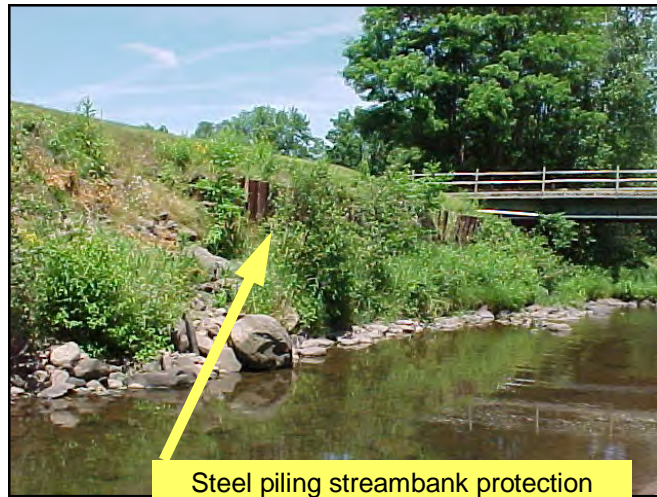
The two smaller bridges located on the golf course property (**Figure VI-33a photos A,B,J**) are primarily used by golf carts and service vehicles. While the bridges are currently stable, the presence of old steel sheet piling and rip rap indicate past channel modifications, and there are some signs that the lower bridge may not effectively pass sediment during larger flood events. Reach 3b also contains a well house for the Town of Windham water system. The well house is located on the floodplain, near the Windham-Ashland-Jewett bus garage. While the well is located far enough from the stream to be protected from significant damage by flooding, the Town of Windham would benefit from development of a Wellhead Protection Plan.

Steel piling streambank protection indicates past instabilities in this area

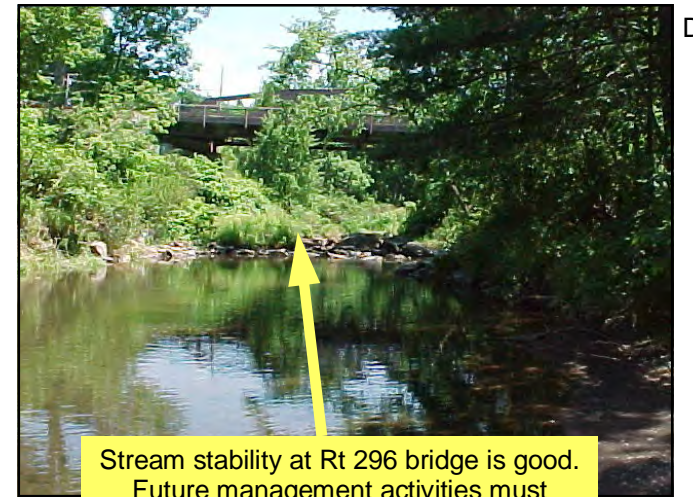
Stream stability at Rt 296 bridge is good. Future management activities must protect stream conditions

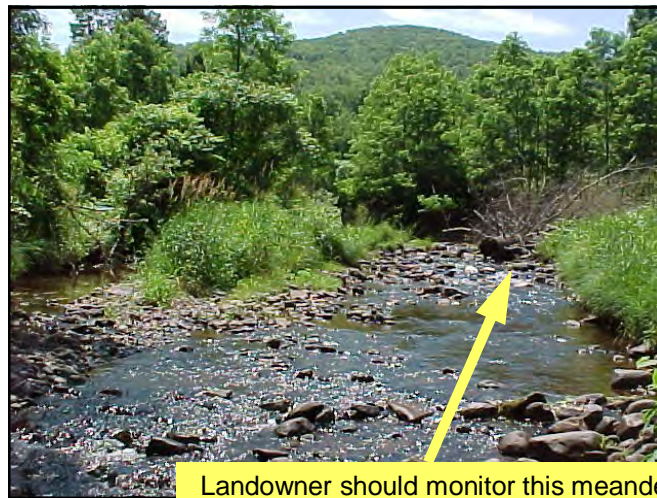
Landowner should monitor this meander for erosion. See GCSWCD for assistance prior to any management activities

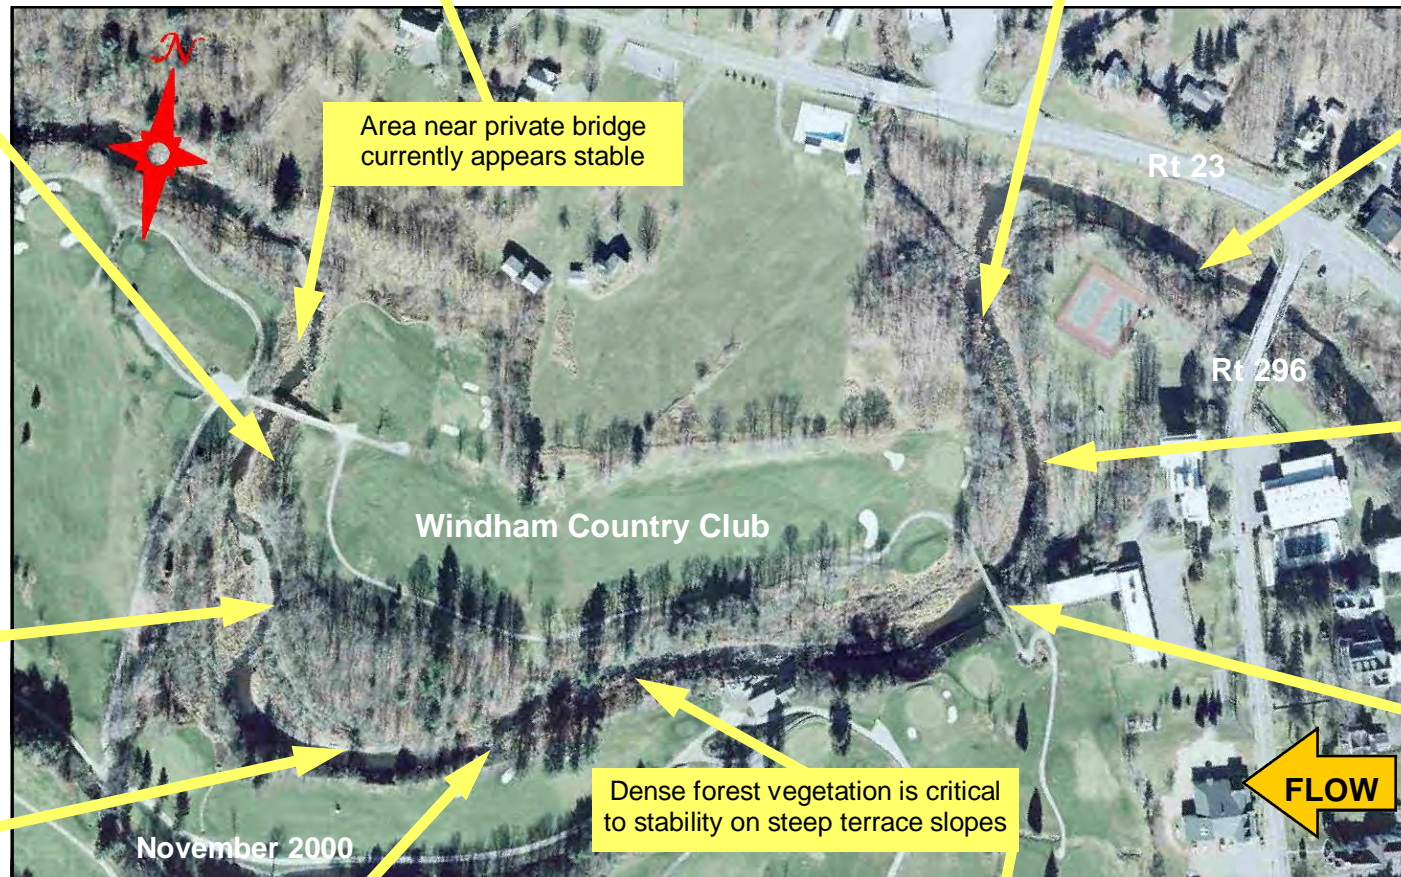
Area near private bridge currently appears stable

Dense forest vegetation is critical to stability on steep terrace slopes

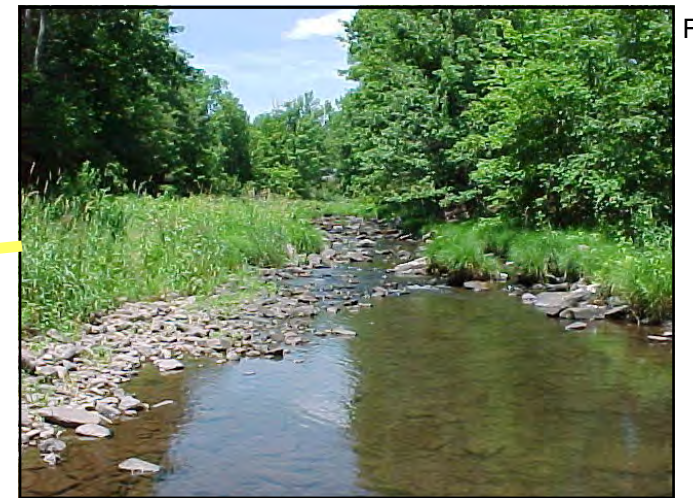
Private bridge exhibits good stability, and does not appear to be impacting the stream

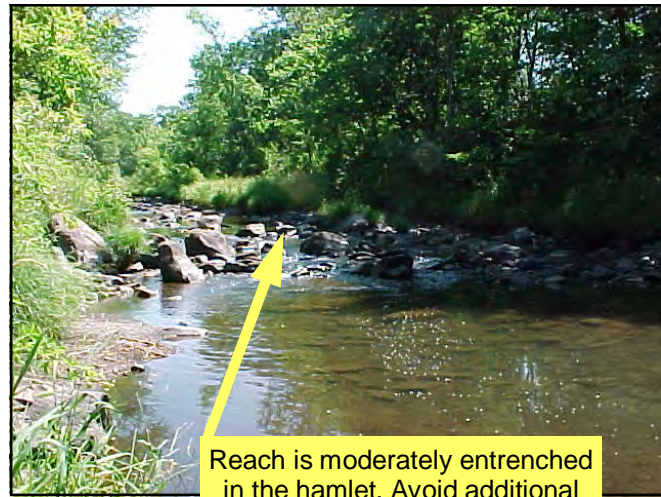
Reach is moderately entrenched in the hamlet. Avoid additional floodplain fills.

As the reach is already constrained by its entrenchment, any future activities should be undertaken so as to avoid fill in the floodplain. The NYSDEC digital flood mapping project for the Schoharie basin will be very useful in conducting additional assessments of flooding risks to the structures located within the hamlet area. A recurring flooding problem associated with an old mill race system located in this reach is being addressed by a GCSWCD and Town of Windham project under the CWC Stormwater Retrofits program.

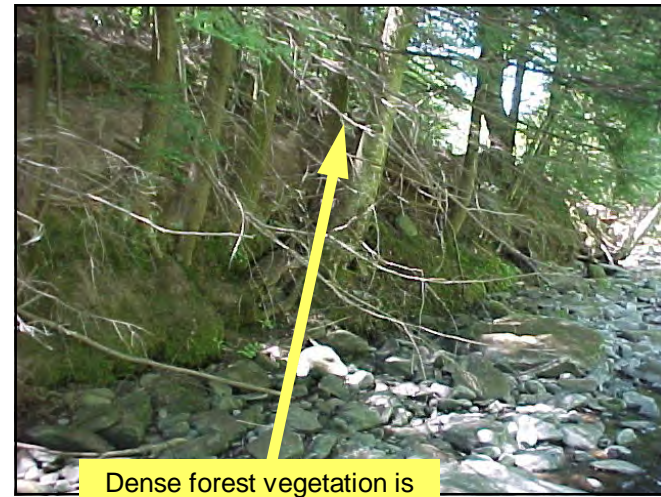
C

Dense forest vegetation is critical to stability of steep slopes along the high terrace

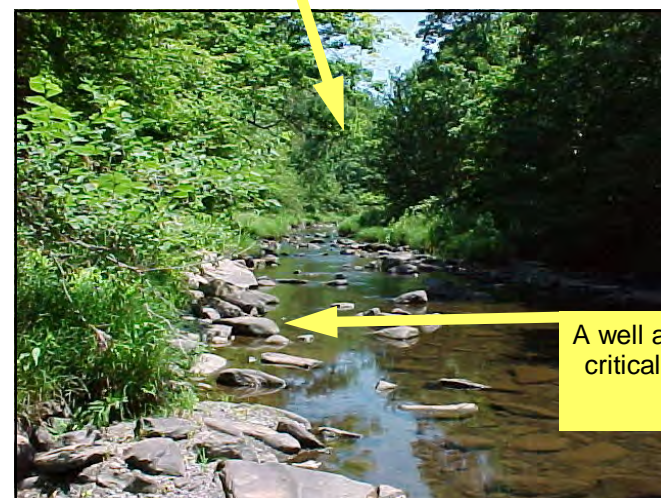
G

A well armored stream bottom is critical to stability. Disturbance must be avoided
