Reach 4b (Valley View Farm to VanEtten Trucking)

Reach 4b is 5,600 feet in length and runs parallel with NYS Route 23 in the Town of Ashland (**Map VI-5**). The reach begins at the Valley View Farm and ends at a point behind VanEtten Trucking. The drainage area of reach 4b ranges from 43.1mi² at Valley View Farm, to 50.8mi² at the bottom of the reach. Tributaries within the reach include the larger North Settlement Creek, as well as one smaller unnamed tributary. The reach is located in Valley Zone 2 (**Figure V-11**) with an average valley slope of 0.3%. The valley morphology is defined by a broad floodplain, with extensive belt width available for stream migration. Multiple river terraces exist along the reach. The upper reach has a steep upland slope on the right bank for approximately 1/3 of its length, but most of the reach is dominated by low floodplain on both sides of the channel. The results of the Phase I Inventory and Assessment (1997) were used to further divide reach 4b into two sub-reaches. Part of this reach was sufficiently unstable and threatening water quality that it was selected in 1998 to serve as a demonstration project reach. See Section VII for a full descr

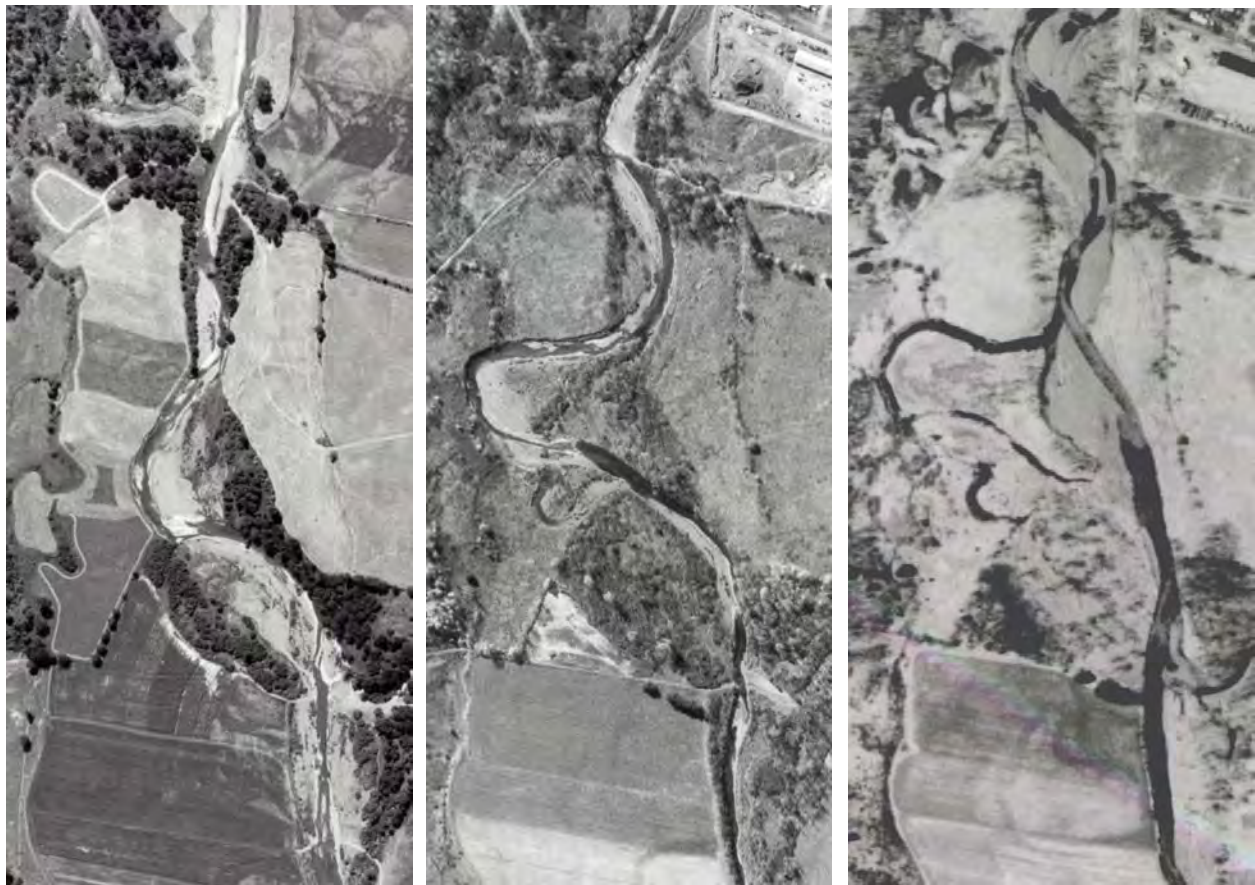
Time series analysis of aerial photographs from 1959 to 2000 confirmed that the lower reach has been experiencing accelerated channel migrations, while the upper section had remained relatively stable (**Figure VI-44**). As shown in the side by side comparison of

aerials from 1959, 1980 and 1997, the lower section of reach 4b has been highly unstable, with evidence of active lateral adjustments present during the entire 40 year period. Extensive channel migration and several channel avulsions have resulted in oxbow cutoff formations in the area downstream of the confluence with North Settlement Creek (**Figure VI-44, right photo**). The analysis of historic channel alignments revealed that over 980 feet of lateral migration had occurred in the lower reach between the years of 1959 and 1997. The presence of these oxbow cutoffs can be distinctly seen in the aerial photographs taken by the GCSWCD in the summer of 1999 (**Figure VI-45**). While this dynamic activity is natural in rivers, GCSWCD held that it was occurring in an accelerated fashion as a result several factors. Because the stream was cutting freshly into clay deposits, it was continually renewing inputs of clay into the Batavia Kill. The Batavia Kill Project as a whole is seeking to determine if water quality can be improved through reducing rates of stream migration to a natural minimum.

Figure VI-44: Historical aerial photograph progression of Brandy Wine site, left to right 1959, 1980, 1997.

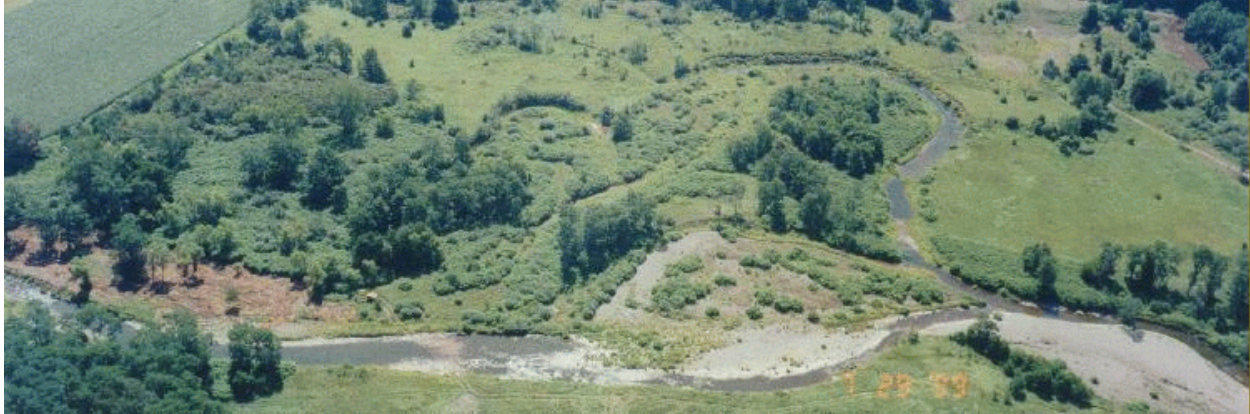
Figure VI-45: July 1999 photograph of oxbow formations present through sections of reach 4b.

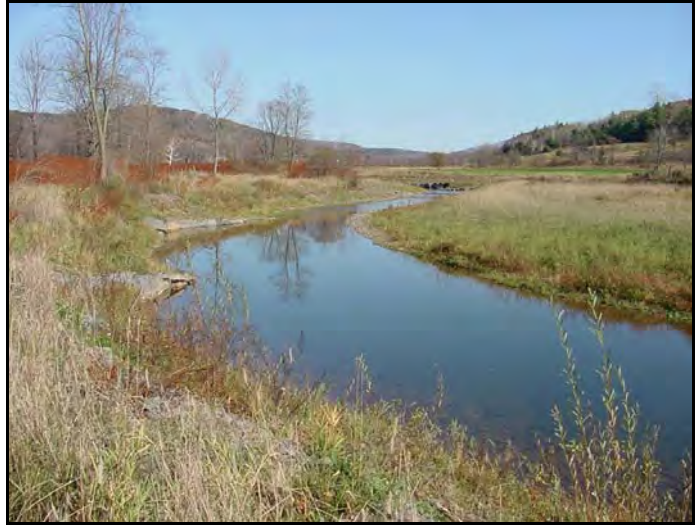
Figure VI-48: View of restored channel looking upstream from behind the Brandywine.

The principal channel process observed was lateral migration related to meander migration. Monitoring between 1997 and 1999 revealed that meanders were eroding as much as 17 feet a year even in the absence of any substantial flows. In 1999, the GCSWCD initiated a restoration project along this reach, and work is ongoing to monitor the project and establish an effective riparian buffer (**Figure VI-48**).

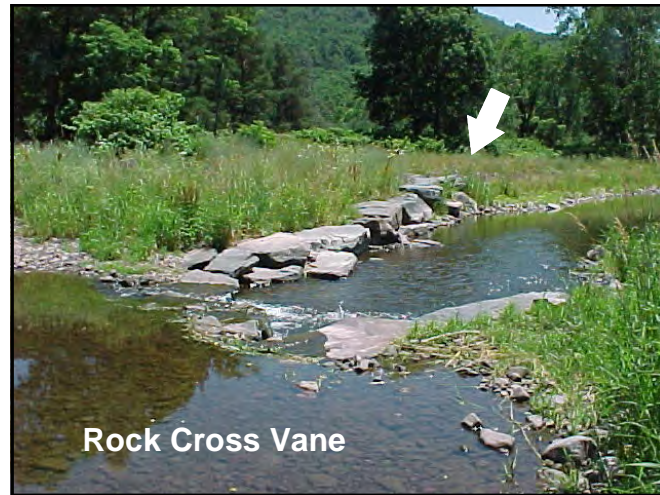
B

Rock Cross Vane

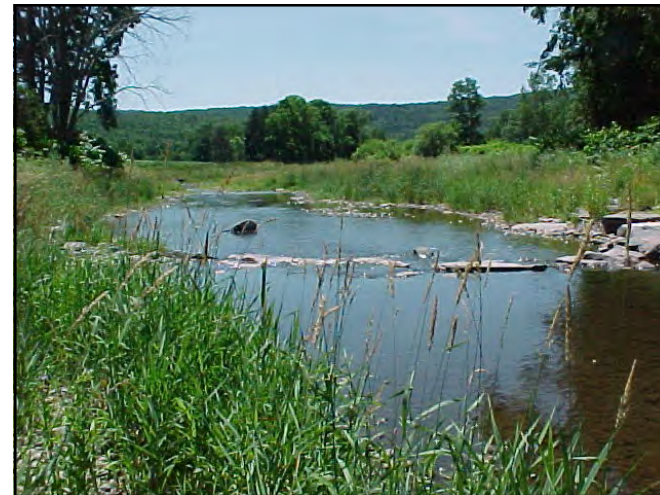
C

Rock Vane on Left Bank

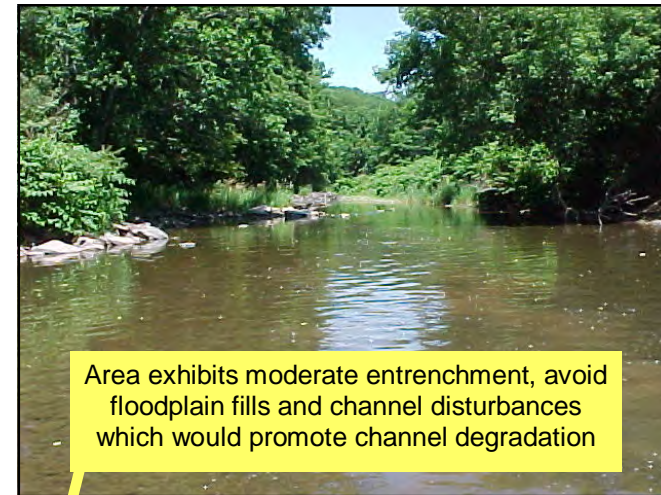
D

Area exhibits moderate entrenchment, avoid floodplain fills and channel disturbances which would promote channel degradation

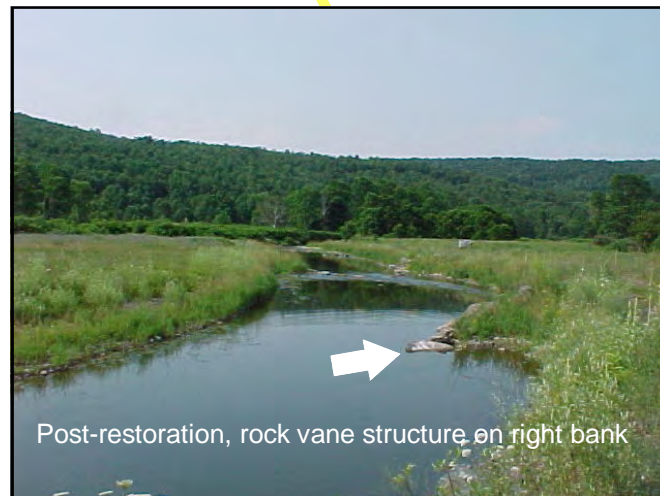
F

Post-restoration, rock vane structure on right bank
