Reach 4d (County Route 17 to Maier Farm Bridge)

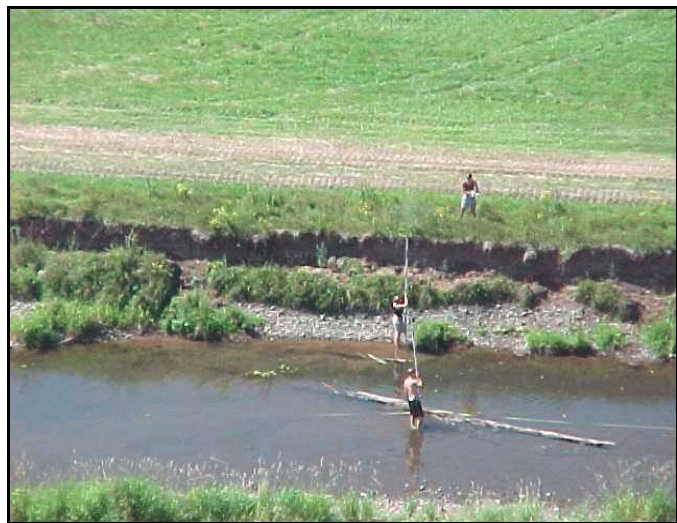
The Phase I Inventory and Assessment conducted in 1997 revealed significant signs of instability in reach 4d, with active streambank erosion noted in the lower end of the reach. The inventory of stream conditions found the section of stream through the Maier Farm property was experiencing adjustments in its meander pattern, with extensive slumping of the banks (**Figure IV-54**).

Figure VI-54: Eroding streambank on Maier Farm property prior to restoration.

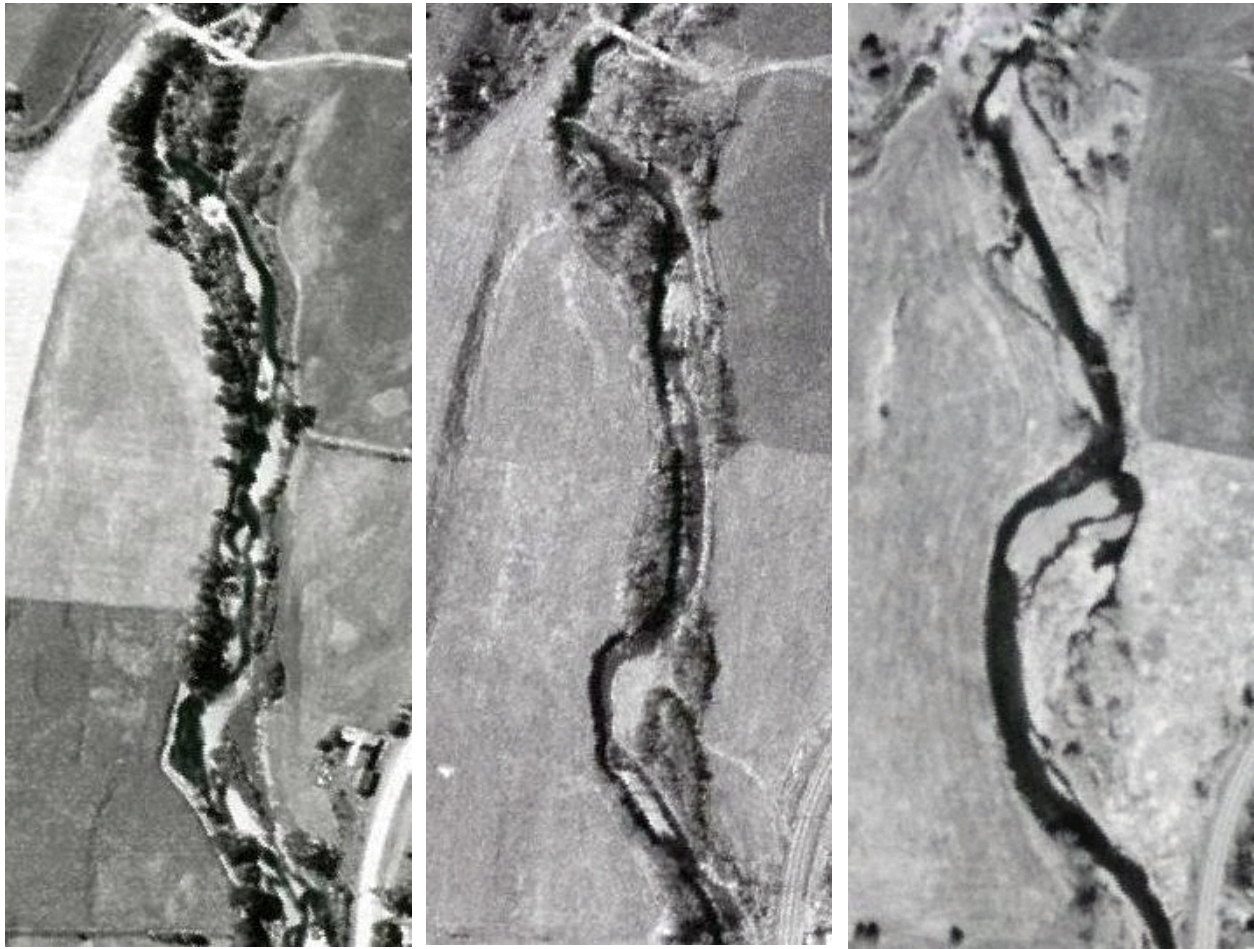
Figure VI-55: Aerial comparison of reach 4d from 1959 (left) 1980 (center) and 1995 (right).

protection law). As seen in the 1959 aerial photo (**Figure VI-55, left**), most of the reach is actively being farmed and the channel planform is much straighter than would be expected for the given valley conditions. Over the past 20 years or more, as agricultural uses have declined and in-stream activities became less frequent, the reach has been attempting to establish a more sinuous form.

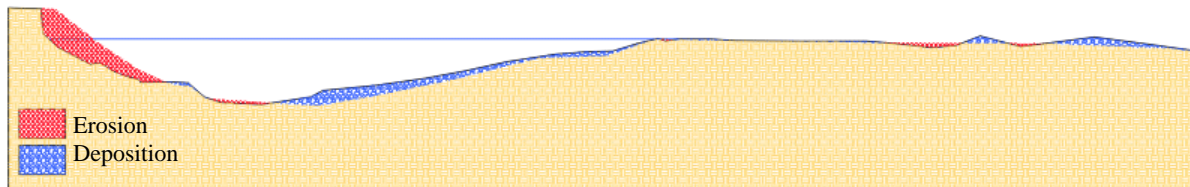
Cross section #1 was located at a point where the stream was meandering to the south (left bank), approximately 50 yards below the end of the rip-rap at NYS Route 23. As shown in **Figure VI-56**, analysis of changes at the cross section over the two year monitoring period indicated that lateral migration of the channel had exceeded eight feet, with 32 ft² of erosion on the south bank. Deposition on the opposite bank of a similar volume to that lost appeared to indicate that the width to depth ratio was not substantially changed during the monitoring period and the channel was not over widening in this area. The cross section also did not indicate any signs of channel degradation.

Figure VI-56: Overlay of Maier Farm cross section #1, 1997 - 1999 (looking downstream).

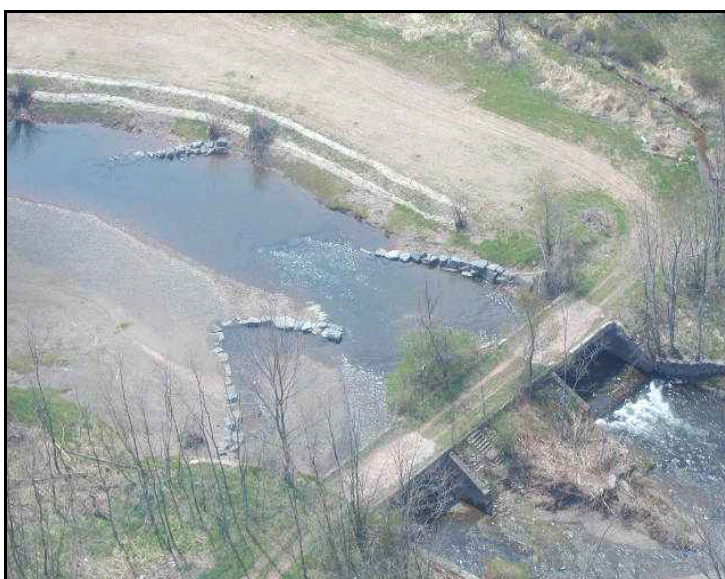
A major factor impacting stream stability on reach 4d is the private bridge at the bottom of the reach. The bridge is thought to pre-date 1900, and at one time contained two long wing walls extending upstream. Old photos owned by the current landowners show that the bridge structure once contained a system of flash boards that were used to close off the bridge openings to create a pool upstream of the bridge. During the days when the Maier Farm was operated as a summer boarding house the temporary lake was used for swimming and fishing. While it appears that the flash board system had not been used for 60 years or more, temporary damming of the stream would have flattened the local stream slope, reduced sediment transport through the reach, and resulted in aggradation of the channel.

Figure VI-58: View of private bridge on Maier Farm post restoration work. Note the two openings with the large, solid center section.

First, a rock structure called a W-weir (**Figure VI-58**) was placed just upstream of the bridge, and was designed to manipulate the flow through each side of the bridge. The w-weir was placed such that under low flow conditions, all flows were directed through the left bridge cell which was in the best shape. As the stream stage rises, and approaches the half bankfull elevation, the W-weir deflects increasing flow through the right side of the bridge opening. The W-weir was also placed so that the expected downstream deposition at the center point in the weir would develop in front of the undermined bridge abutments. The

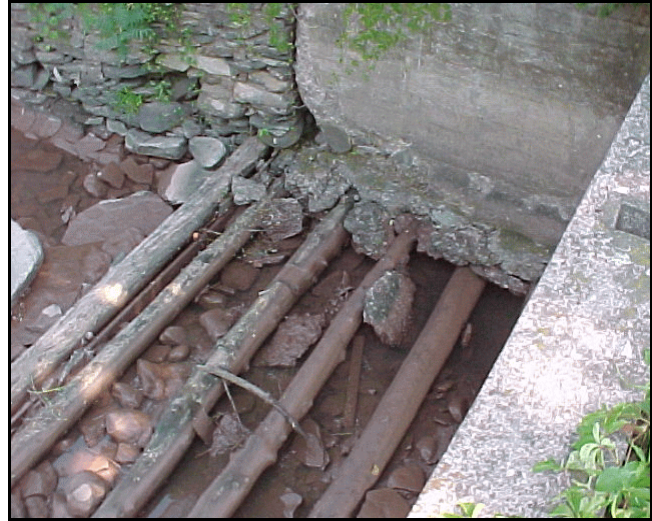
At the time of the GCSWCD's assessment of reach 4d, it was noted that the bridge was in an extreme state of disrepair. The bridge is characterized by two hydraulic openings on either side of the stream, with a large center pier made up of rock and fill that traps large woody debris being carried through the reach (**Figure VI-58**). The structure has suffered extensive damage, presumably caused by debris blockages, abutment scour, channel migration and weathering. Horizontal and vertical cracks several inches in width were noted along the abutments and the invert (bottom) of the bridge openings have been essentially stripped of their concrete covering (**Figure VI-59**). The GCSWCD also noted extensive scour under the concrete abutments, and in certain locations a survey rod could be inserted over 12 feet under the abutment.

Figure VI-59: Invert of right bridge opening. The hemlock logs had been covered by concrete.

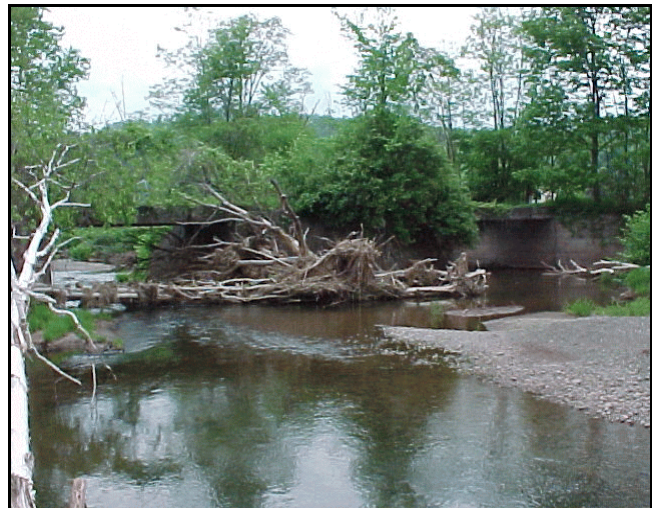
At the time of the Phase I Inventory and Assessment, the GCSWCD observed debris trapped by the center pier of the bridge (**Figure IV-60**). The debris was lodged on the center pier, resulting in blockage of the left opening. It was also noted that the debris was causing localized divergence of stream flow and scour. While some of the debris was fresh, most likely from the 1996 flood, it was obvious that the structure presented a significant obstacle and was frequently impacted by debris.

Figure VI-60: View looking downstream of debris at Maier Farm bridge.

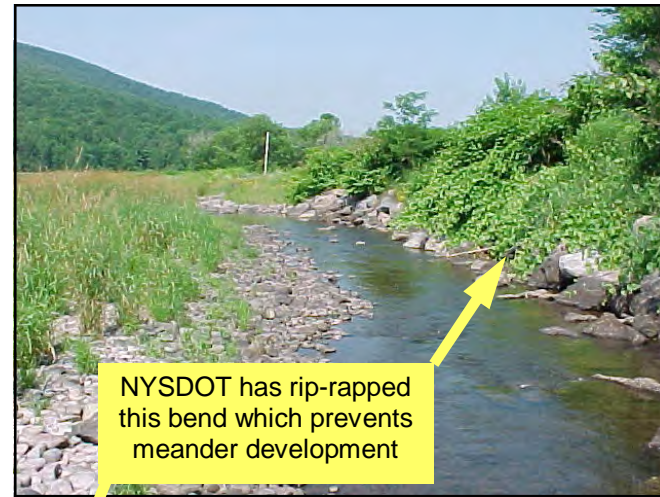
C

NYS DOT has rip-rapped this bend which prevents meander development

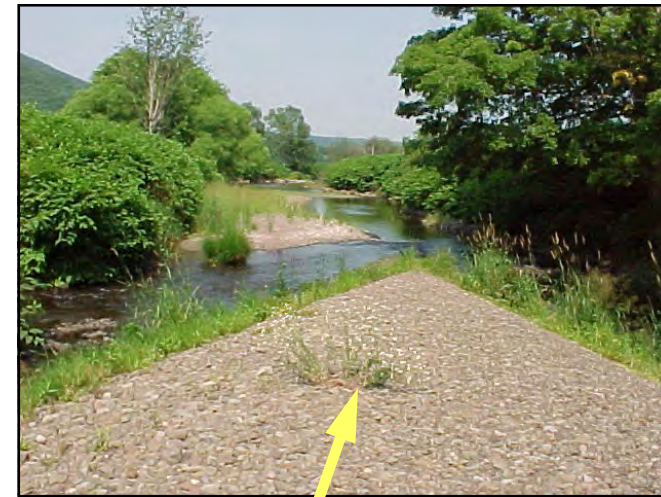
D

In addition to the primary instability noted in the lower end of the reach, the GCSWCD has been observing a small depositional feature located just below the County Route 17 bridge (**Figure VI-61, photo,D,H**). In 1997, the GCSWCD noted the presence of a small, low depositional feature in the center of the channel. This central bar appeared to be stable, with much of it covered in dense sod. In recent years, the GCSWCD has observed an increase in fresh deposition on the bar, and it appears to be getting higher. The GCSWCD has also noted that the streambanks in the immediate area have been showing signs of increased scour on both sides of the deposition area. This would be a typical response when mid-channel deposition features deflect stream velocities against the streambanks. The GCSWCD does not currently have any monitoring cross sections in this section but continues to make routine observations of the channel condition. Further assessment of this section of the reach will be completed in association with future restoration work planned for reach 4c above.

The GCSWCD is monitoring central bar development in this area

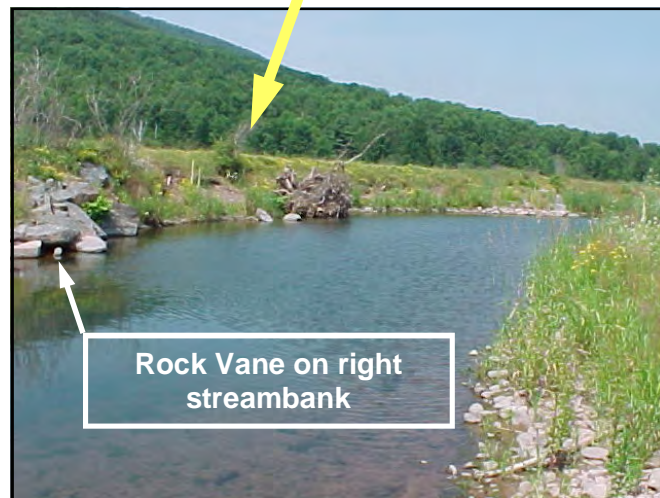
F

Rock Vane on right streambank

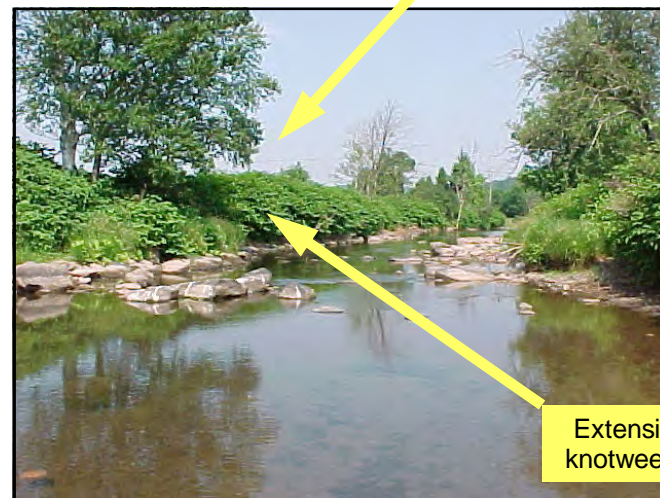
G

Extensive patches of Japanese knotweed are found in this reach
