Reach 5a (Vogiatz to Kane Bridge)

Reach 5a Summary

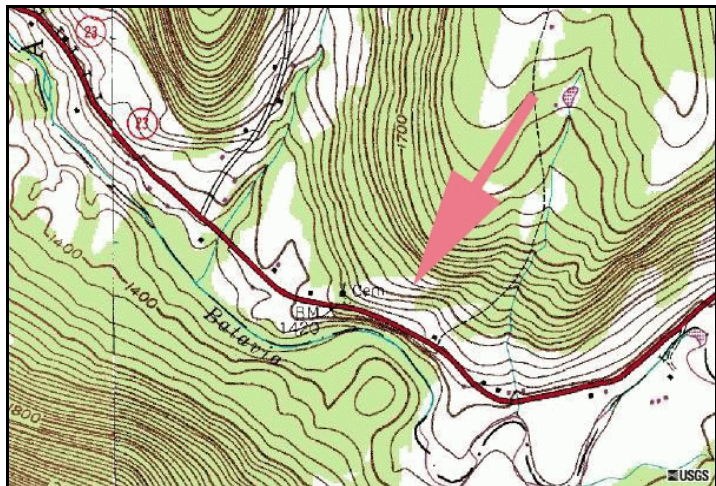
At the very top of the reach, the stream channel is highly entrenched due to a large terminal *moraine* across the valley floor (**Figure VI-80**). The *moraine* is located on a narrow point in the valley, and there is very limited *beltwidth* available to the stream. In this area, the valley floor is often 200 feet or less in width. While NY Route 23 runs adjacent to the stream, it does not appear that the road right-of-way is impacting the stream. Overall, this section of the reach appears to be highly stable, with a well vegetated riparian area and a well armored stream bottom (**Figure VI-82a photo C,D,E,I**).

Figure VI-80: Valley morphology at the head of reach 5a strongly impacts channel entrenchment and sinuosity.

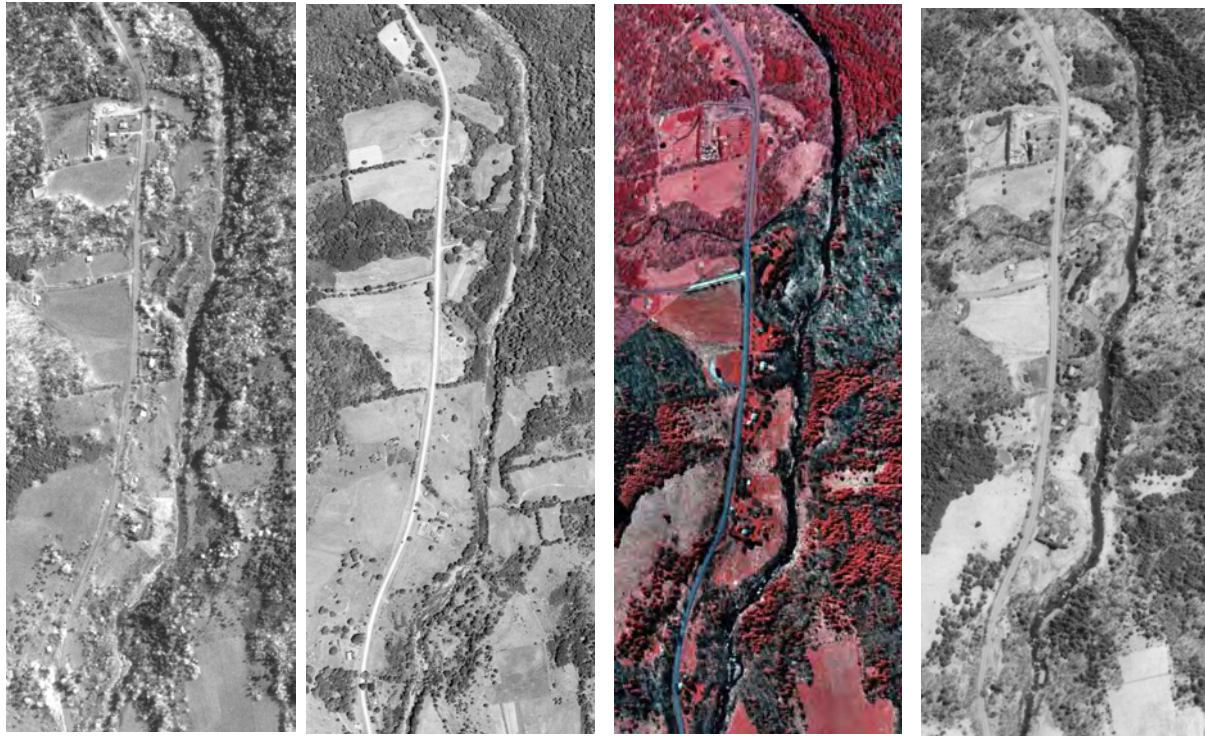
Analysis of historical aerial photographs indicates that the reach has a fairly stable planform, with only minimal changes observed between 1959 and present (**Figure VI-81**). The photographs do indicate some increase in sinuosity in the lower end of the reach, but for the most part valley morphology provides limited opportunity for planform adjustments. While sinuosity would typically be lower due to the steeper valley slope, the aerials clearly

indicate the almost complete lack of meandering through the reach.

Figure VI-81: Comparison of reach 5a planform from 1959, 1967, 1995, 1997 (left to right)

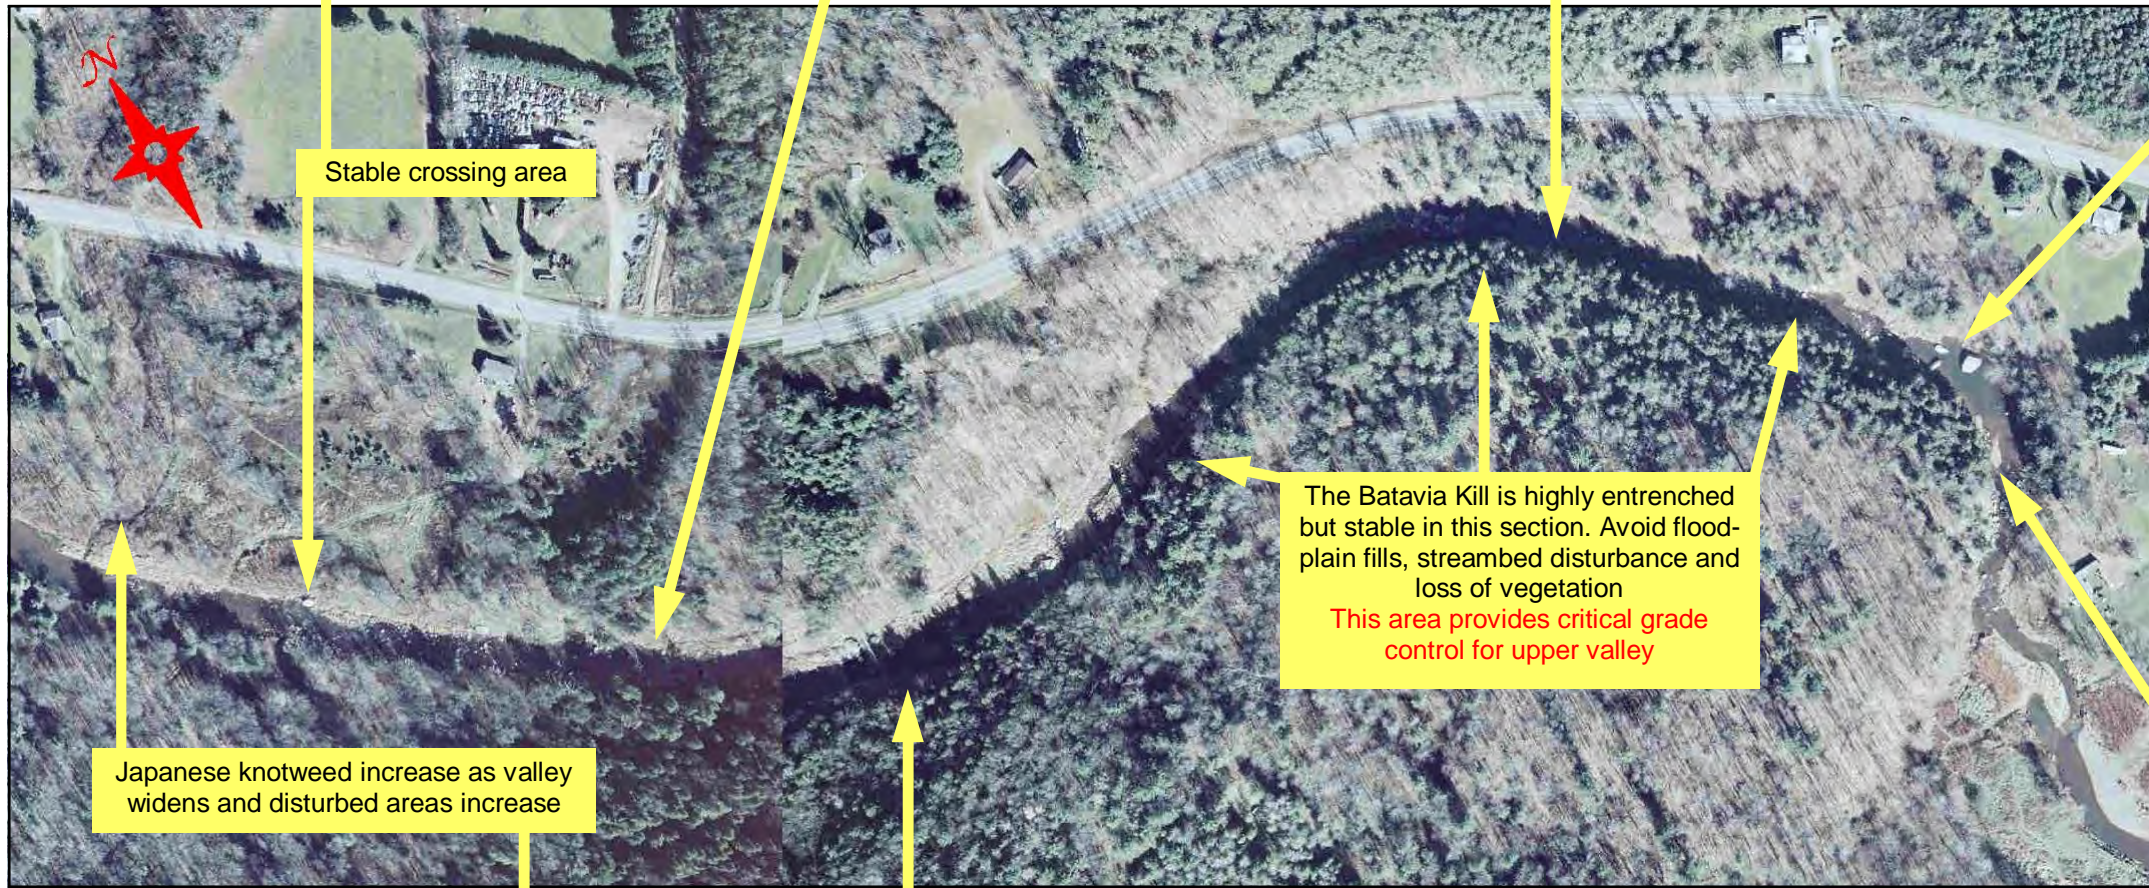
Stable crossing area

The Batavia Kill is highly entrenched but stable in this section. Avoid flood-plain fills, streambed disturbance and loss of vegetation
This area provides critical grade control for upper valley

Streambed materials coarsen as the Batavia Kill slope increases. Well armored stream channel greatly increases stability

Riparian buffer with woody vegetation is a primary factor in stable conditions in Upper reach 5a

Japanese knotweed increase as valley widens and disturbed areas increase

Upper reach 5a is very stable, streambed armor and riparian vegetation are both critical

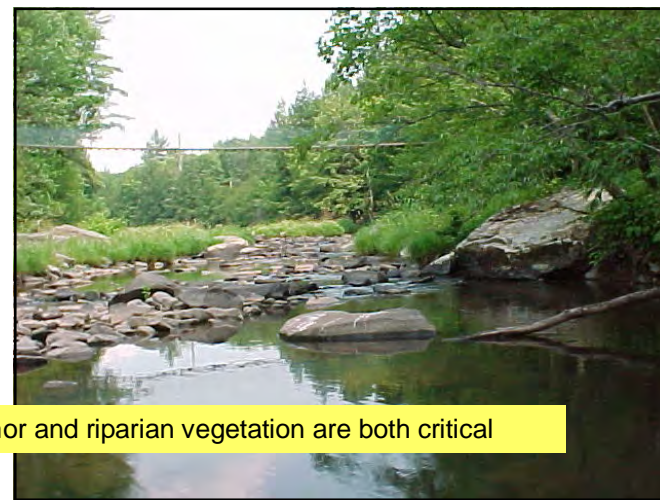
H

Infrastructure in the reach is limited to a swinging foot bridge in the upper portion of the reach, and a private bridge at the bottom of the reach. The swinging foot bridge (**Figure VI-82a photo H**) is located fairly high over the stream channel, and does not appear to have any problem passing floatable debris. The private bridge at the Kane residence is fairly new construction, and it does not appear to be having an impact on stream stability (**Figure VI-82b photo A**). The bridge is tied into the high terrace elevation on the left bank, and on the right bank, minimal fill at the bridge approach has not significantly reduced floodplain capacity. The bridge experienced minor erosion during the September 1999 flood event, but this is to be expected.

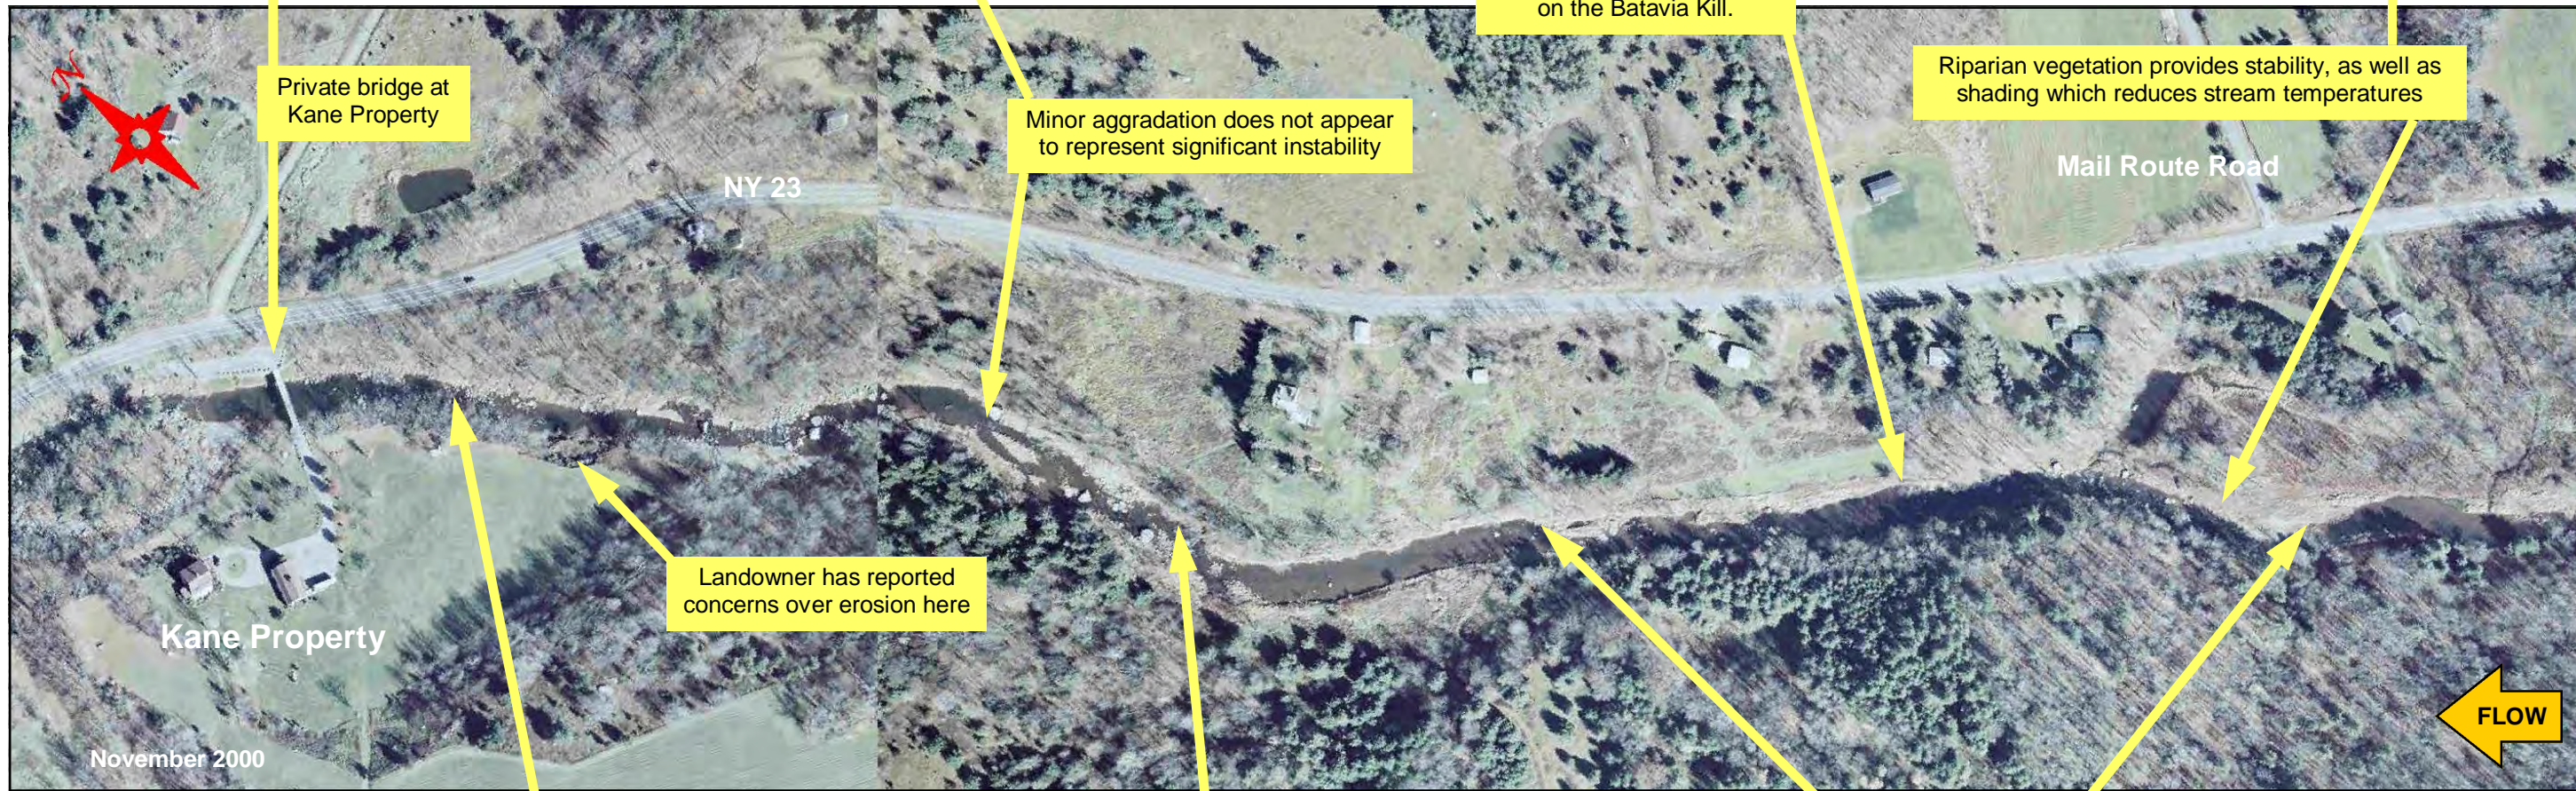
Figure VI-80a: Reach 5a-Lower

Reach 5a is characterized as very stable due to well armored streambed and the presence of dense riparian vegetation
