Reach 5c (Red Falls to below Conine)

Reach 5c begins at Red Falls and continues downstream approximately 2,500 feet to a point just below the Conine farmstead (**Map VI-6**). The reach is located entirely in the Town of Prattsville, and is referred to as the “Conine” site. Drainage area ranges from 68.6mi² at Red Falls, to 71.2 mi² at the bottom of the reach. One larger tributary enters the Batavia Kill at the top of the reach, and drains the sub-basin along Dent Road and County Route 4. The reach is located in Valley Zone I (**Figure V-11**), which has an average valley slope of 1.2%. The valley morphology is characterized by a narrow valley with lateral and terminal moraines, alluvial terraces, and narrow floodplains. These characteristics result in a moderately entrenched stream channel through portions of the reach. A low channel sinuosity results from the narrow valley and a moderately steep valley slope.

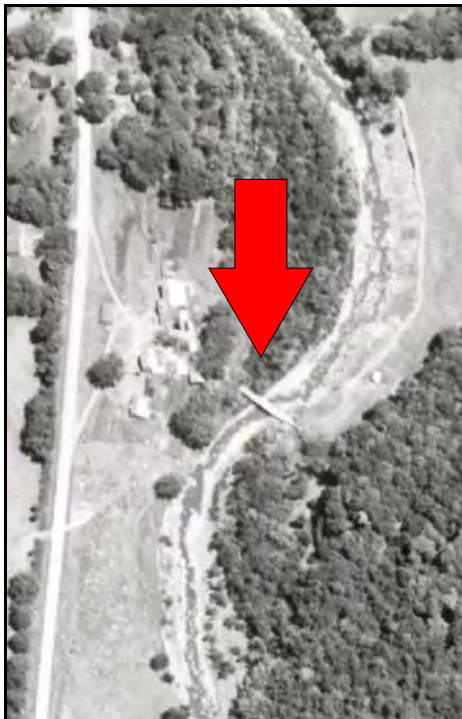
Figure IV-91: 1959 planform in area behind Conine Farm. Planform is stable.

As seen in **Figure IV-91**, in 1959 a private bridge crossed the stream on the Conine Farm. The bridge is still present in 1967, but by the 1980 aeriels, the bridge is gone and the reach has experienced lateral migration on the right bank. In 1995, the planform is rapidly changing (**Figure VI-92**) and the reach is starting to experience severe instability. The channel has divided into 2 main threads and is showing signs of further braiding in some locations.

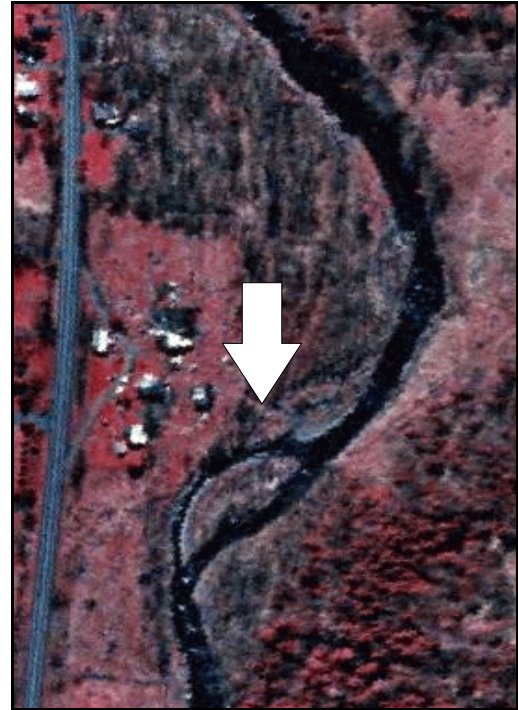
Figure VI-92: 1995 aerial of lower end of reach 5c. Note split channel in location of former bridge.

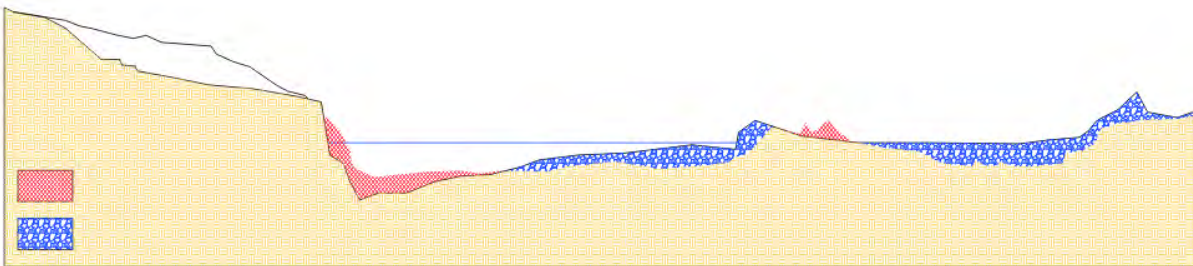
The bank erosion and slope failure are well represented by cross section #7, which is located just behind the Conine farmstead (**Figure VI-93**). As shown by the cross section below, the channel has aggraded on the right and eroded the left bank. The monitoring also detected the changes associated with the geo-technical slope failure. The non-hatched area on the top of the left bank representing a scarp (a fracture on the earth's surface into which water can flow and that eventually can break off and fall or slump) that had developed above the bank. The distance between the line and yellow hatched area is represents the height of the slippage.

Figure VI-93: Monitoring of a cross section behind the Conine Farm has revealed multiple stability problems, including aggradation, lateral erosion and geo-technical slope failure between 1998 and 2000.

It is interesting to note that the soil that has slid towards the channel due to the geotechnical failure, was been quickly eroded away, setting an ideal condition for accelerating the slope failure. As the stream flows down the valley, the high slopes on the left bank moderate and the channel is bounded by a narrow, low terrace (**Figure VI-96 photo F**). As noted in **Figure VI-94**, the right hand channel has become almost completely filled, and lateral erosion is still occurring on the left bank. Note that the left bank height has been greatly reduced.

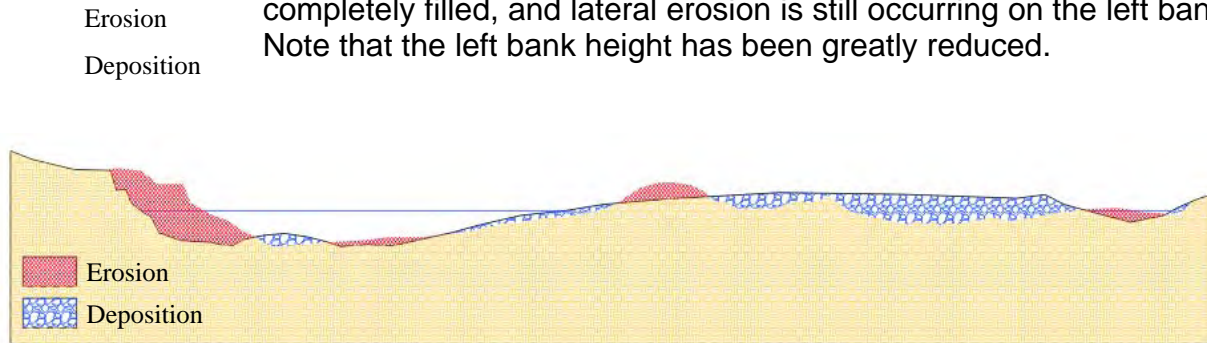
Figure VI-94: Monitoring at cross section #8 between 1998-2000. Right channel has completely aggraded and the left bank continues to experience lateral erosion of the low terrace.

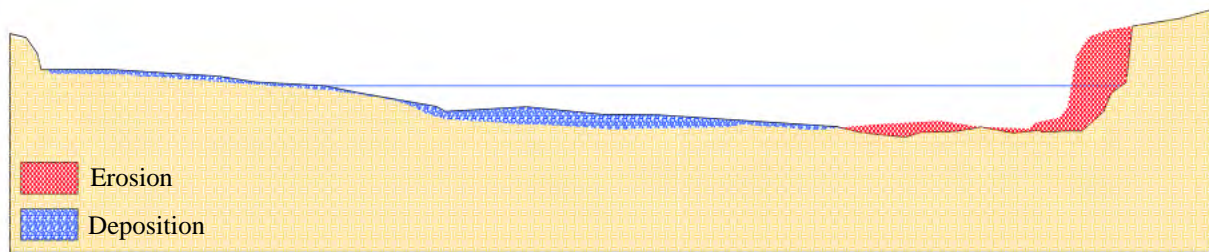
At the bottom of the reach, the stream meanders back across the narrow valley floor, with significant erosion located on the right bank (**Figure VI-95**). The channel has returned to a single thread, and it appears to be attempting to increase sinuosity and rebuild a floodplain on the left bank.

Figure VI-95: At the bottom of reach 5c, the stream is running along a high terrace on the north side of the valley, with significant erosion and aggradation of the channel. 1998 - 2000.

The GCSWCD did not note any current flooding issues in reach 5c. The biggest impact from flooding is property damage associated with eroding streambanks. At the lower end of the reach, a home with several out buildings is located on the high terrace which runs along the right bank. Geo-technical slope failure (**Figure VI-96 photo A**) in the area behind the home has a high probability of extending, and threatening the property. Extreme flood events, coupled with the high degree of instability exhibited by the stream channel, can be expected to accelerate this problem.

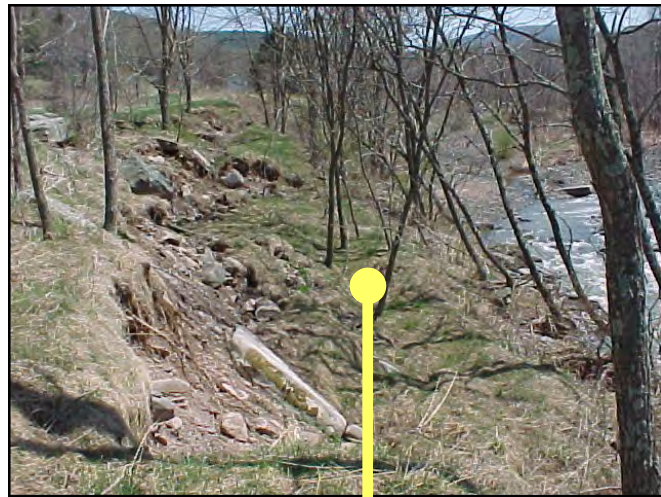
A

Continuing down the reach, the Batavia Kill meanders against the south side of the valley floor, running along the downstream limits of the moraine discussed in reach 5b. In this area, the channel has been gradually widening, and developed a split channel. The high slopes on the left streambank have been experiencing fairly high rates of erosion, as well as geo-technical failure. The widening process has diverted velocities against the exposed banks (**Figure VI-96 photo F**), and an extensive slope failure extends several hundred yards up the slope. Extensive failure scarps can be found over 100 feet above the streambed elevation located quite a distance up the slope (**Figure VI-96 photo A,G**).

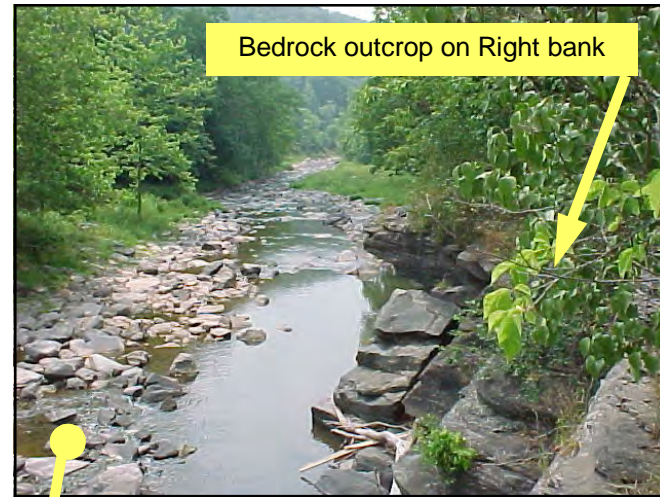
C

assessment. The right bank just below Red Falls has significant protection provided by rock rip-rap both above and below the confluence of the Dent Road tributary, and exposed bedrock ledges (**Figure VI-96 photo C,I**). Stability is assisted by the presence of a narrow floodplain on the opposite bank, which effectively reduces channel entrenchment (**Figure VI-96 photo C,D,I**). Stream type in the upper portion of the reach is predominately C3, with short isolated sections of F3 stream associated with localized stream confinement. The GCSWCD has been monitoring 3 cross sections at the top of the reach, and has observed only minimal erosion.

Bedrock outcrop on Right bank

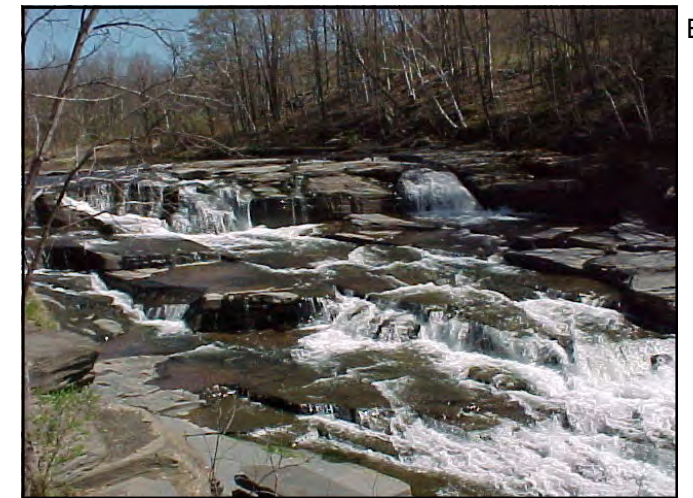
E

Bedrock exposures such as those at "Red Falls", provides grade control, and allows for stable transition in slope.

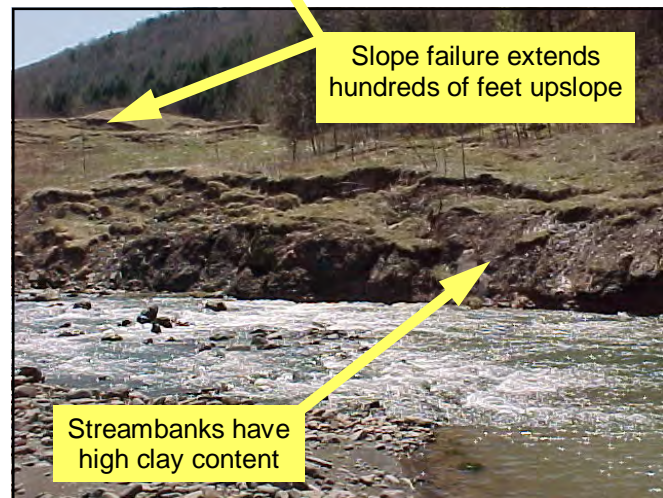
G

Slope failure extends hundreds of feet upslope

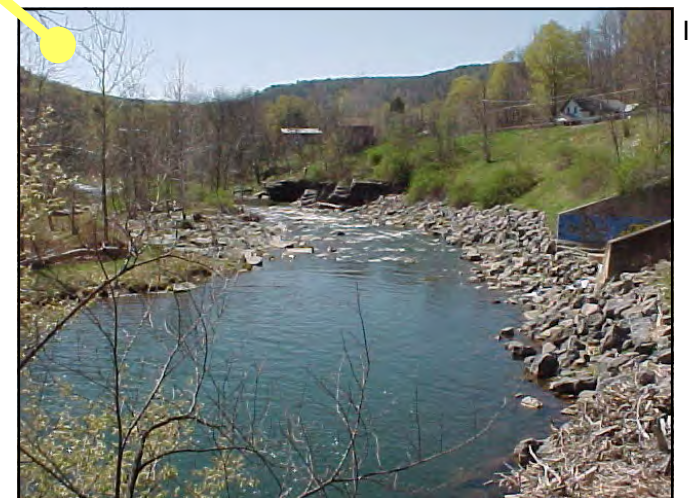
I

While the first 1500 feet of the reach appear to have fair habitat value, the center and lower end of the reach are unstable. Rapid changes in streambed structure, channel aggradation and the lack of riparian vegetation are all factors that would be expected to negatively impact habitat. The culvert that carries the Dent Road tributary under NY Route 23 also appears to present a significant barrier to fisheries access. The culvert invert is located a significant distance above the stream (**Figure VI-96 photo I**), preventing access to the tributary.
