Rondout Creek Management Unit 6

Management Unit 6
Between Station 9,600 and Station 16,300

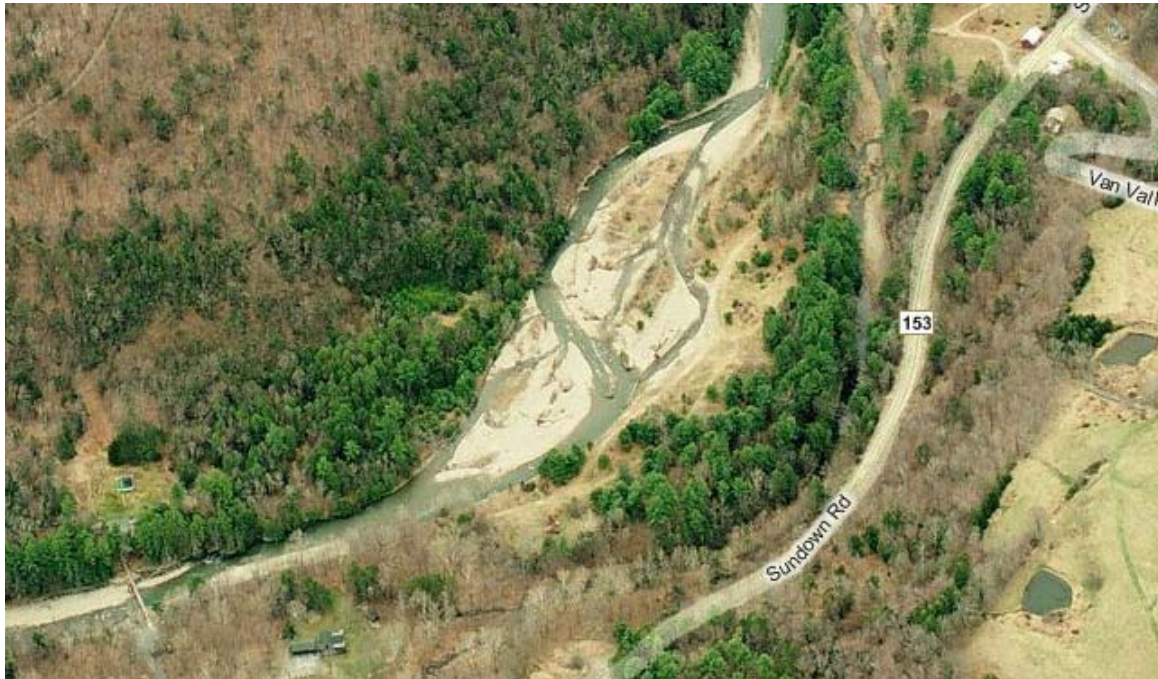
Beginning around Stn 15600, bed aggradation is evident and the bankfull channel becomes overly wide for approximately 1200 ft. (Fig. 4), becoming four times wider at its broadest point. Numerous stream disturbance permits have been issued for work in this section of stream, and mining from gravel bars likely occurred here historically. Braided channels often result from overwidened channels, where depths are reduced and

Figure 4 Braided channels in upper MU6

Recommendations for this site include *full restoration*, to be preceded by an assessment of hydraulics, sediment transport dynamics and channel morphology, to determine. Ideally this work would be done in conjunction with assessments needed to do similar work at the bottom of MU6. A single, narrower channel thread should be reestablished that effectively conveys sediment, and *bioengineering treatments* should be installed on the channel banks and floodplain to increase their resistance to erosion.

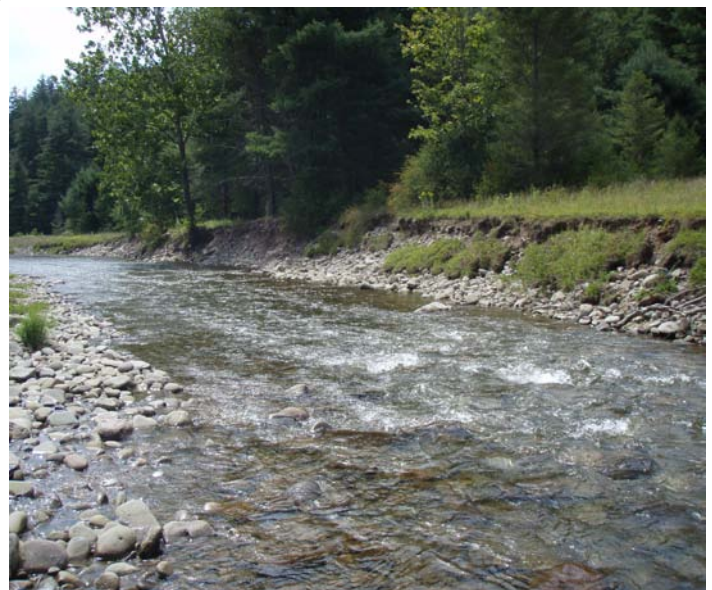
Where they can, aggrading, braided and shifting channels often erode into adjacent floodplains where the streambank lacks mature woody vegetation and the strength provided by its dense root mass (see Fig. 5). This is occurring on the right bank from Station 15600 to Station 15250.

Figure 5 Erosion resulting from channel shifting

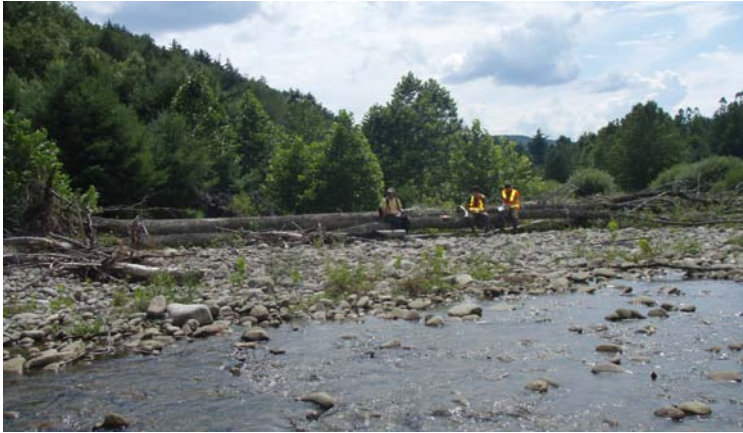
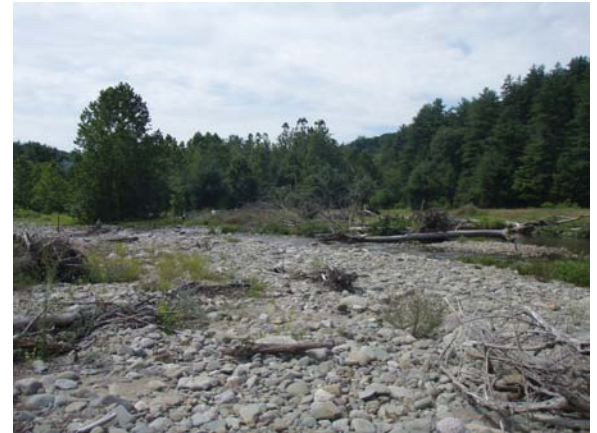
Over-widened, aggrading reaches tend to accumulate woody debris as well as bedload, slowing water velocities and further reducing the ability of the channel to transport sediment (see Fig. 6).

Figure 6 Woody debris accumulated on mid-channel bars in MU6

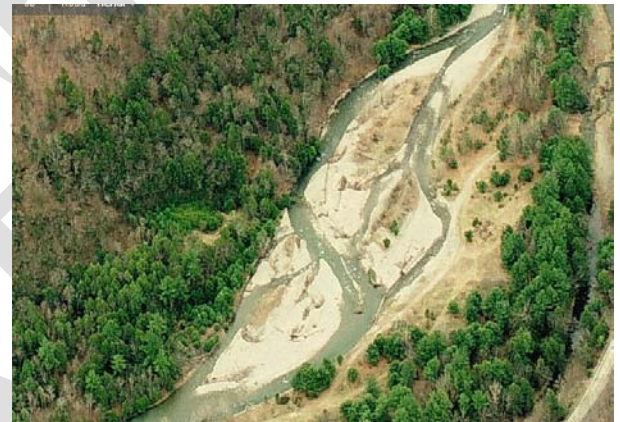
Figure 7 Potential restoration site

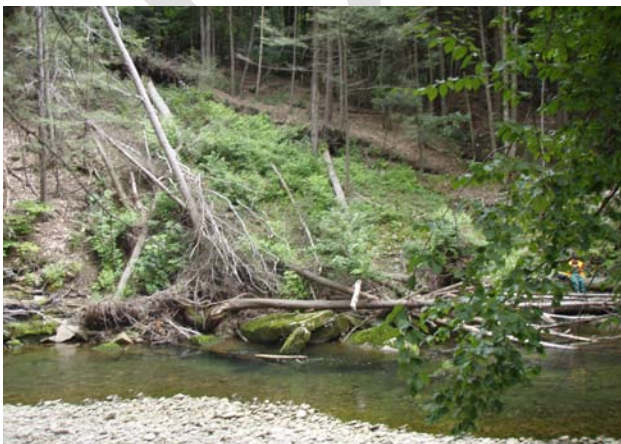
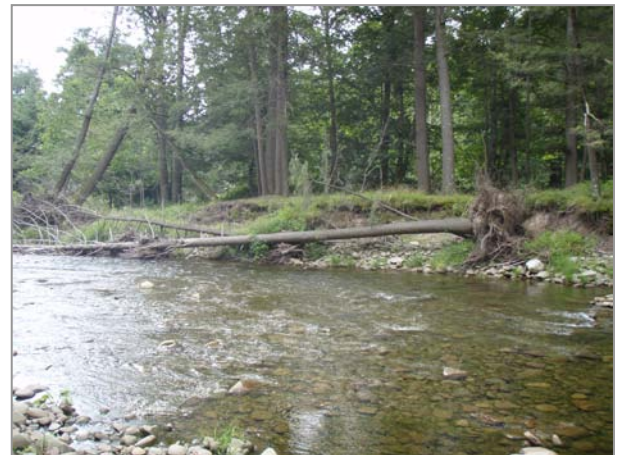
Continuing downstream, the aggraded section ends in a *headcut* around Station 14300, and then the bankfull channel narrows again for approximately 2500 ft., with intermittent berms (400 ft.) and bedrock ledge on the left, and two revetment placements (totaling approximately 1000 ft., varying in functional condition) on the right. These conditions improve the sediment transport capacity of the reach. However, a landslide on the left is bringing down some mature trees at Station 13600, and the right bank is experiencing moderate erosion near Station 13100, which is also introducing large woody material into the stream.

Figure 8 Left bank, mass wasting over bedrock toe; right bank, bank erosion introducing large pines into channel

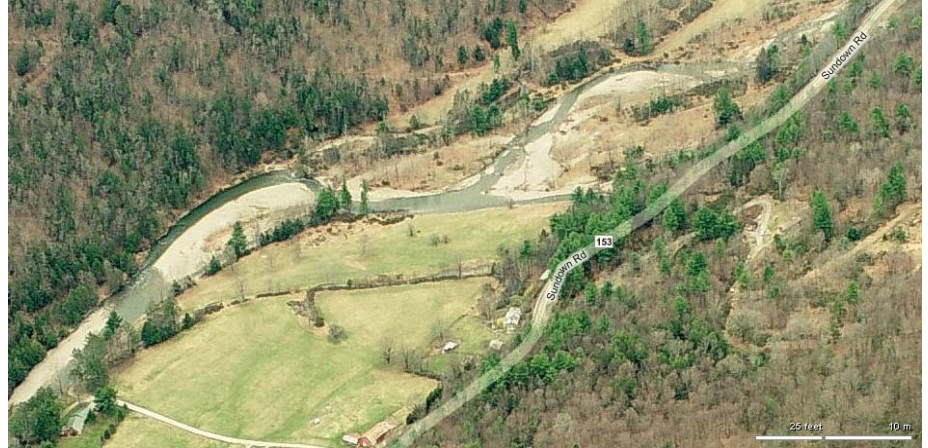
At this point the channel begins to widen again, and for the remaining 3000 ft. of channel in MU6, the reach is aggrading, again producing braided, shifting channels and mid-channel bars (Fig. 9), approximately 135 ft. of bank erosion at a hayfield (Fig. 10) and numerous occurrences of large woody debris (Fig. 11).

Figure 9 Aggradation and braided channels at the bottom of MU6

Full restoration is recommended for this lower reach (Station 12000 to 9600). A primary channel should be designed to effectively convey sediment supplied from upstream; side channels should be left connected at their downstream end to serve as backwater habitats, but channel blocks installed at the upstream ends (including the channel threatening the road embankment); bioengineering practices should be installed along the eroding hayfield and at the road embankment, using locally harvested vegetation (willow, sycamore and sedge spp.). This site has been prioritized by stakeholders as a high priority for property protection, public safety and water quality considerations, and has been nominated as a demonstration project to serve as a training site for best stream management practices. See Section 6 for a more detailed description of the proposed demonstration project.

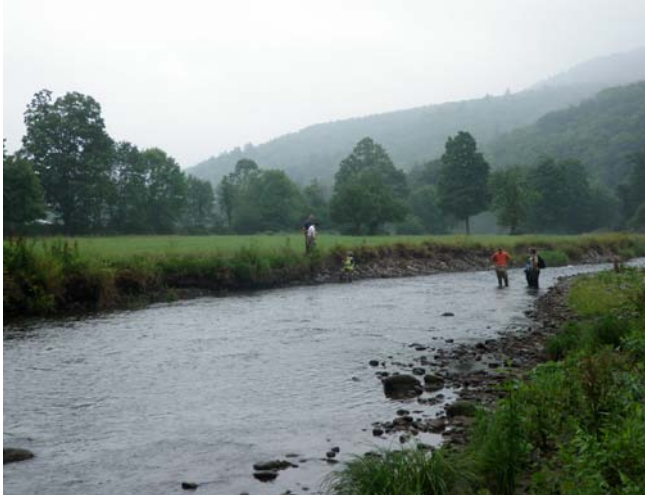
Figure 10 Erosion at hayfield along the right bank

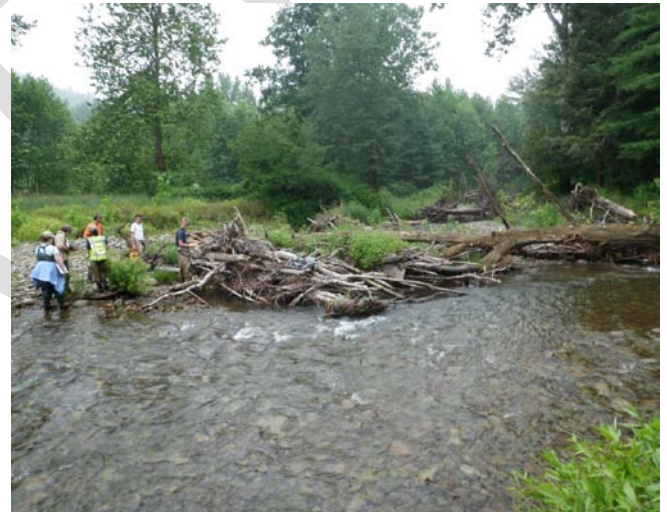
Figure 11 Large woody debris jam, diverting streamflow

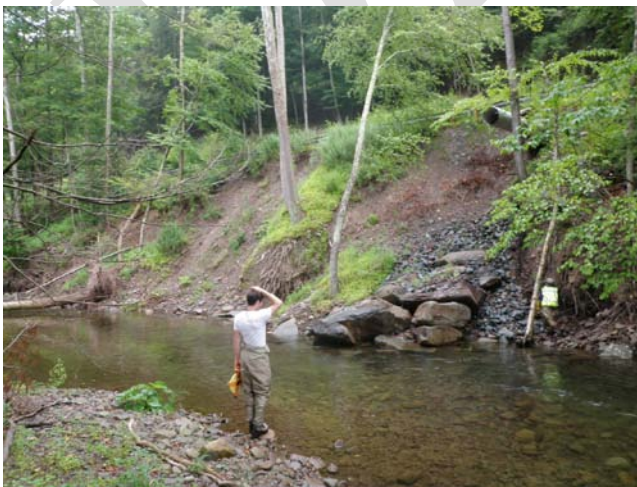
Figure 12 Erosion of embankment along Sundown Rd.

One of the channel threads is capturing increased flows, directing them to the right, and eroding a large glacial till embankment adjacent to Sundown Road (Fig.12), at Station 10500. The erosion has left a piped outfall carrying road drainage cantilevered over dumped rock, which provides some outfall protection. This channel also receives a small spring seep running along the road embankment from upvalley. The embankment is severely threatened, and the fine sediment in the bank represents a water quality concern.

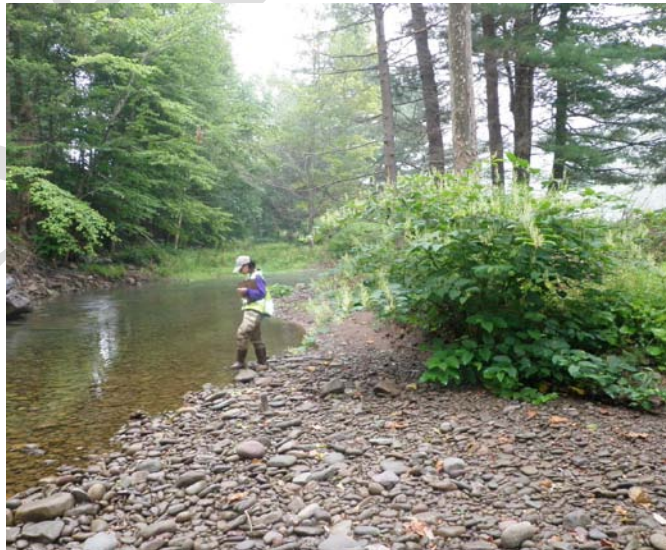
Figure 14 Japanese knotweed stand, at right, an undesirable invasive plant
