Rondout Creek Management Unit 8

Management Unit 8
Between Station 18,500 and Station 22,300

Management Unit Description

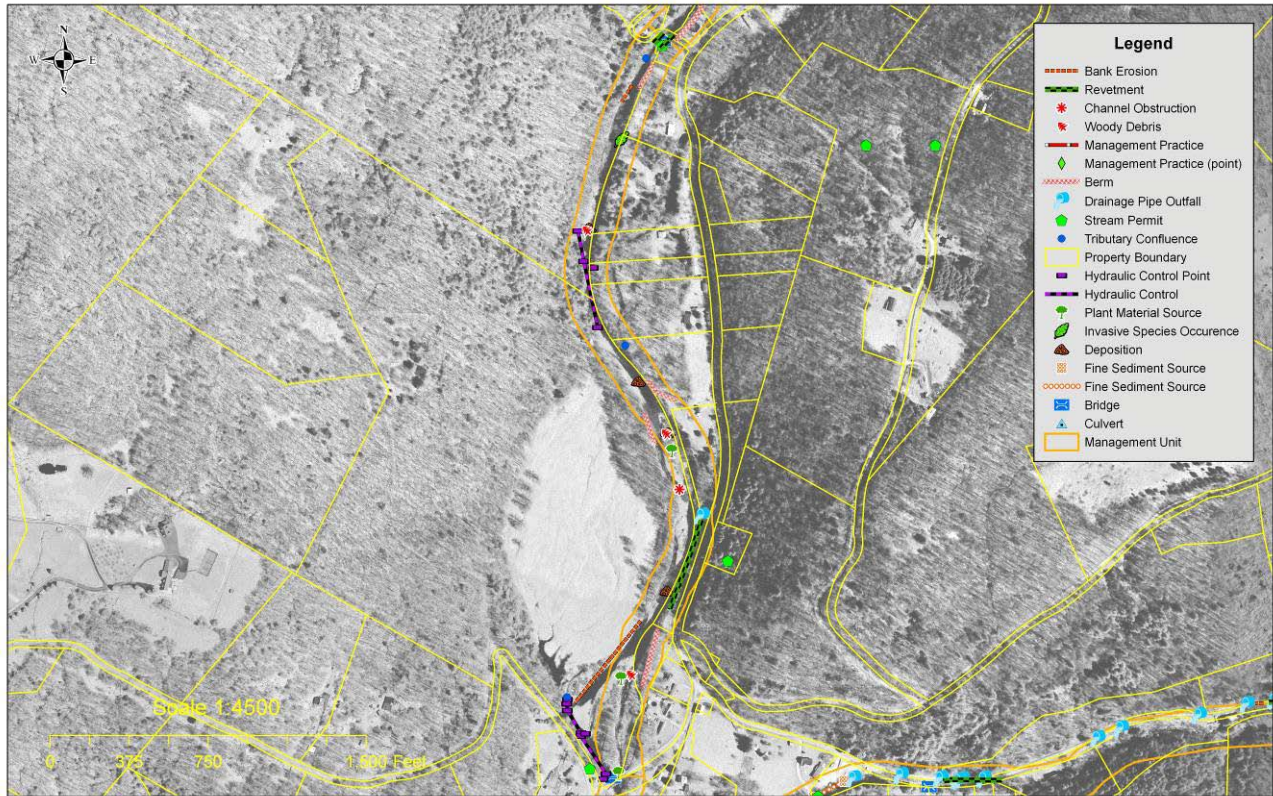
Figure 1 Management Unit 8 Stream feature inventory

The 2008 stream feature inventory revealed that 8 % (593 ft.) of the stream length exhibited signs of active erosion along 3,815 ft. of total channel length (Fig. 1). Revetment has been installed on approximately 7.3 % (556 ft.) of the stream length, associated with the Balace Rd. bridge and the road embankment at Ulster County Rte. 42. At the time of the stream feature inventory 9.2% of the stream banks had been bermed. Bank erosion was occurring on 8 % (593 ft.) of the stream.

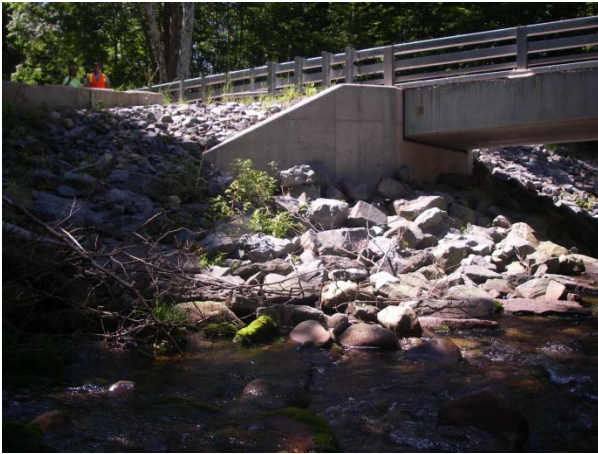
Figure 3 Abutment at Balace Road bridge evident here.

The newly-reconstructed bridge is well armored on both abutments, upstream and downstream (Fig. 3). Approximately 130 ft downstream of the bridge, an unnamed tributary enters from the valley wall on the right, at Station 22200, which appears to be a fairly significant source of *bedload* during large flow events. Further study of this tributary is recommended.

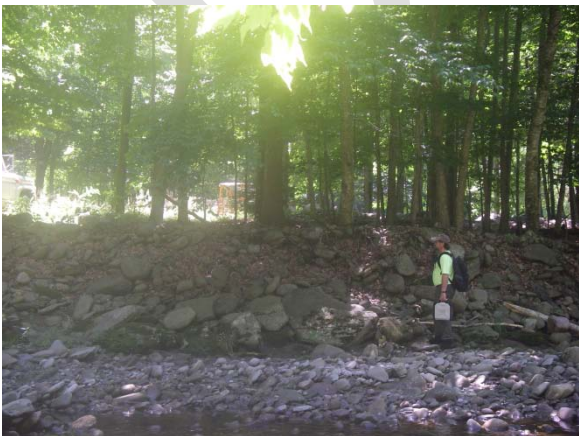
As upstream of the bridge, a berm on the left bank restricts flows across the floodplain here for 134 ft., directly opposite the tributary confluence.

Figure 5 Berm

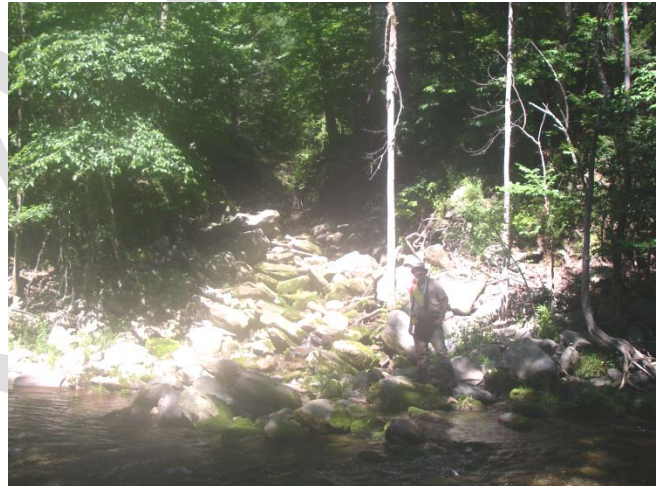
Figure 4 High-bedload tributary

Summary of Recommendations Management Unit 8	
Intervention Level	Assisted self-recovery at Stn 22000; Full restoration between Stns 18800 and 19300.
Stream Morphology	Establish single, competent channel at full restoration site; evaluate sediment transport dynamics throughout reach.
Riparian Vegetation	Improve riparian buffer at Stn 20200, and at full restoration site. Additional buffer plantings as appropriate.
Infrastructure	Monitor changes in channel profile along newly installed stacked-rock wall.
Aquatic Habitat	Watershed fishery study is recommended.
Flood Related Threats	Conduct an updated hydraulics study of the management unit (flood study).
Water Quality	Evaluate resident eligibility and interest in CWC Septic Repair and Replacement Program.
Further Assessment	Evaluate unnamed tributary at Stn 22200 as a significant source of bedload. Conduct hydraulics and sediment transport study (MUs 7-10)

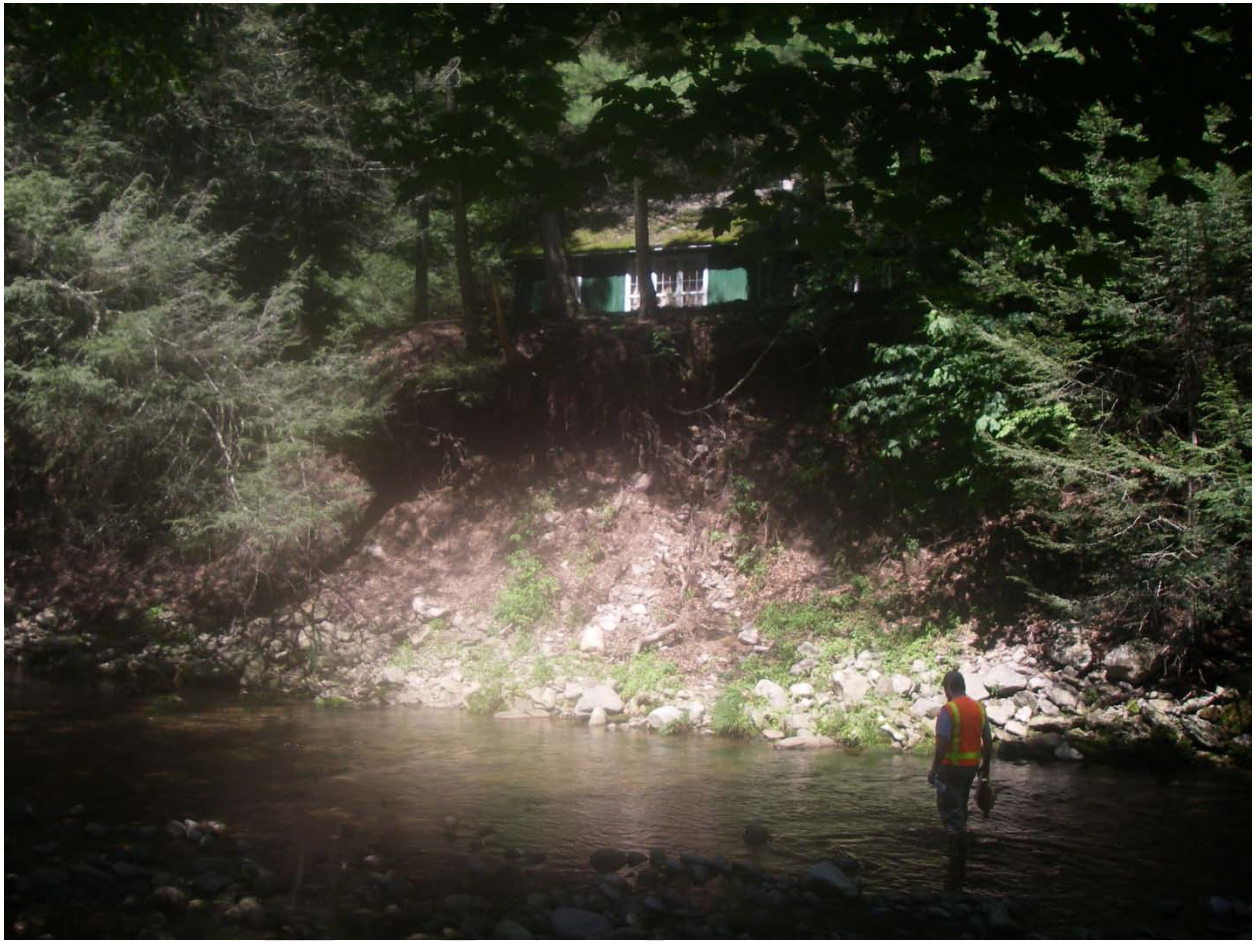
Just downstream and opposite the berm at Station 22000, the right bank is eroding for a length of about 93 ft. This bank, which is predominantly glacial till, is being eroded by entrainment of soil at the toe of the bank. A house sits on a terrace at the top of the bank, less than 50 ft. from the edge of the bank, which has a single line of mature trees, and the erosion threat to this property is a high priority for mitigation. The site should be surveyed and evaluated to determine the appropriate treatment, which would likely include soil bioengineering bank treatments combined with toe protection.

Figure 6 Erosion at Stn 22000, right bank

erosion site at Station 22000 should be stabilized with soil bioengineering methods and toe protection. For technical and financial resources available to landowners to replant banks and floodplains, see Section 2.6, *Riparian Vegetation Issues in Stream Management*.

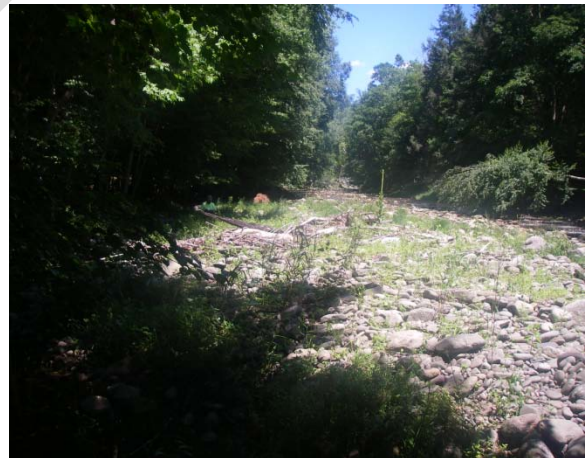
Downstream of the bank erosion, both the channel and floodplain begin to widen, with evidence of historic channel excavation, and there is evidence of aggradation in the bed for about 750ft. A narrow, forested floodplain bench develops at the base of the right valley wall. At the downstream end of this reach, the aggradation is exacerbated by a channel constriction controlled by bedrock in the right bank and in the bed, and by boulder obstruction around Station 21260, the backwater producing a 300' ft. long lateral cobble bar upstream of that point. A significant volume of bedload is stored in this bar.

Figure 7 Long lateral cobble bar, looking upstream

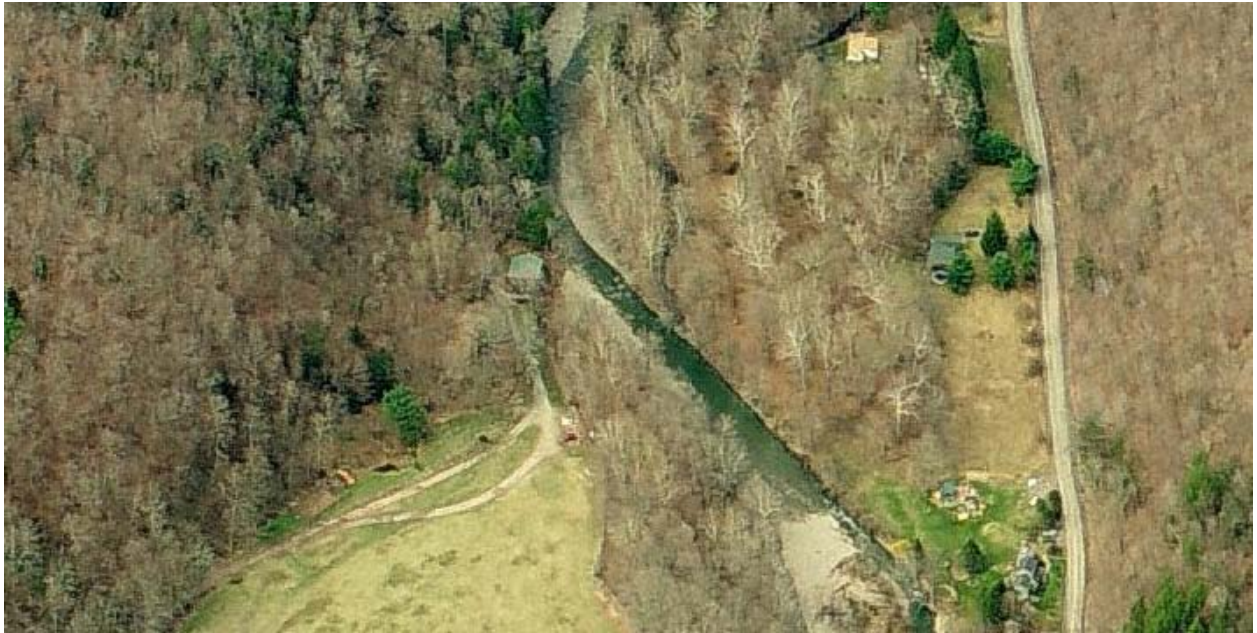
Figure 8 Stream channel crossing the valley floor upstream of the Sundown bridge

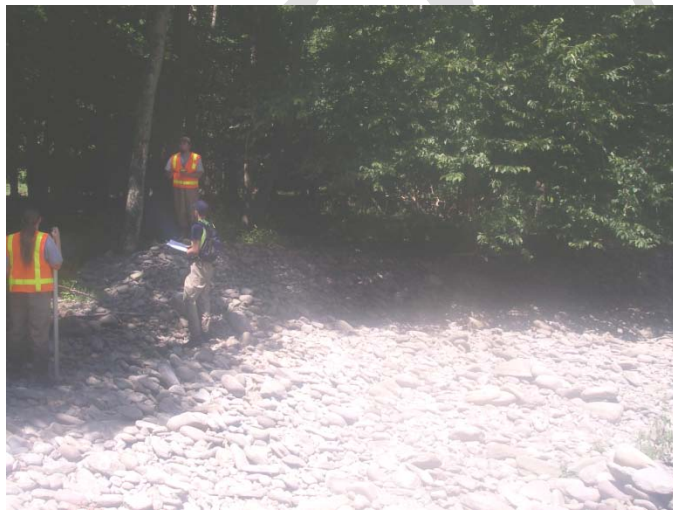
Figure 9 Sidecast berm
