Sundown Creek Management Unit 18

Management Unit 18
Sundown Creek Between Station 0 (Rondout Creek confluence) and Station 3,300

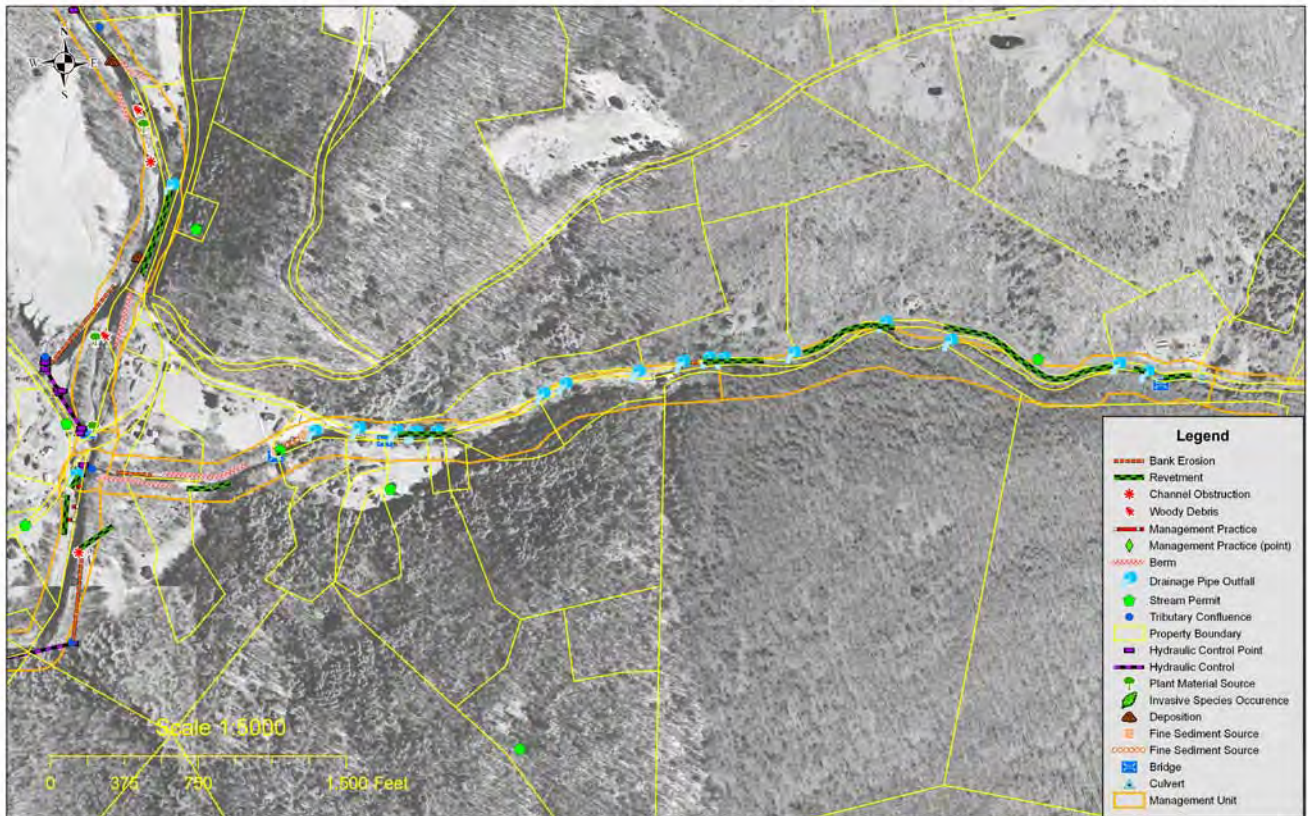
Figure 1 Management Unit 18 Stream feature inventory

The 2009 stream feature inventory revealed that 7 % (454 ft.) of the stream length exhibited signs of active erosion along 3,356 ft. of total channel length (Fig. 1). Revetment has been installed on 8.74 % (599 ft.) of the stream length. 11.59 % of the stream banks had been bermed in this management unit at the time of the stream feature inventory.

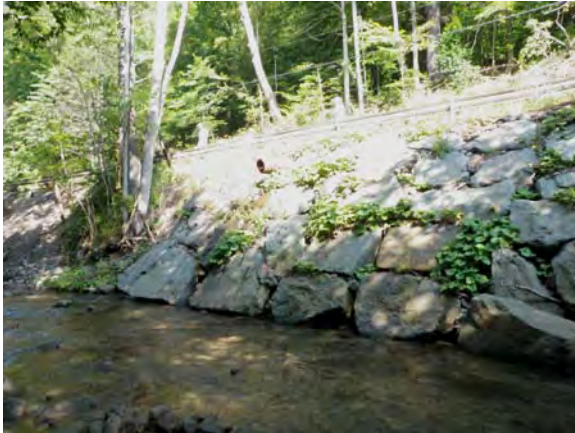
At the beginning of Management Unit 18, Sundown Creek runs immediately adjacent to Greenville Road (Fig.4). Spanning Management Units 18 and 19, the road embankment, on the right, is revetted for a length of approximately 100 ft. with tiled stone (Fig.5),

Figure 5 Tiled rock revetment at Stn 3300, Greenville Road embankment

which also provides some outfall protection for a piped outfall carrying road drainage (Fig 6). Ten piped outfalls carry discharges from small drainages on the opposite side of the road, as well as road drainage, in Management Unit 18. The integrity of the outfall protection at each should be assessed and restored as required.

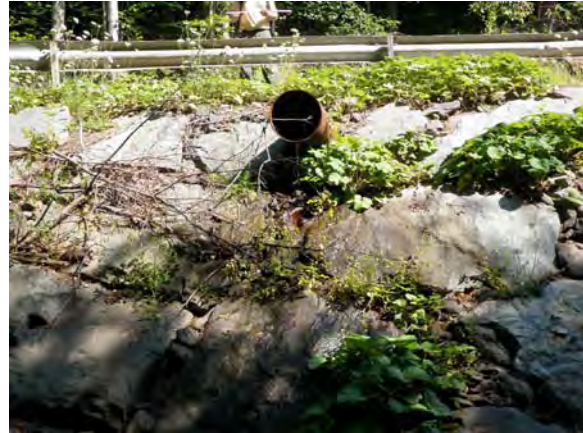
Figure 6 A smooth steel piped outfall causing some scour on the right bank

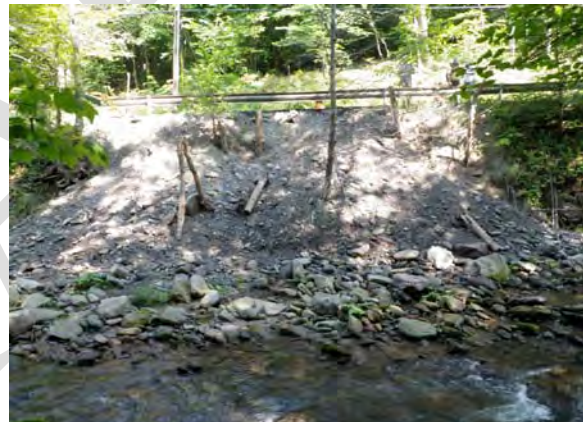
Just downstream of this revetment, at Station 3200, 40 ft. of bank erosion was observed, which has been stabilized temporarily with ungraded dumped fill to establish enough berm to secure the guardrail (Fig. 7). Another piped outfall, with poor outfall protection, is associated with this erosion site (Fig. 8).

Figure 7 Bank erosion, right, Stn 3200, ungraded dumped fill

Recommendations for this site include installation of toe protection and revegetation of the slope with soil bioengineering stabilization practices. Staging repair of revetment in severely entrenched conditions such as these is challenging; if machinery must be

positioned in the channel to perform the maintenance, it may be beneficial to schedule similar activities for much of Management Units 18 and 19 in a single coordinated effort, installing toe protection and bioengineering treatments throughout these reaches. In some locations, severely entrenched conditions warrant the installation of more vertical, stacked rock revetment, potentially allowing the construction of a low, bankfull-stage, vegetated bench within the confines of the entrenched channel.

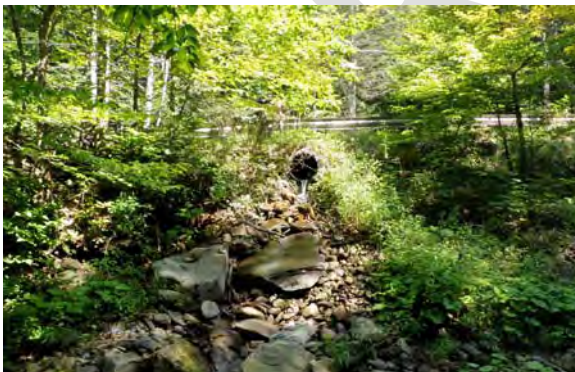
Figure 8 A plastic piped outfall, right bank

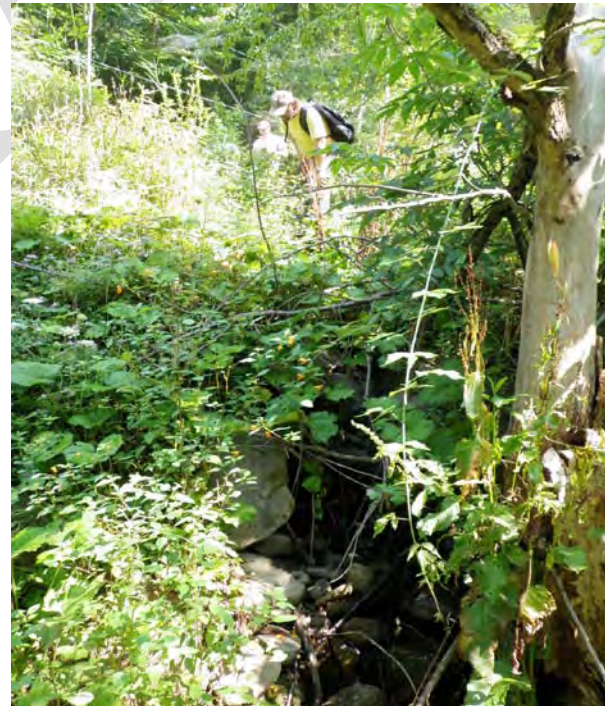
Below the abandoned mobile home site, the channel bends back toward the road for several hundred feet, where at Station 2600 another culvert pipe outfalls (Fig. 11). Piping through the soil around the pipe has undermined this culvert.

Figure 11 Smooth steel culvert outfall, undermined by soil piping beneath pipe

The piping may be the result of inadequate headwall construction on the upstream end or leaks within the pipe. This culvert should be evaluated for possible maintenance or replacement. Another culvert pipe outfalls at Station 2500 onto the floodplain.

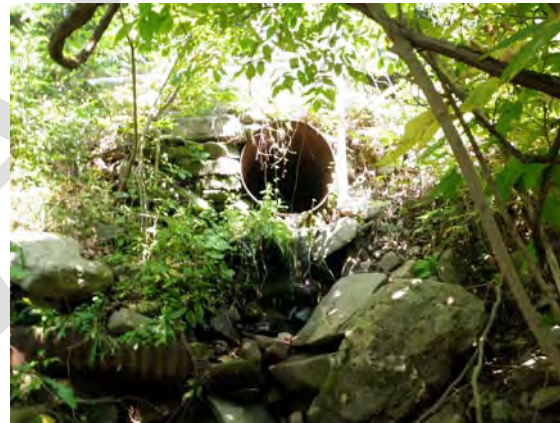
Revetment types include sloped or tiled stone (Fig. 12), dumped stone of varying sizes (Fig. 13) and gabion baskets near the wing walls of the right bridge abutment (Fig. 14). Four culvert pipes outfall in these revetments, all but the last one at Station 1640 having good outfall protection on the revetment.

Figure 15 Culvert outfall near bridge, Stn 1640, with inadequate outfall protection

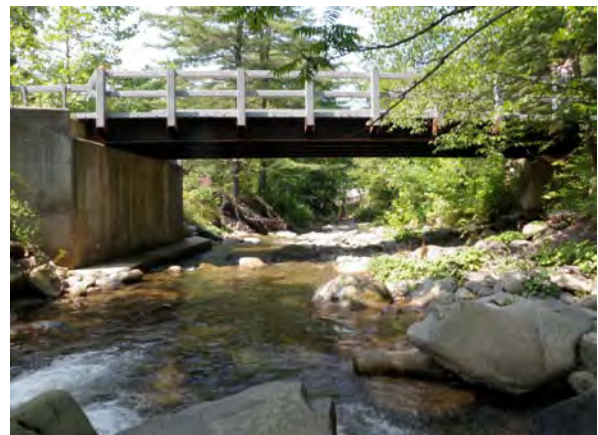
The bridge crossing at Station 1600, which serves the eight residences on the left side of the floodplain, is in good structural and functional condition, and its abutments do not appear to be significantly obstructing bankfull flows (Figs. 16, 23). Downstream of the bridge, however, *back eddy scour* is occurring on the left where high flows, released from the contraction through the bridge, have eroded the bank at Station 1500. (This erosion site was identified, but not documented during the stream feature inventory; it can be seen in the distance, under the bridge, in Fig. 16).

Figure 16 Bridge crossing at Stn 1600

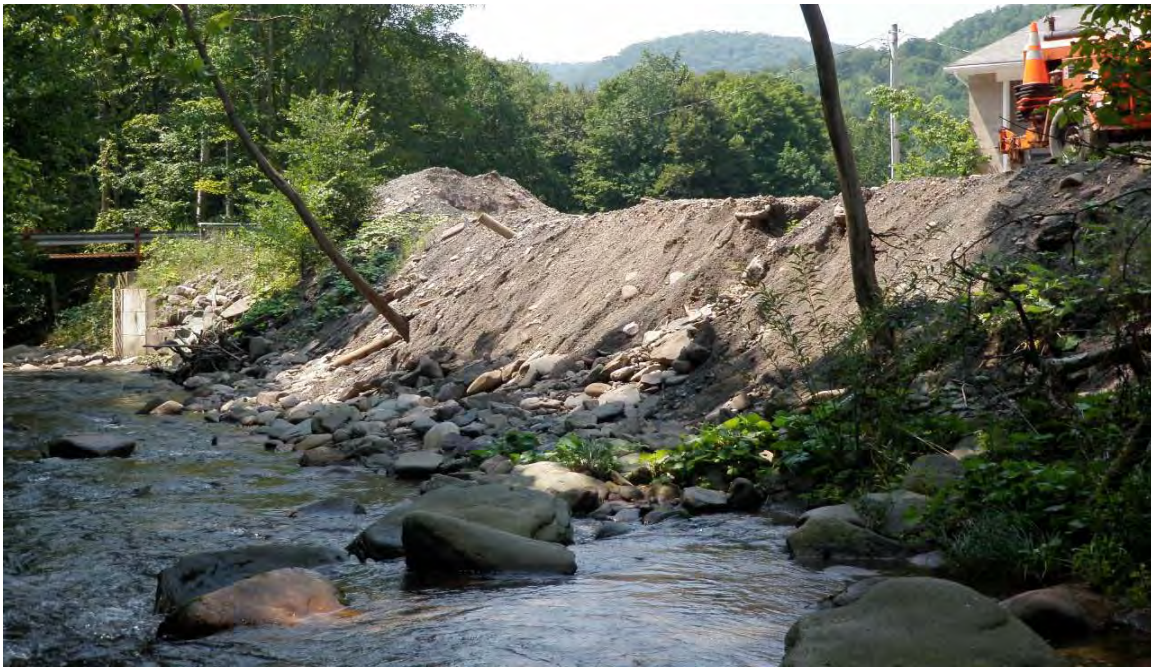
Figure 17 Eroding bank adjacent to Ulster County Highway Garage yard

Recommendations here call for installation of bioengineering soil stabilization treatments to be installed on the eroding bank. Choice of treatments here will be limited to those able to withstand high shear stress situations from the time of installation, without an establishment period.

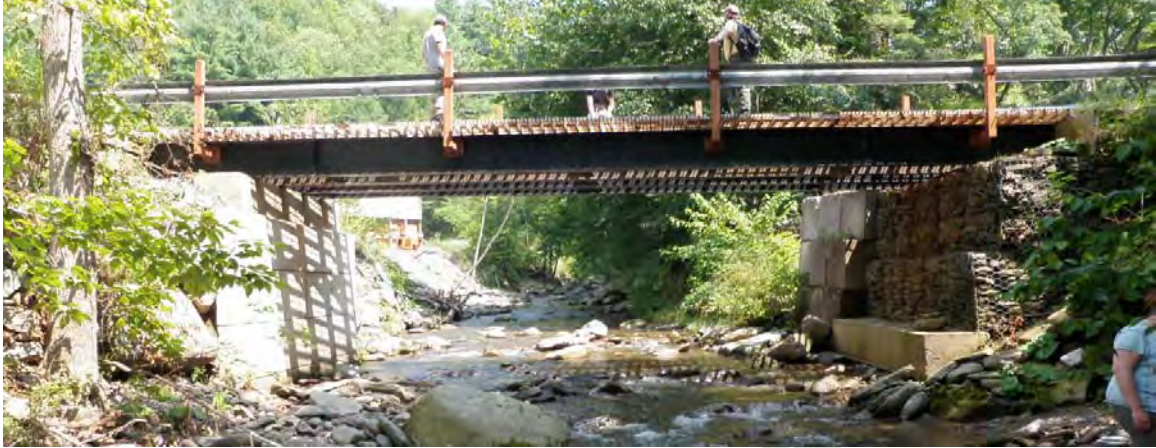
Further complicating this situation is the Sheely Road Bridge, the abutments of which encroach significantly into the bankfull channel, producing a flow obstruction and raising flood elevations upstream. The right bank is revetted with stacked rock upstream of the

Figure 19 Sheely Road Bridge, Stn 1000, looking downstream

Once appropriate channel dimensions have been determined, effective treatments for the three bank erosion sites in the reach can be designed, including channel restoration if warranted. Given the entrenched conditions in much of the channel, these would likely involve installation of rock toe protection where infrastructure is at risk, combined with soil bioengineering bank stabilization practices for banks and floodplain areas. The benefits of increasing the span and setting back the abutments at the Sheely Road Bridge should be evaluated. This should lower flood elevation of moderate flood flows, and

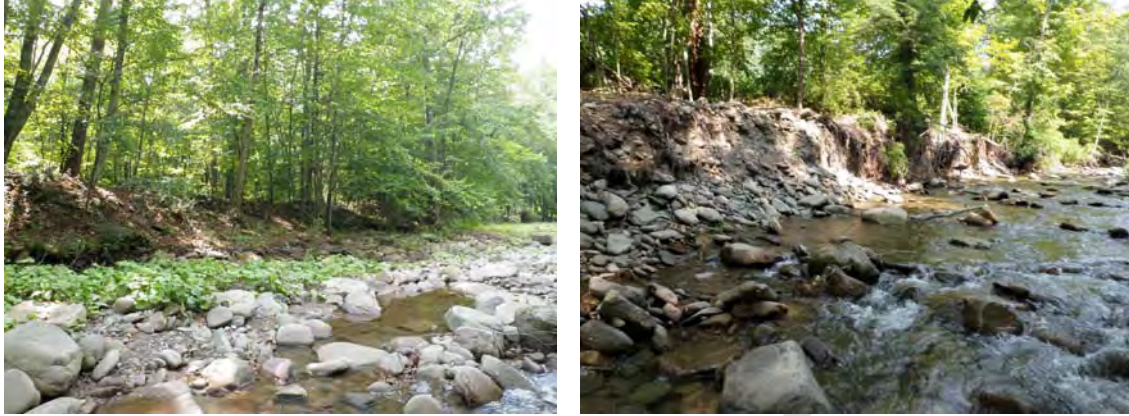
Figure 22 Berm, Stn 100-500, left bank; Erosion, Stns 160-350, right bank

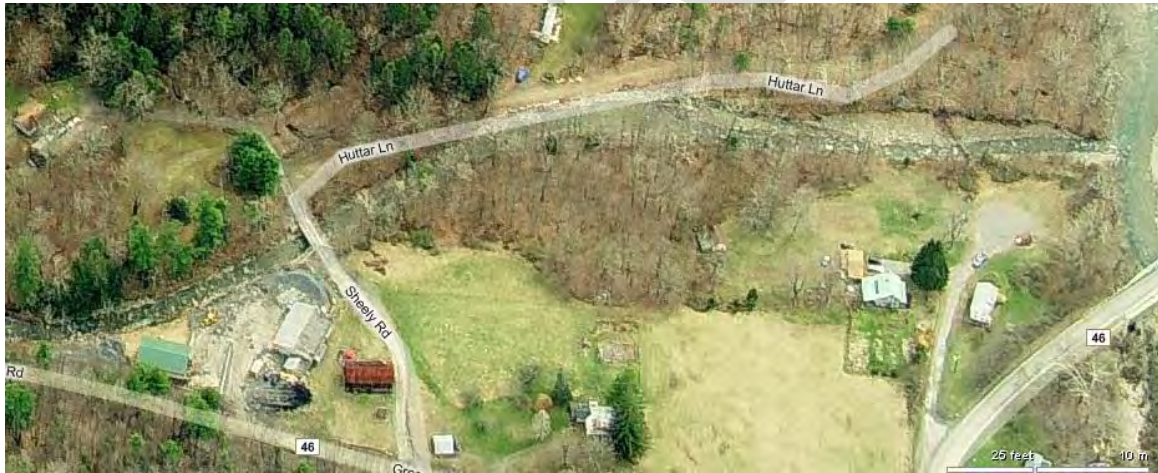
Figure 23 Lower portion of MU18, to confluence

It is recommended that the lower half of Management Unit 18, from Station 0 to the bridge crossing at Station 1600, be treated as a unit for the purposes of its restoration (Fig. 23). A hydraulics study should be conducted to evaluate sediment transport continuity through the reach and water surface profiles under various flows. In particular, the effect of channel constriction at the Sheely Road bridge should be evaluated. Channel morphology should be evaluated to a) determine if current channel dimensions support bed entrainment under appropriate flows to avoid bed aggradation and loss of channel capacity, b) ensure that sufficient low flow channel depths are maintained to provide adequate habitat during summer base flows, and c) evaluate the benefit of setting back berms to reduce water surfaces at moderate flood flows.
