Neversink River East Branch

MANAGEMENT UNIT 13

Summary of Post-Flood Recommendations

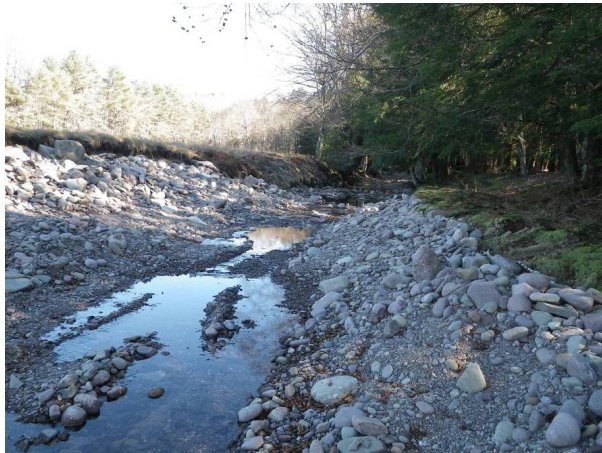
Side channel post-repair efforts, facing upstream. (IMG1509)

changed so extensively that a more expansive project is recommended to address these problem areas. As detailed in the EBMU14 Post-Flood Addendum, this side channel and related eroding bank segments could be addressed in a *full restoration* of this segment of the river.

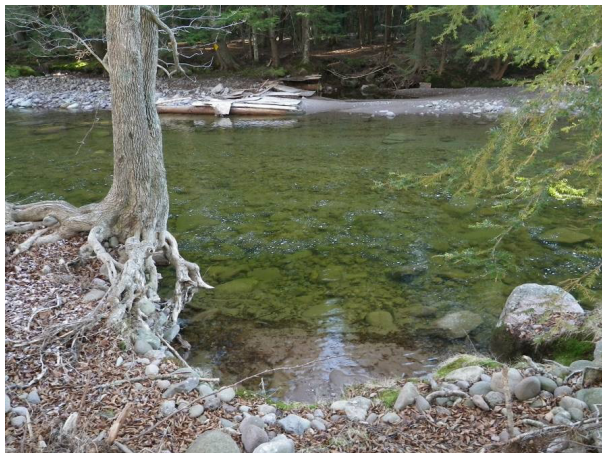
Two timber dams were previously located downstream of the convergence at Station 46110 and Station 45760. Both dams have since been destroyed (See Pictures B34 and B46 on Pages 8 and 9 for pre-flood condition). Remnants of the upstream dam were documented on the left bank in December, 2011.

Remnants of a timber dam destroyed in flooding since 2010, facing the left bank. (IMG1512)

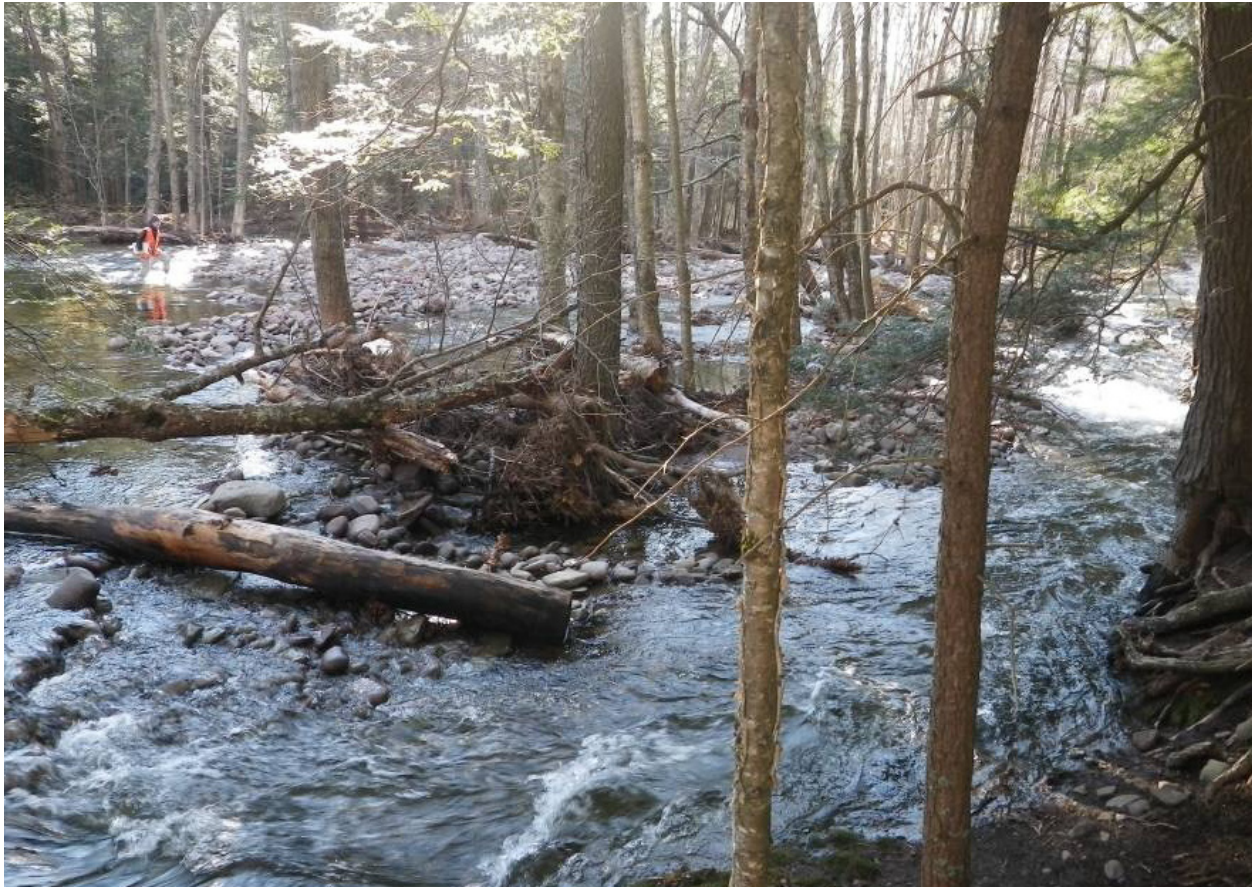
New braided main channel alignment through densely developed forested floodplain. (IMG1519)

Due to this adjusted alignment of the main channel, a significant portion of the flow now joins Flat Brook upstream of the previous confluence and runs adjacent to Denning Road. Prior to recent floods, there was a very narrow riparian buffer between Flat brook and Denning Road, which retreated significantly with increased hydraulic erosion due to increased flow in the adjacent channel. It appears that a stacked stone revetment that is currently in good structural and functional condition was constructed to stabilize this eroding portion of Denning Road after a recent flood. This location also marks where Denning Road begins to encroach on the East Branch and the effects of human development become visible on stream morphology.

Recommendations for this braided channel section include monitoring for any change in condition and a detailed assessment of the channel morphology to better understand sediment transport dynamics and potential future risks to infrastructure in the area. This site should be further evaluated as a threat to water quality as it is likely that Flat Brook contributes chlorides (salt) and petroleum by-products from road runoff to the Neversink, and potentially fine sediment from lacustrine deposits on the left side of the valley floor.

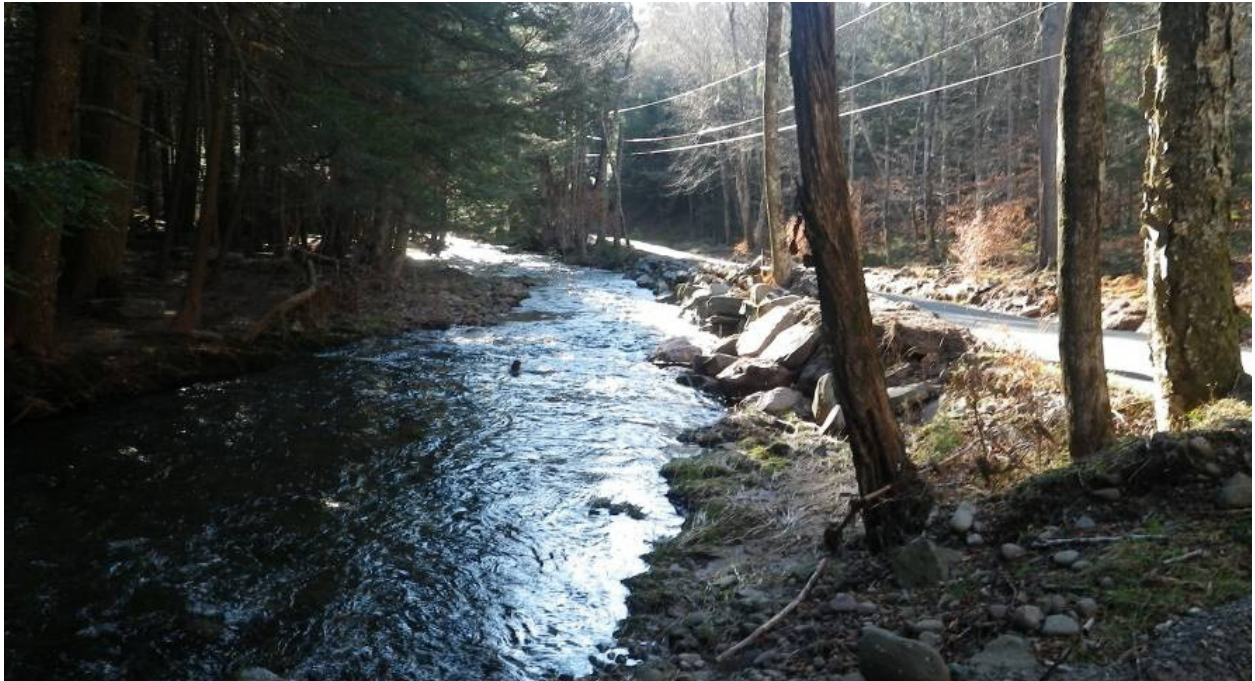
Recently constructed stacked rock revetment adjacent to Denning Road. (IMGP1523)

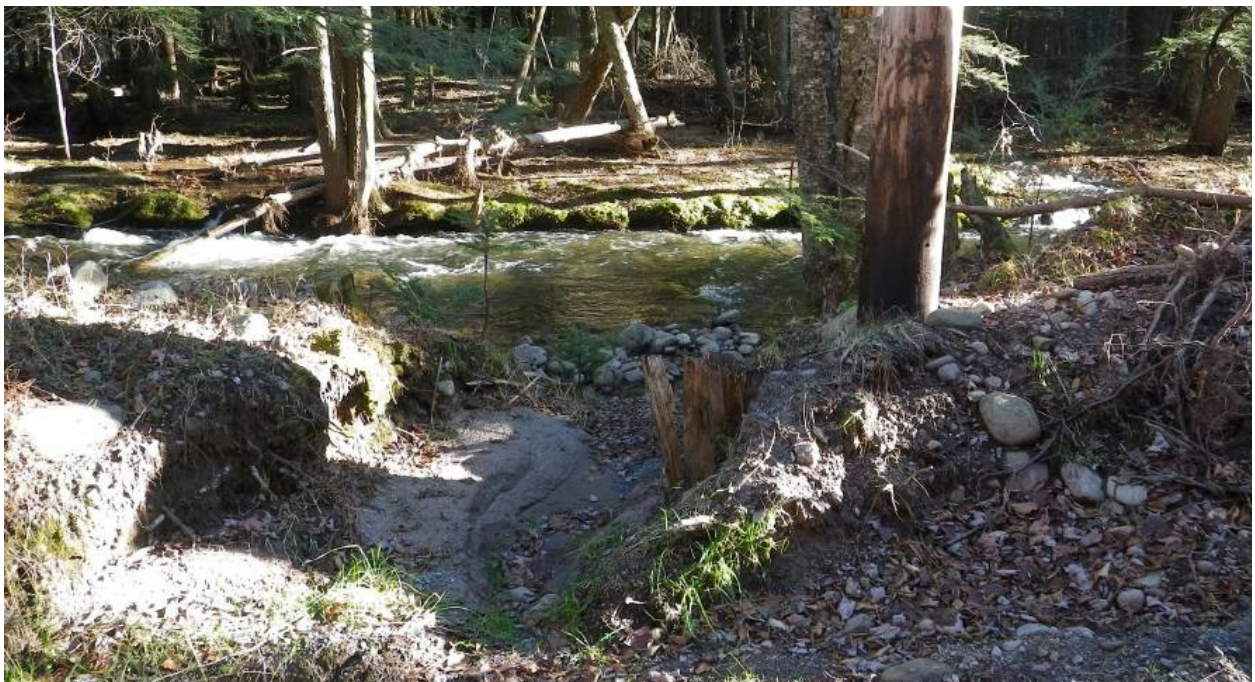
Small channel that conveys runoff from Denning Road to the river. (IMGP1530)
