# Neversink River East Branch

## MANAGEMENT UNIT 5

### Summary of Post-Flood Recommendations

### Stream Channel and Floodplain Current Conditions

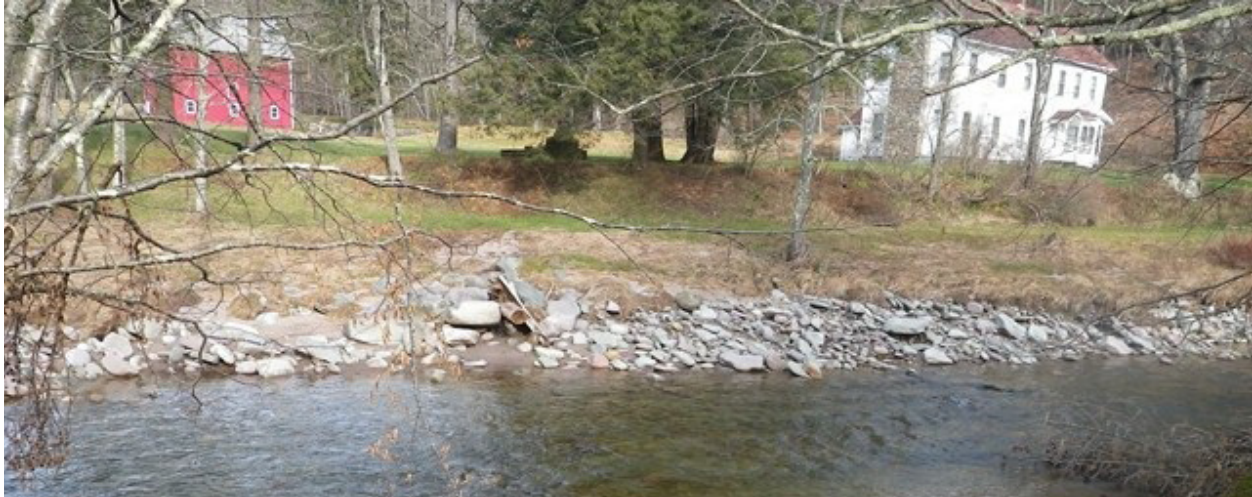
*Remnants of wooden dam. (IMGP1686)*

In 2010 an old wooden dam was documented at Station 18100. The dam was destroyed in the flooding since the initial stream survey. In 2011 the only remaining evidence of the dam was the remnants of a cross timber located on the left bank (See Picture B137 on Page 6 for pre-flood condition).

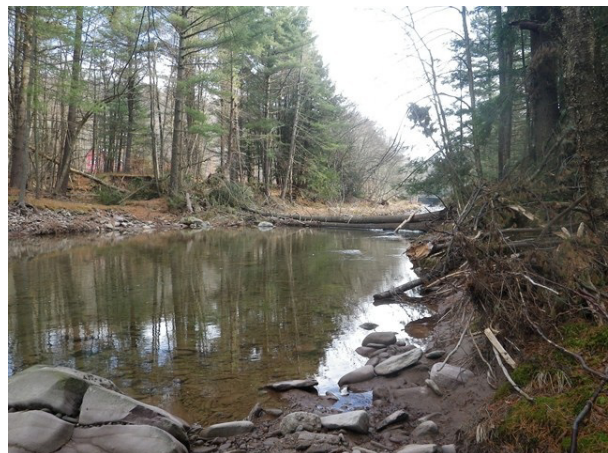
Continuing downstream, the riparian zone becomes well forested on both sides of the stream after Station 18000. The remainder of MU5 is characterized by large woody debris obstructions supplied by this mature forested riparian buffer on both banks. New woody material was released and existing materials were relocated throughout the channel and floodplains during flooding that has occurred since the summer of 2010. For example, the large woody debris jam documented in the left floodplain at Station 17900 and mid-channel at Station 17720 and Station 17410 in 2010 were replaced with a woody obstruction near Station 17700 documented in 2011. A 600-foot cobble side bar documented on the left channel bed beginning at Station 17700, was transported downstream in flooding since 2010 and is no longer present.

*Facing upstream at woody debris jam in main channel. (IMGP1687)*

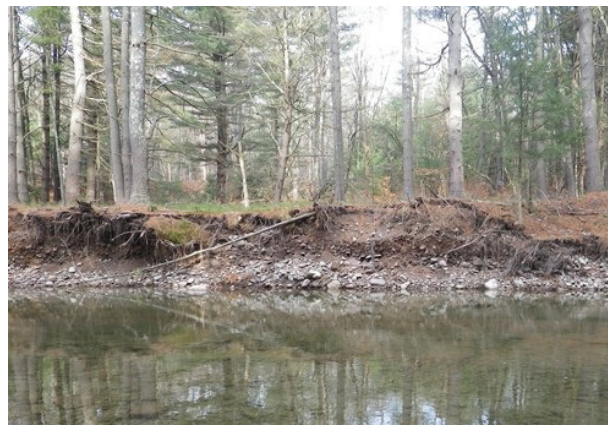
Erosion of the right bank begins at Station 17700, continuing approximately 250-feet to Station 17450 (BEMS # NEB5\_17400). As noted during the 2010 survey, hydraulic pressure on this bank is exposing cobble sized materials which falling from the bank and collecting at the toe. These cobbles, along with the establishment of sedges at the toe of the bank can assist with the re-stabilization of this erosion site. It also appears that the undercut sod mats are continuing to slump down and cover the exposed portion of the bank, offering additional protection from further erosion. It may be possible for this bank to stabilize without treatment (*passive restoration*); however, it is recommended that this site be monitored for changes in condition.

*Hydraulic erosion on right bank. (IMPG1689)*

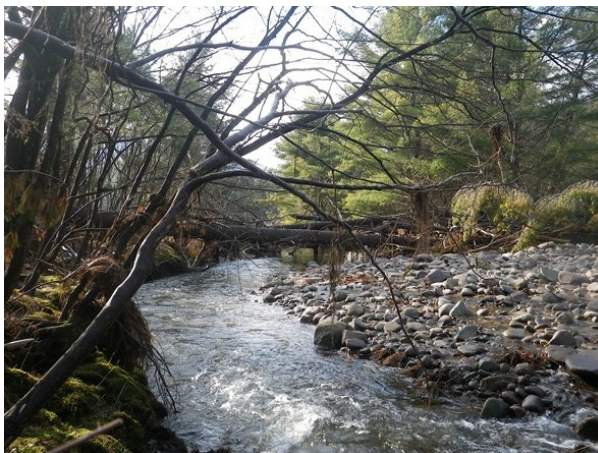
In 2010 portion of the stream flow was diverging into a side channel into the field in the left floodplain at Station 15290. In an attempt to prevent flow from entering this side channel, the left bank had been stabilized with stacked rock revetment in two separate locations adjacent to the open field. Both of these revetments were overtopped during the flood associated with TS Irene in August, 2011 (see Photo A174 on page 8 for pre-flood condition) resulting in significant incision of the side channel and flooding of the adjacent open field and Denning Road.

*Looking downstream at recently incised side channel. (IMGP1706)*

*Assisted Restoration* is recommended for this side channel extending from Station 15300 to Station 14600. Options should be investigated for restoring more of the flow to the main channel, improving sediment transport through this stream reach, and to reduce flow moving through the open field adjacent to the side channel toward Denning Road.

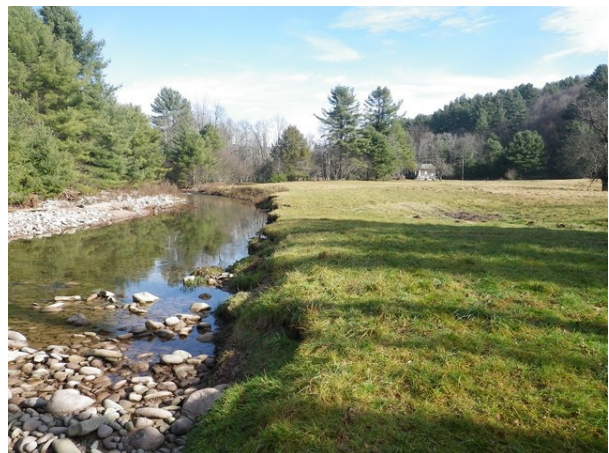
*Facing upstream at recently formed side channel along open field. (IMGP1708)*

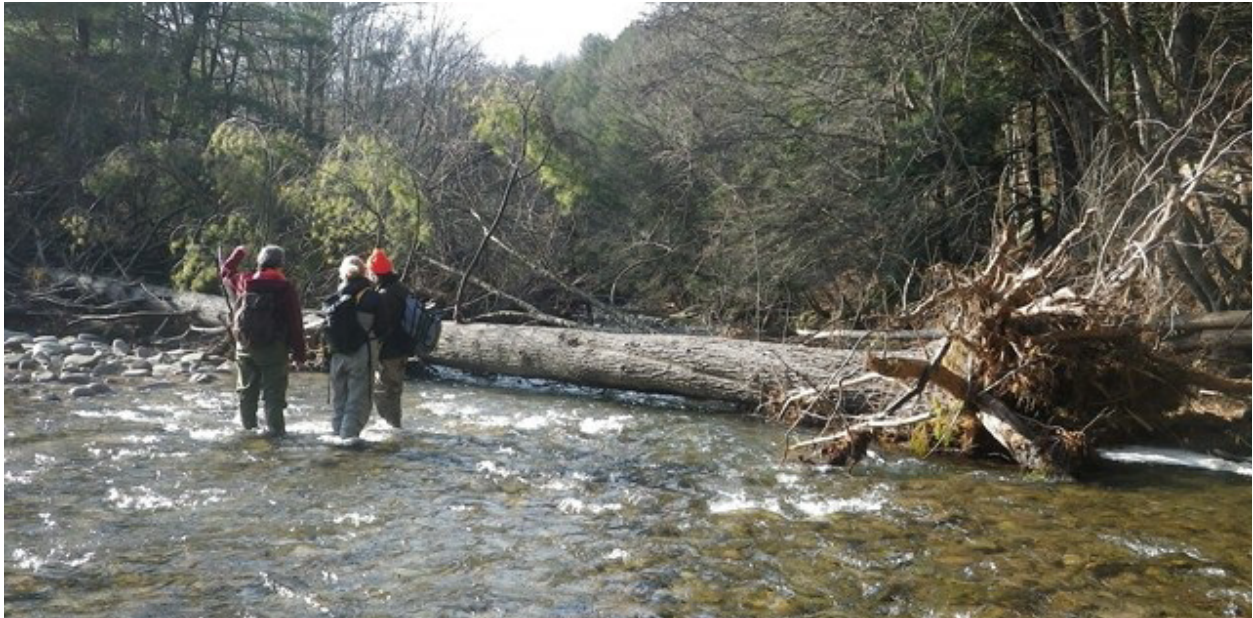
Furthermore, a woody obstruction was documented on the right side of the main channel at Station 15150. This obstruction was diverting a significant portion of the streamflow into the left side channel.

*Large woody debris jam blocking former main channel. (IMGP1704)*

The woody debris obstruction blocking the main channel at Station 15290 was removed during the summer of 2012, and the material was placed without ballast in the side channel to encourage deposition there and encourage increased flow and improved sediment transport in the main channel. A major flow on September 18, 2012 dislodged the placed material.

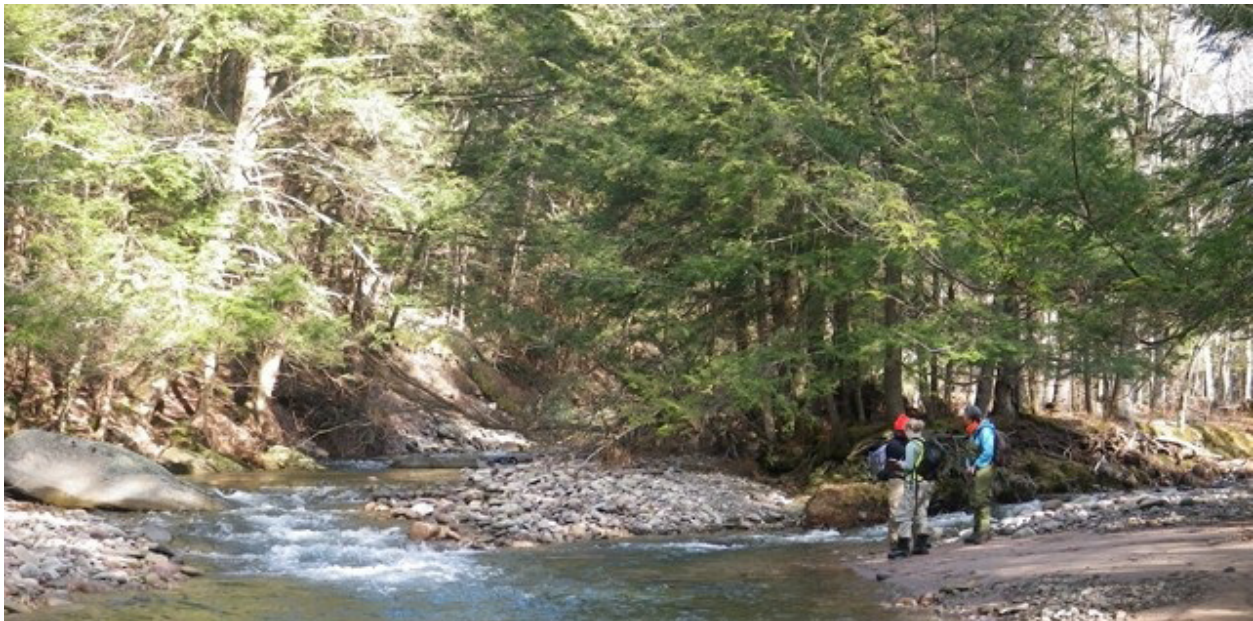
*Facing upstream at headcuts near convergence. (IMGP1710)*

Part of the flow from the side channel that diverged upstream at Station 15290 rejoins the main channel at Station 14700, while the remaining portion continues through another side channel in the left floodplain. Scour is occurring directly downstream of both channels at this convergence because the water faces an abrupt vertical drop as it flows into a deep pool. This continuous scour is resulting in *headcuts* which are actively migrating upstream, and will continue to do so until they meet substrate that is not erodible.
