Neversink River Main Branch

MANAGEMENT UNIT 1

MAIN BRANCH MANAGEMENT UNIT 1
BETWEEN STATION 3000 AND STATION 1000

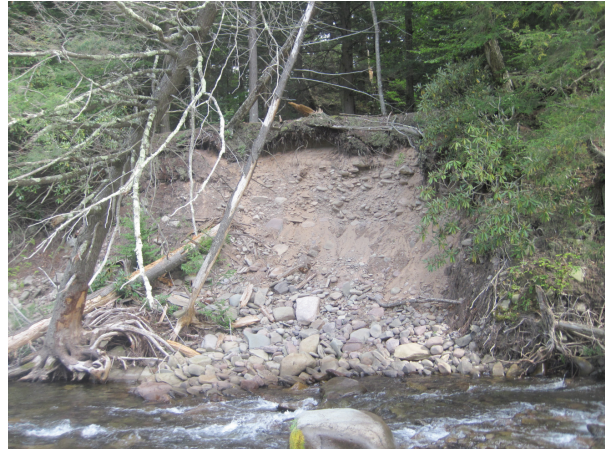
erosion exposing alluvial materials. There were woody debris aggravating scour along the bank, and although parts of the bank segment appear to be revegetating, there is glacial till exposed for 20 feet represented a minor source of fine sediments (A299, A311). There is a headcut in the main channel at Station 2940 (A301).

Woody debris causing scour on right bank (A299)

Recommendations for this segment of bank include *assisted restoration* of the bank using bioengineering techniques to revegetate the eroding bank and provide additional stabilization. The willows documented as plant sources throughout the watershed could provide a source of materials for the restoration effort.

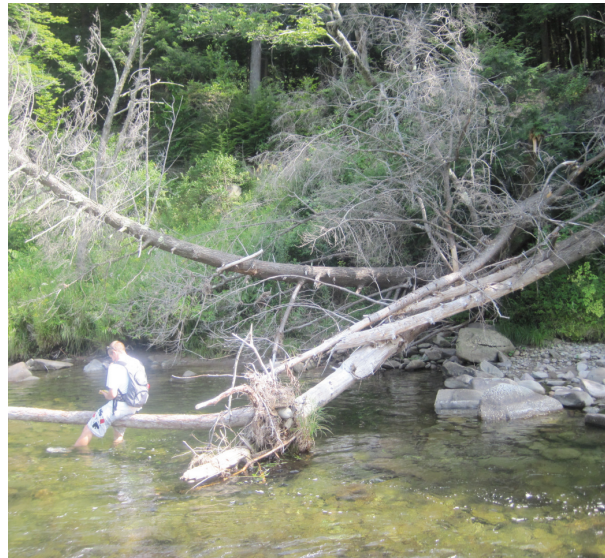
Woody debris in stream channel (A311)

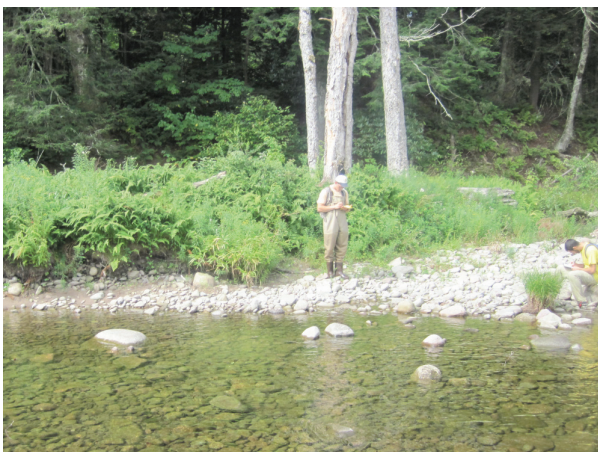
A 247-foot segment of eroding bank was observed from Station 2730 to Station 2483 (BEMS NMB1_2400). This eroding bank segment on the left bank along a side channel appears to be revegetating and will likely stabilize without treatment (*passive restoration*). It is recommended that this site be monitored for changes in condition. (B558)

Left bank erosion appears to be restabilizing (B558)

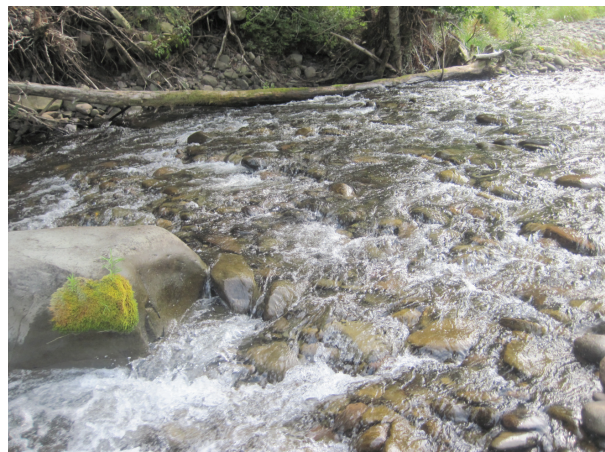
Headcut in main channel at Station 2940 (A301)

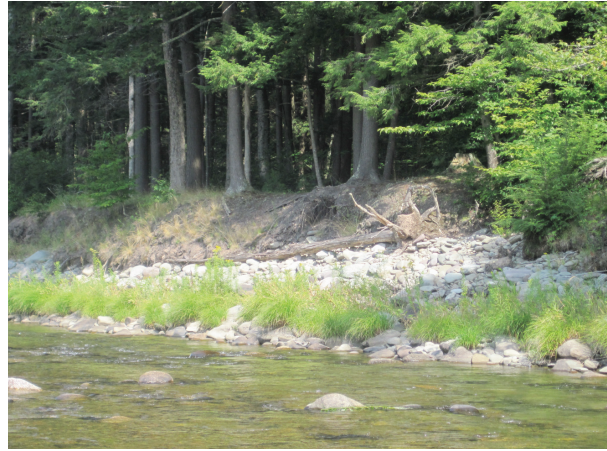
At Station 2240 the side channel converges with the main channel; the channel remains wide and aggradation was observed. Two adjacent eroding bank segments were observed on the right bank near the confluence, extending 275 feet from Station 2400 to Station 2175 (BEMS NMB1_2100) and 90 feet from Station 2175 to Station 2035 (BEMS NMB1_2000). Although more scour and undercutting was observed at the second erosion segment, both appear to be revegetating and will likely stabilize without treatment (*passive restoration*). It is recommended that both sites be monitored for changes in condition. (*A318 and A321*)

Erosion on right bank (A318)

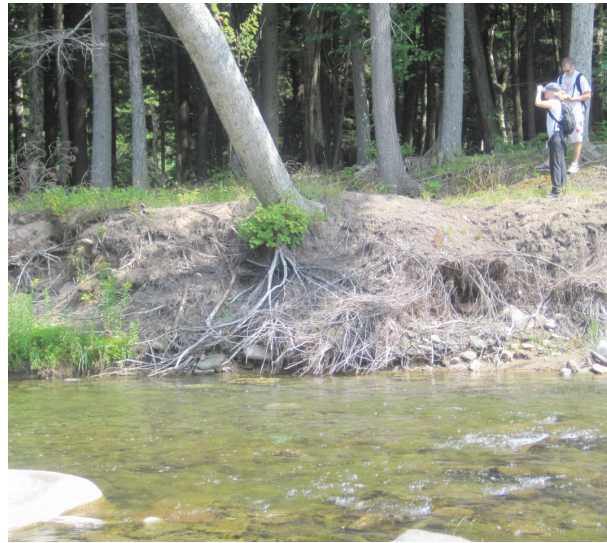
Scour and undercutting on right bank (A321)

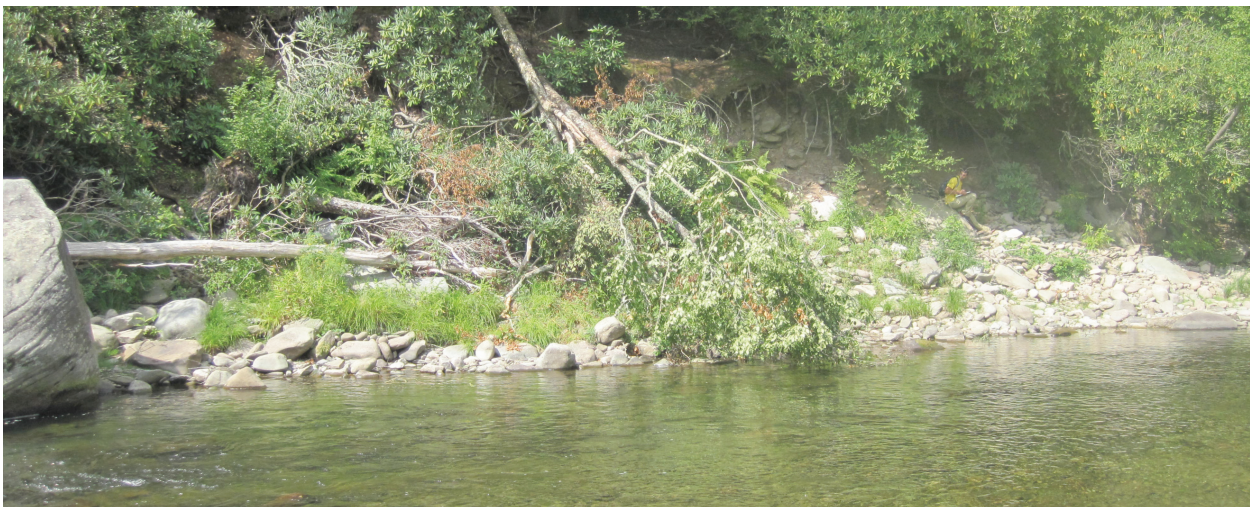
Downstream of these eroding bank segments a side bar is forming on the right bank centered at Station 1800. Across from the side bar a 242-foot long segment of eroding bank was observed on the left bank. This site was documented as active exposing glacial till via hydraulic erosion although it is not a significant source of turbidity. The slope was covered with recently downed trees during the stream survey. (*B575*) This bank appears to be revegetating and will likely stabilize without treatment (*passive restoration*).

Eroding left bank (B575)

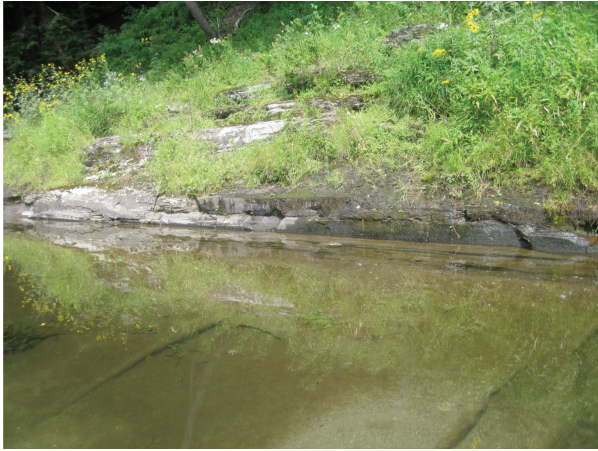
Planform and grade control on right bank (A331)

From Station 1450 to Station to Station 860 bedrock is providing both planform and grade control on the right bank. (A331) Two intermittent tributaries flow over this bedrock to join the main channel at Stations 1300 and 1100 (A335).

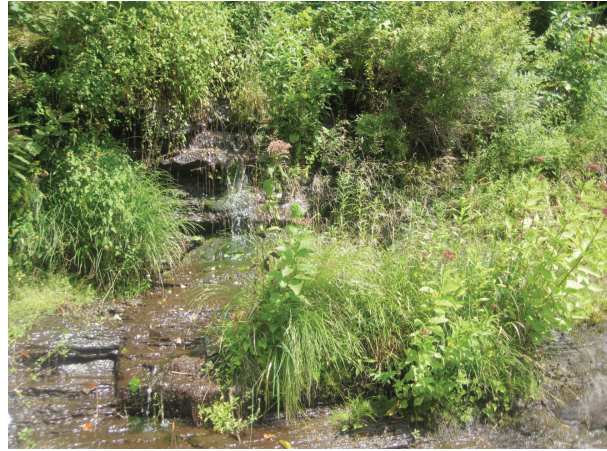
Tributary joining main channel (A335)
