Neversink River Main Branch

MANAGEMENT UNIT 7

MAIN BRANCH MANAGEMENT UNIT 7
BETWEEN STATION 18,600 AND STATION 17,200

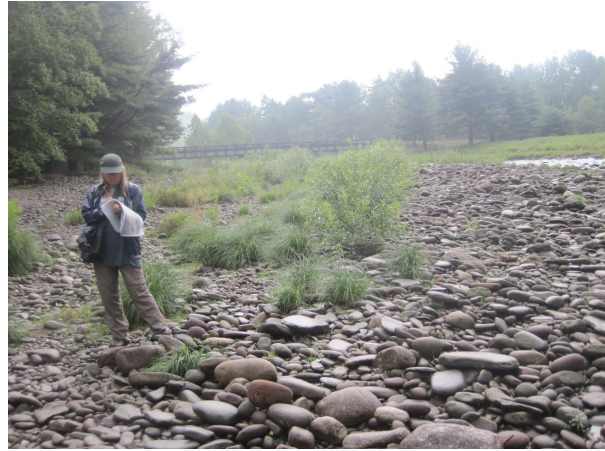
This management unit begins 50 feet downstream of the Hunter Road Bridge located at Station 18650. At this location a depositional point bar begins on the right bank at Station 18600. The cobble point bar is vegetated with willows and sedges and extends 450 feet downstream to Station 18150. (*A171*) Along

Looking upstream at right bank cobble point bar (A171)

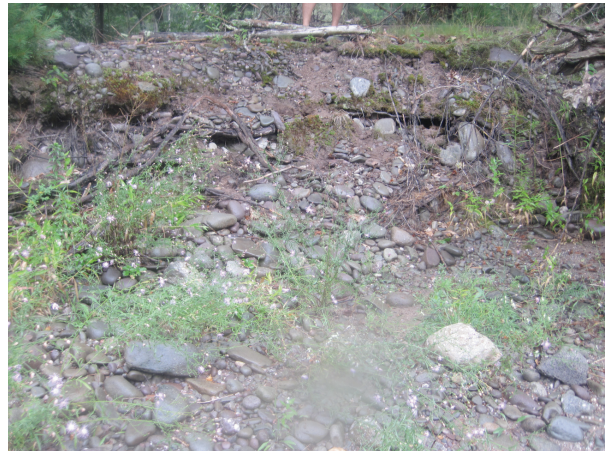
the right bank on the inside of the point bar a 218-foot long segment of bank erosion (BEMS NMB7_17900) runs from approximately Station 18140 to Station 17920. Sedge has established at the toe of the eroding bank indicating that the bank is beginning to stabilize, although the alluvial materials higher in the bank continue to be entrained. (A176) It is anticipated that this bank will revegetate and stabilize without treatment (passive restoration) It is also recommended that this site be monitored for changes in condition.

Sedge and alluvial material at right bank erosion point (A176)

BANK EROSION One area of erosion was documented in MBMU7 during the stream feature inventory. This 218-foot long segment of bank erosion from approximately Station 18140 to Station 17920 (*BEMS* NMB7_17900), is the result of hydraulic erosion of the toe of the bank. It is anticipated that this bank will revegetate and stabilize without treatment (*passive restoration*). However, it is recommended that this site be monitored for changes in condition.

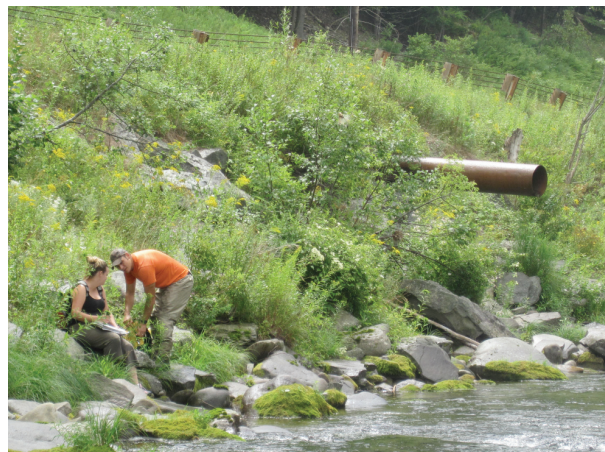
The length of the Neversink River included in MBMU7 forms the apex of a gentle meander to the left, where Claryville Road runs along the left valley wall. In MBMU7 the channel runs directly adjacent to Claryville Road for approximately 300 feet from Station 18300 to Station 18000, with minimal riparian buffer between the river and the road. At this location Claryville Road is within the boundary of the 100-year floodplain, although local residents indicate that road flooding is rare. A placed rip-rap revetment protects the bank for this segment as well as further downstream for an additional 500 feet, stretching from Station 18300 to approximately Station 17500. At Station 18250 a piped outfall constructed of a 15-inch diameter steel pipe running through the revetment conveys runoff from the left valley wall under Claryville Road. (B479)

Piped outfall and rip-rap on left bank adjacent to Claryville Road (B479)

Recommendations for this segment of bank with minimal riparian buffer include *assisted restoration* of revetted bank using bioengineering techniques to inter-plant and further revegetate the eroding bank and provide additional stabilization. The willow growing on the side bar on the inside of this meander could provide a source of materials for the restoration effort.

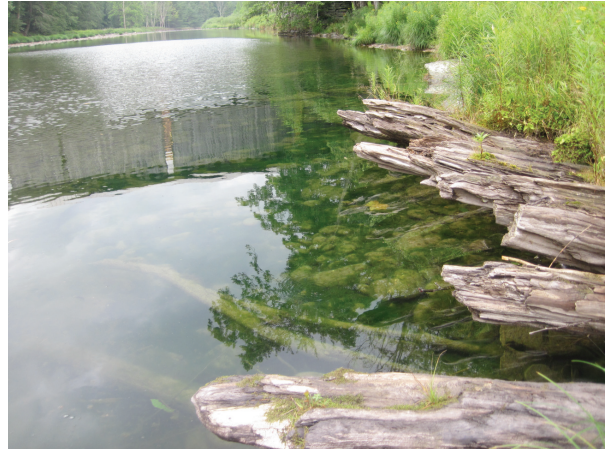
Across from the end of the revetment at Station 17500 a relict timber structure was observed which was most likely designed to provide fish habitat. The structure is in poor structural condition but good functional condition as it appears to create a pool at this location. (A182) Behind the timber structure from Station 17900 to Station 17350, the right bank is littered with woody debris, indicating that this forested floodplain is inundated during flood events. (A185)

Timber structure creating pool for fish habitat (A182)

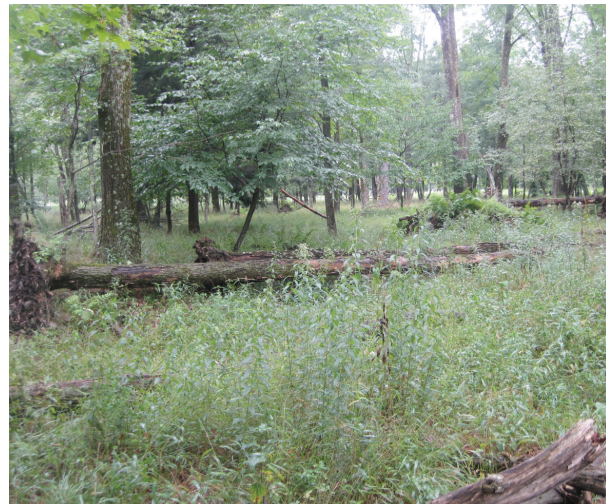
Woody debris on right bank flood plain (A185)

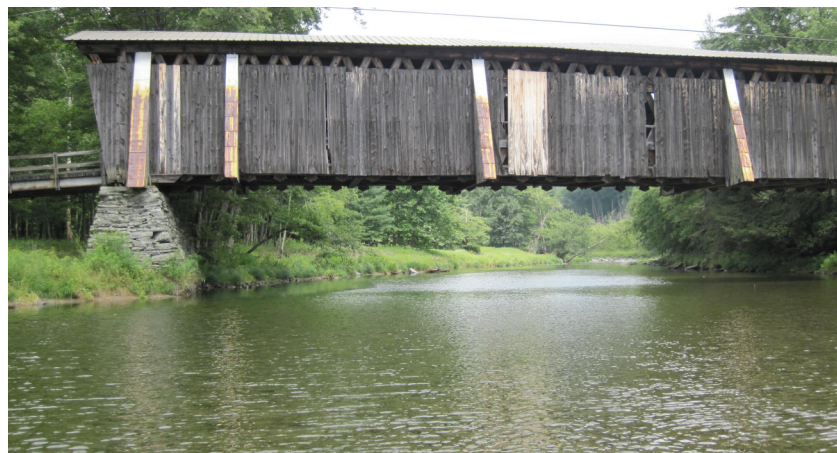
A covered bridge, located at Station 17320, was documented as in good functional condition and fair structural condition with scour documented behind the right abutment. The bridge has a normal and effective span of 108 feet, and encroaches two feet on the right bank and four feet on the left bank. It is constructed of wood timbers with bridge approaches supported by stone abutments. The bridge was identified as County Bridge 192C, and appears to be open for pedestrian traffic based on trails observed nearby and officially remains a town road. This bridge, known as the Halls Mills bridge locally, was in active use as the primary access point for all the residences on the west side of the river until the Hunter Road bridge upstream was constructed in 1962.

According to the Sullivan County Department of Public Works the bridge is scheduled for scour repair but the project is on hold due to lack of funding. In addition, bank retreat on the right bank indicates that the channel may be enlarging at this location

Halls Mills Bridge (B486)

as a consequence of increases in the magnitude of channel forming flows and increases in sediment supply from upstream. Further discussion of this process is included in the description of MBMU6. Assessment of this bridge abutment scour in conjunction with the baseline geomorphic assessment of this reach is recommended to assess the necessity of repairs.
