Neversink River Main Branch

MANAGEMENT UNIT 8

MAIN BRANCH MANAGEMENT UNIT 8
BETWEEN STATION 22,000 AND STATION 18,600

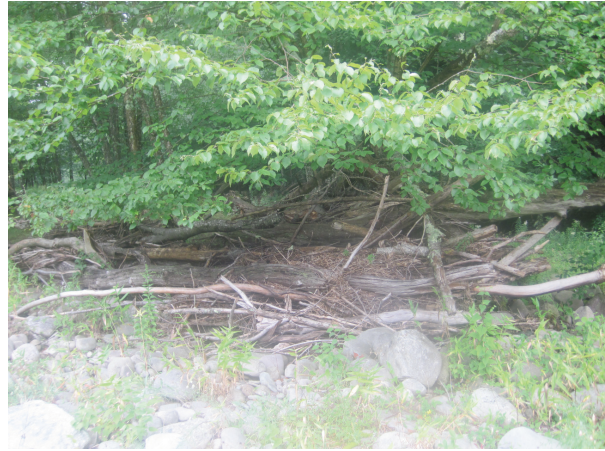
left into the floodplain terrace composed on unconsolidated alluvial sediments. At Station 21250 a side channel continues along the right valley wall, separated from the main channel by a forested floodplain. A large woody debris accumulation on the right bank at the divergence indicates significant flow along the right bank into the side channel during flood events. (A132) The main channel then meanders slightly left, pulling away from the valley wall at Station 21100 around a depositional bar that is well connected to a vegetated floodplain. The main channel then begins a meander to the right around the depositional bar, against a floodplain terrace. At Station 20600 there is a 24-foot long bank erosion segment of this terrace along a mowed field with no riparian buffer. As the bank at this location has retreated, the point of the bar at the apex of the meander appears to be advancing based on analysis of historic channel alignments. (A136). Unconsolidated alluvial sediments exposed by fluvial erosion at this location were observed. (B467) These unconsolidated sediments are highly susceptible to erosion, highlighting the importance of a healthy riparian buffer in these conditions. A riparian buffer including woody vegetation can strengthen the stream bank and slow erosive forces of higher flows during flood events.

Debris accumulation on right bank at divergence (A132)

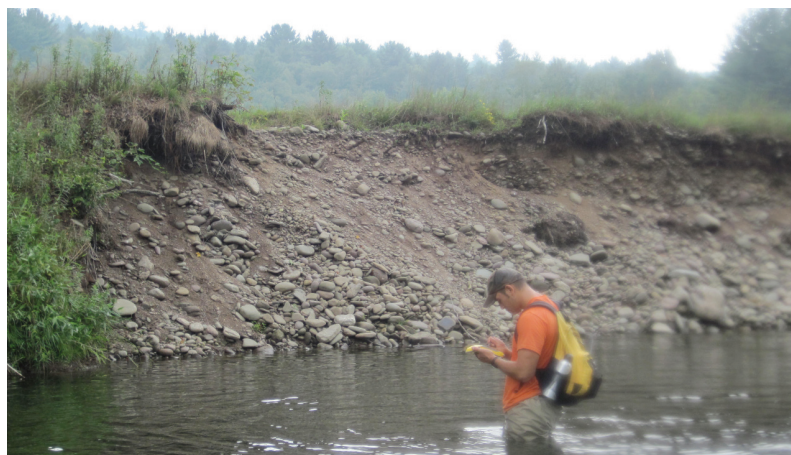
Unconsolidated alluvial sediments on right bank (B467)

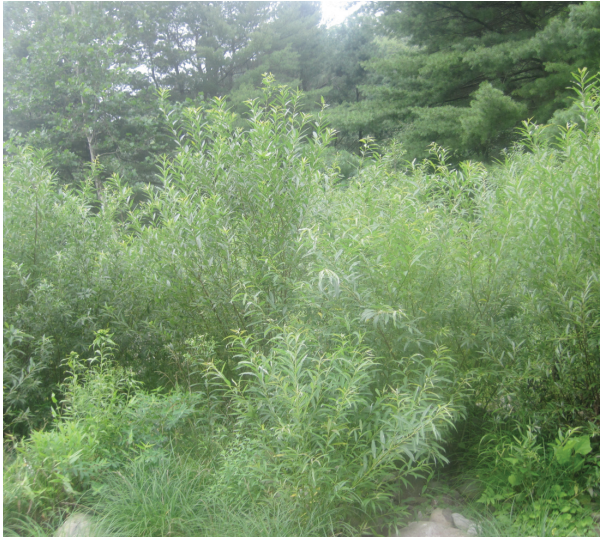
Willow on cobble bar at Station 20850 (A134)

Recommendations for this site include assisted restoration using bioengineering techniques to establish a riparian buffer and stabilize the eroding bank. The willow growing on the cobble bar forming the inside of this meander slightly upstream at Station 20850 could provide a source of materials for the restoration effort. (A134)

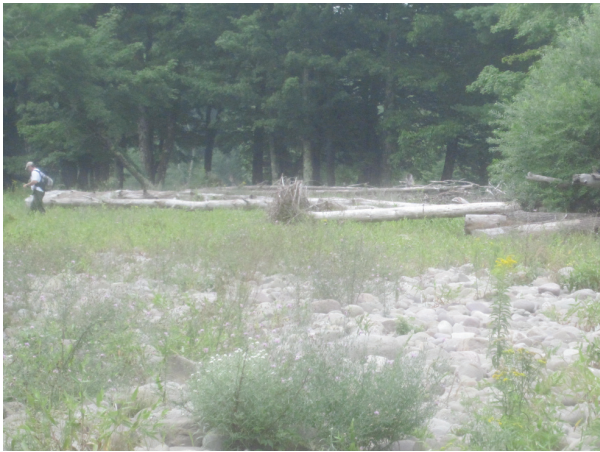
Large debris on flood plain (B469)

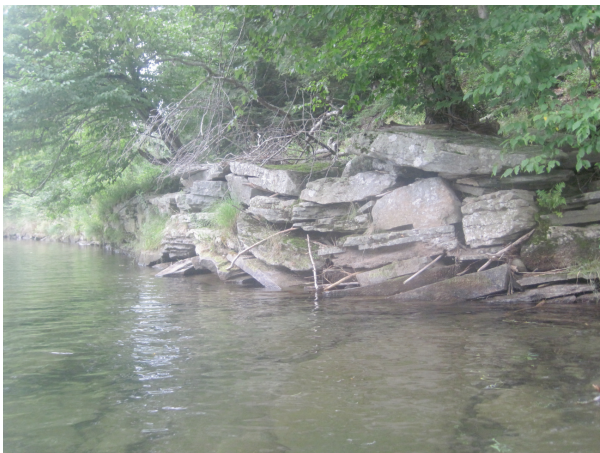
Placed stacked rock revetment on right bank (A140)

Directly downstream of the eroded bank a vegetated cobble point bar has formed partially from alluvial materials eroded from the bank failure on the left bank upstream. This point bar forms the inside of a meander bend that is restricted by the valley wall on the right bank. This point bar and well-connected floodplain are littered with large woody debris and host a native willow colony that could be used a plant source for assisted restoration efforts.(B469) A flood chute has formed through this floodplain along the left bank that conveys significant flow during flood events. This flood chute starts at Station 20300 and converges with the main channel at Station 19300. Residential structures are located in the 100-year floodplain approximately 300 feet to the left of this flood chute (Fig. 1). At Station 20200 the side channel and main channel converge against the right valley wall. From Station 19800 to Station 19600 there is a placed stacked rock wall revetment protecting the right bank and a lean-to slightly up-slope. (A140, A142) This revetment was documented as in fair structure and functional condition.

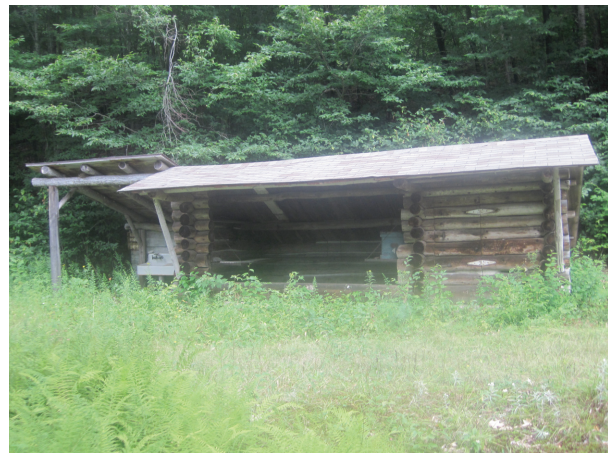
Lean-to on right bank, upslope of revetment (A142)

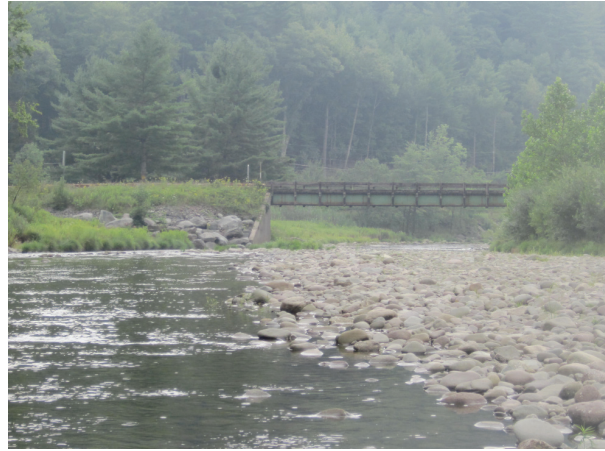
The Hunter Road bridge, county bridge #3357070, has a normal span of 199 feet, an effective span of 192 feet, twelve feet of encroachment on the right bank and nine feet of encroachment on the left bank. These documented field conditions indicate that this bridge does obstruct floodplain flows. However, the exceptionally wide span of this bridge is twice the typical width for a channel with this drainage area in the Catskills region. This overwidened condition creates a shallow channel which lacks the power to convey sediment from

Bridge approach blocking floodplain flow (B474)

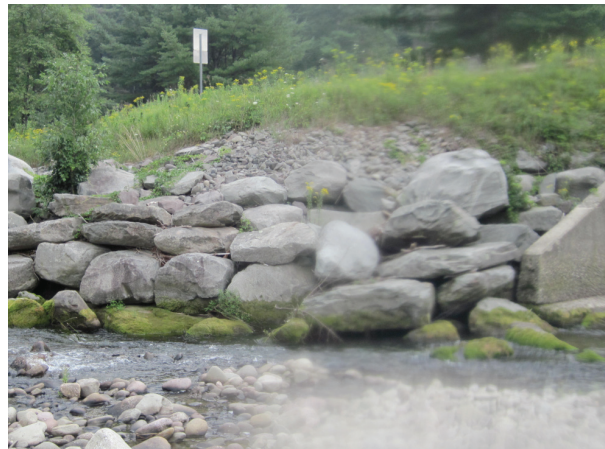
At Station 18750 an unnamed tributary joins the main channel from the left bank, directly upstream of 70 feet of placed rip rap revetment stabilizing the left bank upstream of the Hunter Road bridge abutments. (B476). This revetment was documented as in good functional condition and fair structural condition. Lack of scour protection has allowed flow underneath some of the boulders.

Rip rap revetment upstream of left bank bridge abutments (B476)

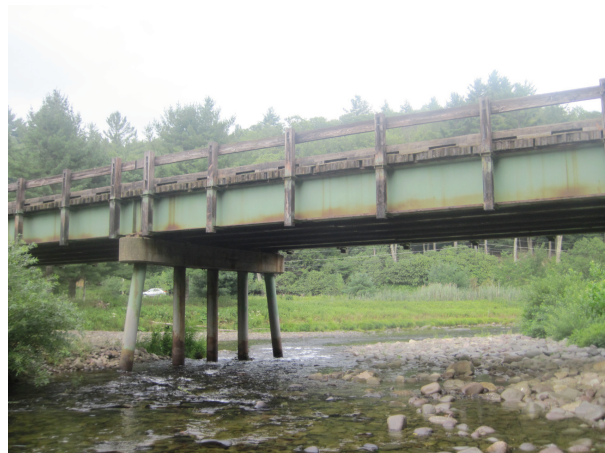
Looking downstream at Hunter Road Bridge (A164)

upstream, contributing to the aggradation observed both upstream and downstream of the bridge. The Hunter Road bridge is constructed with one support pier made of five steel columns, and was documented as in fair functional condition and poor structural condition. (A164)

The Hunter Road bridge is currently scheduled for repair or replacement in the next several years. At that time recommendations for this site is a *full restoration* project from Station 19700 continuing into MBMU7 to Station 18000. This project would require geomorphic and sediment transport analyses of the reach and would likely include re-establishment of an effective bankfull width with construction of a vegetated bankfull elevation bench on the right bank both upstream and downstream of the bridge span. The project might also include placement of *flow deflection structures* to reduce erosive forces on the banks, particularly at Claryville Road (discussed further in MBMU7) and Station 19600.
