Neversink River West Branch

MANAGEMENT UNIT 11

WEST BRANCH MANAGEMENT UNIT 11
BETWEEN STATION 40000 AND STATION 43700

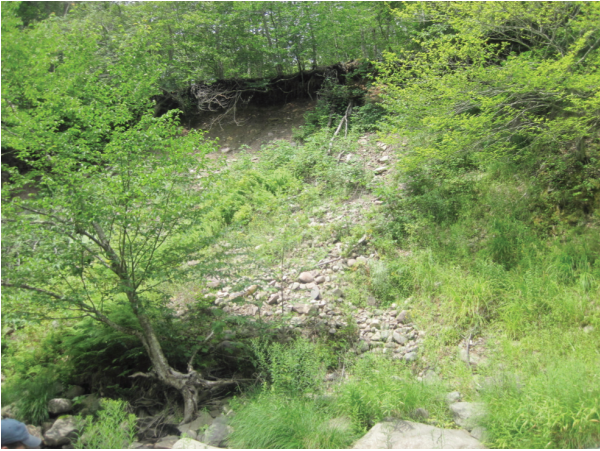
WBMU11 begins as a side channel meanders across the valley floor towards Frost Valley Road and the right valley wall. At the apex of the meander, from Station 43700 to Station 43600 an eroding bank segment was observed on the right bank (BEMS NWB11_43600). This site was documented an active

erosion into a 60-foot high bank caused by both surficial failure and hydraulic erosion at the toe. Shrubs, grasses and sedges were observed growing throughout the exposed till bank and additional boulder accumulation and vegetation was observed at the bank toe. Therefore it is likely that this bank will revegetate and stabilize without treatment (*passive restoration*). However, it is recommended that this site be monitored for changes in condition. (A1000)

Bank failure on right bank of side channel (A1000)

BANK EROSION One area of erosion was documented in the management unit during the stream feature inventory. From Station 43700 to Station 43600 an eroding bank segment was observed on the right bank (BEMS NWB11_43600). This site was documented an active erosion into a 60-foot high bank caused by both surficial failure and hydraulic erosion at the toe. Shrubs, grasses and sedges were observed growing throughout the exposed till bank and additional boulder accumulation and vegetation was observed at the bank toe. Therefore it is likely that this bank will revegetate and stabilize without treatment (*passive restoration*). However, it is recommended that this site be monitored for changes in condition.

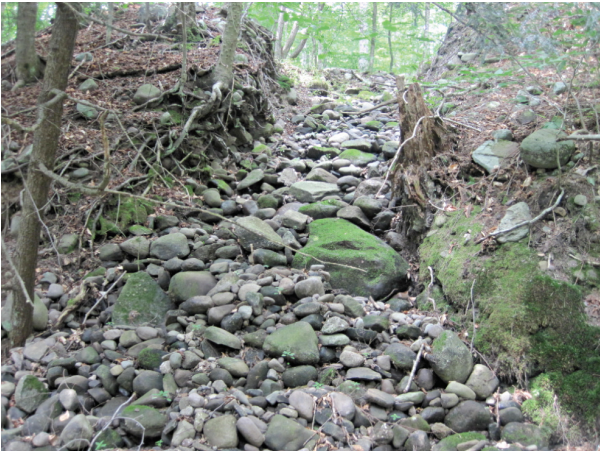
Directly downstream of the eroding bank segment a intermittent tributary conveying road drainage from Frost Valley Road was observed joining the side channel from the right bank. (A1005)

Intermittent tributary conveying road drainage (A1005)

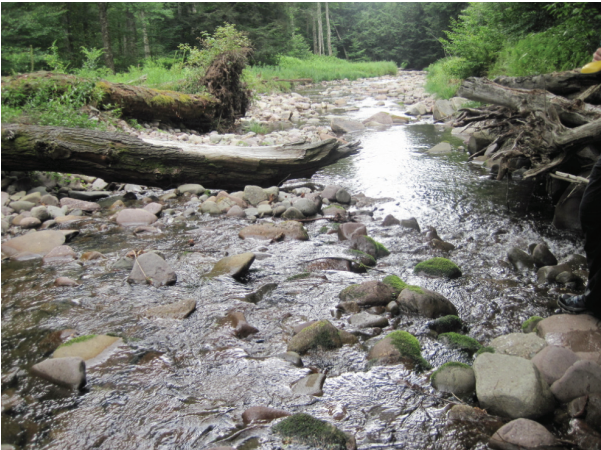
At a similar elevation further left on the valley floor the main channel is littered with woody obstructions which form sediment deposition areas and pools throughout. At Station 43500 a headcut migrating upstream through the cobble bed was observed in the main channel. (A1006, A1009) A series of three significant sediment deposition areas were observed upstream of a divergence around a center island near Station 42950.

Woody debris contributing to pools and deposition (A1006)

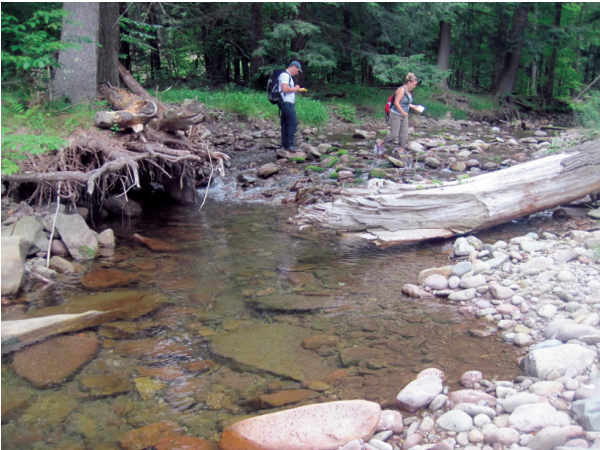
Headcut migrating upstream (A1009)

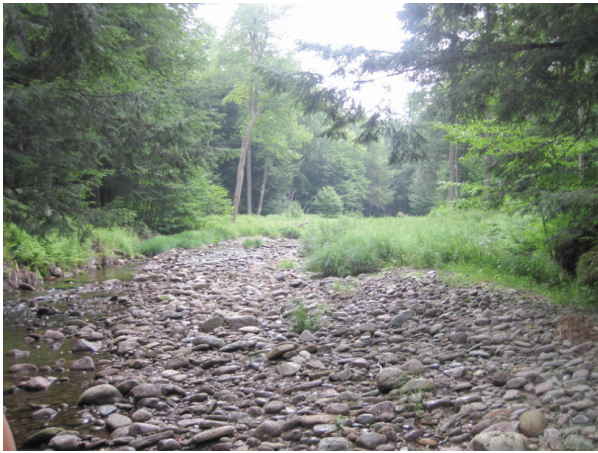
Center bar upstream of bridge (A1011)

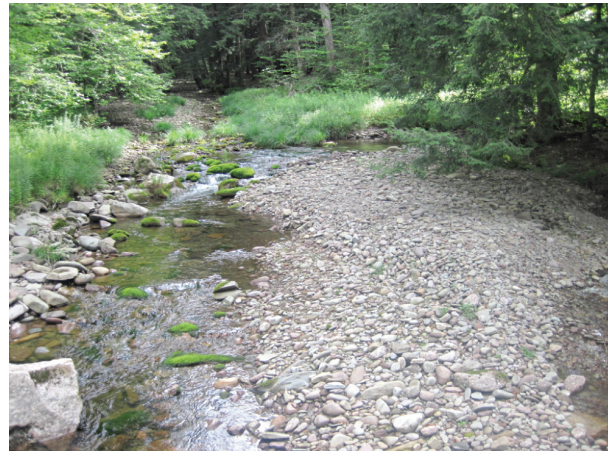
The side channel joins the main channel at the downstream end of the island near Station 42900, directly upstream of the bridge that provides access to the east entrance of the Frost Valley Model Forest. (A111, A1018) Depositional features, such as this center island and the bar extending downstream from the island, often form upstream of bridges where the bridge approaches restrict flows that would otherwise effectively transport sediment. Beginning at Station 42900 and continuing until Station 40100, large tracts of herbaceous vegetation fragment the riparian forest along the right floodplain and should be further assessed for the potential of improving the riparian buffer through planting efforts (Figure 7).

Looking upstream at island (A1018)

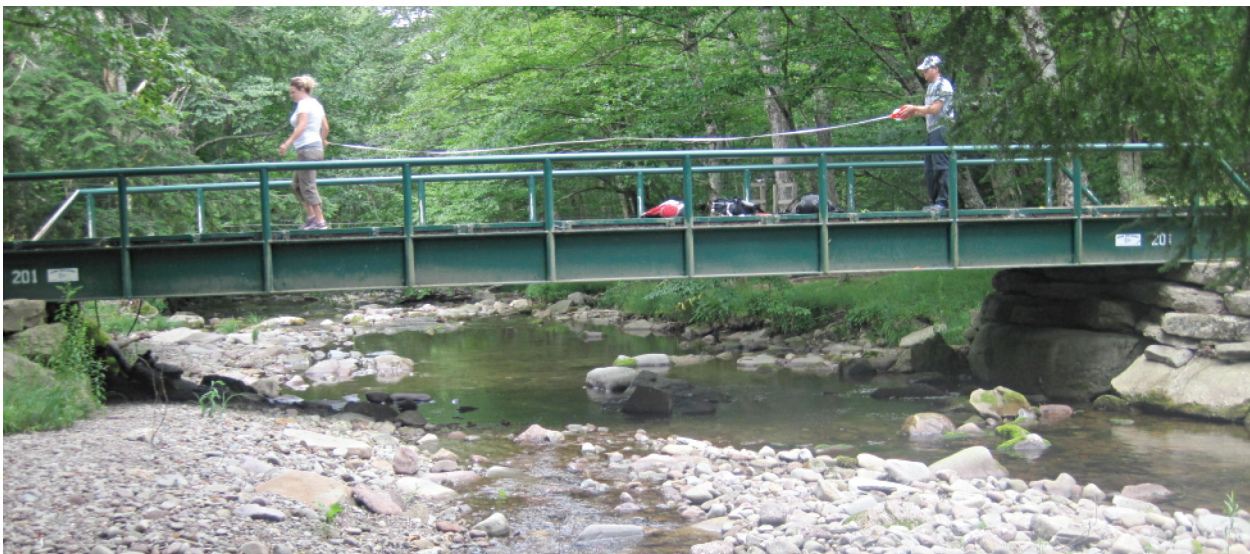
The East Entrance Bridge was documented as in good structural and good functional condition. The *normal span* and *effective span* of 38 feet. The bridge is a single span bridge with stacked stone abutments; the right abutment encroaches 4 feet while the left abutment encroaches 9 feet. (A1016)

East Entrance Bridge (A1016)

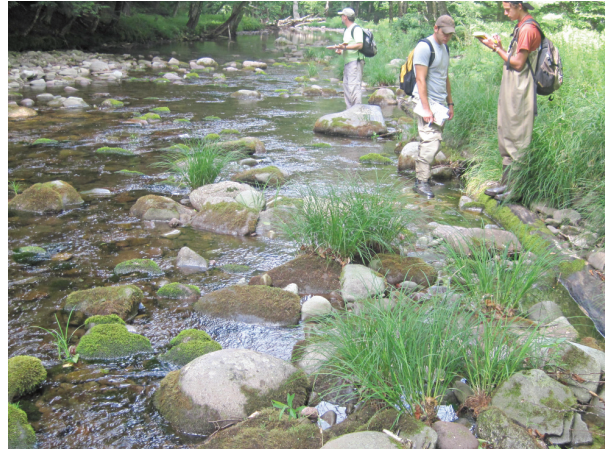
a log cribbing revetment was observed on the right bank. (B909) This structure was documented in fair structural condition; because the purpose and past use of the structures remain unclear the functional condition cannot be assessed. Overall, the reach-scale affect of the barbs appears to be formation of a vegetated depositional side bar on the right bank.

Log cribbing revetment on right bank (B909)

It is difficult to decipher the original design objectives of these structures; they may have been designed to improve or enhance aquatic habitat or to protect banks. It is recommended that the history and original objectives of these features be investigated to better understand the current function and ongoing hydraulic effects. Long term monitoring of the structures is also recommended.

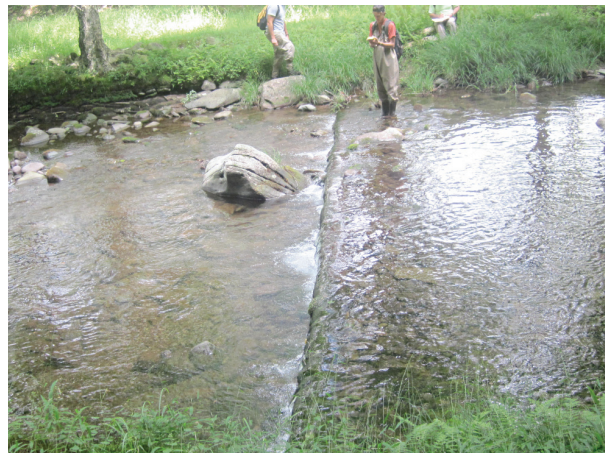
Near Station 40080 a log check dam and log cribbing in the left and right bank were observed. This structure was documented in good structural condition; because the purpose and past use of the structures remain unclear the functional condition cannot be assessed. Overall, the reach-scale affect of the check dam and cribbing appears to aggradation throughout this reach. (B912)

Log check dam and log cribbing (B912)

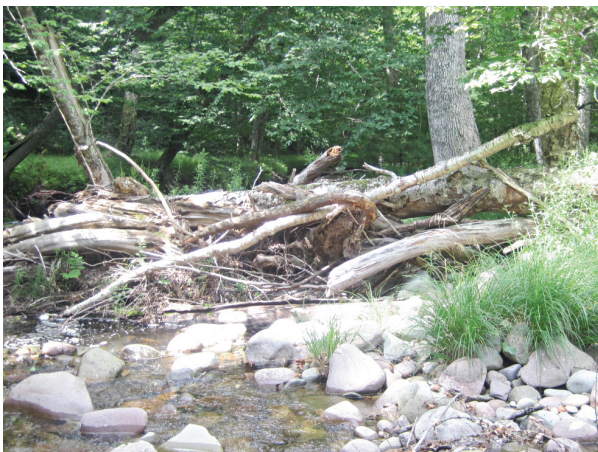
Woody debris obstruction causing divergence (B920)

At Station 40950 a dry side channel with a cobble bed a 5-7 years of emergent vegetation diverges from the main channel at a woody debris obstruction. (B920, B916) Japanese Barberry, an invasive species, was observed on the right bank of the side channel near Station 40700. (A1033). Across from the barberry bank scour was observed on the right bank extending 30 feet exposing alluvial cobbles with undercutting into a thin riparian buffer on top of the bank. Up slope from the eroding bank site is a covering structure within the FEMA-mapped 100-year flood.

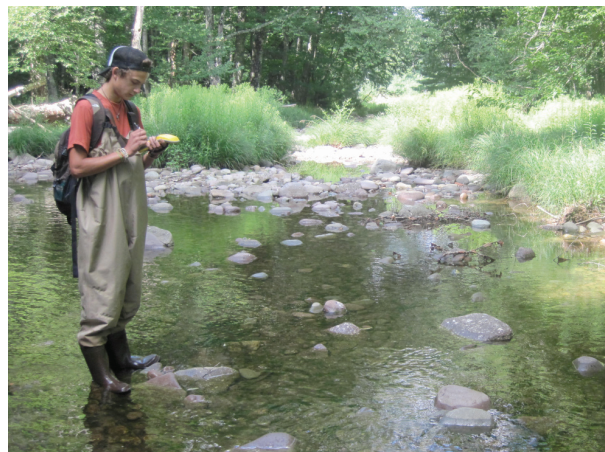
Divergence with dry side channel (B916)

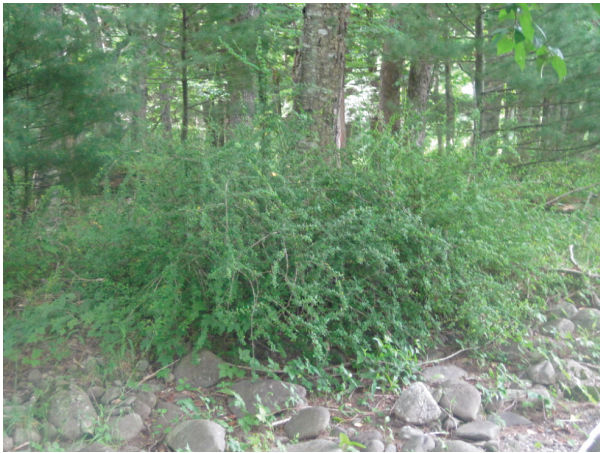
Japanese Barberry, invasive species (A1033)

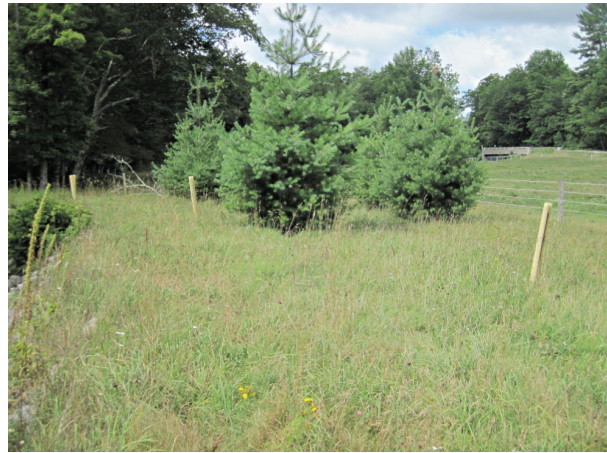
Re-vegetating pasture with White Pine and White Oak saplings (A1037)

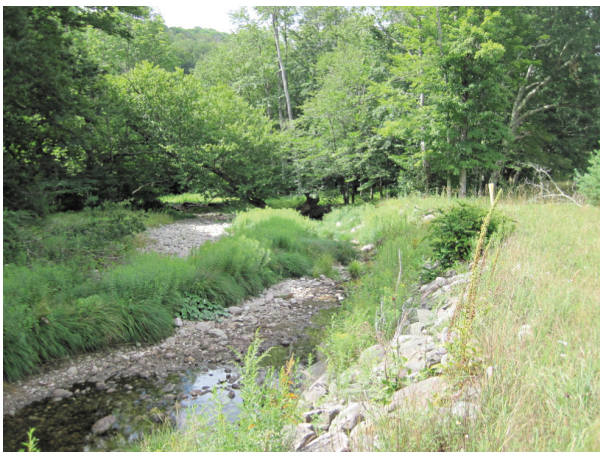
Directly downstream of the scour a sloped stone revetment was observed extending 175 feet from Station 40670 to Station 40495. The revetment was documented in good structural and functional condition as it appeared to be stabilizing the bank along a pasture with no riparian buffer, although some bank scour was observed at the downstream end aggravated by a woody obstruction. Efforts to revegetate along the top of the bank with white pine and white oak saplings were observed. (A1038, A1037) A large clump of barberry was observed on the left bank of the side channel across from the revetment. (A1039)

Sloped stone revetment on right bank (A1038)

INFRASTRUCTURE A sloped stone revetment was observed extending 175 feet from Station 40670 to Station 40495. The revetment was documented in good structural and functional condition as it appeared to be stabilizing the bank along a pasture with no riparian buffer, although some bank scour was observed at the downstream end aggravated by a woody obstruction. Efforts to revegetate along the top of the bank with white pine and white oak saplings were observed.

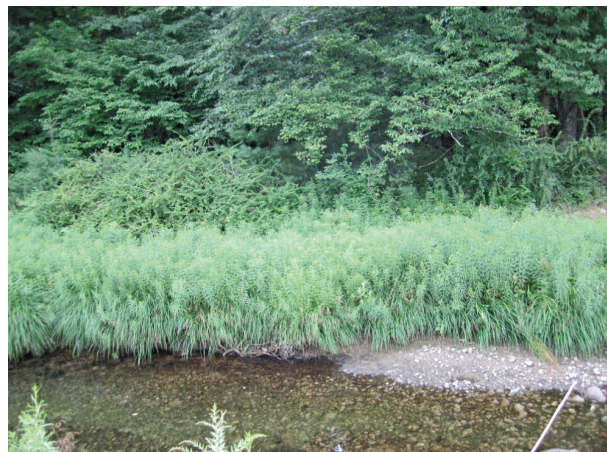
Japanese Barberry on left bank (A1039)

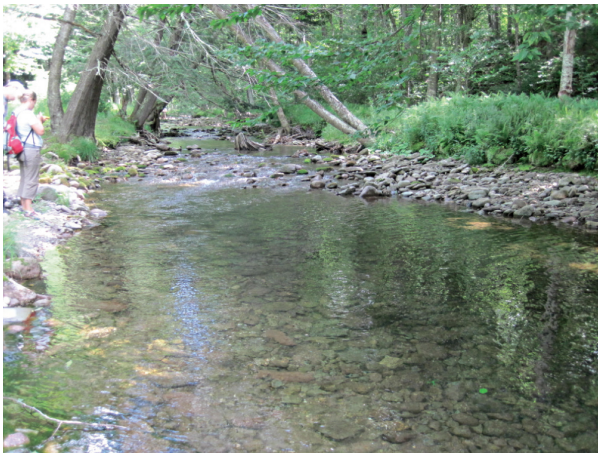
The side channel converges with the main channel at Station 40430 directly upstream of a headcut in the main channel bed followed by a scour pool. (A1043, A1046).

Headcut and scour pool in main channel (A1046)

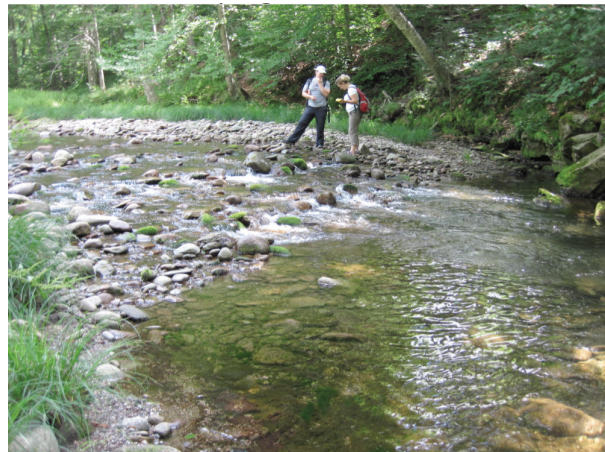
Headcut in cobble bed of channel (A1052)

(A1052) This series of headcuts is most likely associated with the exposed bedrock forming a grade and planform control on river migration observed slightly downstream on the left bank from Station 40180 through the end of WBMU11 at Station 40000.
