Neversink River West Branch

MANAGEMENT UNIT 15

WEST BRANCH MANAGEMENT UNIT 15
BETWEEN STATION 59000 AND STATION 64300

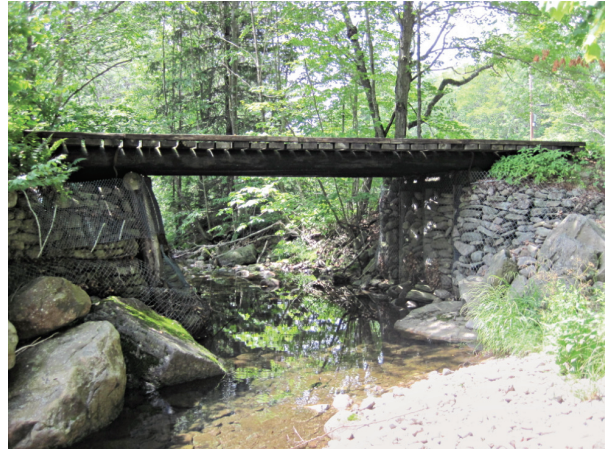
had a log and timber deck with stacked gabion abutments. (A775) The bridge was documented in good functional and structural condition. Depositional features, such as the side bar on the right bank upstream of this bridge, often form upstream of bridges where the bridge approaches restrict flows that would otherwise effectively transport sediment. The upstream deposition and encroachment indicate that this bridge does obstruct floodplain flows.

Private bridge (A775)

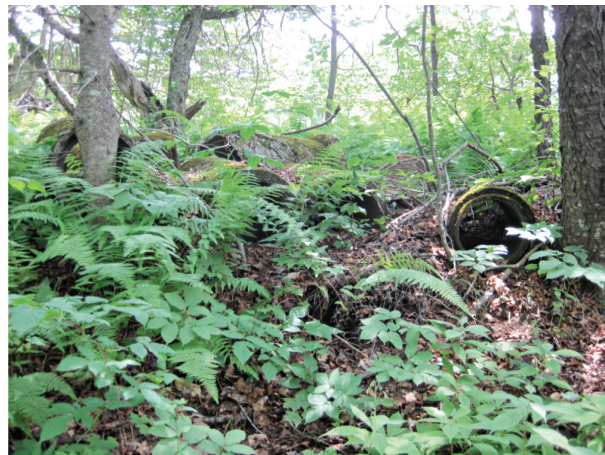
Directly downstream of the bridge a dumping site was observed on the left bank that included woody debris and discarded concrete culvert segments. (A782) It is recommended that this dump site be cleaned up to prevent additional pollution of the riparian buffer and main channel and the source of the garbage be identified to prevent future dumping. The potential for improvement of the riparian buffer from Station 64300 to 64100 should be investigated.

Dumping site on left bank (A782)

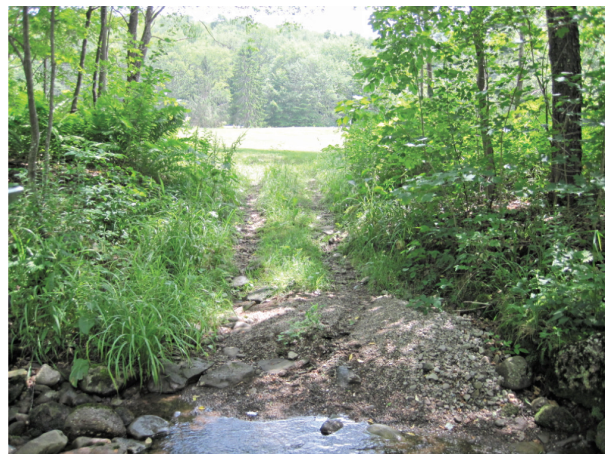
At Station 64200 a stream crossing was observed which possibly provided access to the Shandaken Rod & Gun Club pond and cabins during construction of the bridge. (A784) It is recommended that the previously disturbed banks of this crossing be planted to both prevent future crossings in this location and re-established a riparian buffer.

Crossing site (A784)

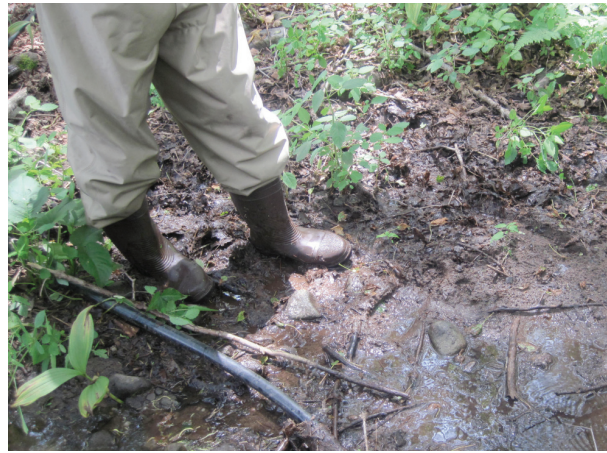
At Station 63800 the spillway from the Shandaken Rod & Gun Club pond joins the main channel. Fine sand and silt sedimentation as well as some active dumping of plastics sheeting and construction materials were observed in this spillway approximately 100 feet upstream of the convergence. (B596, B597) Approximately 70 feet upstream of the convergence an ATV trail was observed crossing the spillway (B602).

Fine sand and silt sediment (B596)

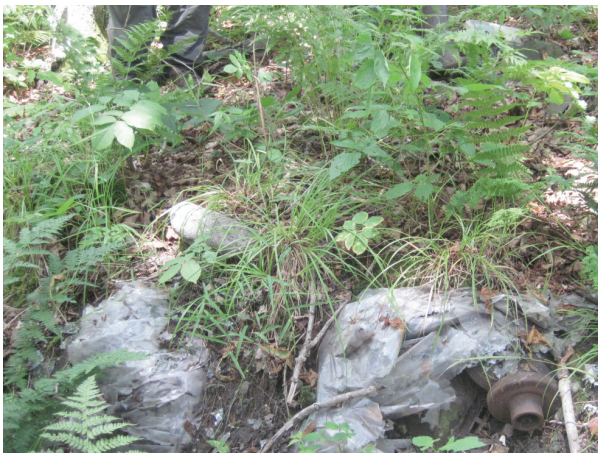
Dumping site (B597)

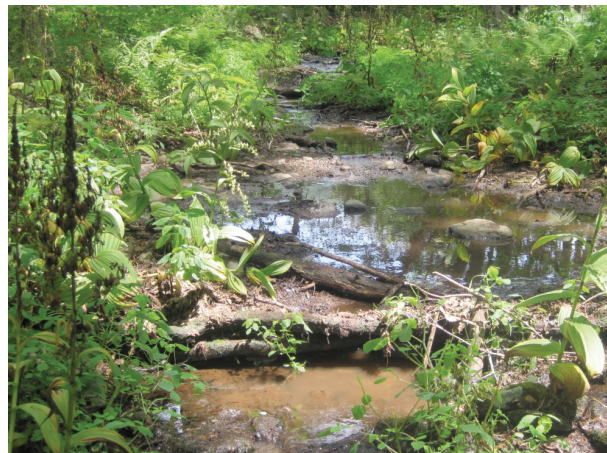
Convergence of ATV trail (B602)

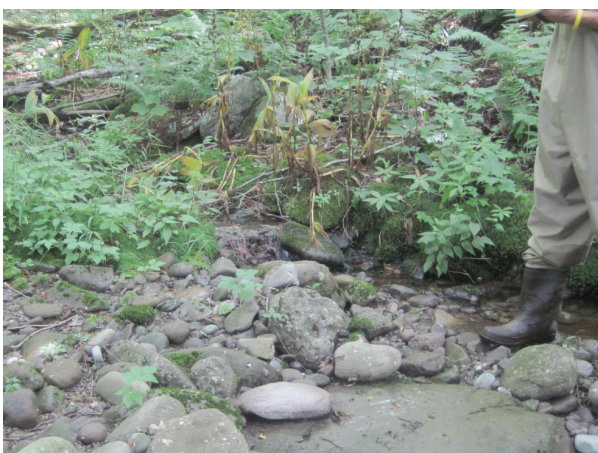
Tributary entering on left (B608)

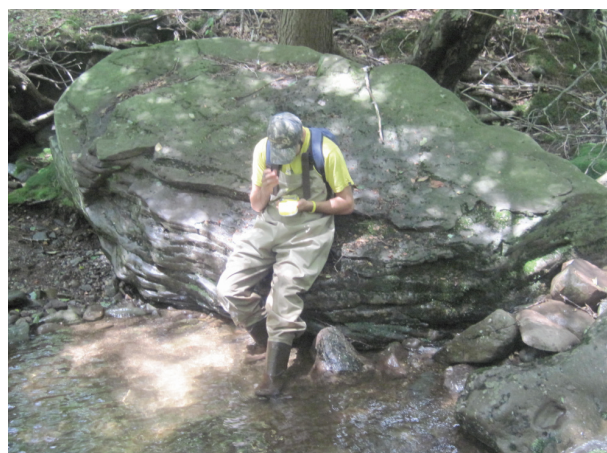
Large boulder controlling lateral movement (B617)

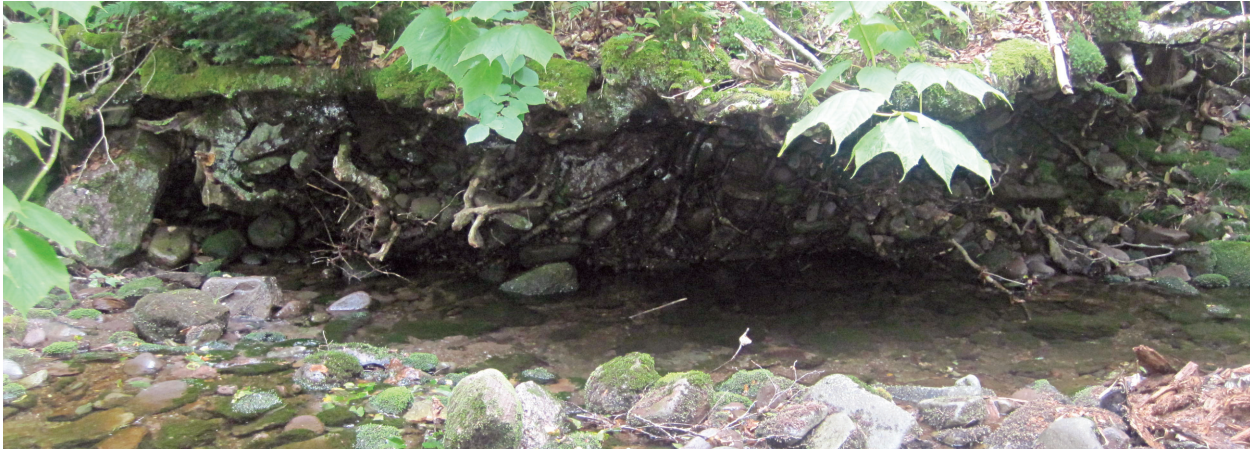
Eroding bank segment (B621)

A 22-foot long eroding bank segment was observed centered around Station 63520 that was documented with banks undercut by up to 3 feet due to hydraulic erosion. Due to the location of this erosion site separated from the road by a dense forest floodplain and the healthy woody riparian buffer on the top of the bank, it is anticipated that this bank will revegetate and stabilize without treatment (*passive restoration*), however, it is recommended that this site be monitored for changes in condition. (B621)

A 22-foot long eroding bank segment was observed centered around Station 63520 that was documented with banks undercut by up to 3 feet due to hydraulic erosion . Due to the location of this erosion site separated from the road by a dense forest floodplain and the healthy woody riparian buffer on the top of the bank, it is anticipated that this bank will revegetate and stabilize without treatment (*passive restoration*), however, it is recommended that this site be monitored for changes in condition

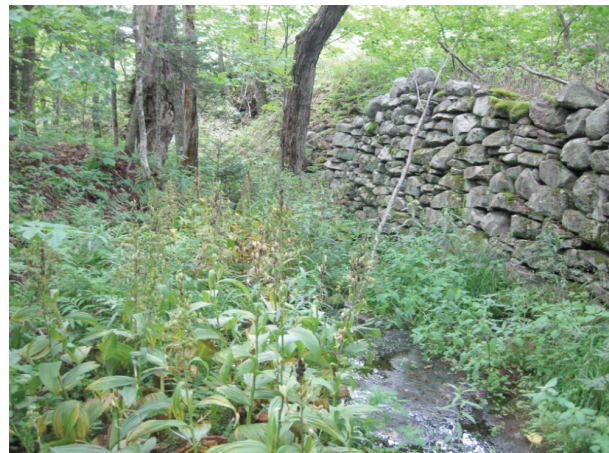
Stacked stone wall on right bank (A787)

From Station 63360 to Station 63310 a 50-foot stacked stone wall was observed in the forest floodplain on the right bank. It is possible that this berm was a containment wall for a mill race or an abutment for an old bridge. The proximity of Frost Valley Road indicates that perhaps it provided stabilization for the road before it was paved and managed for storm water runoff (According to Michael Kudish Frost Valley Road connected Branch, NY, a hamlet east of Frost Valley, and the Esopus watershed over the next ridge as early as 1875). (A787)

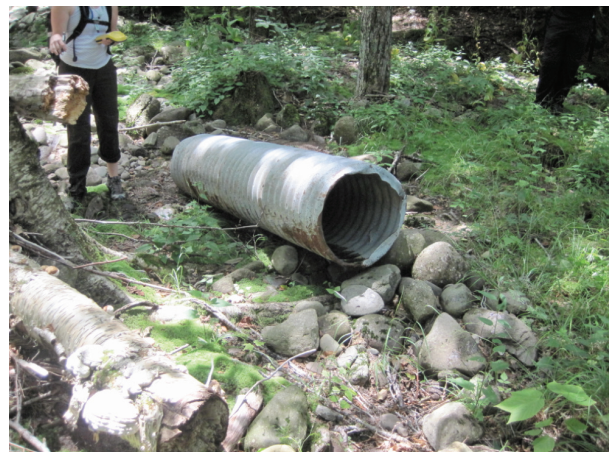
Culvert and woody debris (A789)

At Station 63210 more concrete culvert sections were observed that had most likely been conveyed downstream from the dumping site near the Shandaken Rod & Gun Club driveway bridge by a high flow event along with a woody debris jam nearby. (A789) Slightly downstream road drainage from Frost Valley Road joins the main stem creating a delta bar of fine sediments most likely deposited here from the road. (A790, A791)

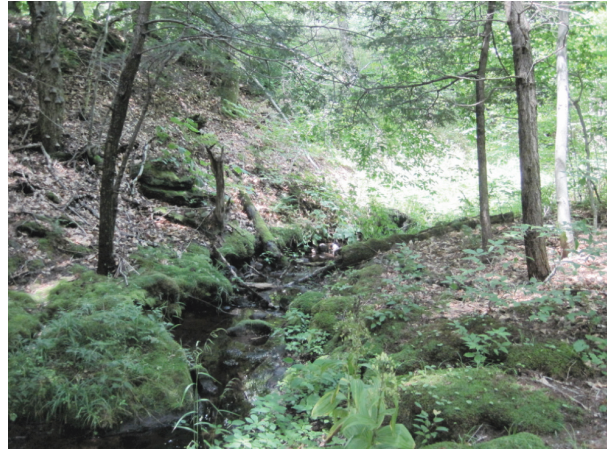
Road drainage joining main channel (A790)

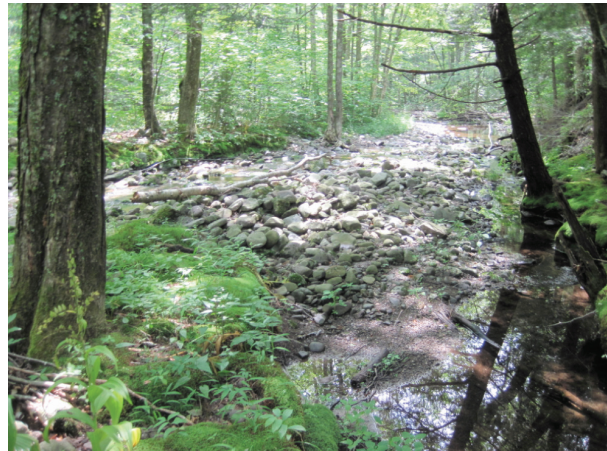
Delta bar composed of fine sediments (A791)

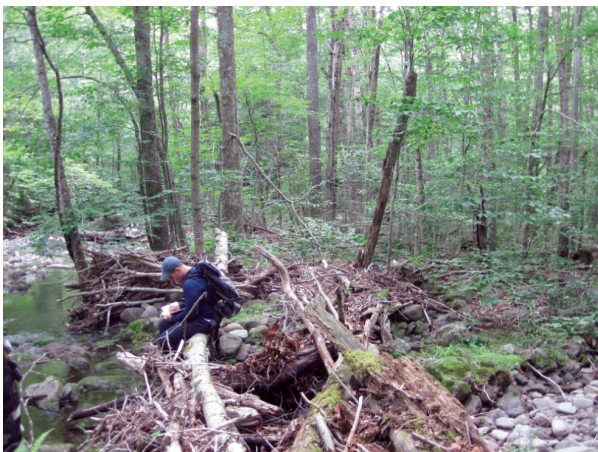
Divergence due to woody debris (A794)

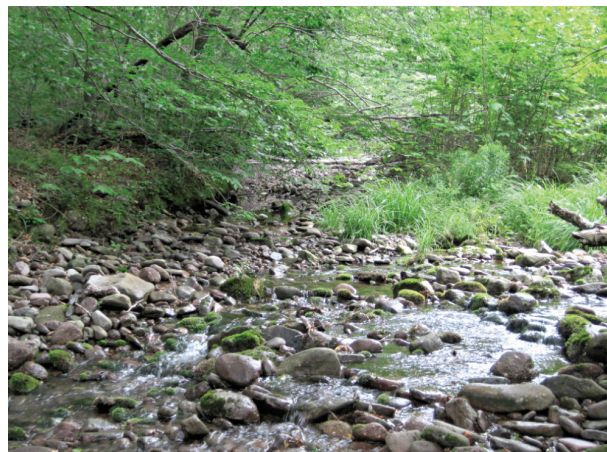
At Station 63080 a large woody debris jam diverts flow from an historic channel on the right into a channel that instead meanders to the left flowing adjacent to the left valley wall from Station 63000 to Station 62500. (A794) Throughout this semi-confined reach the forest floodplain on the right bank is braided with many side channels and flood chutes with cobble beds that convey flow during high flow events. (A815)

Side channel joining main channel (A815)

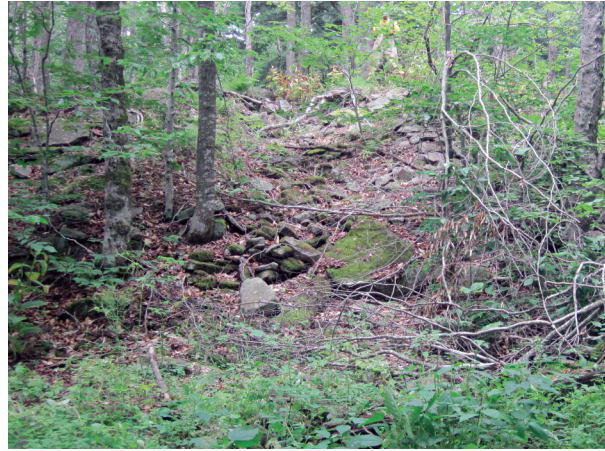
At Station 62700 there is a 36-foot long eroding bank segment caused by piped runoff from both the right valley wall and Frost Valley Road (BEMS NWB15_62700). (B634). Is it likely that this tributary conveys fine sediments from Frost Valley Road to the main channel in this location. It is

Eroding bank segment caused by piped runoff (B634)

At Station 62700 there is a 36-foot long eroding bank segment causing by piped runoff from both the right valley wall and Frost Valley Road (BEMS NWB15_62700). It is recommended that the drainage design for Frost Valley road be reviewed in this area, and sediment traps bioengineering techniques that would prevent addition of fine sediments to the river be considered in any renovations or replacements.

recommended that the drainage design for Frost Valley road be reviewed in this area, and sediment traps or bioengineering techniques that would prevent addition of fine sediments to the river be considered in any renovations or replacements.

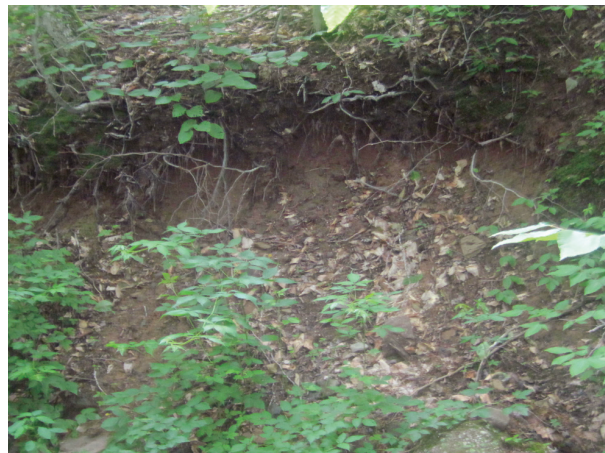
Approximately 300 feet downstream near Station 62400 a fine sediment source--exposed glacial till with high sand and clay content-- was observed. (B640) While maps of Catskill geology identify mostly alluvium of modern floodplains, moraines, and thick glacial deposits in this valley, it is possible that this is a small area of exposed lacustrine clay. It is recommended that the geology of this site be investigated for its potential water quality implications, and that the site be monitored for changes in condition.

Exposed glacial till with high sand and silt content (B640)

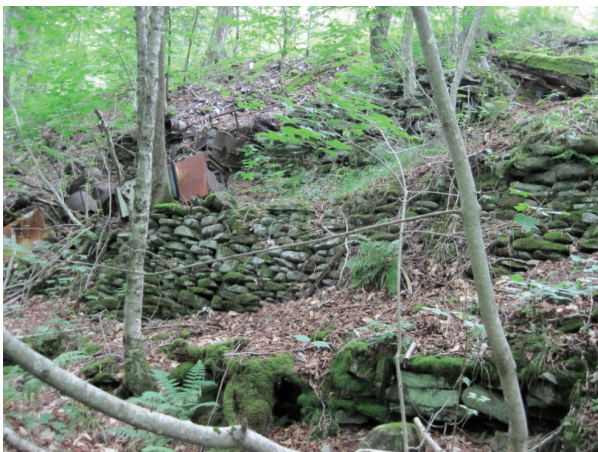
Three level stone wall terrace on right bank (A824)

into the terrace wall on three levels on the right bank. (A824) The bench surfaces created by the stone walls are an apparently inactive dump site. (A822) Slightly upstream of the berm there is an intermittent seepage that conveys flow down a chute through the berm into the main channel. (A825) It is possible that this berm was designed for bank stabilization to prevent bank failure on the steep terrace wall. It is recommended that this dump site be remediated to improve the integrity of the riparian buffer and stream, and that the road frontage be secured to prevent future dumping.

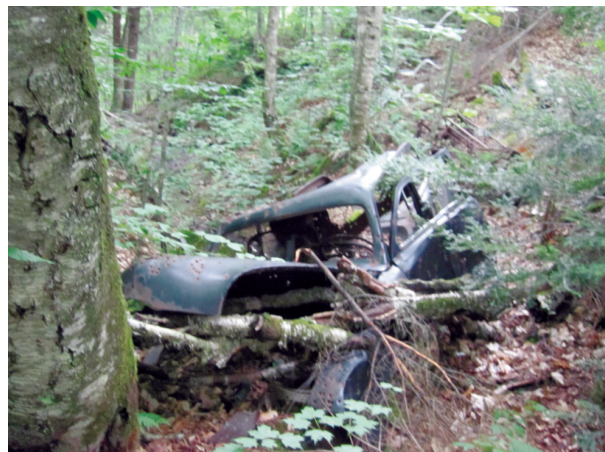
Car dumped on terraced berm (A822)

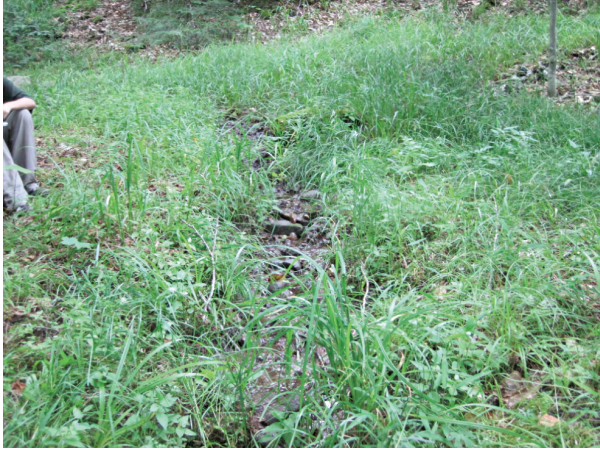
Chute conveying intermittent seepage (A825)

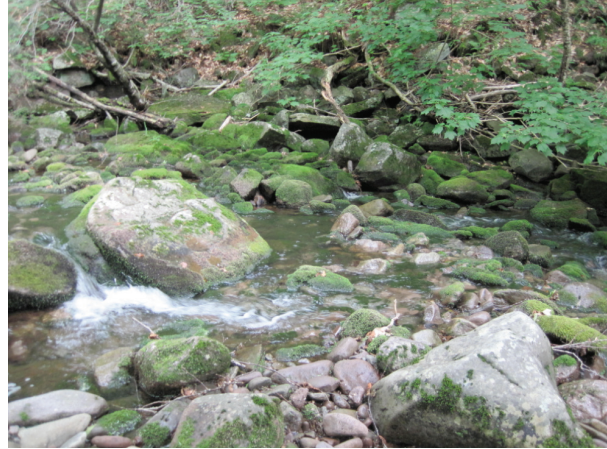
Headcut migrating upstream through cobble deposition (A827)

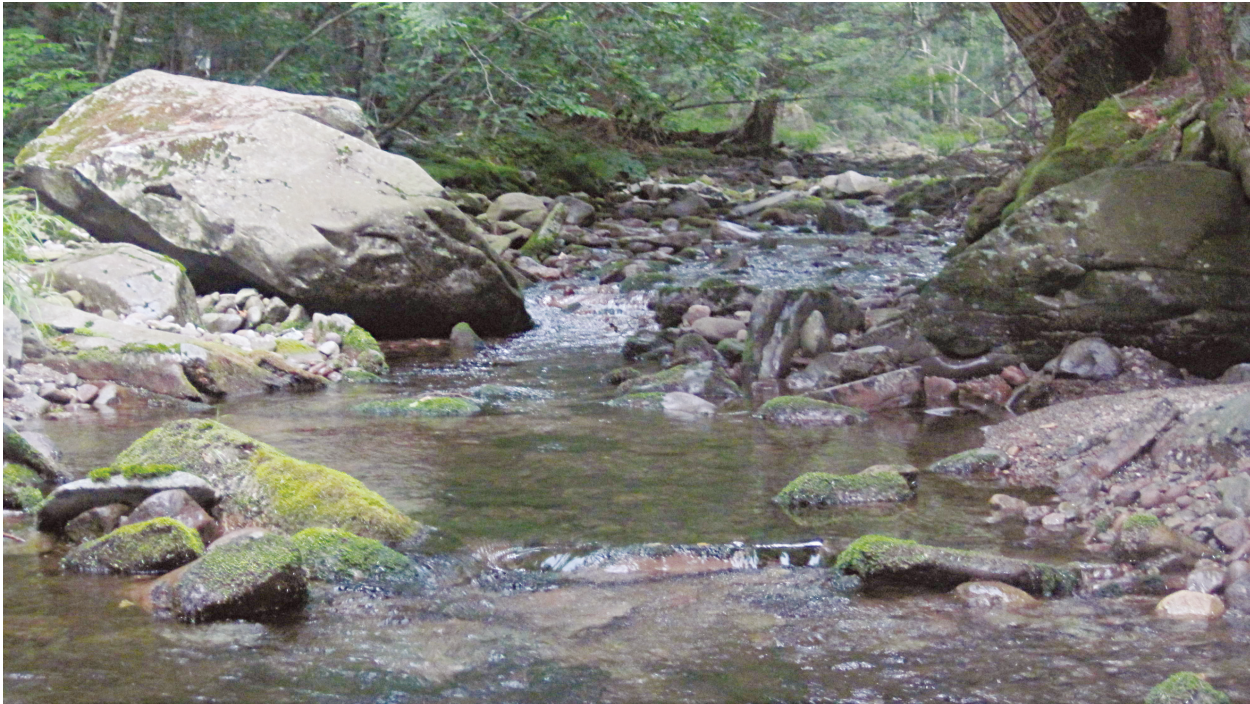
Large boulders constraining main channel (B650)

At Station 62000 the main channel becomes a series of step pools connected by steep cobble riffles, for approximately 500 feet. (B650) At this location, the channel is still relatively confined, with a low bankfull bench on the right bank leading to a steep terrace wall, and a similar terrace on the left bank. The channel is characterized by step-pools formed by woody debris and large boulders. Near Station 61600, a headcut appears to be migrating upstream through cobble deposition from a boulder control point on the left bank. (A827) Similar step-pool conditions characterize the channel from downstream at Station 61550.

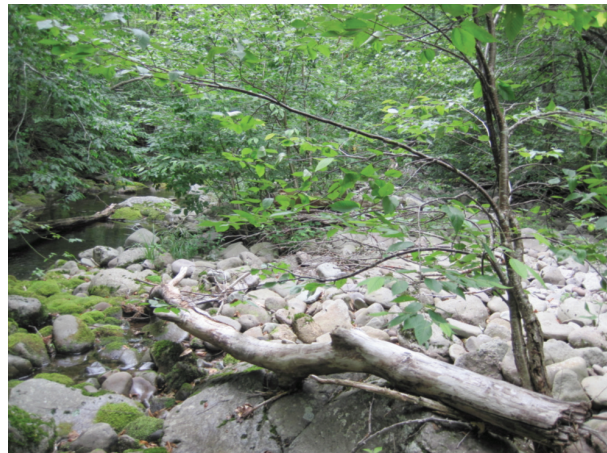
At Station 61200 there is a 20-foot wide depositional side bar on the right bank composed of imbricated cobbles and some woody vegetation (A832). At Station 61100 a second depositional side bar on the right bank has revegetated with shrubs. (A834) At Station 60950 a large log was observed lodged across the channel that has led to the formation of a cobble deposition bar upstream and a scour pool immediately downstream. (A835) Floodplains on the right and left banks become broader and more connected with the channel for the next 500 feet.

Depositional side bar on right bank (A832)

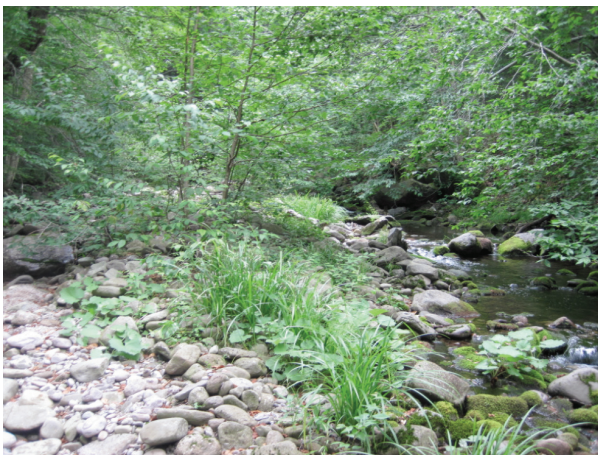
Side bar on right bank with sedge and vegetation (A834)

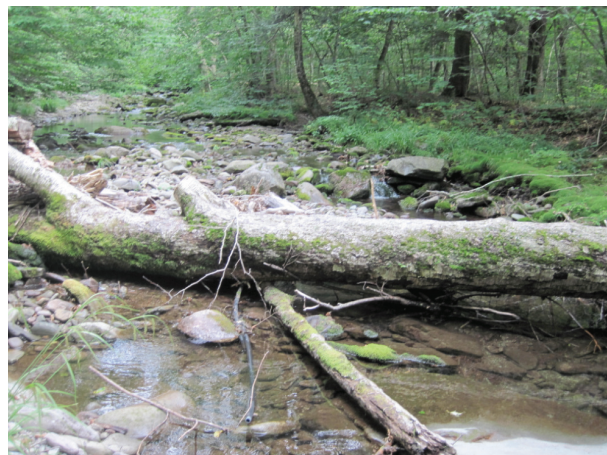
Large log in channel causing scour and deposition (A835)

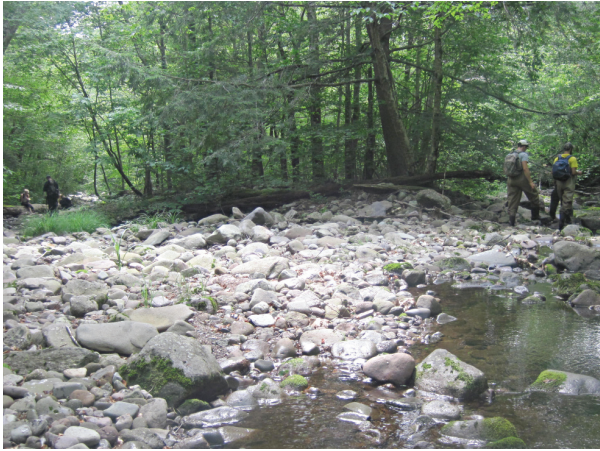
Divergence with aggradation upstream (B658)

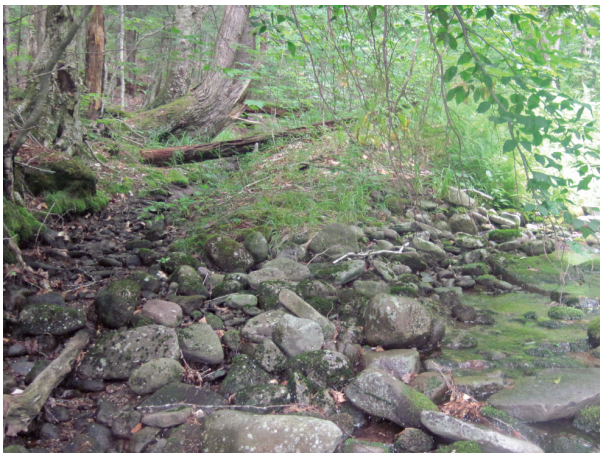
Near Station 60900 there is a well-used camp site on the right terrace. The channel splits approximately 100 feet downstream near Station 60800; aggradation was observed upstream of this divergence, (B658) and woody debris accumulations were observed in both channels. The side channel converges with the main channel at Station 60580. An intermittent tributary joins the main channel from the right bank at Station 60750. Piped flow from Frost Valley road was not observed near this location so it is likely that this is concentrated drainage from the right bank floodplain upstream of this location. (B659)

Intermittent tributary joining main branch (B659)

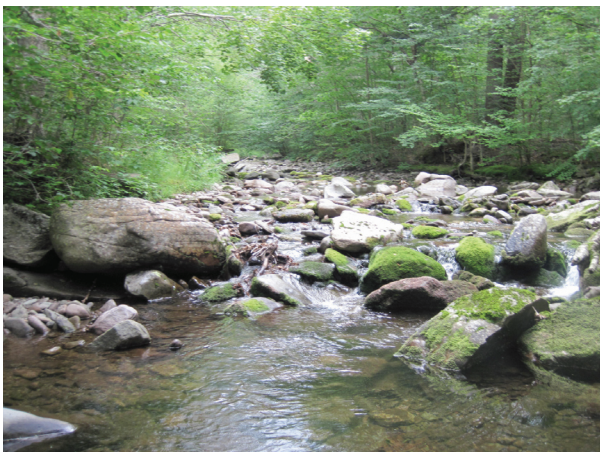
At Station 60450 a natural rock weir across the main, composed of large boulders and cobbles, forms a scour pool downstream. (A842) Immediately downstream of the weir the channel splits, with substantial wood debris observed in both channels, and three tributaries draining the left valley wall contribute to flow in that left channel before it rejoins the main channel at Station 60200. At the convergence a large boulder is controlling the grade of the main channel consistent with patterns upstream. (A845, A847) At Stations 60150 and 60090 unnamed

Large boulder and cobble rock weir (A842)

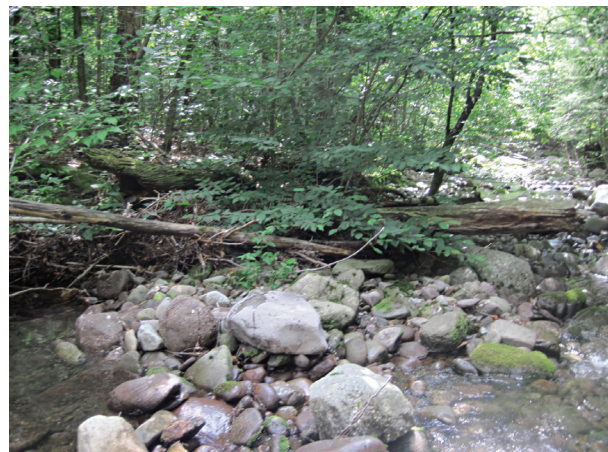
Woody debris on both the main and side channel (A845)

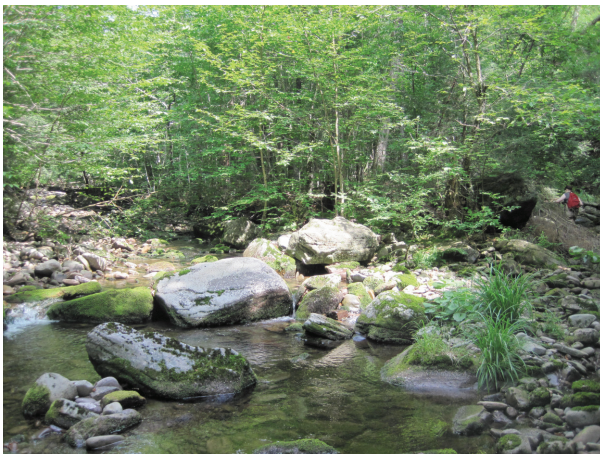
Looking upstream at convergence (A847)

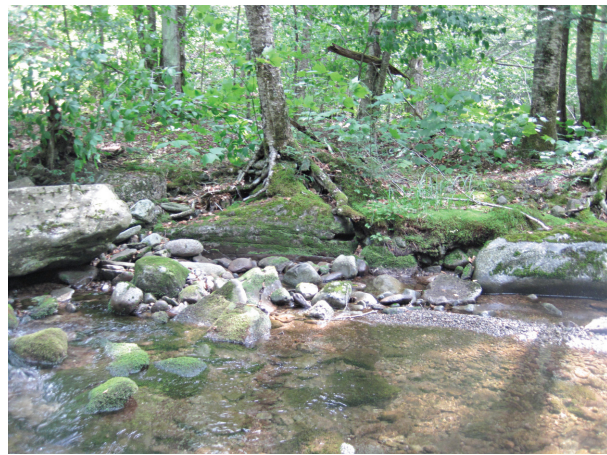
intermittent tributaries join the main channel from the right bank, and there is another large boulder on the left bank providing lateral control. (A849)

Boulders constraining lateral movement of main channel (A849)

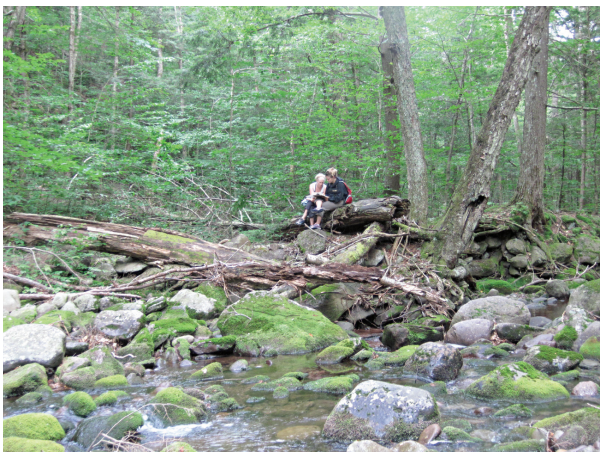
Near Station 59400 the channel splits again, with flow directed into a side channel against a terrace in the left valley wall by a large woody debris jam. (A860) Near Station 59340 the side channel flows adjacent to a mudstone ledge with an apparently unstable surficial layer of till, and numerous accumulations of woody debris in the channel. (B681) The side channel converges with the main channel again near Station 59290.

Large woody debris jam (A860)

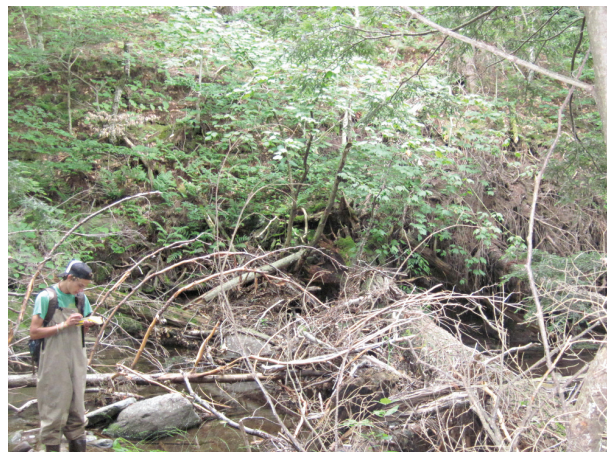
Large woody debris jam (B681)

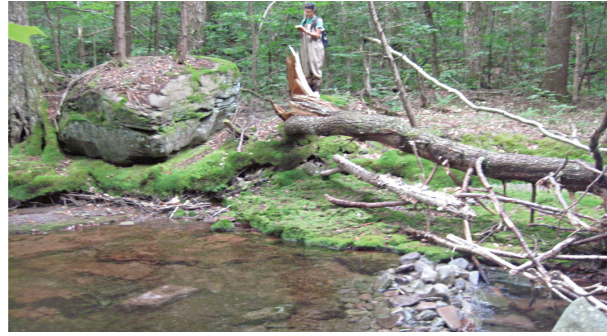
Through the end of the WBMU15, woody debris deposits were observed on both floodplains. At Station 59100 a large downed tree above bankfull was observed downstream of a pool with a mudstone bottom and a boulder forming an obstruction on the right bank. (B691)

Downed tree and boulder forming obstruction (B691)

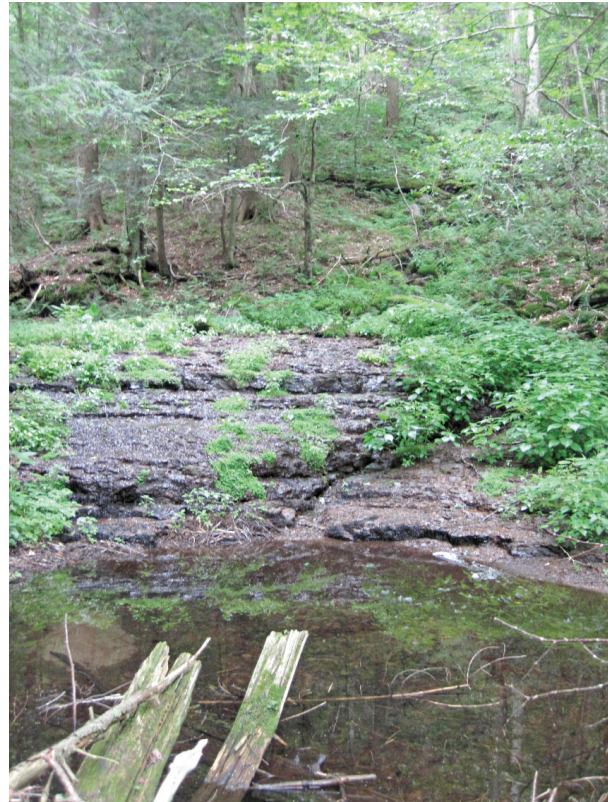
WBMU15 ends at Station 59000 where the river bed and both banks are composed of mudstone that forms a series of steps resulting in a 20-foot elevation drop. (A862)

Stream bed and both banks are composed of mudstone at station 59,000 (A862)
