Neversink River West Branch

MANAGEMENT UNIT 2

Summary of Post-Flood Recommendations

Stream Channel and Floodplain Current Conditions

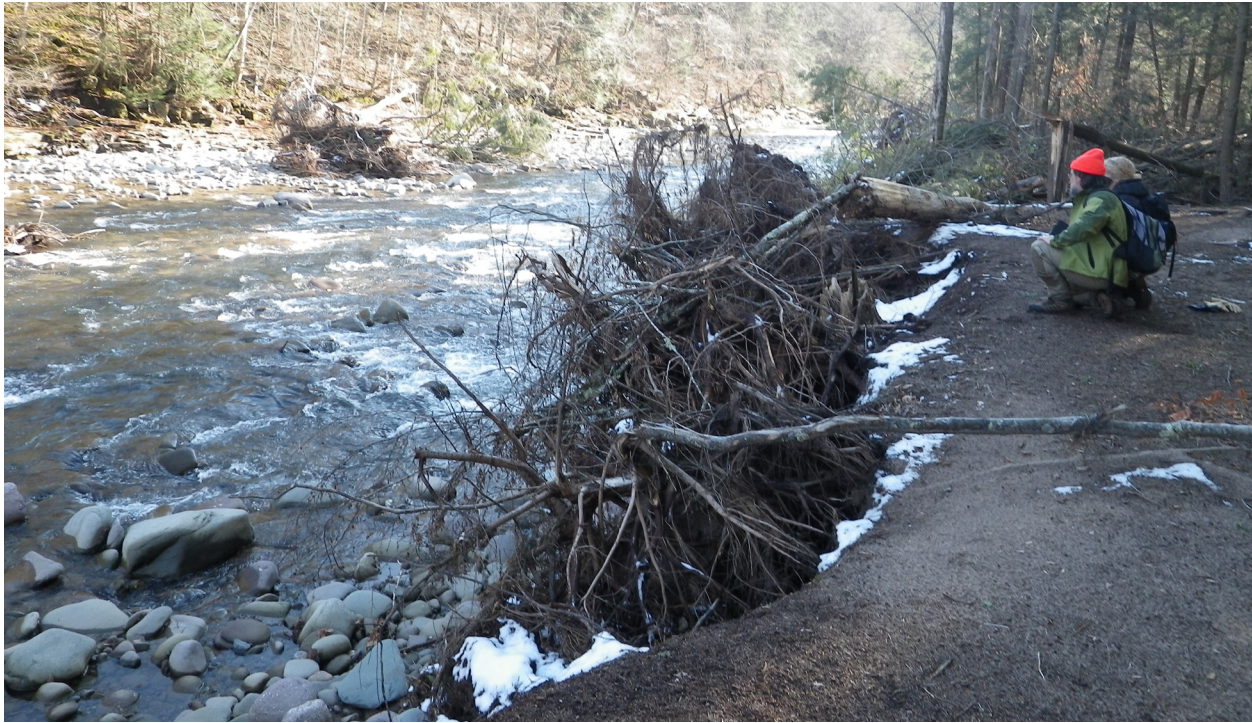
Significant erosion of the right bank, with mature trees undercut. Here, at Station 5600, flow from the main channel accesses the floodplain during overbank flow events, concentrating in a back-channel running nearly the length of this MU2. (2267)

The entire right bank along this floodplain should be assessed for potential *Assisted Restoration*, using soil bioengineering techniques to restablize the bank. Any trailing trees on undercut banks should be used as *rootwad revetment*. The floodplain on the right ends around Station 3000, where the back-channel running along Frost Valley Road converges with the main channel.

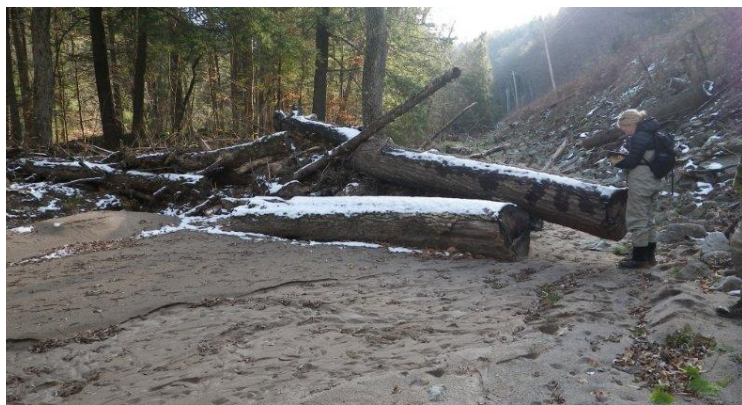
Large woody debris, obstructing floodplain flows in the backchannel along Frost Valley Road. Note grass in this backchannel, lower right, an indication of relatively low velocities on the floodplain floor. (2272)

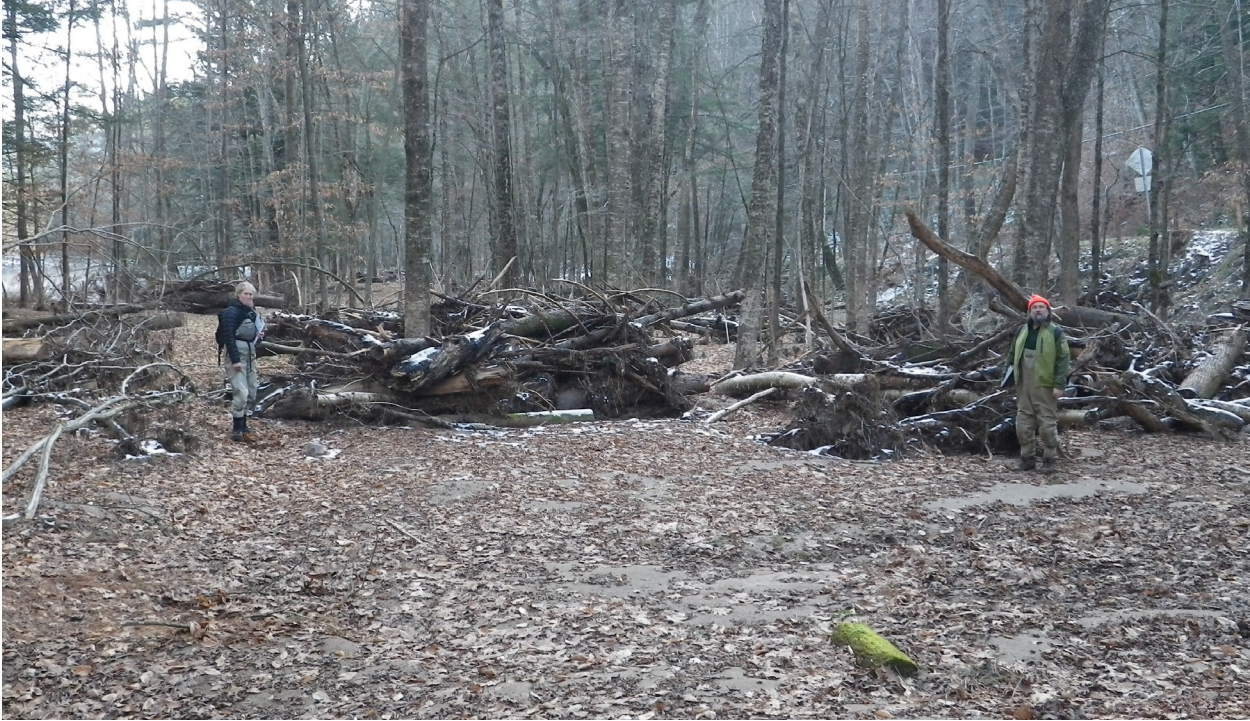
Large woody debris, locked into standing timber on the right floodplain, serving to slow velocities of overbank flows. (2273)

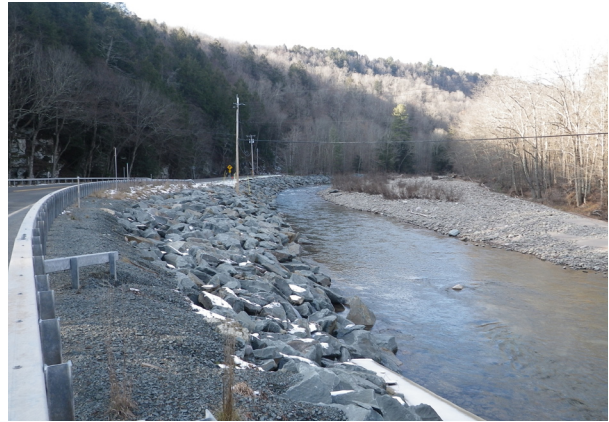
During the 2011 inventory, significant deposition of bedload following Irene was observed to have completely filled the left channel thread, to a height of six feet in some locations. With all of the flow confined to an undersized left channel, it was observed that erosion at the toe of the revetment was undermining the structural integrity of the placement, and the rip rap was sliding in several locations, exposing the underlying geotextile fabric.

Gravel bar, Dec. 14, 2011

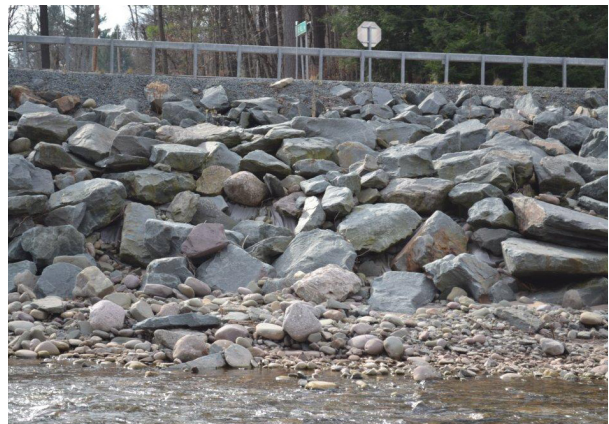
Failing rip rap, Nov. 12, 2012

with a protective bankfull floodplain bench adjacent to the rip-rapped embankment on the right, interplant the rip-rap revetment, reestablish floodplain connectivity on the left, and improve alignment through the bridge to hasten sediment transport.

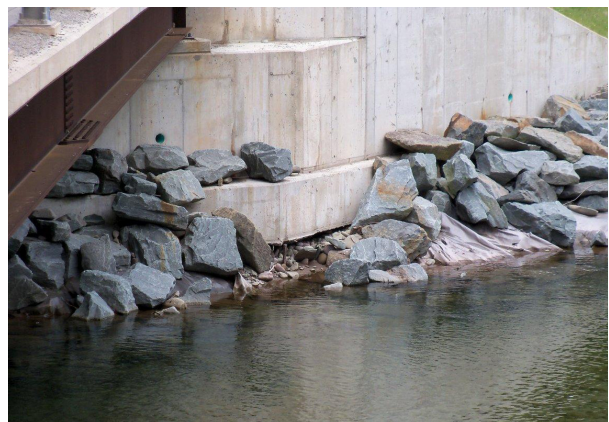
The bridge abutments on both sides were scoured by Irene's flows. This was consistent with expectations following the 2010 inventory, which resulted in recommendations *Full Restoration* to narrow the channel

Bridge abutment pre-repair, June 7, 2012
