Neversink River West Branch

MANAGEMENT UNIT 5

WEST BRANCH MANAGEMENT UNIT 5
BETWEEN STATION 15200 AND STATION 21300

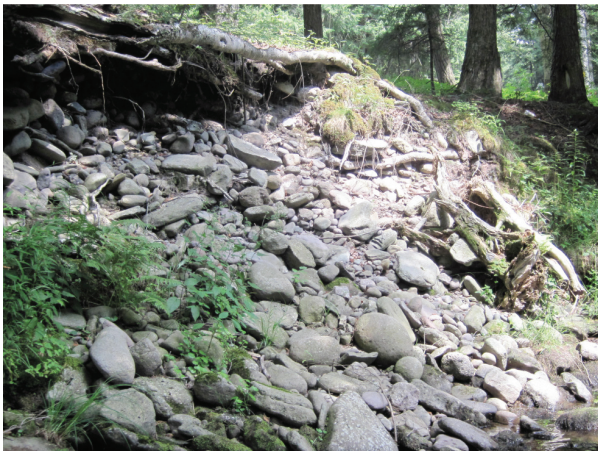
WBMU5 begins at Station 21300 near the confluence of Flat Brook. A 10-foot long eroding bank segment was observed on the right bank upstream of the confluence (BEMS NWB6_21300). This site was documented as active and appeared to be caused and aggravated by scour associated with the woody obstruction at the downstream extent of the erosion site leading to exposed alluvial materials on the 10-foot high bank. No vegetation was observed at the site, although the top of bank is a thick riparian forest. (A146).

Eroding segment on right bank (A146)

It is likely that the wide band of forested wetland between the main channel and Frost Valley Road will significantly slow erosion. Therefore, it is recommended that this bank be left to revegetate and stabilize without treatment (*passive restoration*) and that the site be monitored for changes in condition.

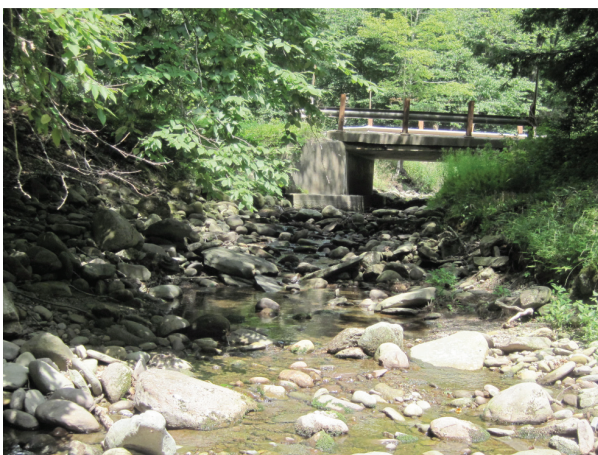
The confluence of Flat Brook was observed at Station 21240. The Flat Brook watershed is 1.6 square miles (3 stream channel miles) that drains the southern face of High Falls Ridge. Significant cobble aggregation was observed at the confluence of the tributary. (A147) Across from Flat Brook an intermittent tributary was observed on the left bank conveying flow over some exposed bedrock from the left valley wall to the main channel.

Aggregation at Flat Brook confluence (A147)

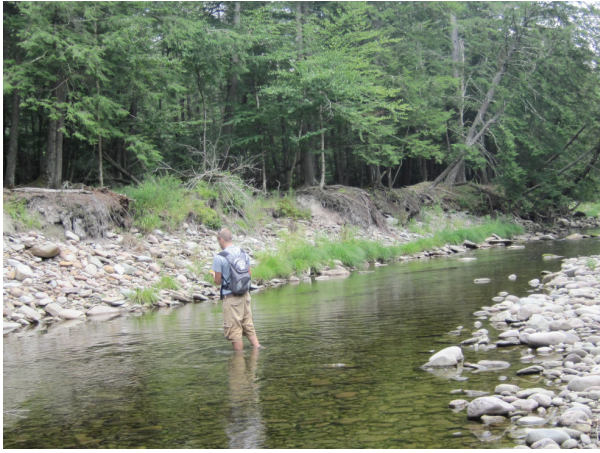
An eroding bank segment was observed on the right bank extending 414 feet from Station 20914 to Station 20500 (BEMS NWB5_20500). This bank site was documented as active with hydraulic erosion leading to bank scour and exposure of unstratified alluvial materials. Some vegetation was observed on the slope and there was hardening at

Eroding segment on right bank (A156)

An eroding bank segment was observed on the right bank extending 414 feet from Station 20914 to Station 20500 (BEMS NWB5_20500). This bank site was documented as active with hydraulic erosion leading to bank scour and exposure of unstratified alluvial materials.

the toe. (A156) It is likely that the wide band of forested wetland between the main channel and Frost Valley Road will significantly slow erosion. Therefore, it is recommended that this bank be left to revegetate and stabilize without treatment (*passive restoration*) and that the site be monitored for changes in condition.

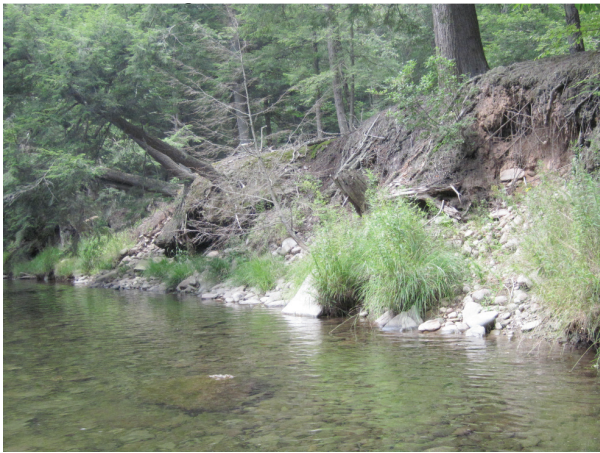
Eroding right bank (A159)

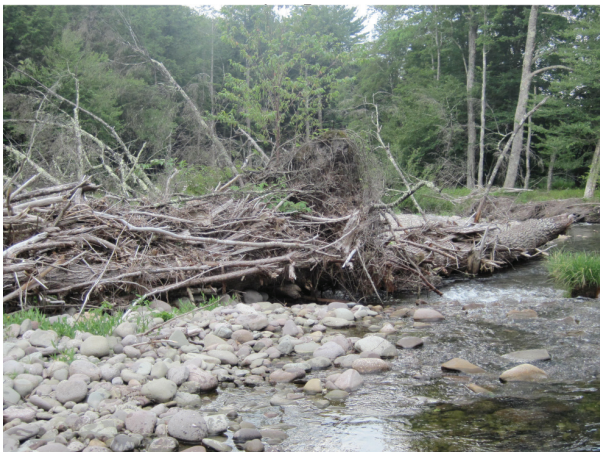
Divergence around vegetated cobble bar with log jam (A165)

Willows growing in the right bank floodplain near Station 19800 could provide a plant source for future restoration projects in this section of the Neversink River watershed. At Station 19800 the channel diverges around a vegetated cobble bar with a log jam and the upstream end of the depositional bar. (A165) Downstream of the divergence an eroding bank segment was observed on the left bank extending 290 feet from Station 19715 to Station 19425 (BEMS NWB5_19425). This bank site was documented as an active hydraulic erosion with soil failure, exposing stratified alluvial materials and some glacial till with a thin riparian buffer at the top of the bank. (A175) Recommendations for this site include assisted restoration to improve bank stability and establish a healthy riparian buffer.

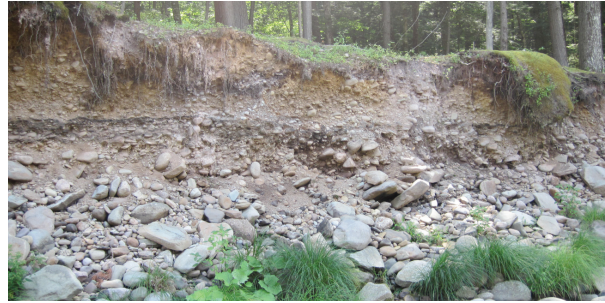
This bank site was documented as active, caused by hydraulic erosion and soil failure that has exposed alluvial materials with some undercut banks leading to overhanging trees. Some vegetation was observed at the toe while none was observed on the slope of this bank site. A headcut was observed in the channel bed at the convergence of a small side channel at the downstream end of this eroding bank segment. (P7280081) Recommendations for this site include *assisted restoration* to improve bank stability and prevent additional erosion and possible blockage of the channel due to failure of the undercut and leaning trees.

Active hydraulic erosion with soil failure site (A175)

An eroding bank segment was observed on the left bank extending 160 feet from Station 19135 to Station 18975 (BEMS NWB5_18975). This bank site was documented as active, caused by hydraulic erosion and soil failure that has exposed alluvial materials with some undercut banks leading to overhanging trees. Some vegetation was observed at the toe while none was observed on the slope of this bank site. A headcut was observed in the channel bed at the convergence of a small side channel at the downstream end of this eroding bank segment. Recommendations for this site include *assisted restoration* to improve bank stability and prevent additional erosion and possible blockage of the channel due to failure of the undercut and leaning trees.

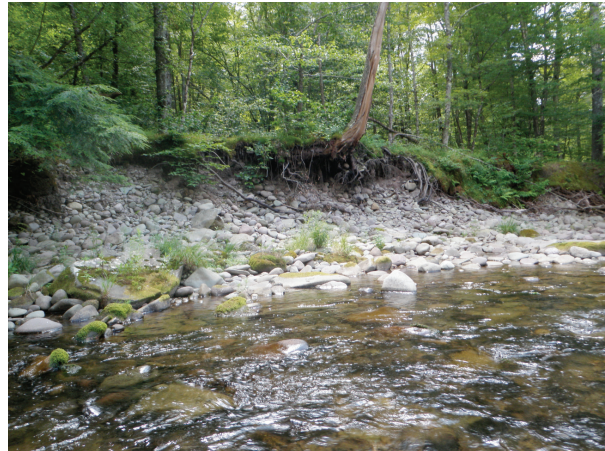
Hydraulic erosion exposing alluvial material (P7280081)

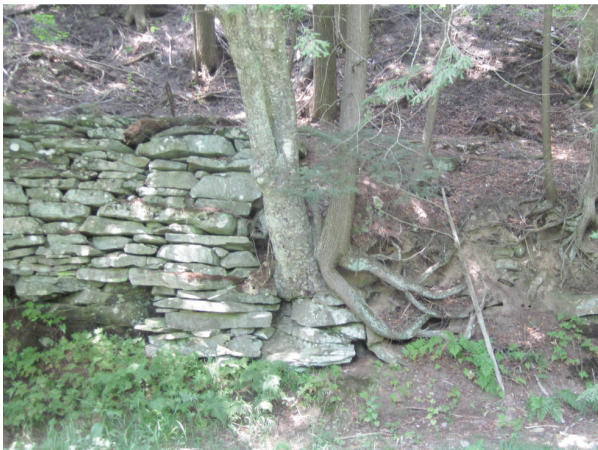
An old stacked rock berm was observed in the right floodplain near a small flood chute extending 50 feet downstream from Station 19300. (A181) Slightly downstream on the right bank of the flood chute near Station 19100 a rip rap revetment was observed that was most likely designed to protect Frost Valley Road when flow is conveyed in the flood chute during high flow events. The revetment was documented in fair structural and functional condition. (A183) This flood chute converges with the main channel at Station 18950.

Stacked rock berm in right floodplain (A181)

An old stacked rock berm was observed in the right floodplain near a small flood chute extending 50 feet downstream from Station 19300.

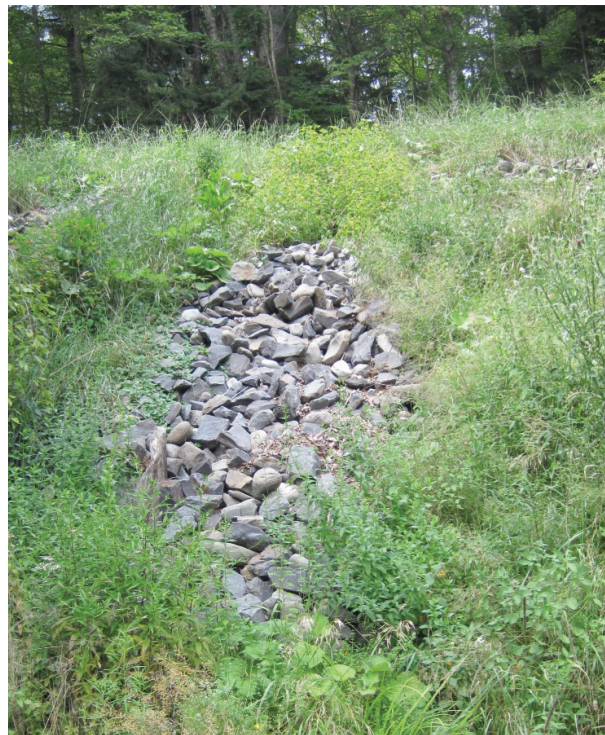
Rip-rap revetment protecting Frost Valley Road (A183)

INFRASTRUCTURE Slightly downstream on the right bank of the flood chute near Station 19100 a rip rap revetment was observed that was most likely designed to protect Frost Valley Road when flow is conveyed in the flood chute during high flow events. The revetment was documented in fair structural and functional condition.

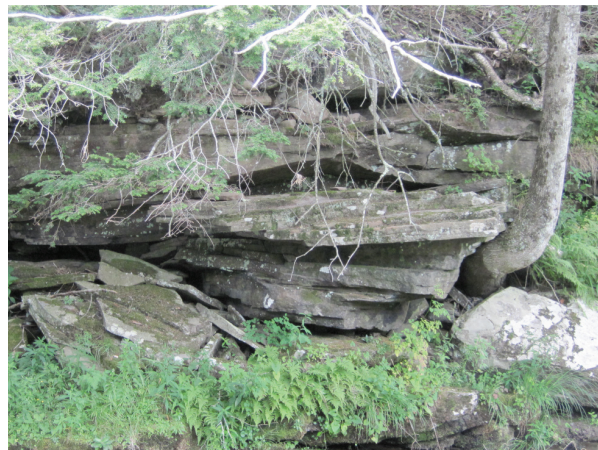
Exposed shale bedrock (A184)

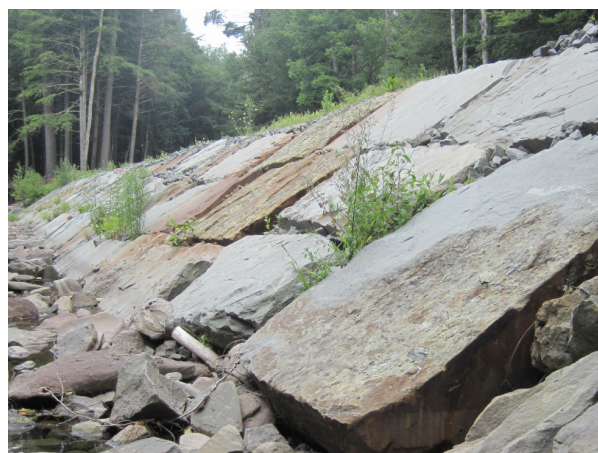
Sloped stone and rip-rap revetment (A188)

A sloped stone revetment with rip rap between rock slabs was observed on the right bank extending 200 feet downstream from Station 18800. This revetment was documented in good structural and functional condition.

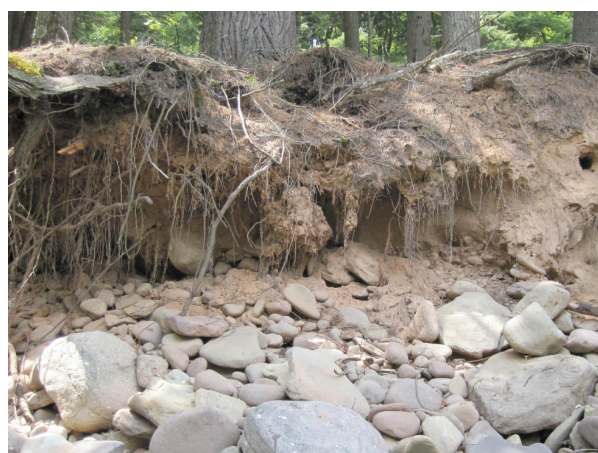
A short eroding bank segment was observed at the downstream end of the revetment extending 20 feet from Station 18620 to Station 18600 (BEMS NWB5_18600). This bank failure was appeared to be caused by hydraulic erosion and fluvial entrainment leading to scour and undercutting exposing stratified alluvial sediments and some glacial till. (A191) Due to the proximity of this site to the road and the revetment, recommendations for this site include *assisted restoration* to improve bank stability and establish a healthy riparian buffer.

Eroding bank segment downstream of revetment (A191)

A short eroding bank segment was observed at the downstream end of the revetment extending 20 feet from Station 18620 to Station 18600 (BEMS NWB5_18600). This bank failure was appeared to be caused by hydraulic erosion and fluvial entrainment leading to scour and undercutting exposing stratified alluvial sediments and some glacial till. Due to the proximity of this site to the road and the revetment, recommendations for this site include *assisted restoration* to improve bank stability and establish a healthy riparian buffer.

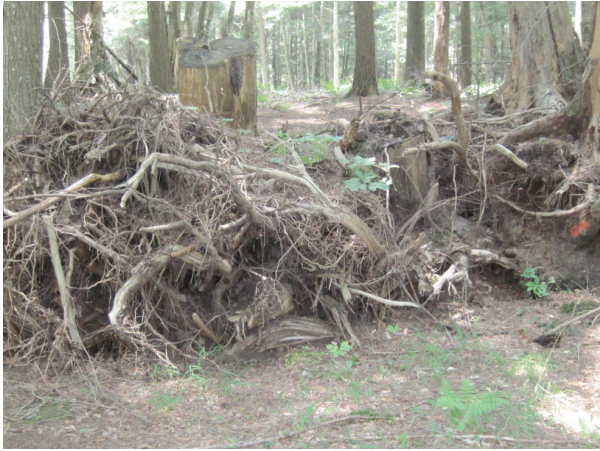
A dump site composed of dead root wads was observed on the right bank forested floodplain near Station 18350. (A193) A root wad and debris jam was observed on the right bank near Station 18180 which had led to sediment deposition upstream and some scour on the right bank downstream. (A194)

Dump site of dead root wads (A193)

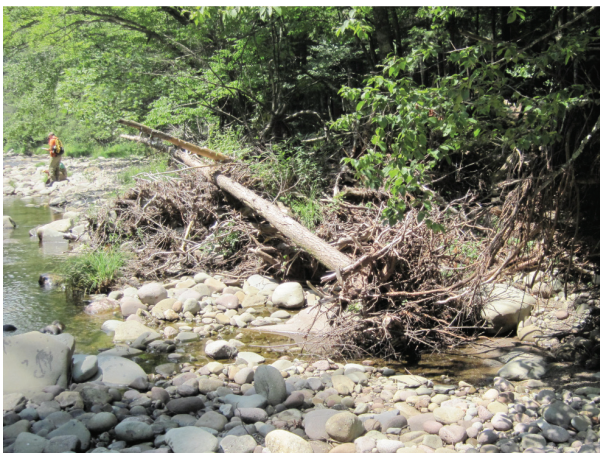
Deposition upstream of woody debris jam (A194)

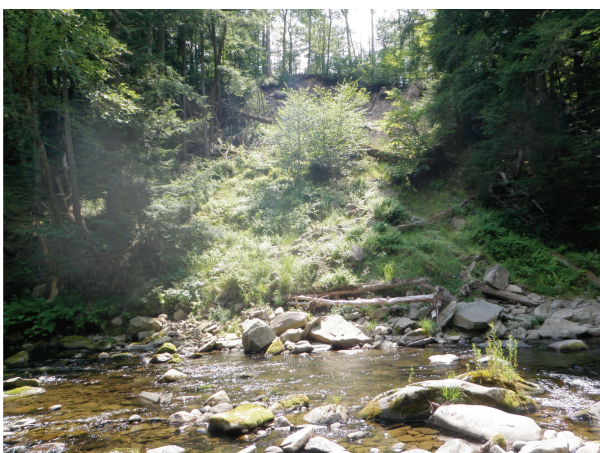
A bank failure site was observed on the right bank extending 60 feet from Station 18100 to Station 18040. Although the slope of the 60-foot high bank failure is thickly vegetated, surficial erosion (most likely runoff from the right valley wall)

Bank failure exposing glacial till (P7280091)

is leading to undercutting and entrainment of glacial till at the crown of the slope failure. This site was documented as a fine sediment source due to the exposure of glacial till, but is not a significant source of turbidity in the main channel. (P7280091) Recommendations for this site include further investigation and evaluation of the source of the surficial runoff, as well as *assisted restoration* to prevent further entrainment of fine sediments, improve bank stability, and establish a healthy riparian buffer.

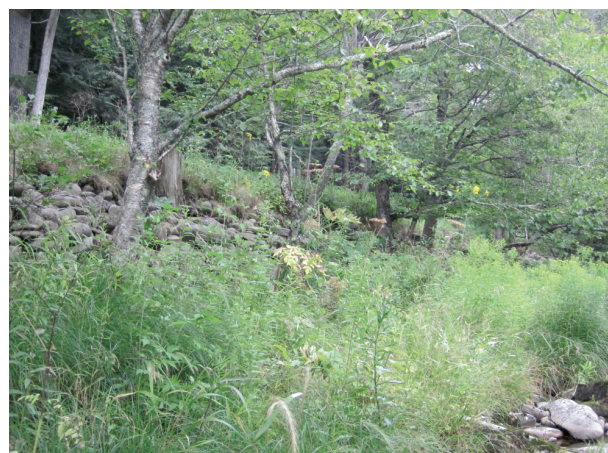
Dumped cobble revetment on right bank (A202)

A dumped cobble revetment was observed on the right bank from Station 17900 to Station 17800. This revetment was documented in food structural and functional condition although no scour protection was observed at the upstream end.

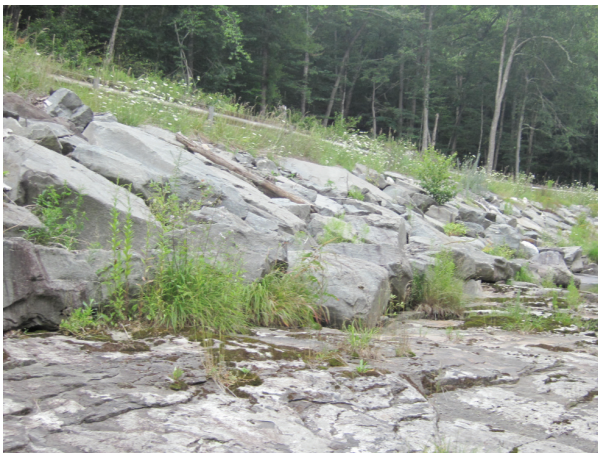
good structural and functional condition. (A208) The foundation of the revetment was keyed in to exposed bedrock that was observed in the left stream bed from Station 17750 to Station 17450. (A211) This revetment should be investigated for possible interplanting and enhancement of the riparian zone.

Sloped stone revetment on right bank (A208)

A sloped stone revetment was observed extending 250 feet on the right bank from Station 17700 to Station 17450. This revetment was documented in good structural and functional condition.

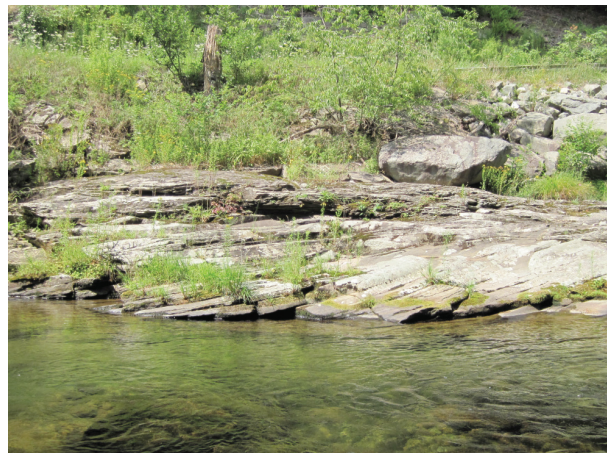
Revetment keyed into exposed bedrock (A211)

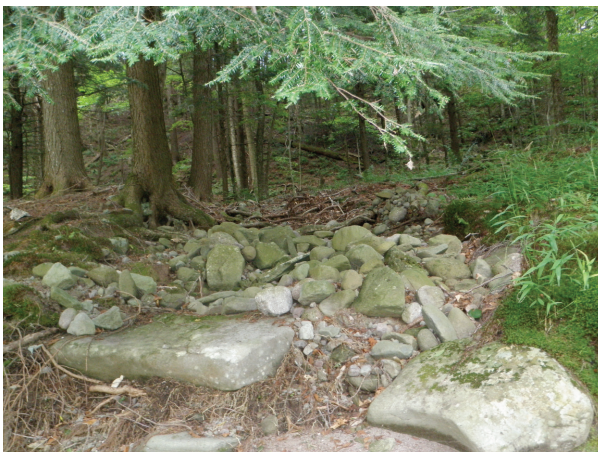
An intermittent stream converges with the main channel conveying flow from the left valley wall near Station 17200. The tributary has a cobble lined channel with some large boulders. (P7280094) Slightly downstream near Station 17020 a piped outfall conveying flow from the right floodplain and Frost Valley Road was observed in a stacked rock wall on the right bank. The piped outfall was constructed of a 15-inch diameter plastic culvert with 2 feet of outfall. The outfall protection was documented in fair condition. It is recommended that the water quality impacts of this outfall be investigated to better understand and possibly mitigate the water quality implications of this conveyance.

Intermittent stream with cobble and large boulders (P7280094)

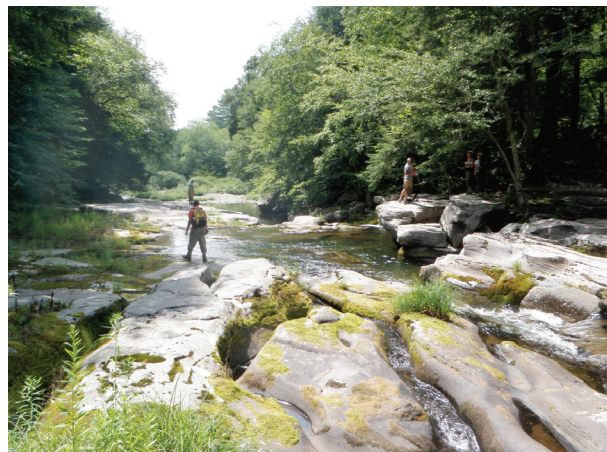
Bedrock cascade (P7280097)

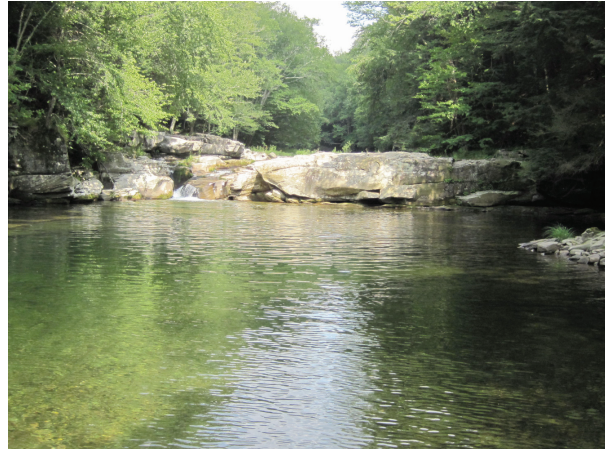
Large pool downstream of bedrock cascade (A216)

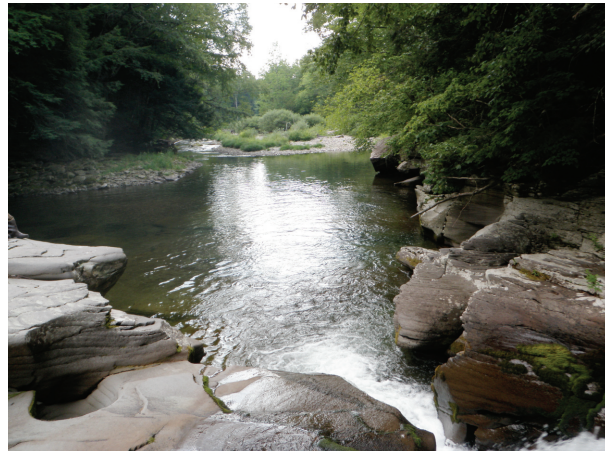
Looking downstream at pool from cascade (A7280098)

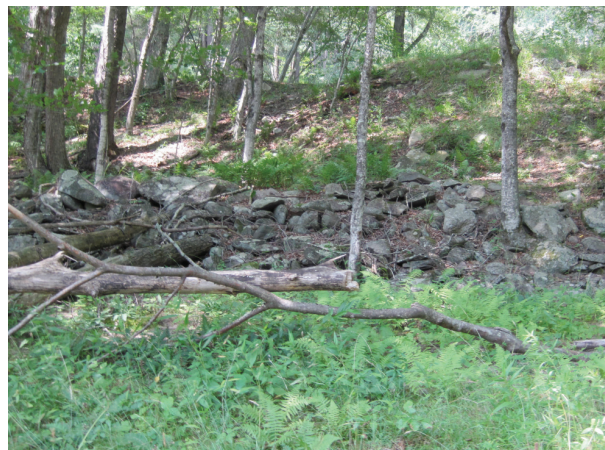
After a relatively straight and low gradient sediment transport reach from Station 17400 to Station 16400, a bedrock cascade with some large bedrock pools was observed from Station 16400 to Station 16150. According to the map of Forest Industries in the Catskills and the associated descriptions included in *The Catskill Forest: A History* by Michael Kudish (Purple Mountain Press, 2000), Charles Leroy and Lewis S. Trickey owned a sawmill with turning works that were formerly located a quarter-mile upstream from the convergence with Fall Brook in WBMU5, which coincides with this location. It is likely that the hydraulic pressure of a bedrock cascade near Station 16400 was utilized in sawmill operations. According to Beers' 1875 Atlas, it was located on the left bank and is believed to be operational through at least 1880. A large pool extends 100 feet downstream of the bedrock cascade, and a cobble depositional feature begins at the downstream end of the pool near Station 16050. (P7280097, A216, P7280098) A stone berm was observed along the right bank of the pool parallel to the road from Station 16155 to Station 16100. The berm was documented as 4 feet wide and 4 feet high. (A218)

Stone berm along right bank (A218)

A stone berm was observed along the right bank of the pool parallel to the road from Station 16155 to Station 16100. The berm was documented as 4 feet wide and 4 feet high.

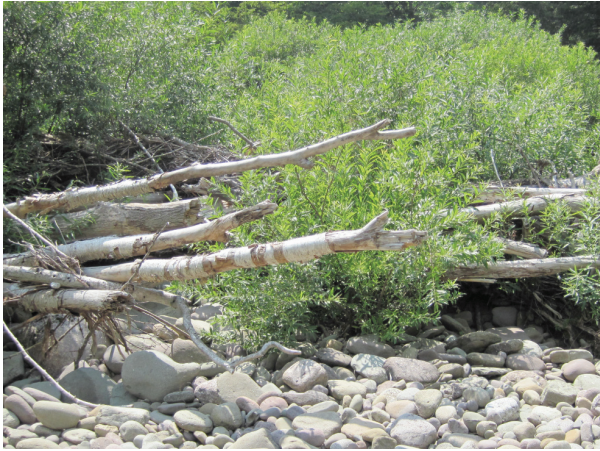
Two large woody debris accumulations were observed near the upstream end of the vegetated depositional point bar observed on the right bank from Station 16050 to Station 15600. (A219 and P7280100) The combined affects of these woody

Woody debris accumulation (A219)

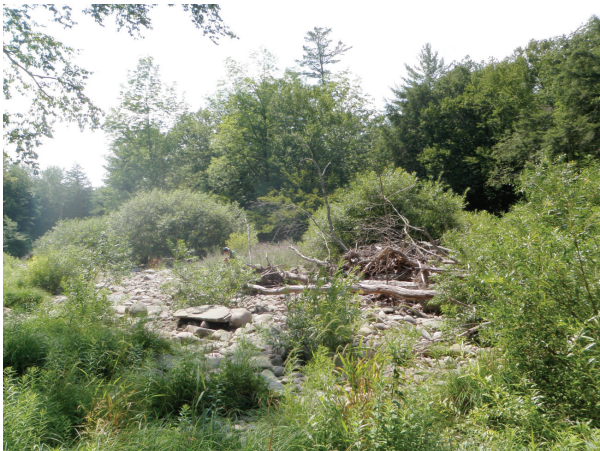
Woody debris accumulation (P7280100)

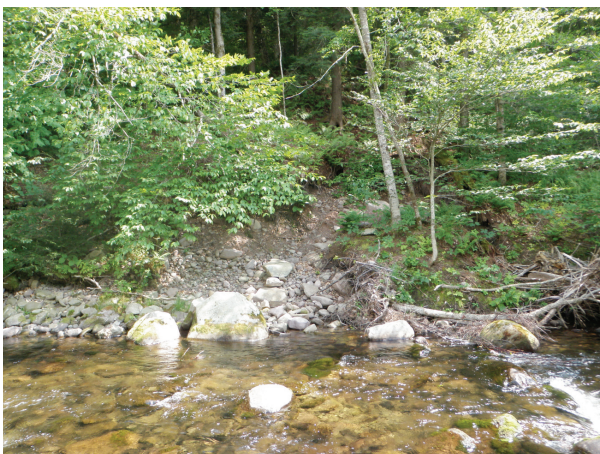
Eroding left bank segment (P7280103)

An eroding bank segment was observed on the left bank of the main channel across from the point bar, extending 30 feet from Station 15830 to Station 15800 (BEMS NWB5_15800). The failure appeared to be caused by hydraulic erosion and soil failure resulting in exposure of stratified alluvial materials. A thick riparian buffer was observed on the top of the bank, and the site appeared to be hardening at the toe. (P7280103) It is likely that this bank will continue to vegetate and stabilize without treatment (*passive restoration*). It is recommended that this site be monitored for changes in condition.

An eroding bank segment was observed on the left bank of the main channel across from a point bar, extending 30 feet from Station 15830 to Station 15800 (BEMS NWB5_15800). The failure appeared to be caused by hydraulic erosion and soil failure resulting in exposure of stratified alluvial materials. A thick riparian buffer was observed on the top of the bank, and the site appeared to be hardening at the toe.

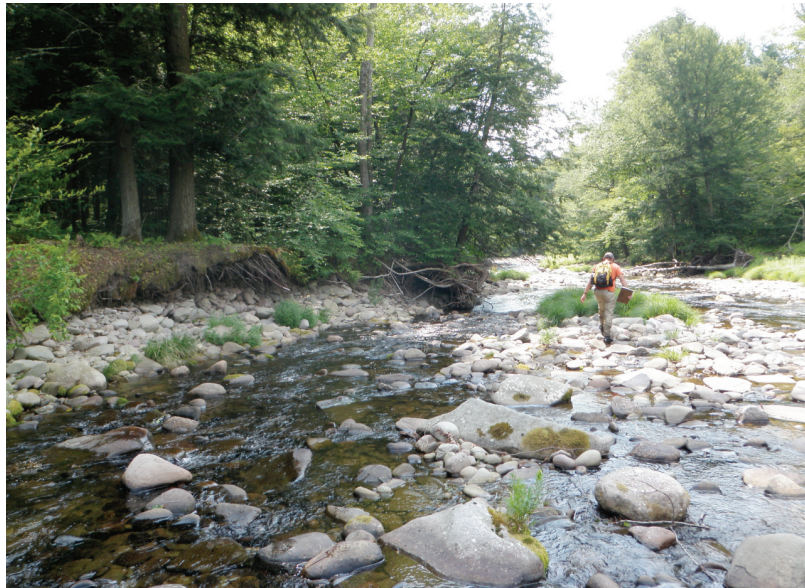
A second eroding bank segment was observed on the right bank of the main channel at the convergence of the dry side channel, extending 75 feet from Station 15750 to Station 15500 (BEMS NWB5_15500). The bank scour appeared to be caused by hydraulic erosion and fluvial entrainment which is undercutting the bank and exposing root of the riparian vegetation at the top of the bank. A transverse bar and headcut were observed in the main channel directing flow toward the eroding bank. Some sedge was observed growing at the toe of the bank although the bank scour was documented as active. (P7280106)

Bank retreat can be expected in this area as all flow has been diverted into this channel leading to higher flows and lower channel gradient in this section facilitates lateral migration towards both banks. However, the wide band of riparian forest at the top of this bank will significantly slow or prevent erosion. Therefore, it is recommended that this bank be left to stabilize without treatment (*passive restoration*) and that the site be monitored for changes in condition.

Transverse bar and headcut (P7280106)

An eroding bank segment was observed on the right bank of the main channel at the convergence of a dry side channel, extending 75 feet from Station 15750 to Station 15500 (BEMS NWB5_15500). The bank scour appeared to be caused by hydraulic erosion and fluvial entrainment which is undercutting the bank and exposing root of the riparian vegetation at the top of the bank. A transverse bar and headcut were observed in the main channel directing flow toward the eroding bank. Some sedge was observed growing at the toe of the bank although the bank scour was documented as active.

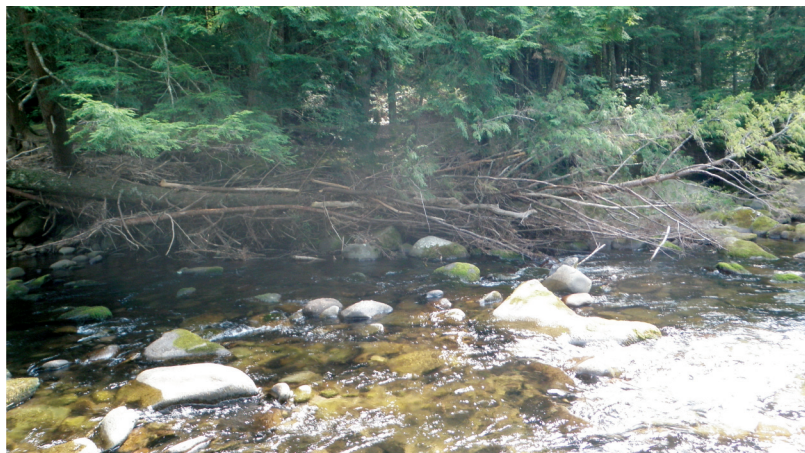
A downed tree was observed causing some bank scour on the right bank near Station 15450, and some woody debris were observed on the left bank near Station 15280. (P7280110, A221)

Downed tree causing bank scour (P7280110)

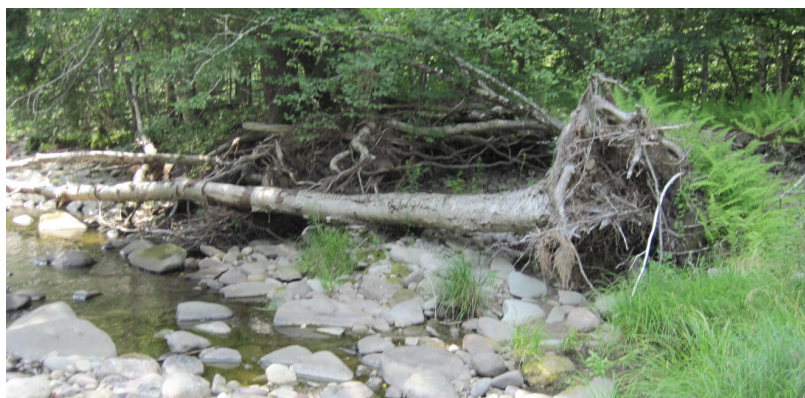
Woody debris along left bank (A221)
