Management Unit 20

Ulster County - Town of Shandaken
Between Cross Section 186 & 187 to Cross Section 189

Management Unit Description

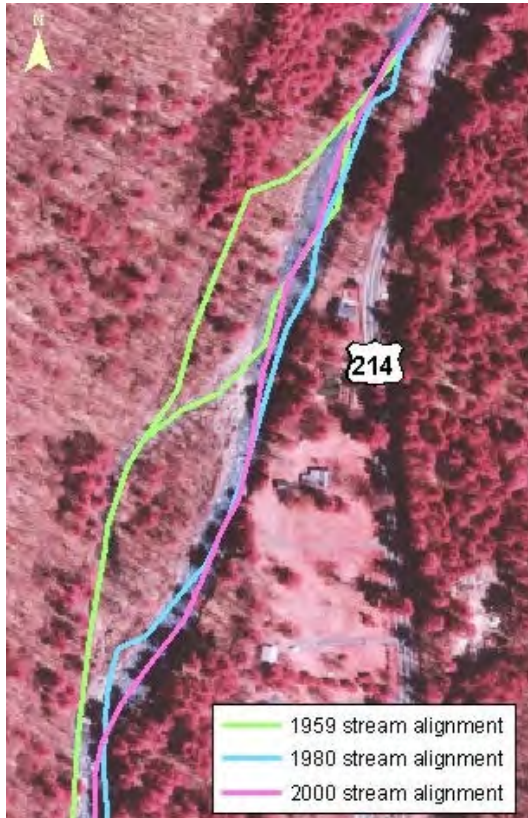
Figure 2 Historical stream channel alignments in Management Unit 20

As seen from the historical stream alignments, the channel has shifted significantly over the years (Fig. 2).

Between 1959 and 1980 the channel migrated to the left in this management unit, toward NYS Route 214. This migration most likely occurred during a single large flood event. This channel shift has caused many erosion problems at the residential properties in the unit.

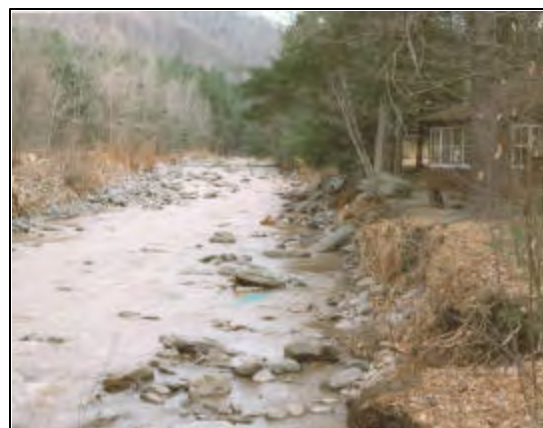
Figure 3 Erosion from 1996 Flood at VanNorstrand Property, looking upstream

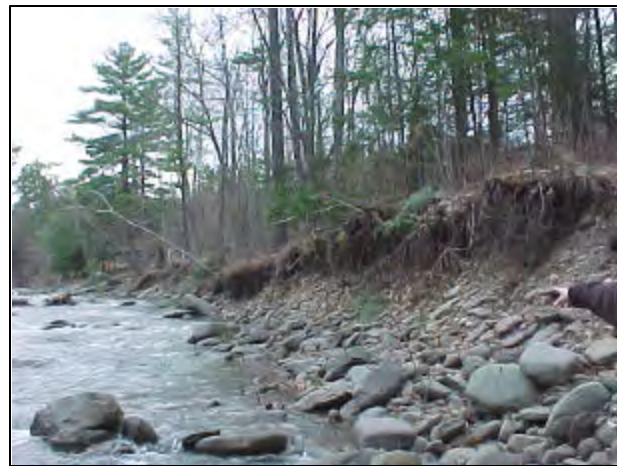
As the channel becomes entrenched, stream type transitions to F3 for the remaining 510 ft. of this management unit. At the top of this reach, the landowner has installed 156 ft. of rip-rap along the left stream bank (Inset F). This rip-rap has begun to fail at the toe of the revetment. At the downstream end of this rip-rap, a 242 ft. stretch of eroded, devegetated bank begins (Inset E). If not treated, this bank will continue to erode, possibly undermining trees in the mature forest on the terrace beyond the bank (Fig. 5).

Figure 5 Stream bank erosion, looking upstream

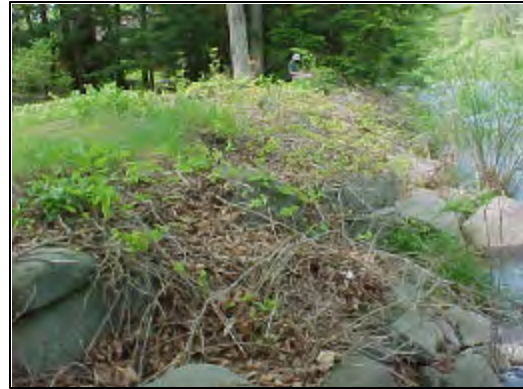
Figure 8 Planting Site #53

Planting site #53 is located at the first revetment described in this management unit (Fig. 8). The stream bank is approximately 5 ft. in height with a few shrubs, sloping back to a grass lawn. Woody debris has been dumped on the stream bank.

Joint planting of the existing rip-rap, by inserting plantings into the soil between the openings in the rip-rap rocks, is recommended at this site. Joint planting will strengthen and increase the longevity of this rip-rap. These plantings will also improve the aquatic habitat by providing shade, resulting in cooler water temperatures. Willow *fascines* should be planted along the toe of the stream bank to provide protection against toe erosion.

The practice of dumping yard clippings, including loose brush, on the stream bank can kill existing bank stabilizing vegetation, inhibit growth of new vegetation and contribute to bank instability. As grass clippings and leaves decompose they input unnecessary nutrients into the stream causing the depletion of the dissolved oxygen needed by fish and other aquatic organisms. As a result, this practice is not recommended.

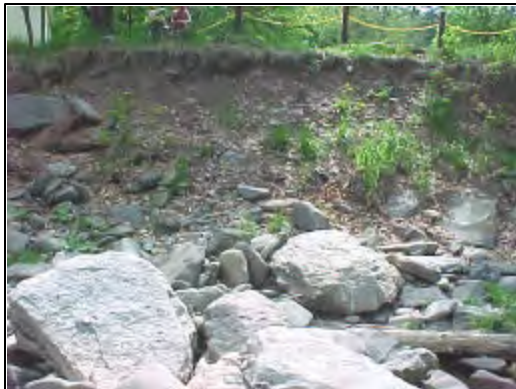
Figure 9 Planting Site #54

Planting site #54 is located on the left stream bank of two residential properties near the middle of the management unit (Insets B,F,G). This planting site consists of a stream bank which has a length of rip-rap, then an eroding section, followed by more rip-rap (Fig. 9). The upland area is mowed lawn (Fig. 10). Woody debris has been dumped on the sections of the stream bank.

Joint planting the rip-rap and log cribbing is recommended. To provide protection against toe erosion, willow *fascines* and sedges should be planted along the toe of the bank throughout the site. This treatment is critical along the eroding section, the face of which should also be planted with native trees and shrubs. Native trees and shrubs should be planted throughout the upland area. Increasing the riparian buffer width by at least 20 feet will improve bank stability and buffer functionality while still allowing a significant lawn area. Again, the practice of dumping yard clippings and loose brush on the stream bank is not recommended.

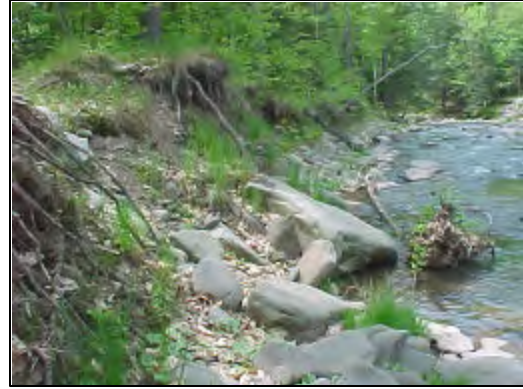
Figure 11 Planting Site #55

Planting site #55 is located on two residences near the downstream end of the management unit (Fig. 11), where the left stream bank is experiencing erosion (Inset E). The upstream residence has some trees atop the stream bank, while the downstream residence has a dense riparian buffer.

Installation of willow *fascines* and sedges along the toe of the bank is recommended to provide protection against toe erosion. Native trees and shrubs, including willows should be planted on the face of stream bank. On the upstream property the stream buffer should be denser and the width should be increased by at least 20 feet to improve stream bank stability and buffer functionality.
