TOWN OF OLIVE LOCAL FLOOD ANALYSIS

**FLOOD ENGINEERING ANALYSIS REPORT
HAMLETS OF BOICEVILLE AND WEST SHOKAN
TOWN OF OLIVE
ULSTER COUNTY, NEW YORK**

Woidt Engineering & Consulting, PC
11 South Washington Street
Binghamton, New York 13903

December 30, 2016
Revised May 26, 2017
Revised July 11, 2017
Revised August 8, 2017

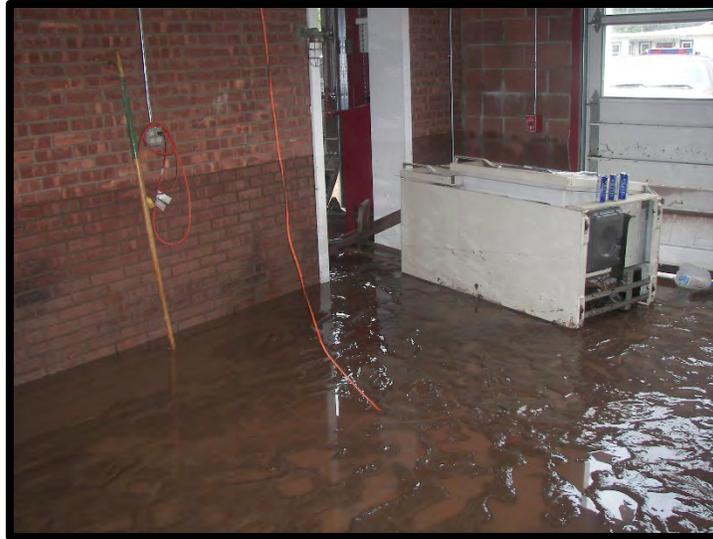
Figure 4: High Water Mark at Fire House Co. #5 (The line between light and dark bricks)

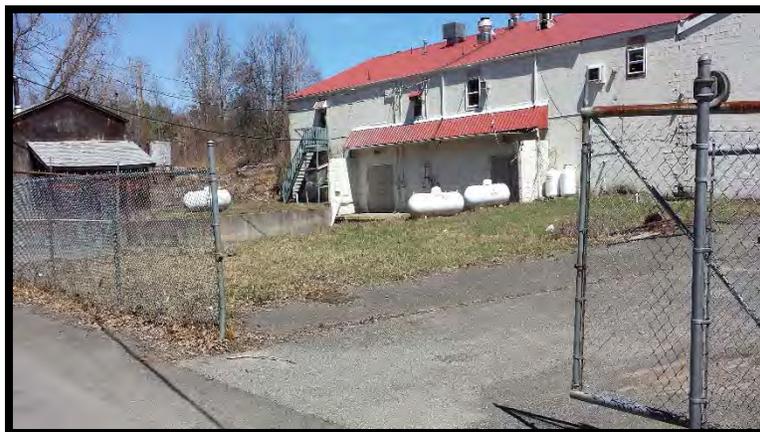
When overbank flooding occurs several buildings will become inundated starting around the 25-year flood return interval. These are commercial and residential buildings which may contain chemicals and hazardous waste that create water quality concerns. Around the 50-year flood event, floodwaters reach petroleum storage tanks about 200' northwest of the market (see Figure 8). If these tanks are not anchored properly they can cause water quality and public safety issues.

Figure 8: Petroleum Tanks located Northwest of Boiceville Market

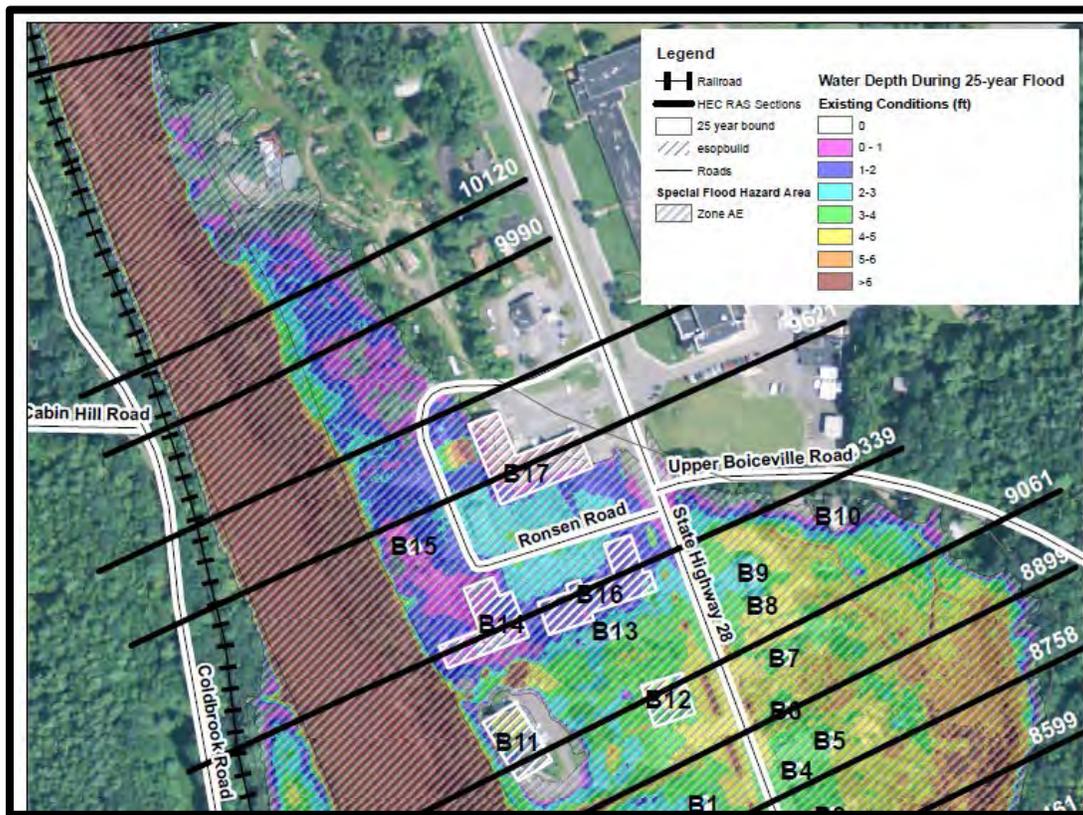
As seen in Appendix Figure B-6, (the 100 year water depth map, there are 17 buildings surrounded by water during the 100-year flood and most of the buildings are shown to have water around the foundations starting at the 25-year flood (Appendix Figure B-3). Figure 13 is a close up of Appendix Figure B-3 and shows there is approximately 1-2' of water in the Boiceville Market (Building B-16) during the 25-year flood. Interviews of community members reported around 2' of water during the 2005 flood which closely matches the 25-year flood water depth map.

Figure 13: Water Depths Around the Boiceville Market (B-16) during the 25 year flood.

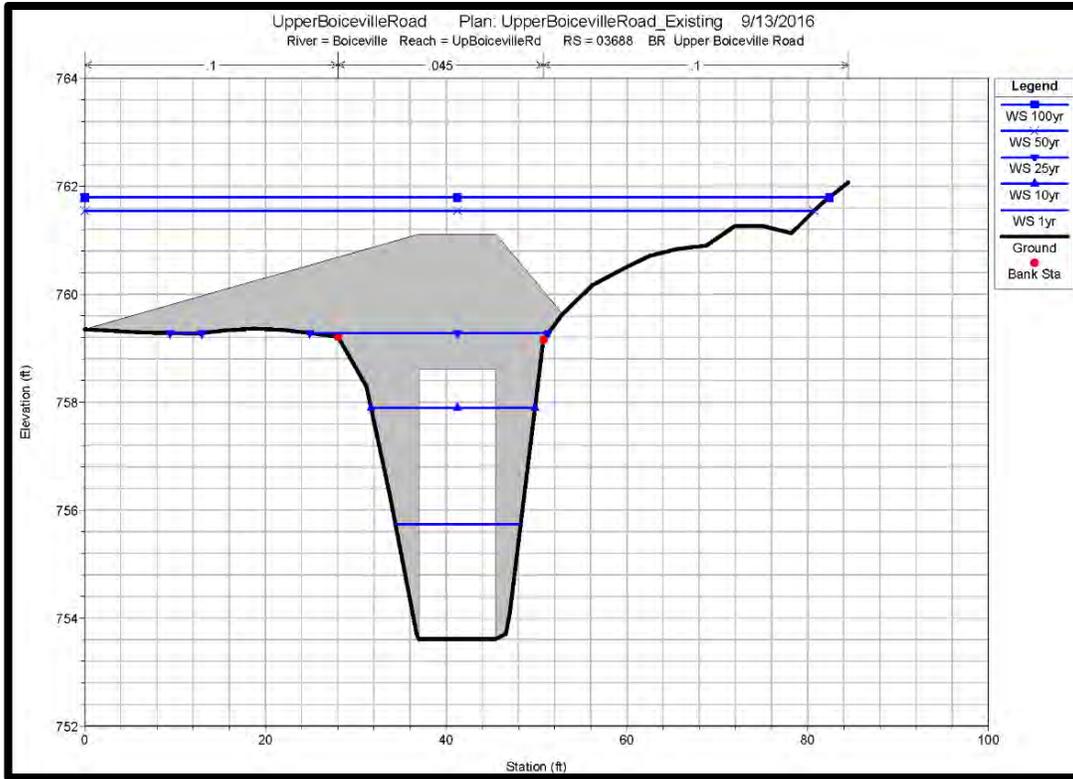
The HEC-RAS model was run for the six discharges. The crossing can be seen in section view in Figure 24 and shows that the bridge is overtopped starting at the 50-year return interval storm assuming unobstructed flow. The crossing can be seen in profile view in Appendix Figure B-39. Site observations show the upstream abutments are failing (as seen in Figure 25 and in Appendix Figure B-40) due to material failure and scour along the abutment toe or both.

Figure 24: Section View of Existing Upper Boiceville Road Crossing

Results: Increasing the clear span from 7' to 12' will pass the 50-year storm and meet the desired freeboard requirements. The proposed dimensions will also pass the 100-year storm. Increasing the clear span 5' does not appear to have notable construction constraints since there is adequate space on either side of the existing bridge to widen the crossing. The proposed crossing can be seen in section view in Figure 26 below and in profile view in Appendix Figure B-41. The proposed structure would be a three sided box culvert (natural stream channel bottom) with concrete wing walls.

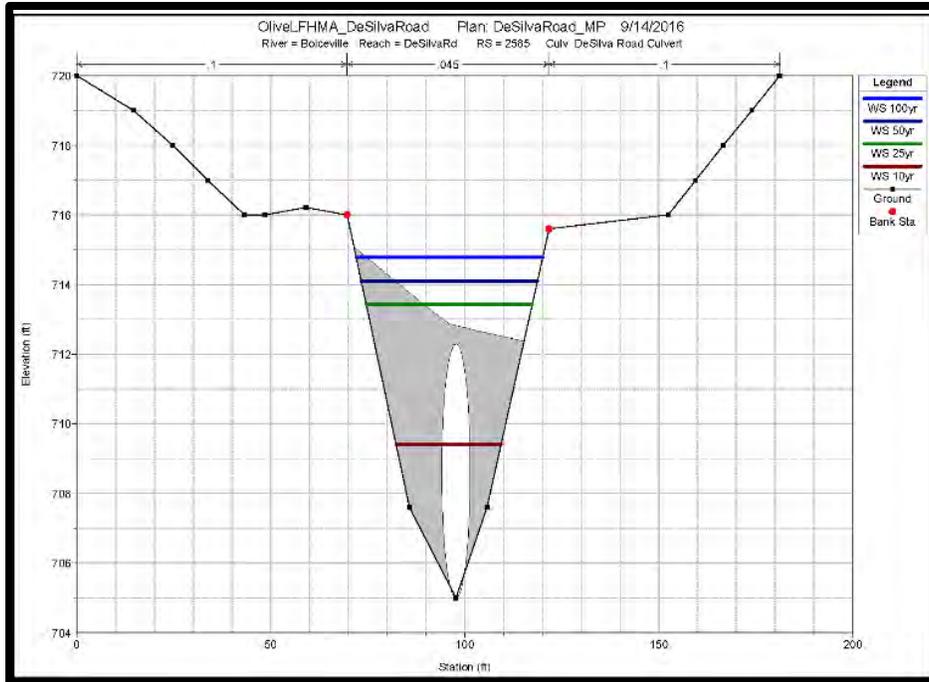
The HEC-RAS model was run for the six discharges. The DeSilva Road crossing can be seen in section view in Figure 29 and in Figure 30. This culvert is overtopped by a 1.0' of water starting at the 25-year flood. The State Route 28 crossing can be seen in section view in Figure 31 and in Figure 32. This crossing is overtopped by 0.2' of water starting at the 50-year flood. The crossings can be seen in profile view in Appendix Figure B-45. Typical hydraulic design standards for town roads such as DeSilva Road is the 10-year flood and the existing hydraulic conditions meet this standard. State Route 28's design criteria were not met. Site observations showed both crossings' wingwalls and headwalls appear to be structurally intact as seen in Figure 30 and Figure 32. In Figure 32 note there is a transition between the arch culvert on the upstream end of the State Route 28 crossing and the four sided box culvert on the downstream end which reduces hydraulic efficiency.

Figure 29: Section View of Existing Hydraulic Conditions at DeSilva Road Crossing

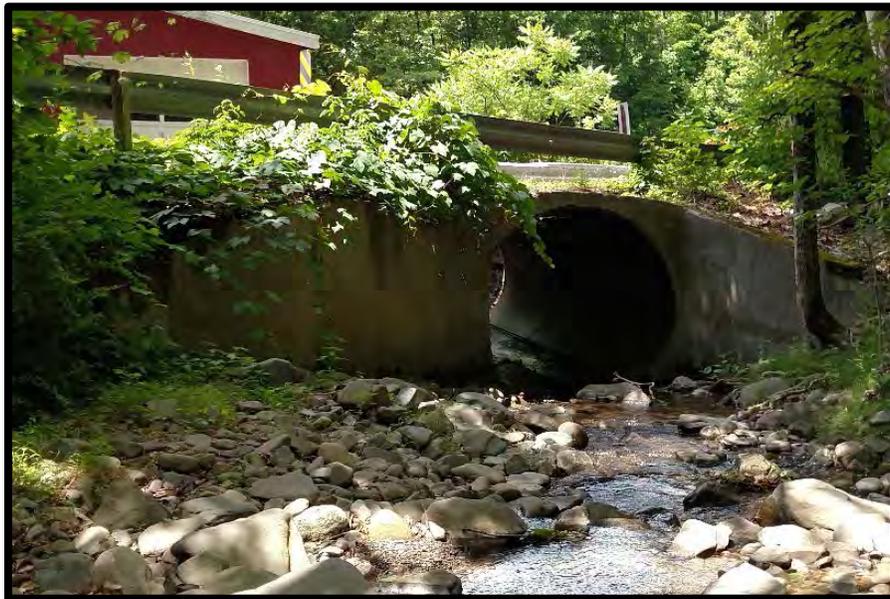
Figure 30: Looking Downstream at DeSilva Road Crossing

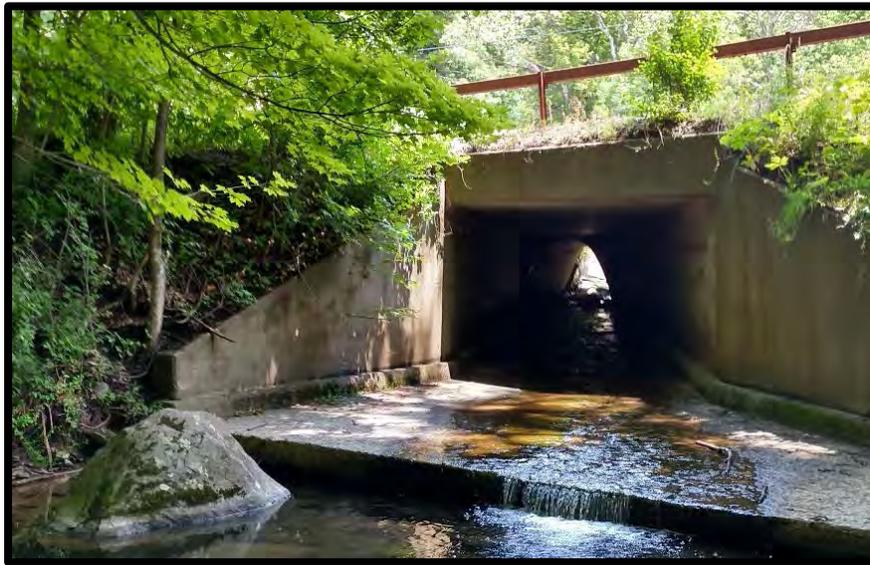
Figure 32: Looking Upstream at State Route 28 Crossing

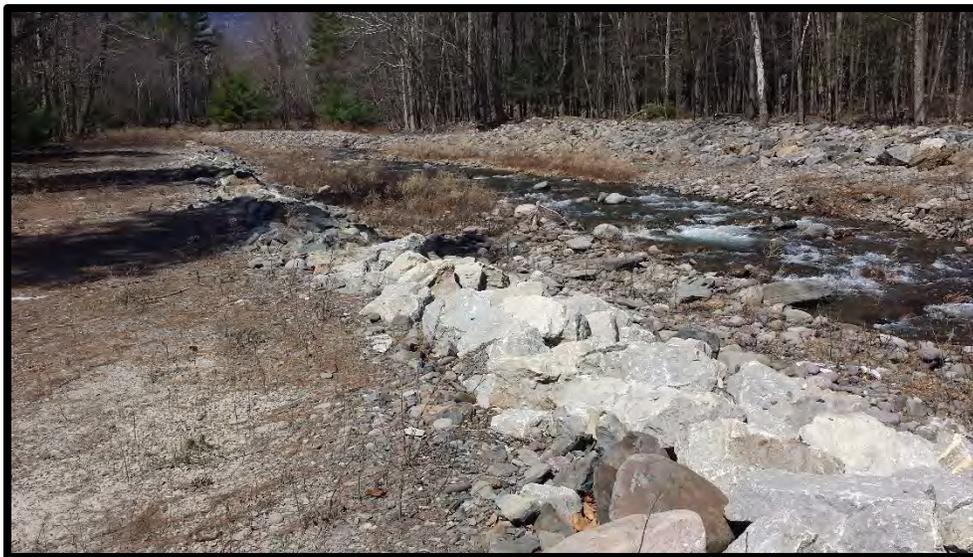
Figure 35: Looking upstream of the Maltby Hollow Brook Bridge at rip rap revetment. Note stream spoil berms upstream of revetment on left bank

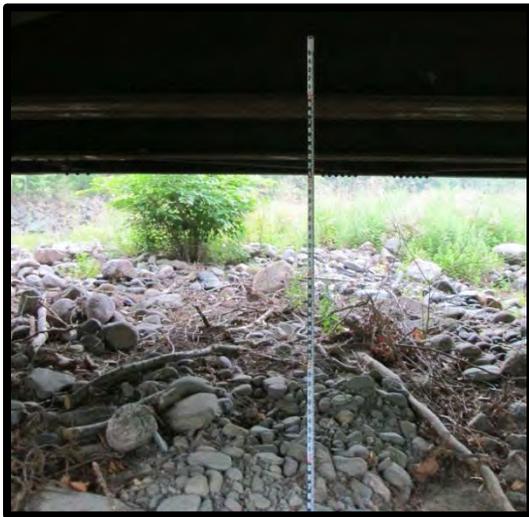
Figure 40 Looking Downstream at Watson Hollow Bridge

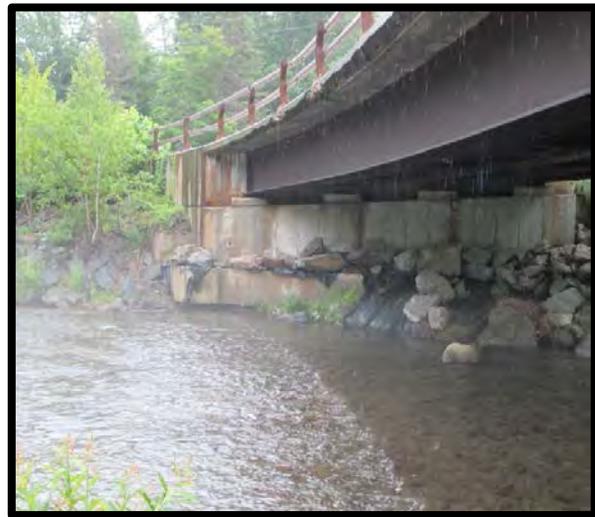
Figure 41: Looking at Right Bank at Watson Hollow Bridge

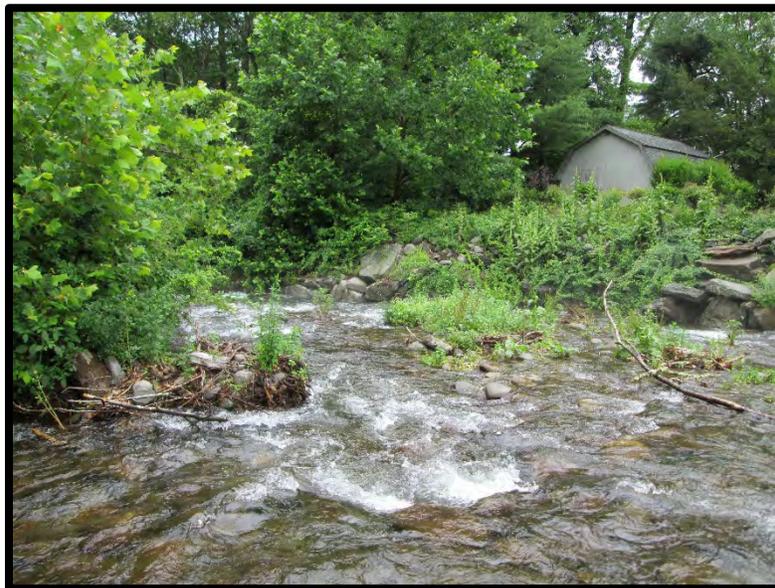
**Figure 43: Looking at Right Bank near the Homes.
Note Mature Vegetation in the Center of the Bushkill**

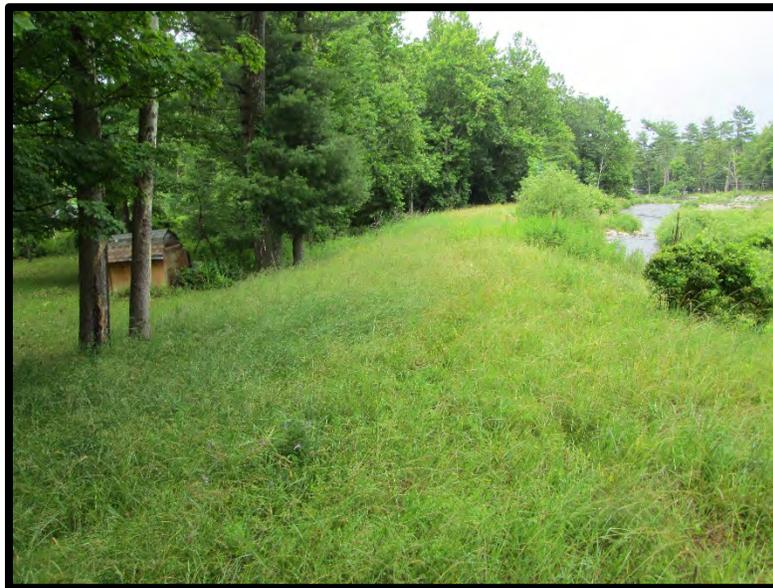
Figure 46: Photo Taken at Photo Point #4. Looking Downstream at Man Made Berm

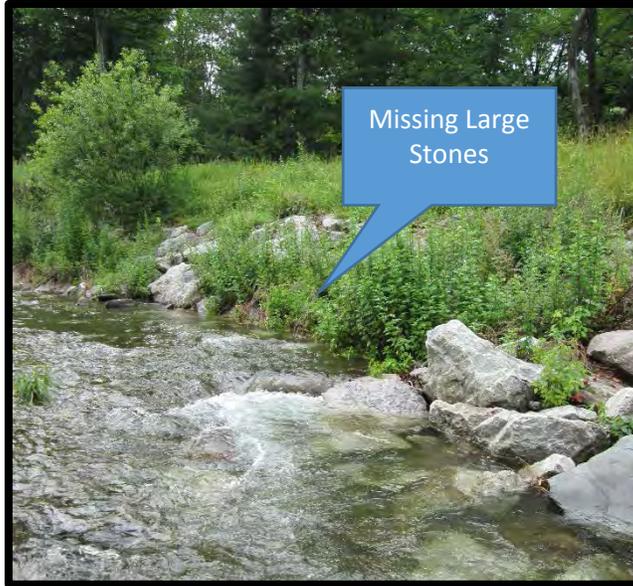
**Figure 47: Photo Taken at Photo Point #4
Looking Upstream at Man-made Berm and Missing Large Stones**

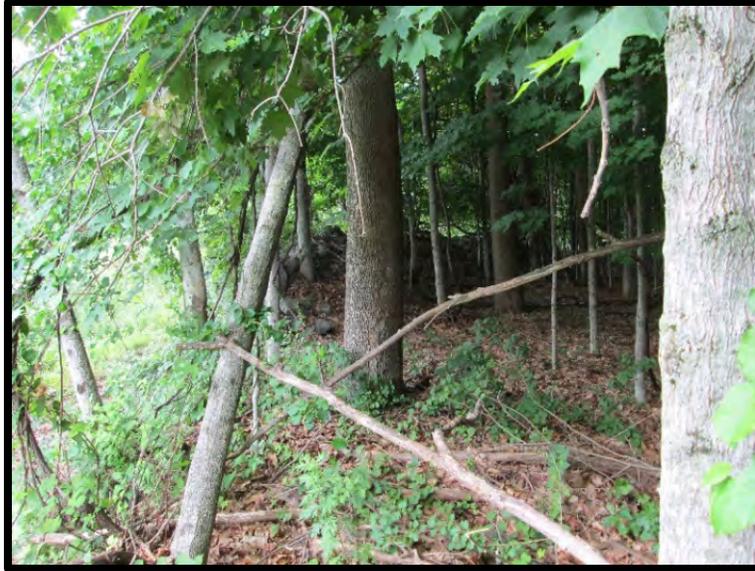
Figure 50: Looking Downstream at Side Cast Berm

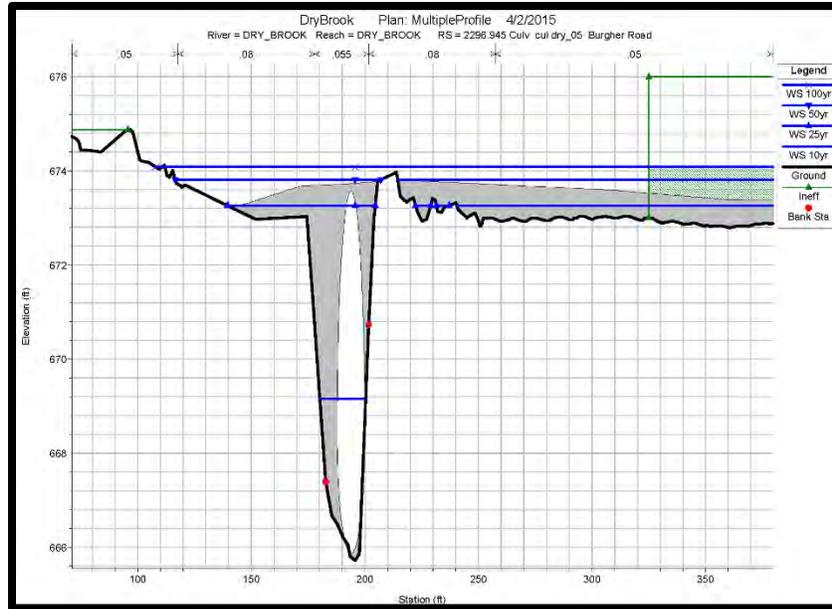
Figure 53: Section View of Existing Hydraulic Conditions at Burgher Road

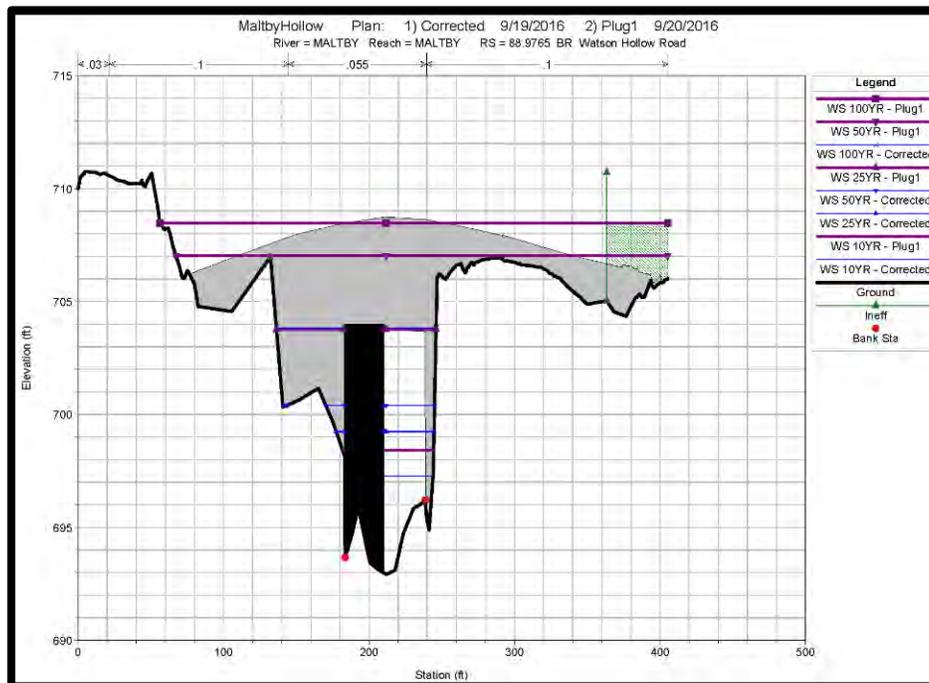
Figure 57: Section View of Plugged Conditions at Maltby Hollow Bridge
