Broadstreet Hollow Stream Restoration Project

IMPLEMENTATION & MONITORING REPORT

Broadstreet Hollow
Town of Lexington, Greene County, NY

UPDATED
March 2008

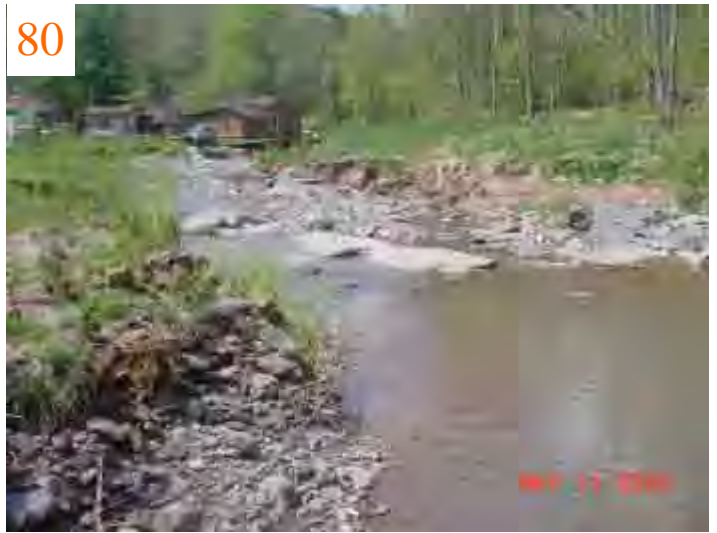
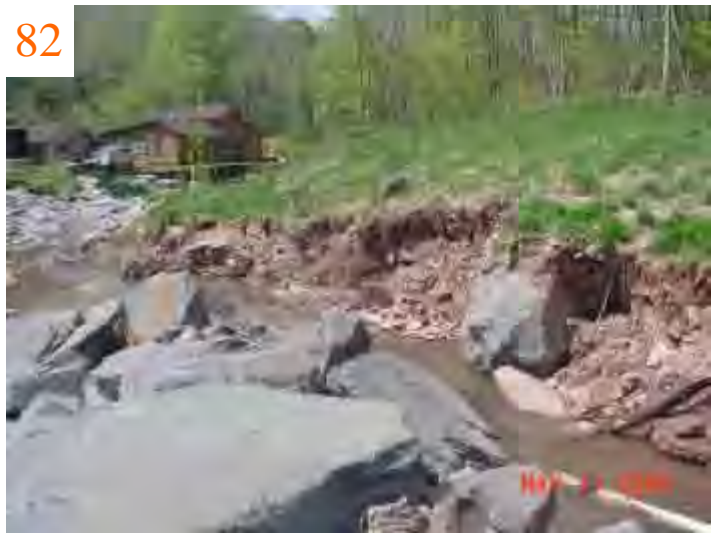
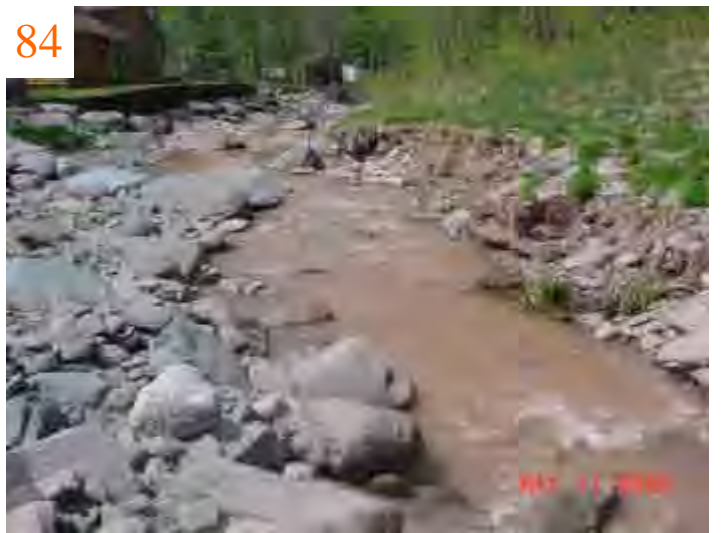
- Photograph 79: View looking upstream at upper bridge noting minor right bank scour.
- Photograph 80: Image looking downstream through middle of reach displaying right and left bank erosion and damaged well.
- Photograph 81: Left bank erosion near cross section 4, at fourth downstream cross vane with exposed keyway.
- Photograph 82: Right bank erosion near cross section 5 and exposed well casing.
- Photograph 83: Left bank erosion near cross section 8.
- Photograph 84: Right bank erosion near cross section 8 .
