**Project Design Report
R.A. Hill Stables Demonstration Project
West Kill Creek**

**December 31, 2006
Prepared by Mark Vian¹ and Joel Dubois²**

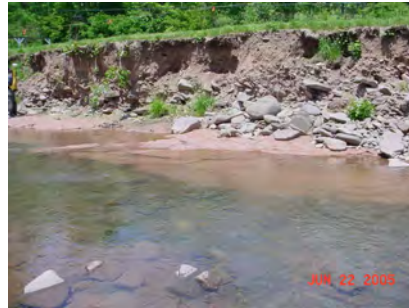
Three stream banks on the site experienced significant erosion during the April flood. Extensive exposures of lacustrine clay deposits have been documented at two of the three eroded banks. Entrainment of colloidal clay materials poses a significant health concern from a water quality perspective. Turbidity resulting from flowing water in direct contact with clay can degrade drinking water quality, and the aesthetic quality of the water resource. In addition to the water quality impacts on the site, the erosion has undermined the pasturing facilities of eroding banks will allow for continued use of the facilities. This is of special concern to the project owner, as the compromised pasture is their primary facility.

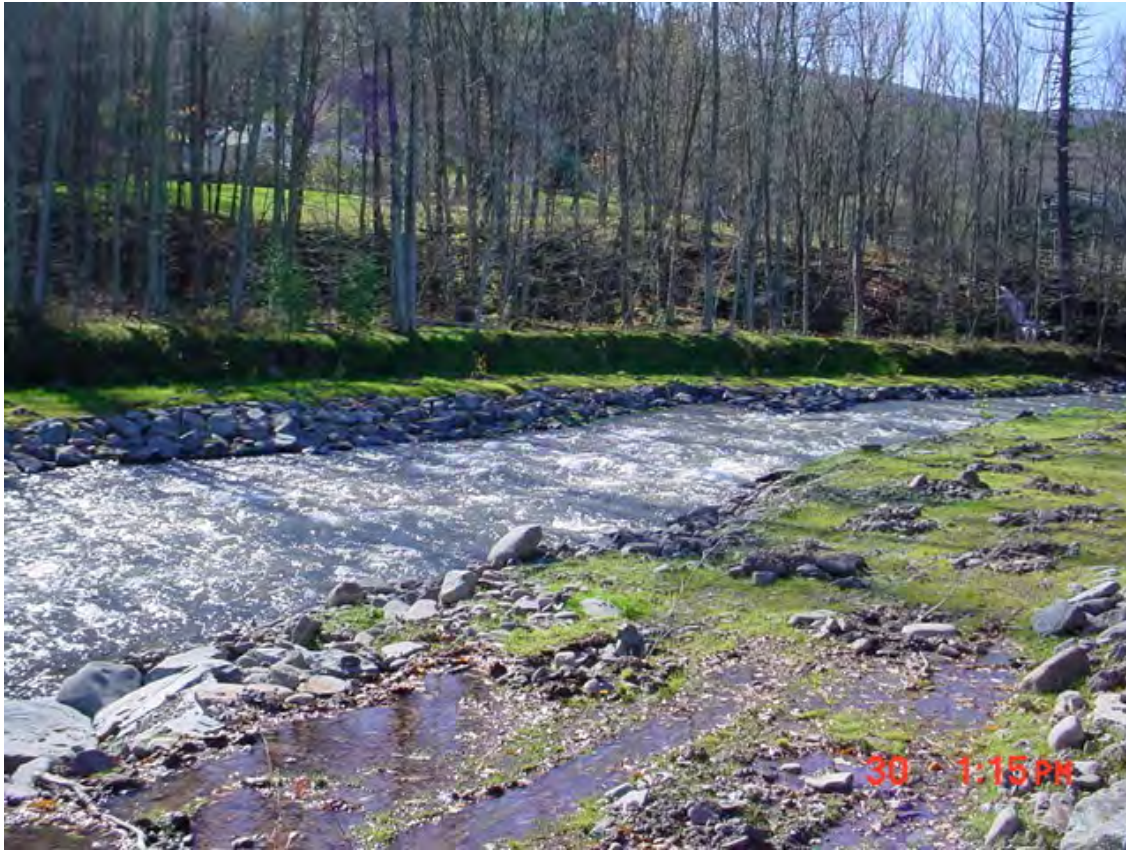
Figure E9 Lower bankfull bench, left

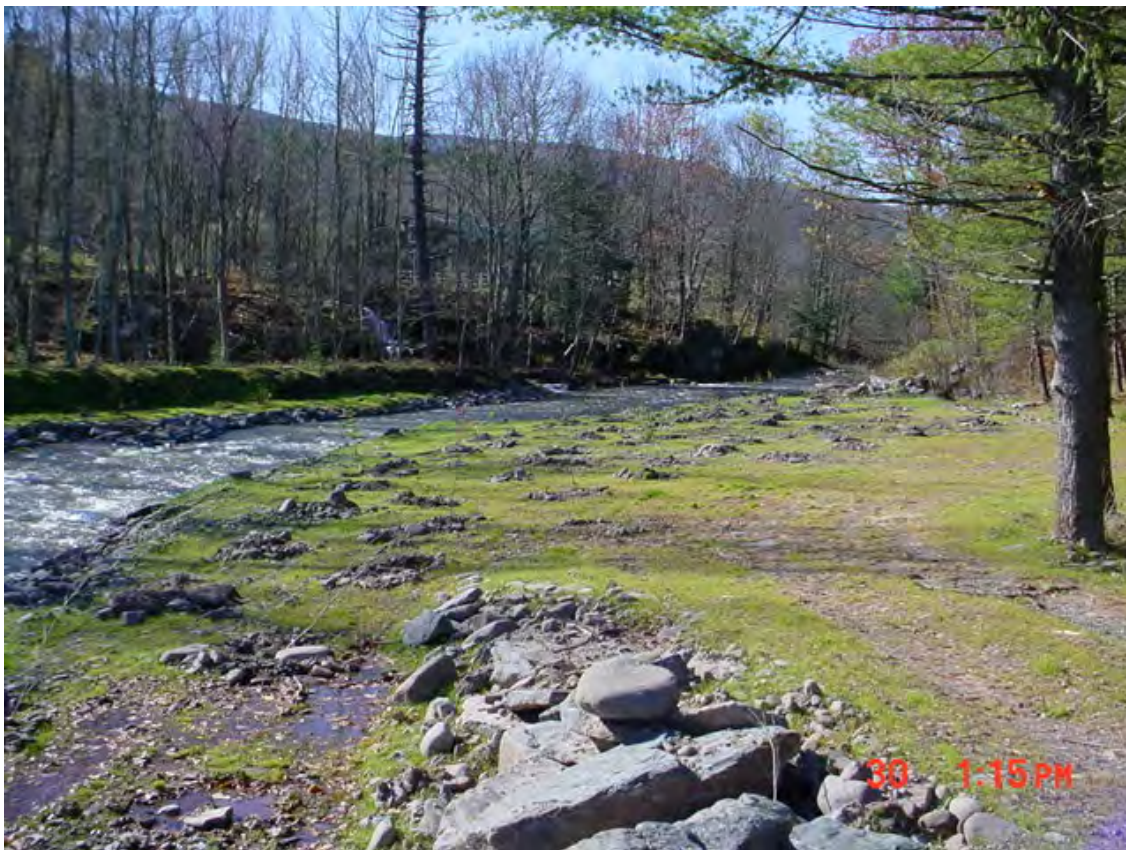
Figure E10 Point bar opposite lower bench, with plantings
