Local Flood Analysis

Villages of Stamford and Hobart, Hamlet of South Kortright
Town of Stamford, New York
October 2020

Prepared for:
Delaware County Soil and
Water Conservation District
44 West Street, Suite 1
Walton, New York 13865

Prepared by:
MILONE & MACBROOM, INC.
231 Main Street, Suite 102
New Paltz, New York 12561
(845) 633-8153
www.mminc.com

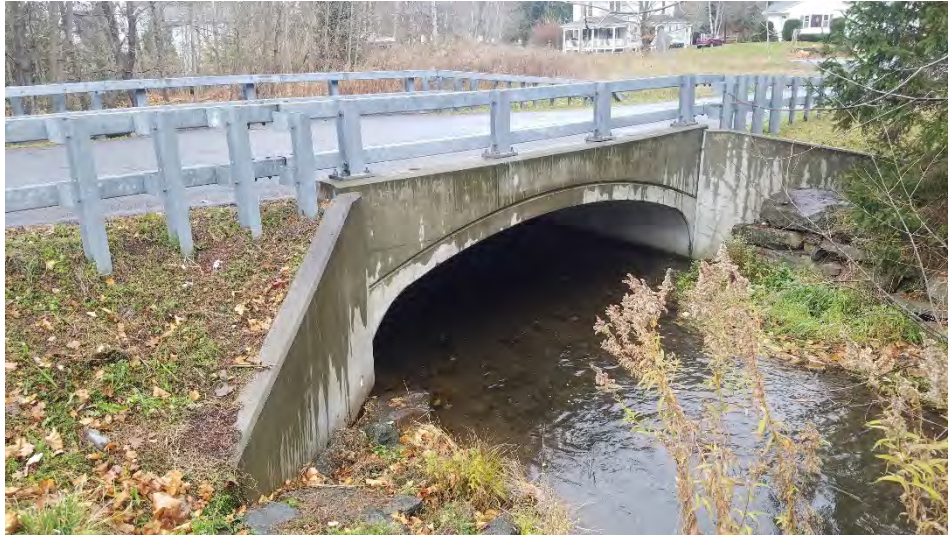
of water. Removing the bridge from the hydraulic model is shown to have significant reductions in water surface elevations for the 100-year storm event only, resulting in a 2.0-foot reduction at the crossing. This reduction diminishes moving upstream approximately 370 feet and is fully contained within the stream channel. This is illustrated in Figure 4-2.

Figure 4-1: Roosevelt Avenue over WBDR (looking downstream at culvert inlet)

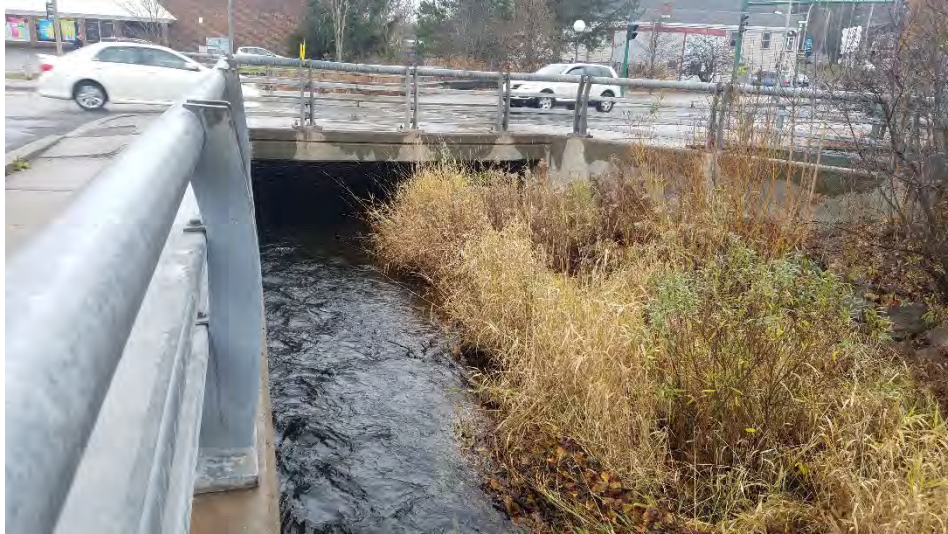
Removing the culvert in the hydraulic model resulted in reductions in water surface elevations of approximately 0.3 feet for the 10-, 25-, and 50-year discharges. During the 100-year storm event, the 'no crossing' analysis showed water surface elevation reductions of approximately 0.5 feet, which extend upstream for about 500 feet before fully diminishing. This modest drop in flood depth for the 100-year storm did not result in significant reductions in the lateral extent of inundation for the surrounding area.

Figure 4-3: Main Street culvert over WBDR (looking downstream at culvert inlet)

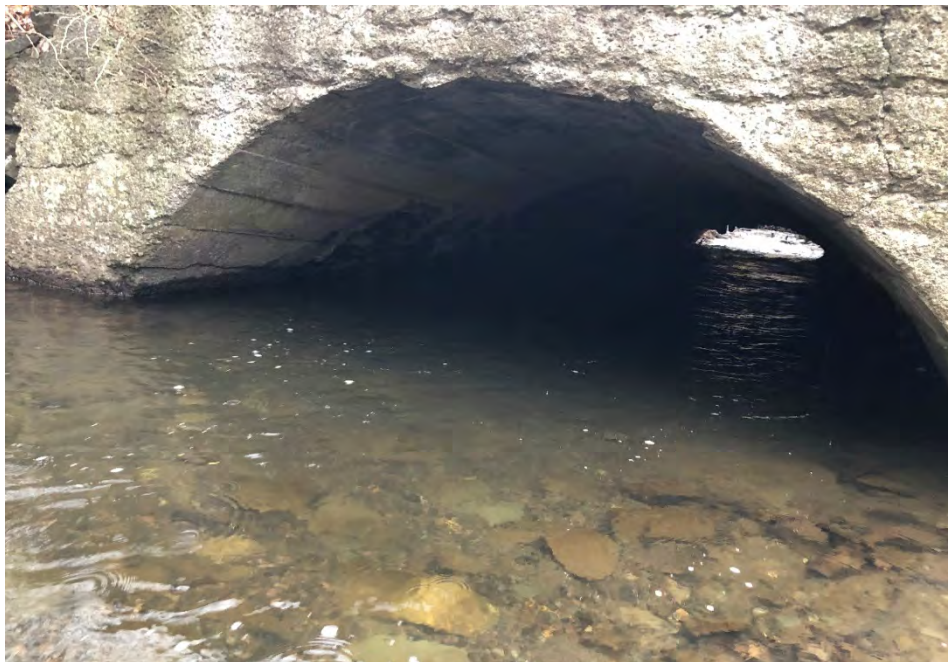
Figure 4-6: South Street culvert outlet (looking upstream through culvert)

Hydraulic modeling indicates that the current structure has the capacity to convey only the 10-year peak discharge and overtops at all greater flows. A 'no crossing' simulation demonstrated that the culvert under South Street gravely obstructs stream flow conveyance and contributes to major energy losses. For the 25-, 50-, and 100-year discharges, removal of the existing structure would result in water surface elevation reductions of roughly 2.5 feet at the culvert extending upstream for roughly 250 feet before diminishing. As illustrated in Figures 4-7 and 4-8, the resulting reductions in flood depths would prevent floodwaters from breaking over the stream banks during the 25-year and 50-year storms, eliminating the inundation of the left adjacent roadway.

Priority	Location	Existing		Recommended		Notes
		Inlet Description	Inlet Capacity	Description	Capacity	
1	South Street	9-foot-span and 4-foot-rise concrete arch culvert in poor condition	10-year flood	20' x 5' concrete box w/wingwalls	100-year flood	Requires modifications of channel sections upstream and downstream of the crossing to accommodate new structure
2*	Buntline Drive	4-foot-diameter corrugated metal pipe in moderate condition	10-year flood	10' x 4' concrete box w/wingwalls	100-year flood	Proposed culvert inverts should be kept the same as existing to prevent drawdown of the Department of Environmental Conservation wetland.
3*	Graham Drive	2-foot- and 3.5-foot-diameter dual corrugated metal pipes in poor condition	<10-year flood	12' x 5' concrete box w/wingwalls	100-year flood	Alternative configurations should be investigated in order to reach a cost-effective solution.
4	Maple Avenue	5-foot-diameter smooth metal pipe in poor condition	10-year flood	10' x 7' concrete box w/wingwalls	100-year	Requires modifications of channel sections upstream and downstream of the crossing to accommodate new structure

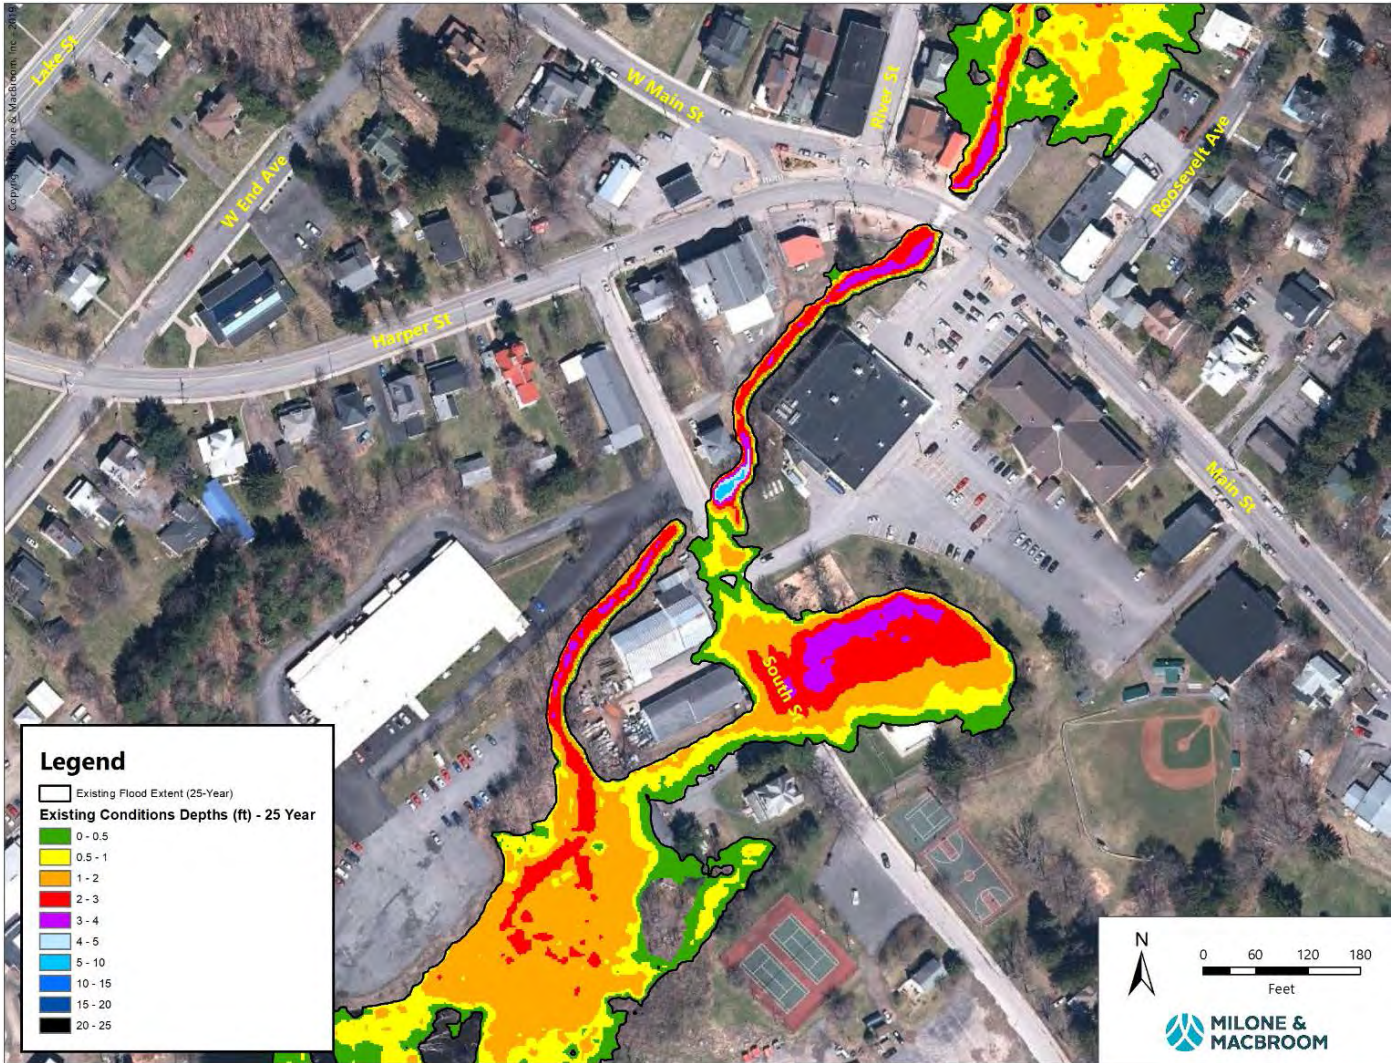
Figure 4-7: Existing conditions depth grid mapping of South Street culvert (25-year)

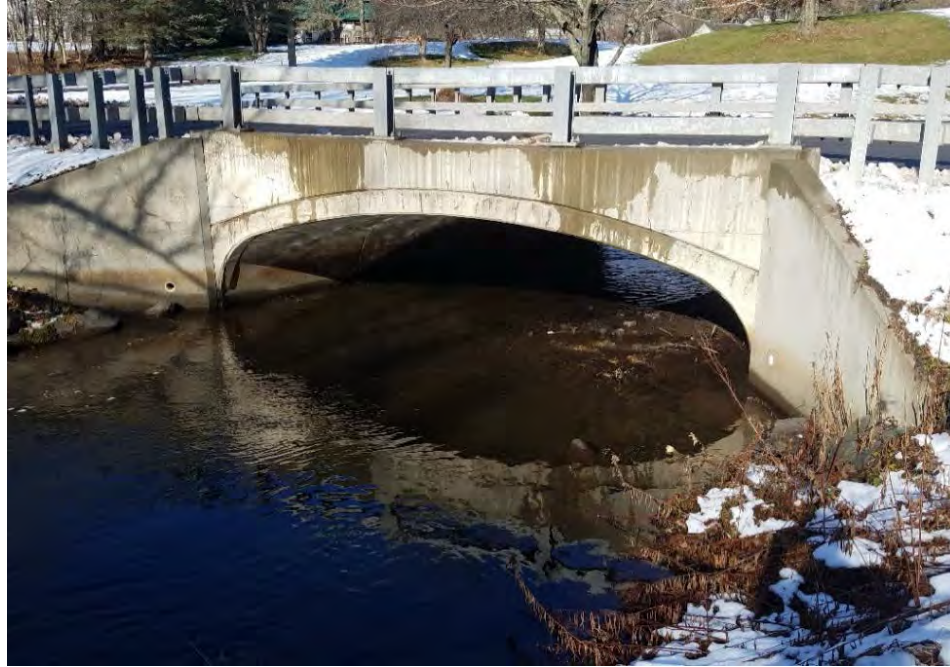
The structure that spans the WBDR along Railroad Avenue is a CON/SPAN arch bridge that measures 20 feet wide by about 5 feet high. Like the Roosevelt Avenue bridge, this crossing is also county owned, was installed in the year 2012, and is listed as being in good structural standing as of its last inspection in September 2018. Residents did not report any past flooding issues at this crossing.

Figure 4-14: Railroad Avenue outlet (looking downstream)

The baseline conditions model shows this bridge passing the 10-, 25-, and 50-year peak flows. The predicted water surface elevation for the 100-year discharge is shown to be just barely overtopping the adjacent roadway to the right. During such an event, the bridge and road embankment backwater flows for approximately 175 feet upstream; however, there are no flood-prone properties situated within the resulting inundation extent (Figure 4-15). Given the relatively new bridge crossing and the fact that there is no development upstream that is impacted by the backwaters, there are no further recommendations for the Rail Avenue bridge aside from regularly scheduled inspection and maintenance. In addition, if the roadway were to overtop during a flood event, it is recommended that the village temporarily close the thoroughfare and implement effective signage for alternative routes. A 2.0-mile detour is available to residents situated on Railroad Avenue if the roadway were to be closed during a major storm. Recommendations are summarized in Section 6.0.

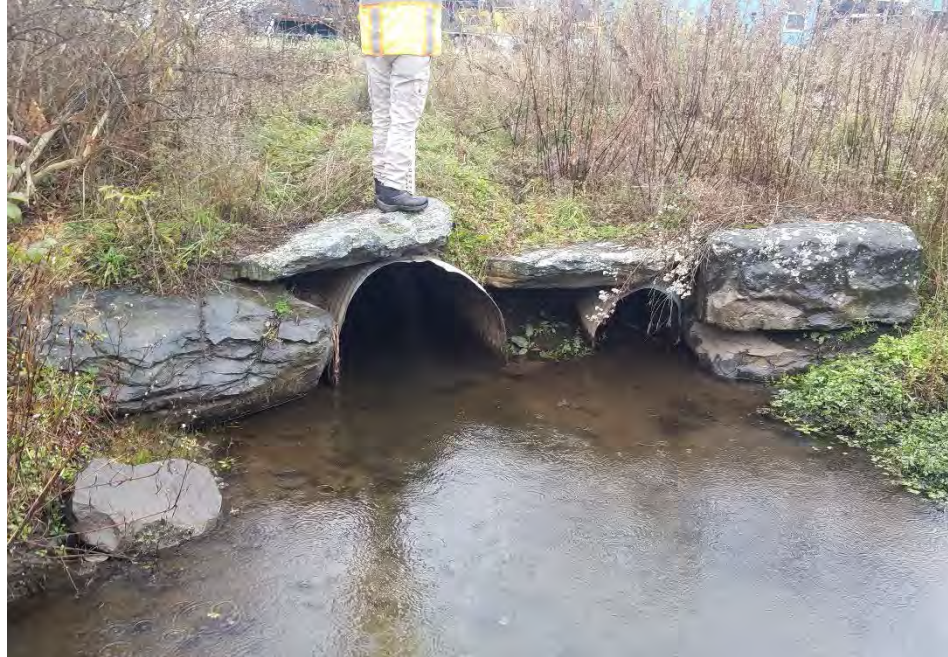
WBDR T1 is carried under Graham Drive in two metal corrugated pipes that measure 2 feet and 3.5 feet in diameter (Figure 4-16). The existing structure inlets are covered with a few inches of fill material, abutted with poorly aligned stacked stone wingwalls, and run underground for approximately 214 feet. Graham Drive is a dead-end road that serves as the only means of access to an apartment complex situated due east of the crossing. There are no detours available in the event of a flood. Discussions at FAC meetings indicate that the roadway floods at this location from time to time.

Figure 4-16: Graham Drive culvert outlets (looking upstream)

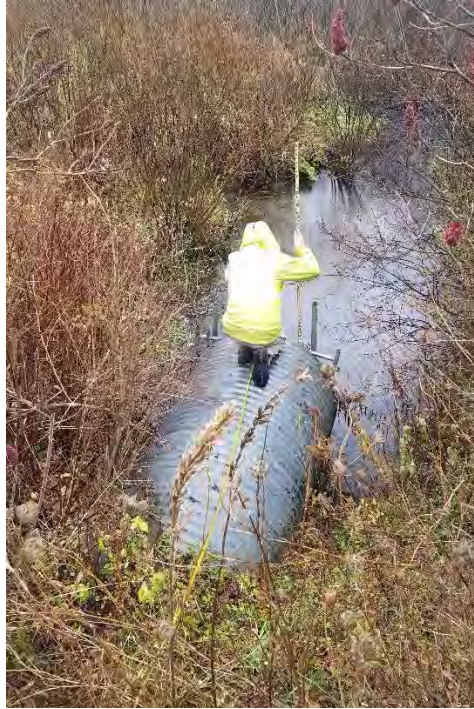
village. The roadway runs perpendicularly to the direction of flow of the WBDR T1, across a registered DEC wetland, where the existing culvert functions as the only means of river connectivity through the earthen embankment. Public narrative suggests that this culvert is susceptible to debris jams and requires frequent upkeep.

Figure 4-17: Buntline Drive culvert carrying WBDR T1 (looking downstream at projecting culvert outlet)

Replacing the existing structure with a 10-foot-span by 4-foot-rise box culvert was also investigated. The proposed hydraulic simulation showed that this scenario would lead to additional flood depth reductions of 1.5 feet compared to the previous scenario, or 5.0 feet when compared to the existing conditions model for the 100-year peak flow. The proposed box culvert would greatly reduce inundation extents upstream of Buntline Drive as illustrated in Figure 4-18.

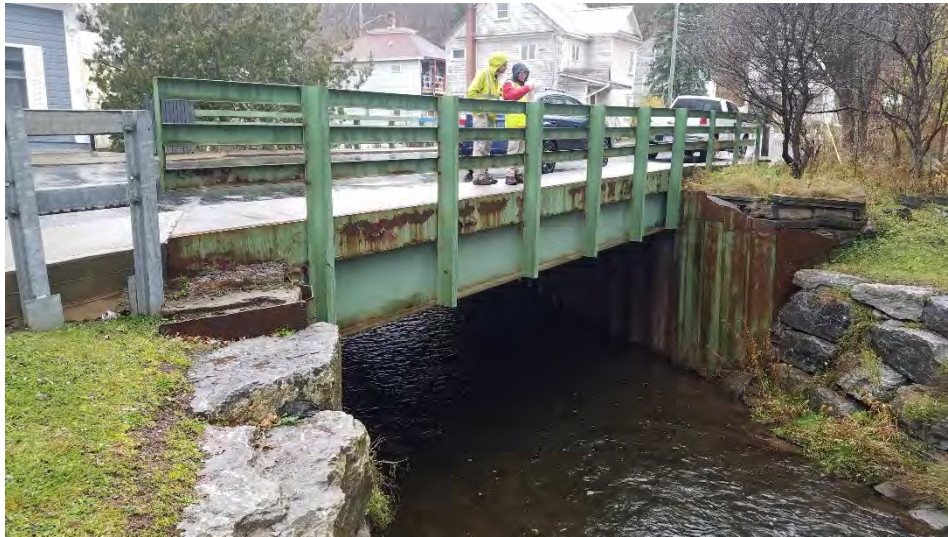
The Cornell Avenue steel girder bridge over the WBDR measures 31 feet long and has an approximately 10-foot-high opening. The bridge's abutments have been armored with sheet piling. Built in 1980, the conduit has served village of Hobart residents as one of the two ways for getting across the WBDR at this location. According to the 2020 NY State Highway Bridge Data for Delaware County, the Cornell Avenue bridge was last inspected in spring 2019 and is listed as being in overall good condition. There are no reports of prior flooding at this bridge crossing.

Figure 4-19: Cornell Avenue bridge upstream opening (looking downstream)

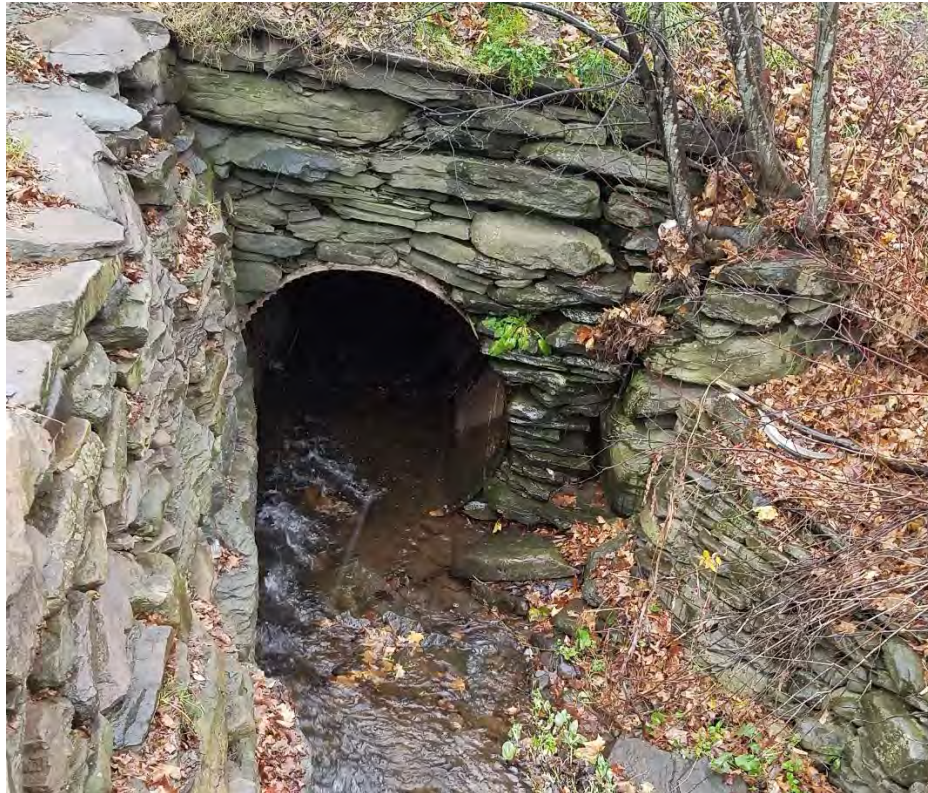
There were no reports from the public of flooding at this location although the hydraulic model shows this crossing as being severely undersized, only capable of conveying the 10-year peak discharge and overtopping at all greater flows. The model also indicates that the two upstream homes nearest to the stream could see flooding as frequently as the 25-year storm. Two additional homes are shown to flood during the 100-year storm, making a total of four residences upstream of the culvert that are mapped within the 100-year floodplain.

Figure 4-20: Maple Avenue culvert inlet (looking downstream at upstream headwall)

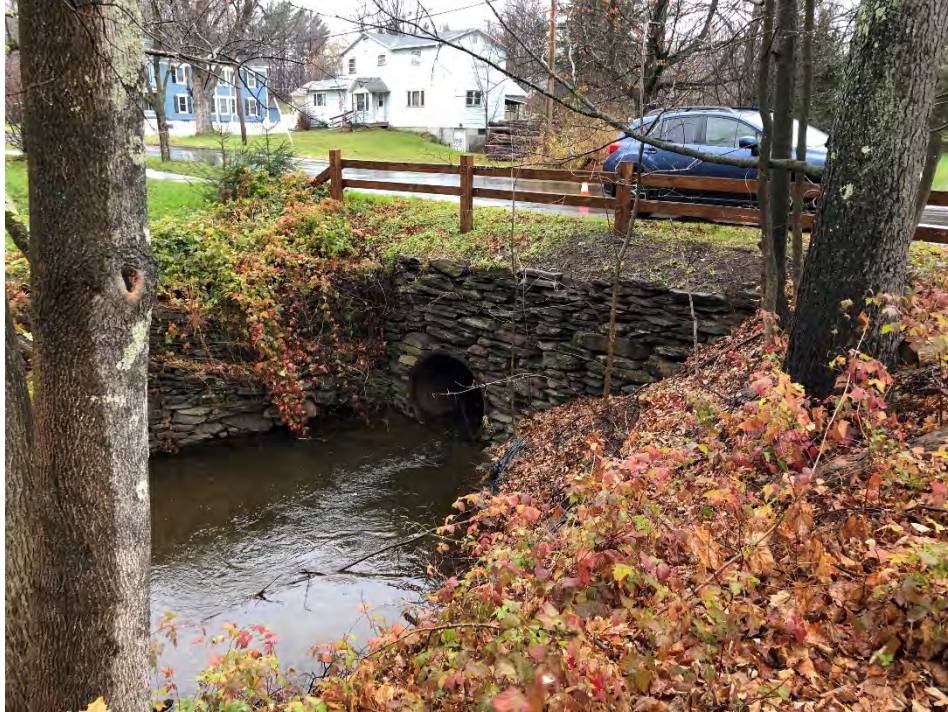
Figure 4-21: Maple Avenue culvert outlet (looking upstream at downstream headwall)

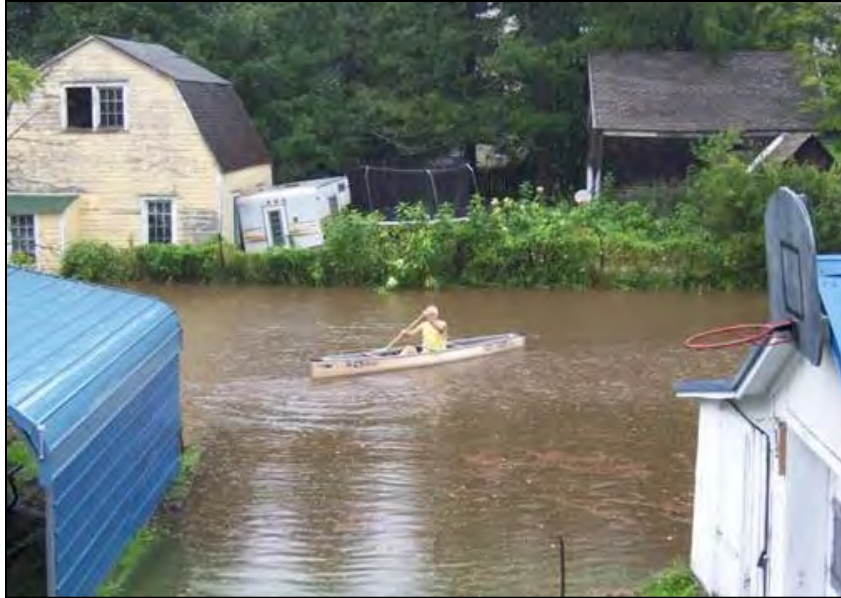
Figure 4-35: Flooding behind 12½ Roosevelt Avenue during Tropical Storm Irene 2011

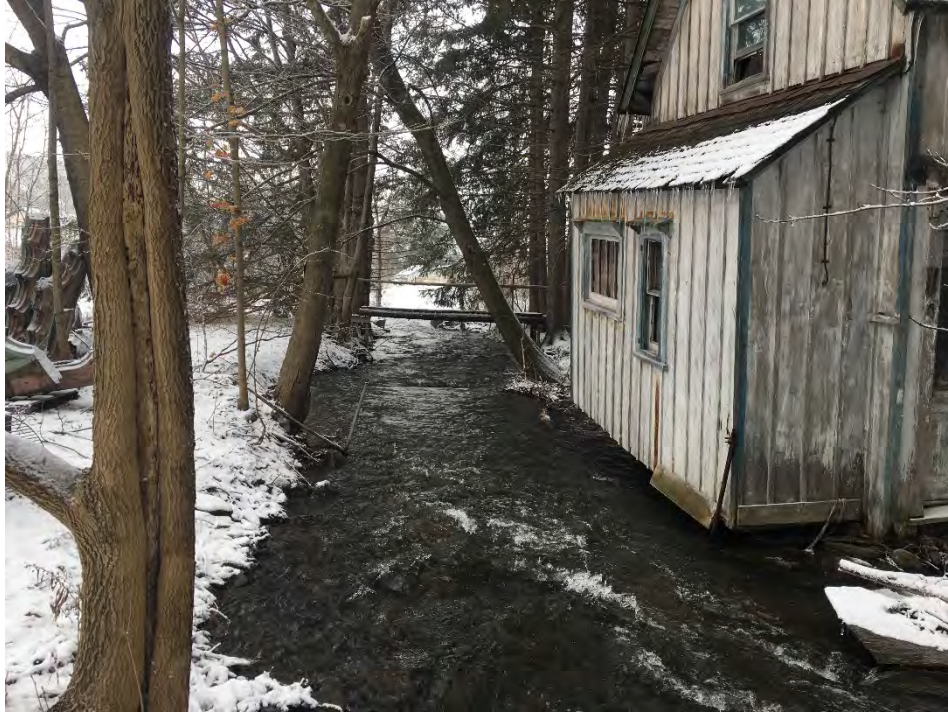
Figure 4-36: Structures potentially obstructing flows on the WBDR and lack of well-established riparian buffer zone

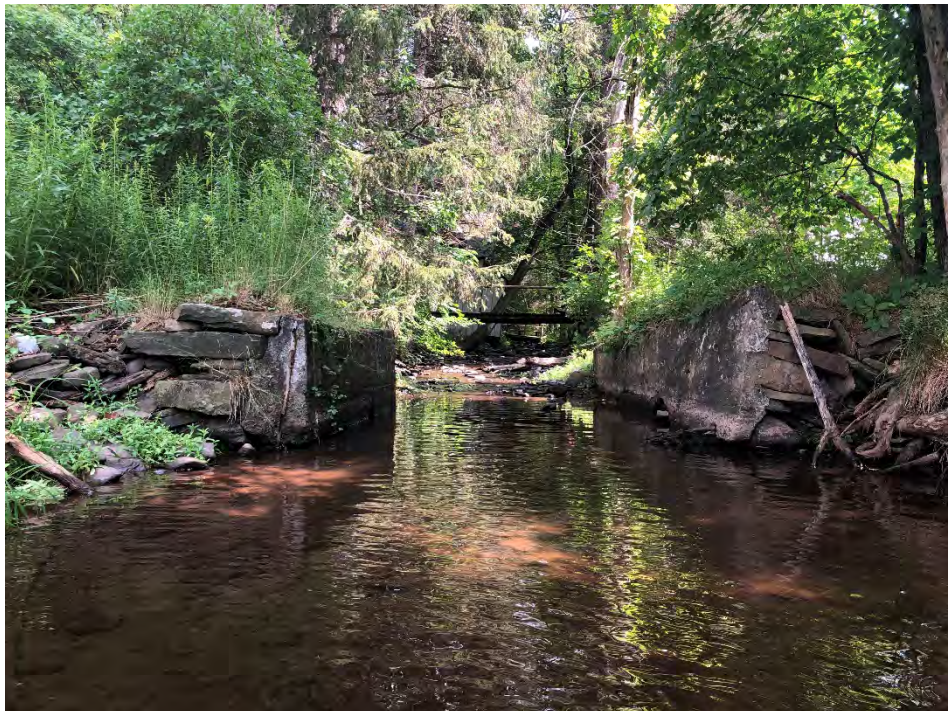
Figure 4-37: Abutment remains restricting low flows on the WBDR

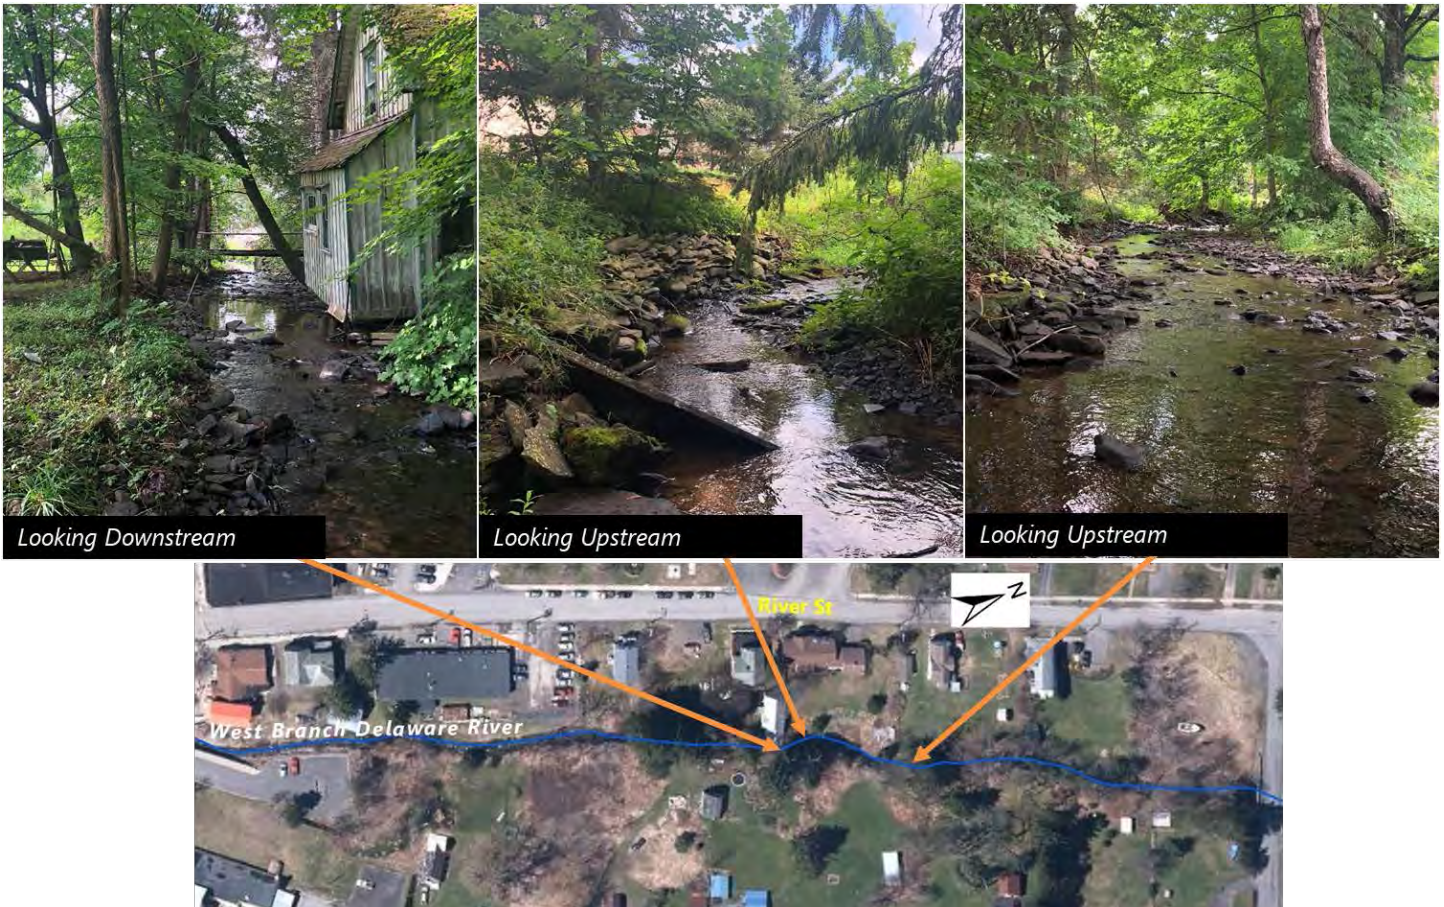
Figure 4-38: Photographs of the channel form illustrating the drastic change in channel top width as the stream approaches the area where regular flooding is being reported

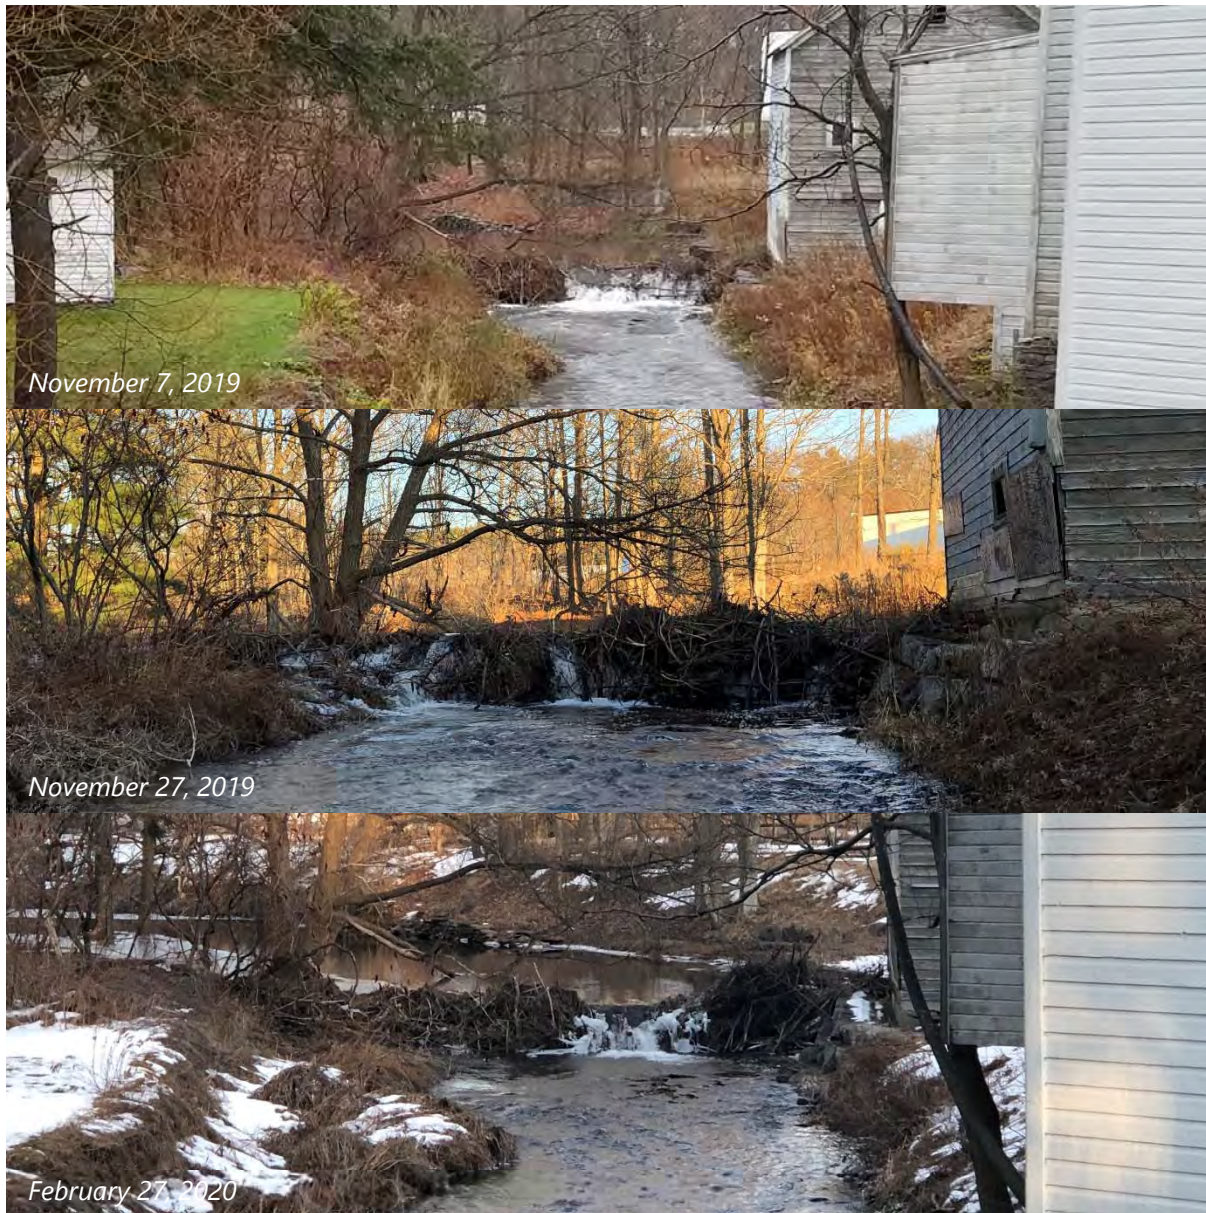
Figure 4-42: Photos of dam remnants taken at three separate occasions. Middle image shows beaver dam built across the top of the dam.

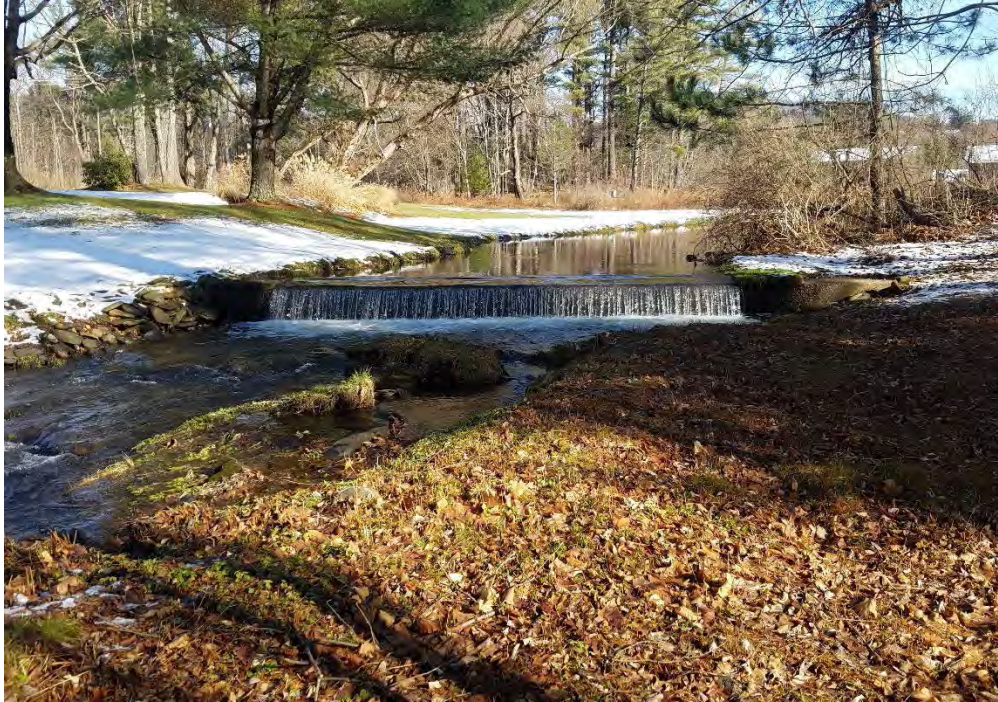
Figure 4-43: Low-head dam on the WBDR (looking upstream)
