East Kill Management Unit 2

Town of Jewett – Colgate Lake Dam (Station 73769) to Vista Ridge Road (Station 67789)

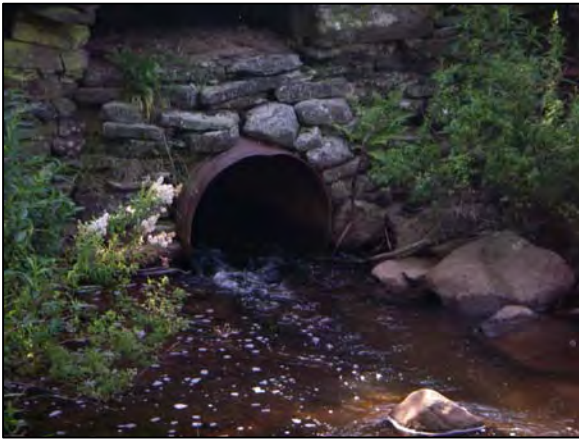
Culvert at toe of dam, Station 73728

This management unit begins (Station 73769) as the stream flows from the Colgate Lake Dam through a culvert (Station 73728) under the dam outfall. The dam is an earth gravity dam that was constructed of compacted fine-grained materials and concrete for recreational purposes. It measures 15 feet high and 275 feet in length. The drainage area of the dam is 5.5 mi². The maximum storage space in the reservoir is

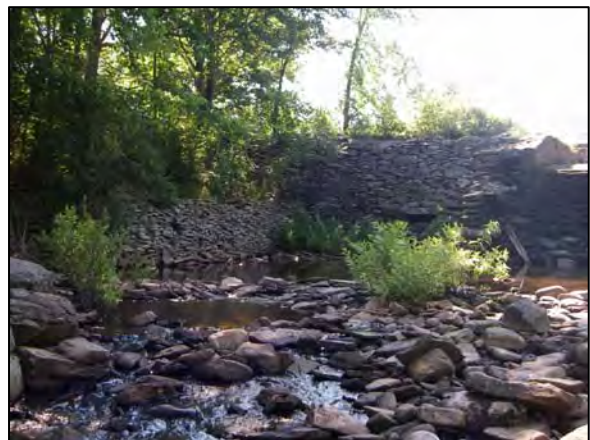
Rock wall at Station 73728

bank; both forms of revetment were in good structural and functional condition at the time of the stream feature inventory and assessment. In this area, the stream was experiencing full channel *aggradation*, or sediment deposition. As the stream flowed close to Colgate Road, there was rip-rap along the toe of the bank protecting the road embankment that was experiencing some scour.

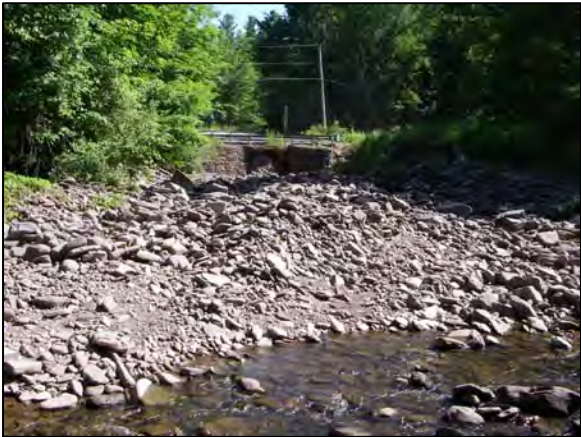
Tributary at Station 73374 – looking at

Through a culvert under Colgate Road, an unnamed tributary entered from the right bank (Station 73374); this tributary drains Black Dome and Black Head Mountains. At the time of the assessment, there was a small trickle of flow through the culvert and flow was subsurface at the confluence with the East Kill. There was a large drop-off and significant aggradation at the confluence.

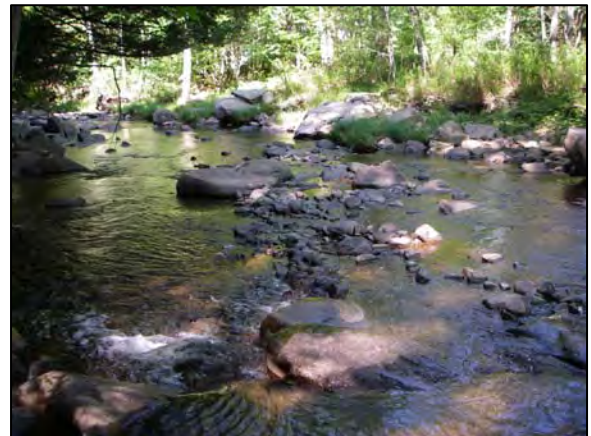
Along this stretch of stream, there were multiple locations of aggradation including a *transverse bar* (Station 72480), or a diagonal accumulation of sediment within the stream channel, and two side bars. As the stream approached a private

Transverse bar at Station 72480

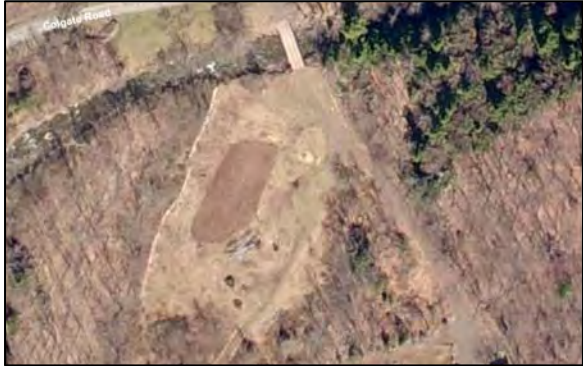
Planting site at Station 72223

Downstream of the bridge, there was some scour on the left stream bank, where the herbaceous vegetation is mowed to the edge of the stream. Recommendations for this site (Station 72223) included planting native trees and shrubs along the stream bank and the upland area. Buffer width should be increased by the greatest amount agreeable to the landowners. Increasing the buffer width to at

least 100-feet will increase the buffer functionality and protect the stream from nearby land uses.

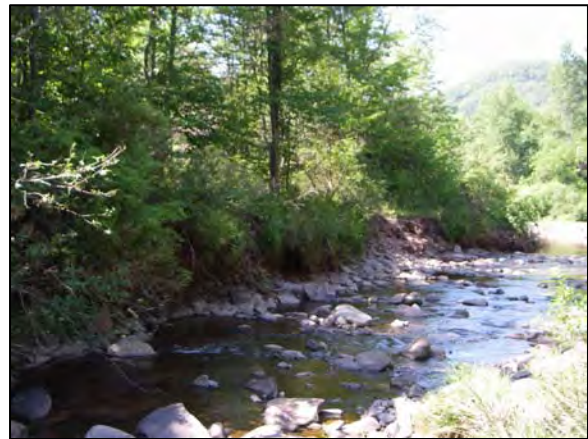
Continuing downstream, there was approximately 295 ft of minor erosion along the right bank (Station 72043) and several depositional areas including, a transverse bar, side bar and two *point bars*, or sediment deposited on the inside of a meander bend. Before the stream meandered to the left, the left bank was experiencing erosion (Station 71482) for approximately 187 feet, with

Eroding bank at Station 71482

minor scour at the toe of the bank. There was vegetation overhanging the bank and an accumulation of woody debris at the end of the erosion; the woody debris obstruction appeared to be exacerbating or contributing to the erosion, but was also providing good cover and shading for fish. As the stream began to meander to the left, there was aggradation along the left bed and revetment (Station 71300, Figure 4.2.1 Inset C) along the right bank. There was a house at the top of this bank; the upper portion of the stream bank was protected with quarry-stone rip-rap and there were large stones placed at the toe of the bank on the outside of the meander bend where the *thalweg*, or deepest part of the stream channel, would hit

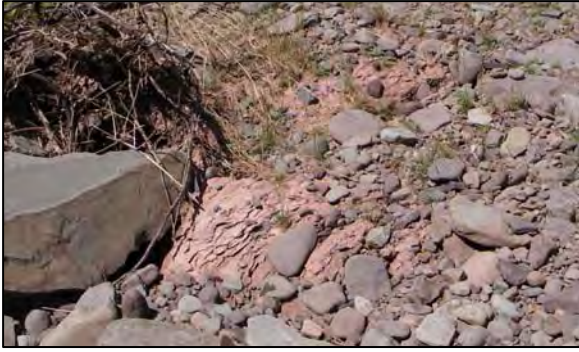
Clay exposure at Station 71289

during high flows. There was a bar along the floodplain bench in front of the rip-rap, where 10 feet of lacustrine clay (Station 71289) has been exposed near the stream's edge. Clay inputs into a stream are a serious water quality concern because they increase *turbidity*, degrade fish habitat, and can act as a carrier for other pollutants and pathogens. It is

recommended to interplant native shrub and sedge species through the rip-rap and along the toe of this stream bank. This planting will help to strengthen the revetment, while enhancing aquatic habitat. Beyond the rip-rap installation there was mown grass to the edge of the bank. The risk to bank stability can be minimized by maintaining mature trees along the critical 100 foot buffer zone. While it may not be feasible to increase the buffer width by 100 feet, the buffer width should be increased by the greatest amount agreeable to the landowners.

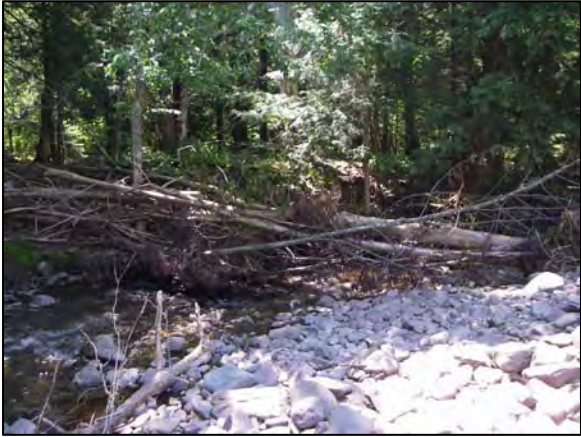
Woody debris at Station 71000

Continuing downstream there were multiple areas of sediment deposition and woody debris accumulation along both stream banks and within the channel. At the downstream end of a point bar that stretched for 450 feet along the right bed and bank, there was significant woody debris accumulation (Station 71000) that extended across the channel and along both stream banks. This debris caused a minor obstruction

at low flows, but may pose a more significant obstruction at higher flows; and it appeared to be contributing to aggradation upstream of the obstruction and scour downstream of the obstruction. However, woody debris is beneficial to a stream system, it provides critical habitat for fish and insects, and adds essential organic matter that will benefit organisms downstream.

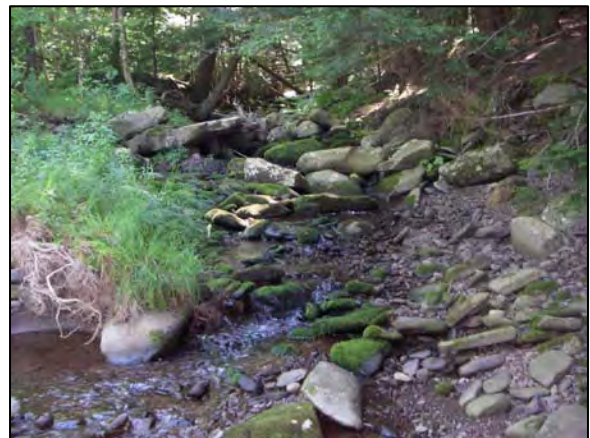
*Tributary confluence at Station 70039
photo orientation - looking at*

tributary (Station 70039) entered through the eroding bank on the left; sediment had accumulated at its confluence with the East Kill. Downstream of the tributary there were some fallen trees associated with the left bank erosion.

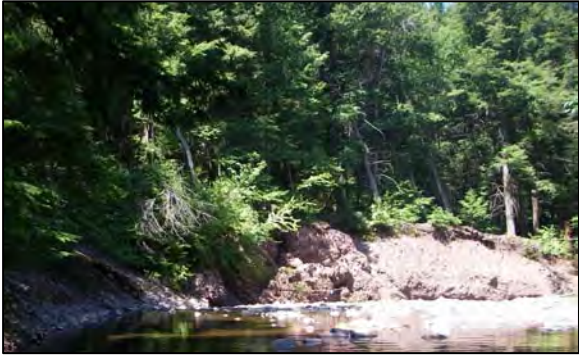
Bank Erosion Monitoring Site at Station 69703

The minor hydraulic erosion on the left stream bank was followed by a *mass failure*, a large slope failure associated with down-cutting stream channels and undermined support of steep slopes (Station 69857 to Station 69611). Stream bank erosion often occurs on the outside of meander bends where the stream velocity is greatest during

high flows; along this section of stream, the thalweg flowed up against the toe of the bank undermining the steep slope, resulting in an erosion area of approximately 7,408 ft², exposing mixed till (Figure 4.2.1, Inset B) and compromising mature trees along the bank. During high flows and times of active erosion, a significant amount of clay enters the stream from this bank, which was observed during the assessment and monitoring efforts at this site; this poses a water quality threat due to the turbidity associated with clay exposures. There were also multiple small seeps along this bank, further exacerbating the erosion and mass failure at this site. To study erosion along this reach, this bank has been monumented as a Bank Erosion Monitoring Site (BEMS # 06EK1601, Station 69703). A cross-section and long profile survey were conducted to collect baseline data. In the future this cross-section can be resurveyed to calculate the bank's erosion rate. It is recommended that monitoring of this site continue.

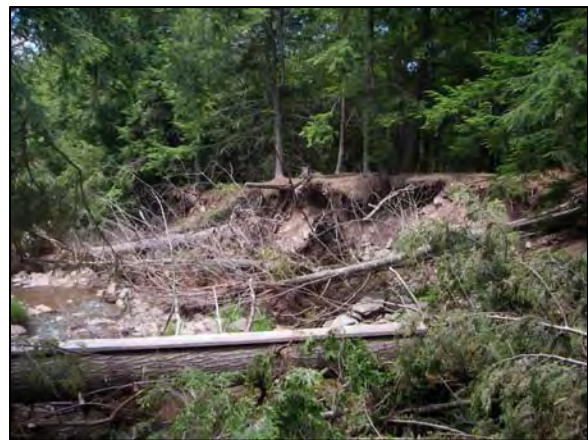
Continuing downstream, the right stream bank has been affected by a combination of mass failure and hydraulic erosion (Station 69616 to Station 69400), resulting in an erosion area of approximately 2,162 ft². There were several fallen trees

*Erosion along right stream bank
Stations 69616-69400*

along the eroding bank that extended into the channel and there was considerable aggradation along this reach. The fallen trees appeared to be contributing to scour upstream and downstream, though they may provide some protection to the stream bank.

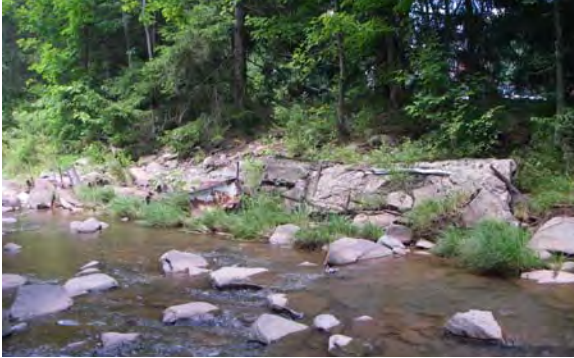
Dump site at Station 69132

site (Station 69132) be cleared to eliminate the potential safety and pollution hazards associated with the materials.

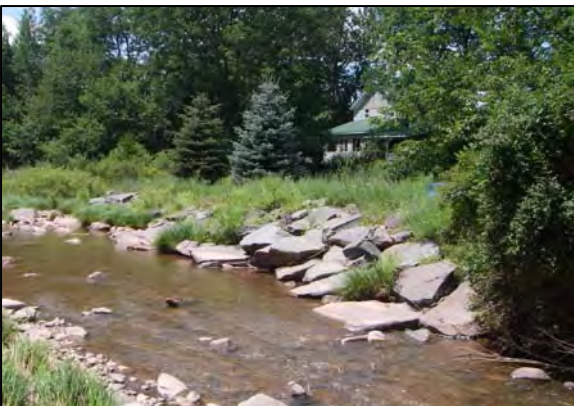
Rip-rap along right bank at Station 68717

Opposite the first wetland, the right stream bank was reinforced with rip-rap in two locations (Stations 68717 and 68575). The lawn was mowed to the top of the stream

bank along the edges of both revetted areas. Although the rip-rap was in good structural and functional condition at both locations, it is recommended to interplant native shrub and sedge species through the rip-rap and along the toe of this stream bank. This planting will help to strengthen the revetment, while enhancing aquatic habitat. The risk to bank stability can be minimized by maintaining mature trees along the critical 100-foot buffer zone. While achieving a 100 ft vegetated buffer may not be feasible due to the nearby residential structures along both revetted banks, the buffer width should be increased by the greatest amount agreeable to the landowners.

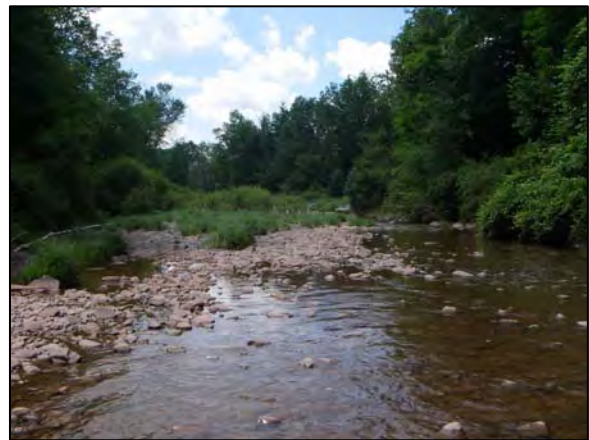
Point bar at Station 68600

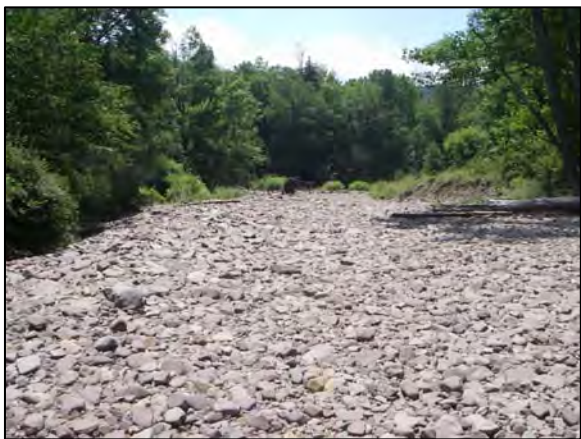
Flood chute at Station 68481

Just before the stream meandered to the right, the channel diverges, forming a secondary channel that appeared to function primarily as a flood chute (Station 68481). Review of the historical channel alignments showed that this channel has been present since at least 1959 and that it functioned as the main channel in 1980. The flood chute converged with the main channel approximately 544 feet downstream, just

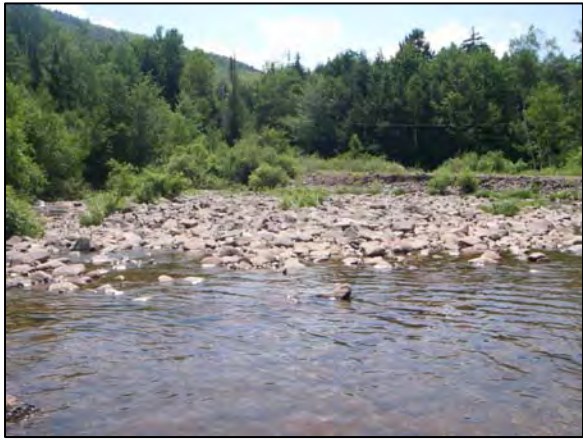
Center bar at Station 68093

As the stream meandered to the left, flowing away from Colgate Road, there was a center bar (Stations 68093 – 67869) forming a split channel; the secondary channel flowed around the bar and close to Vista Ridge Road and converged with the main channel just upstream of the Vista Ridge Road Bridge. It appeared that this private access road may become compromised by high flows if depositional conditions persist along this

reach and the stream continues to flow up against the toe of the road embankment. Reinforcing the road embankment with native shrub and sedge species is recommended.

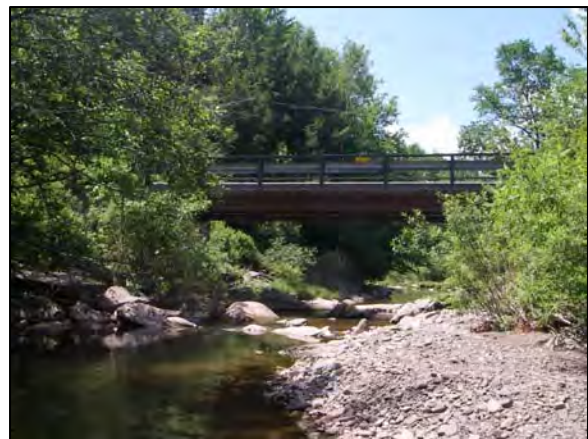
Vista Ridge Road Bridge at Station 67777

approached Vista Ridge Road Bridge (Station 67777). This bridge marks the end of management unit #2. As mentioned previously, there was excessive sediment deposition upstream of the bridge. Aggradational conditions such as these are commonly caused by inadequate sizing of the bridge opening. An undersized bridge opening causes water to back up upstream of the bridge, reducing stream velocity, which results in sediment deposition. While bankfull flows may flow freely through this bridge, higher flows may backwater, resulting in the upstream aggradation. If this bridge is replaced in the future, it is recommended that a hydraulic analysis be conducted in order to determine the appropriate bridge width that will provide the capacity to convey flood flows through the opening.
