Schoharie Creek Management Unit 8

Town of Jewett – Station 91473 to Carr Road Bridge (Station 83957)

Schoharie Creek Management Unit 8 Stream Feature Inventory

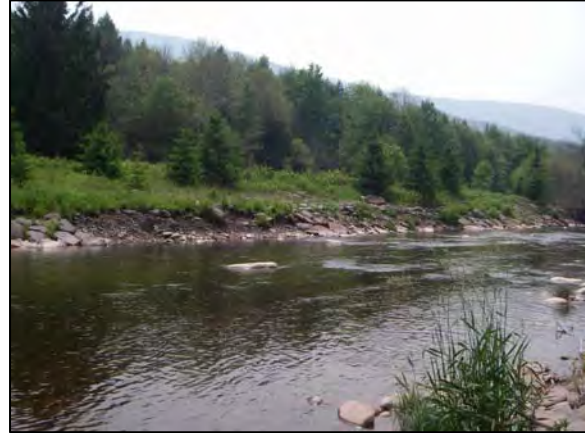
Directly downstream from the bridge, rip-rap had been installed along 290ft of the left streambank (Station 91400). This rip-rap was in poor condition, and at two locations where the rip-rap had failed clay/silt exposures were documented. Fine sediment inputs from these exposures can be a water quality concern because they increase *turbidity* and can act as a transport mechanism for other pollutants and pathogens. While rip-

Rip-rap and planting site at Station 91400

rap and other hard controls may provide temporary relief from erosion, they are expensive to install, degrade habitat, require ongoing maintenance or may transfer erosion problems to upstream or downstream areas. Alternate stabilization techniques should be explored for streambanks whenever possible. Native shrub and sedge species should be interplanted along the toe of this streambank to help strengthen the revetment, while enhancing aquatic habitat. A combination of trees and shrubs should also be planted along the streambank and adjacent *riparian* buffer to increase bank stability. At the downstream end of this rip-rap the left streambank had eroded along 108ft and had caused several mature trees to fall from the

top of the bank (91100). The stability of this streambank could also be improved with plantings along the toe and bank.

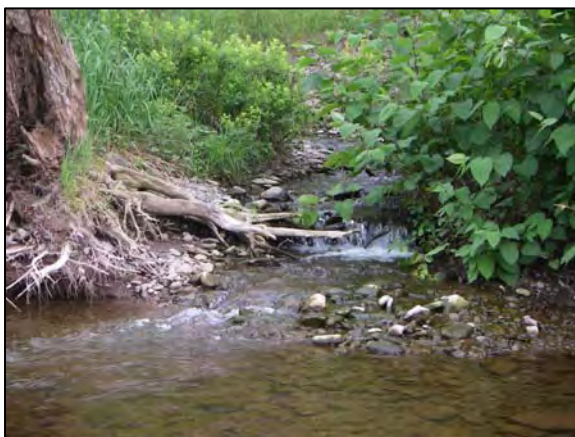
Tributary at Station 90200 - looking upstream

Downstream on the left streambank, an unnamed *tributary* entered the Schoharie Creek (Station 90200). This tributary drains the steep slopes of Rusk Mountain, before it reaches the flatter topography of the valley floor where it enters the Schoharie Creek. As

a result of this stream slope change, the tributary loses its ability to transport sediment gathered from the mountain slopes, and began to deposit sediment at its mouth and into the more gently sloped Schoharie Creek. This is a common feature of confluence areas, which often contain extensive sediment bars, function as important sediment storage areas, and are typically among the most dynamic and changeable areas in the stream system. The New York State Department of Environmental Conservation classifies streams and rivers based on their “best use” (NYSDEC, 1994). This tributary was classified as C, indicating that the best uses for this stream were the support of fisheries and other non-contact activities.

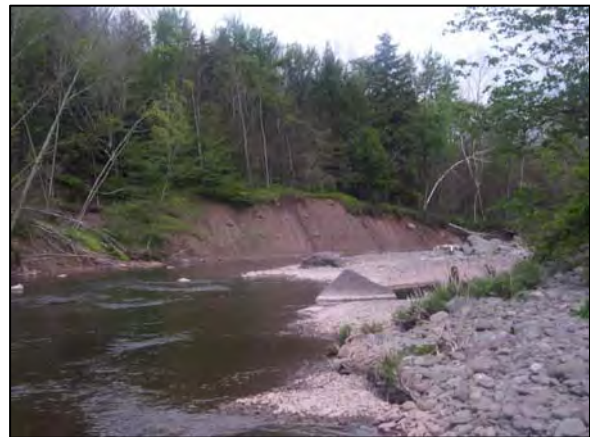
This reach, including the flood chute, serves as a storage area for excess sediment and woody debris supplied by upstream tributaries and streambank erosion. The resulting *aggradation* had shifted the erosional force of flood flows onto the left streambank of the main channel resulting in a large erosion area of approximately 5,343ft² and exposing a 270ft² area of clay (Station 89670). Due to the erosion, many mature trees have fallen into the stream adding to in-stream woody debris and sediment.

Bank erosion at Station 89670

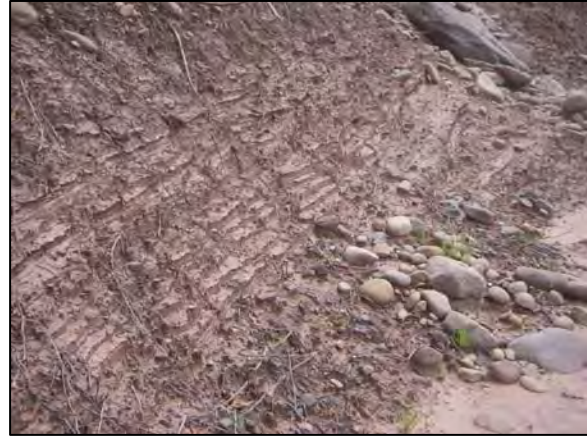
As the stream *meandered* downstream, the *thalweg*, or deepest part of the stream channel, flowed up against the right streambank causing significant bank erosion (Station 89000, Inset C). Streambank erosion often occurs on the outside of meander bends where the stream velocity is greatest during high flows. A 9,013ft² area of streambank had been left unvegetated exposing a substantial amount glacial lake silt/clay (Station 889000).

Clay exposure at Station 88900

A bank erosion monitoring site (BEMS) was installed along this bank to study this erosion (Station 88700). A cross-section and longitudinal profile survey were conducted to collect baseline *morphology* data. In the future, this cross-section can be resurveyed to calculate the bank's erosion rate. If the erosion rate accelerates significantly, full restoration to address property loss and water quality threats should be considered for this site. This would likely involve establishment of a well-vegetated bench on the right bank with rock vanes to direct stream flows away from the bank, regrading and then revegetation of the bank face, and establishment of channel geometry throughout the unit to more effectively convey the *sediment load*. The riparian area at the top of the bank was covered by *herbaceous* vegetation and if left undisturbed should allow for native tree and shrub species to establish. To speed this process trees and shrubs could be planted. While enhancement to the riparian buffer is recommended for this site, alone it will not solve this erosion problem.

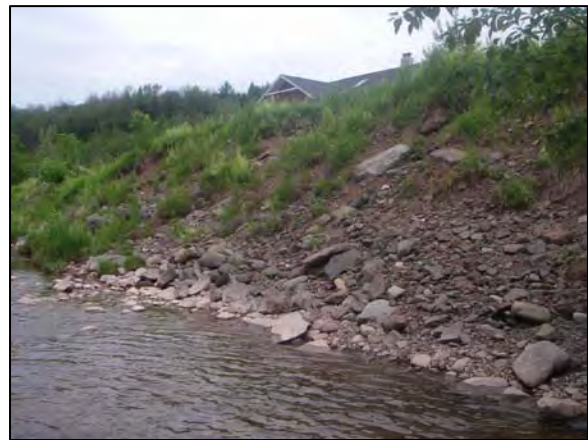
The right streambank had also been eroded with only herbaceous vegetation in the riparian zone (Station 88000). Mown lawn or pasture does not provide as much resistance to streambank erosion as the deep and dense root structure found in streamside forest. To promote a more mature vegetative community along the streambank and in the floodplain mowing to the stream edge should be stopped. Gradually, vegetation will begin to grow within the buffer but planting of native trees and shrubs can give the buffer a good head start. If it is important for the landowner to maintain a stream view, plantings of low growing vegetation could be installed. Plantings of shrubs and sedges along the streambank will also help to reduce erosion.

Bank erosion and planting site at Station 88000

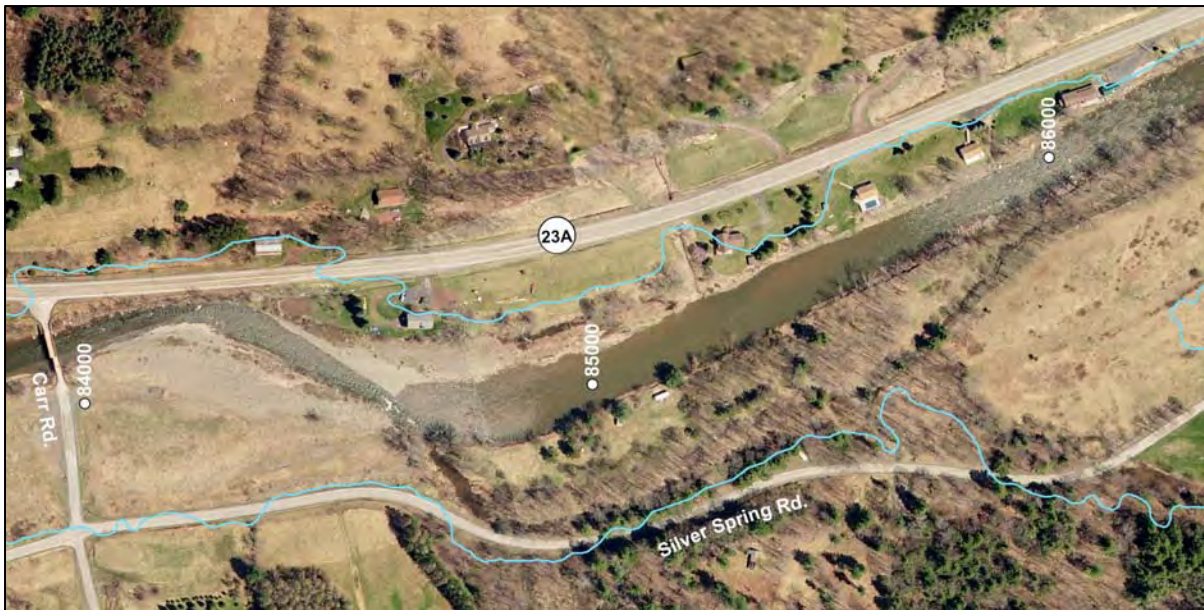
From Station 86200 downstream to the end of the management unit at Carr Road, residences along the right streambank have suffered repeated flooding due to their location within the floodplain. To resolve flooding issues, the best solution would be to relocate these structures outside the 100-year floodplain to allow the stream to utilize its floodplain without causing property damage. However this option seems unlikely. Silver Spring Road was first built along the Schoharie Creek. After years of sustaining flood damage, the Town of Jewett working with landowners, relocated the road outside the floodplain to its present day location.

2006 aerial photograph with 100-year flood boundary represented by blue line

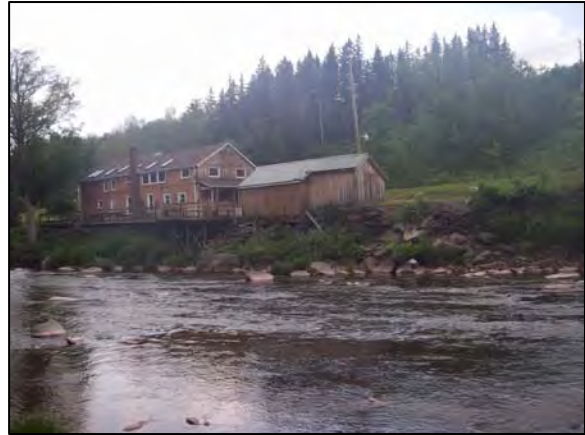
A 320ft stacked rock wall was installed to protect a home on the right streambank at the edge of the Schoharie Creek (Station 86250). A section of this wall had failed due to stormwater which flows over the edge of the bank. This problem may be corrected with grading at the top of the bank to redirect stormwater. The building of a well-vegetated bench within the stream channel could reduce flood water velocities near this bank and lessen its susceptibility to failure.

Stacked rock wall at Station 86250

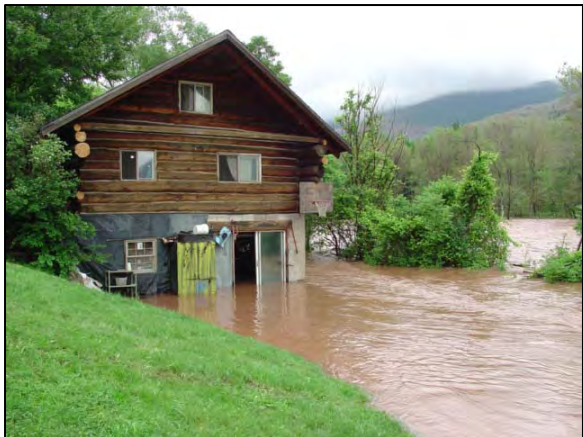
Flooding of residence at Station 84700

Downstream, floods regularly flow through the lower level of the home on the right streambank (Station 84700). To protect this home an upstream berm had been built. The berm was approximately 45ft in length and started at the existing high terrace, which the house sits upon, and ran perpendicular to the home towards the stream. The berm was roughly 20ft wide and 4-6ft high. Although this berm may protect the home from some

flooding, additional flood proofing of the lower level is recommended. The septic system for this home poses a water quality threat and should be relocated outside of the floodplain. The homeowner is currently working with the Catskill Watershed Corporation (CWC) Septic Rehab and Replacement program to replace this septic system (See Section 2.12). Construction is expected by the end of 2007.

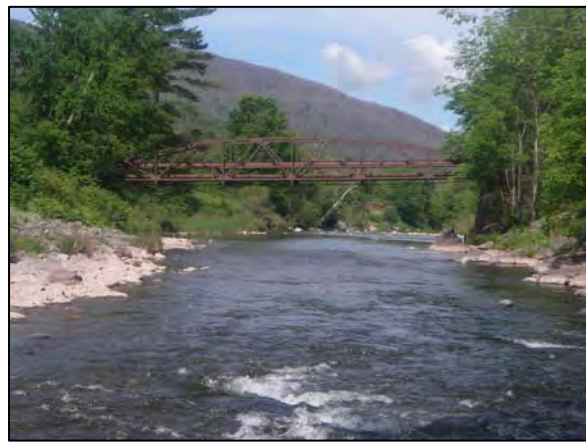
At the end of this management unit, the stream passed under Carr Road bridge. While *bankfull* flows appeared to flow freely through this bridge, higher flows overtop the bridge and flow over Carr Road rendering the bridge impassable. This bridge is the sole access residents have to cross the Schoharie Creek, and during floods residents are cut off from emergency services. Repeated repair of Carr Road after flood events has also been very costly. Installation of *floodplain drainage*, using culverts set at the floodplain elevation under the bridge approach, would increase hydraulic capacity of the bridge and help mitigate this problem. A hydraulic analysis of Carr Road bridge and upstream floodplain is the first step necessary to begin planning for remediation of flood concerns in this area.

Bridge at Carr Road (Station 83957)
