Neversink River East Branch

MANAGEMENT UNIT 8

EAST BRANCH MANAGEMENT UNIT 8
BETWEEN STATION 30800 AND STATION 28000

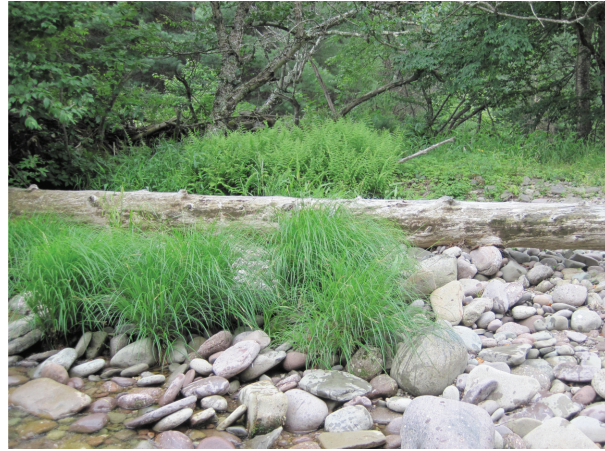
EBMU8 begins downstream of a convergence with a retention pond drainage channel that was documented in EBMU9. At Station 30760 there is large woody debris that has deposited and become an obstruction on the left side of the channel. (*A317*) This obstruction is reducing the streams power to move sediment through this reach, resulting in the formation of a depositional bar directly downstream. This bar

Large woody debris on left side of channel (A137)

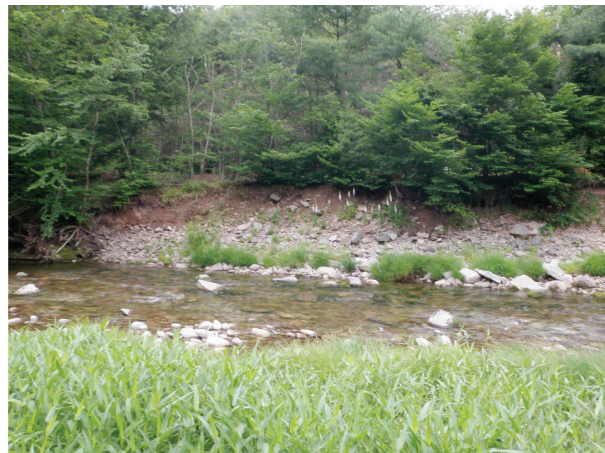
Erosion on right bank due to hydraulic pressure (B224)

BANK EROSION Due to a number of conditions in EBMU11, the stream bank at one location is experiencing active erosion. Hydraulic pressure during large events is causing approximately 167-feet of erosion on the right bank between Station 30700 and Station 30530 (BEMS NEB8_30500). Large rocks and sedges are beginning to deposit at the toe of this eroding bank, indicating that it is possible for this bank to stabilize without treatment (*passive restoration*).

Intervention Level	Passive restoration of the bank erosion site between Station 30700 and Station 30500. (BEMS NEB8_30500)
Stream Morphology	Assess sediment deposition and channel migration from the accumulation of large woody debris supplied by the watershed upstream. Conduct baseline survey of channel morphology.
Riparian Vegetation	None.
Infrastructure	Assess flood threats to Denning Road.
Aquatic Habitat	Fish population and habitat survey.
Flood Related Threats	None.
Water Quality	None.
Further Assessment	Long-term monitoring of erosion site. Assess effects of excessive woody debris accumulation and channel migration.

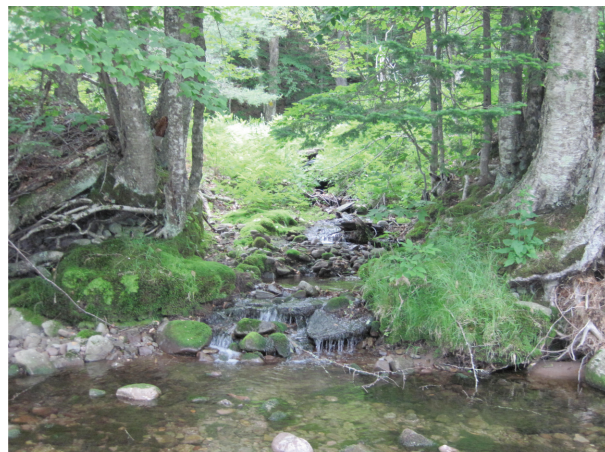
Continuing downstream, the first of several small unnamed tributaries documented in EBMU8 enters from the right at Station 30390. (A318) This tributary is conveyed under Denning Road through a culvert before flowing into the main channel. Small feeder streams such as this often play an integral role in ecosystem integrity, as they are a source of the cold and well oxygenated water that is necessary to support a diversity of aquatic life.

Small tributary entering on right bank (A318)

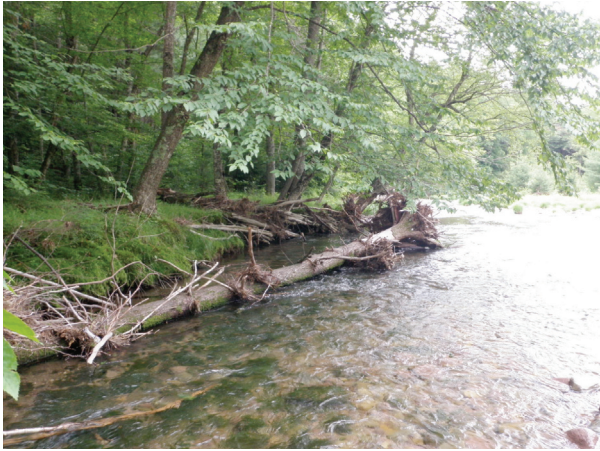
The stream continues in a relatively straight reach for 400-feet before entering a series of large woody debris obstructions that are contributing to sediment deposition. A large tree with the root structure still attached has deposited along the left bank at Station 30000. (B226) At Station 29900, another woody obstruction has deposited

Large tree deposited along left bank (B226)

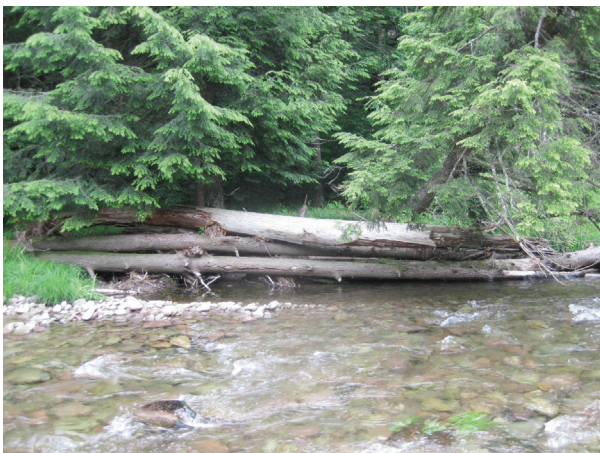
Woody obstruction causing deposition on right side of channel (A319)

on the right side and is contributing to sediment deposition downstream. (A319) Continuing past this obstruction, the channel moves out of the straight reach and begins to meander to the left up against the valley wall. A small perennial tributary enters through the bedrock on the left. (B230)

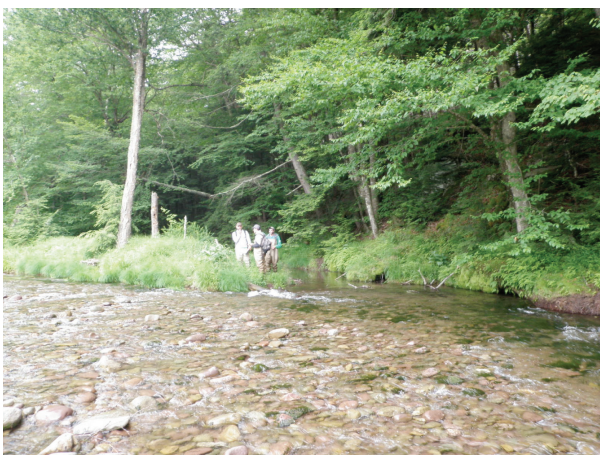
Small tributary enters on left through bedrock (B230)

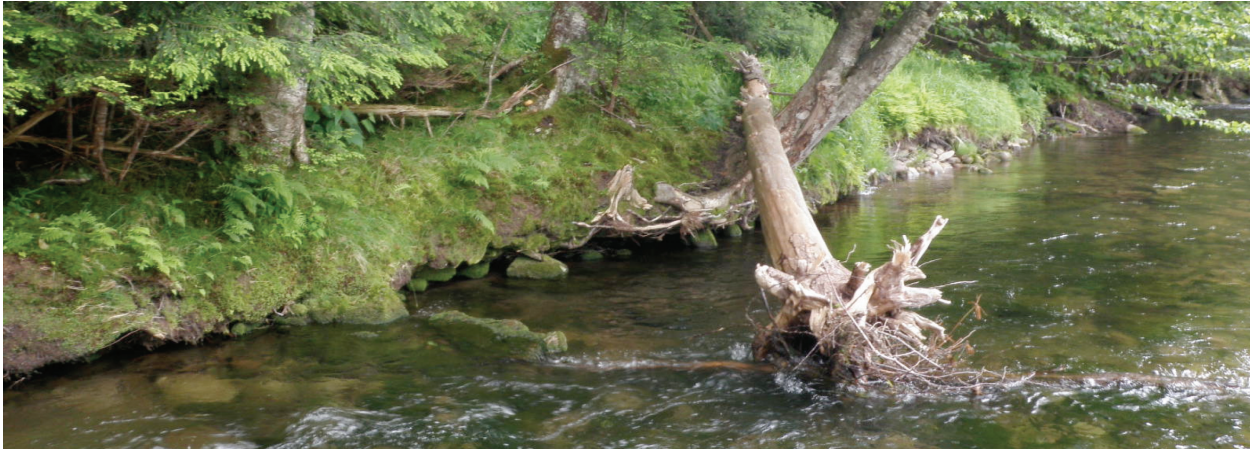
At Station 29720 a downed tree has become lodged on the left bank, leaving its root structure extending into the center of the stream as an obstruction to flow. (B231) This obstruction did not appear to be secured on the bank and is likely to be washed from its location in future flood events. Two adjacent small tributaries enter from the left at Station 29650 (B235) and Station 29680 (B233). Both contribute a perennial cold water flow to EBMU8.

Downed tree has become lodged on left bank (B231)

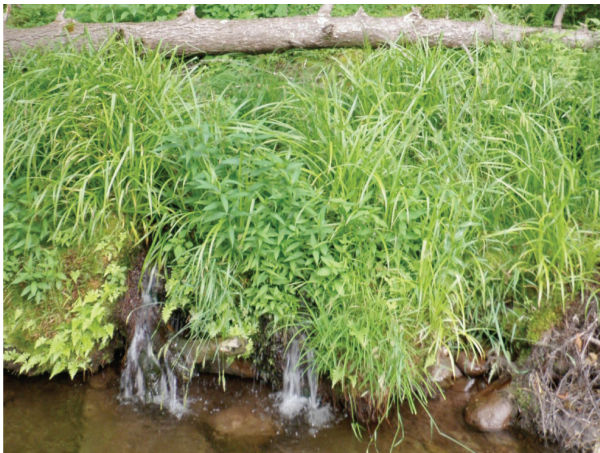
Small tributary entering on left bank (B235)

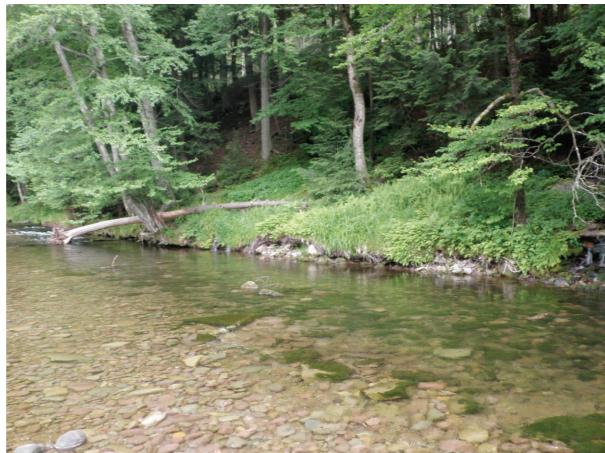
Two small tributaries enter from left bank (B233)

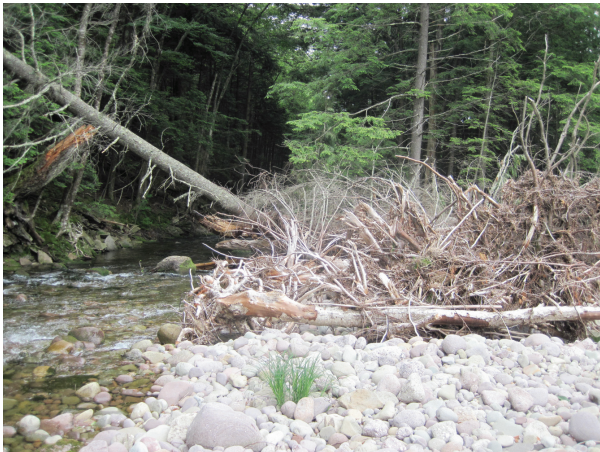
The channel begins to meander back to the right towards Denning Road near Station 29570. Large woody debris has accumulated and is obstructing flow at this station, contributing sediment deposition to the point bar located directly upstream. (A320) During larger events this obstruction causes part of the flow to diverge into a small side channel on the right. (A323) This side channel was dry at the time that this inventory was conducted; however, it was clear of leaf debris indicating that it has received flow at some point this year.

Large woody debris contributing to deposition upstream (A320)

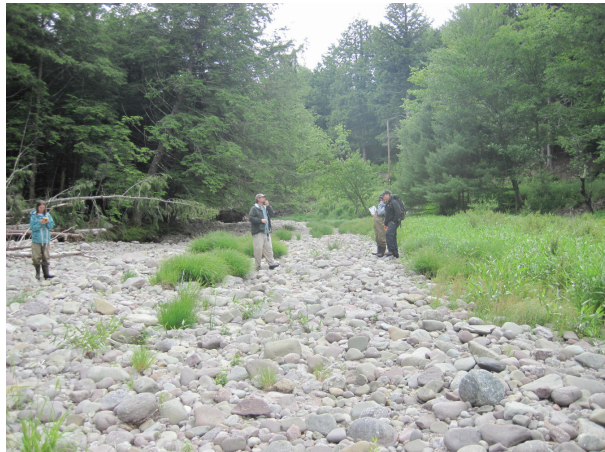
Diverging right side channel (A323)

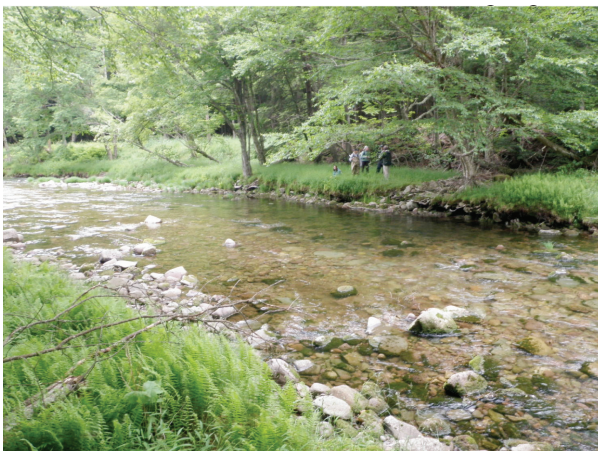
The channel is controlled laterally by the left valley wall for a 250-foot stretch between Station 28900 and Station 28650 before the valley floor begins to widen towards the end of EBMU8. (B240) As the floor widens it begins to form a low elevation floodplain bench on both sides of the stream while remaining very well forested. A large downed tree has deposited as an obstruction to higher flows on the right bench at Station 28750. (A332) The deposition of such large debris in close proximity to the road illustrates the threats associated with designing infrastructure in the floodplains.

Widening channel floor (B240)

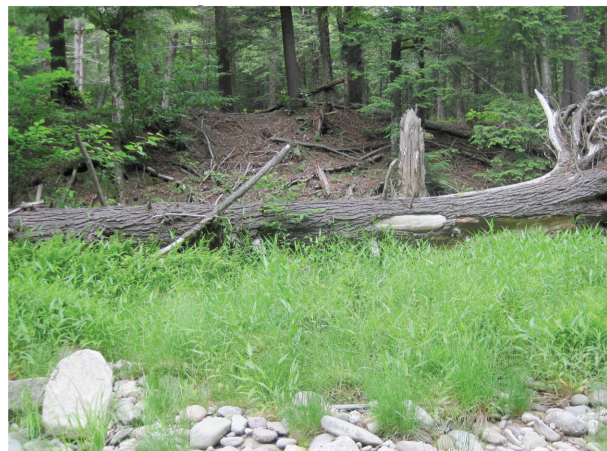
Large downed tree deposited on right bench (A332)

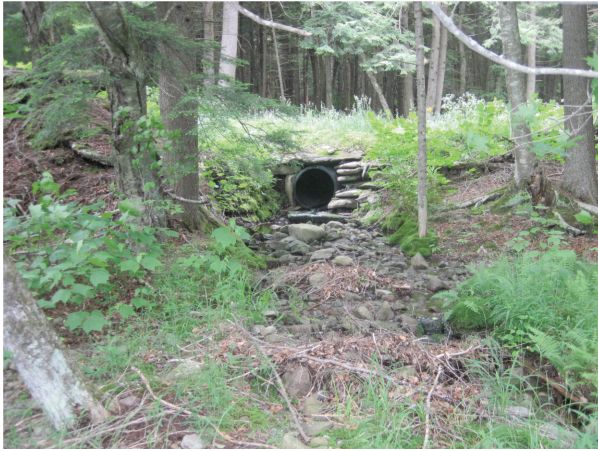
A small tributary enters from the right bank at Station 28500 through a drainage culvert that runs under Denning Road. (A334) This culvert appears to be in relatively good structural condition and is protected both at the headwall and outfall by stone. This drainage was assessed under low flow conditions and it is unclear whether it can effectively convey large flows without contributing to road wash out. The remainder of channel in EBMU8 was documented as being in very stable condition, as evidenced by the well connected floodplain benches on both sides and lack of significant erosion. (B241) A significant tributary flows adjacent to New Hill Road before it enters from the left at Station 28080. This tributary contributed a relatively large flow even during dry conditions. (B243)

Small tributary entering on right bank through culvert under Denning Road (A334)

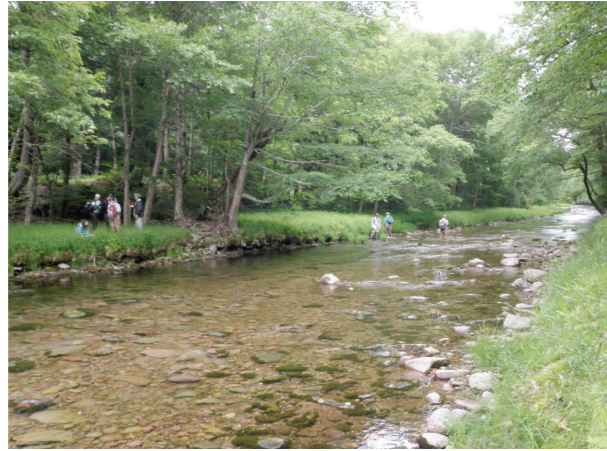
Floodplain benches on both sides lack erosion and indicate stability (B241)

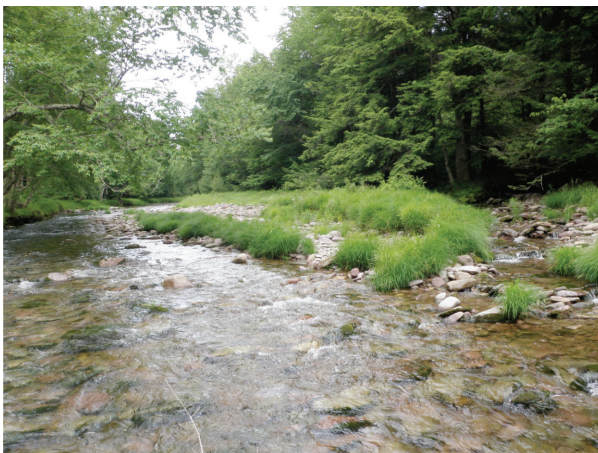
Significant tributary flowing adjacent to New Hill Road (B243)

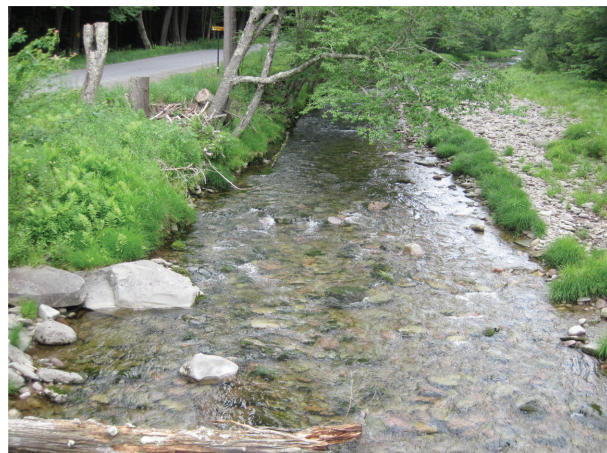
EBMU8 ends at Station 28000, where a bridge allows a stream crossing for Denning Road. The bridge was documented as in good structural and functional condition at the time of this inventory. It appeared to be conveying flows relatively effectively, but displayed some aggradation upstream and scour near the abutments which is typical for bridges under designed to handle large flows. (A336)

Looking upstream from Bridge on Denning Road (A336)
