Neversink River West Branch

MANAGEMENT UNIT 4

WEST BRANCH MANAGEMENT UNIT 4
BETWEEN STATION 10300 AND STATION 15200

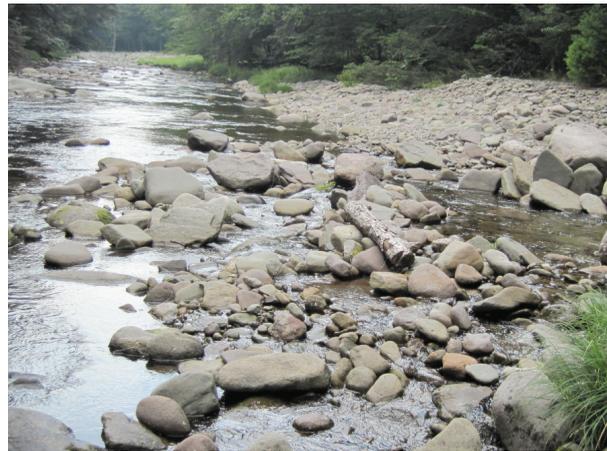
Cobble delta bar in main channel at confluence (A224)

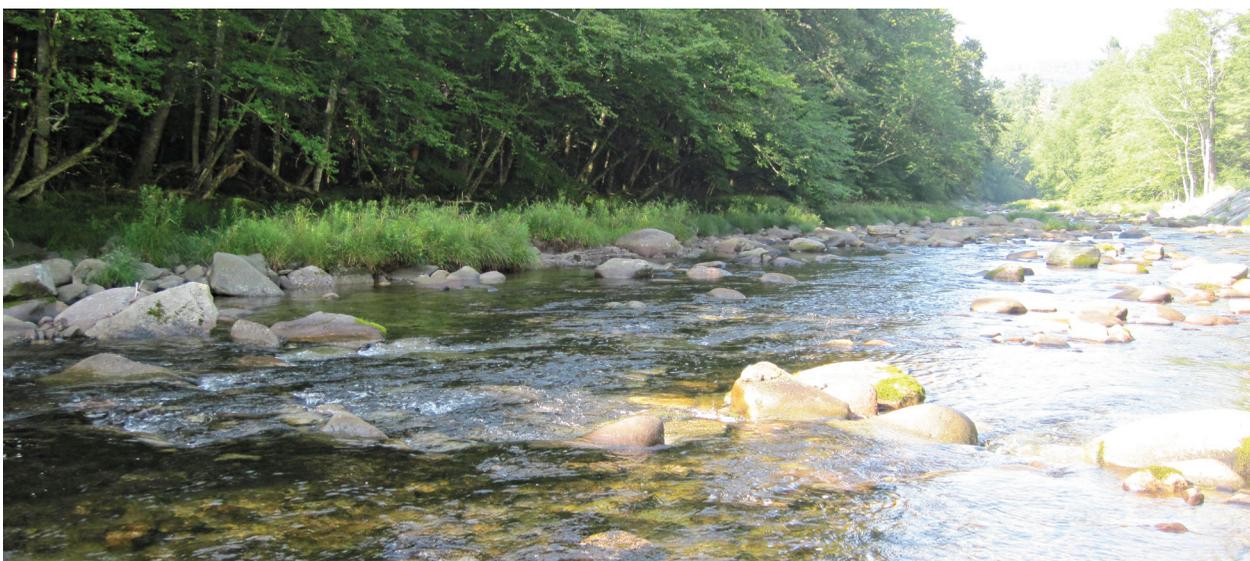
Cobble bankfull bench (A228)

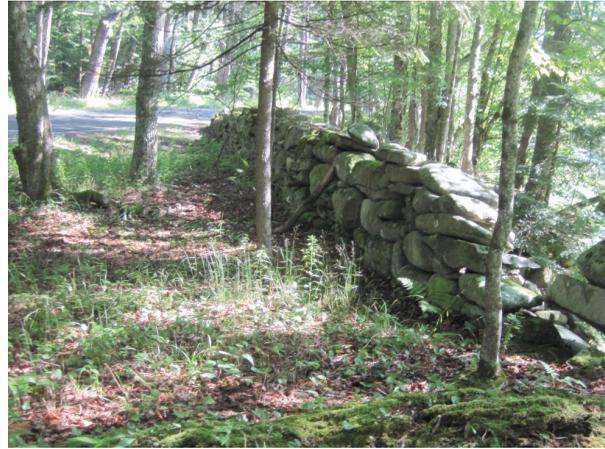
At Station 13900 a 115-foot stone berm was observed in the thick forested riparian buffer between a flood chute in the right floodplain and Frost Valley Road. The berm appeared to be actively maintained as evidenced by recently placed stones. Some scour was observed on the right bank at the downstream end of the berm indicating that the flood chute conveys flow during high flow events. (A237 and A235) A headcut was observed in the main channel near at large boulder at Station 13800 that has caused a minor drop in stream grade at this location.

Actively maintained berm on right floodplain (A237)

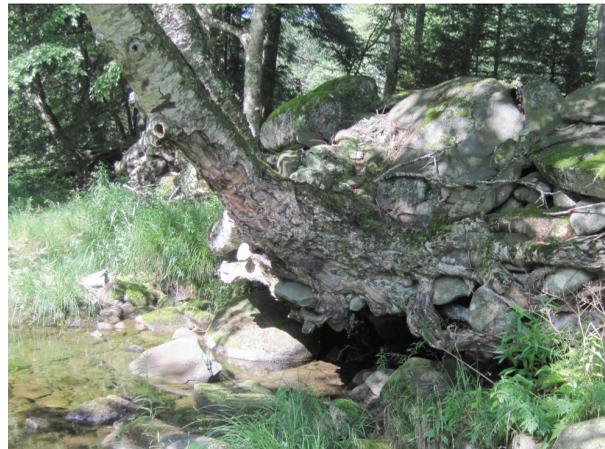
Scour on right bank downstream of berm (A235)

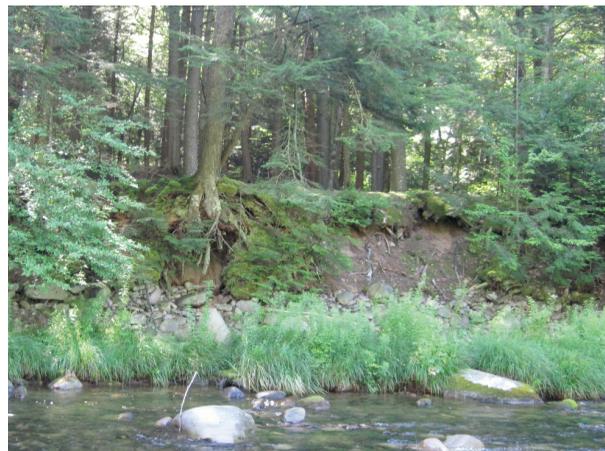
Erosion on left bank (A242)

An eroding bank segment was observed on the left bank extending 340 feet from Station 13540 to Station 13200 (BEMS NWB4_13200). This bank failure site was documented as active; while there is hardening at the toe, hydraulic erosion and fluvial entrainment are causing scour at the crown of the bank exposing glacial till. The 50-foot length of the eroding segment from 13450 to 13400 was documented as a fine sediment source although it is not a significant source of turbidity. Due to the active erosion at the tip of the bank failure, recommendations for this site include *assisted restoration* to improve bank stability.

The riparian buffer has the potential to be improved along the right bank between Station 13550 and Station 12910. An eroding bank segment was observed on the left bank extending 340 feet from Station 13540 to Station 13200 (BEMS NWB4_13200). This bank failure site was documented as active; while there is hardening at the toe, hydraulic erosion and fluvial entrainment are causing scour at the crown of the bank exposing glacial till. The 50-foot length of the eroding segment from 13450 to 13400 was documented as a fine sediment source although it is not a significant source of turbidity. In addition, an unnamed tributary conveying flow from the right valley wall (and former location of Prothero sawmill) was observed joining the main channel across from the bank failure site near Station 13400. It is possible that the additional sediment and flow conveyed by this tributary is contributing to this bank erosion. (A242) Due to the active erosion at the tip of the bank failure and the ongoing contribution from the tributary, recommendations for this site include *assisted restoration* to improve bank stability.

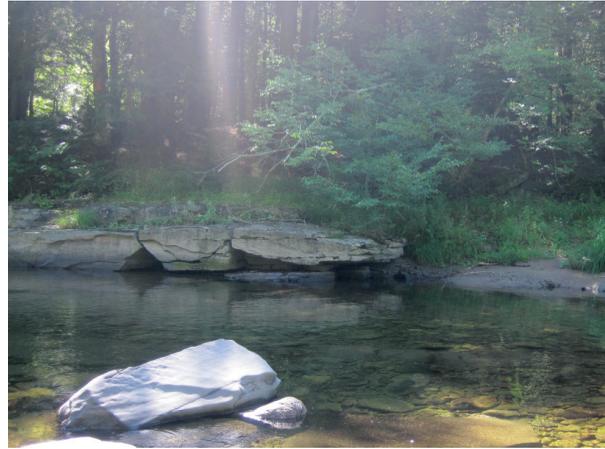
Bedrock grade and planform control (A253)

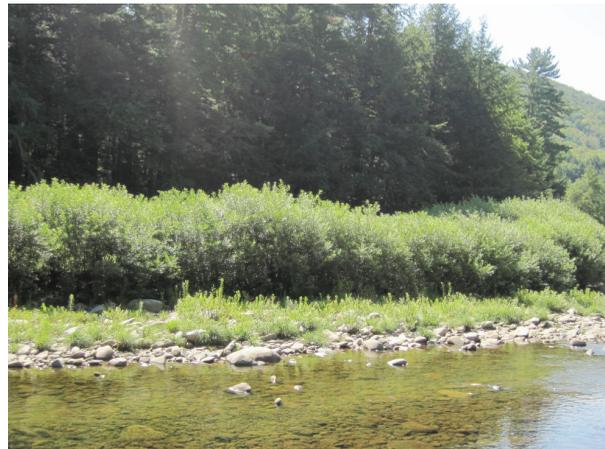
Potential willow harvest source (A258)

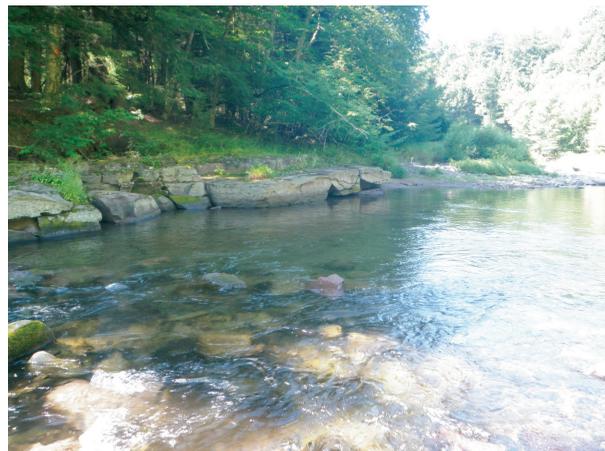
Placed quarry rock forming grade control (P7290125)

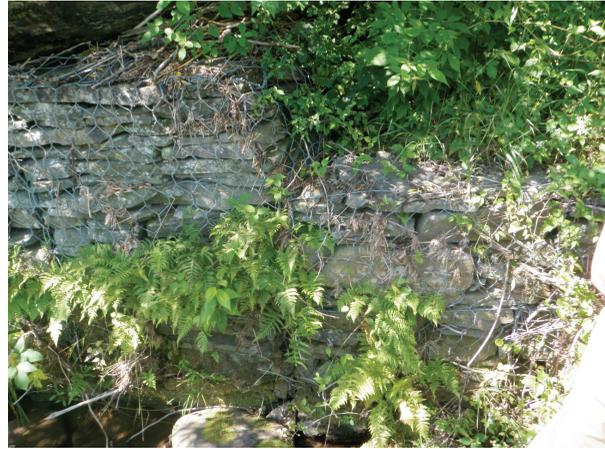
Stone gabion revetment on right bank (P7190130)

INFRASTRUCTURE A stone gabion revetment was observed extending 100 feet from Station 12520 to Station 12420 on the right bank. This revetment was documented as in good structural and functional condition, although the riparian buffer was documented as thin with mangled fencing on top of the gabions. A sloped stone revetment was observed in good structural and functional condition extending 60 feet from Station 12420 to Station 12360. Both of these revetments were most likely designed to stabilize the bank near Frost Valley Road.

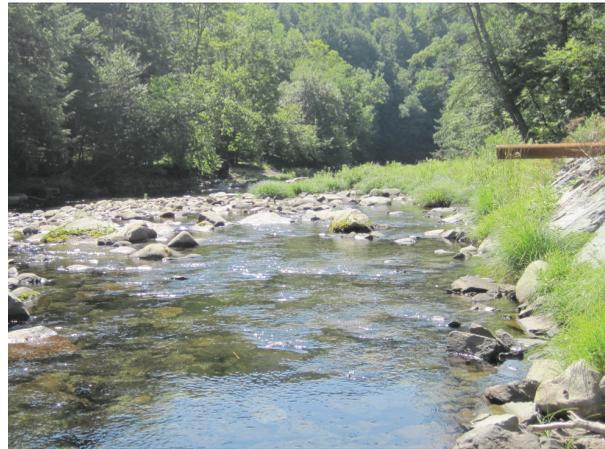
Piped outfall conveying flow from Frost Valley Road (A263)

A piped outfall was observed at the end of this revetment near Station 12360 conveying flow from Frost Valley Road to the main channel. The outfall is constructed of a 2-foot diameter smooth steel pipe with 3 feet of outfall and good outfall protection. (A263) It is recommended that the water quality impacts of this outfall be investigated to better understand and possibly mitigate the water quality implications of this conveyance.

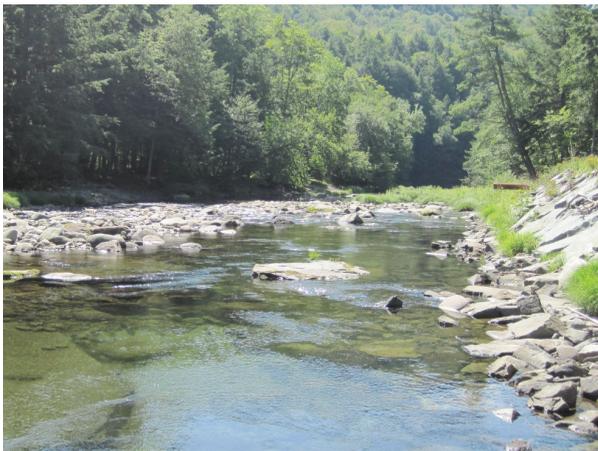
Exposed bedrock providing grade control (A260)

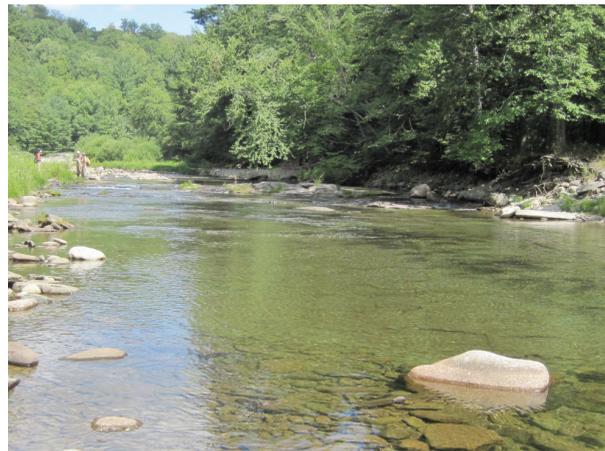
Bedrock grade control (A266)

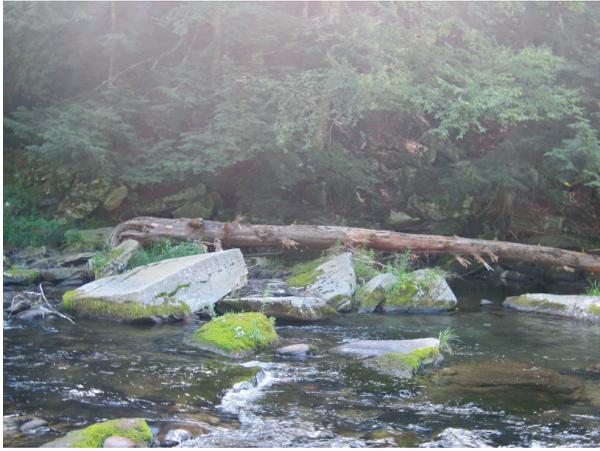
Fallen tree above bankfull height (A272)

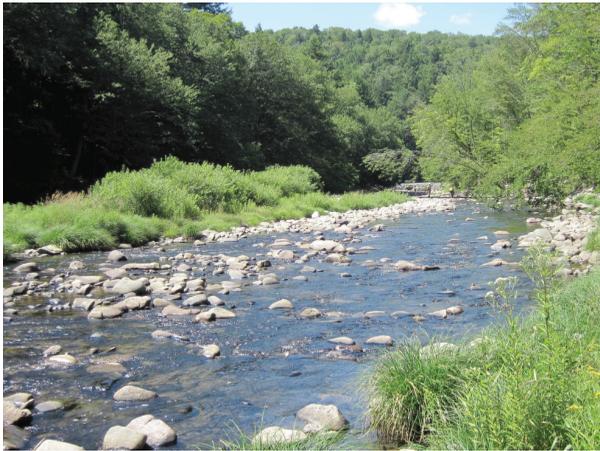
Vegetated cobble center bar (A276)

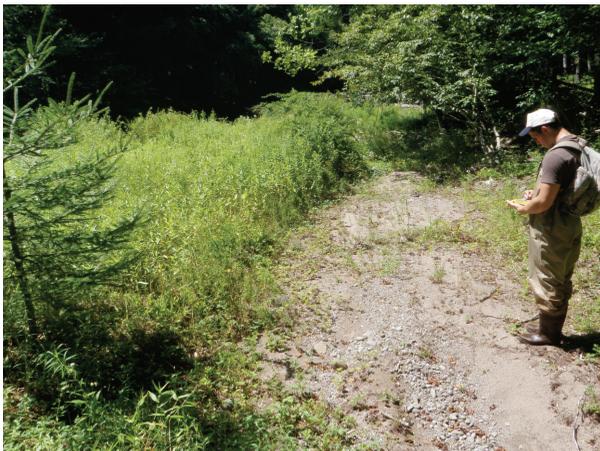
Fine sediment outwash on right bank (P7290144)

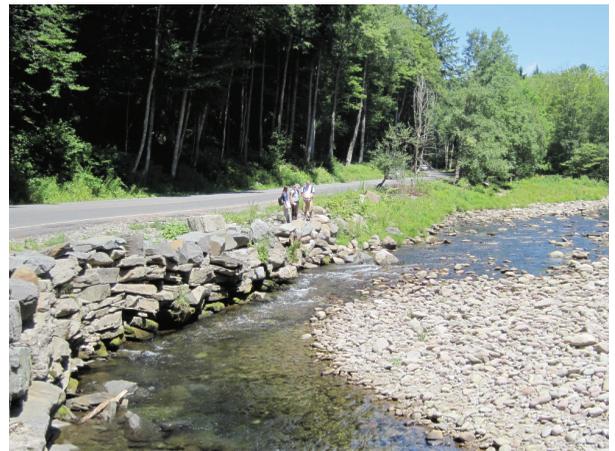
Stacked rock revetment protecting Frost Valley Road (A280)

A stacked rock revetment was observed protecting Frost Valley Road for the last 80 feet of the management unit beginning near Station 10380 and continuing into WBMU3. The revetment was documented in good structural and functional condition although deposition on the left bank appeared to be directing flow toward the revetment, which could be causing scour below the water level. It is recommended that this revetment be inspected for structural stability.

A stacked rock revetment was observed protecting Frost Valley Road for the last 80 feet of the management unit beginning near Station 10380 and continuing into WBMU3. The potential exists for adding a riparian buffer to this revetment. The revetment was documented in good structural and functional condition although deposition on the left bank appeared to be directing flow toward the revetment, which could be causing scour below the water level. It is recommended that this revetment be inspected for structural stability. (A280)
