Local Flood Analysis

Town of Halcott, Greene County, New York
November 2019

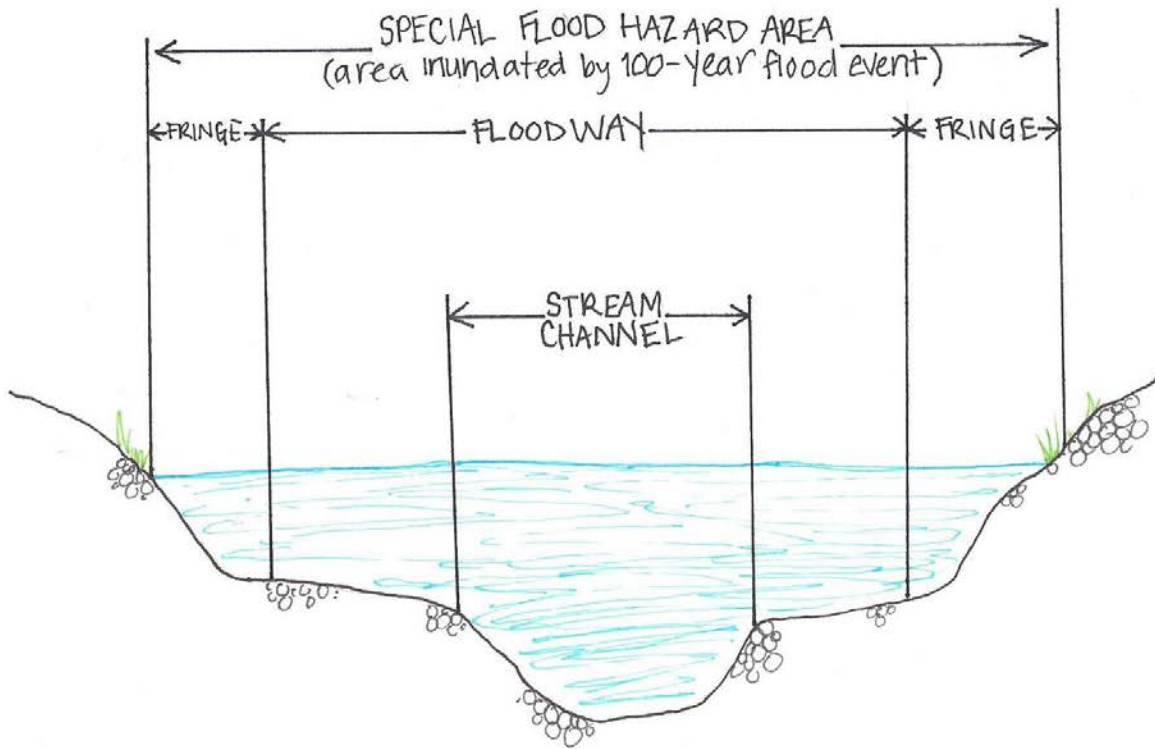
Figure 1-1: Special Flood Hazard Area (SFHA), Floodway, and Flood Fringe

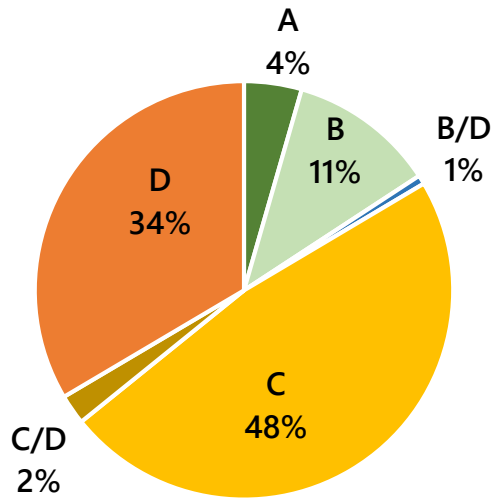
Figure 2-1: Distribution of hydrologic soil groups in Vly Creek watershed

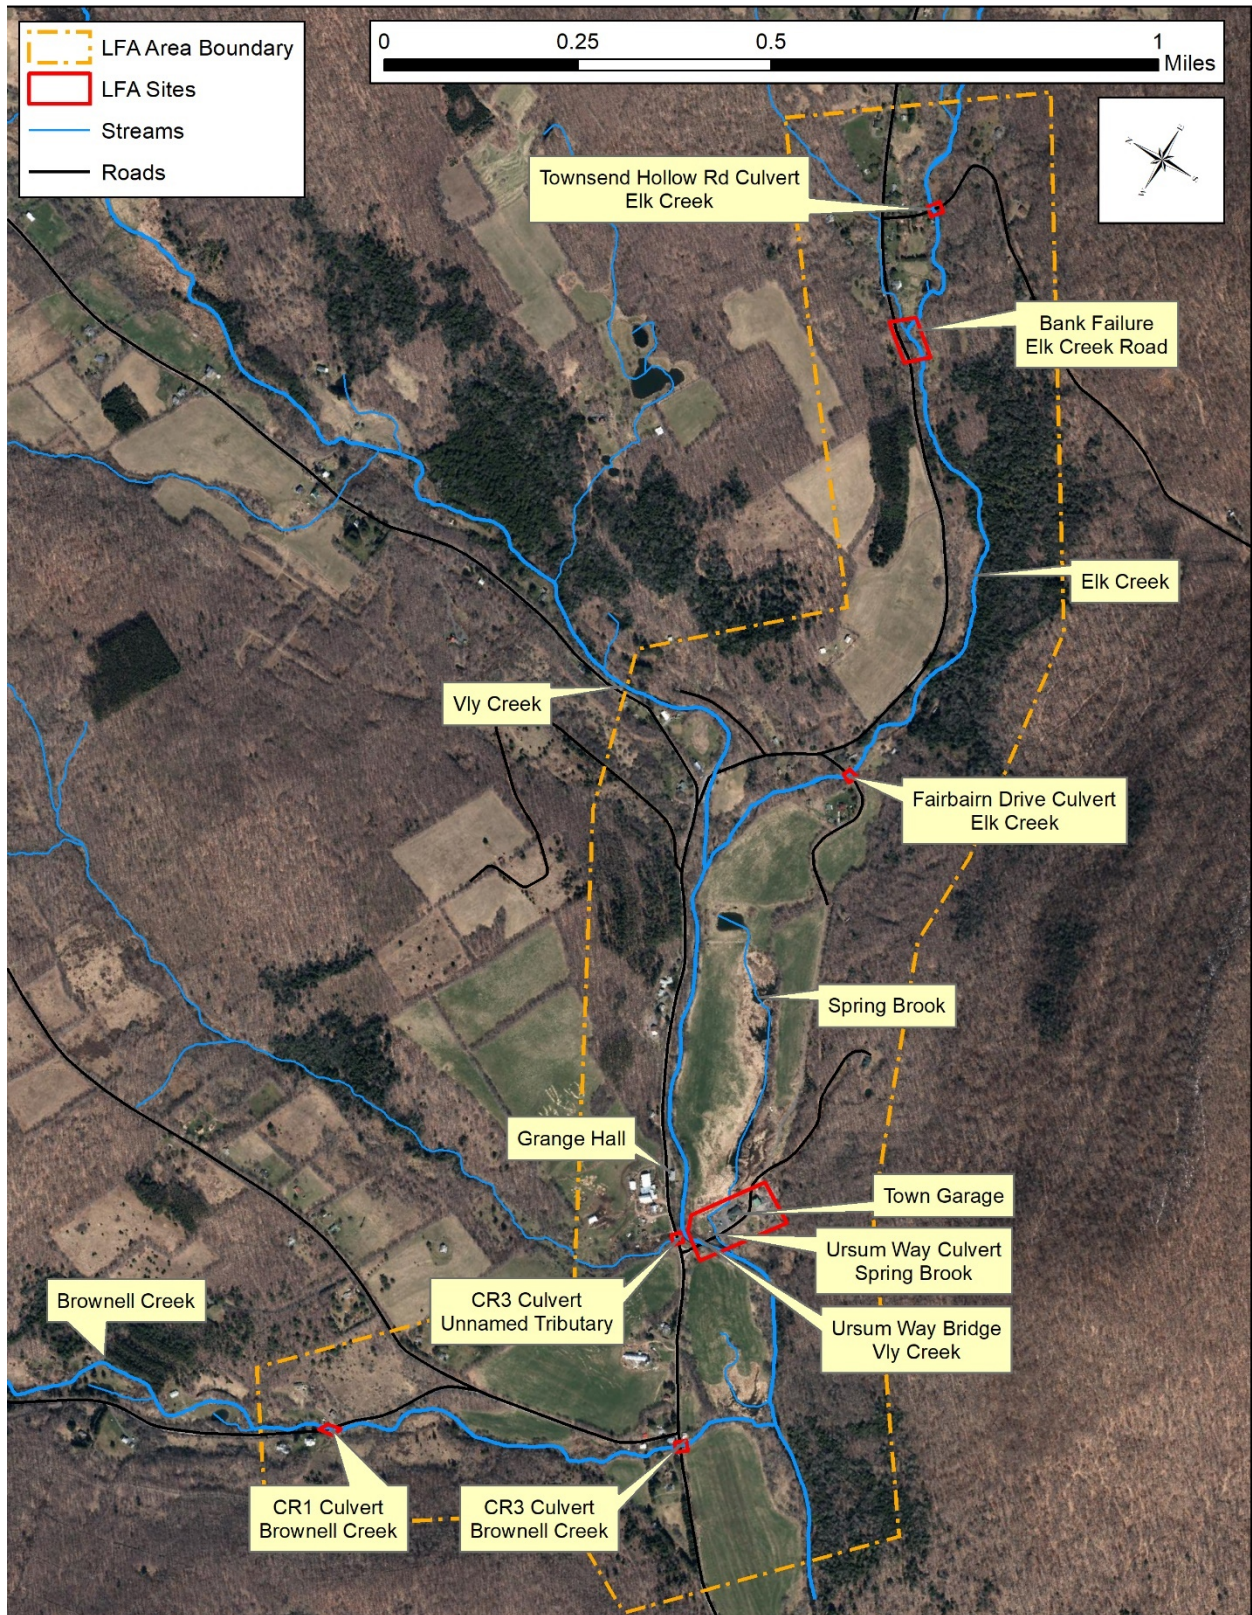
Figure 4-1: Town of Halcott LFA sites

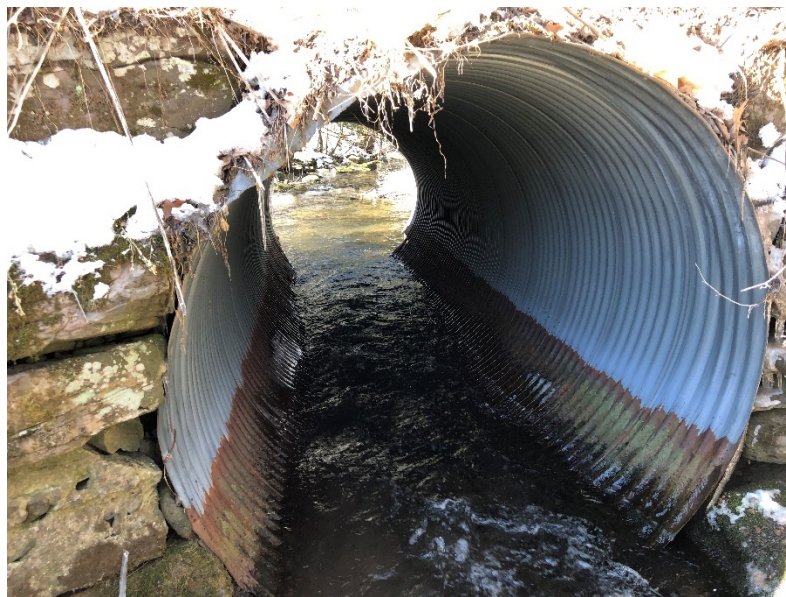
Figure 5-2: Townsend Hollow Road culvert carrying Elk Creek. View looking downstream through culvert.

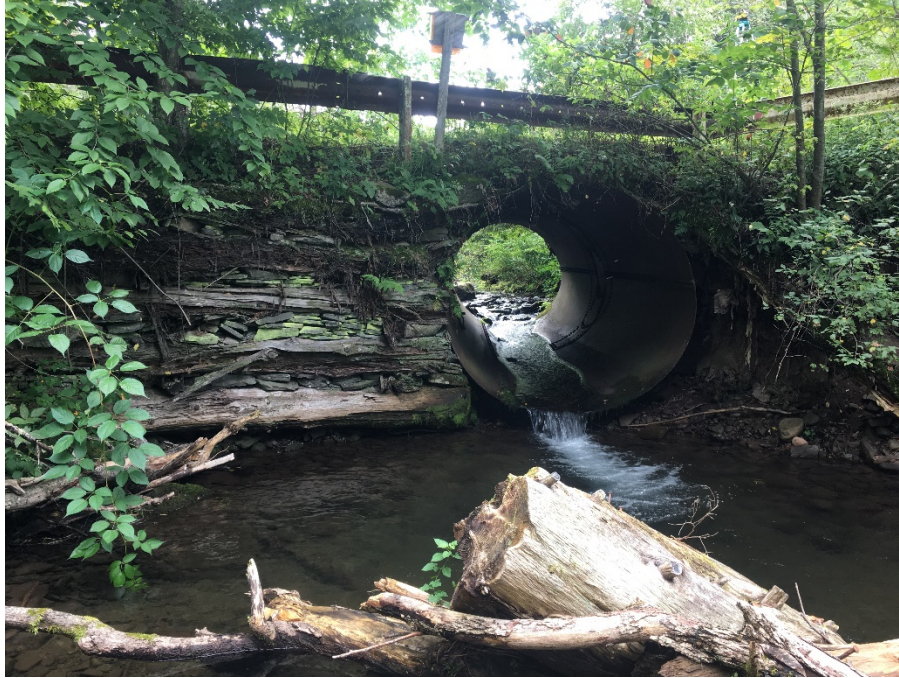
Figure 5-3: Fairbairn Drive culvert carrying Elk Creek. View looking upstream at culvert outlet. Left wingwall (right side of photograph) has failed; right wingwall (left side of photograph) is in fair condition. Perched outlet is an impediment to aquatic organism passage and may contribute to headwall failure.

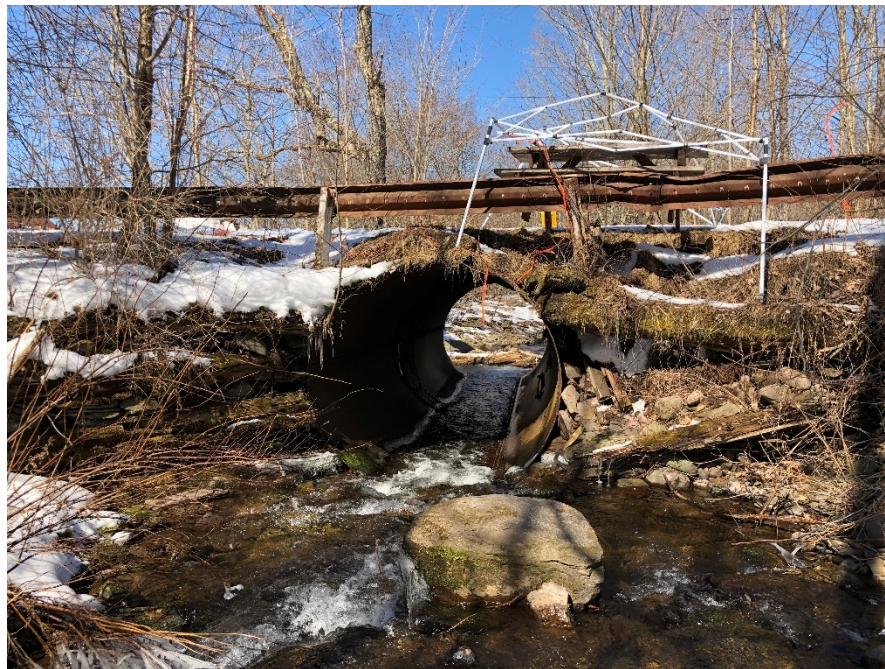
Figure 5-4: Fairbairn Drive culvert carrying Elk Creek. View looking downstream at culvert inlet. Right wingwall has failed and collapsed. Left wingwall is in poor condition. Tent frame and picnic bench cover collapsed portion of road embankment.

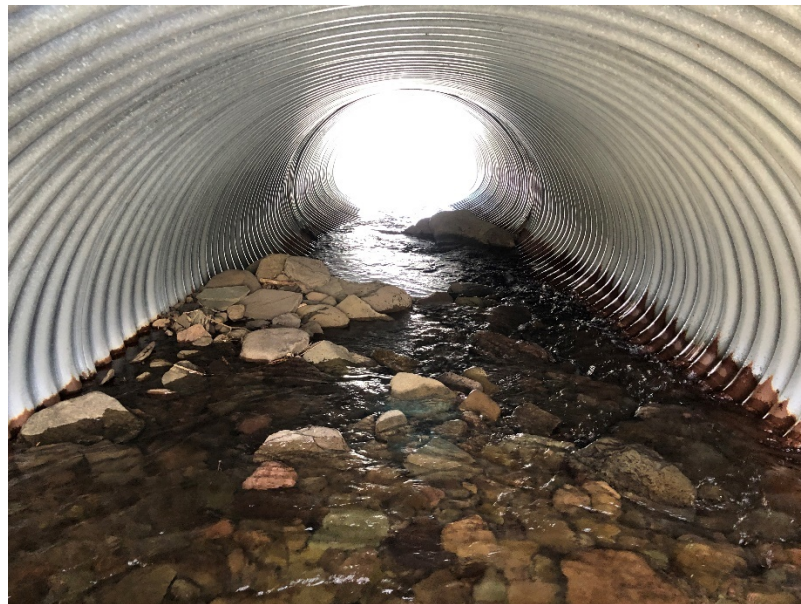
Figure 5-5: County Route 3 culvert carrying unnamed tributary. View inside culvert, looking downstream. Sediment aggradation has reduced the hydraulic capacity of the culvert.

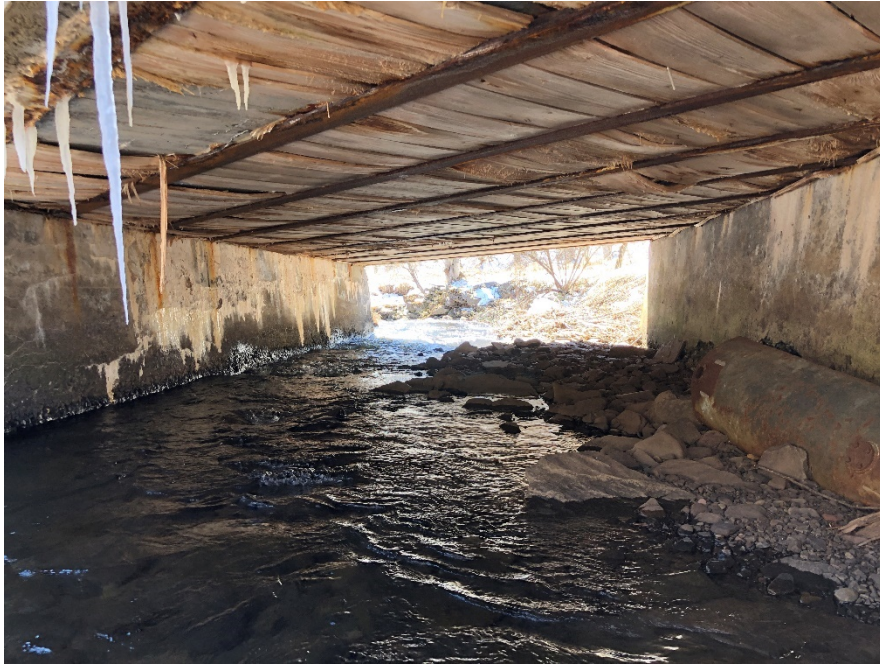
Figure 5-7: County Route 1 culvert over Brownell Creek. View inside culvert, looking downstream.

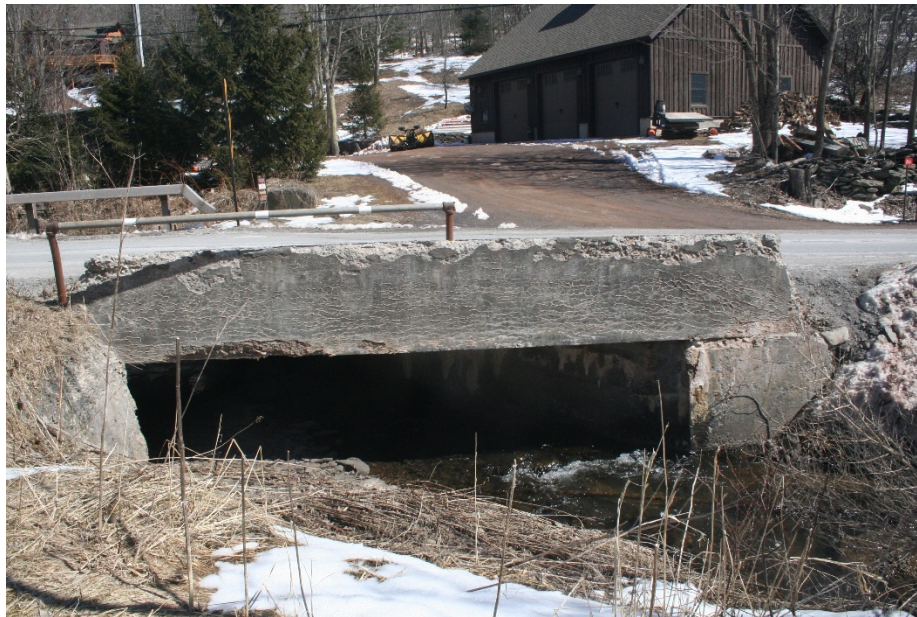
Figure 5-8: County Route 1 culvert over Brownell Creek. View from right bank, looking upstream. In floods, water flanks this culvert on the left side, flows across the driveway in the background of the image, and down the road.

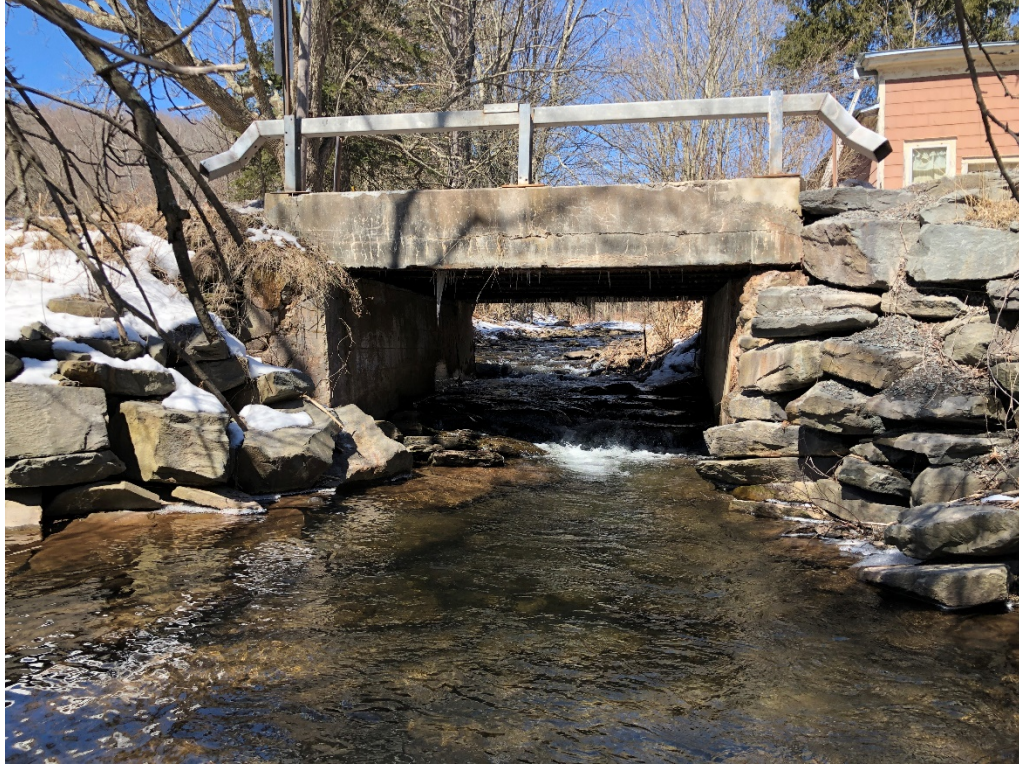
Figure 5-9: County Route 3 crossing of Brownell Creek. View looking upstream.

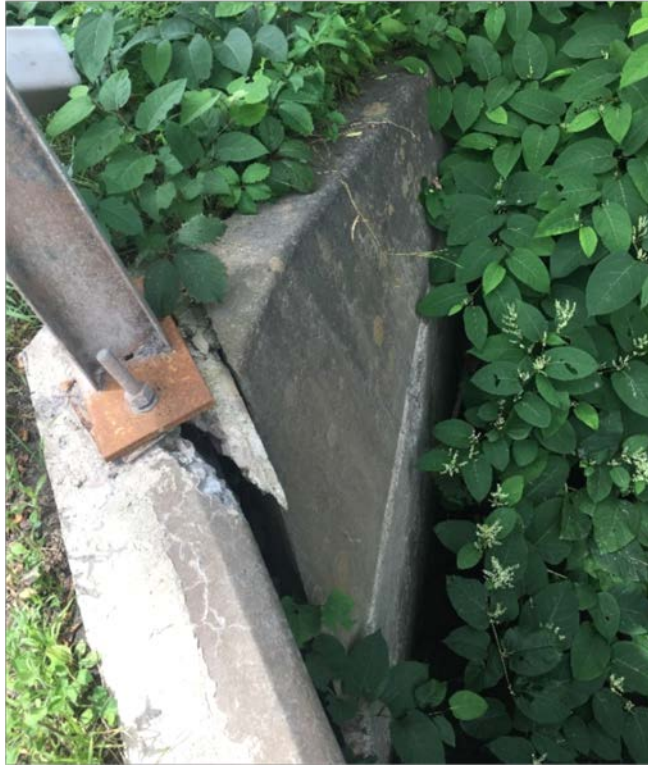
Figure 5-10: Upstream right wingwall separated from structure

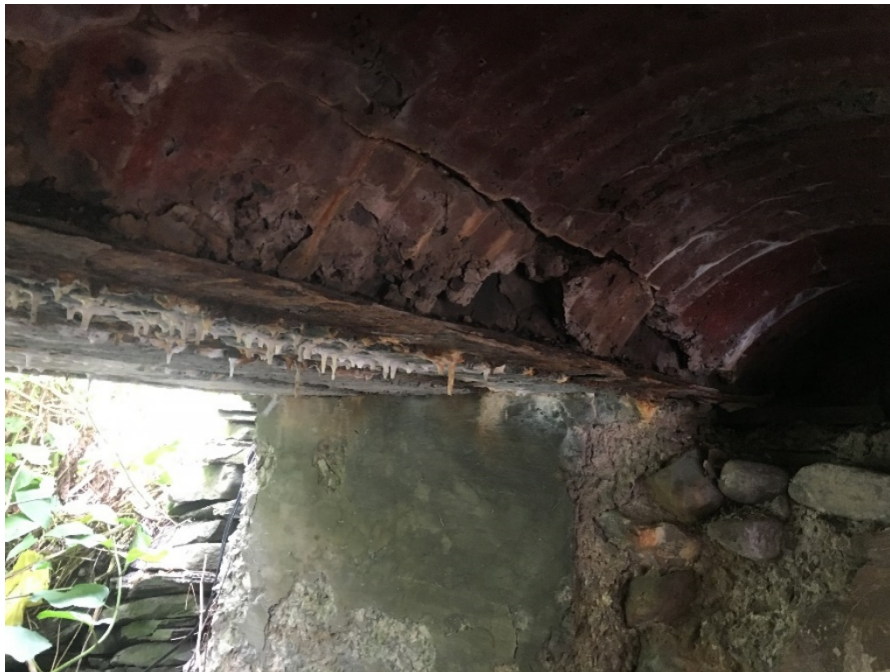
Figure 5-11: Deteriorated concrete and steel, looking at upstream left abutment. The half-pipes used as concrete forms hide the condition of the concrete where they have not yet rusted away. Note large cobbles used as aggregate in concrete abutment.

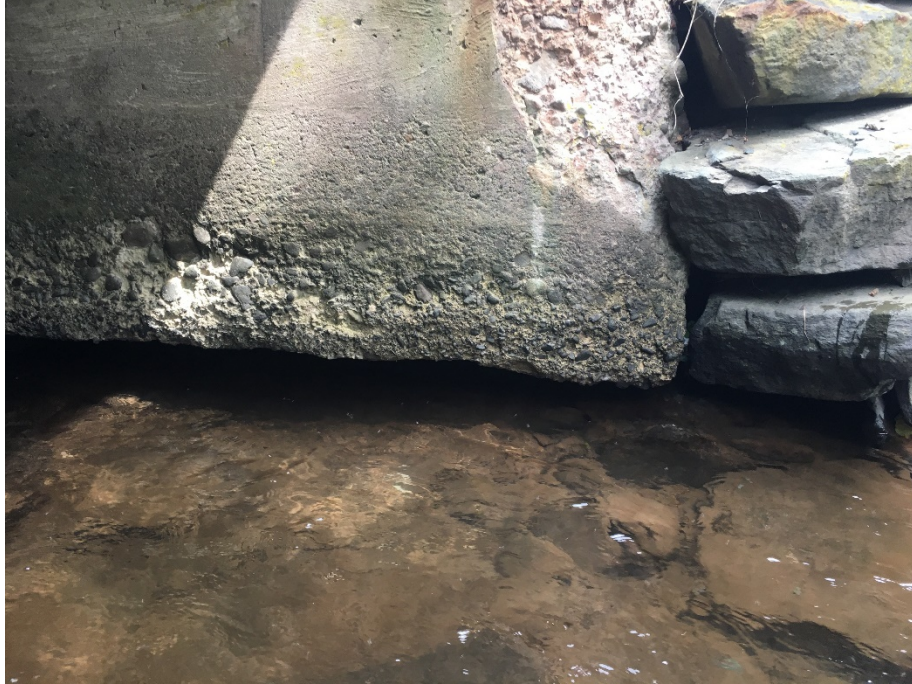
Figure 5-12: Scour has undermined several feet of the left abutment.

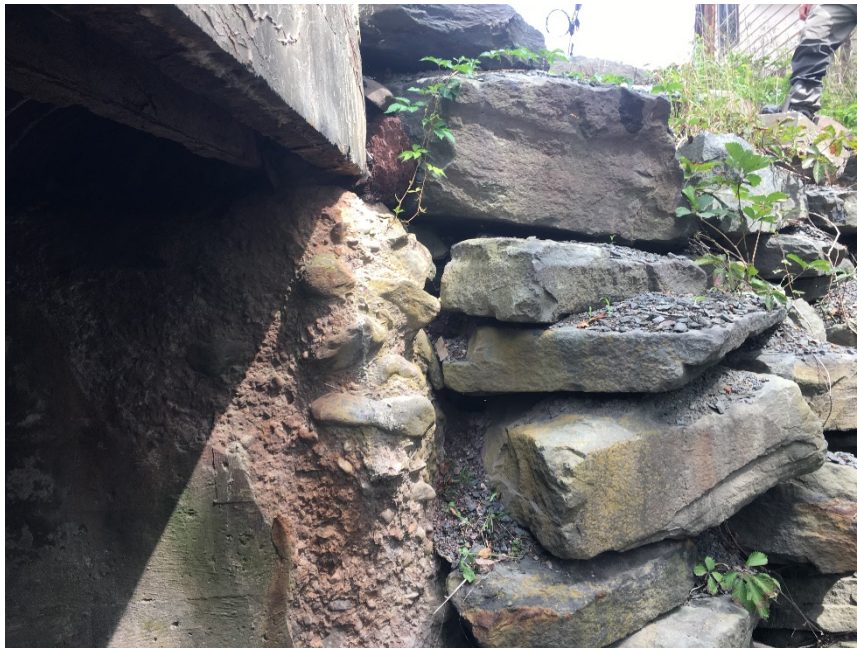
Figure 5-13: Deteriorating concrete abutment, downstream left. Note large cobbles used as aggregate in concrete.

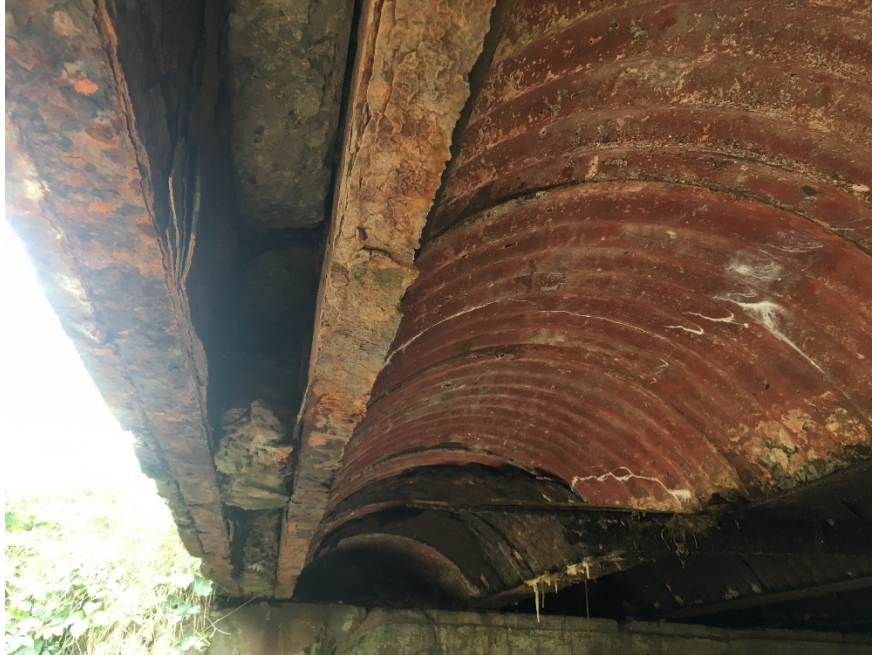
Figure 5-14: Underside of deck, looking at downstream right corner. Steel beams are rusted and exfoliating. A large amount of concrete appears to be missing from between the two beams along the left side of the image.

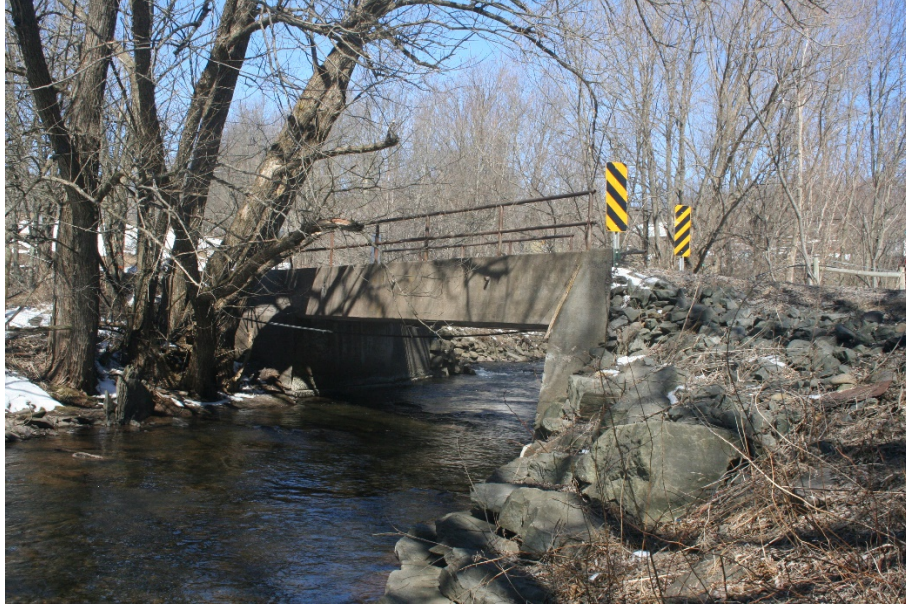
Figure 5-15: Ursum Way bridge over Vly Creek. Looking upstream from left bank.

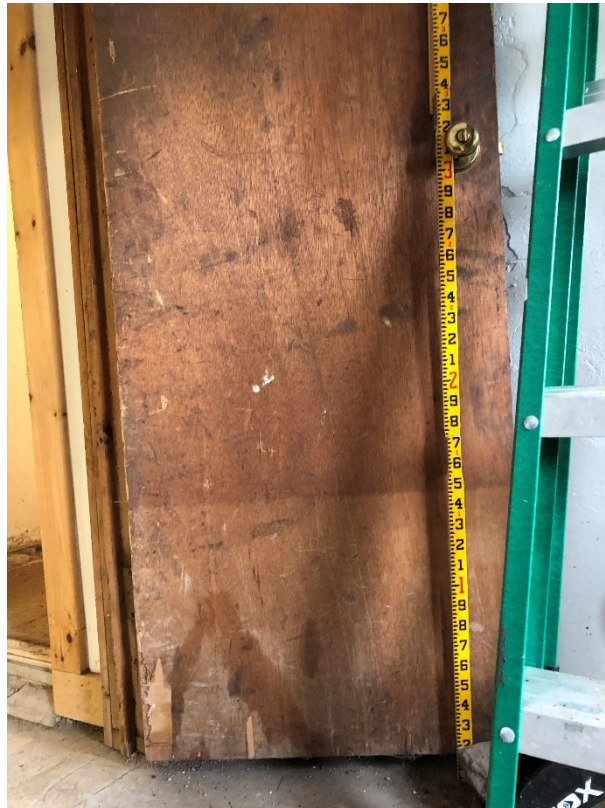
Figure 5-18: High-water mark on door inside Town Highway Garage (1.45 feet)

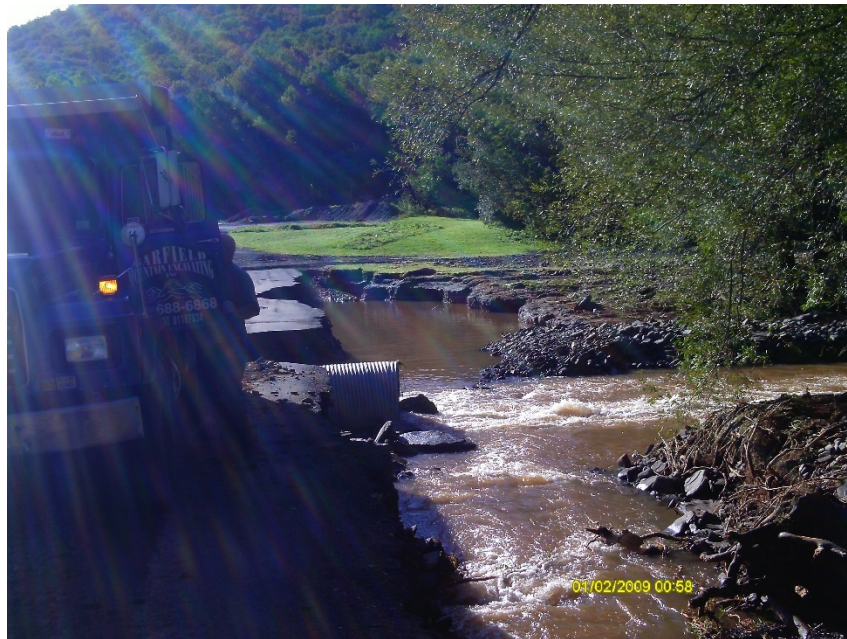
Figure 5-19: Contractors repairing Ursum Way and culvert following Tropical Storm Irene

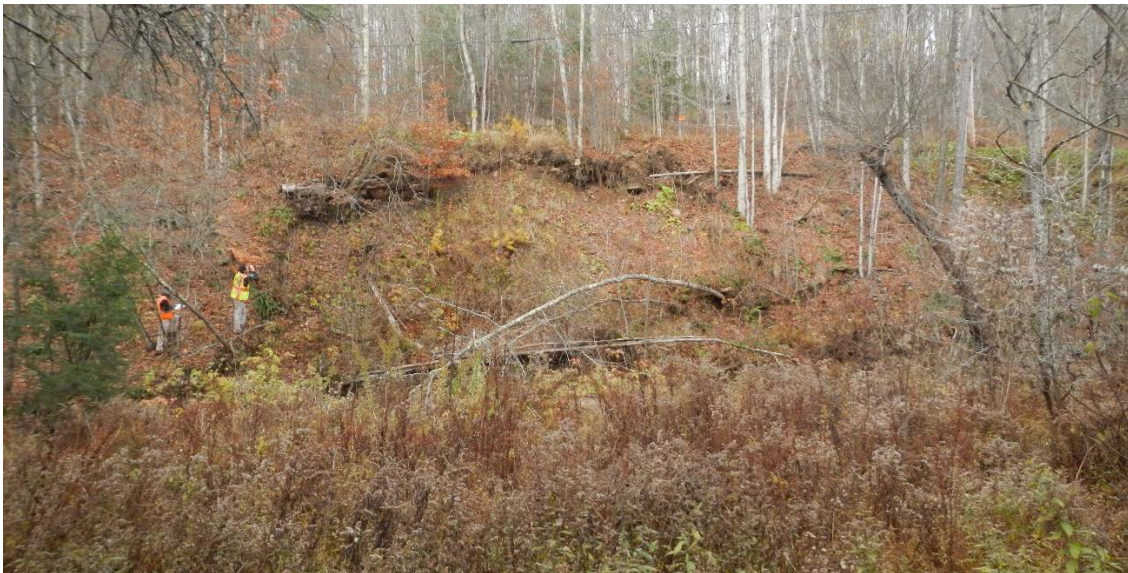
Figure 5-20: Bank failure along Elk Creek Road. Photo taken from opposite bank of Elk Creek.

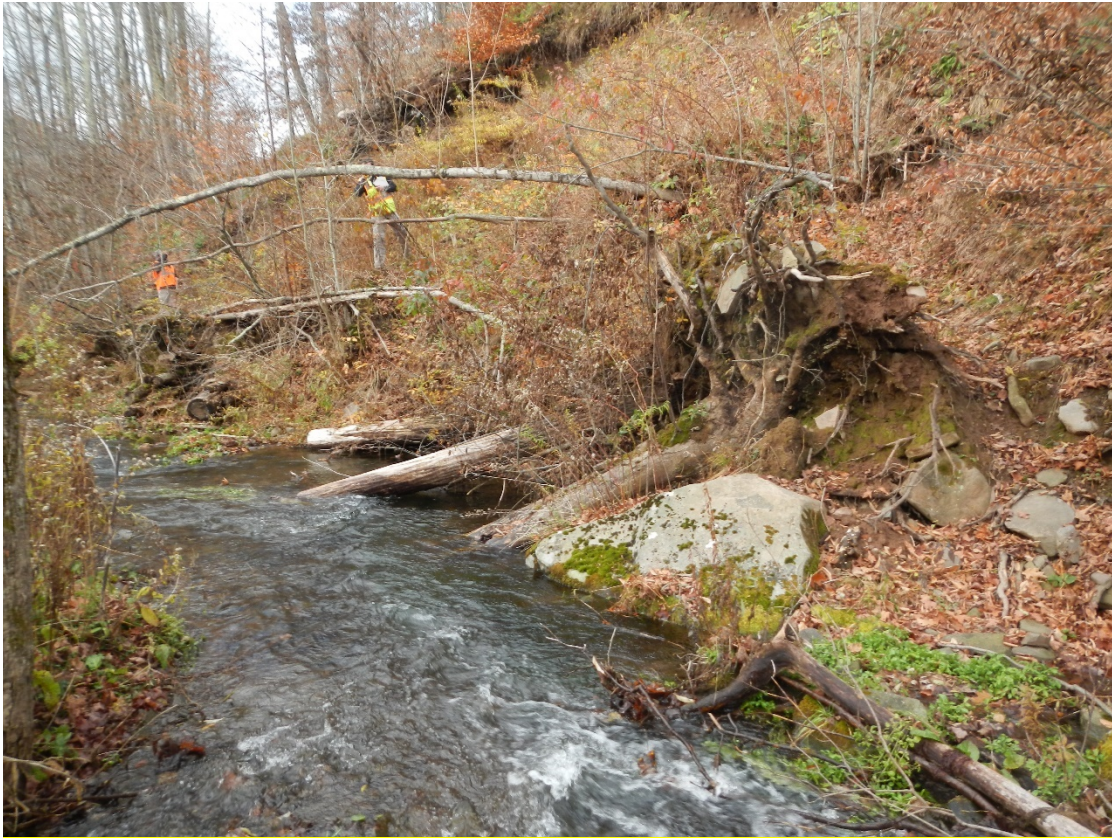
Figure 5-21: Tree trunks and debris from the failed embankment provide toe protection during normal low flows.

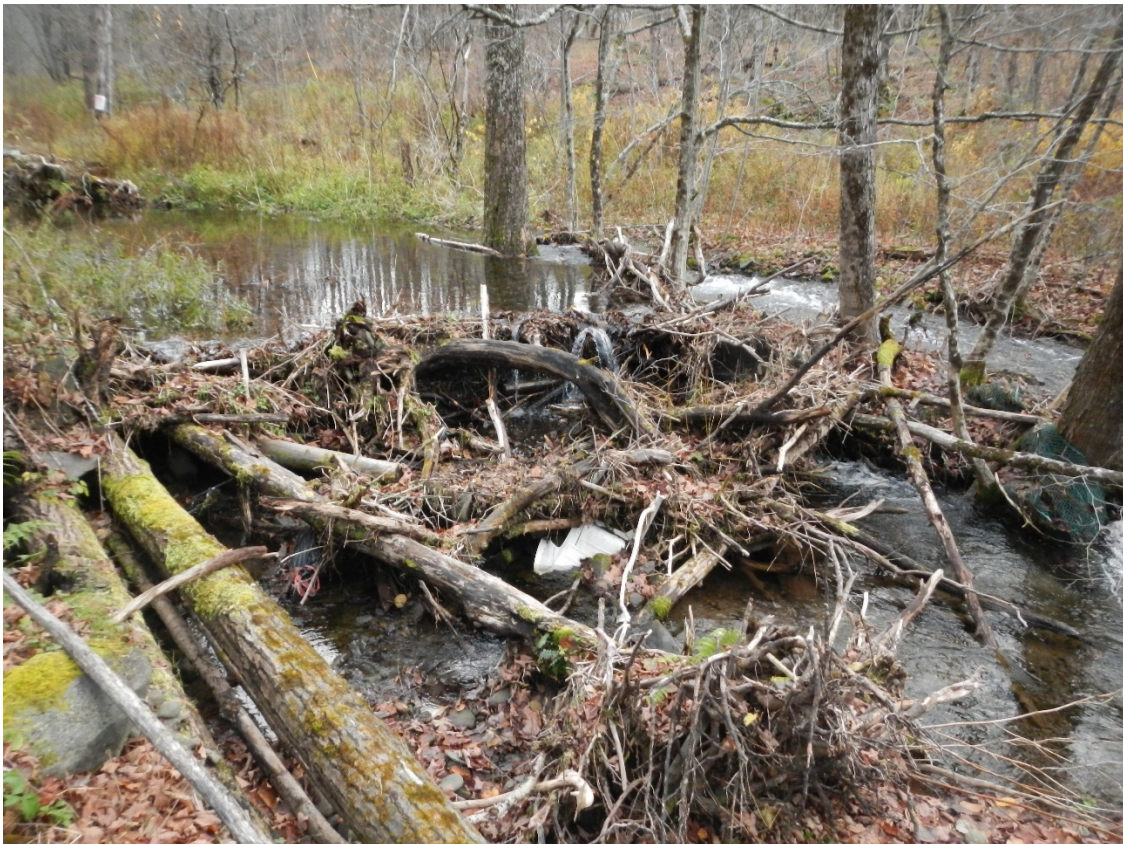
Figure 5-22: Large debris jam just downstream of Elk Creek Road bank failure.

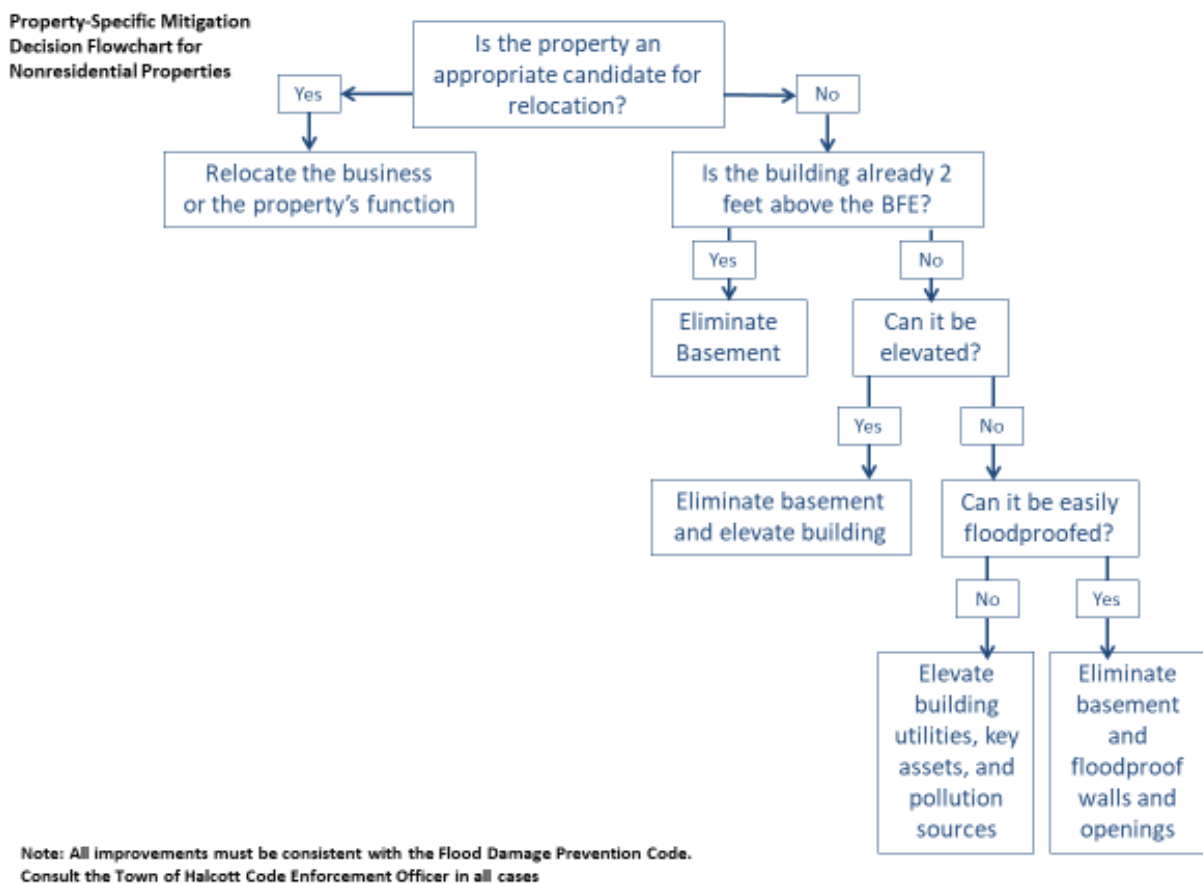
Figure 5-24: Property-Specific Mitigation for Nonresidential Properties

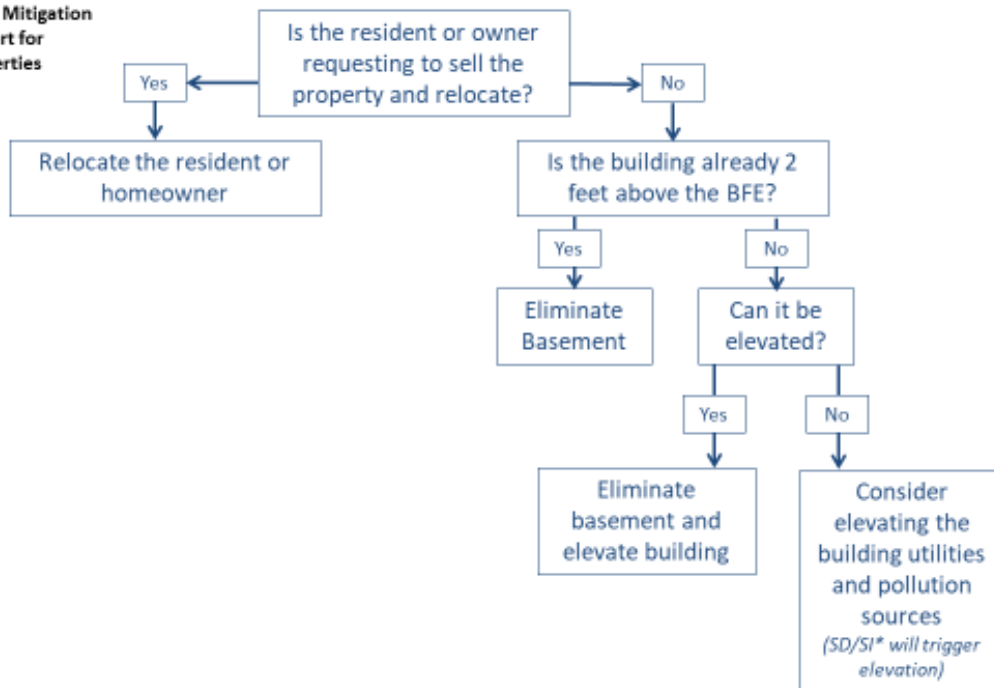
*Substantial Damage/Substantial Improvement

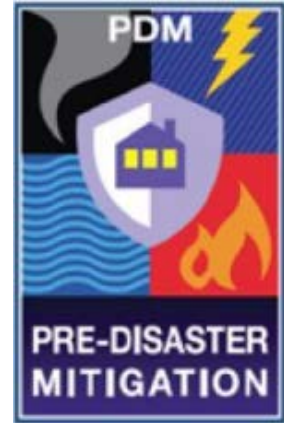
FEMA Hazard Mitigation Grant Program (HMGP)

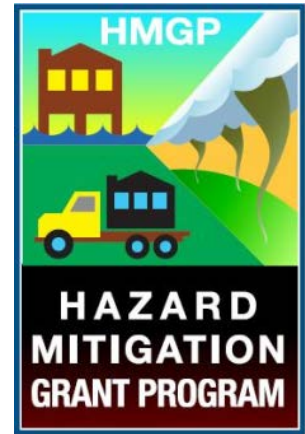
FEMA Flood Mitigation Assistance (FMA) Program

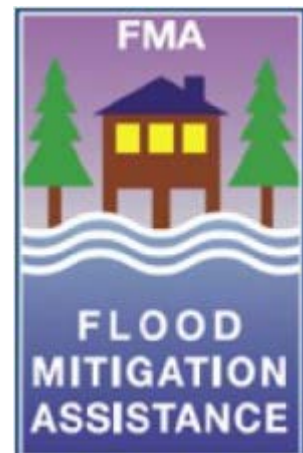
- The definitions of repetitive loss and SRL properties have been modified.
- Cost-share requirements have changed to allow more federal funds for properties with RFC and SRL properties.
- There is no longer a limit on in-kind contributions for the nonfederal cost share.
