VII. Demonstration Restoration Projects

A primary goal of the Batavia Kill Stream Corridor Management Pilot Project was to demonstrate the effectiveness of Natural Channel Design (NCD) concepts in the Catskills. While these methods have been used successfully to restore long term stability to streams in other areas of the country for close to 30 years, NCD principles had not been tested to any significant extent in the northeast. The NYCDEP and GCSWCD believed that NCD could be used not only to reduce sediment loading and turbidity from in-stream sources, but that these methods could also provide benefits associated with improved fish and wildlife habitat, flood protection, property protection, and aesthetics.

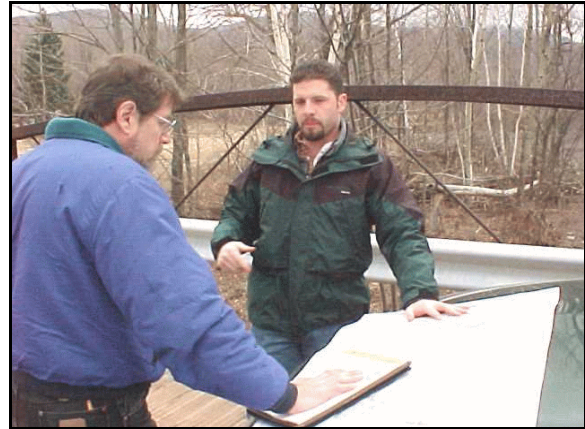
Figure VII-2: Prior to construction, the GCSWCD conducts on-site reviews with a variety of consultants.

At the beginning of the Batavia Kill project, the GCSWCD and NYCDEP elected to provide training to program staff such that they could complete the major design work on these projects, and have effective project over-sight. On each demonstration project, the design work was completed by the GCSWCD, under the supervision of E. Schwarzenegger from Kaaterskill Engineering Associates PC. Additionally, Rocky Powell of Clear Creeks Consultants was also consulted as necessary. The GCSWCD developed all necessary permit applications, bid documents and contracts. The following is a summary of the key components of the design process;

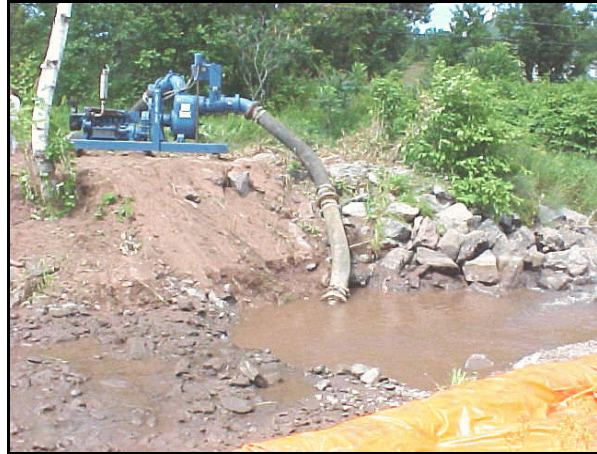
Figure VII-3: A 12" diesel pump was used to intercept and pump around all upstream flow entering the project site.

On the Maier Farm and Brandywine projects, a 12" diesel pump (**Figure VII-3**) rated at over 8,000 g.p.m. was used in conjunction with over 1,400 linear feet of 12" aluminum pipe, while the Big Hollow project was constructed under drought conditions and required much smaller pumps. De-watering on the Maier Farm and Brandywine projects represented approximately 25% of the total project costs, but was lower on the Big Hollow site. Once de-watering was started, it was maintained full-time, 24 hours a day, 7 days a week, until the channel work was completed.

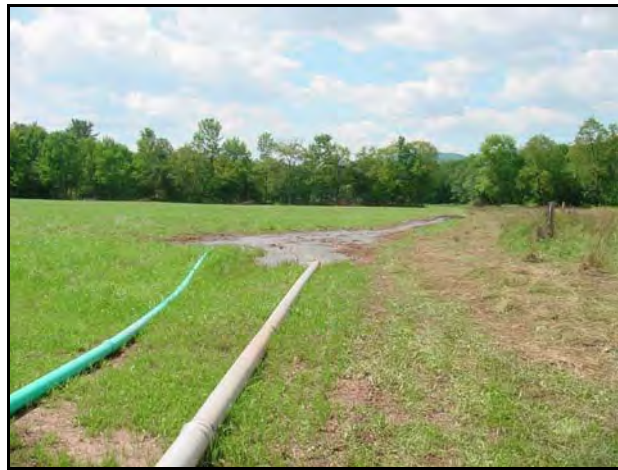
Figure VII-4: Sediment-laden water is pumped to grassy fields for settlement of solids.

Sediment Control: In regard to pollution control during construction, the GCSWCD is held to the same standards as the private sector. With the stream restoration projects, the primary consideration is erosion and sediment control, and avoidance of impacts from turbidity. Due to their very nature, these stream projects do not allow for a traditional erosion control plan. Since the streams are at the lowest point in the landscape, silt fences are generally not effective as they would have to be placed up-slope of the work. To address sediment pollutants during construction, the GCSWCD developed an effective method based on capture and treatment of sediment-laden water. A second cofferdam is placed at the project's downstream limit, and additional pumps and a pipeline system are used to move the turbid water to a well vegetated area where it typically soaks into the ground leaving the sediment on the surface (**Figure VII-4**). This method is less effective during periods when the ground is saturated, it requires full time operation and maintenance of pumps, and in many cases the treated water reenters the project reach via groundwater and is again cycled back for treatment. It has, however, proven to be the most effective method to insure little or no discharge of turbid water from the project reach.

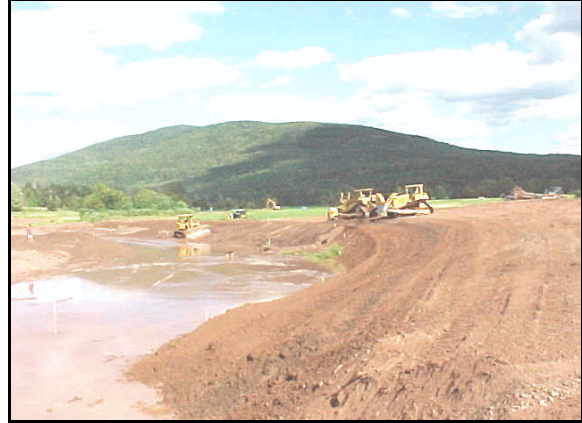
Figure VII-5: Extensive grading was required to create the new channel form.

Construction Sequence: Once the stream channel is de-watered and the sediment treatment system is in place, construction commences on the major project components. Initially, existing on-site materials are re-graded to produce the design dimensions, pattern and stream profile. Grading also includes the reconstruction of the adjoining floodplain with remnant channels, and eroded areas are filled. In all three demonstration

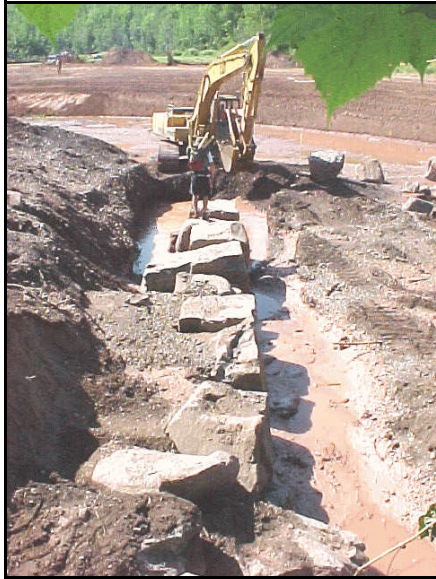
Figure VII-6: Construction of rock vanes proceeds after the channel is graded .

Once the channel takes shape, a crew comes immediately behind the grading operations and starts installation of the in-stream rock structures. When the rock vanes and cross vanes are in place, the water is re-routed back into the stream channel and final grading of the upper banks and floodplain continues without the need for de-watering.

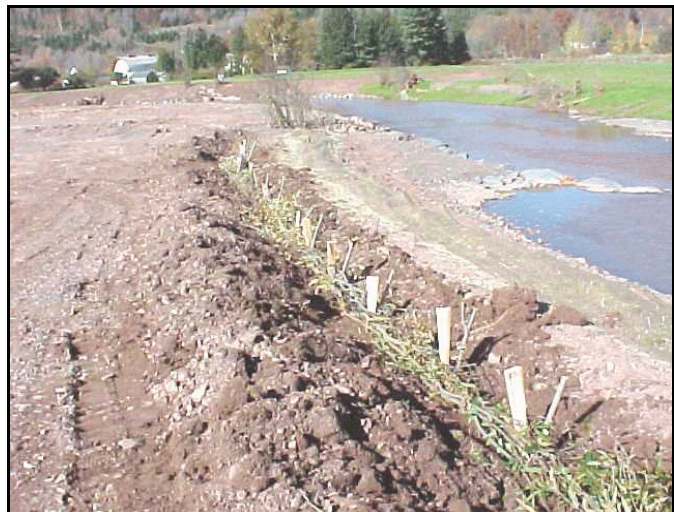
Figure VII-7: Rows of willow fascines are planted on meander bends to provide vegetative protection.

Vegetation Establishment: Upon completion of the major construction, all disturbed areas on the site are stabilized by seeding and mulching. To date, the GCSWCD has used a typical conservation seed mix consisting of fescue, rye and trefoil. This mix has proven to grow well under adverse conditions and provides short term stability until woody vegetation established. The GCSWCD has preferred hydro-seeding as the method of application due to its ability to remain in place in areas subject to strong winds. In the late fall when the leaves

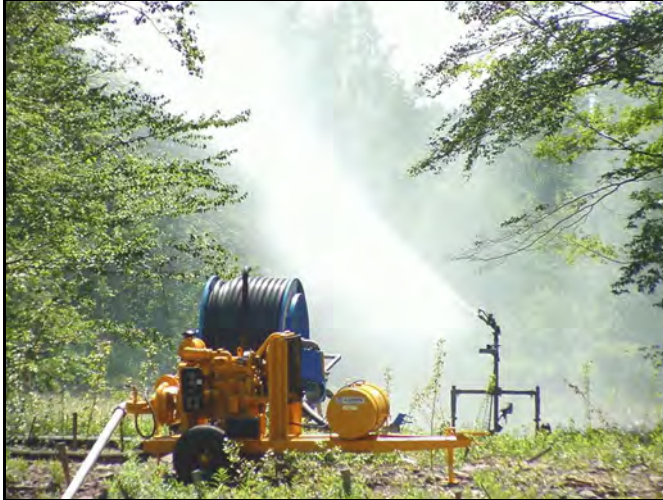
Figure VII-8: Irrigation during plant establishment period is critical.

have dropped, the dormant cuttings of willow and dogwood can be effectively harvested and planted on the project sites. On the demonstration sites, the GCSWCD has used a variety of standard bio-engineering techniques to establish woody vegetation including live fascines, brush layering and live stakes (**Figure VII-7**). These methods have generally been successful, but the GCSWCD continues to plant additional materials and to develop better methods for insuring plant establishment. Recently, the GCSWCD has provided increased focus on improving irrigation methods to insure moisture at critical times (**Figure VII-8**).

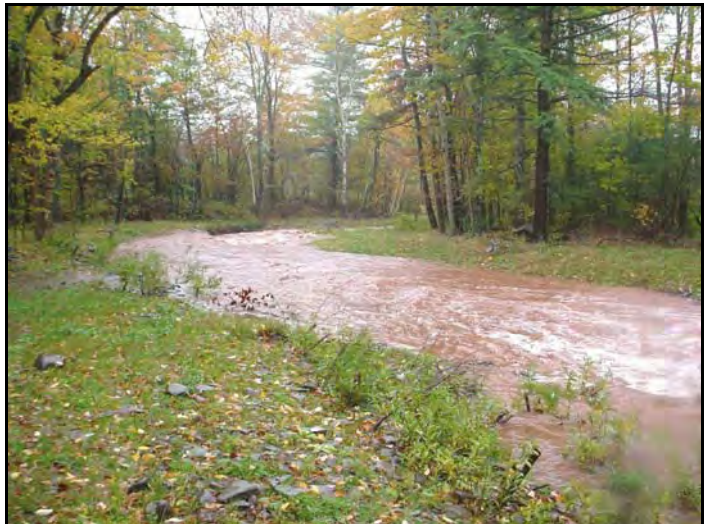
Figure VIII-9: Site visits during high flow events are useful for observing how the project reach is functioning.

In addition, the projects are inspected on a routine basis, with a detailed site review after each significant flow event. Larger events, that meet or exceed the bankfull discharge, may require a re-survey of cross sections after the event if changes are noted. The GCSWCD places a high priority on routine inspections, with re-survey of the monumented cross sections completed on an annual basis. Photo documentation is also useful in monitoring change over time. The GCSWCD and NYCDEP will be using Batavia Kill demonstration sites in a long term study of restoration project stability. Project inspections and monitoring are also a requirement under the GCSWCD ACOE permit conditions.

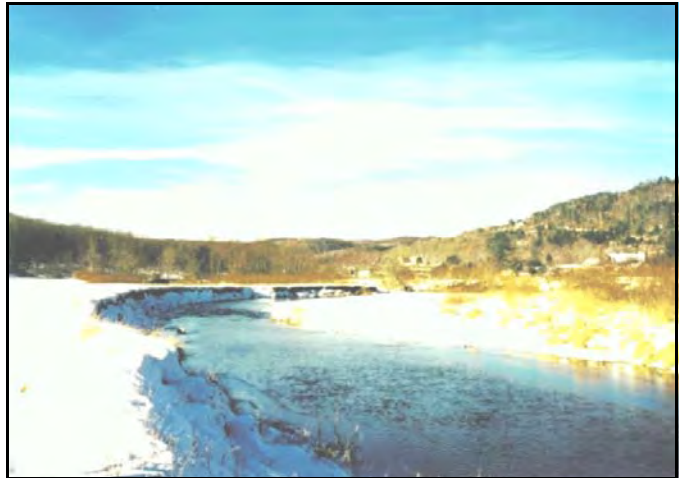
Figure VII-10: Erosion of left streambank along the Maier Farm project site. Note eroded bank on left of photo.

As noted in **Section VII-D**, the primary stability problem observed at the Maier Farm site was associated with unstable meander geometry and down valley meander migration. The Maier site was characterized by nearly 1,000 feet of actively eroding streambanks as a result of the channel’s attempt to seek a stable planform. The erosion was contributing excess sediment to the stream system and presented a water quality concern.

While the GCSWCD had a limited period to conduct an assessment of reach stability, the primary cause of the instability was attributed to the loss of an effective riparian buffer, as well as past anthropogenic activities. While specific human activities that may have contributed to the instability are difficult to pinpoint, it was known that rip-rap had been recently installed on the meander immediately upstream of the project reach, and that gravel removal on the upstream point bar had occurred after past floods. The site’s riparian buffer was dominated by active hayfields, with minimal deep rooted woody vegetation. The invasive species Japanese knotweed (*Polygonum cuspidatum*) had colonized significant portions of the streambanks and floodplain, further contributing to the lack of bank stability.

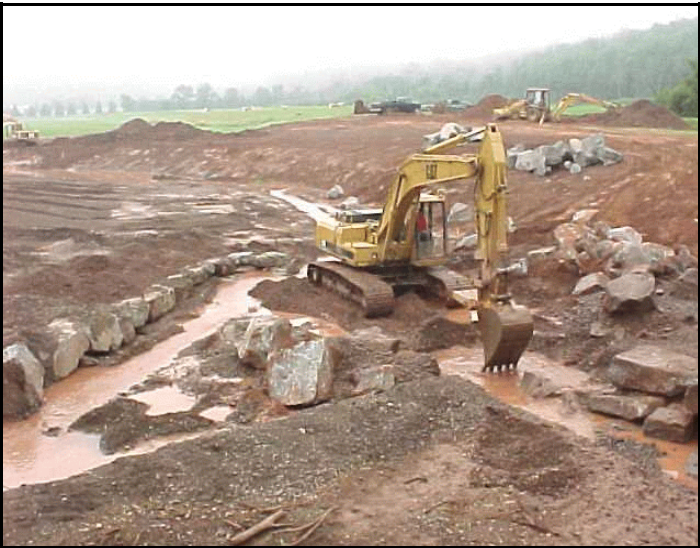
Figure VII-12: Construction of w-weir.

As discussed in **Section VII-D**, the private bridge at the bottom of the project reach presented several limitations that were addressed in the restoration design. First, to control flow in each side of the bridge opening, a W-weir was constructed just upstream of the bridge (**Figure VII-12 & VII-13**). The weir was constructed such that it would direct base flows through the bridge opening that was in the best structural condition. As stream stage rises to one half the design bankfull, the other side of the weir becomes active, and it starts to divert flows and velocities toward the other bridge opening.

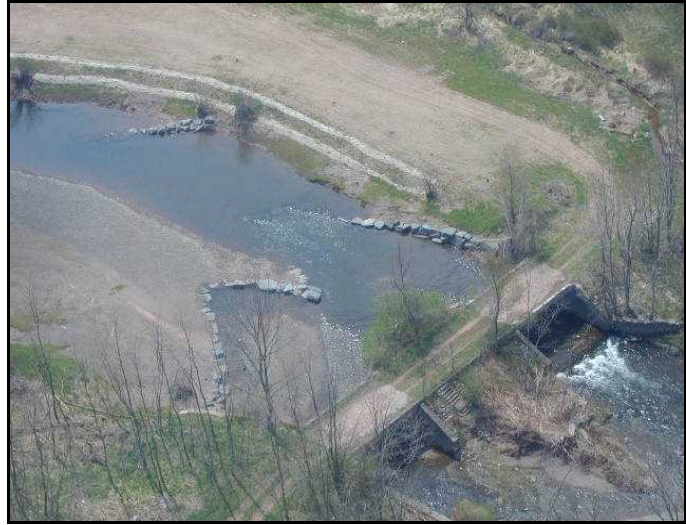
Figure VII-13: Aerial view of completed w-weir

In addition to the w-weir, the restoration design also included the construction of a bypass channel to convey higher flow events around the bridge on the floodplain. Since the bridge openings are undersized for larger floods, the bridge can act as a dam and cause water to back up upstream of the bridge. This backwater effect is characterized by lower velocities, which in turn reduce the stream's ability to transport sediment, resulting in aggradation upstream of the bridge. Constructed so as to take water when the stream reaches the bankfull stage, the high flow channel will route water around the bridge and reduce the backwater effect. Approximately 21 days after completion of the project, the Batavia Kill Watershed was hit by tropical storm Floyd. The storm hit the watershed on September 16th to 17th, and the impact on the demonstration projects is addressed later in this section.

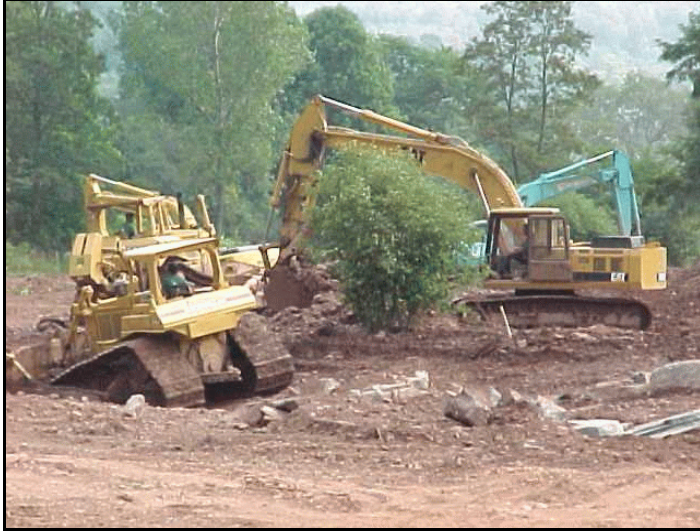
Figure VII-14: Heavy equipment working to construct the design channel at the Brandywine site.

The Brandywine project is located just upstream of the Maier Farm project, and is located behind the Brandywine restaurant. Similar to the Maier Farm site, the stream condition at the Brandywine project was also characterized by poor riparian vegetation, unconsolidated soils, and severe bank erosion associated with meander adjustments. The invasive species Japanese knotweed (*Polygonum cuspidatum*) had colonized significant portions of the streambanks and floodplain, further contributing to bank instability.

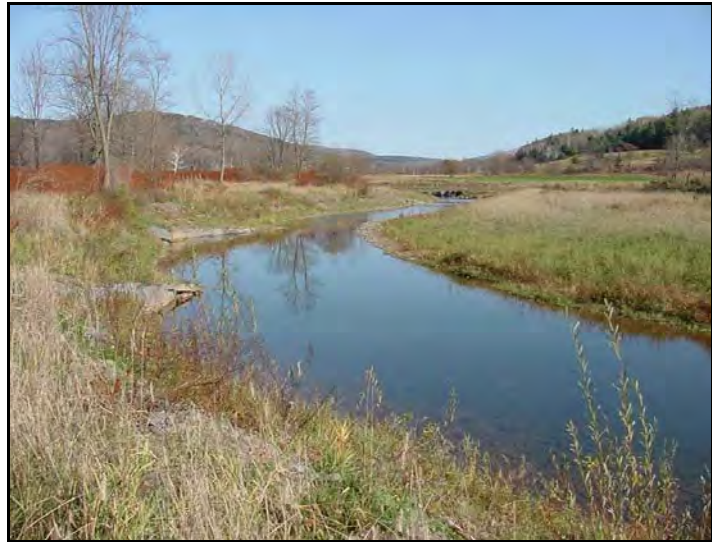
Figure VII-16: Brandywine site one year after the project was repaired.

As discussed later in this section, the GCSWCD evaluated both the Maier Farm and Brandywine sites after the flood event and decided to immediately repair the Maier site and leave the Brandywine until the following year. In late August 2000, the GCSWCD returned to the site with the original contractor, and the Brandywine project was repaired. The repairs took approximately two weeks to complete, and the GCSWCD used the opportunity to make some adjustments in the design. By 2001, the site was characterized by good coverage of grasses, and willow plantings were becoming established (**Figure VII-16**).

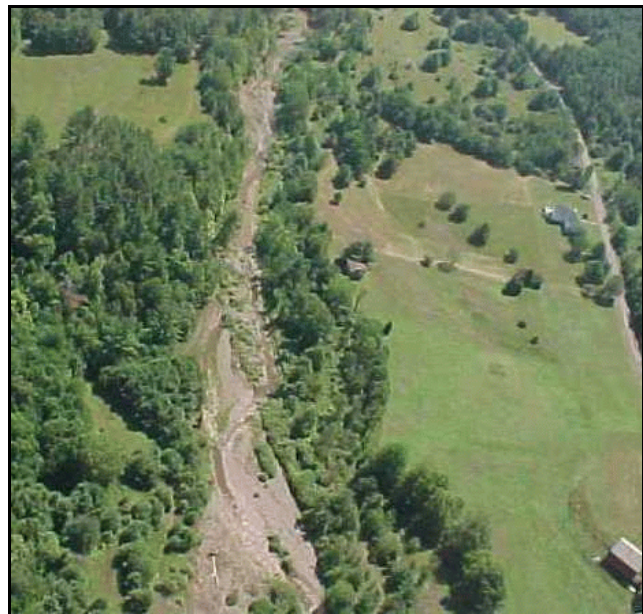
Figure VII-17: Preconstruction aerial view of Big Hollow site, note the braided channel at bottom, and lack of sinuosity at top.

As previously discussed, the Big Hollow project reach was selected due to its identification as a significant contributor to water quality impacts. The impacts on water quality were primarily the result of active incisement of the stream channel into the deep clays that underlie much of the valley floor. In addition, exposures of harder, more densely packed lodgement tills in the streambanks also contributed to water quality degradation. Between 1998

and 2000, when the GCSWCD was monitoring stream changes, the reach was shown to be highly dynamic and there was no evidence that the stream was moving toward stabilizing its form.

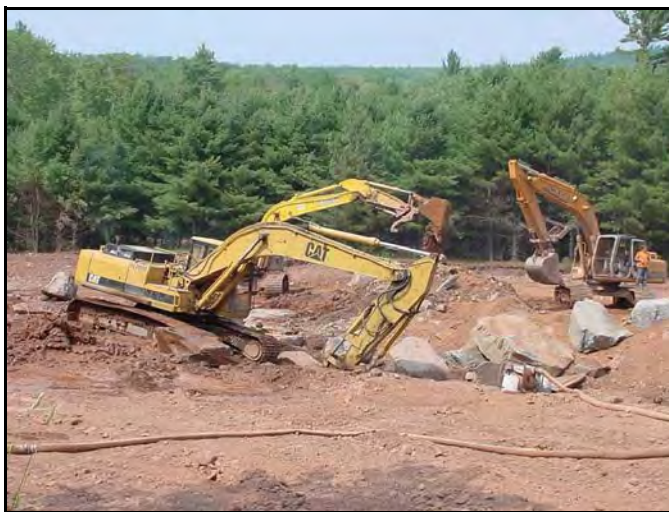
Figure VII-19: Construction of rock structures at the Big Hollow site.

stream type, with a typical meandering riffle-pool morphology. Channel form and meander pattern was derived from analysis of historical aerial photographs, as well as analytical, regime and reference reach techniques. As in the other demonstration sites, rock vanes were used primarily on meander bends to protect stream banks from erosion, with cross vanes installed for grade control in critical areas.

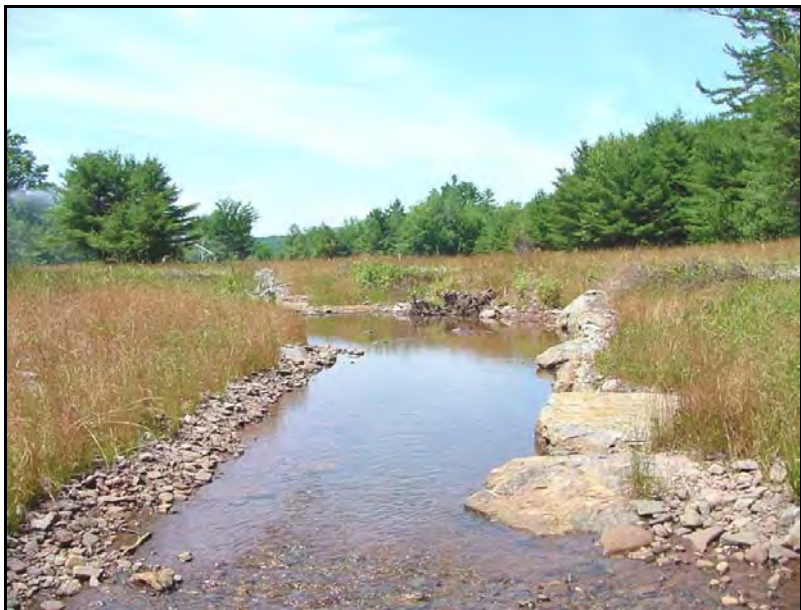
Figure VII-20: View of completed Big Hollow reach less than one year after construction.

While the design of the project is directed at improving water quality and reducing excess sediment inputs to the Batavia Kill, the added benefits of the restoration included enhanced fish habitat and improvements to the riparian buffer. Like the other projects constructed on the Batavia Kill, stability of the proposed C4 stream type is highly dependant on providing a good vegetative cover for protection of streambanks. Similar to the Maier Farm and Brandywine sites, the GCSWCD utilized live willow fascines and stakes, but this project also incorporated

brush layering as well as extensive plantings of bareroot tree and shrub stock. In addition to the typical plantings on the streambanks, the GCSWCD also had to undertake extensive plantings on the new floodplain. While some of this work was accomplished by the contractor, GCSWCD staff and volunteers also planted significant quantities of materials. In November 2001, the GCSWCD held a very successful volunteer planting weekend, with over 70 people assisting in the planting of trees and shrubs on the floodplain. Volunteers included staff from NYSDEC, NYSDOT, NYCDEP, Trout Unlimited, and Boy Scouts, as well as citizens and others interested in stream restoration. In addition to the mile of stream reach restored, the GCSWCD had to stabilize over 14 acres of floodplain and borrow areas.

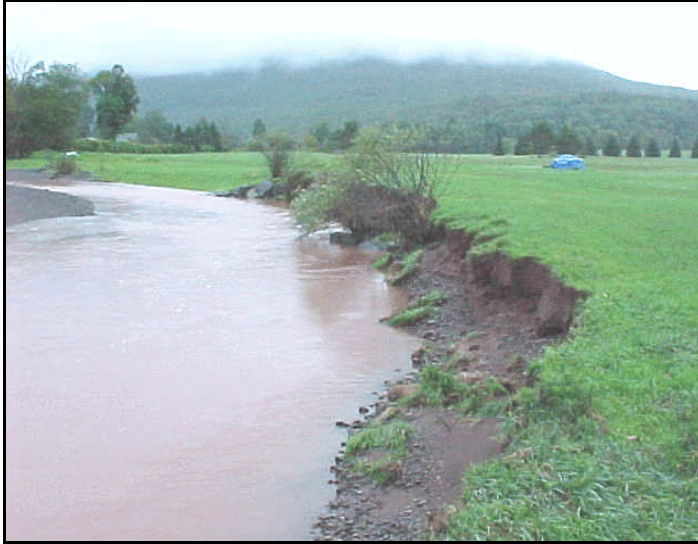
Figure VII-22: Erosion on upper streambanks after tropical storm Floyd. The lower toe of bank remained unchanged.

When the Maier Farm project was examined, it was evident that the flood produced some erosion, but the measured rate was significantly less than the erosion rates measured at the Maier Farm site between 1997 and 1999. The flood event erosion rate was also significantly lower than the erosion at the Kastansis control reach. The highest lateral erosion rate measured post-flood was six feet, and this occurred primarily on the very uppermost streambank. While the outer meanders appeared to have significant erosion, the toe of the slope remained essentially unchanged, with no impact on channel planform.

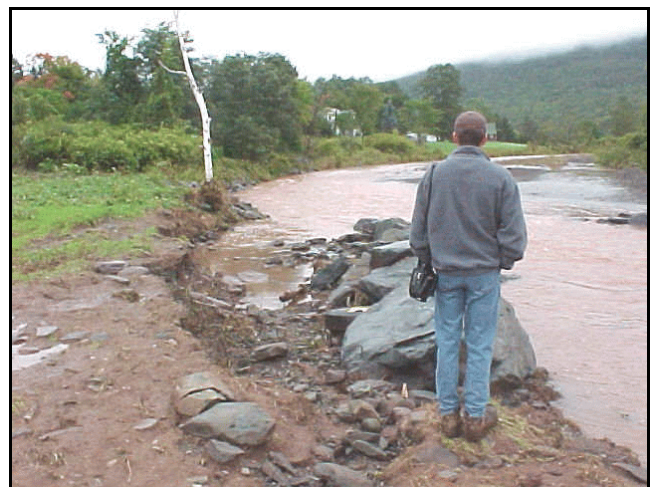
Figure VII-23: Scour behind Cross Vane arm due to loss of depositional feature attributed to voids between vane rocks

On both the Maier Farm and the Brandywine projects, a number of rock vanes and cross vanes were also damaged during the flood event. After the storm, it was noted that the depositional wedge upstream of the structures was lost due to voids between the top rocks and footer rocks that allowed sediment to pass through the structure. The absence of deposition was primarily noted in the middle of the vane, with the structure generally still keyed in on the upper end, and buried in sediment on the lowest area. The lack of large

enough bed load material to plug the holes, combined with the excessive erosional forces experienced during the flood, resulted in the loss of the depositional feature and the inability of the vanes to effectively reduce shear stress against the streambank.

[1] On damaged structures, additional rock was placed to strengthen the vanes and to chink the voids. Larger cobble (6"-18") was obtained from a local gravel bank and used to fill the voids and as fill in the upstream depositional area on each structure.
