## 2.6 Riparian Vegetation Issues in Stream Management

### **Riparian Vegetation in Stony Clove**

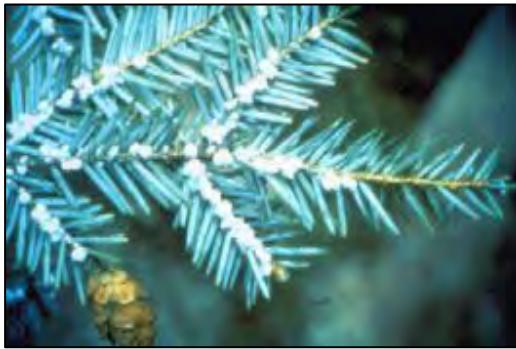
**Figure 3 Hemlock woolly adelgid on the underside of a branch.**

Pests and diseases that attack vegetation can also affect changes in the ecology of the riparian area and could be considered a disturbance. The hemlock woolly adelgid (*Adelges tsugae*) is an insect, which feeds on the sap of hemlocks (*Tsuga spp.*) at the base of the needles causing them to desiccate and the tree to take on a greyish color. Stress caused by this feeding can kill the tree in as little as 4 years or take up to 10 years where

conditions enable the tree to tolerate the attack (McClure, 2001). This native insect of Japan was first found in the U.S. in Virginia in 1951 and has spread northward into the Catskills including Stony Clove (Adams, 2002).

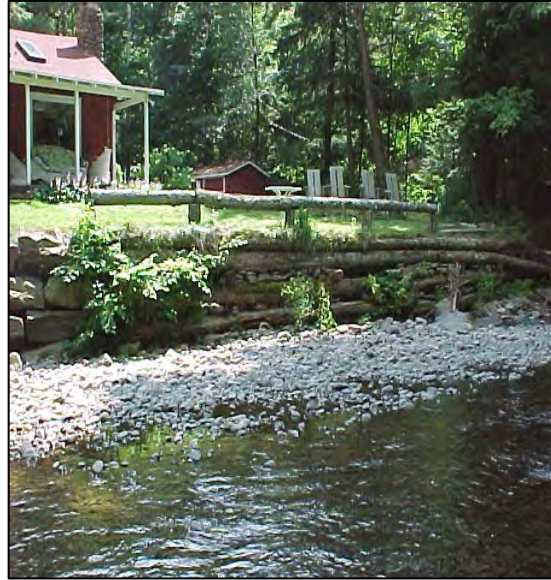
**Figure 4 Mowing to the edge of the stream leads to bank failure. This bank has been reinforced with log cribbing.**

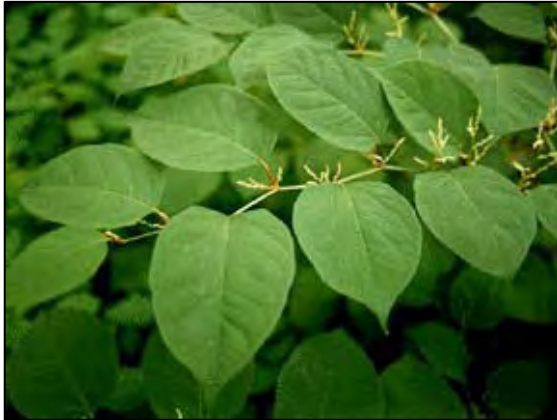
**Figure 5 Knotweed's leaf pattern.**

Clove, is an example of a plant capable of causing such a disruption. As its common name implies, Japanese knotweed's origins are in Asia, and it was brought to this county as an ornamental garden plant. This plant spreads rapidly on disturbed sites and prefers the moist, open conditions of the stream edge and bank for colonization. After establishing itself, Japanese knotweed will shade out existing vegetation and form dense stands along the bank. The primary concern with this plant is that it will reduce the ability of a stream bank to resist erosion. Although the impact of a Japanese knotweed invasion on the ecology of the riparian area is not fully understood, this plant may also displace other life dependent on the native vegetation for shelter, food or cover.

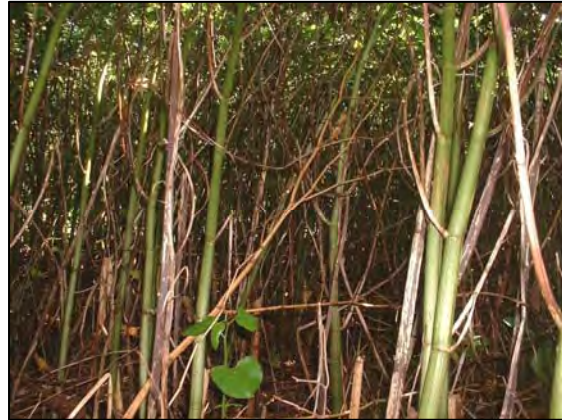
**Figure 6 Dense stand of knotweed.**

Japanese knotweed spreads primarily by vegetative means. Often, earthmoving contractors, highway department crews or gardeners transfer small portions of the roots in fill or soil that gets dumped on a stream bank. These roots then grow into a new plant that soon becomes a colony. Once in the riparian area, high flows scouring the bank may spread portions of the root downstream where it establishes new colonies on disturbed sites or sediment deposits. The above ground portion dies back each fall and re-grows to a height of 6-9 feet tall each spring. The canopy of the dense stands of bamboo-like stalks, covered by large heart shaped leaves (Fig. 5), blocks out almost all light from reaching the soil (Fig. 6), thereby shading out other plants and leaving the soil bare.

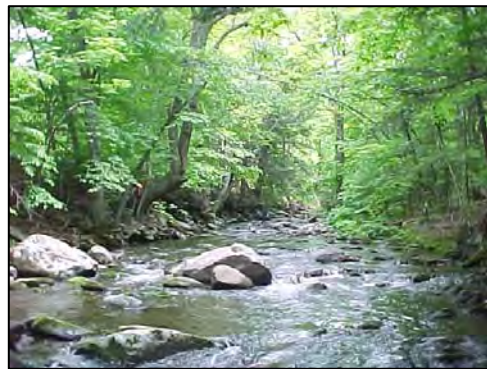
**Figure 8 Riparian vegetation (closed deciduous), protects stream banks and water quality, and provides habitat and food sources for fish and wildlife.**

According to this riparian vegetation assessment, closed deciduous (200+ acres) and herbaceous (120+ acres) are the largest physiognomic classes followed by closed coniferous (90 acres). This predominance of closed forest cover helps to provide a high degree of stability to the watershed. Forest cover slows storm runoff and the stream banks in much of the watershed have some woody vegetation to protect against bank erosion. Protection of the forest communities near the stream will help ensure long-term stream stability, but the effectiveness of stream protection provided by vegetative communities, differs based on their width, plant density, vegetation type and the stream's geomorphic characteristics.

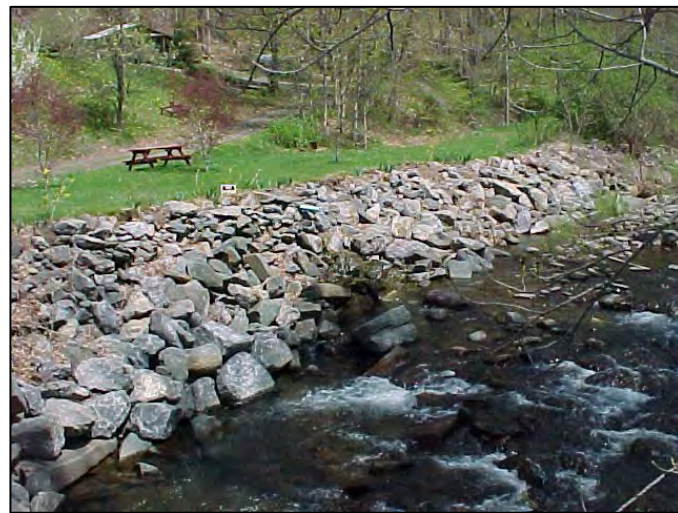
**Figure 10 Joint plantings at this site would increase stream bank stabilization and improve fish habitat**

The results of this de-selection were compared with coverage of reveted areas, to be targeted for joint planting. Joint planting involves placing of live stakes in the soil between the opening of previously installed rock rip-rap. It is intended to increase the effectiveness of the rock system by forming a living root mat underneath the rock and to improve the habitat and aesthetic value of the rip-rap.

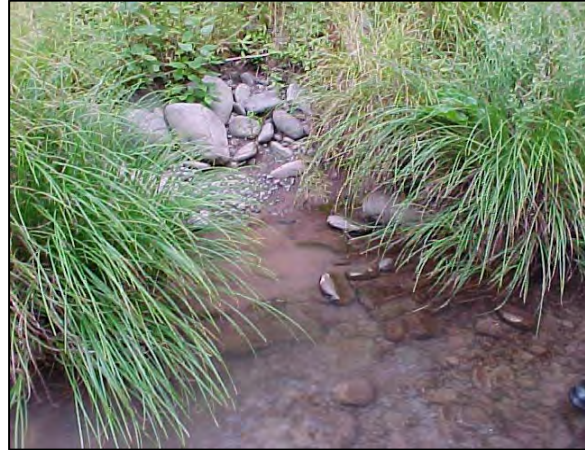
**Figure 11 Sedges are grass-like plants that grow at the edge of the water along stream banks. Their roots are very strong and their form helps reduce stream velocity at high flows.**
