# **Local Flood Analysis**

**Town of Conesville  
Schoharie County, New York  
June 30, 2017**

MMI #2884-08-06

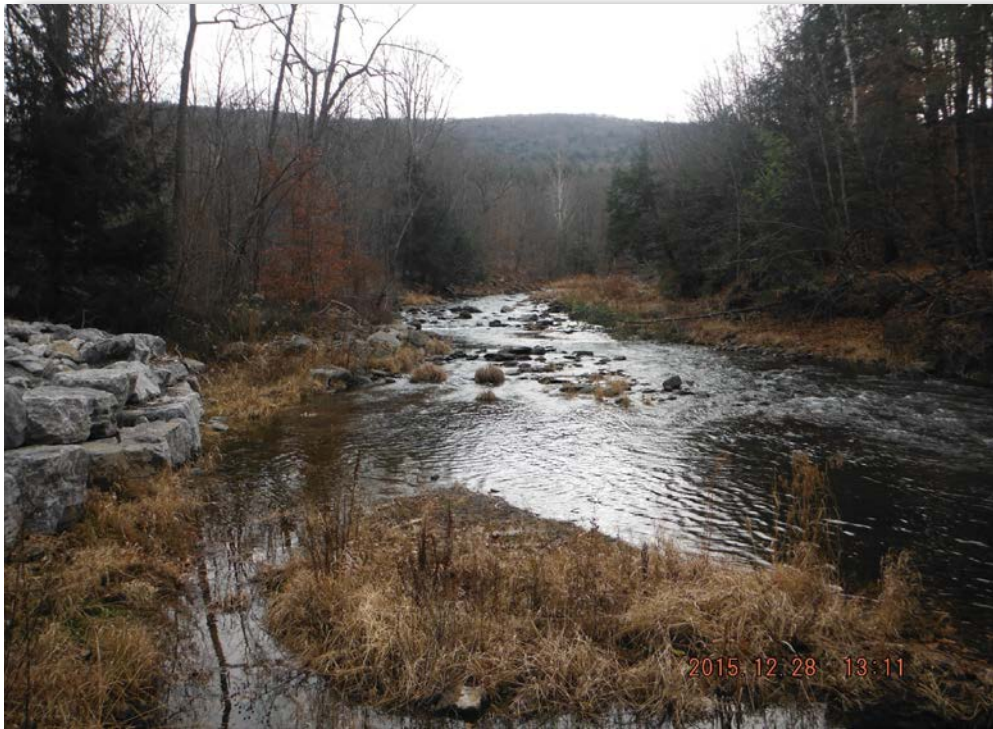
**Figure 2-3**  
**Project Area 1: View looking upstream on Manor Kill near Pangman Road**

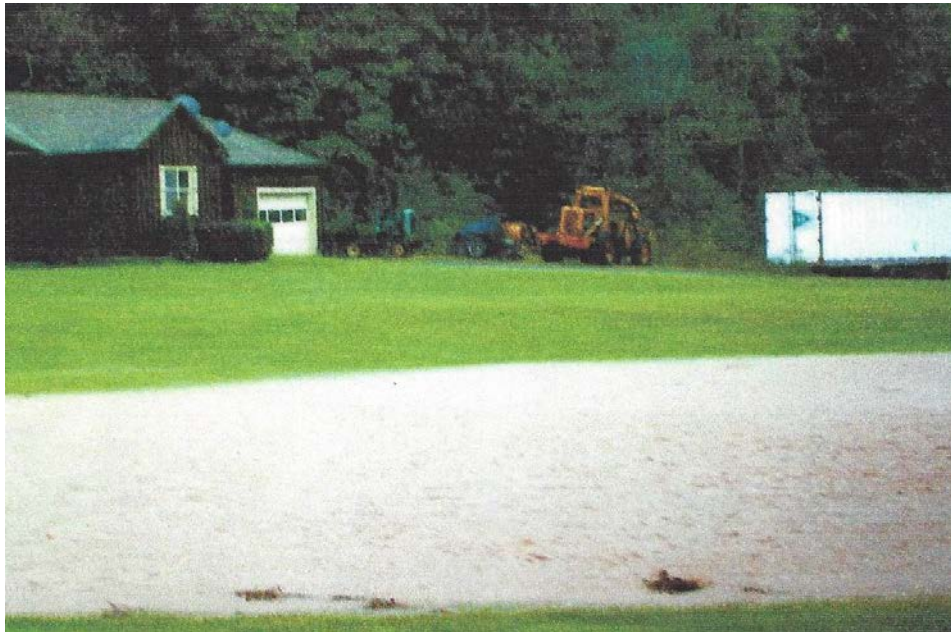
**Figure 2-5**  
**Project Area 1: Floodwater from the Manor Kill flowing through yard at 111 Pangman Road during Tropical Storm Irene, August 2011.**

- Bank erosion continues to occur at the forced bend downstream of the Pangman Road bridge.
- During Irene, floodwaters reportedly exited the Manor Kill channel upstream of the Pangman Road bridge and cut across the inside of the bend in the creek, flowing through the yard of the Hughes property (111 Pangman Road) at a depth of approximately 2 feet before returning to the creek (see Figure 2-5). The house at 111 Pangman Road was surrounded by water but remained dry, including the basement. The surrounding property including the firewood operation and equipment were flooded and sustained damages. The area along the bank where flows exited the Manor Kill channel has subsequently been bermed and armored with heavy stone.

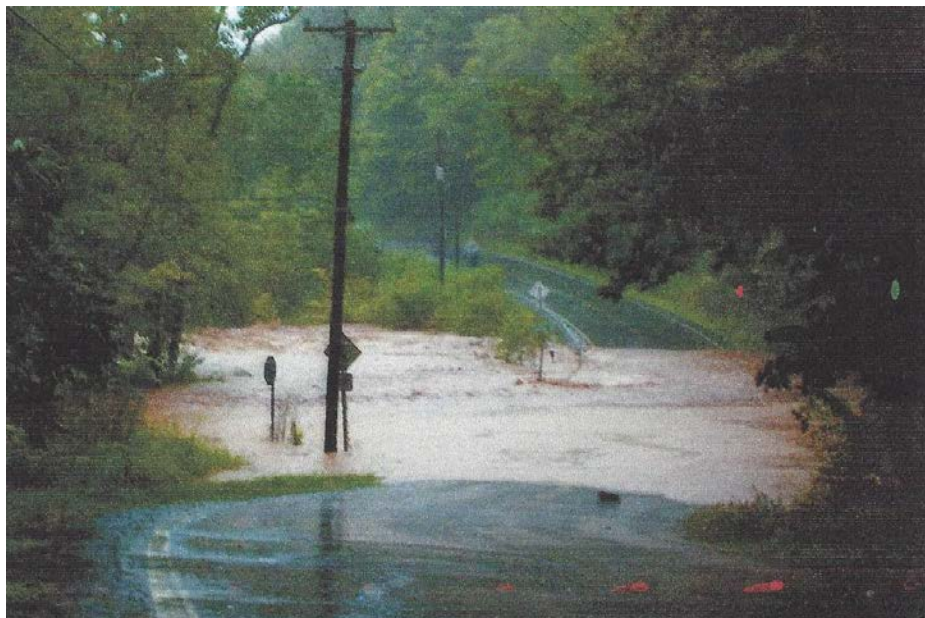
**Figure 2-6**  
**Project Area 1: Floodwater from the Manor Kill flooding intersection of Pangman Road and Route 990V during Tropical Storm Irene, August 2011.**

- The section of Pangman Road between NYS 990V and the bridge was washed out. The area in the vicinity of the stop sign was flooded by approximately 8 feet of water (see Figure 2-6). The road was subsequently repaired and armoring was placed on the bank.

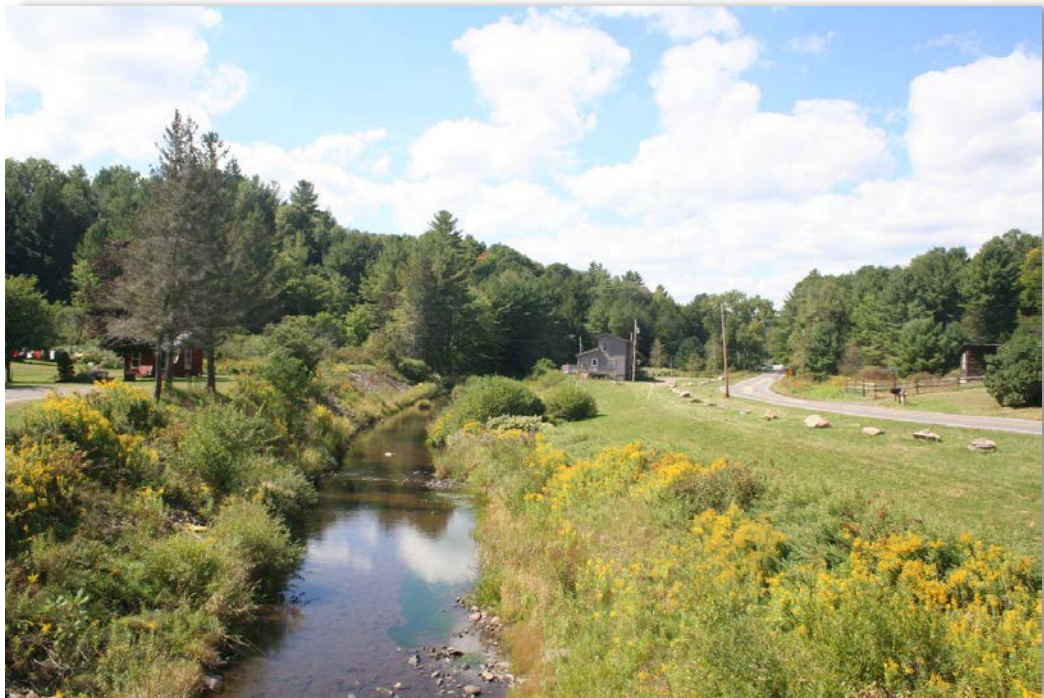
**Figure 2-9**  
**Study Area 2: View looking downstream from South Mountain Road Bridge**

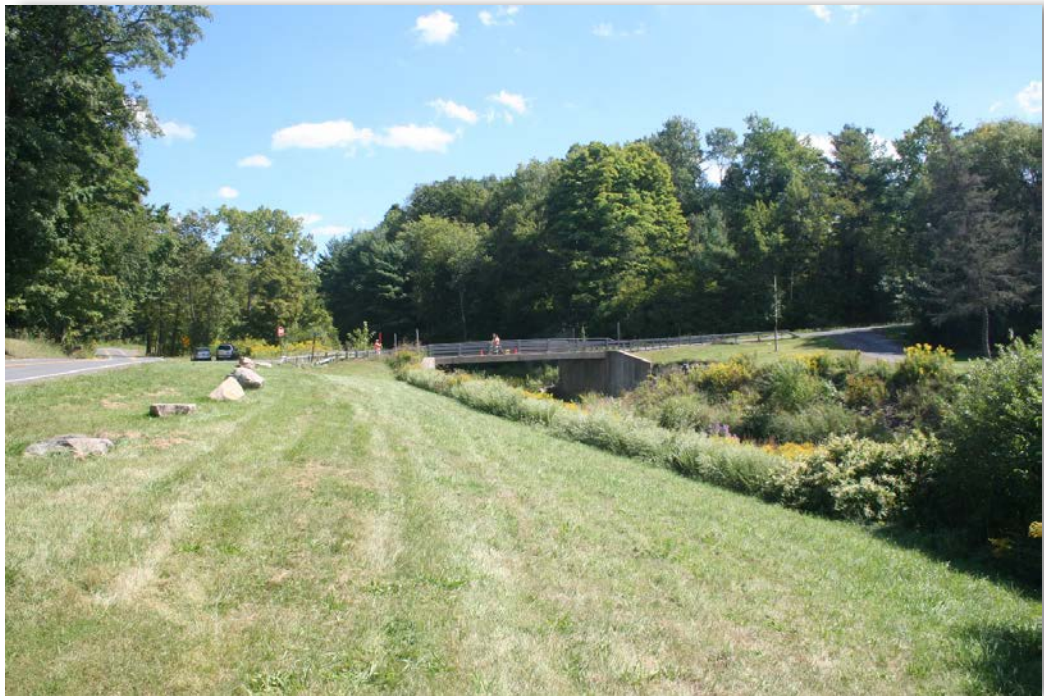
**Figure 2-10**  
**Study Area 2: View of South Mountain Road Bridge from downstream**

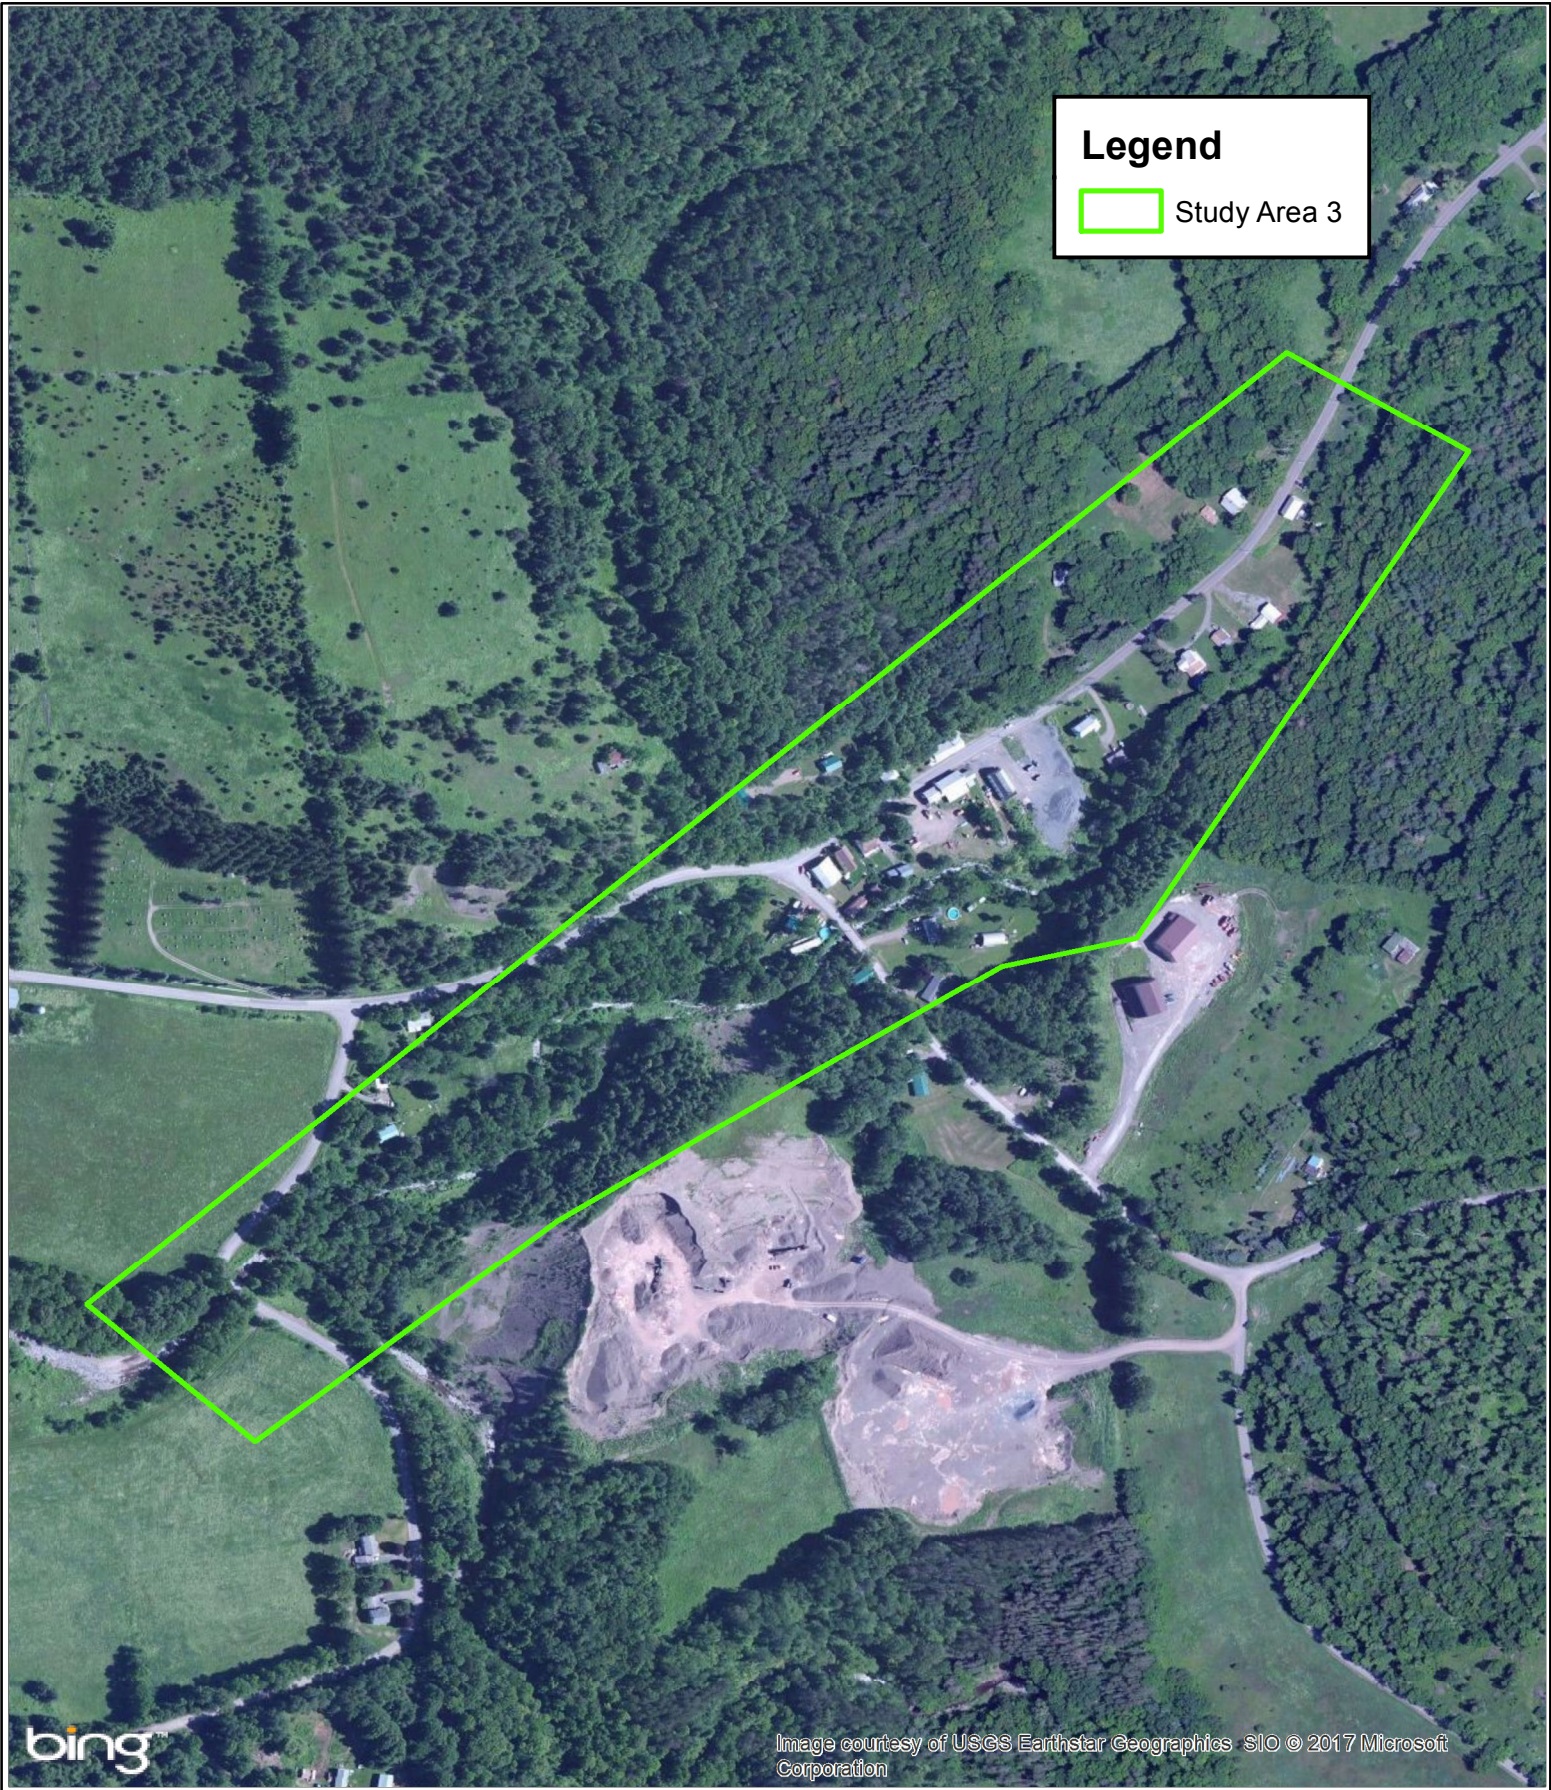
**Figure 2-11: Study Area 3**

Study Area 3 is located along the Manor Kill in the hamlet of Manorkill. It extends from approximately 1,800 feet upstream of the Durham Road bridge to approximately 225 feet downstream of the Beaver Hill Road bridge (Figure 2-11). Evaluation of this area includes a detailed assessment of two bridges—Durham Road bridge and Beaver Hill Road bridge—and approximately 3,700 feet of stream channel. The Manor Kill is joined by an unnamed tributary just upstream of the Beaver Hill Road bridge.

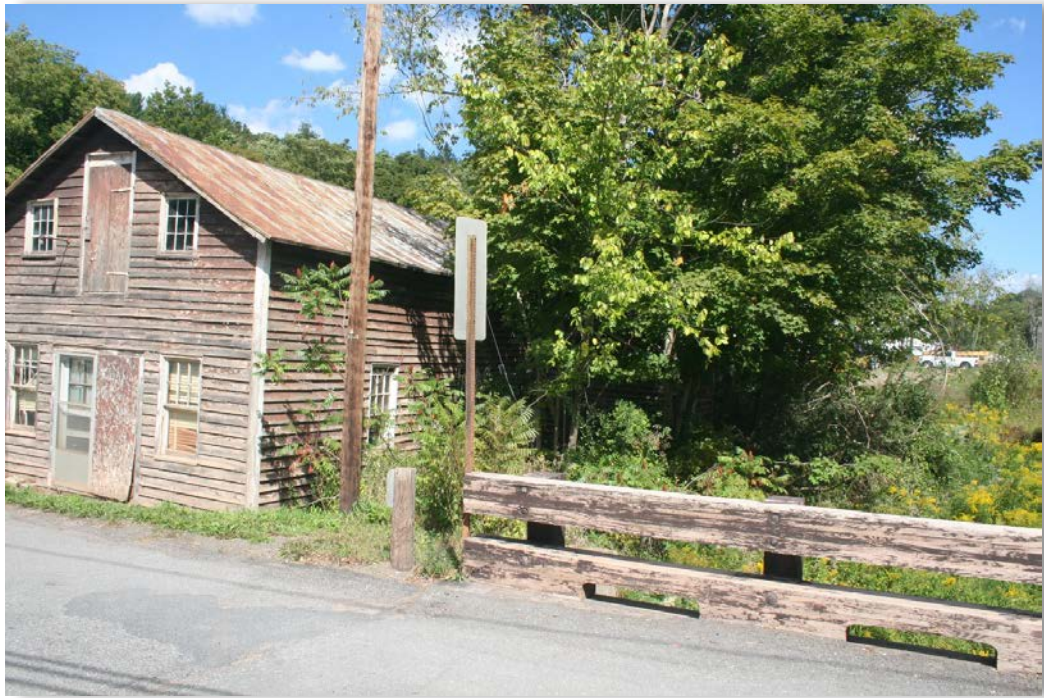
**Figure 2-13**  
**Study Area 3: Durham Road Bridge and Abandoned Structure**

- Some floodprone structures in the vicinity of the Durham Road bridge have been abandoned as a result of damages sustained during previous flood events. Hydraulic modeling indicates that water surface elevations upstream of the Durham Road bridge are sensitive to debris jamming, and as a result, structures located upstream of the bridge become increasingly floodprone as the bridge opening becomes more clogged with debris.

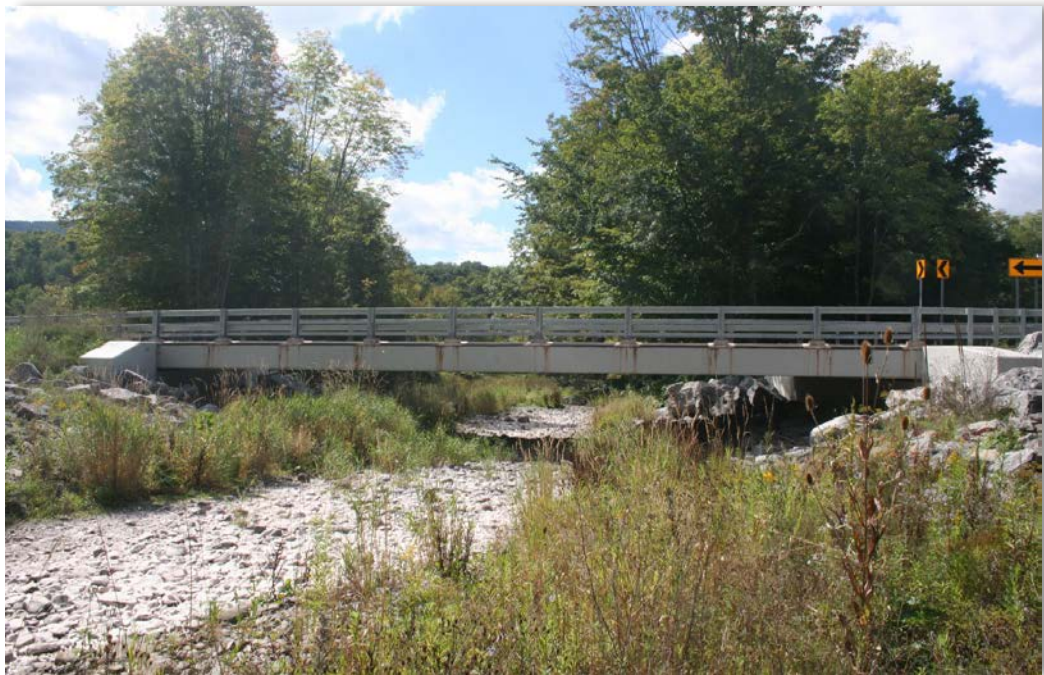
**Figure 2-14**  
**Study Area 3: Beaver Hill Road Bridge**

- The replacement bridge at Beaver Hill Road (constructed after Tropical Storm Irene) is adequately sized and does not contribute to flooding of homes.

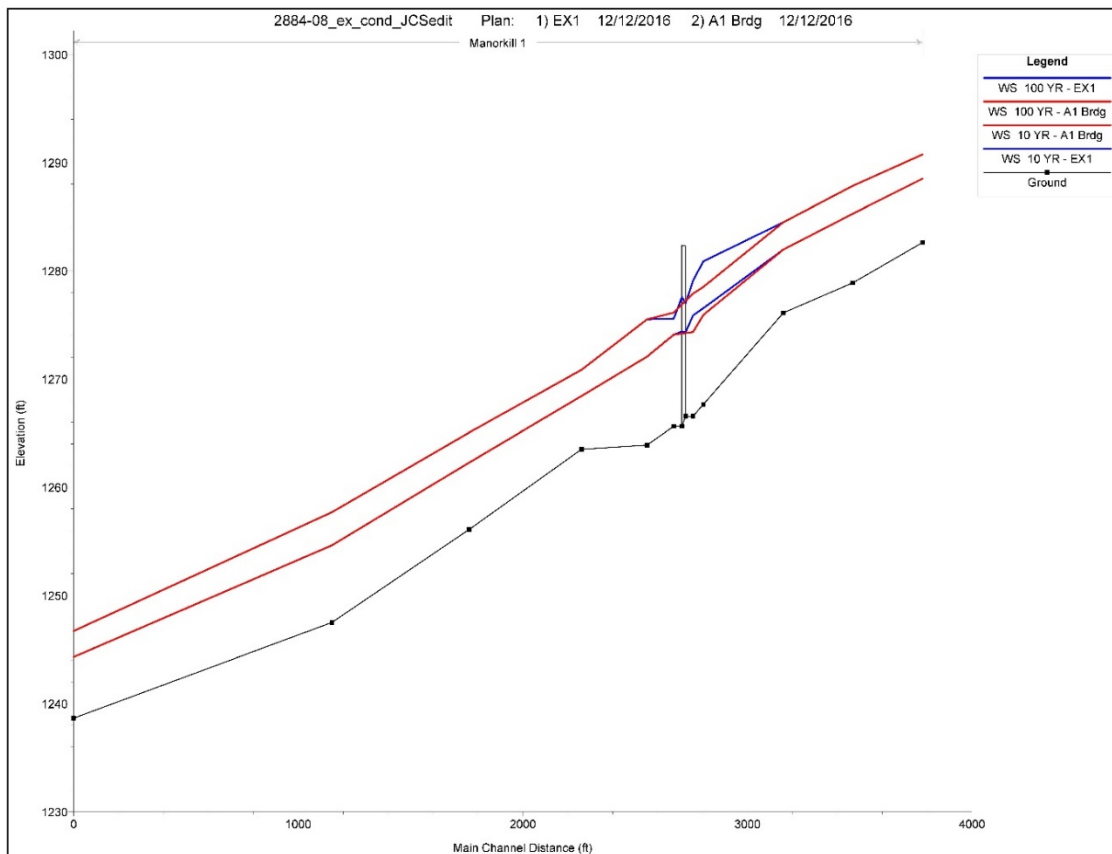
Figure 4-9 is a longitudinal profile of the Manor Kill in Study Area 1, showing water surface elevation profiles for the 10-year and 100-year flood events under existing conditions (in blue) and with the Pangman Road bridge removed (in red).

**Figure 4-9**  
**Study Area 1 Modeling Results – Longitudinal Profile Showing Pangman Road Bridge**

- The Pangman Road bridge is sufficiently sized to pass the 100-year flood event and does not create a hydraulic constriction that contributes to flooding of buildings.
- Valley confinement results in a high stream power setting that creates powerful erosive forces and unstable channel conditions, which in combination with the two forced channel bends that direct flows at the banks likely contributed to the severe stream bank erosion and the washout of the bridge abutments and portions of the roadway that occurred in this area during Tropical Storm Irene.

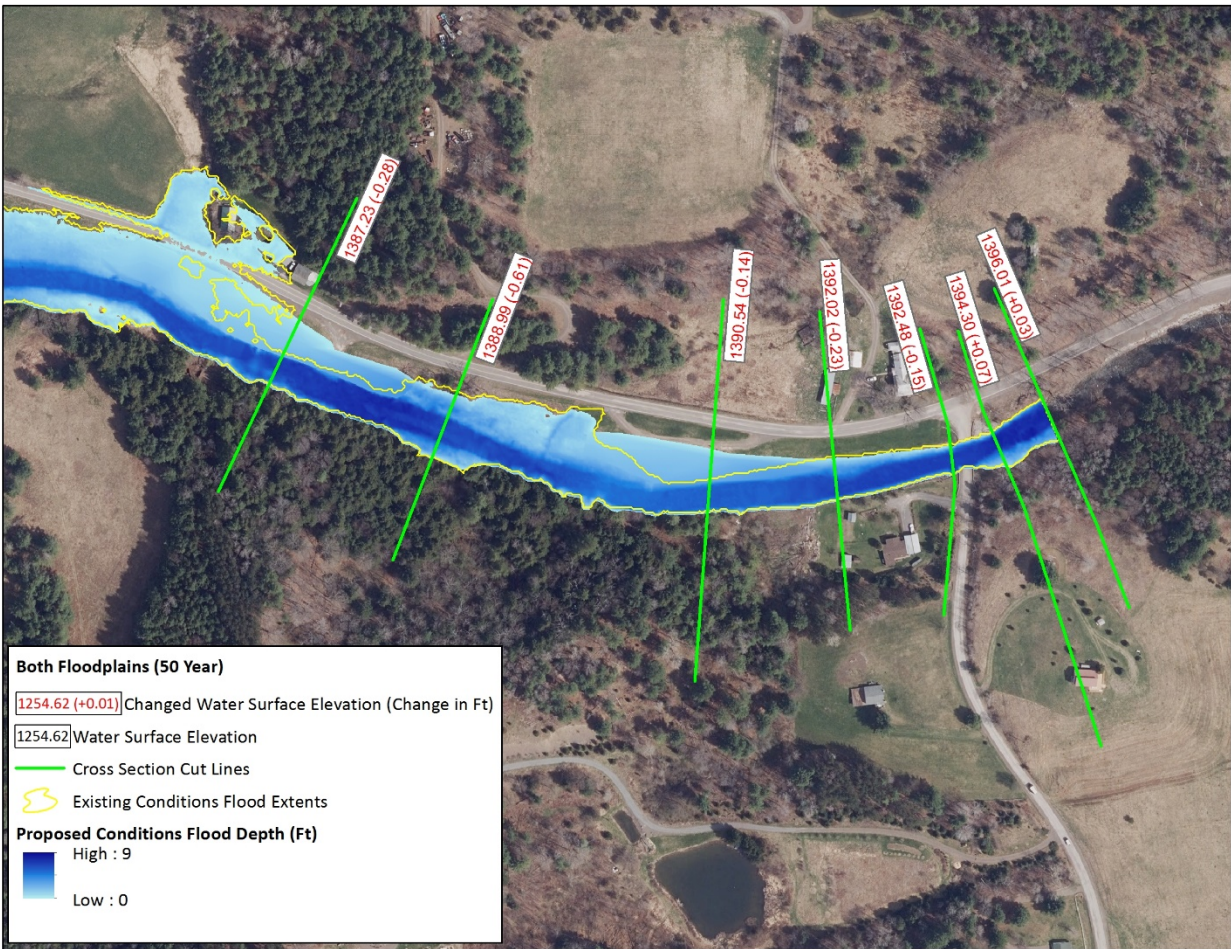
Figure 4-19

During the 50-year flood event, Floodplain Enhancement Scenario 2 would result in water surface elevation reductions ranging from 0.35 feet to 0.61 feet through the two sites of the floodplain enhancement with smaller reductions extending upstream to the South Mountain Road bridge. Similar to Floodplain Enhancement Scenario 1, the flooding of Potter Mountain Road would be reduced as would flooding of the home to the north of the roadway at 195 Potter Mountain Road. The overall flood reduction benefits are very similar to Floodplain Enhancement Scenario 1, with only minimal additional benefit resulting from the addition of the upstream floodplain enhancement area.

The figures below show the resulting reduction in flooding under Scenario 2 (downstream and upstream floodplain enhancements) during the 50-year (Figure 4-19), 100-year (Figure 4-20), and Irene (Figure 4-21) flood events. The numbers in red indicate a change in water surface elevation and the numbers in parentheses indicate the amount of change in feet.

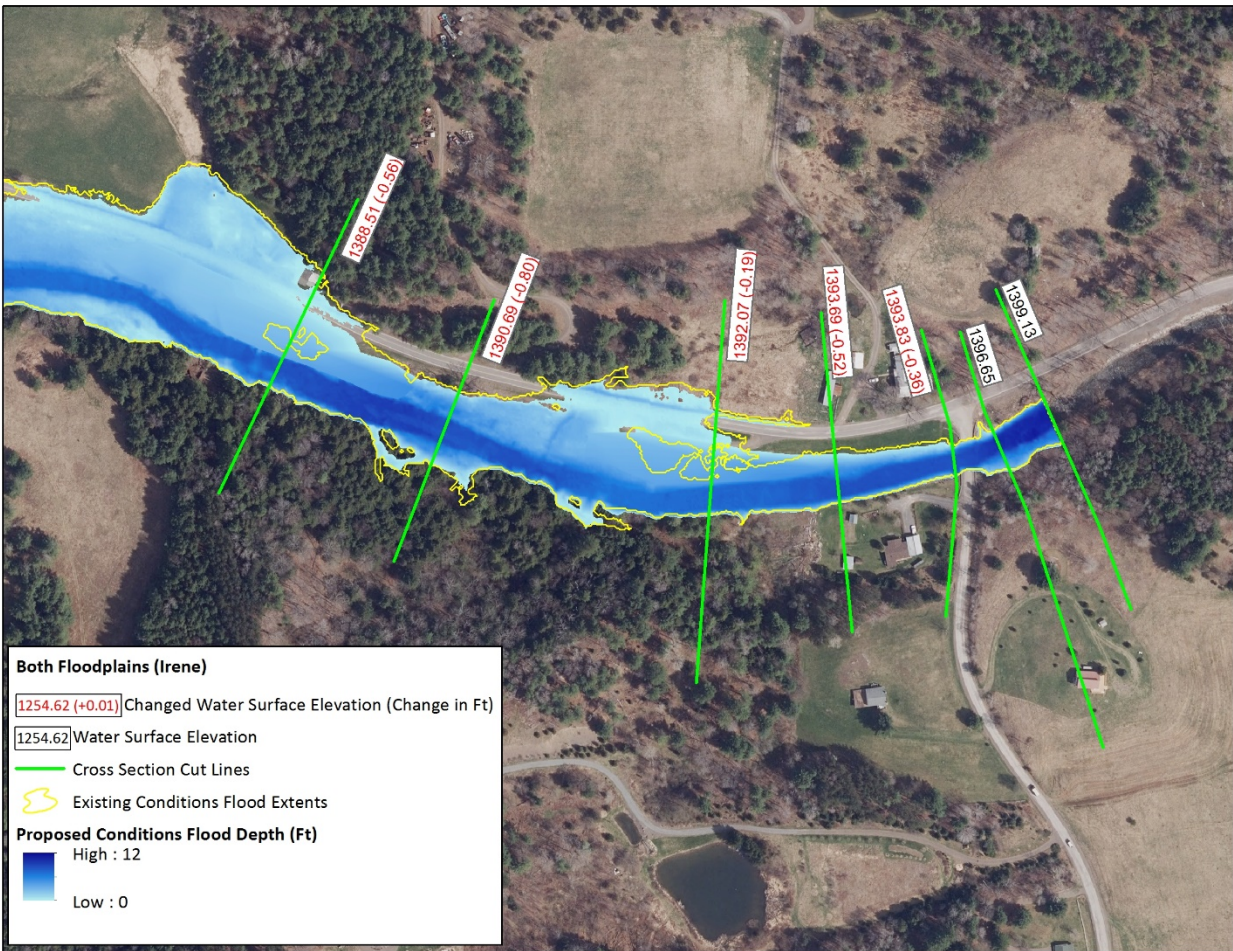
**Figure 4-21**  
**Study Area 2 – Floodplain Enhancement Scenario 2 – Proposed Conditions, Irene Flow**

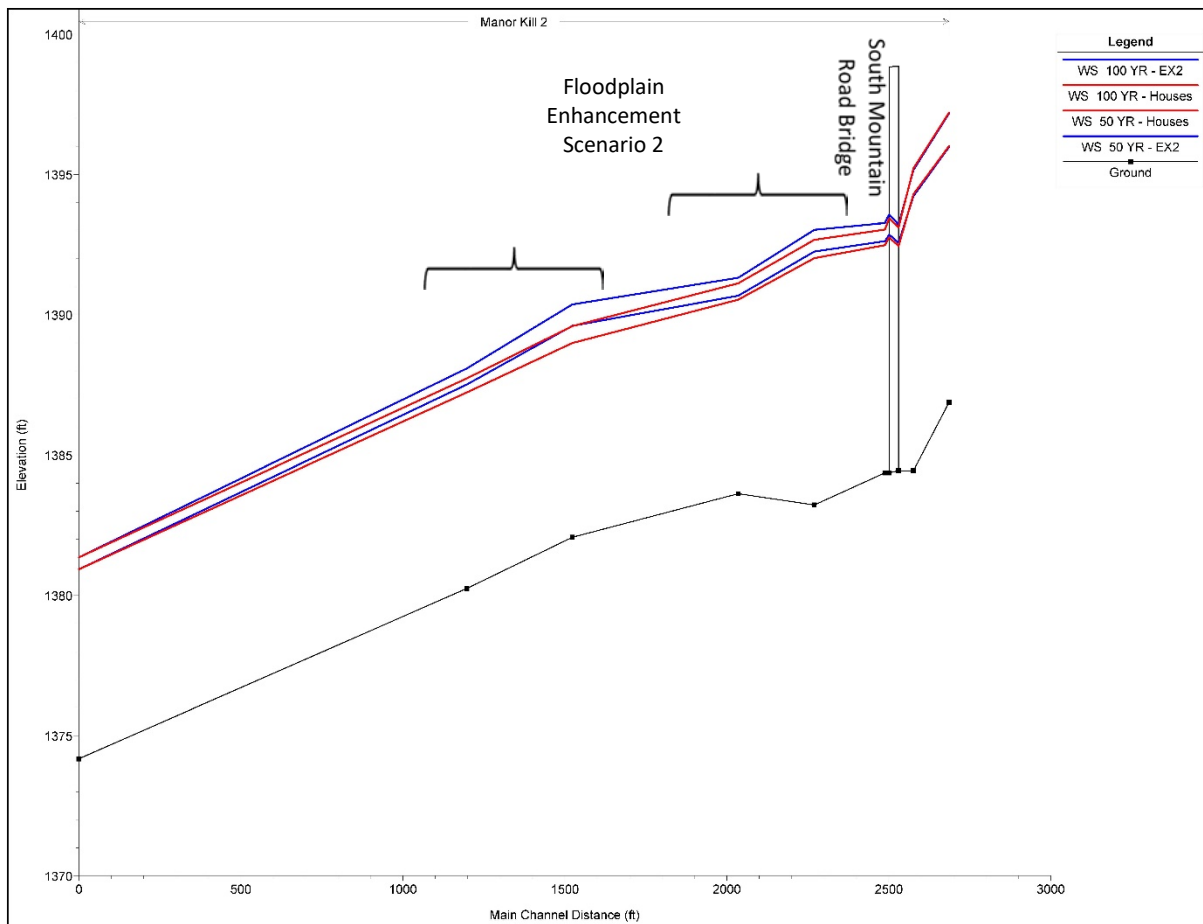
Figure 4-22 is a longitudinal profile from the hydraulic model showing water surface elevation reductions in Project Area 2 under Floodplain Enhancement Scenario 2. The brackets indicate the locations of floodplain enhancement.

**Figure 4-22**  
**Study Area 2 – Longitudinal Profile - Floodplain Enhancement Scenario 2**

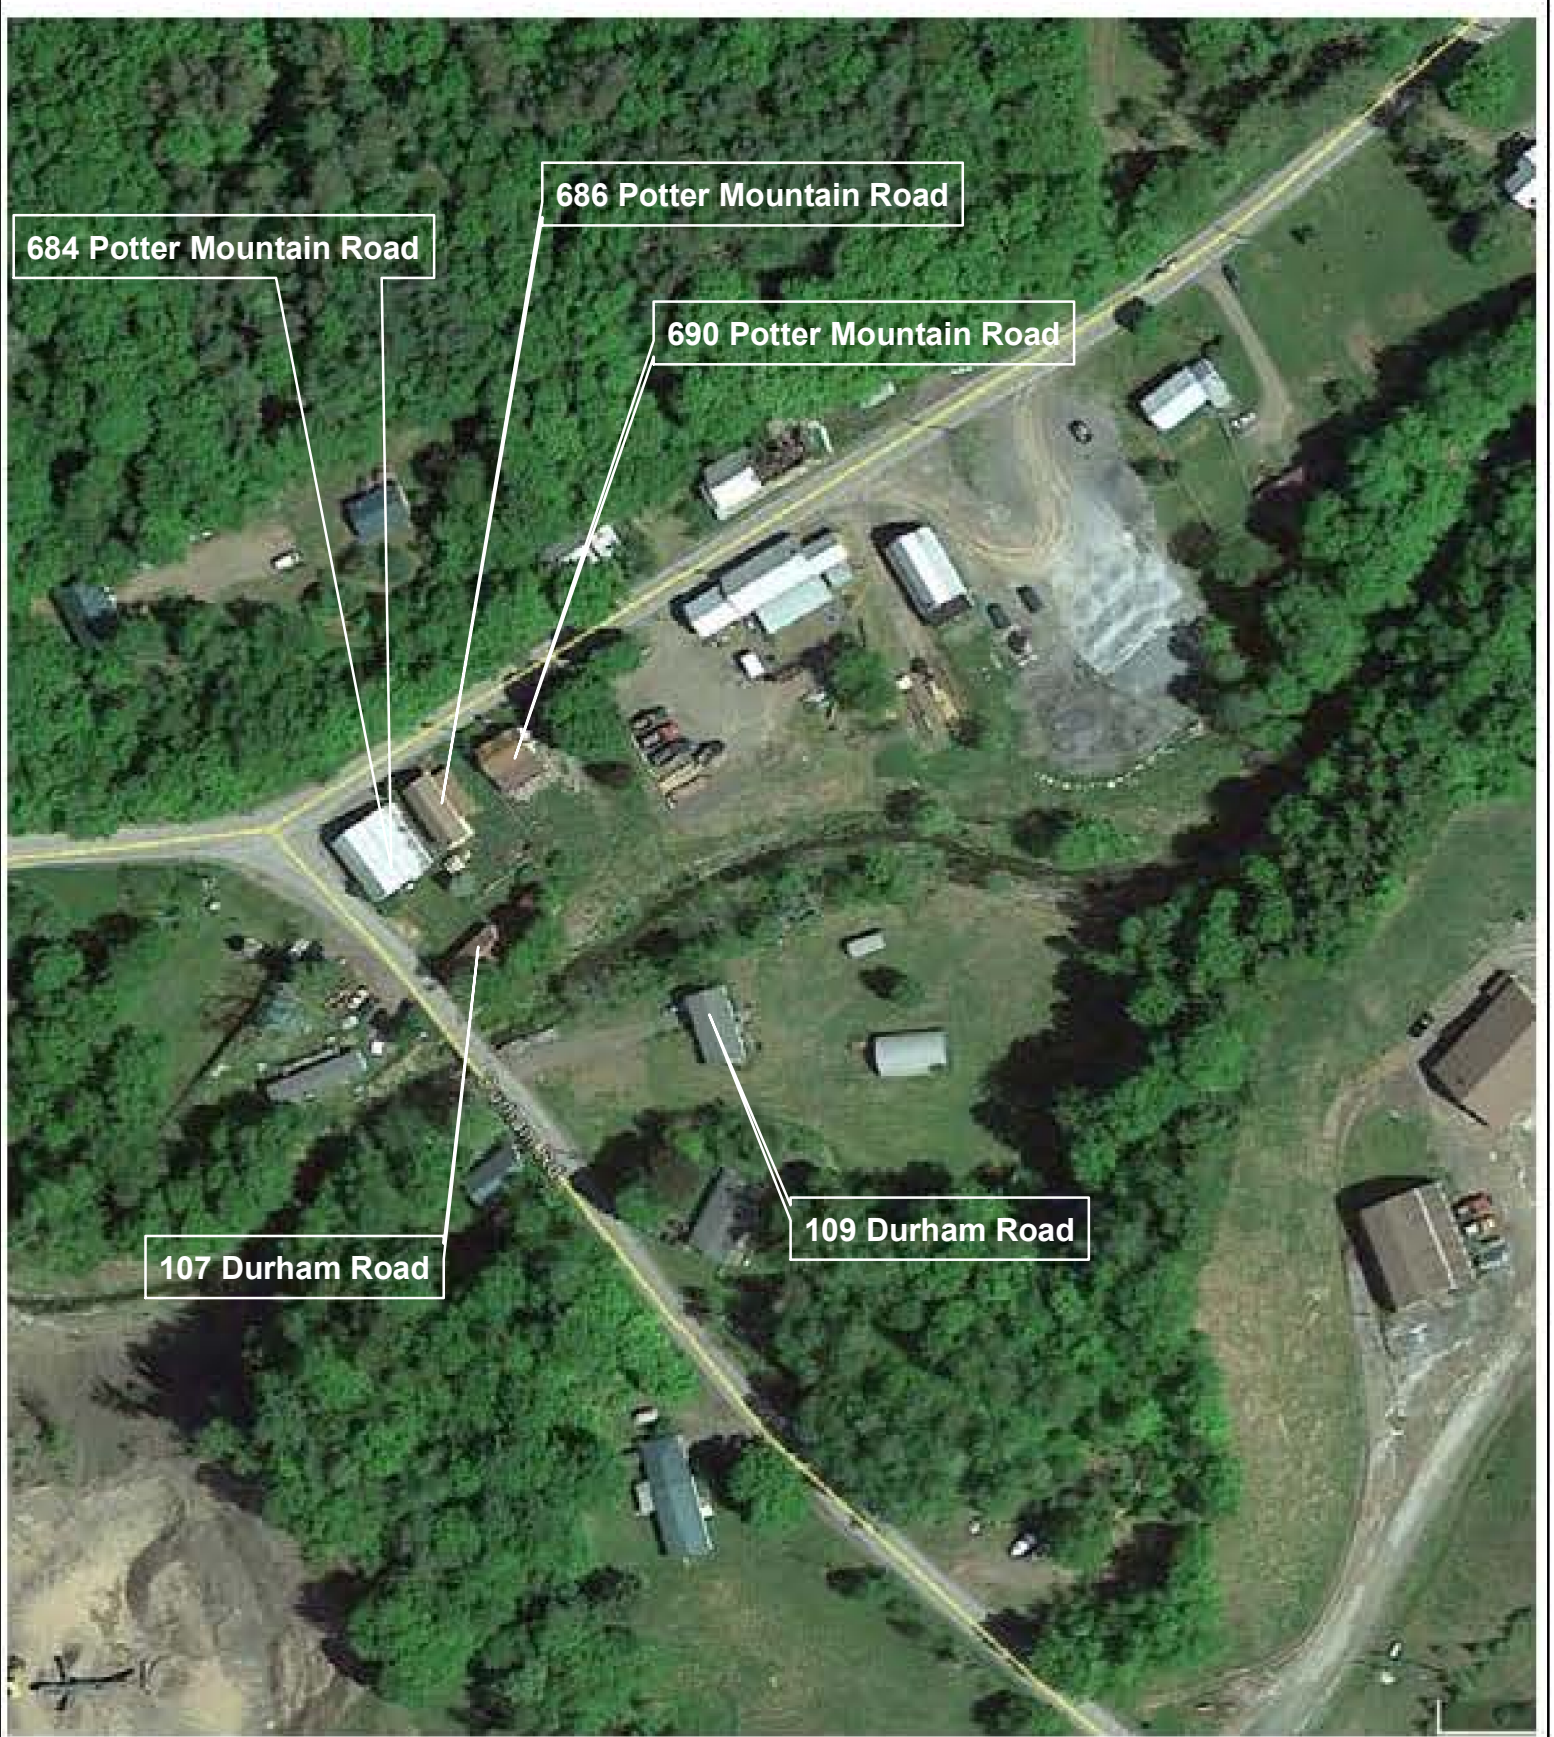
**Figure 6-1: Study Area 3**

- If the Durham Road bridge were to be slated for replacement in the future, it is recommended that its replacement be appropriately sized so as not to increase the flood risk at structures located upstream of the bridge. Specific properties are identified in Figure 6-1.
- To the extent possible, the Durham Road bridge should be kept free of debris.
- Encourage homeowners in the vicinity of the Durham Road bridge who have expressed interest in the flood buyout program to work with the town, NYCDEP, and the CWC to document flood damages, flood damage costs, and high water marks.
- Closely monitor bank erosion along the high bank failure downstream of Durham Road and implement repair and protection measures if required.
