**FINAL DRAFT LOCAL FLOOD HAZARD MITIGATION ANALYSIS
EXECUTIVE SUMMARY**

**SCHOHARIE CREEK WATERSHED
TOWN OF PRATTSVILLE
GREENE COUNTY, NEW YORK
September 2013**

FINAL DRAFT LOCAL FLOOD HAZARD MITIGATION ANALYSIS

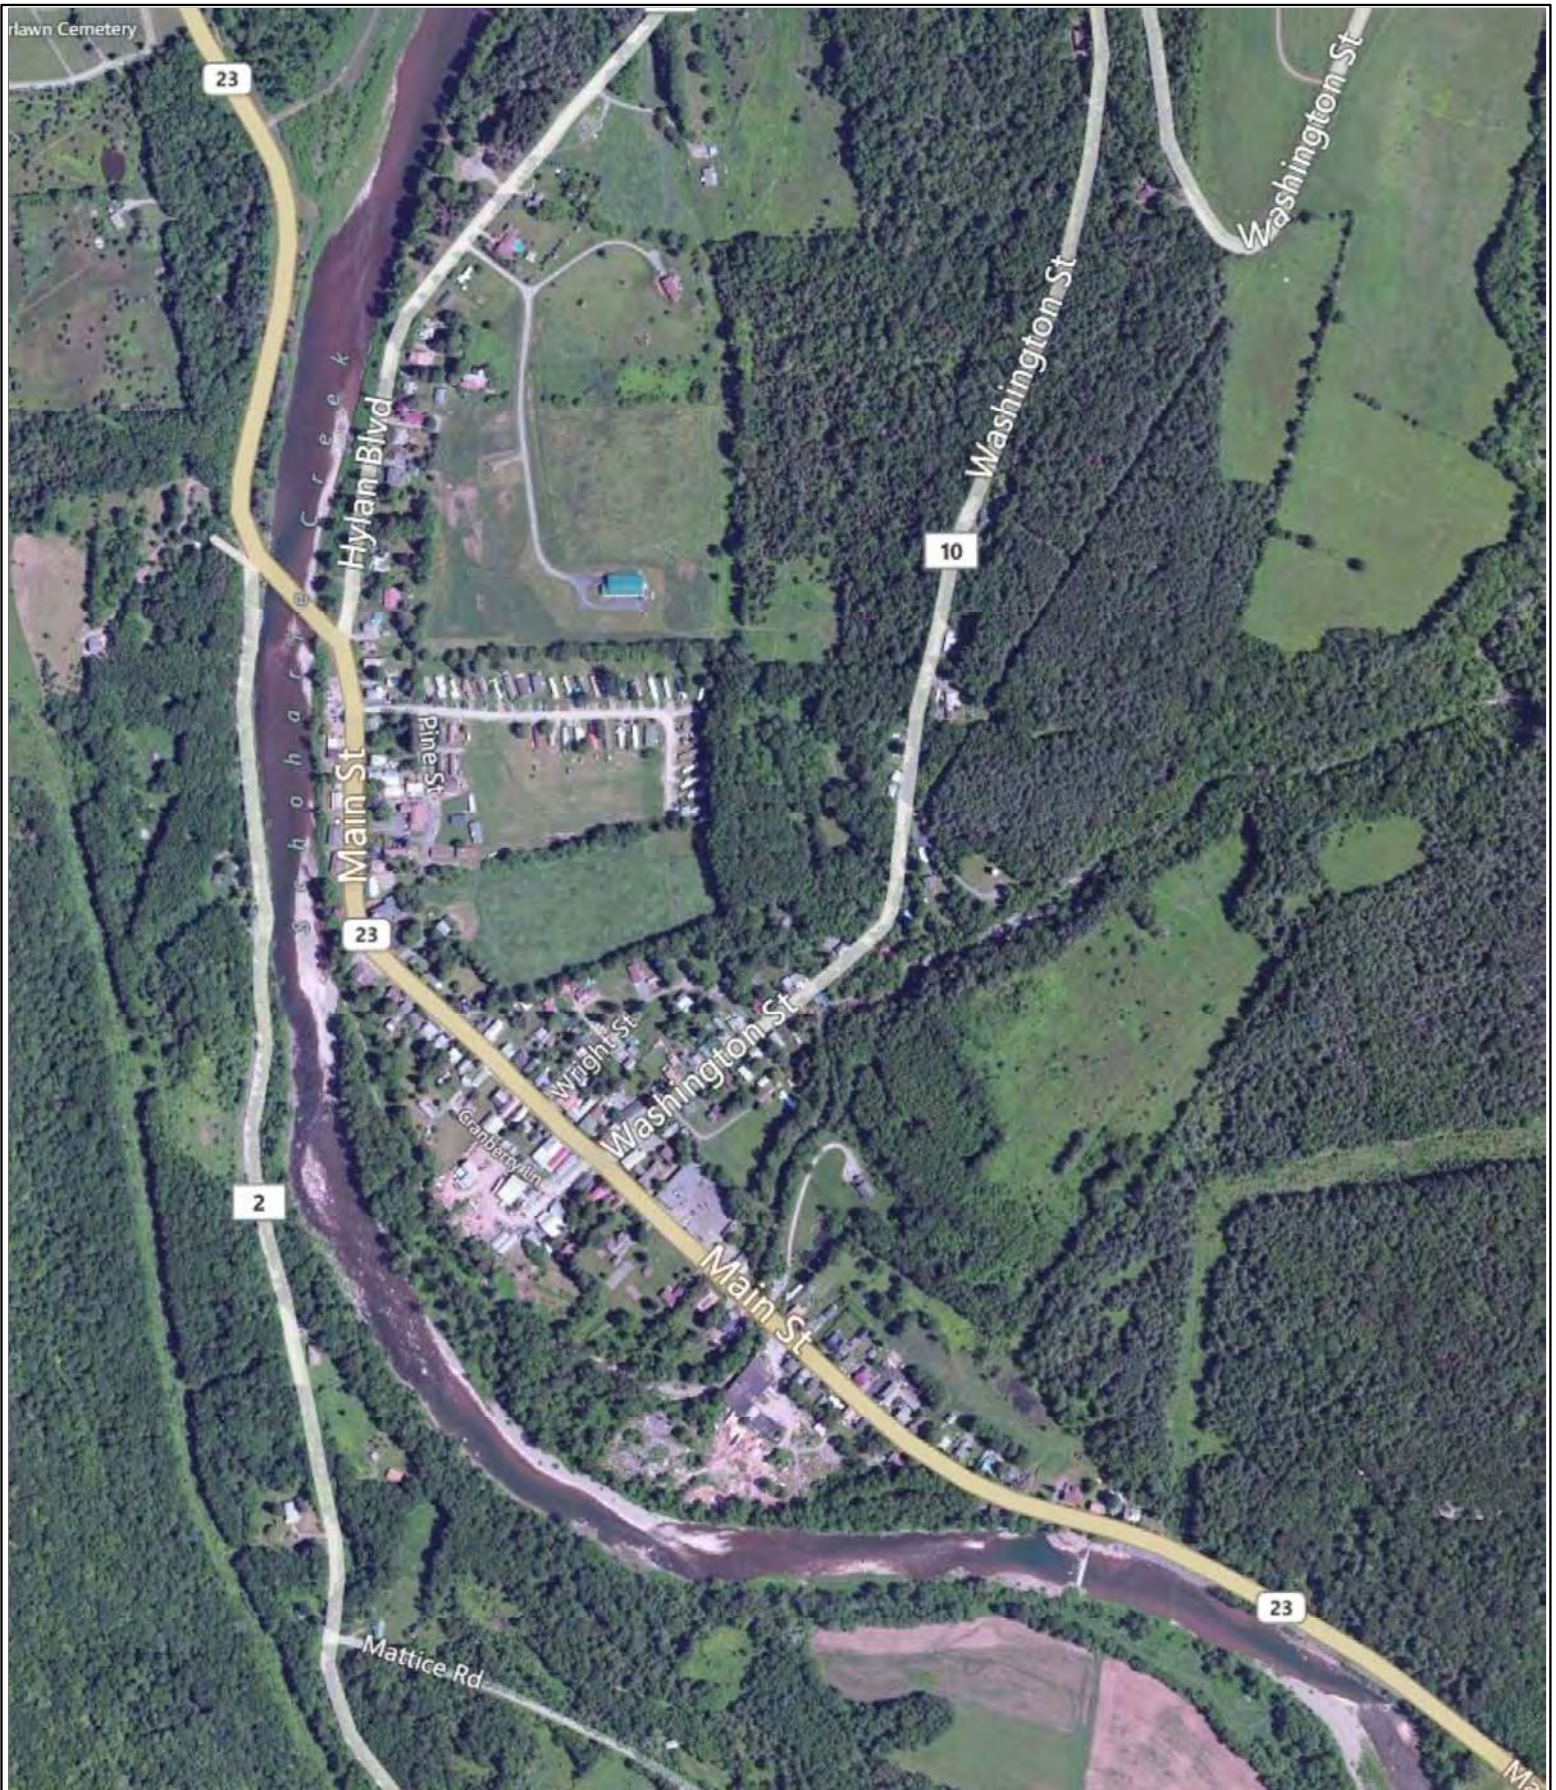
Figure 1-2: Location Plan of Business District

The business district in Prattsville is located at the intersection of two major roads – Main Street (Route 23), which is parallel to Schoharie Creek, and Washington Street, which is perpendicular to it. Many of the small businesses and homes are located along these two roads, very similar to a 1903 topographic map published by the United States Geological Survey (USGS). Figure 1-2 is a plan showing the business district today. It extends for approximately one mile along State Route 23, parallel to the river and is located on a terrace situated on the right side (facing downstream) of the Schoharie Creek channel.

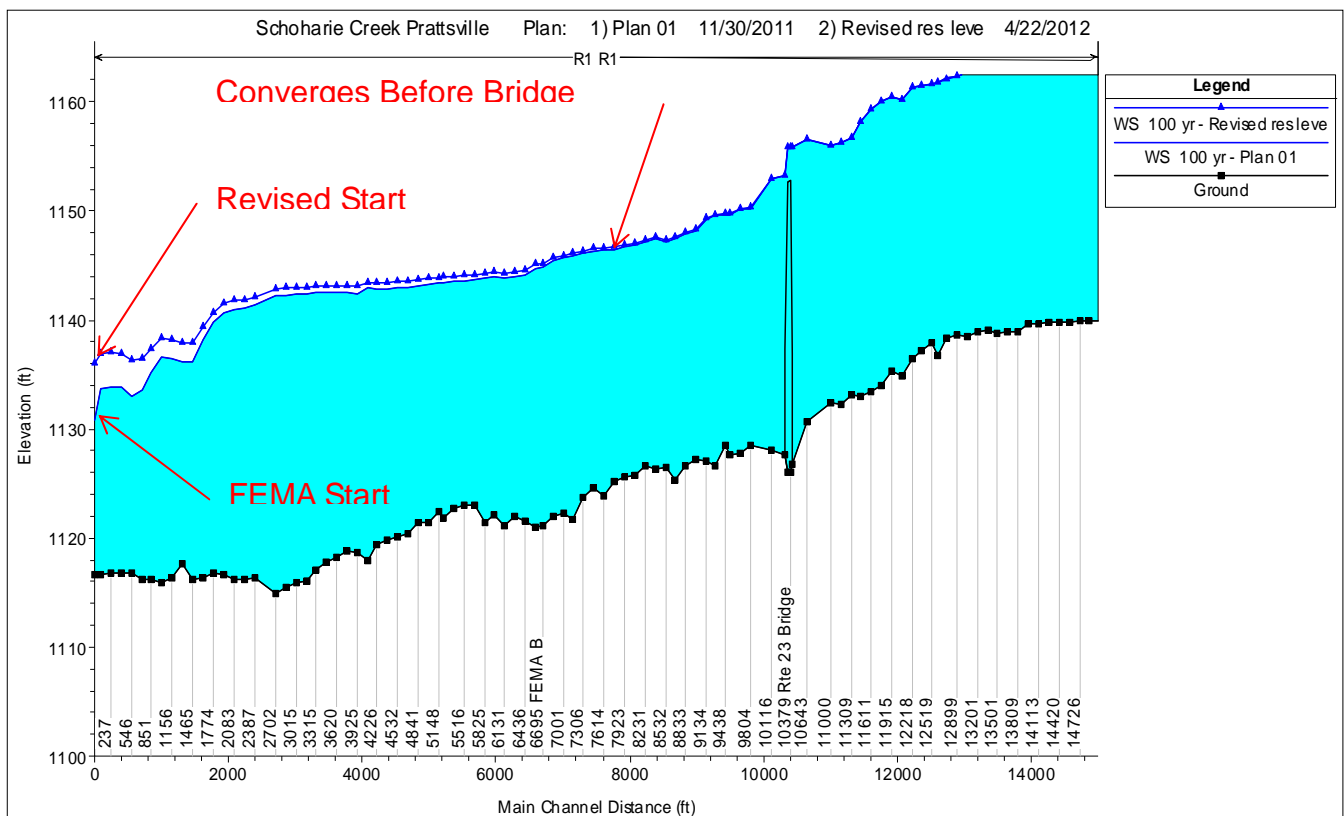
FIGURE 4-1
Effect of the Schoharie Reservoir on Flooding in Prattsville

Model results are presented in Figure 4-1 below. The graph depicts existing FEMA modeling water profile compared against the MMI model, run with the higher water surface elevations that account for the downstream reservoir, under stream flows that reflect the 100-year flood event. As is evident in the figure, the two models converge downstream of the Route 23 bridge.

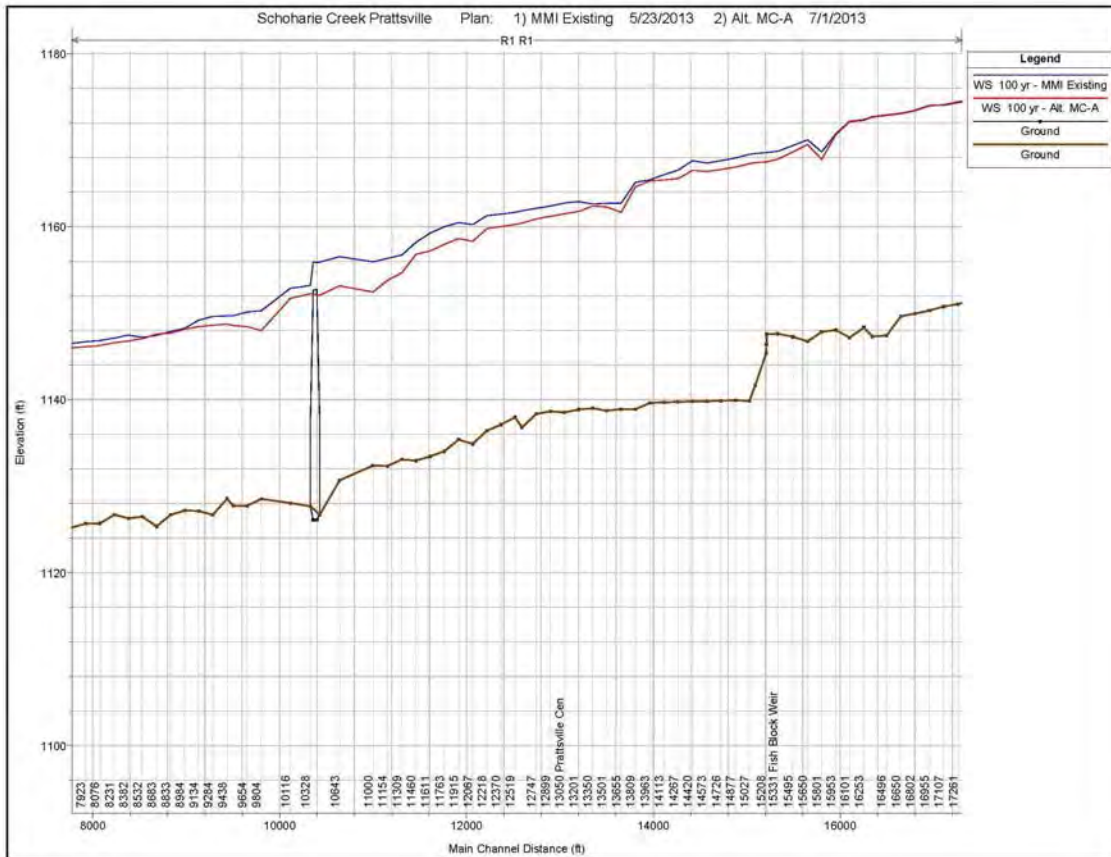
FIGURE 5-2
Alternative 2 – Replace Route 23 Bridge – Water Surface Profile

Figure 5-2 is a profile of the river showing existing and proposed water surface elevations for this alternative. Figure 5-3 shows the inundation area associated with this alternative. As seen in the inundation mapping, while implementation of this alternative will decrease flood *depths*, the horizontal *extent* of flooding will not be significantly reduced. Removing and replacing the bridge would help limited sections of Main Street. It would also allow enlargement of the narrow channel on both sides of the bridge.

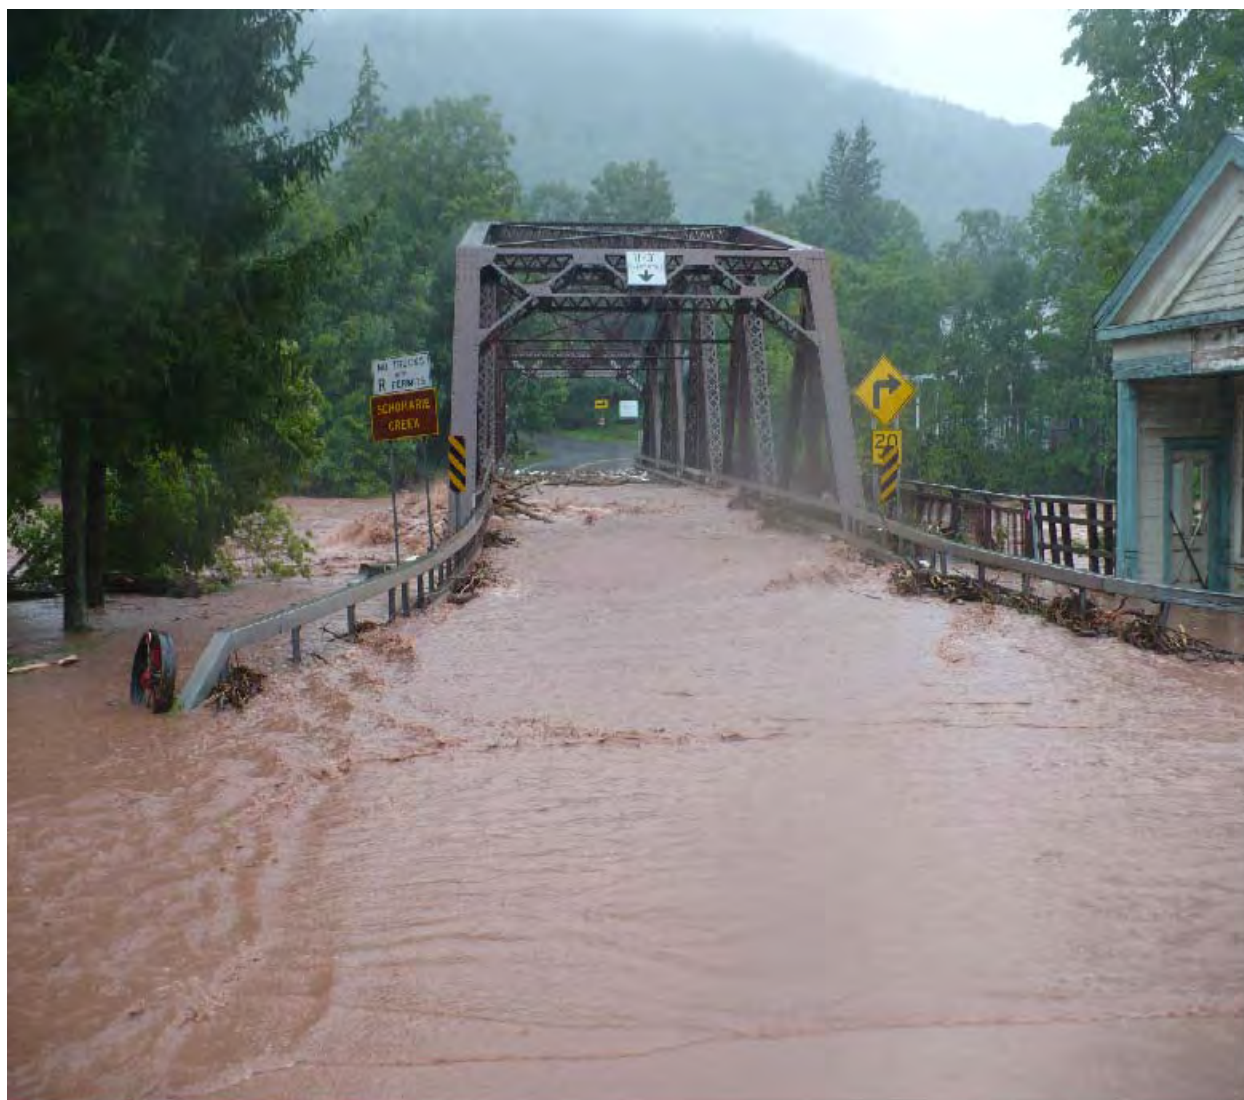
Figure 1.—Bridge over Schoharie Creek near Lexington, N.Y., Aug. 28, 2011. Photo taken by Travis L. Smith (USGS Troy NYWSC).

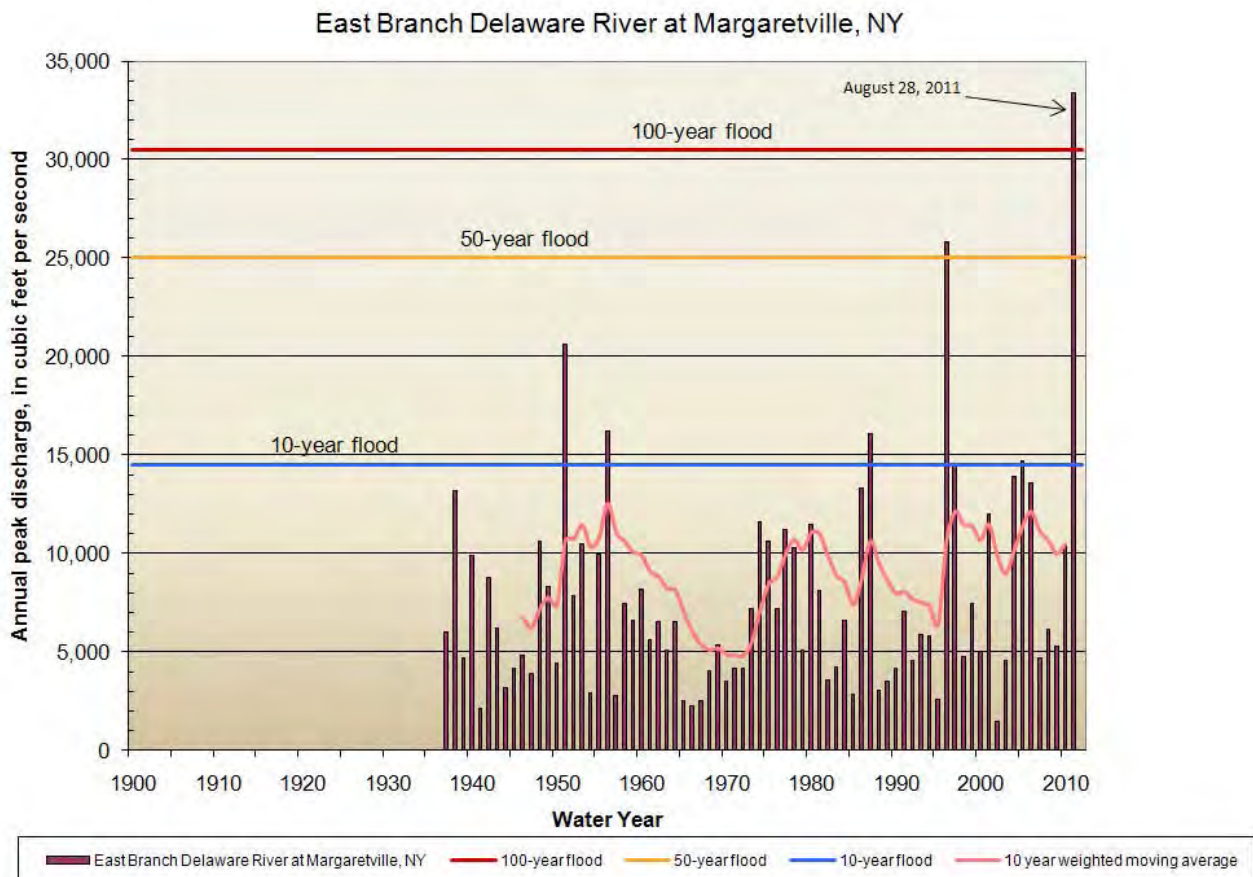
Figure 2. - Annual peak discharges through 2010, provisional peak of August 28, 2011 and discharges of the 10-, 50-, and 100-year recurrence intervals for selected stations in the Delaware River basin.

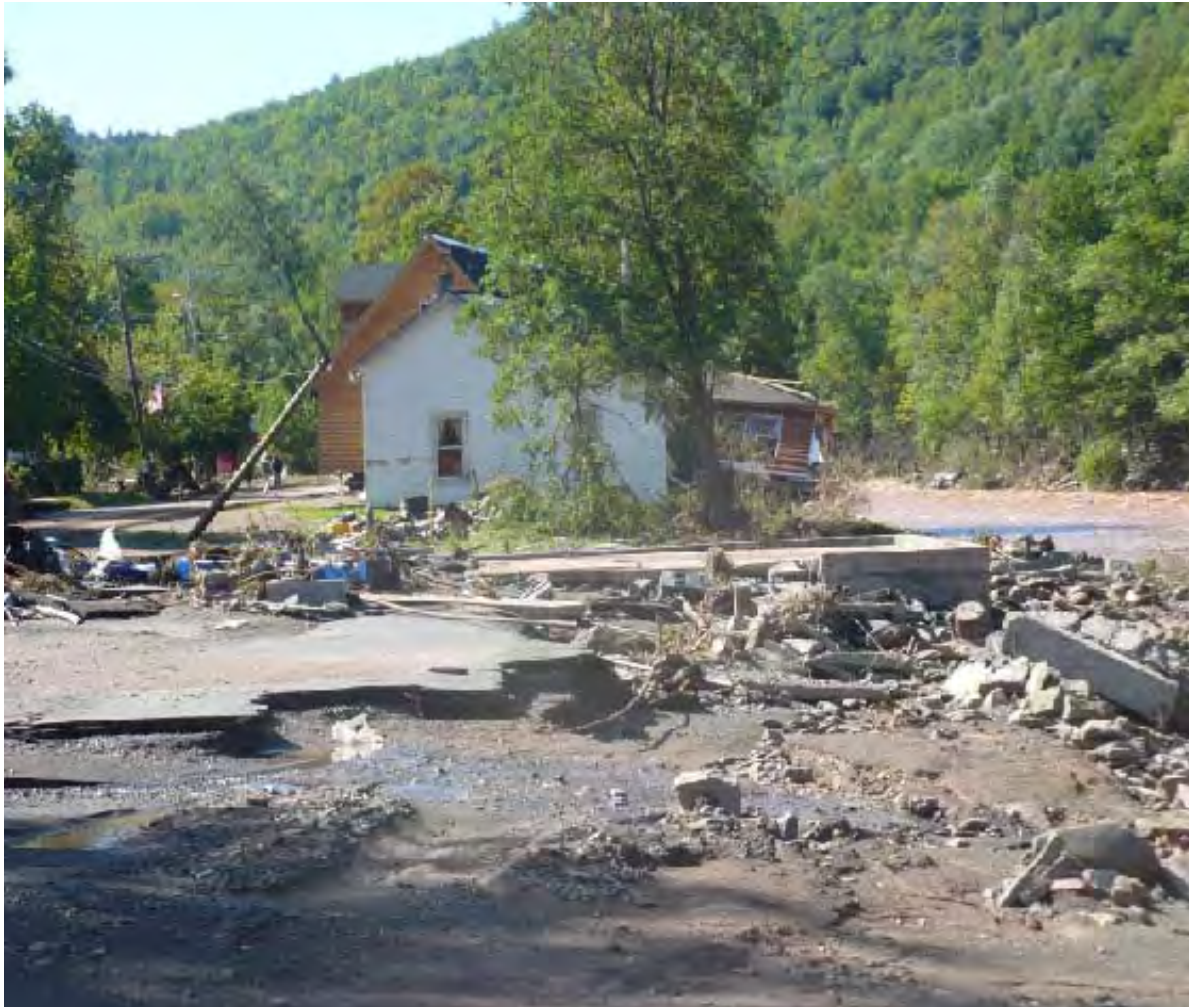
Figure 3.-- Road and homes damaged along the Schoharie Creek near Prattsville, NY, Aug. 29, 2011. Photo taken by K.D. Reisig (USGS Troy NYWSC).
