LOCAL FLOOD ANALYSIS

**EAST BROOK, WEST BROOK, AND THIRD BROOK
VILLAGE AND TOWN OF WALTON
DELAWARE COUNTY, NEW YORK**

October 2017
Revised December 2017

MMI #5197-06

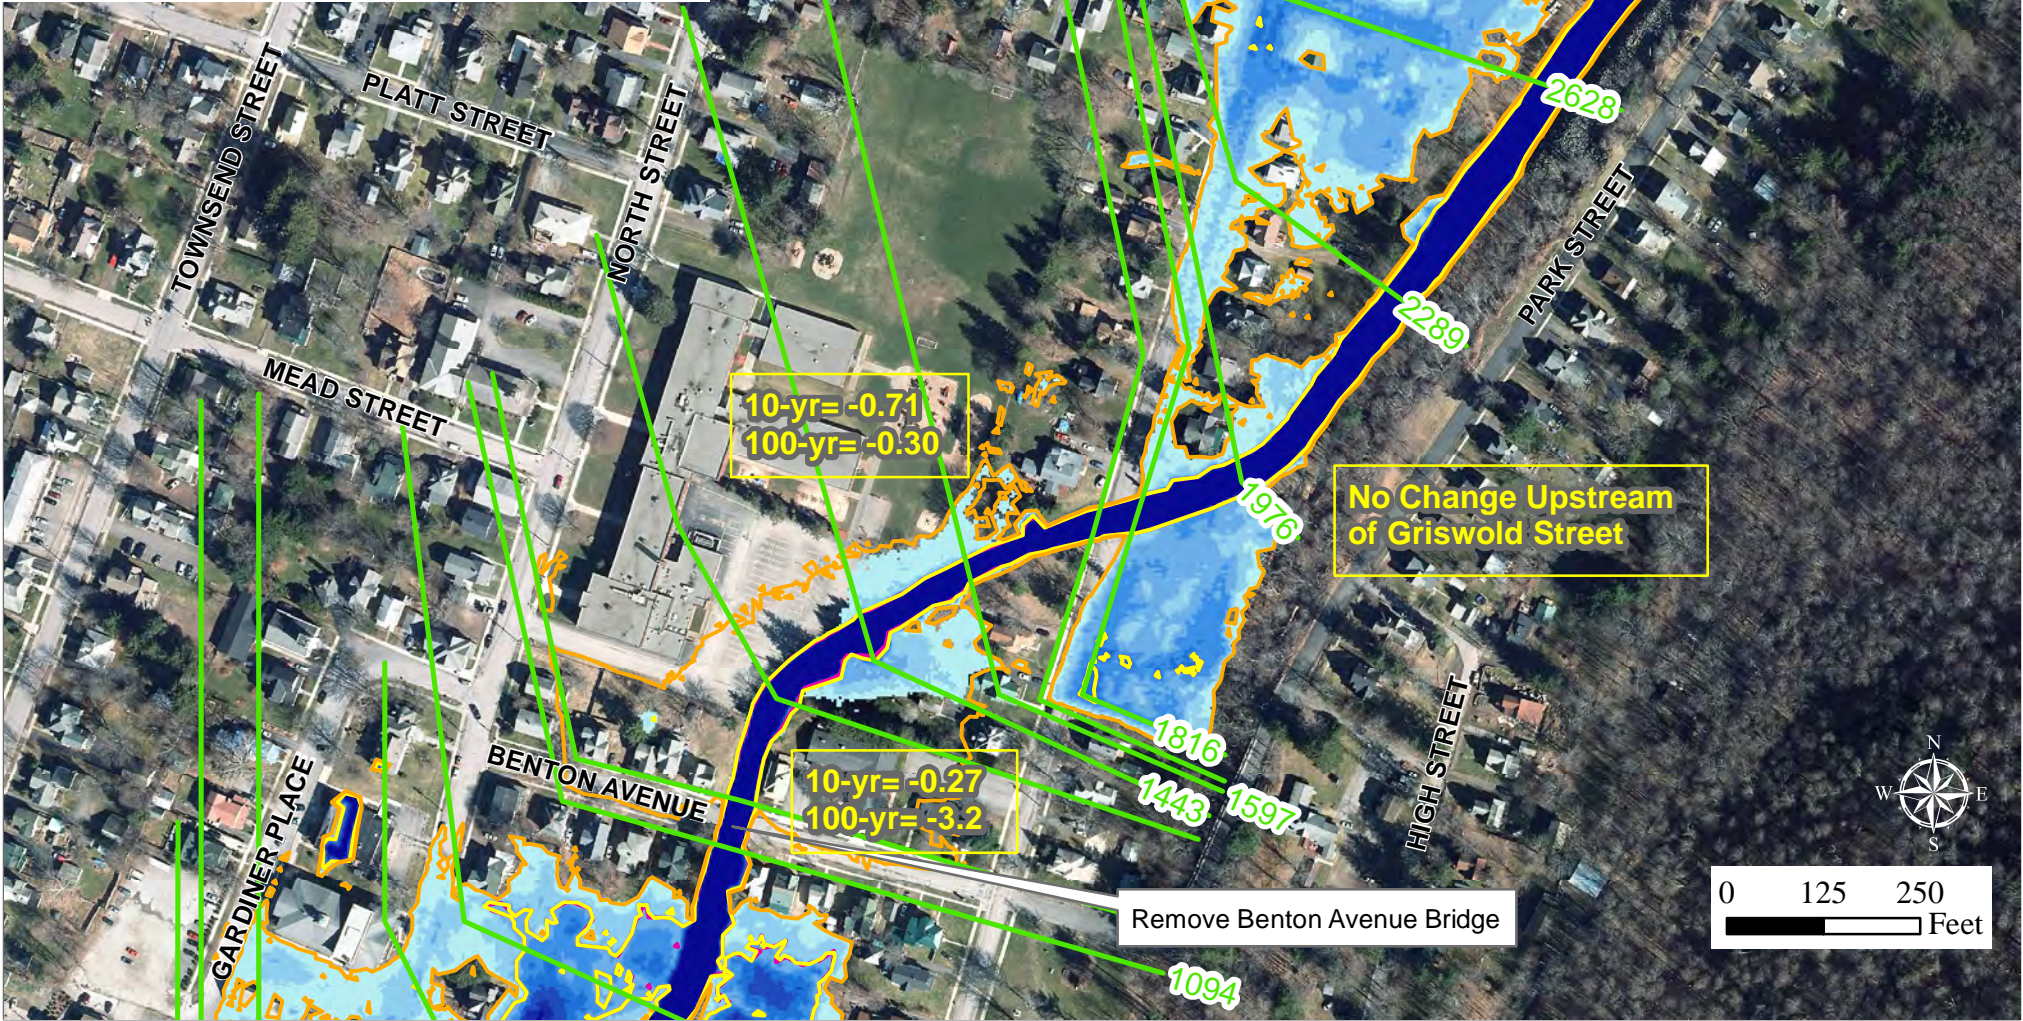
FIG. 5-8: BENTON REMOVAL AND NO REPLACEMENT DEPTH MAPPING
 MXD: Y:\5197-06\Maps\Report Figures\Fig 5-8 Benton Removal Depth.mxd

The church is an example of a property that benefits most from bridge removal. For alternative #8 water surface elevation was reduced 1.2 feet for the 10-year flood and 3.2 feet for the 100-year flood.
