Local Flood Analysis

Hamlets of Shandaken and Allaben

Ulster County, New York

February 2018

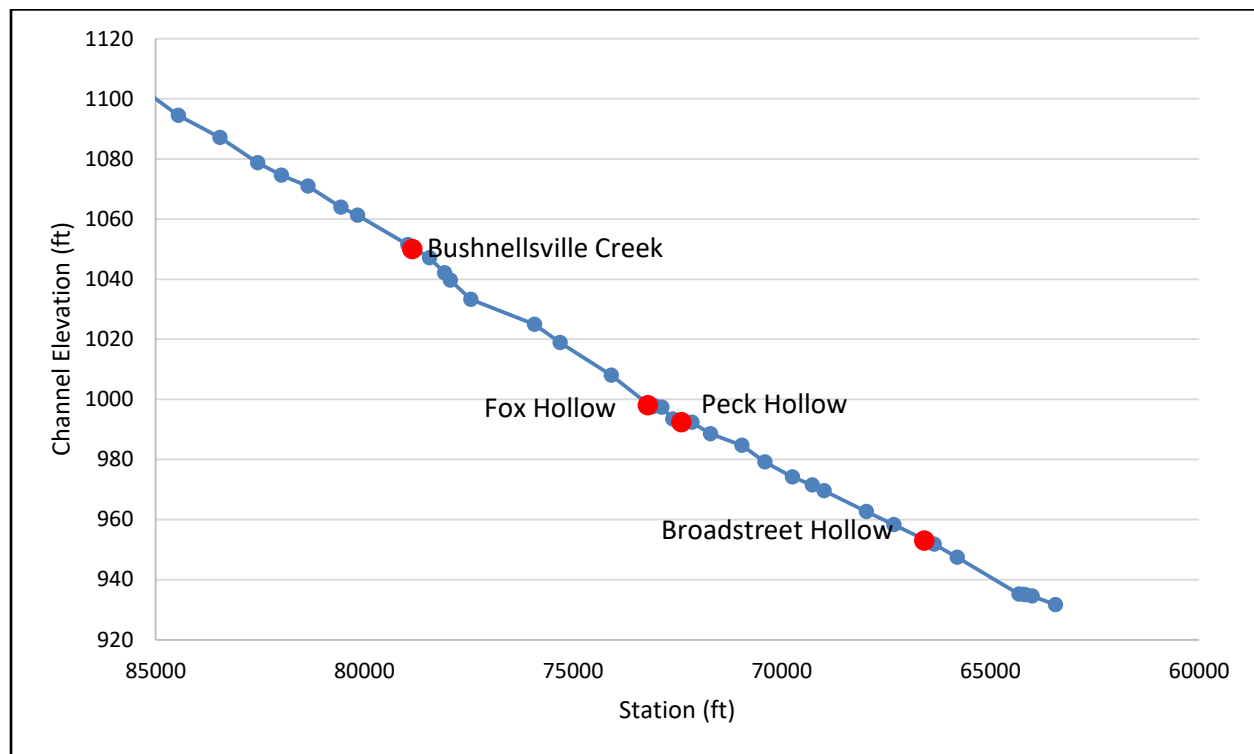
Figure 2-2
Esopus Creek Longitudinal Profile within the Project Area

Figure 2-2 represents a longitudinal profile of Esopus Creek within the project boundaries as well as the location of tributaries included in the study. A longitudinal profile of a river depicts the change in elevation of the channel between two points, thereby showing the rate of change in slope, or gradient, for a certain distance downstream.

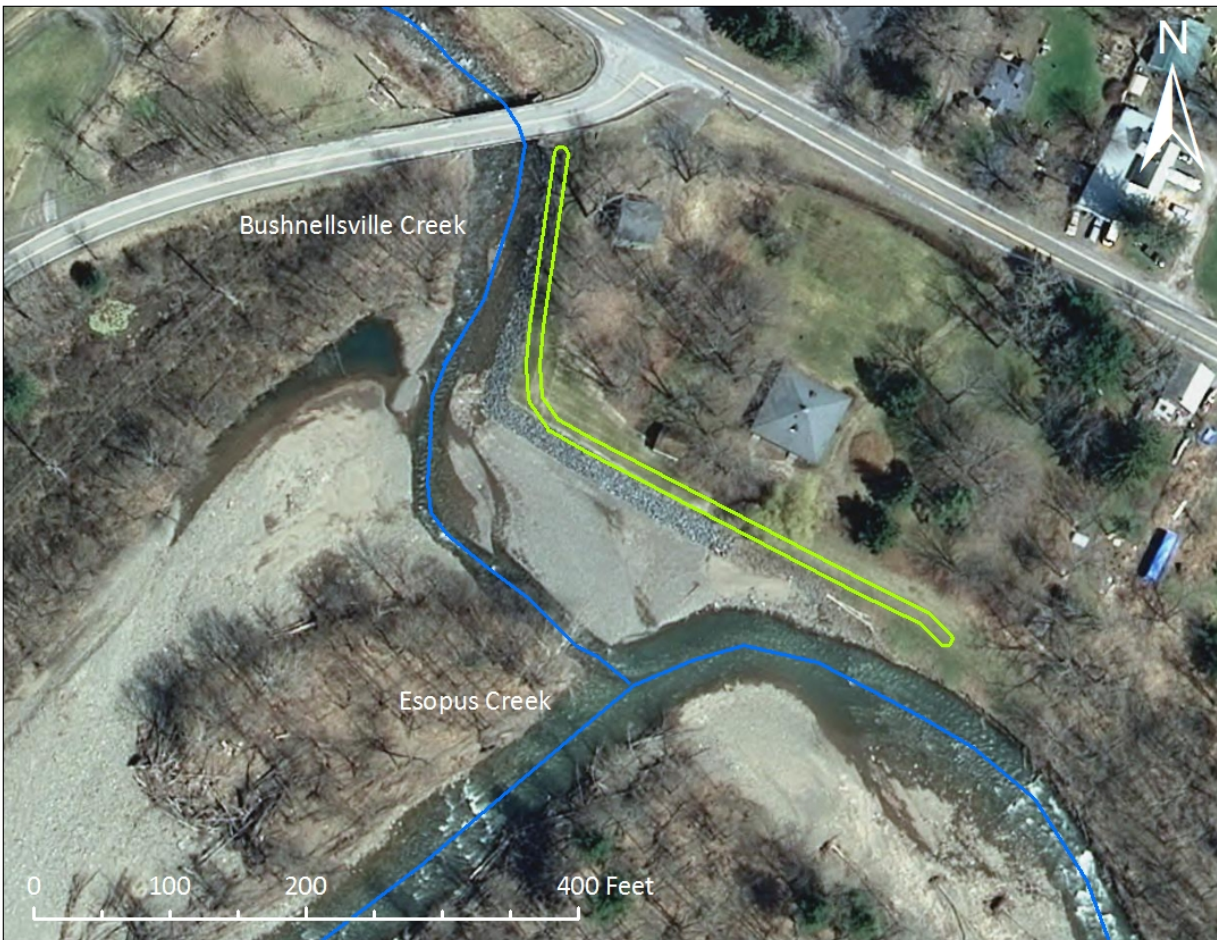
Figure 2-7
Levee at Bushnellsville Creek and Esopus Creek Confluence Prior to Tropical Storm Irene

In the hamlet of Shandaken, a flood control levee lines the left bank of the Bushnellsville Creek and Esopus Creek confluence. The levee begins on Bushnellsville Creek immediately downstream of the County Route 47 bridge. It extends 155 feet along the left bank of Bushnellsville Creek. The levee then turns and runs along the left bank of Esopus Creek for an additional 445 feet (Figure 2-7).

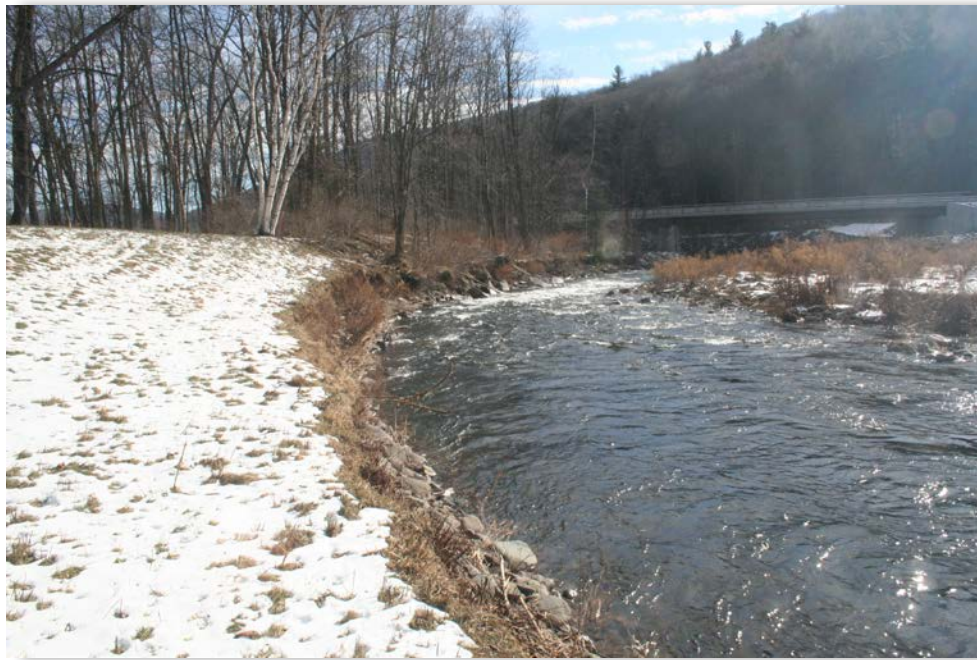
Figure 2-8
Erosion along Flood Control Levee in Shandaken

Since the repairs were made in 2011, the levee has experienced erosion at the downstream end. This erosion is due to the change in course of the Esopus Creek. Prior to Tropical Storm Irene, Esopus Creek ran parallel to the lower portion of the levee. However, following Tropical Storm Irene, the channel cut through the floodplain on the right bank, and the course of the stream was diverted directly toward the lower portion of the levee.

- The flood control levee that currently lines the left bank of the Bushnellsville Creek and Esopus Creek confluence was breached in 2011, resulting in significant damage. Since repairs were made in 2011, the levee has experienced erosion at the downstream end. Further evaluation of the levee is recommended, and armoring of the levee in the area of the erosion is likely warranted.

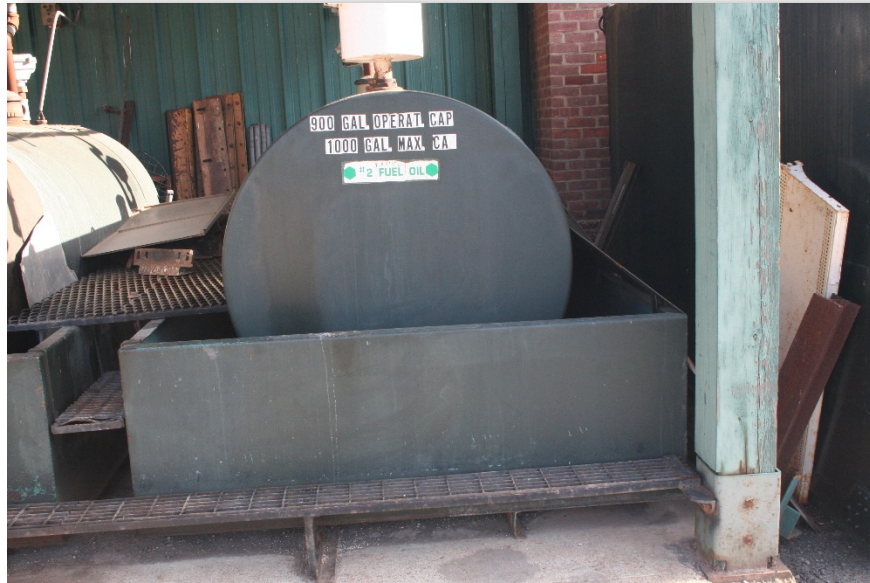
Figure 2-10
1000-gallon Fuel Storage Tank at Highway Department Garage

The town Highway Department garage property currently stores over 5,000 gallons in combined automotive and industrial chemicals including fuel, oil, antifreeze, and additives. Approximately 3,000 of these 5,000 gallons are stored at a location on the outside western face of the Highway Department garage in three fuel storage tanks containing heating oil and diesel fuel, as seen in Figure 2-11. Other potential pollutants such as old tires, empty fuel drums, and containers (Figure 2-12); paints (Figure 2-13); acetylene torches; and asphalt road patch material are present within and in the immediate vicinity of the garage. Although chemical storage appears to be in compliance with regulations, the best solution to reduce the risk of contamination of Esopus Creek and Ashokan Reservoir during a flood event is to relocate the facility and its contents outside of the floodplain. If the Highway Department garage were to be inundated during a flood event, and floodwaters were to come in contact with and transport

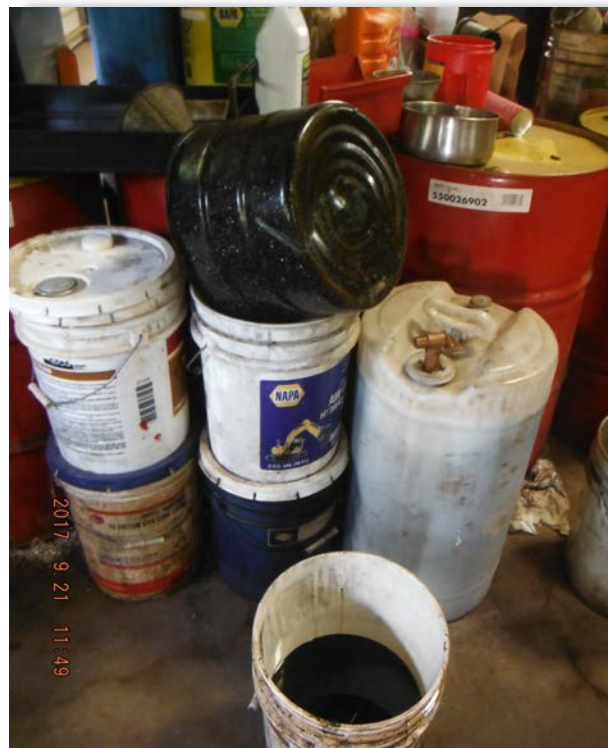
Figure 2-11
Old Oil Stored Inside Various Containers at Highway Department Garage

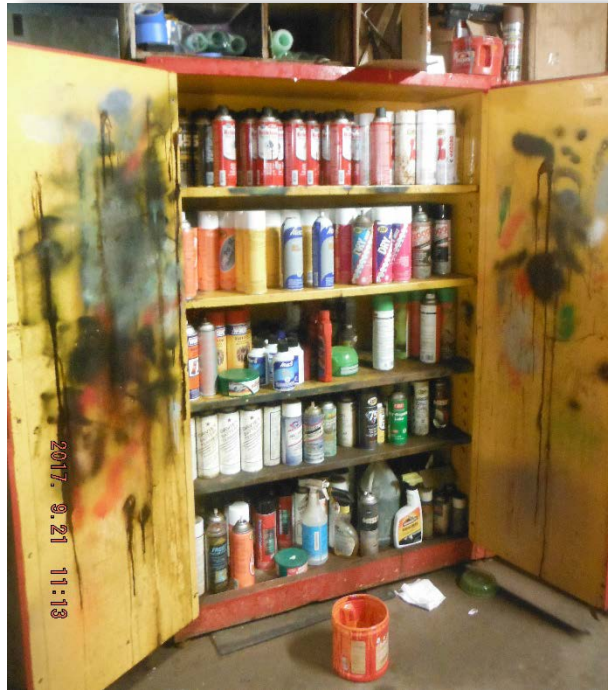
Figure 2-12
Paints and Other Chemicals Stored at Highway Department Garage

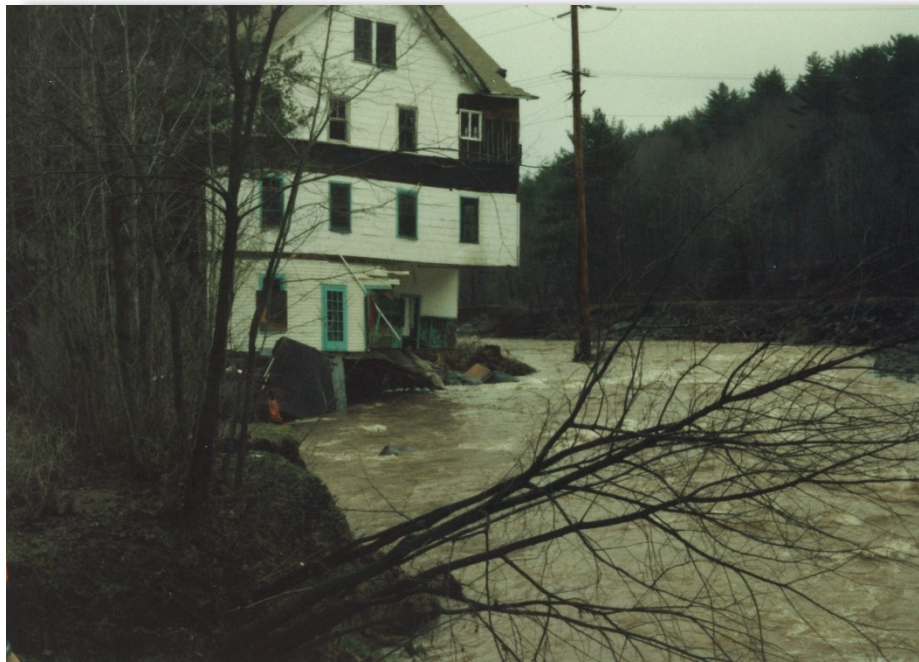
Figure 3-1
Shandaken Manor on Esopus Creek during the 1987 Flood

The USGS has maintained an active gauge on Esopus Creek in Allaben since the early 1960s. During the 1960s and 1970s, there were no floods that exceeded the 10-year discharge event. However, between 1980 and 2011, there have been several major flood events in the Esopus Basin. The first major flood of this period occurred between March 21 and 22, 1980, with a peak discharge of 15,000 cfs. Heavy rains contributed to flooding resulting in an estimated \$6 million in damages within the town of Shandaken. Floods of similar discharges occurred again in 1987 (16,100 cfs) and 1996 (15,000 cfs). Figure 3-1 provides an illustration of the extent of flooding that occurred along the Esopus Creek during the 1987 flood.

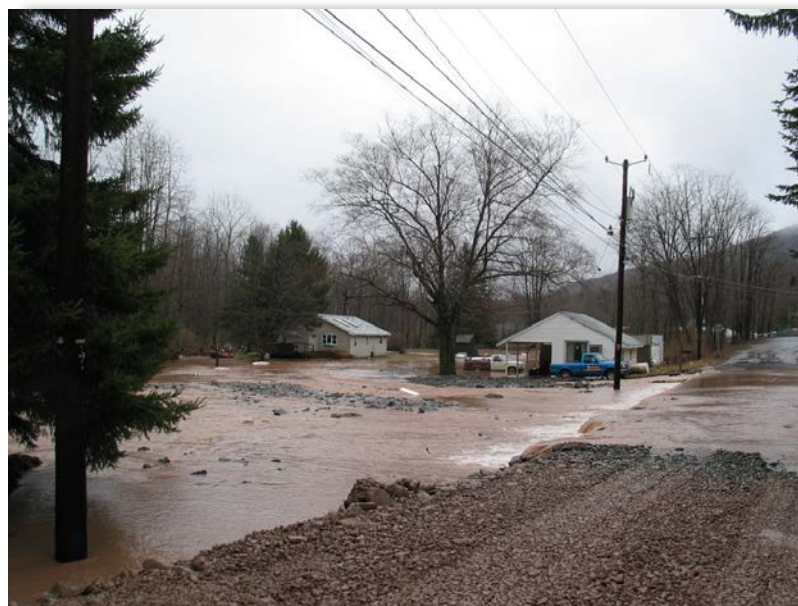
Figure 3-2
Fox Hollow Road Washed Out During the 2005 Flood Event

On April 2, 2005, a major flood occurred with a discharge of 21,700 cfs at the USGS gauge in Allaben. The recurrence interval for this flood was close to the 50-year discharge event, which is estimated to be 24,274 cfs according to the FEMA Ashokan Reservoir Hydrology Study (FEMA, 2012). This flood resulted in significant damage in the town of Shandaken (Figure 3-2).

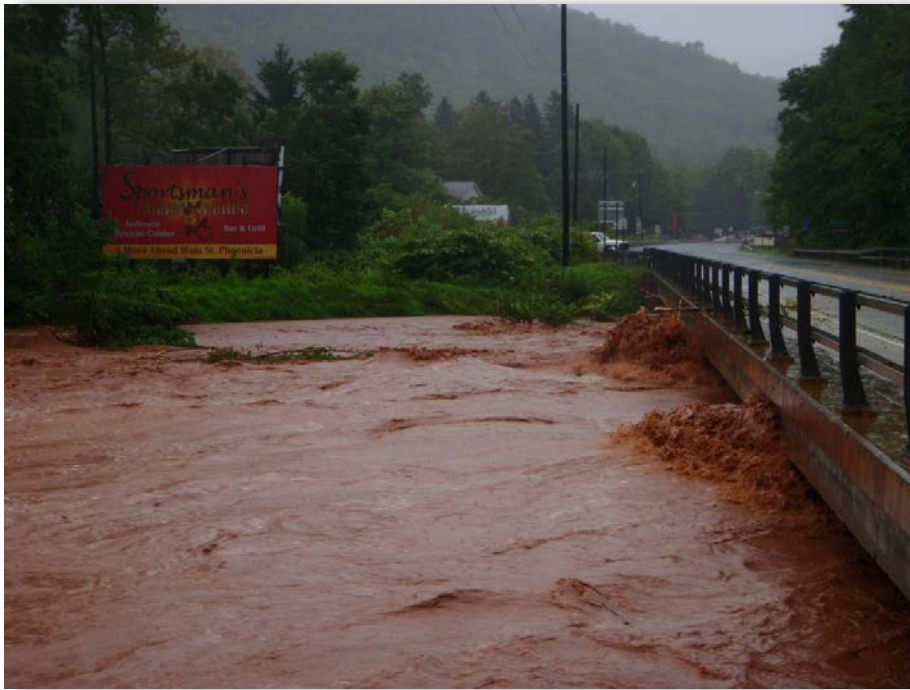
Figure 3-4
Esopus Creek Nearly Reaching Deck of State Route 28 Bridge in Shandaken

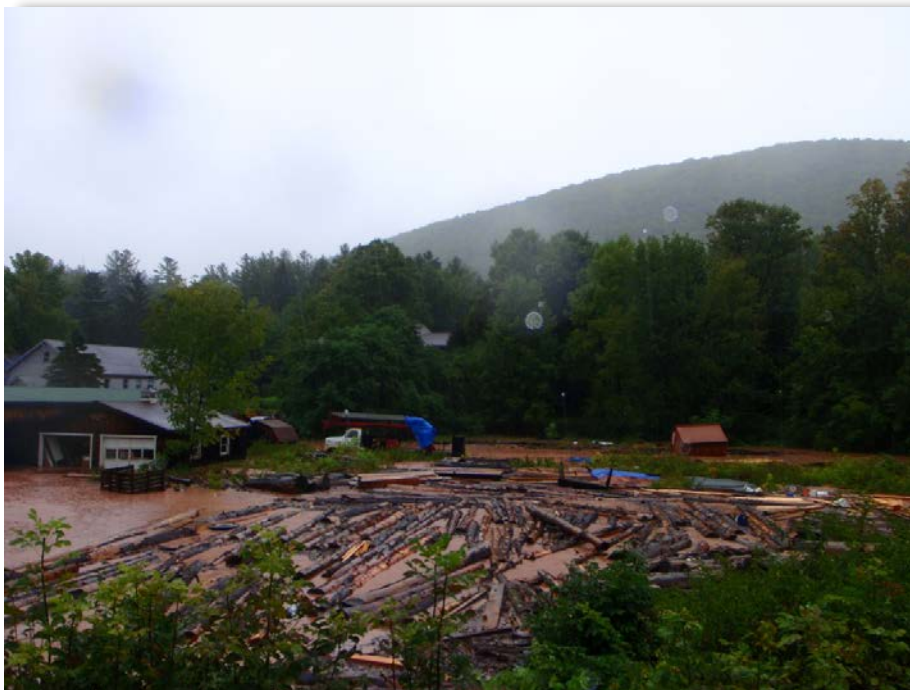
Figure 3-5
Flooding at Farmer Jones Barns Property in Shandaken, New York

extensive damage (Figures 3-4 and 3-5). In the hamlet of Allaben, flooding was severe and resulted in damages to homes and vehicles (Figures 3-6 and 3-7).

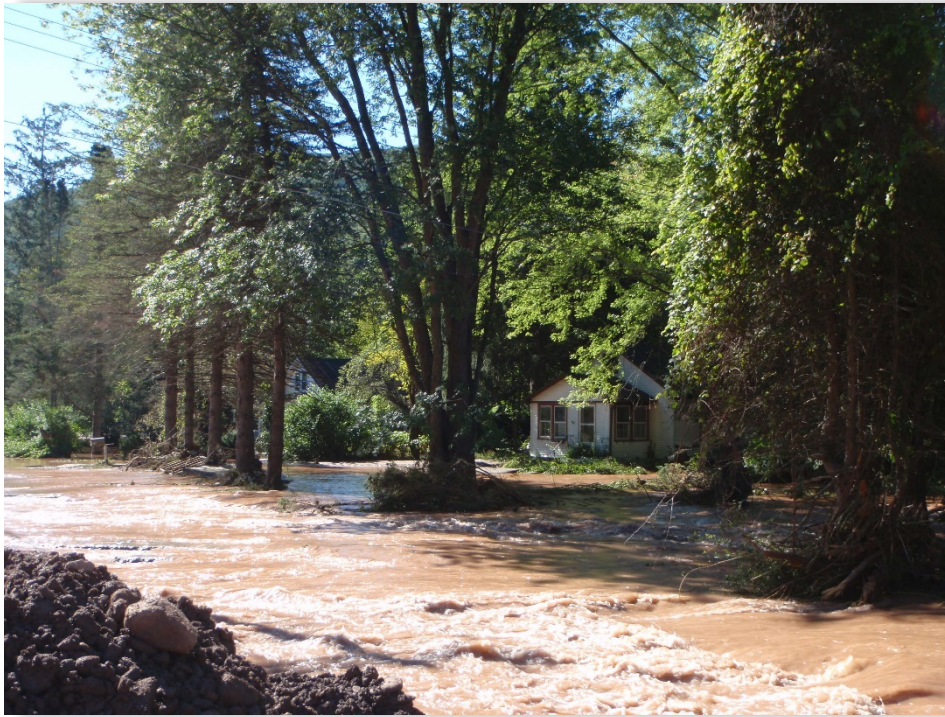
Figure 3-6

Flooding of Homes along Esopus Creek near Confluence with Fox Hollow Creek in Allaben

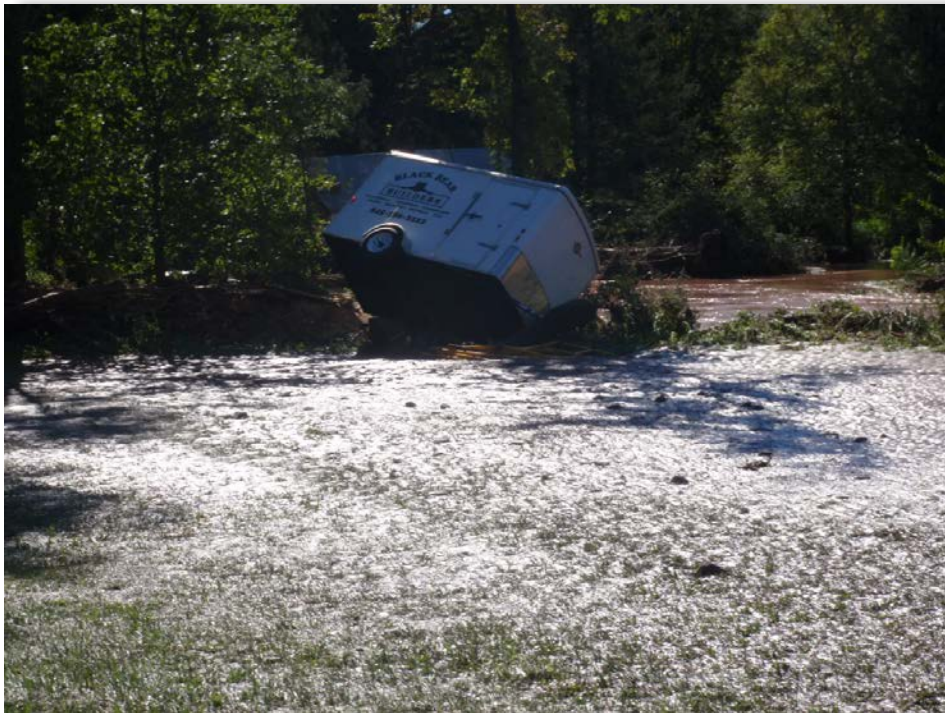
Figure 3-7

Damage to Trailer along Esopus Creek near Confluence with Fox Hollow Creek in Allaben

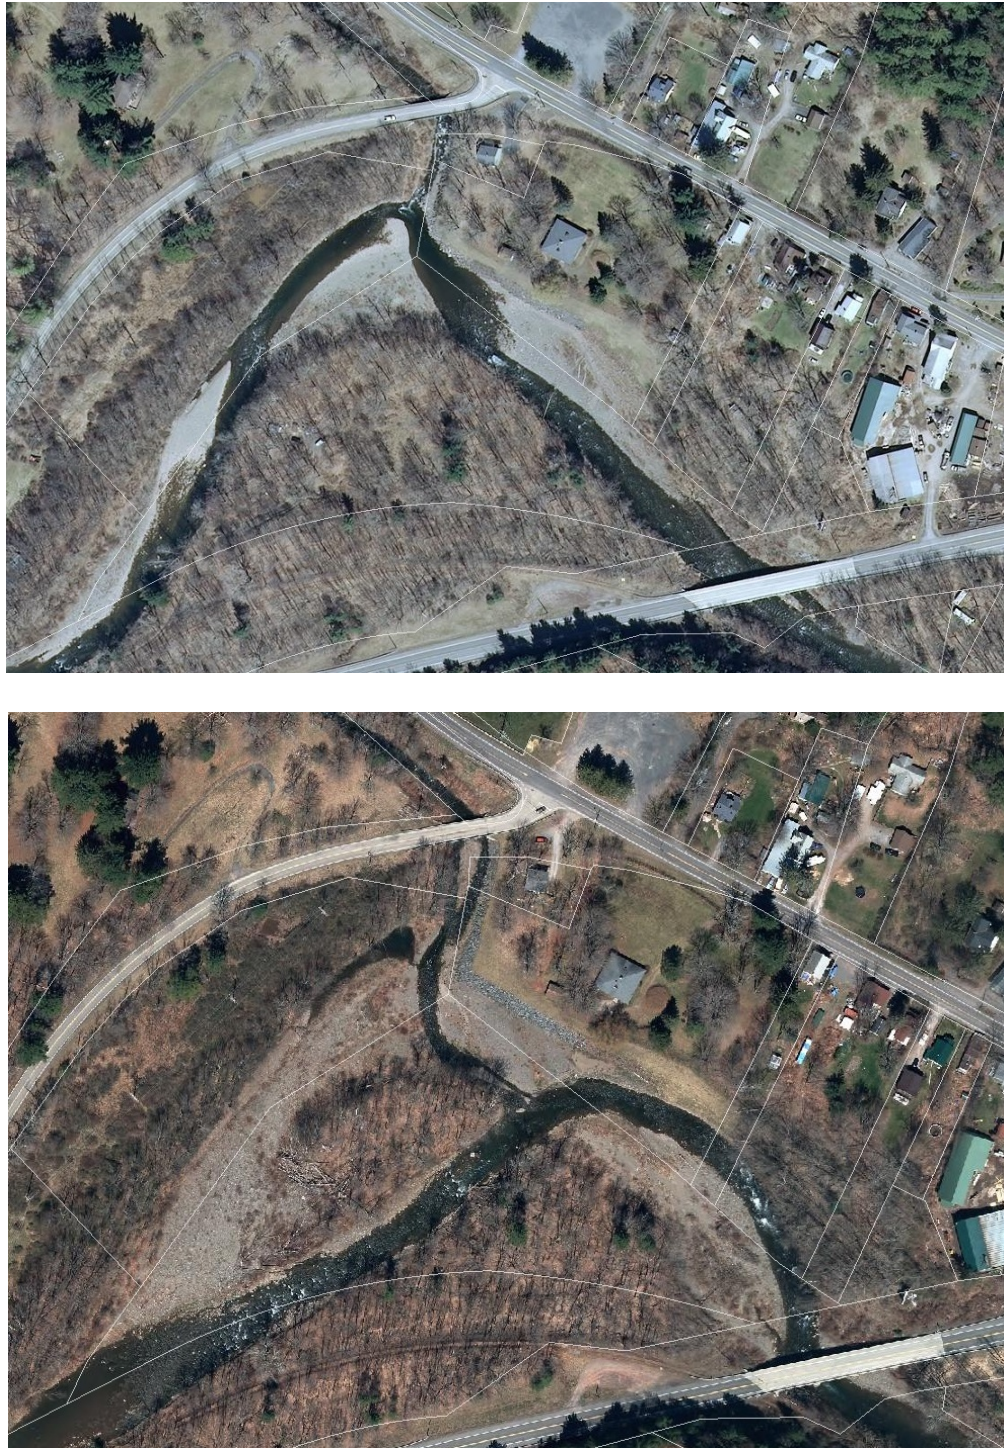
Tropical Storm Irene dramatically altered the stream channels at the Esopus Creek/Bushnellsville Creek confluence (Figure 5-1). The Esopus Creek avulsed toward the south, and as a result, the confluence moved approximately 240 feet downstream of its previous location. Although the survey form is dated October 11, 2011, the HEC-RAS model clearly uses pre-Irene channel geometry. This is clearly shown by the location of the main channel and the bank stations at cross section 78961 in the model relative to their current physical locations.

Figure 4-1
Aerial View of Esopus Creek/Bushnellville Creek Confluence in 2009 (top) and 2016 (bottom)

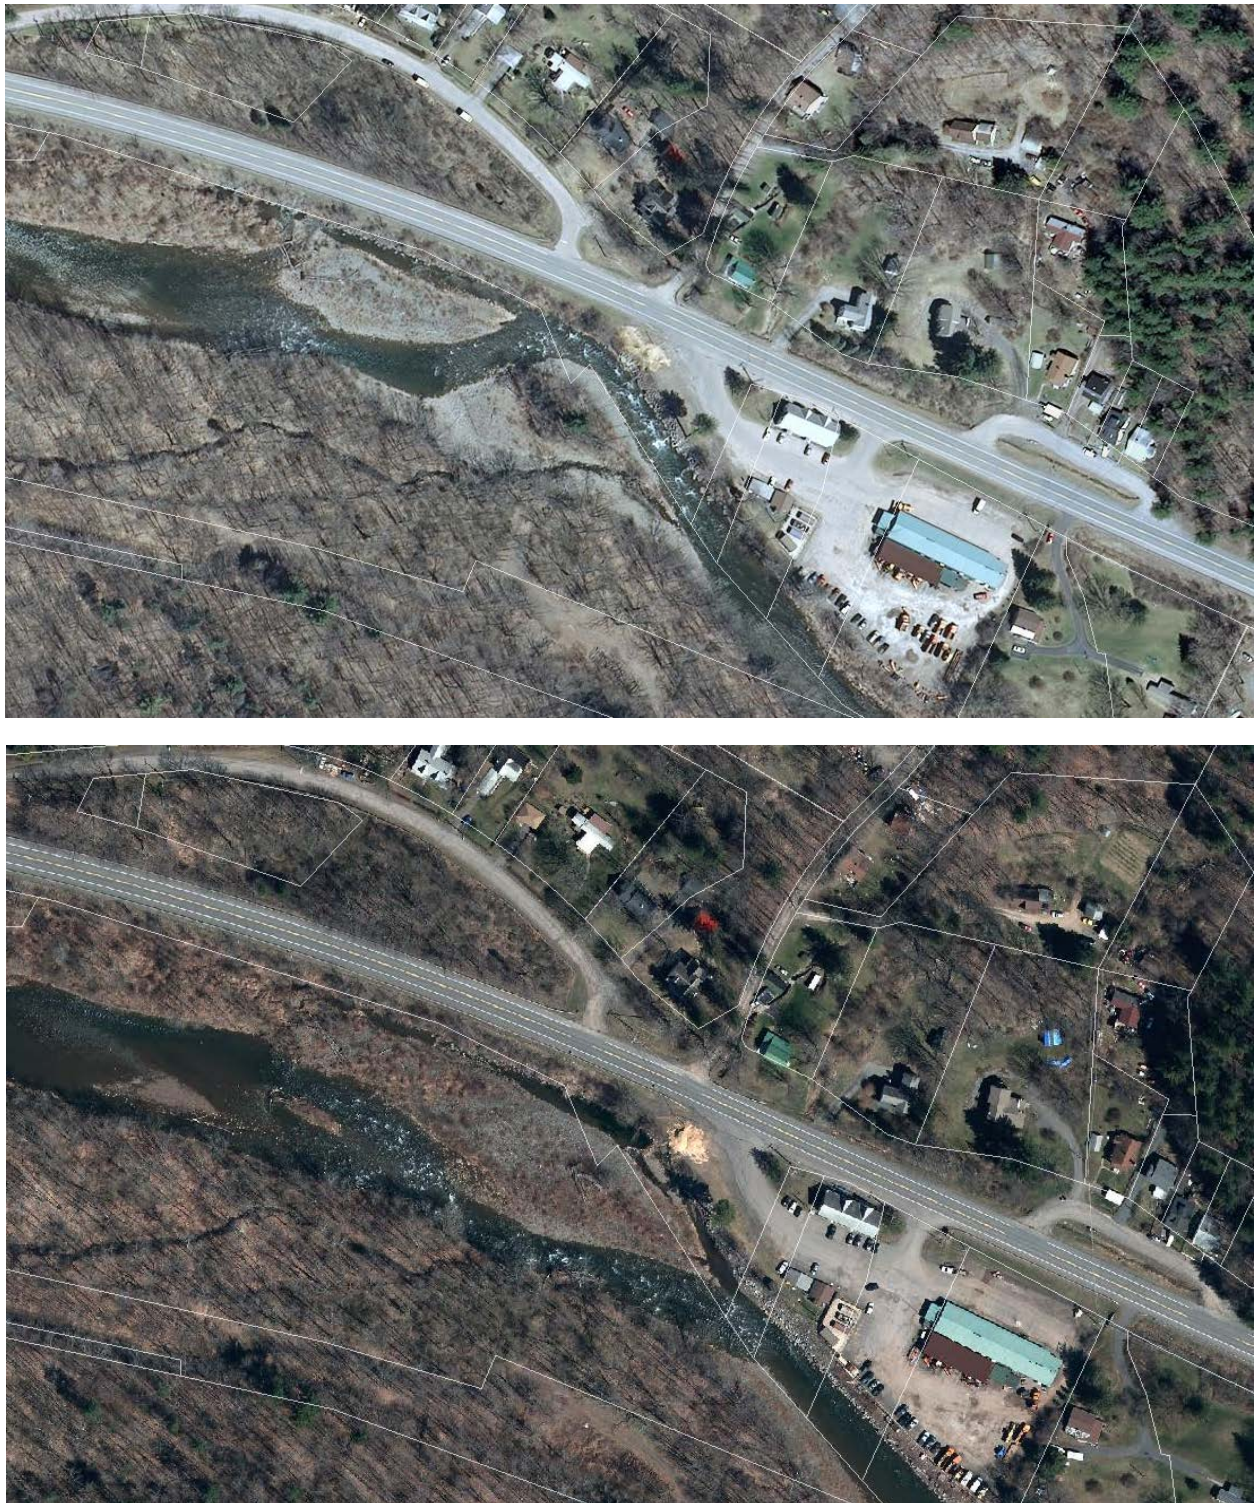
Figure 4-2

Aerial View of Esopus Creek near Shandaken Town Hall in 2009 (top) and 2016 (bottom)

Another key location where there appears to be a discrepancy between the date of the survey form and the channel geometry is cross section 70410, which is located immediately upstream of the town hall and Highway Department garage (Figure 4-2). Prior to Tropical Storm Irene, Esopus Creek ran along the

base of State Route 28. After Irene, the centerline of the channel shifted approximately 170 feet south, away from the road. The survey form is dated October 2011, which is post-Irene. However, the HEC-RAS cross section and bank stations indicated that the channel runs along State Route 28.

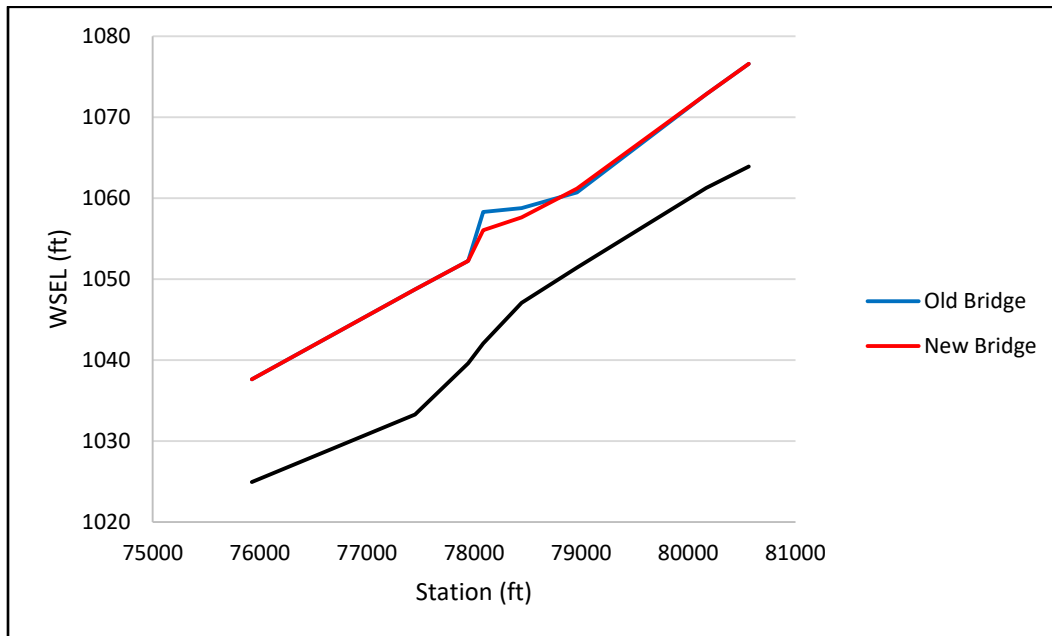
Figure 4-3
Water Surface Elevations at State Route 28 Bridge at 100-Year Discharge

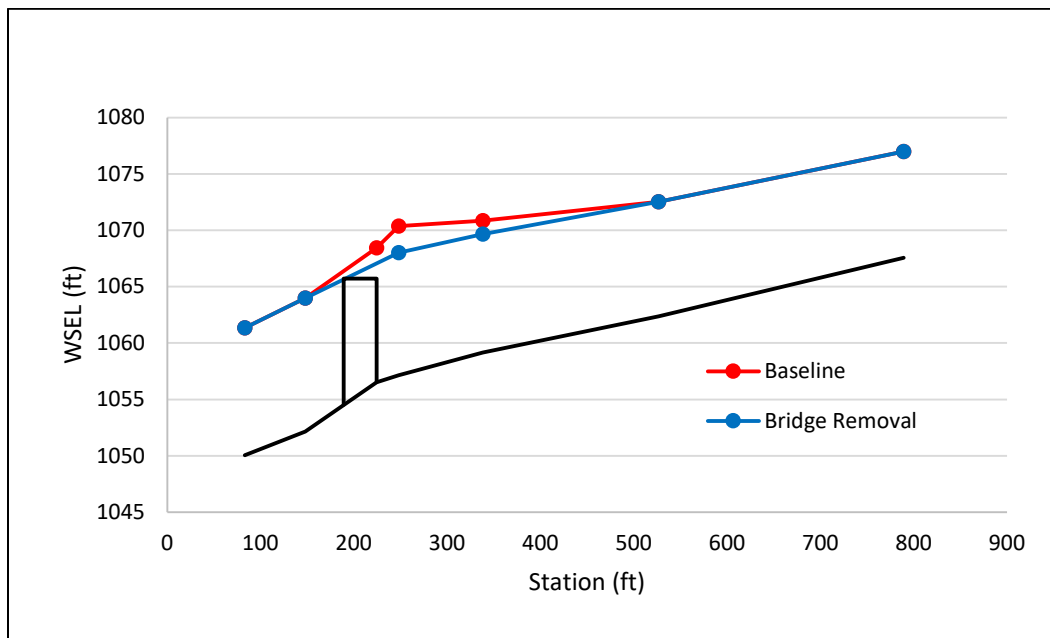
Figure 4-4
Change in Water Surface Elevations at Creekside Drive/County Route 47 Bridge over Bushnellsville Creek at 100-Year Discharge

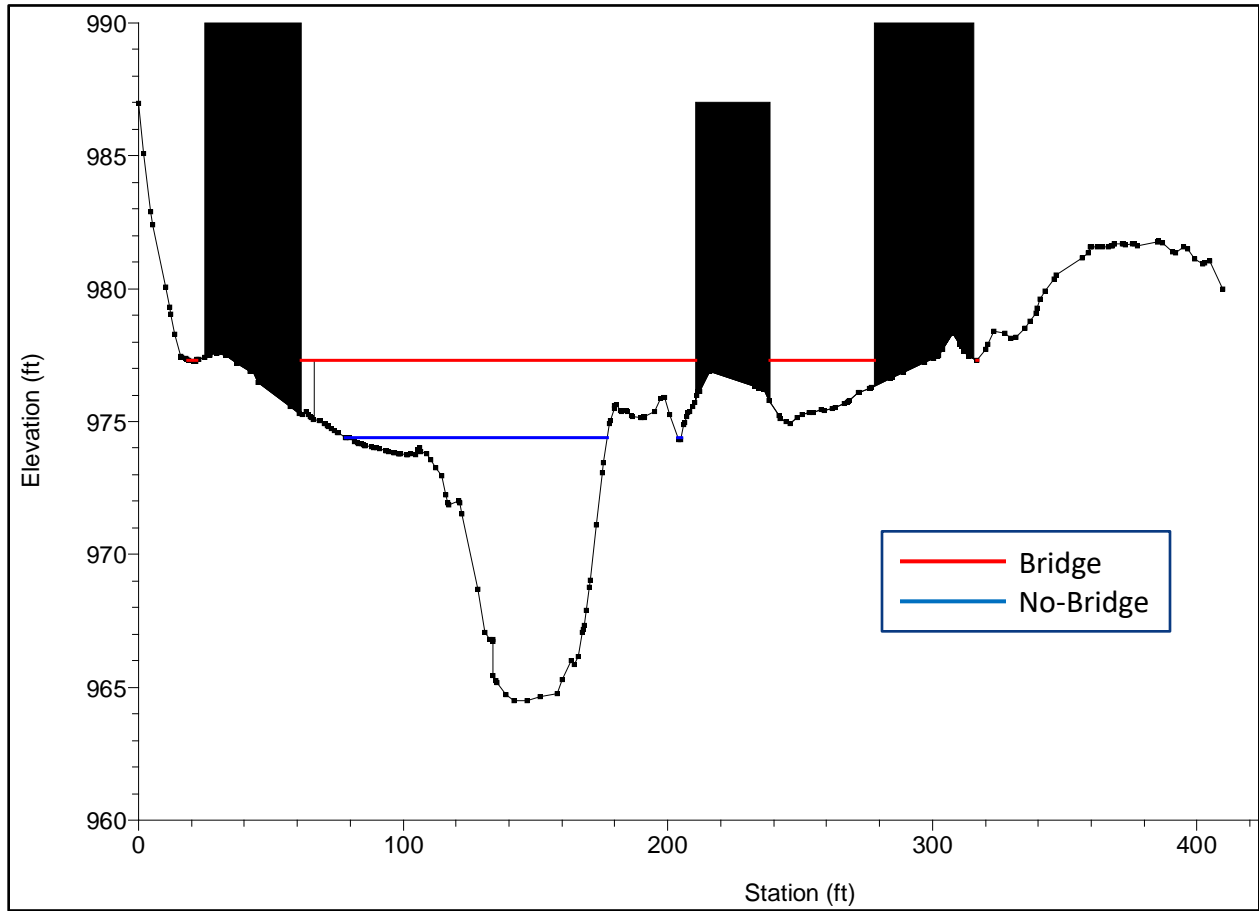
Figure 4-11
100-Year Discharge Water Surface Elevation Reductions at Cross Section 612.5810 Preventing Flooding of Structures along Broadstreet Hollow Creek

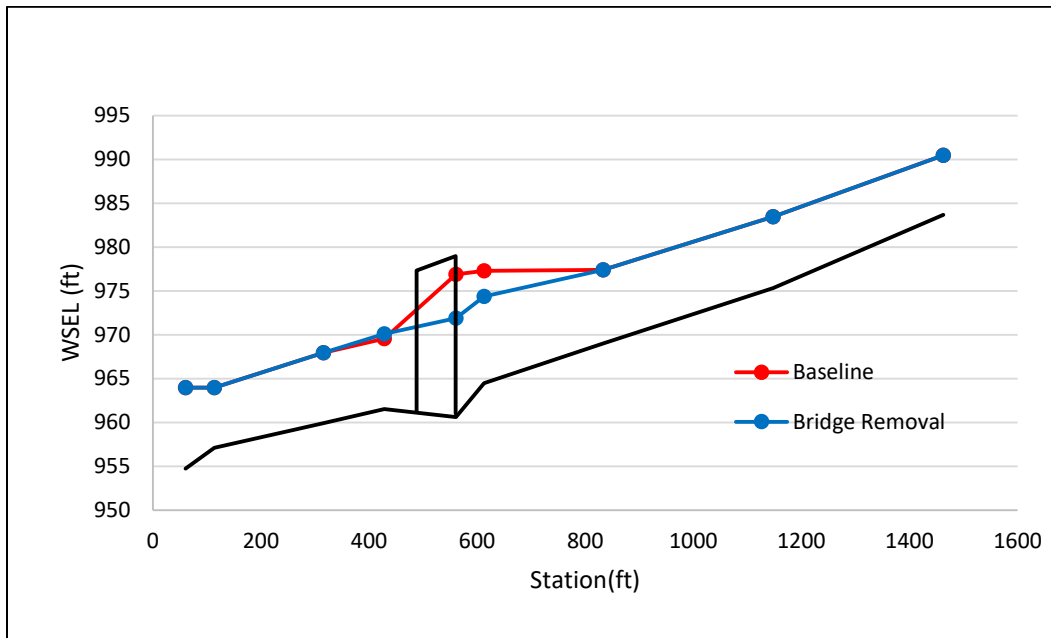
Figure 4-12
 Change in Water Surface Elevations at State Route 28 Bridge over Broadstreet Hollow Creek at 100-Year Discharge

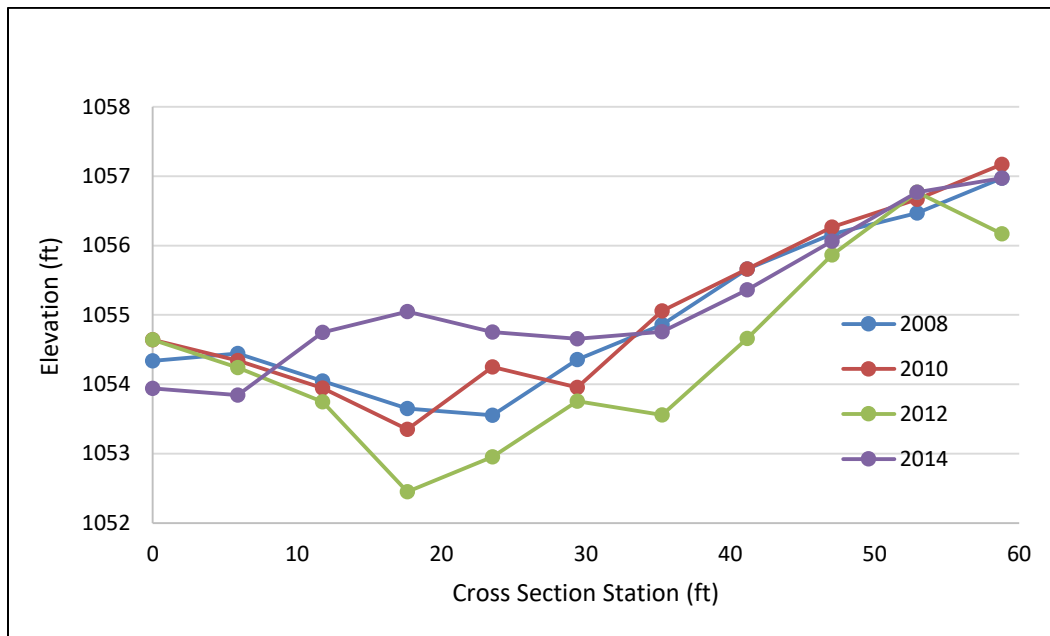
One of the comments heard during the first public meeting and from SAFARI members was that sediment had accumulated under the County Route 47 bridge, contributing to flooding upstream. To help assess aggradation under the bridge, the UCSWCD provided MMI with NYSDOT bridge inspection reports from 2010, 2012, and 2014. The reports describe the physical condition of the bridge, the roadway, and the channel of Bushnellville Creek under the bridge. They also contain channel cross-section measurements at the upstream and downstream openings (Figures 4-14 and 4-15) as well as photos of the bridge and channel. The 2010 report contains additional channel measurements from the 2008 inspection.

Figure 4-14
NYSDOT Upstream Bridge Opening Measurements 2008-2014

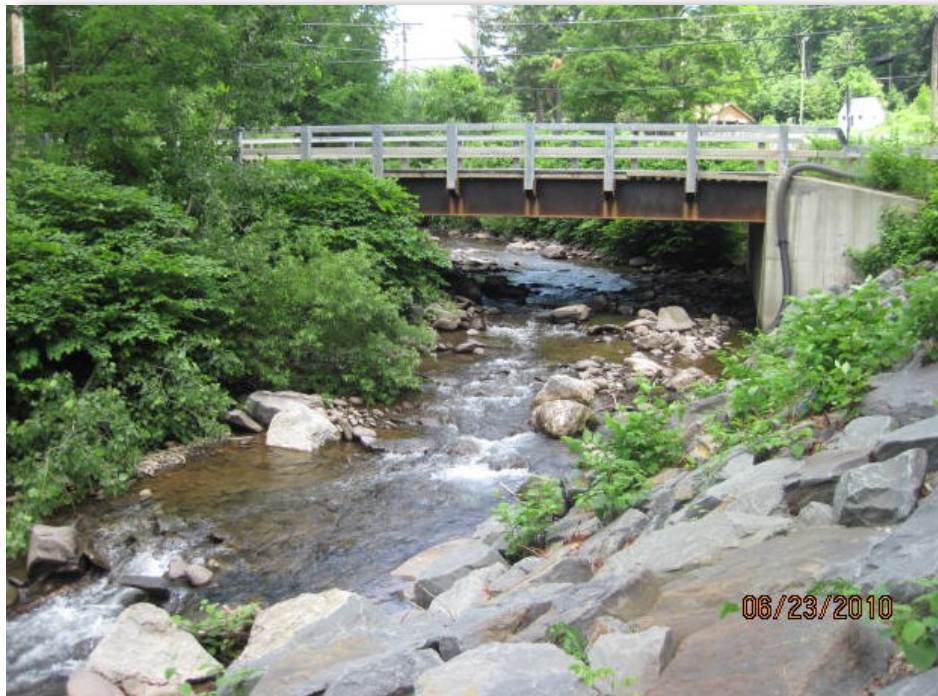
Figure 4-16

2010 Photo of Bushnellsville Creek Downstream of the Creekside Drive Bridge (NYSDOT)

The 2014 report describes significant changes in the Bushnellsville Creek channel. None of the woody debris identified in the previous report was noted. However, a large gravel bar had formed under the bridge and extended about 100 feet downstream (Figures 4-16 and 4-17). This gravel bar was noted by MMI in 2017.

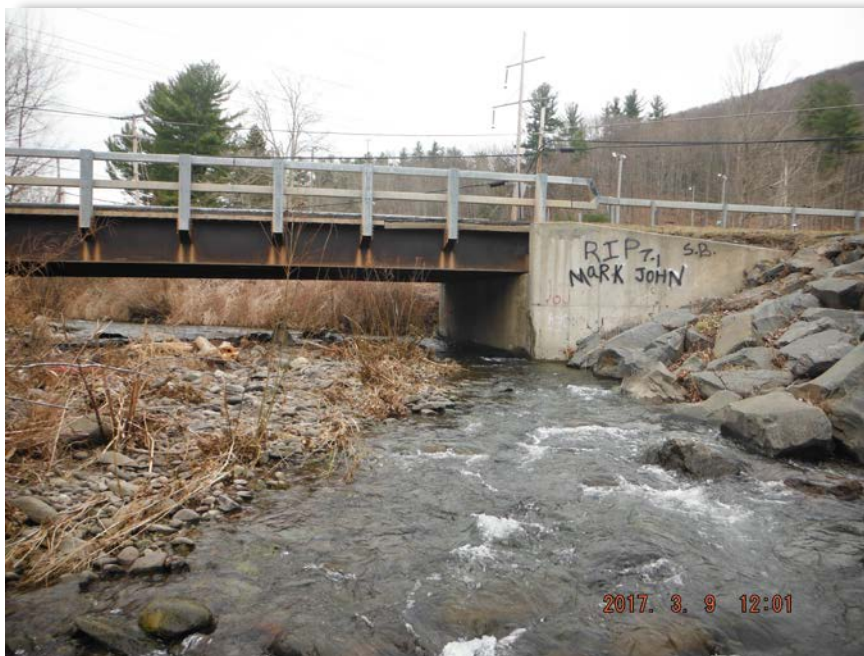
Figure 4-17

2017 Photo of Bushnellsville Creek Downstream of the Creekside Drive Bridge (MMI)

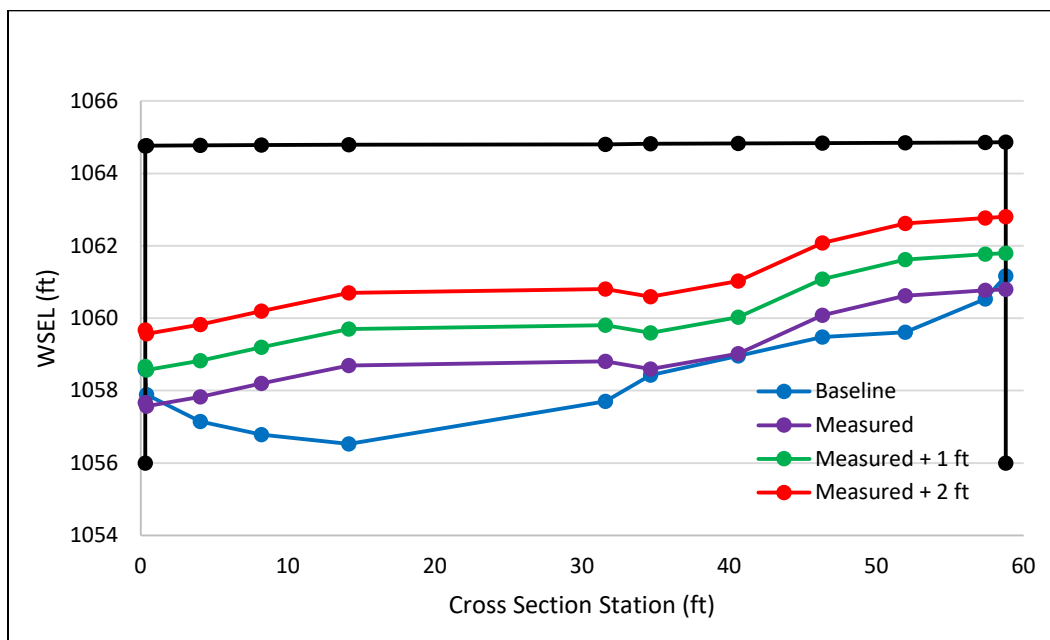
The new channel elevations at the bridge were modeled in HEC-RAS to assess the effect of water surface elevations in the region of the bridge. Additionally, 1- and 2-foot increases above the measured elevations in the channel were modeled to simulate sediment aggradation as well as bridge blockage due to debris (Figures 4-18 and 4-19).

Figure 4-18
 Creekside Drive Bridge Opening Conditions Simulated in HEC-RAS

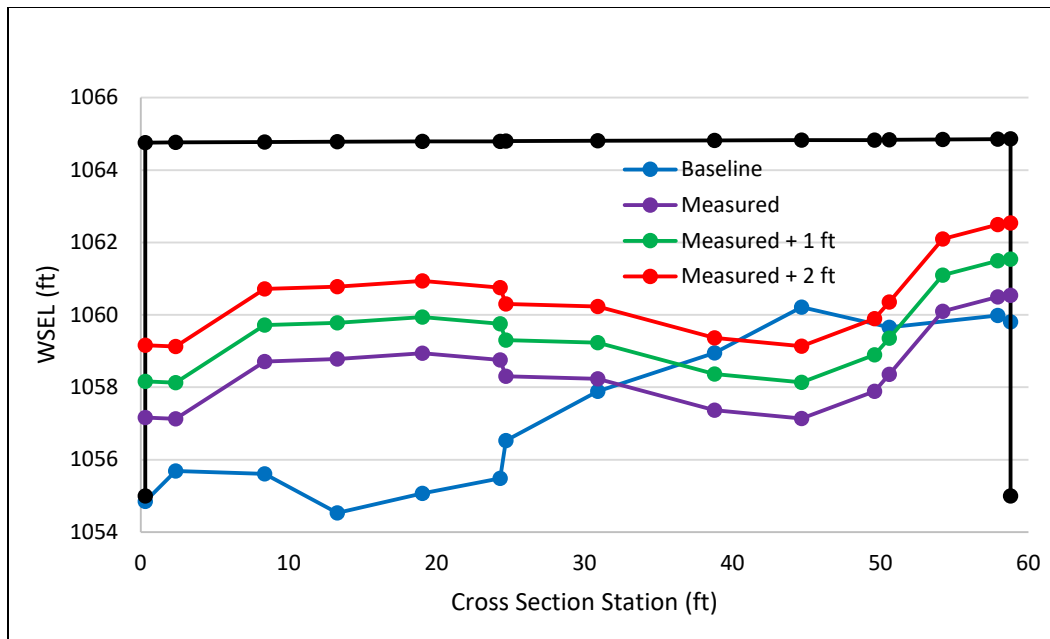
Figure 4-19
Creekside Drive Bridge Exit Conditions Simulated in HEC-RAS

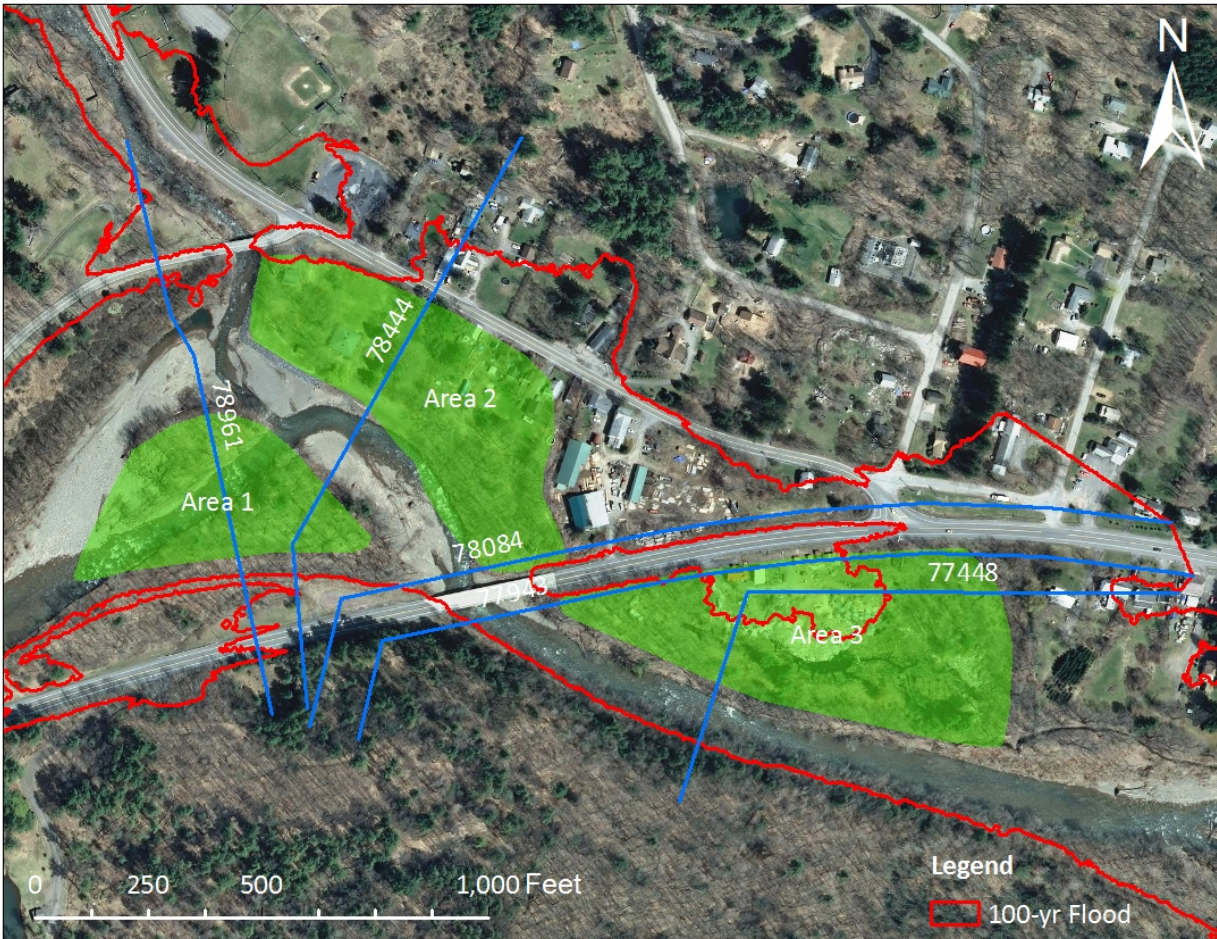
- Scenario 1: Removal of gravel bars and enhancement of the floodplain on the right bank upstream of the State Route 28 bridge (Area 1)
- Scenario 2: Removal of the levee on the left bank between Bushnellsville and Esopus Creeks (Area 2)
- Scenario 3: Enhancement of floodplain on the left bank downstream of the State Route 28 bridge (Area 3)
- Scenario 4: This is a combination of Scenarios 1 and 2 (Areas 1 and 2).
- Scenario 5: This is a combination of Scenarios 1, 2, and 3 (Areas 1, 2, and 3).

Figure 4-24
Areas of Floodplain Enhancement at the Confluence of Esopus and Bushnellville Creeks

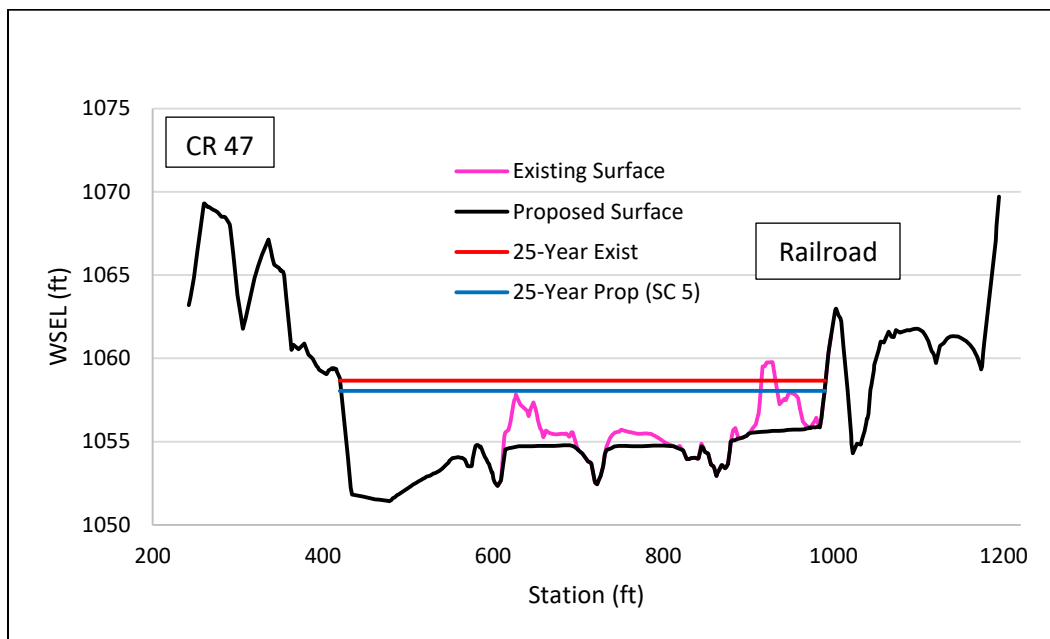
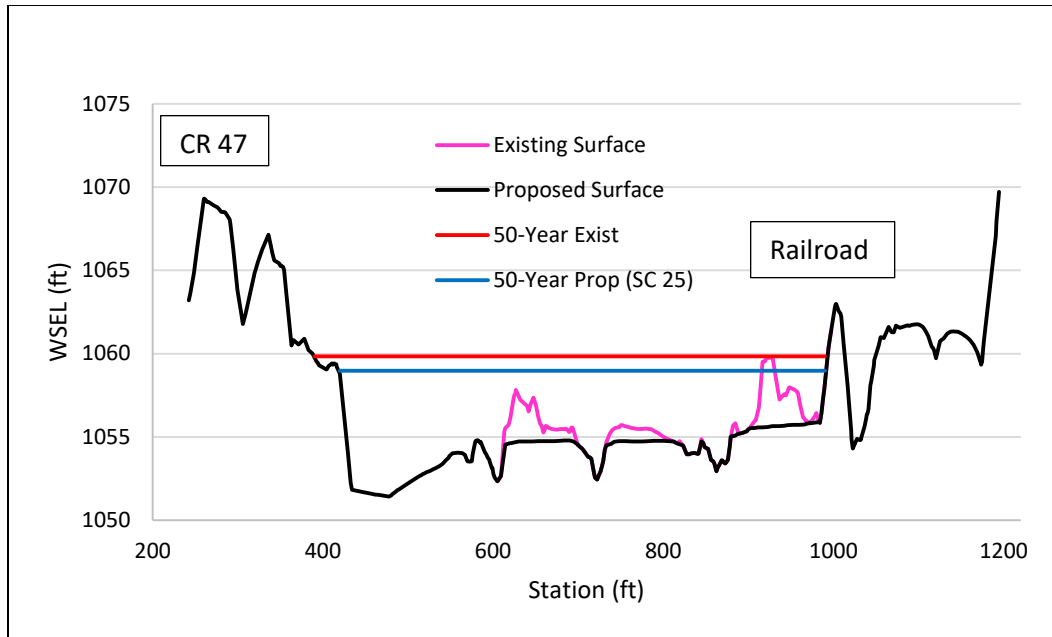
The figures illustrate that the largest flows do not inundate County Route 47 and do not overtop the railroad trestle on the right bank of the stream. As no houses are located in the vicinity of this cross section, there are no flood mitigation benefits at this particular location.

Figure 4-25
XS 78961 Floodplain Enhancement: 25-Year Discharge

Figure 4-26
XS 78961 Floodplain Enhancement: 50-Year Discharge

Figure 4-27
XS 78961 Floodplain Enhancement: 100-Year Discharge
