Local Flood Analysis

Hamlets of Shandaken and Allaben

Ulster County, New York

February 2018

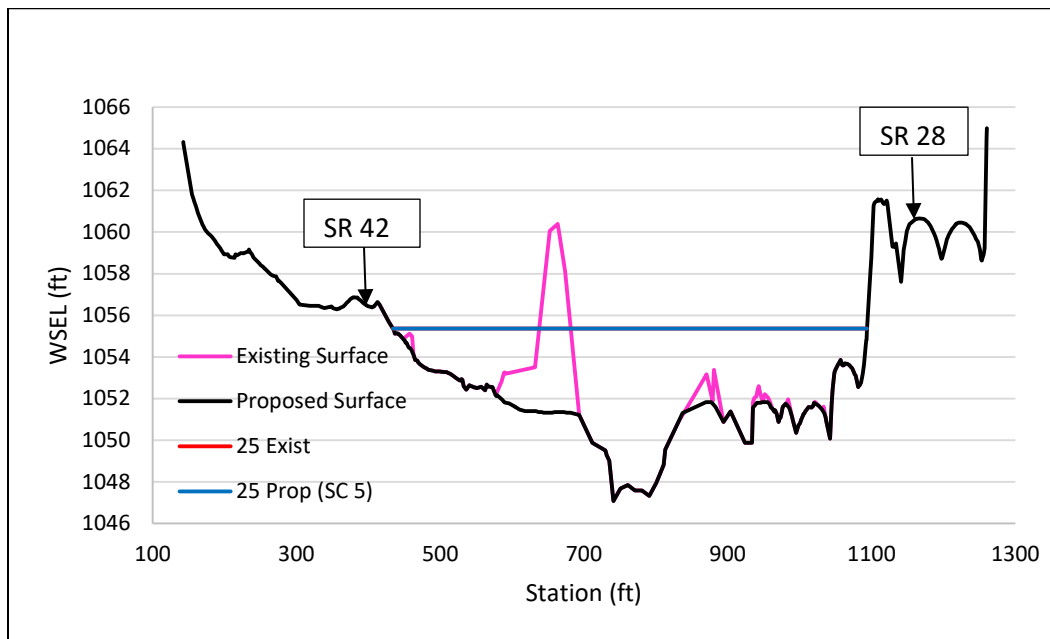
Figure 4-28
XS 78444 Floodplain Enhancement: 25-Year Discharge

Figure 4-29
XS 78444 Floodplain Enhancement: 50-Year Discharge

Figure 4-30
XS 78444 Floodplain Enhancement: 100-Year Discharge

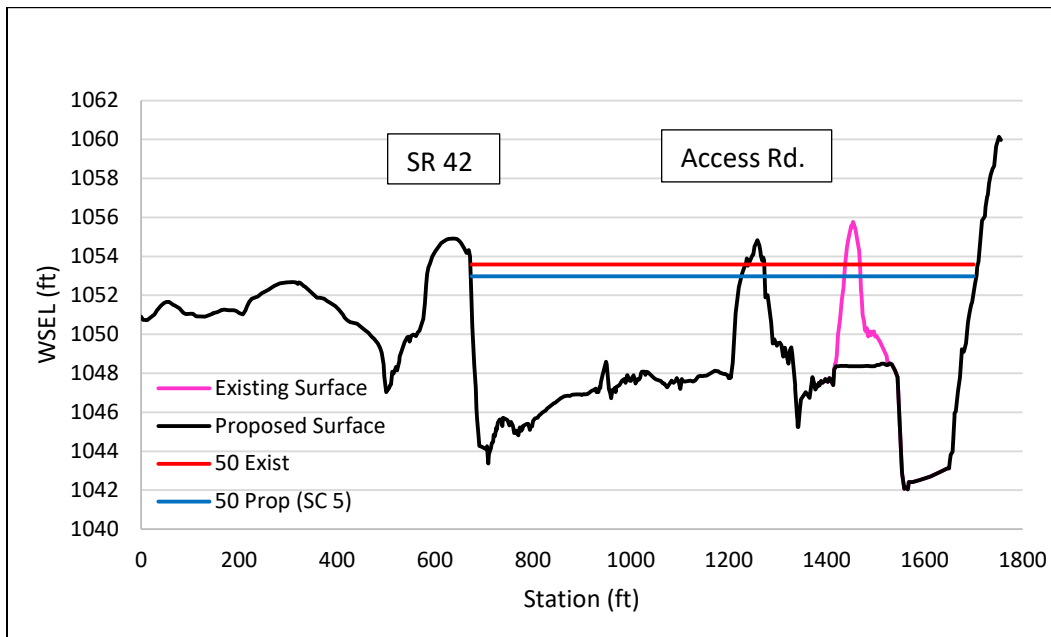
Figure 4-31
XS 78084 Floodplain Enhancement: 25-Year Discharge

Figure 4-32
XS 78084 Floodplain Enhancement: 50-Year Discharge

Figure 4-33
XS 78084 Floodplain Enhancement: 100-Year Discharge

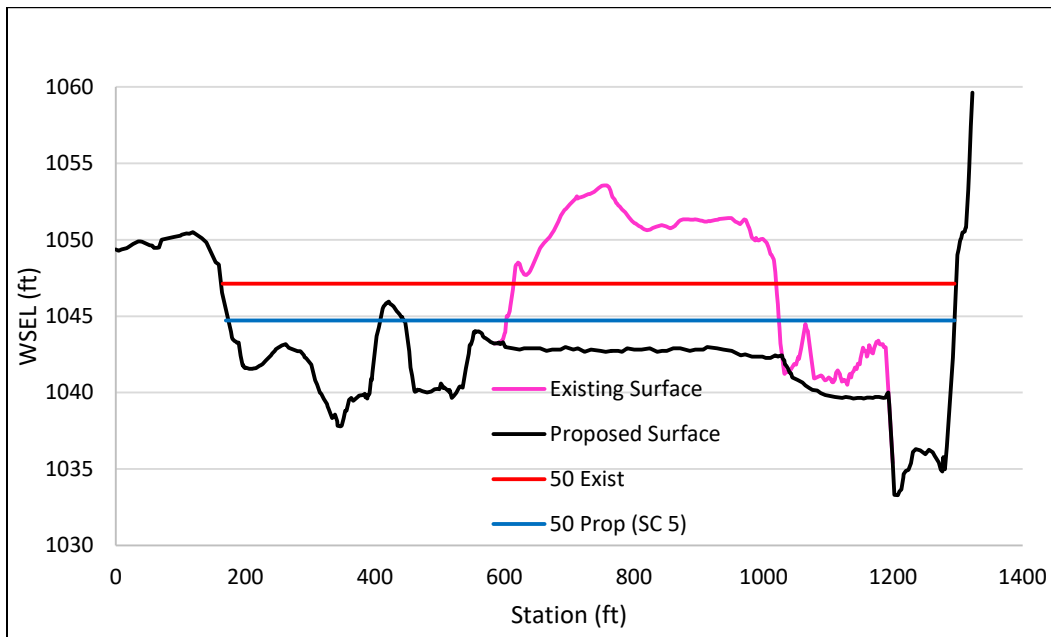
Figure 4-34
XS 77448 Floodplain Enhancement: 25-Year Discharge

Figure 4-35
XS 77448 Floodplain Enhancement: 50-Year Discharge

Figure 4-36
XS 77448 Floodplain Enhancement: 100-Year Discharge

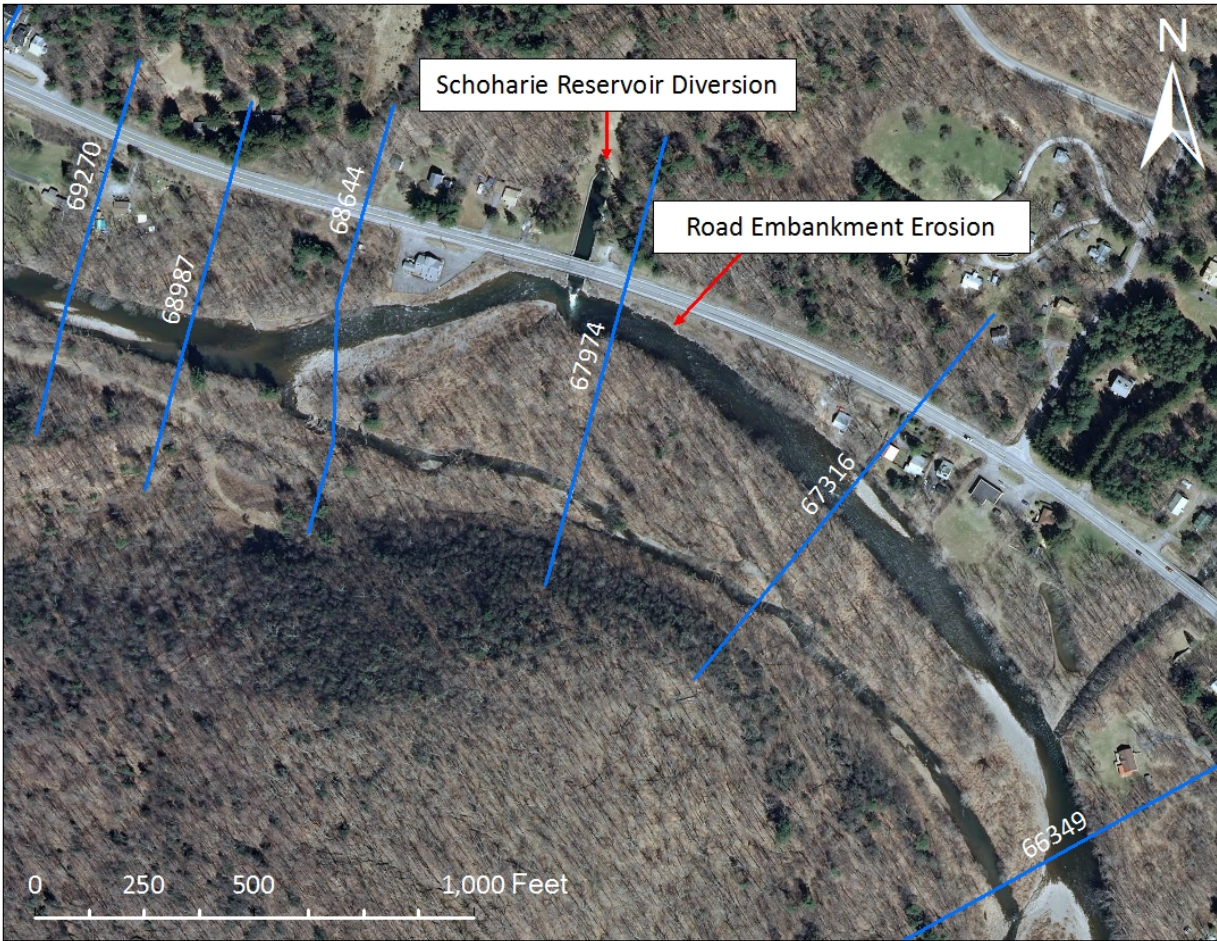
Figure 4-37
Pre-Irene Channel Conditions in the Vicinity of the Shandaken Tunnel

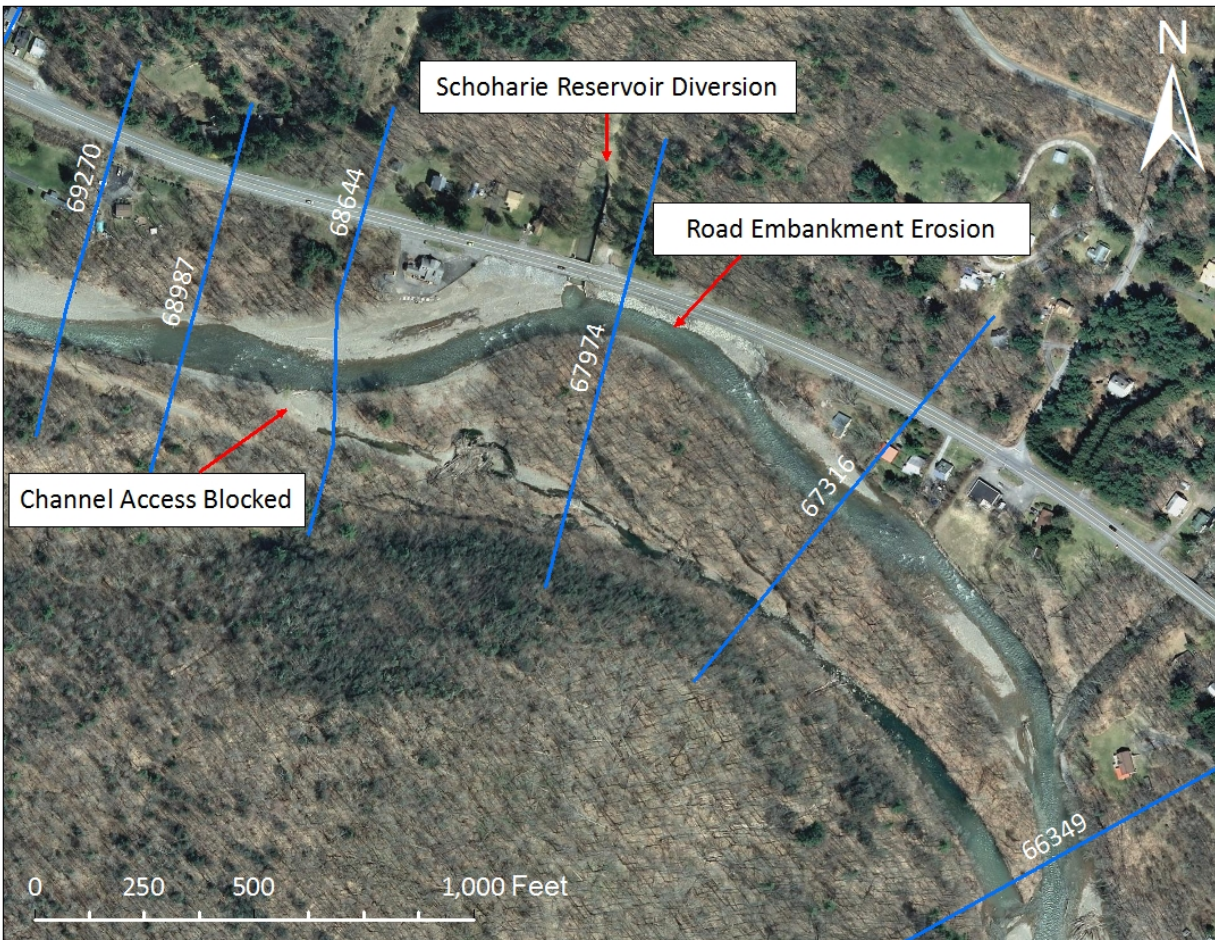
Figure 4-38
Post-Irene Channel Conditions in the Vicinity of the Shandaken Tunnel
