# **Local Flood Analysis**

**Village of Hunter**

**Town of Hunter**

**October 2018**

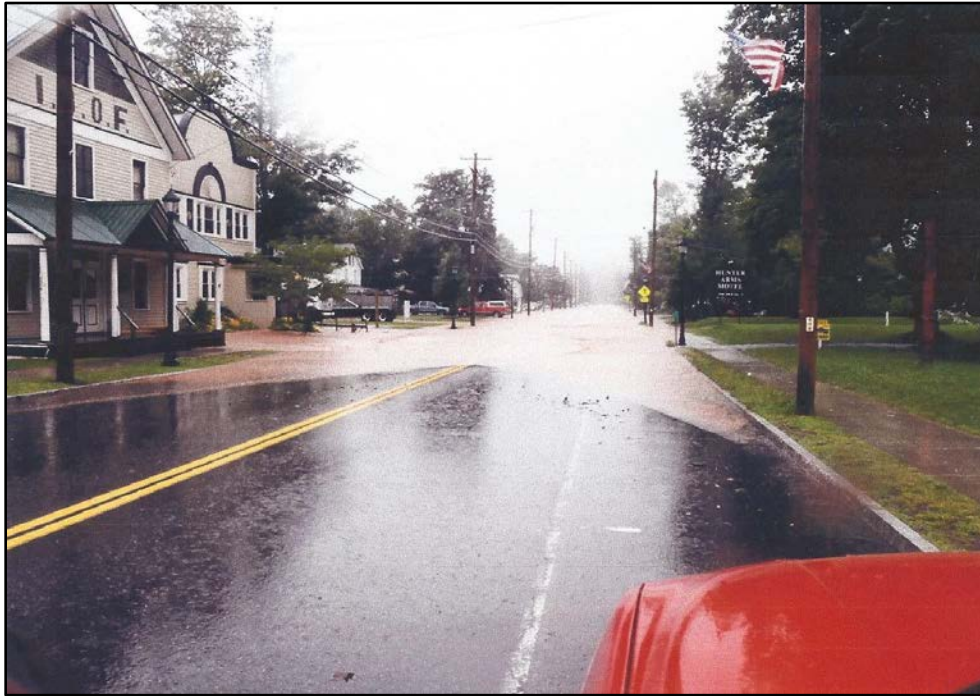
**Figure 3-3**  
**Floodwaters across Main Street near Mason Hall in Hunter**  
**Tropical Storm Irene, August 28, 2011**

Water flooded onto Main Street reportedly due to excessive flows in Schoharie Creek combined with high flows on the smaller tributaries. Figures 3-3 through 3-7 depict conditions in Hunter during Tropical Storm Irene.

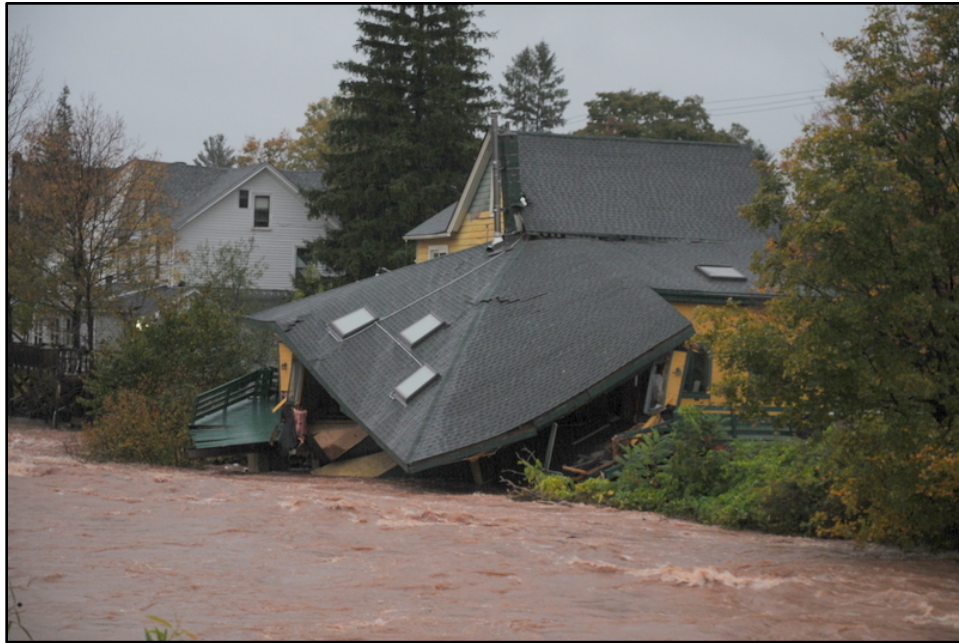
**Figure 3-6**  
**Home along Schoharie Creek Damaged by Flooding and Bank Erosion**  
**Tropical Storm Irene, August 28, 2011**

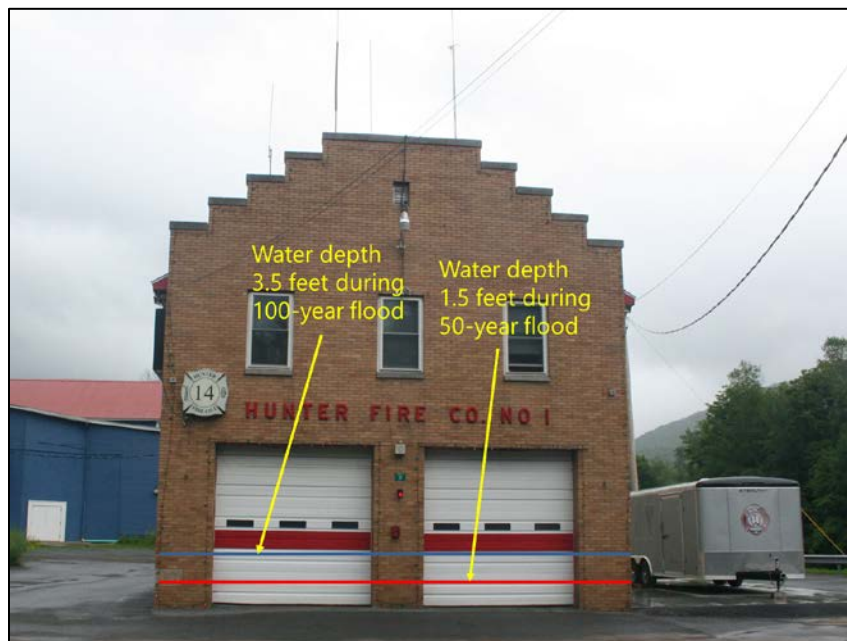
Figure 4-1  
50- and 100-Year Flooding Depths  
Hunter Fire Station on Bridge Street

The hydraulic model for Schoharie Creek was used to predict water surface elevations at several buildings within the LFA area, including those that have been identified as critical facilities or anchor businesses. These elevations were then converted to flooding depths, which were superimposed as lines onto photos of the buildings (Figures 4-1 through 4-5). When the 50-year flooding depth is not shown, this indicates that the building is not flooded during the 50-year flood event.

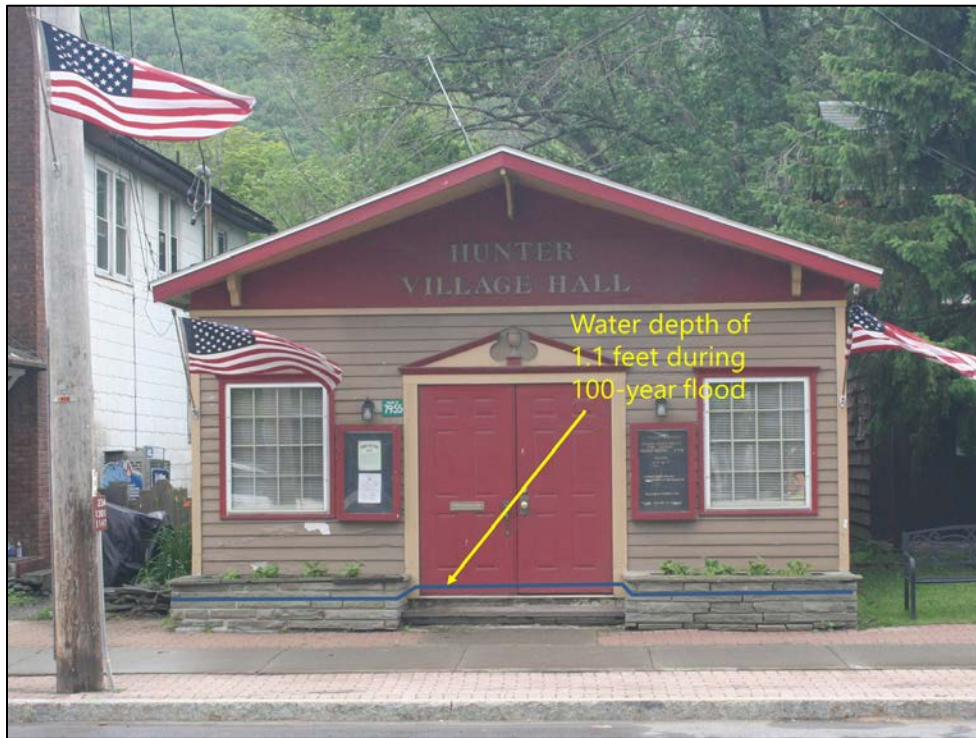
**Figure 4-2**  
**100-Year Flooding Depth**  
**Hunter Village Hall on Main Street**

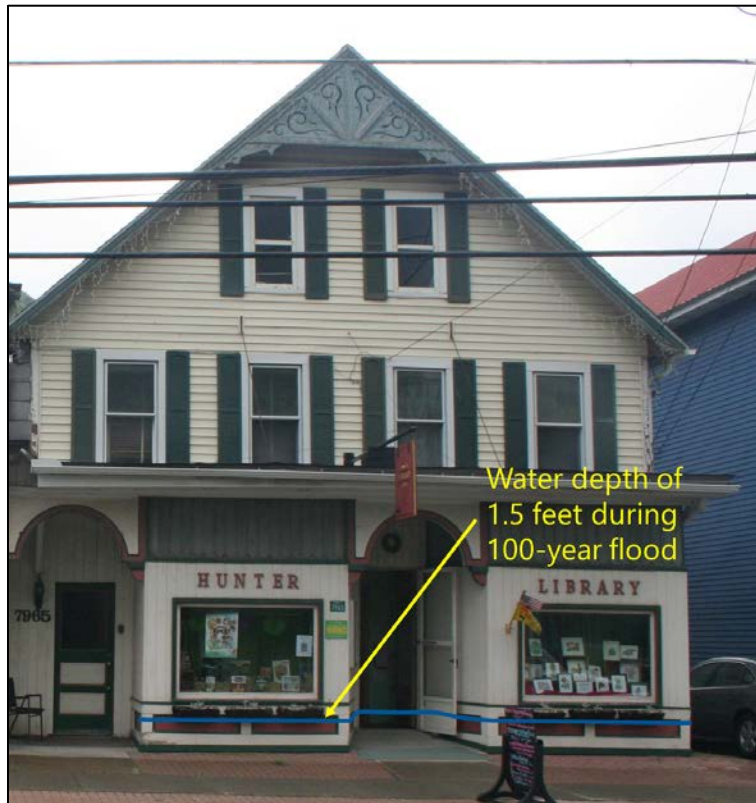
**Figure 4-4**  
**100-Year Flooding Depth**  
**Hunter Library on Main Street**

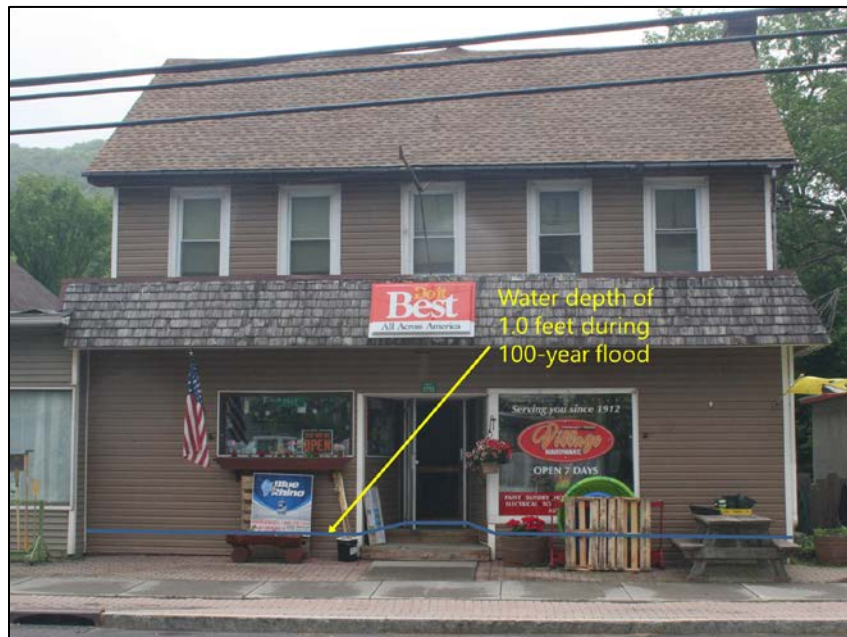
**Figure 4-5**  
**100-Year Flooding Depth**  
**Hardware Store on Main Street**

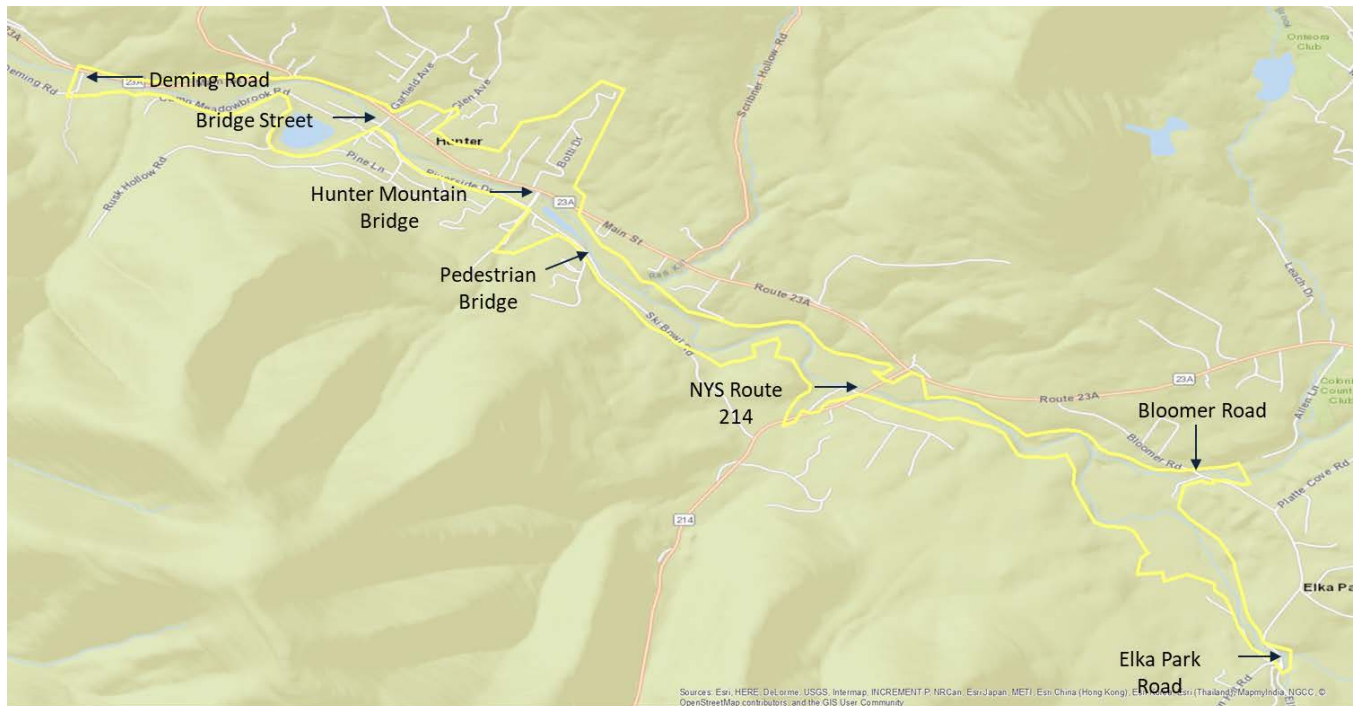
**Figure 4-6**  
**Bridges Assessed in Hunter LFA**

Six bridges on Schoharie Creek and one bridge on Gooseberry Creek were evaluated, and the modeling results for each bridge are discussed in the sections that follow. The bridge locations are shown in Figure 4-6.

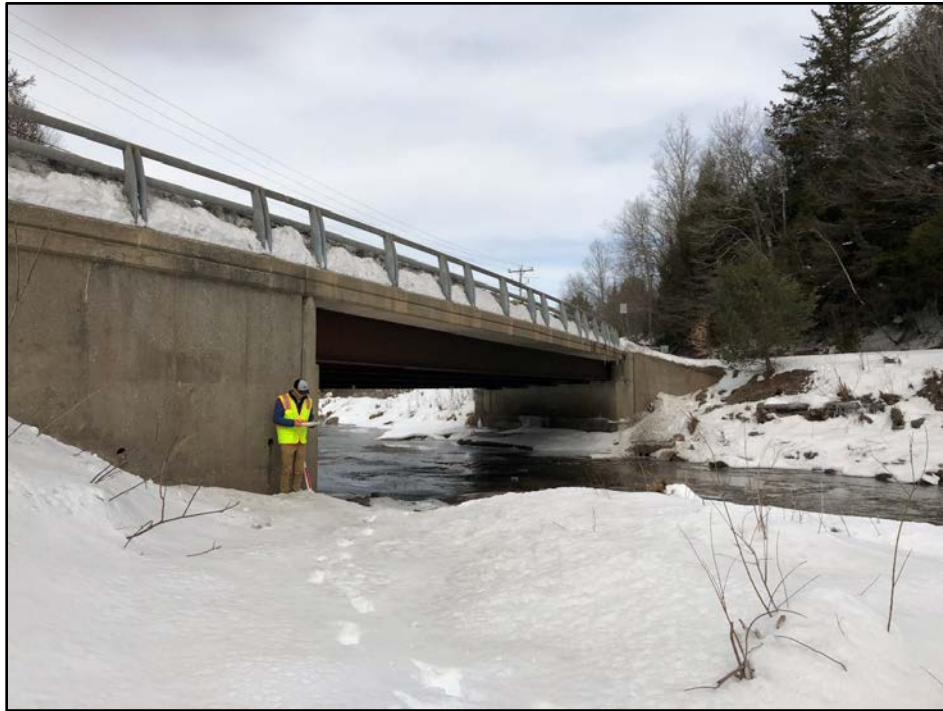
**Figure 4-7**  
**Elka Park Road Bridge over Schoharie Creek**

When the Elka Park Road bridge is due for a regularly scheduled replacement, the new bridge should be adequately sized so that the 100-year flood can safely pass without overtopping the bridge or the adjacent roadway. If the dam located downstream of the bridge is no longer providing a useful service, its removal should be considered. Recommendations are discussed in Section 6.

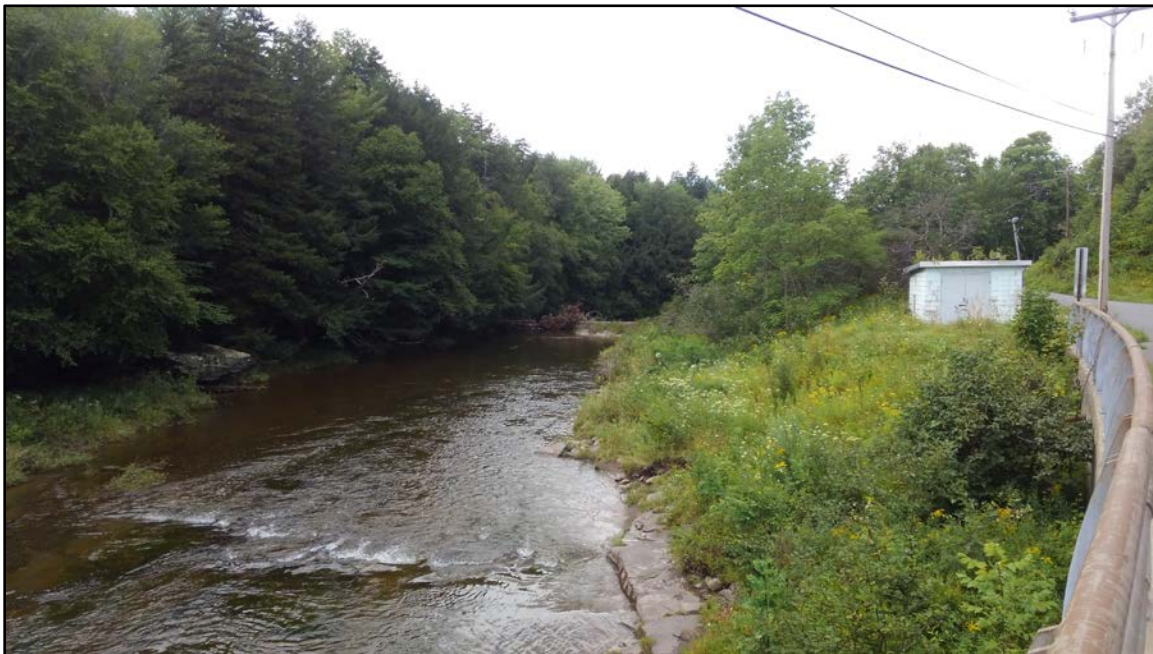
**Figure 4-8**  
**Dam Located Downstream of Elka Park Road Bridge**

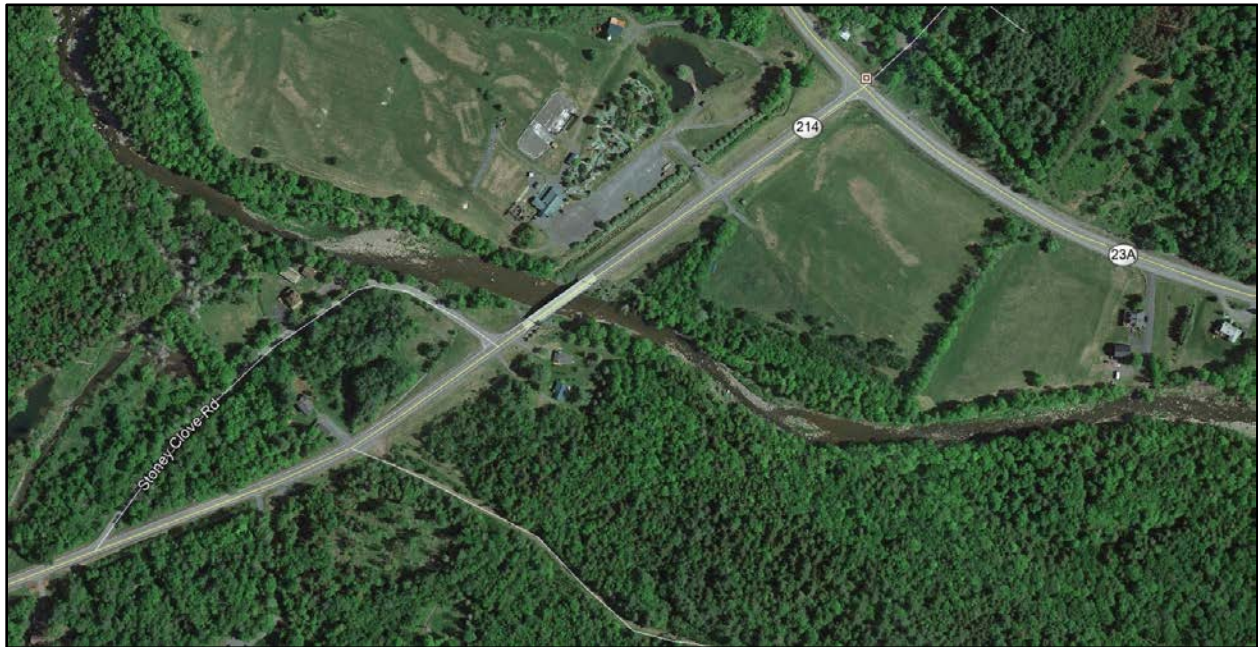
**Figure 4-9**  
**NYS Route 214 Bridge over Schoharie Creek**

NYS Route 214 (Figure 4-9) connects the Hunter/Tannersville area to Route 28 in Phoenicia. No reports of flooding or roadway overtopping have been received for the Route 214 bridge over Schoharie Creek, and it was reported that this bridge remained open during Tropical Storm Irene. Hydraulic modeling indicates that the bridge is able to pass the 100-year flood event with nearly 2 feet of freeboard and does not act as a hydraulic constriction.

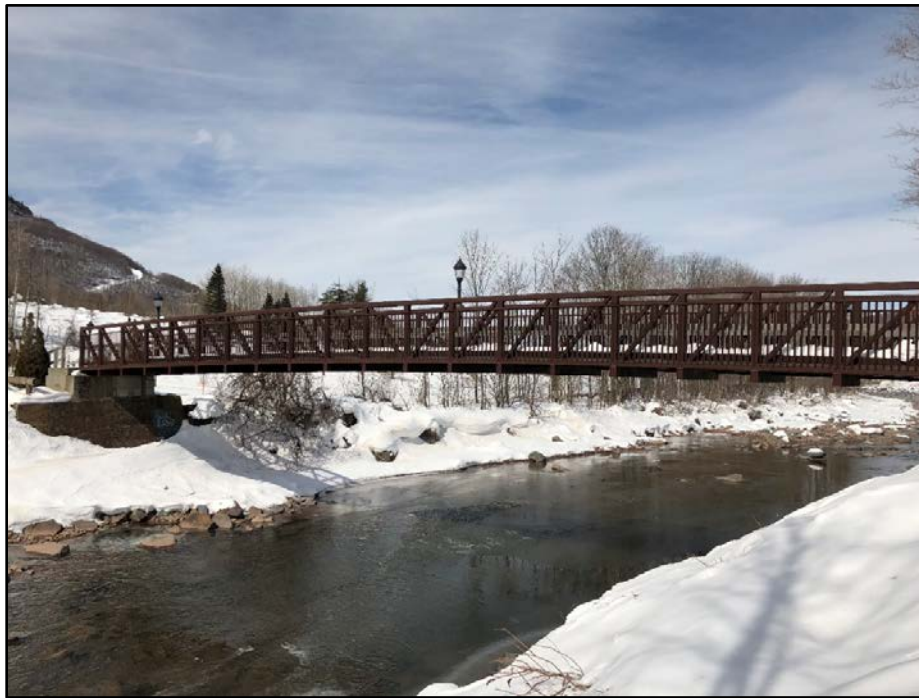
**Figure 4-10**  
**Pedestrian Bridge over Schoharie Creek**

A pedestrian bridge crosses Schoharie Creek just upstream of the village of Hunter (Figure 4-10). No reports of flooding or overtopping were received for this bridge. Hydraulic modeling indicates that the bridge can pass the 50-year flood event but is overtopped by floodwaters during the 100-year flood. Also, the bridge acts as a hydraulic constriction during the 100-year flood event. Removal of the bridge from the hydraulic model results in a 6-foot reduction in water surface elevations at the upstream face of the bridge. This reduction diminishes moving upstream of the bridge, resulting in a reduction of 1 foot at a point 480 feet upstream of the bridge and a negligible reduction at a point 1,000 feet upstream of the bridge (Figure 4-11). Inundation mapping depicts the depth and extent of flooding during the 100-year flood event with and without the pedestrian bridge in place (Figures 4-12 and 4-13).

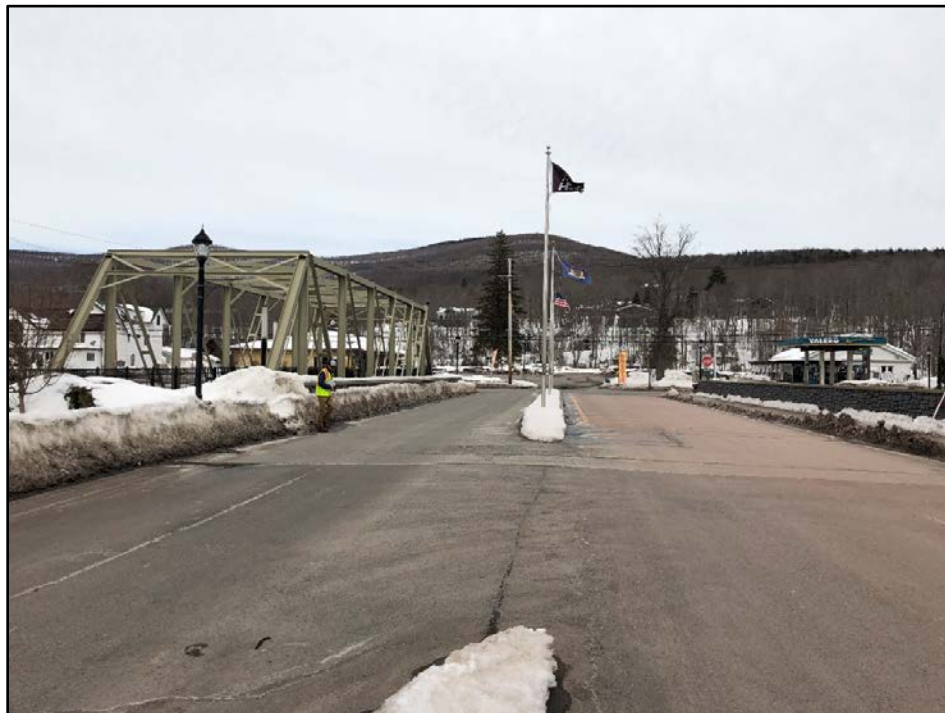
**Figure 4-14**  
**Hunter Mountain Bridge over Schoharie Creek**  
**(original truss bridge to left, traffic bridge in center)**

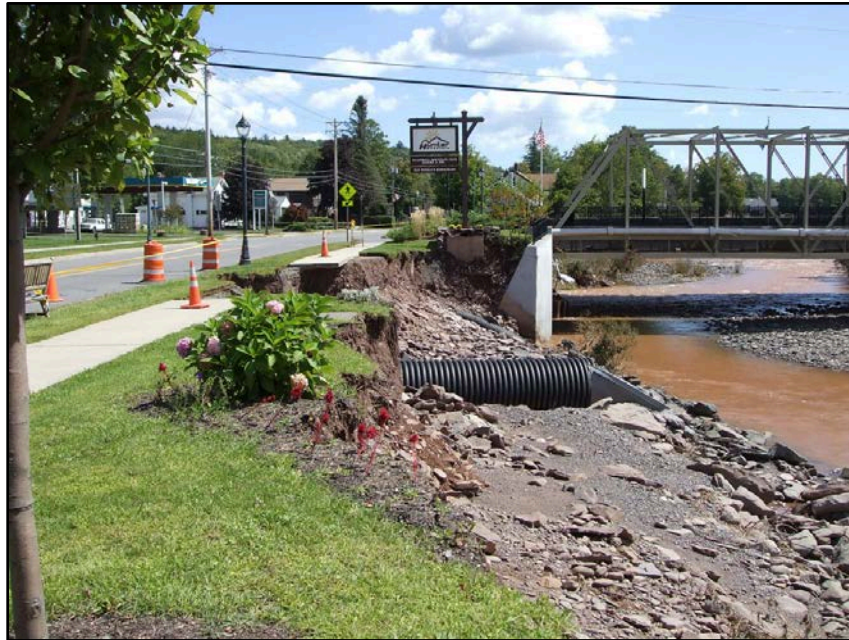
**Figure 4-15**  
**Hunter Mountain Bridge over Schoharie Creek**  
**Evidence of Erosion following Tropical Storm Irene**

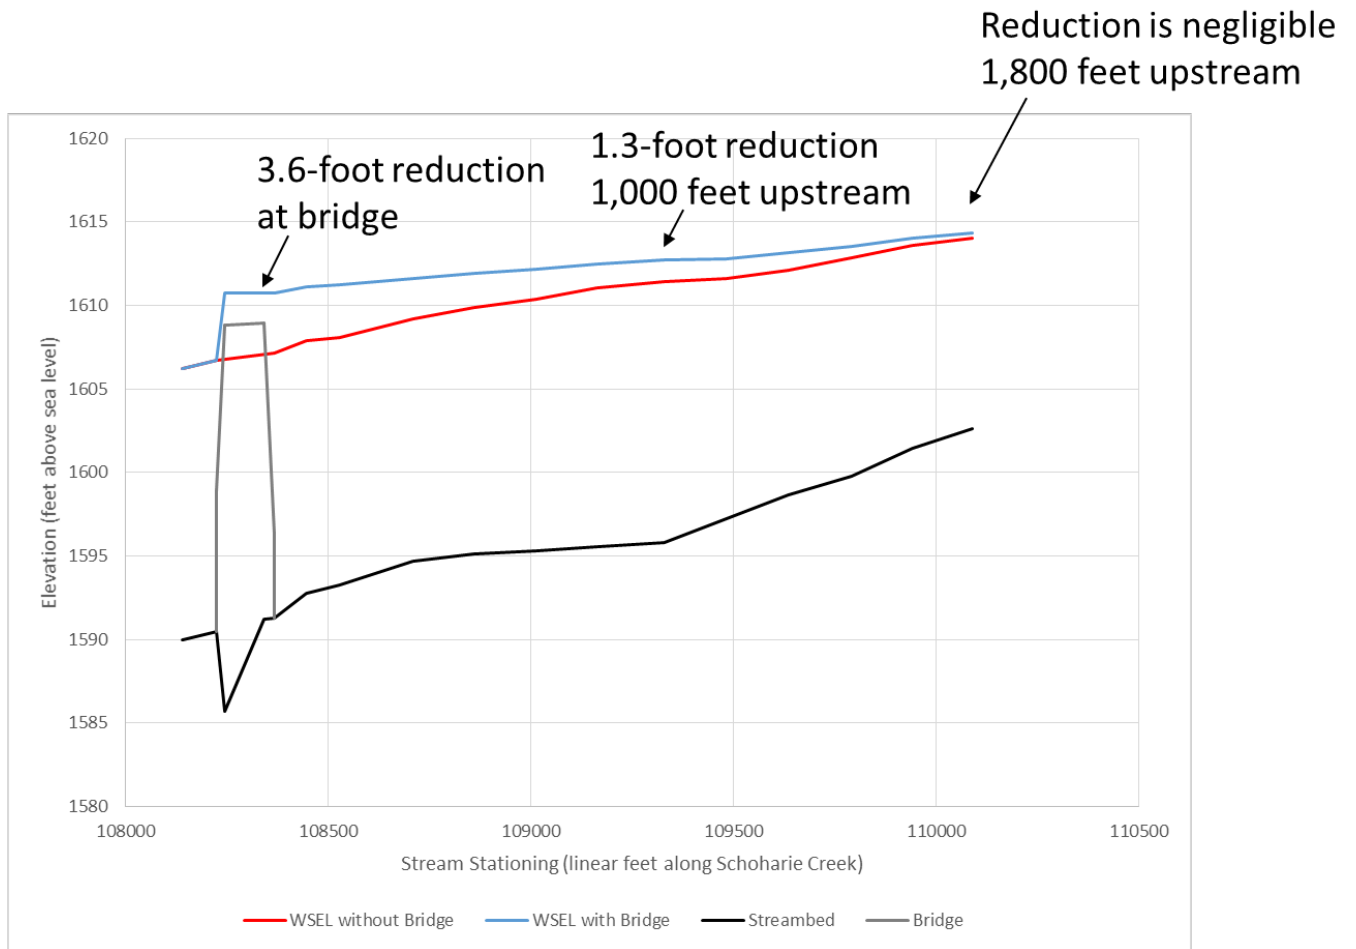
**Figure 4-16**  
**Longitudinal Profile – 50-Year Flood**  
**Hunter Mountain Bridge over Schoharie Creek**

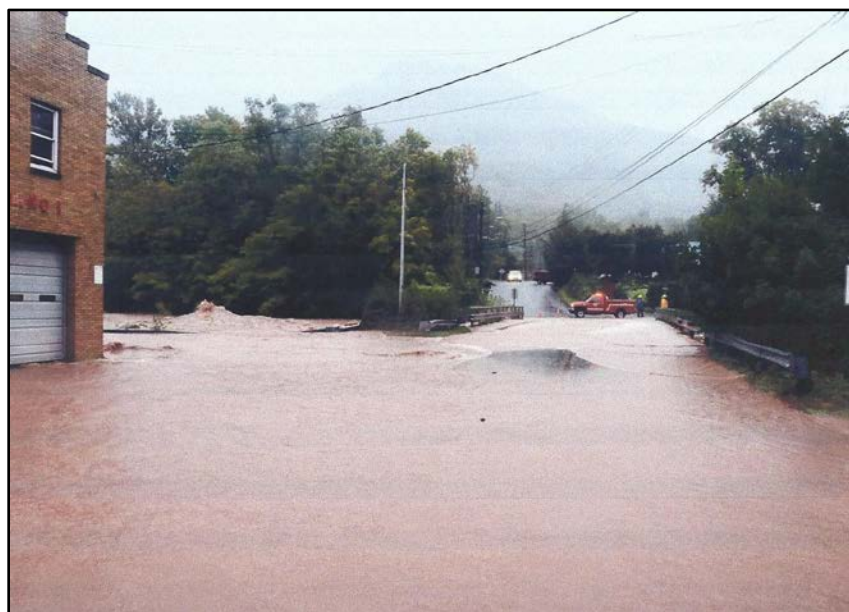
**Figure 4-22**  
**Bridge Street over Schoharie Creek during Tropical Storm Irene**

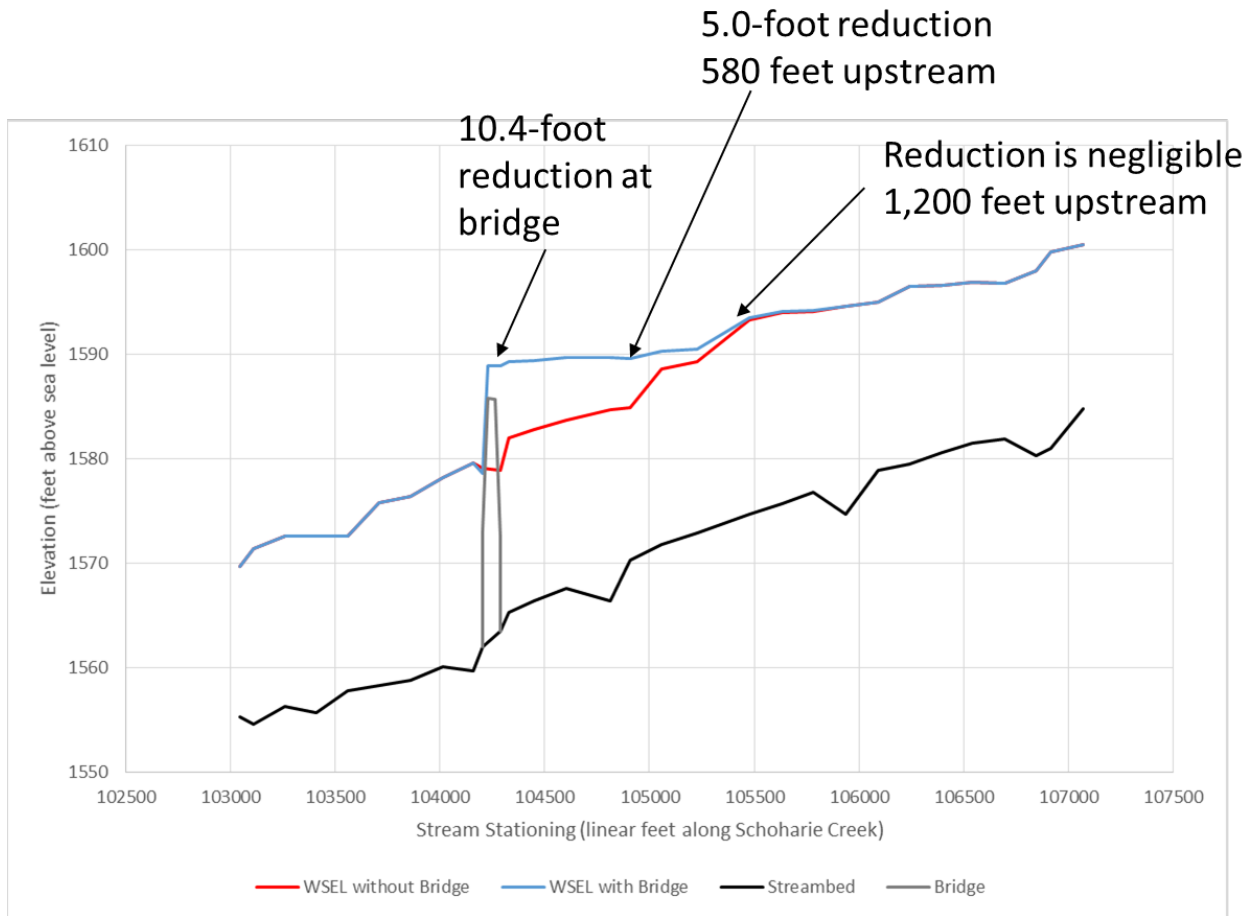
**Figure 4-23**  
**Longitudinal Profile – 50-Year Flood**  
**Bridge Street Bridge over Schoharie Creek**

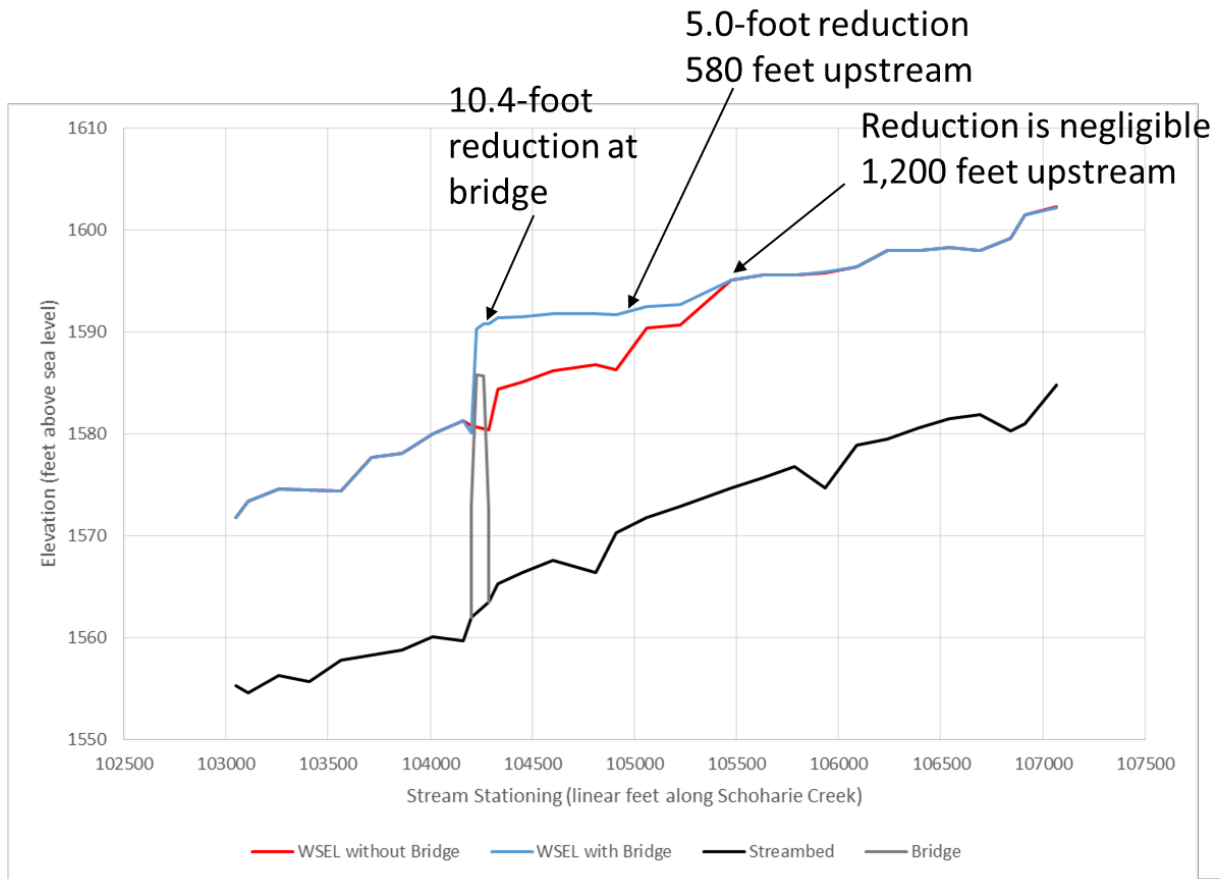
**Figure 4-26**  
**Longitudinal Profile – 100-Year Flood**  
**Bridge Street Bridge over Schoharie Creek**

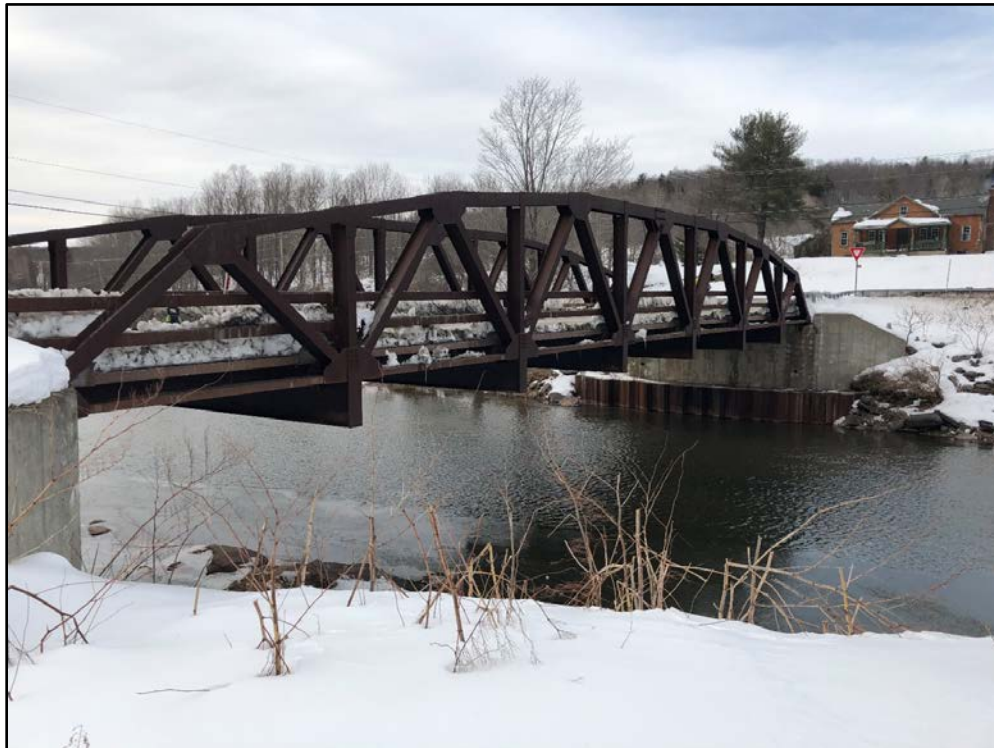
**Figure 4-29**  
**Deming Road over Schoharie Creek**

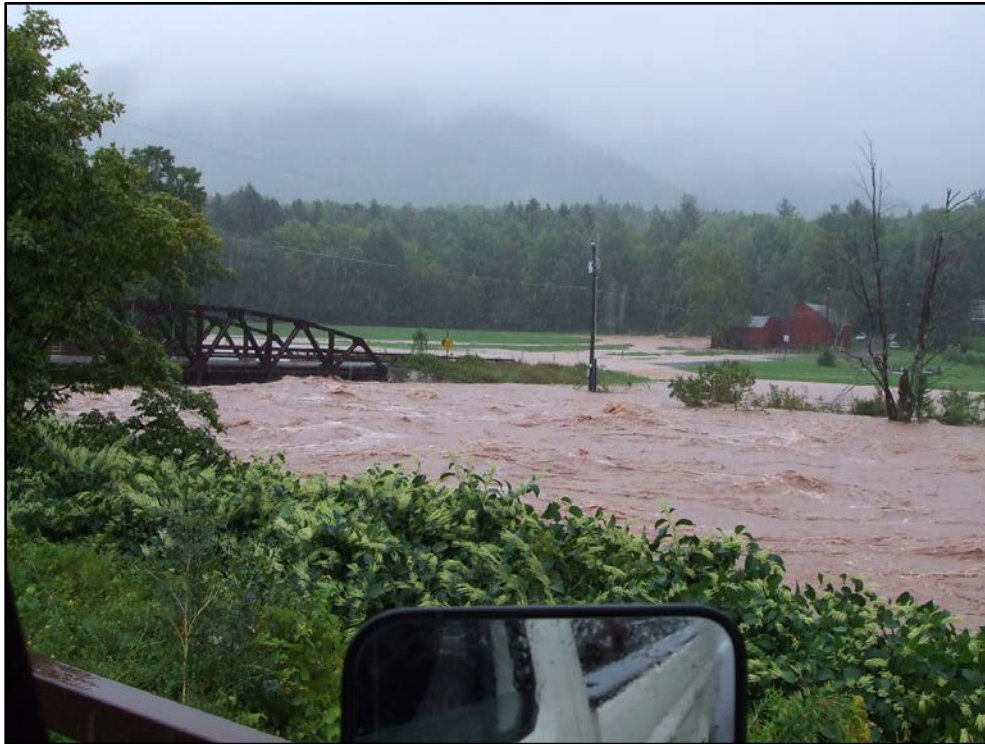
**Figure 4-30**  
**Deming Road over Schoharie Creek during Tropical Storm Irene**

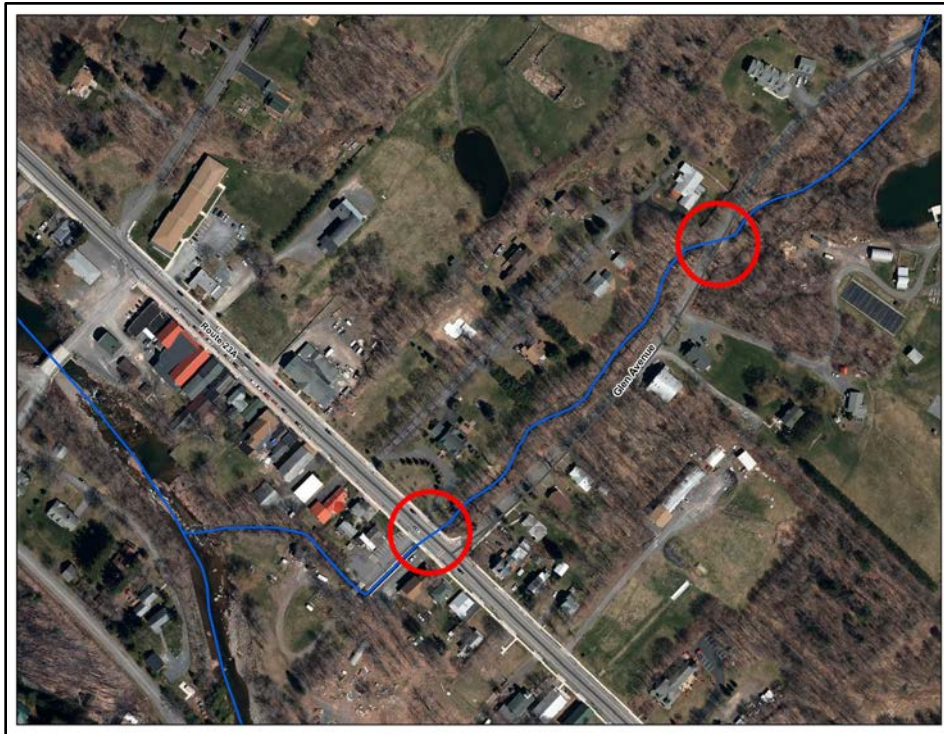
**Figure 4-44**  
**Locations of Culverts along Mad Brook**

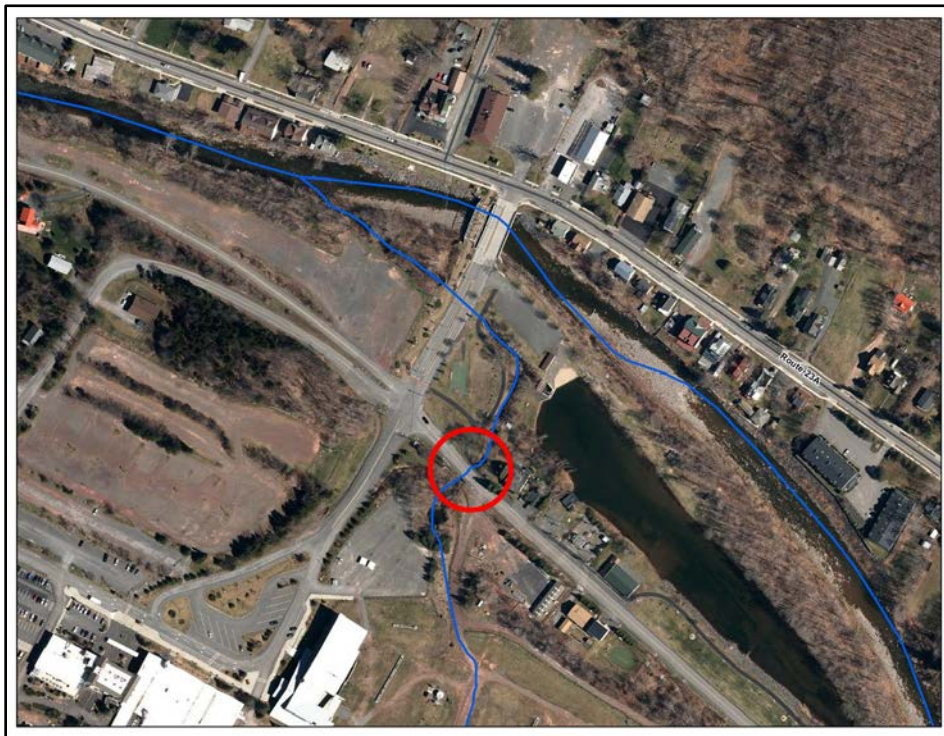
**Figure 4-45**  
**Location of Culvert on Shanty Hollow Brook**

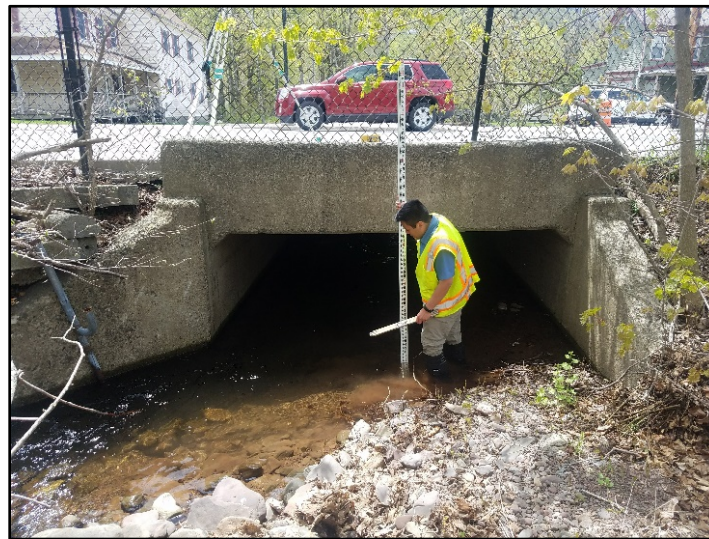
**Figure 4-46**  
**Main Street Culvert over Mad Brook**

The existing culvert conveying Mad Brook under Main Street (Figure 4-46) is a four-sided concrete box culvert with approximately 1 foot of accumulated sediment at the time of the field visit. Hydraulic analysis indicates that this culvert has the capacity to convey 306 cfs. The culvert passes the 25-year flow of 281 cfs but not the 50-year flow of 353 cfs. Downstream of the culvert, Mad Brook passes through a narrow concrete channel and then takes a hard bend to the right before flowing under a private bridge (see Figure 4-44). Utilities including sewer and water are located in close proximity to the culvert.

Initial modeling indicates that a 13-foot x 5-foot concrete box culvert at this location would pass 405 cfs, which exceeds the 50-year flood event.

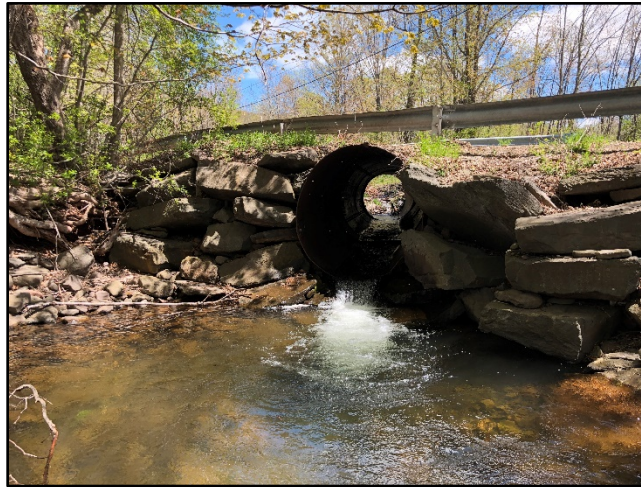
**Figure 4-47**  
**Glen Avenue Culvert over Mad Brook**

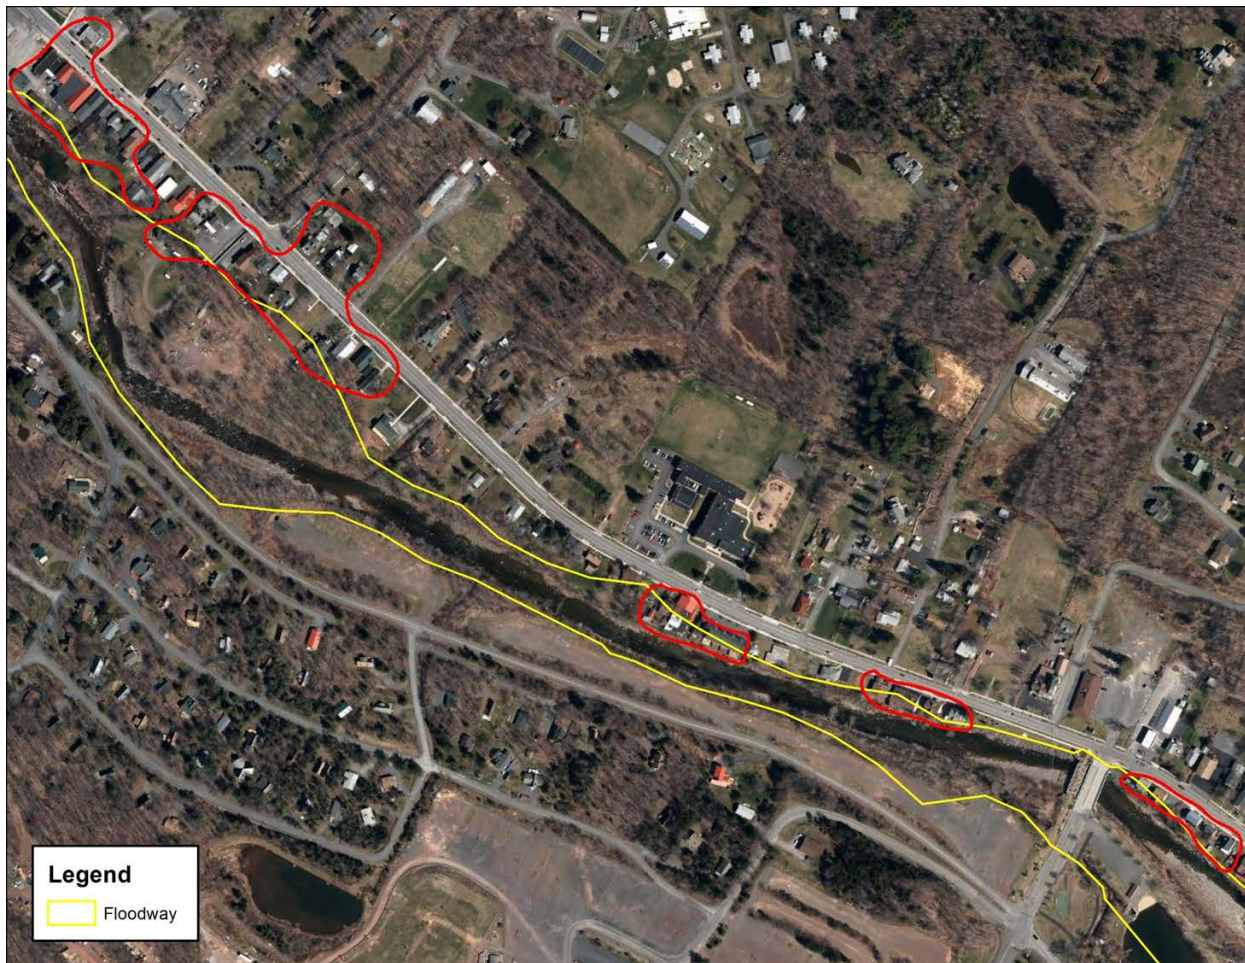
**Map Depicting FEMA Floodway and Areas Prone to Flooding Depth of Greater Than 2 Feet during 100-Year Flood**

- It is recommended that the town and village work to flood proof or relocate the most flood-vulnerable properties where there is owner interest and programmatic funding available through flood buyout and relocation programs. The two flow charts below provide decision-making guidance for nonresidential (Figure 6-1) and residential (Figure 6-2) properties.
- It is recommended that the town and village identify priority areas and structures that are prone to most frequent and deepest flooding. Figure 6-3 shows the boundaries of the FEMA floodway in Hunter and also highlights areas along Main Street where flooding depths may exceed a 2-foot depth during the 100-year flood event. These areas should be considered the highest priority for individual flood protection measures.

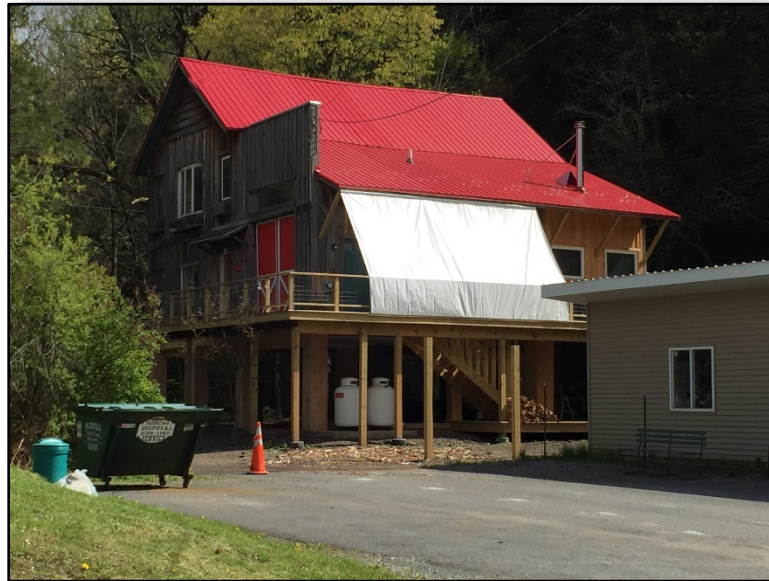
**Figure 6-4**  
**Example of an Elevated Structure**
