Esopus Creek Stream Restoration Project

Demonstrating multi-objective stream restoration and monitoring as part of the Esopus Creek Stream Management Plan

Project Construction

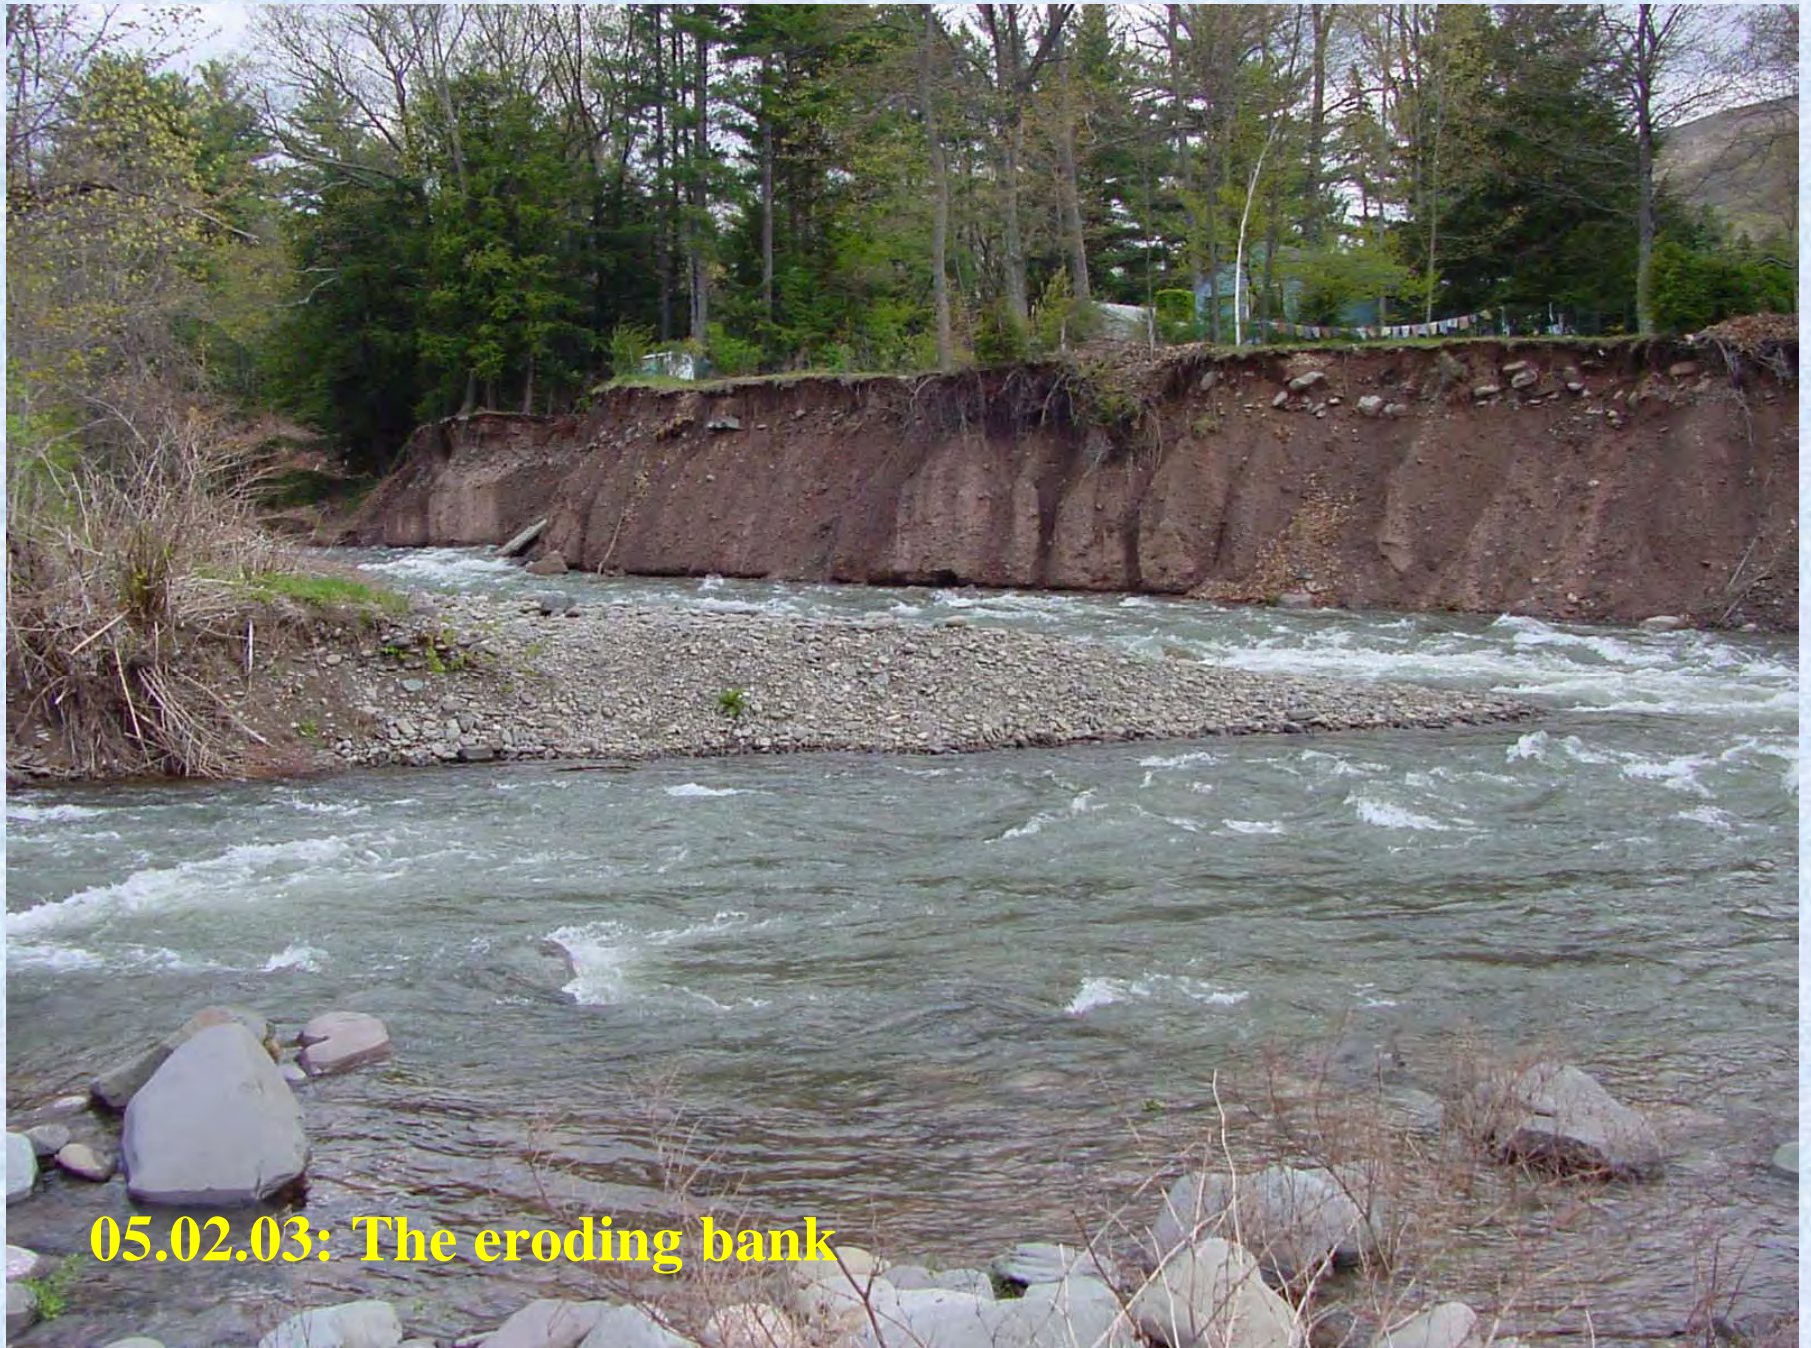
05.02.03: The eroding bank

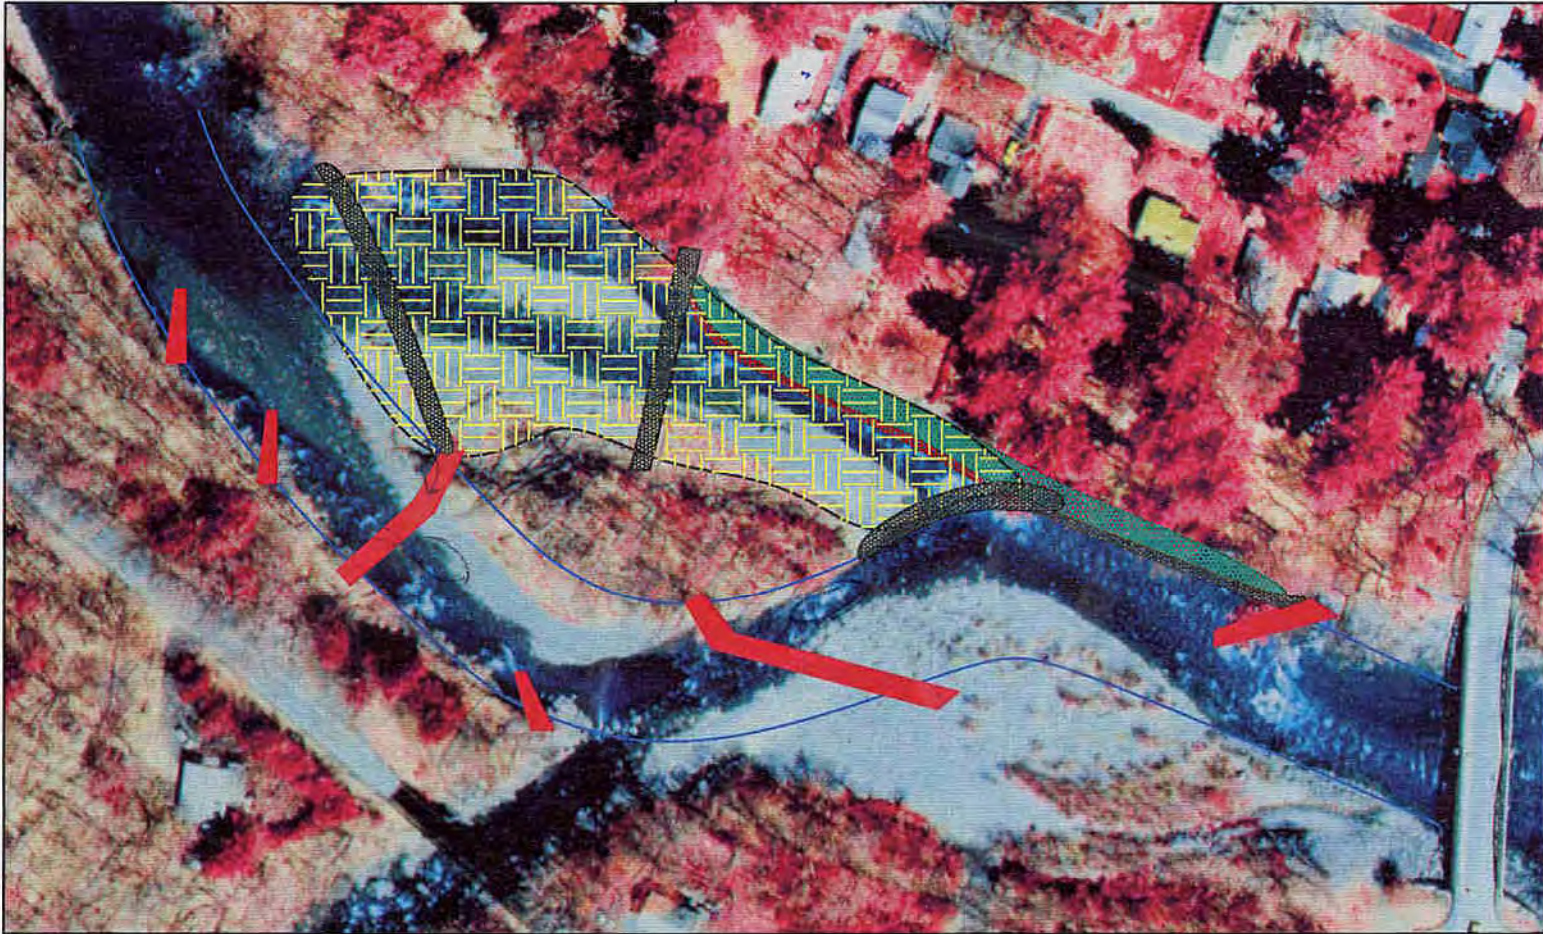
General Plan
Esopus Creek
New York City DEP

Fill Zone
-

Stone Channel Block
-

VRSS System
-

Vane
-

Weir

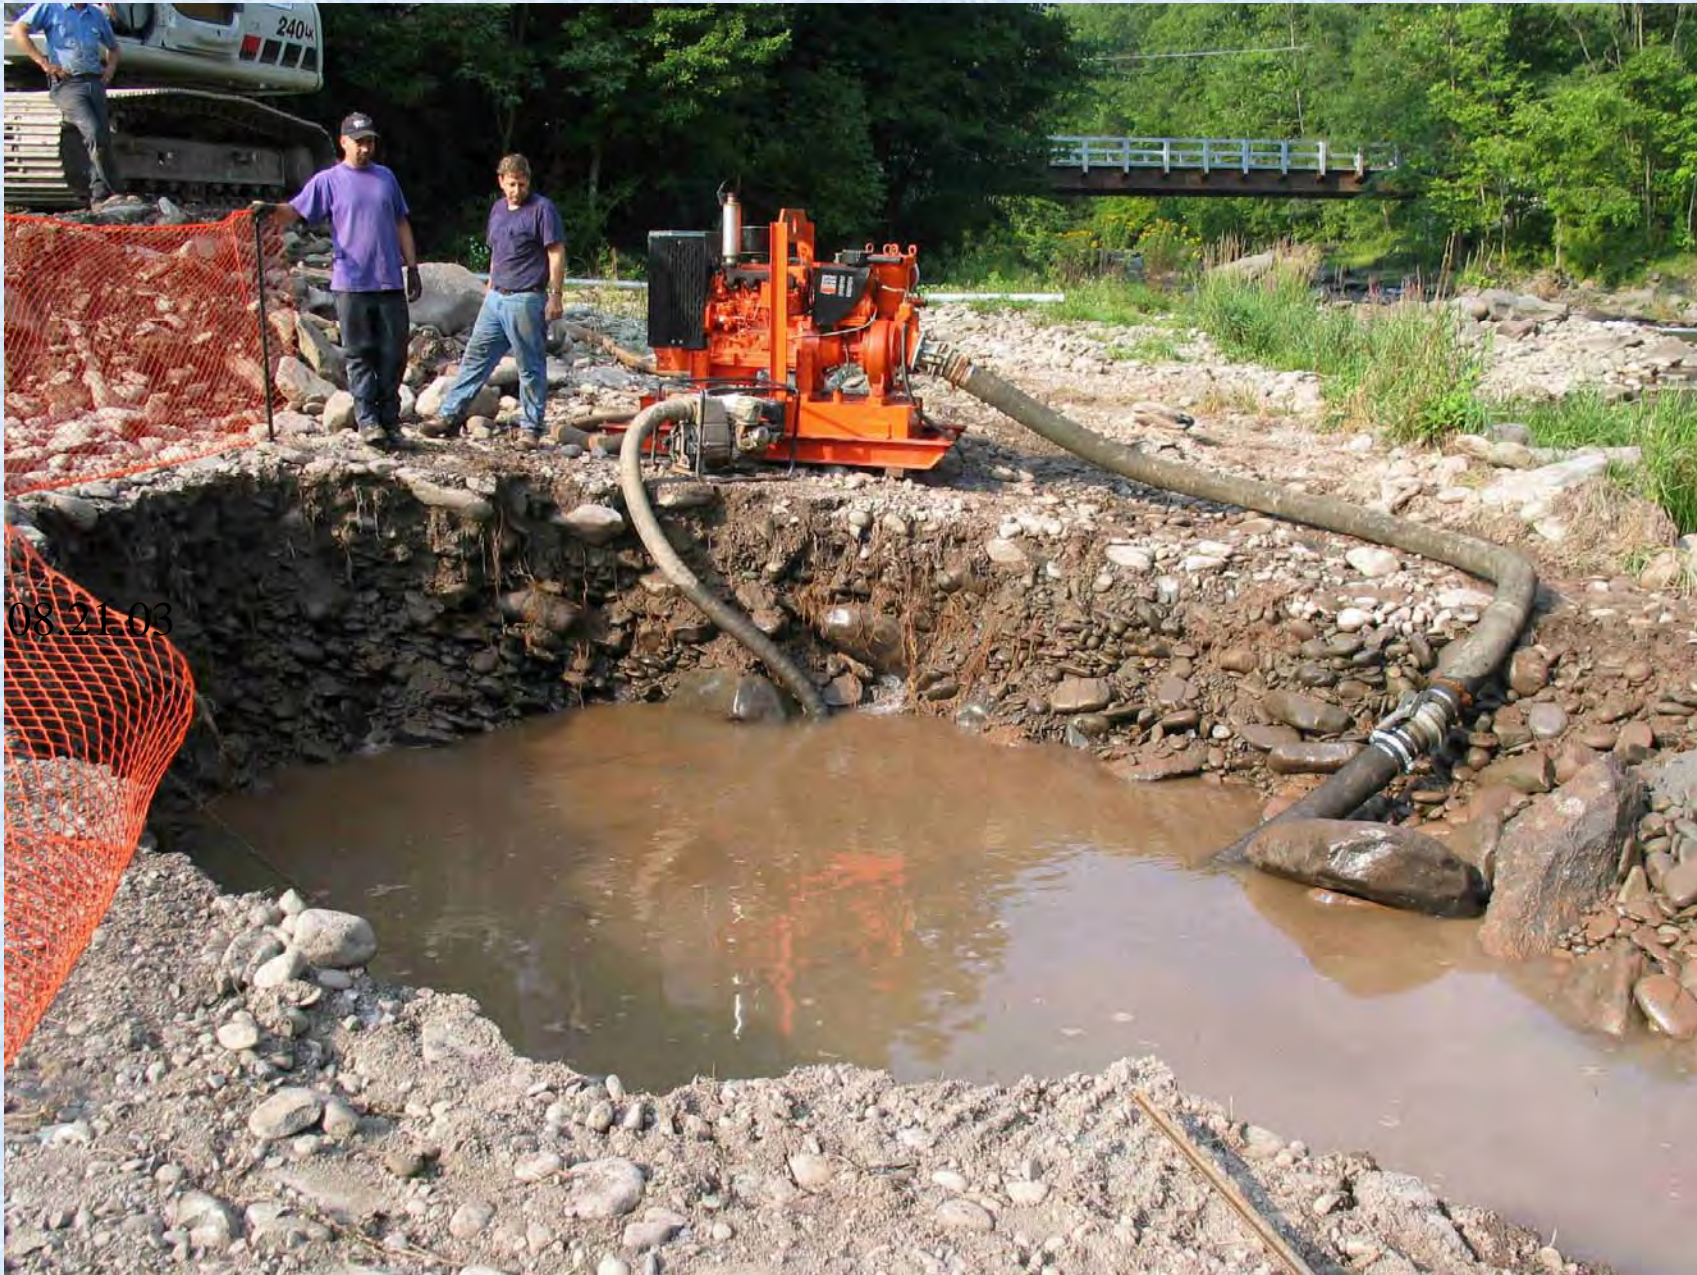
Dewatering in a saturated cobble bar

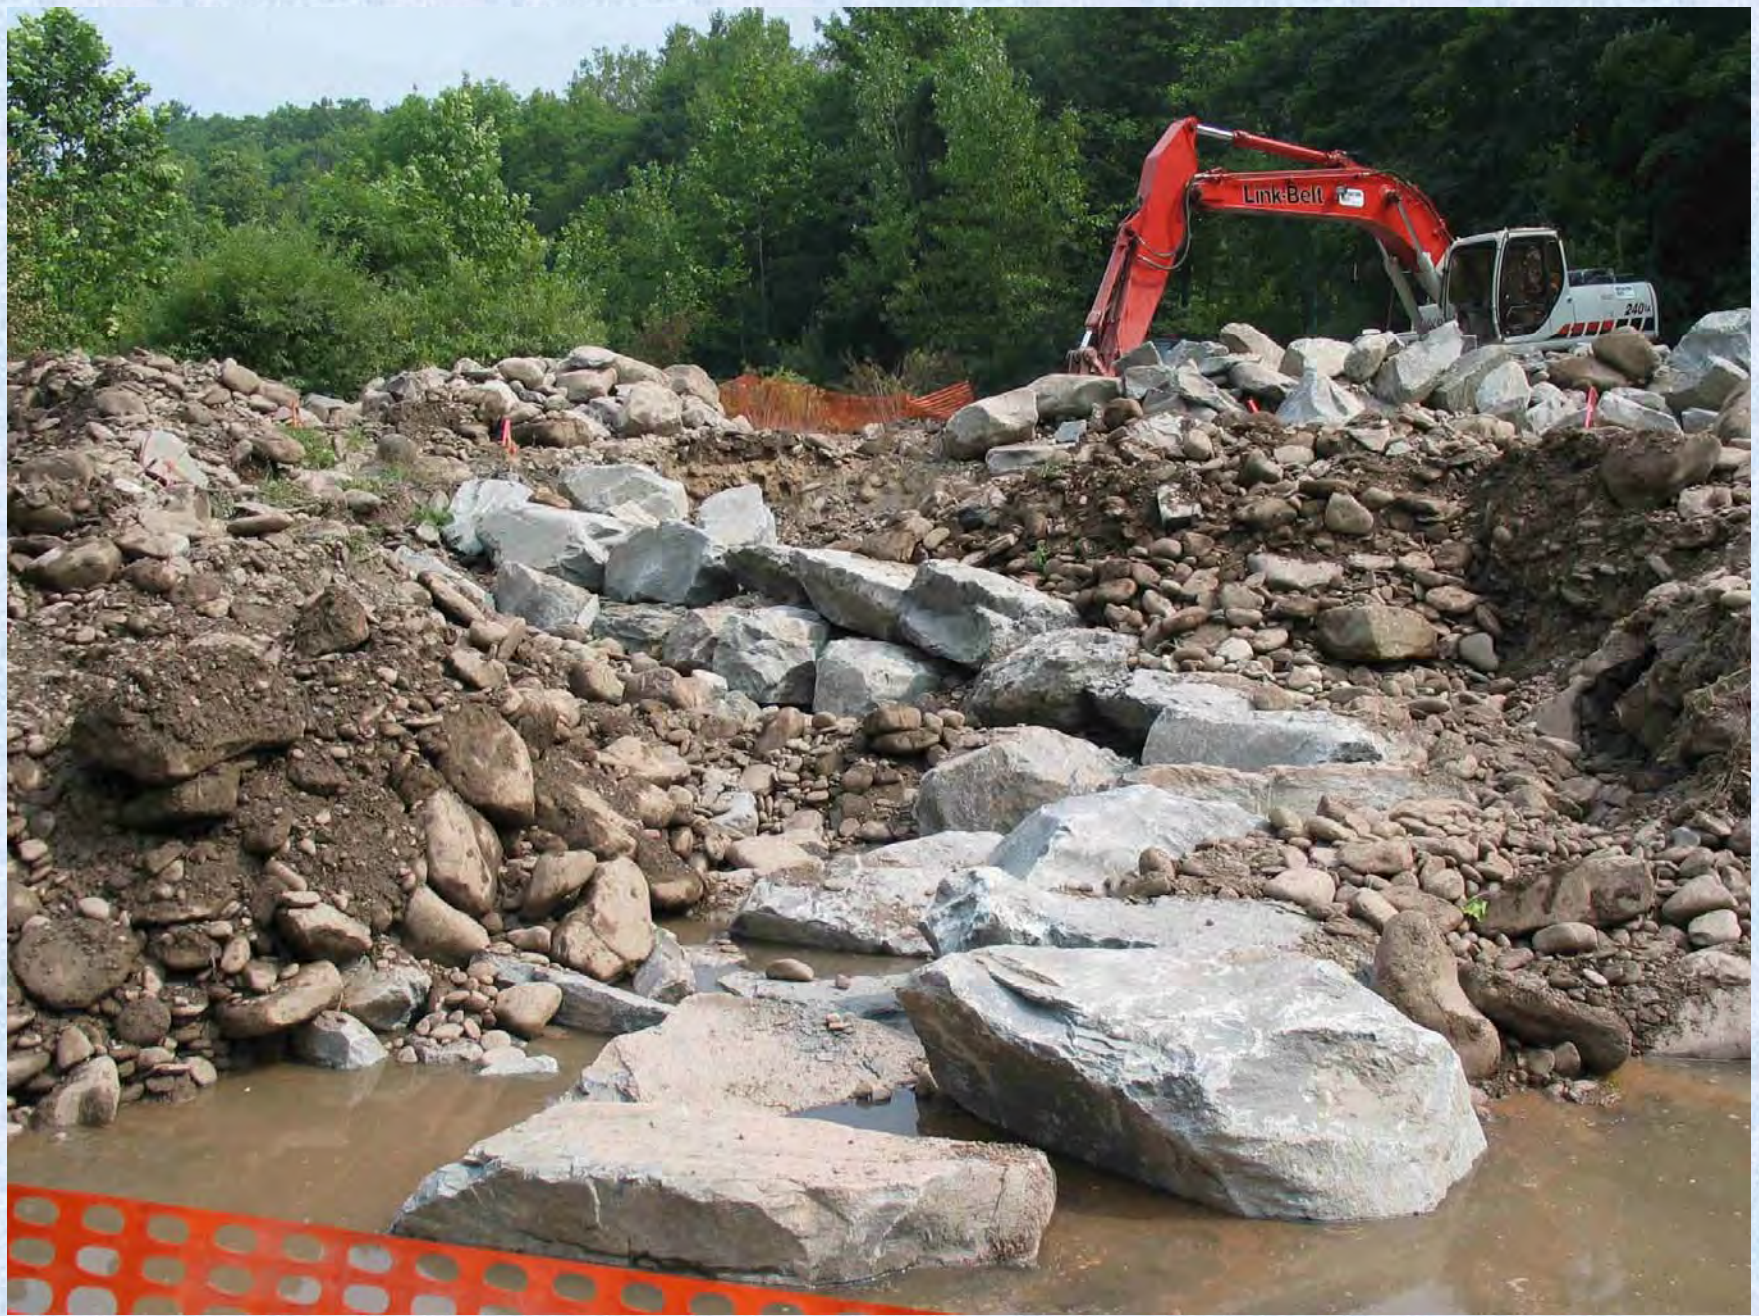
Constructing DS Boulder Weir

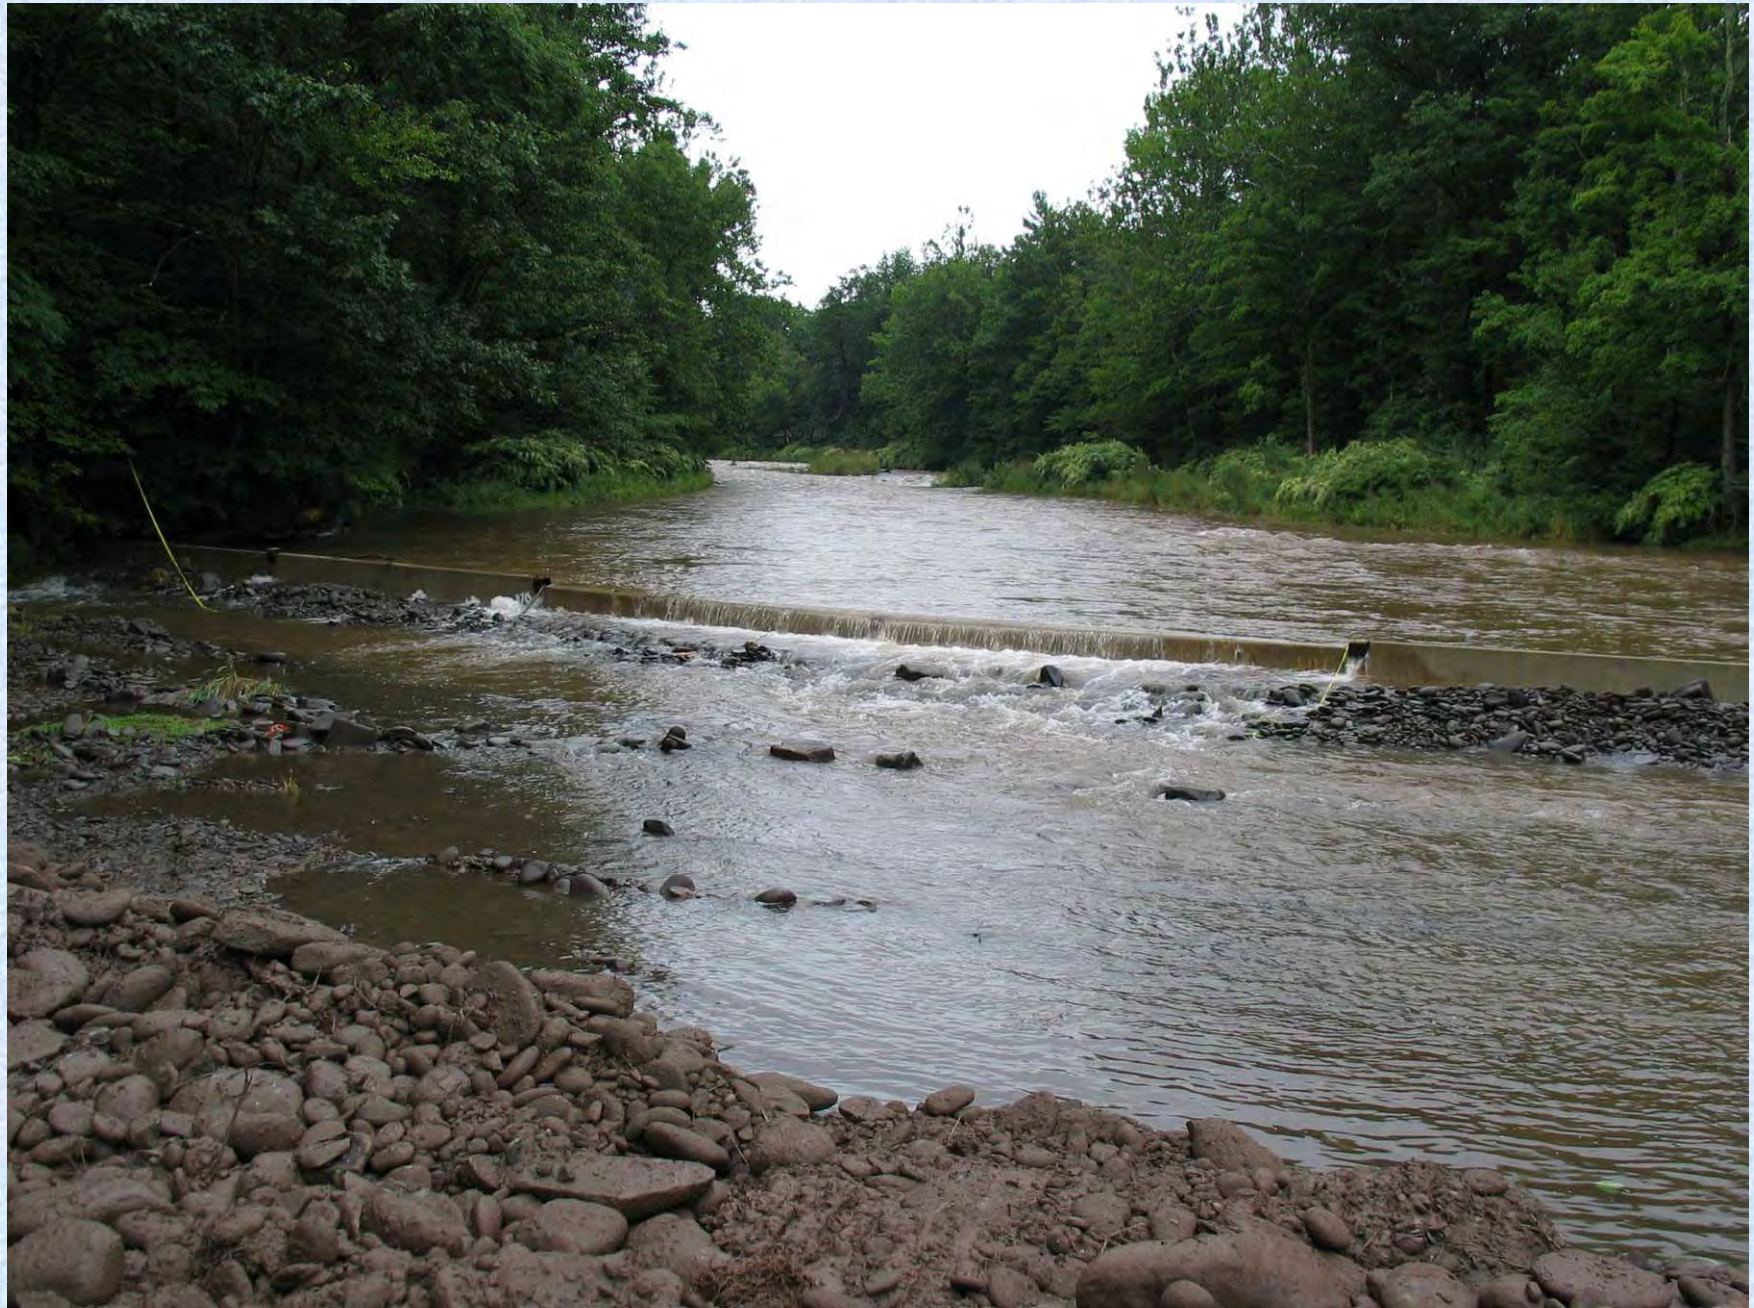
Diverting Esopus Creek high water with jersey barriers and berms 09.02.03

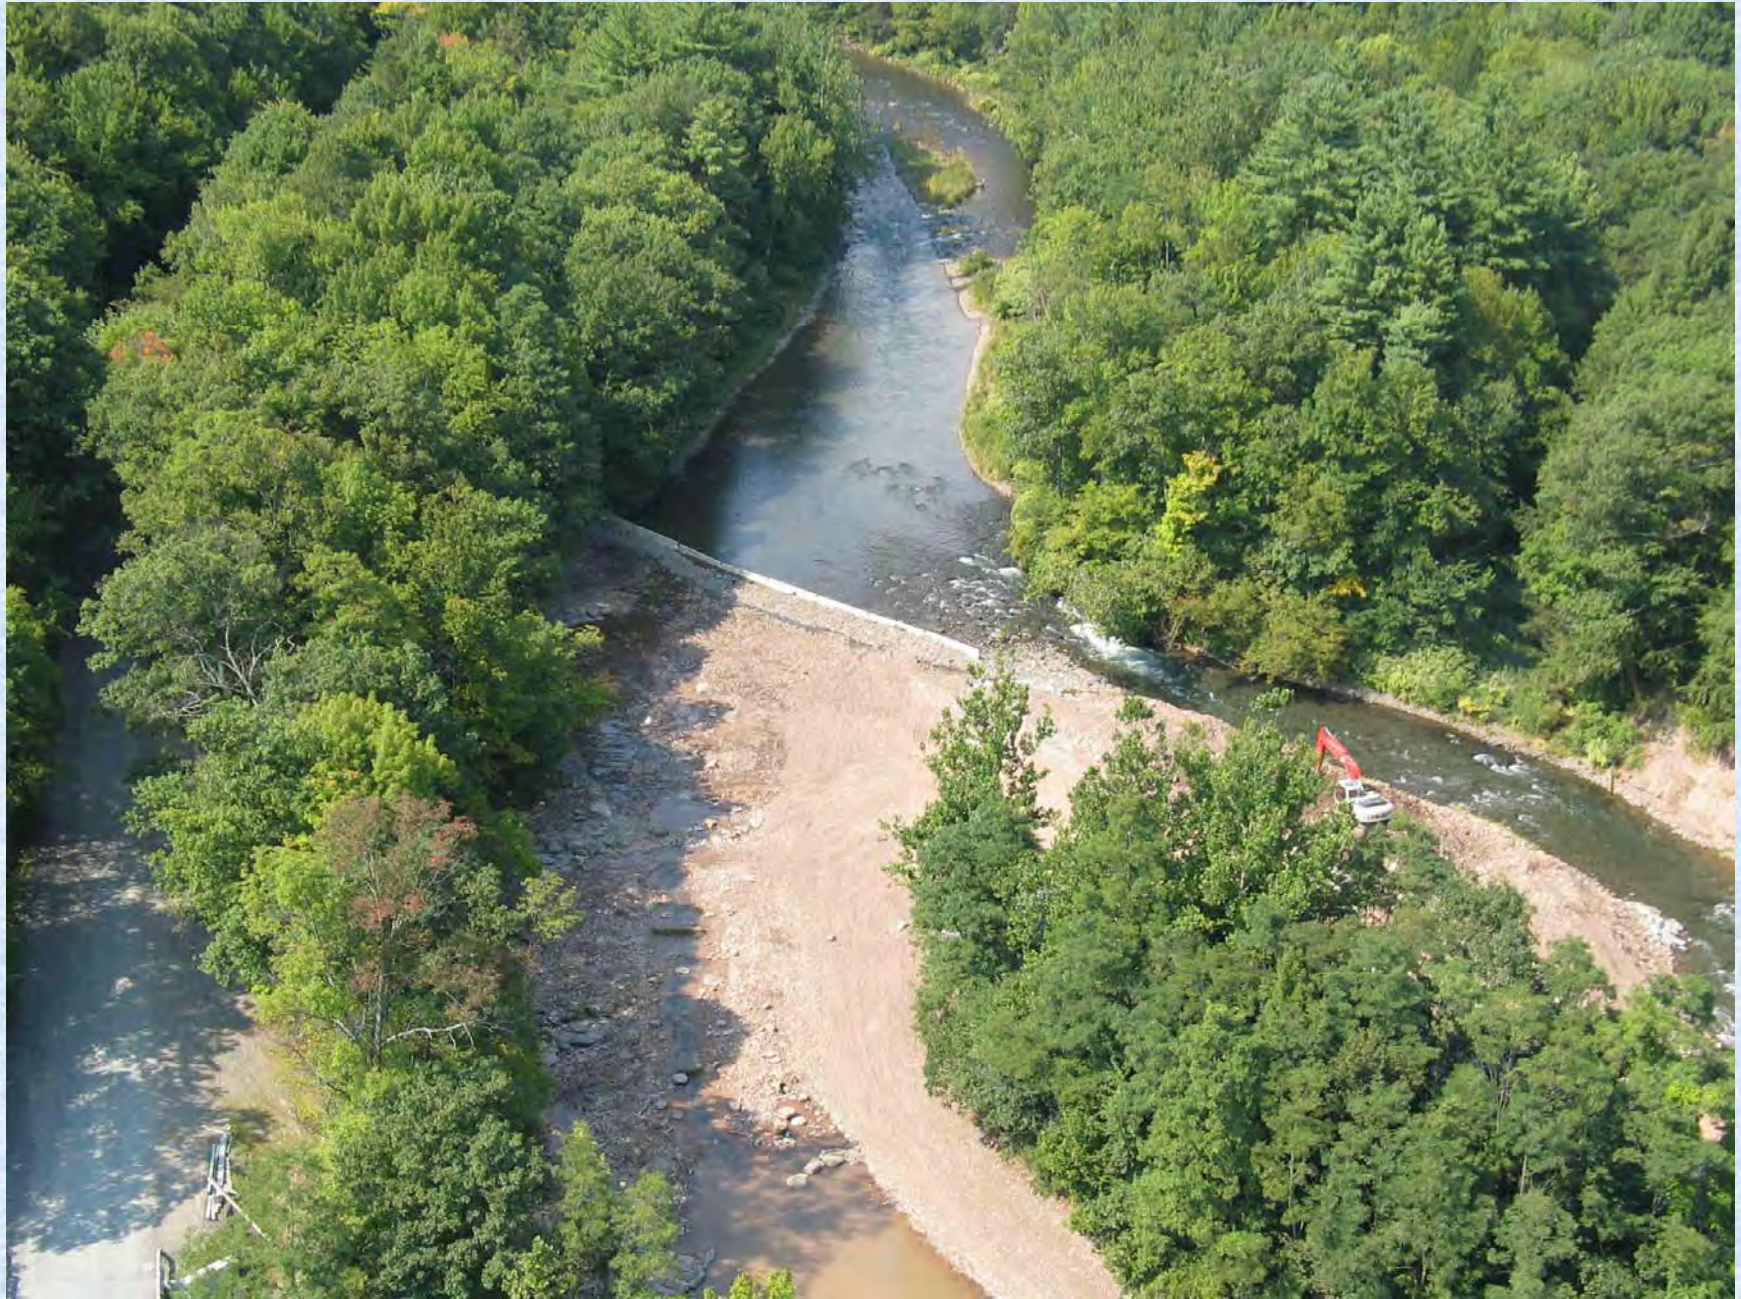
Diverting Esopus Creek flow into north channel

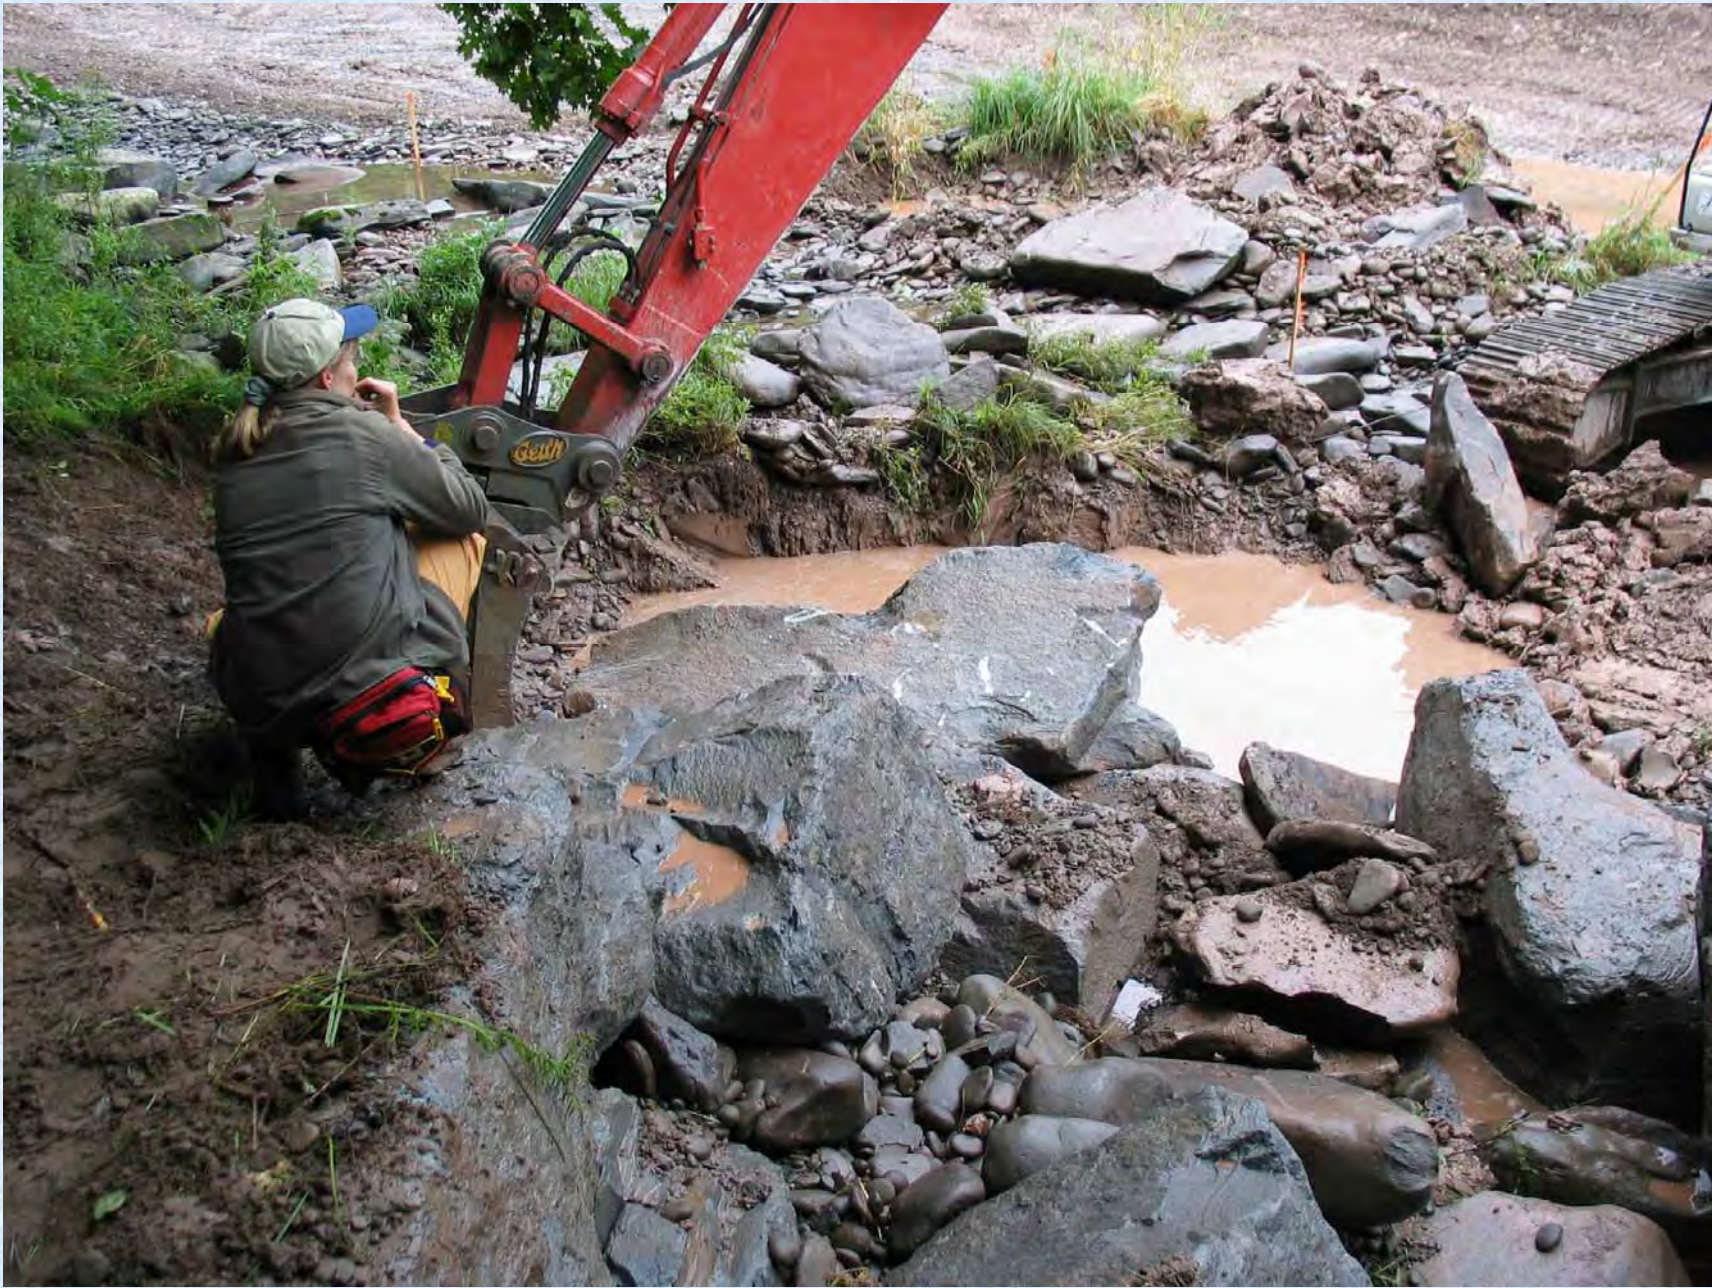
Constructing US boulder weir in glacial lake clay substrate

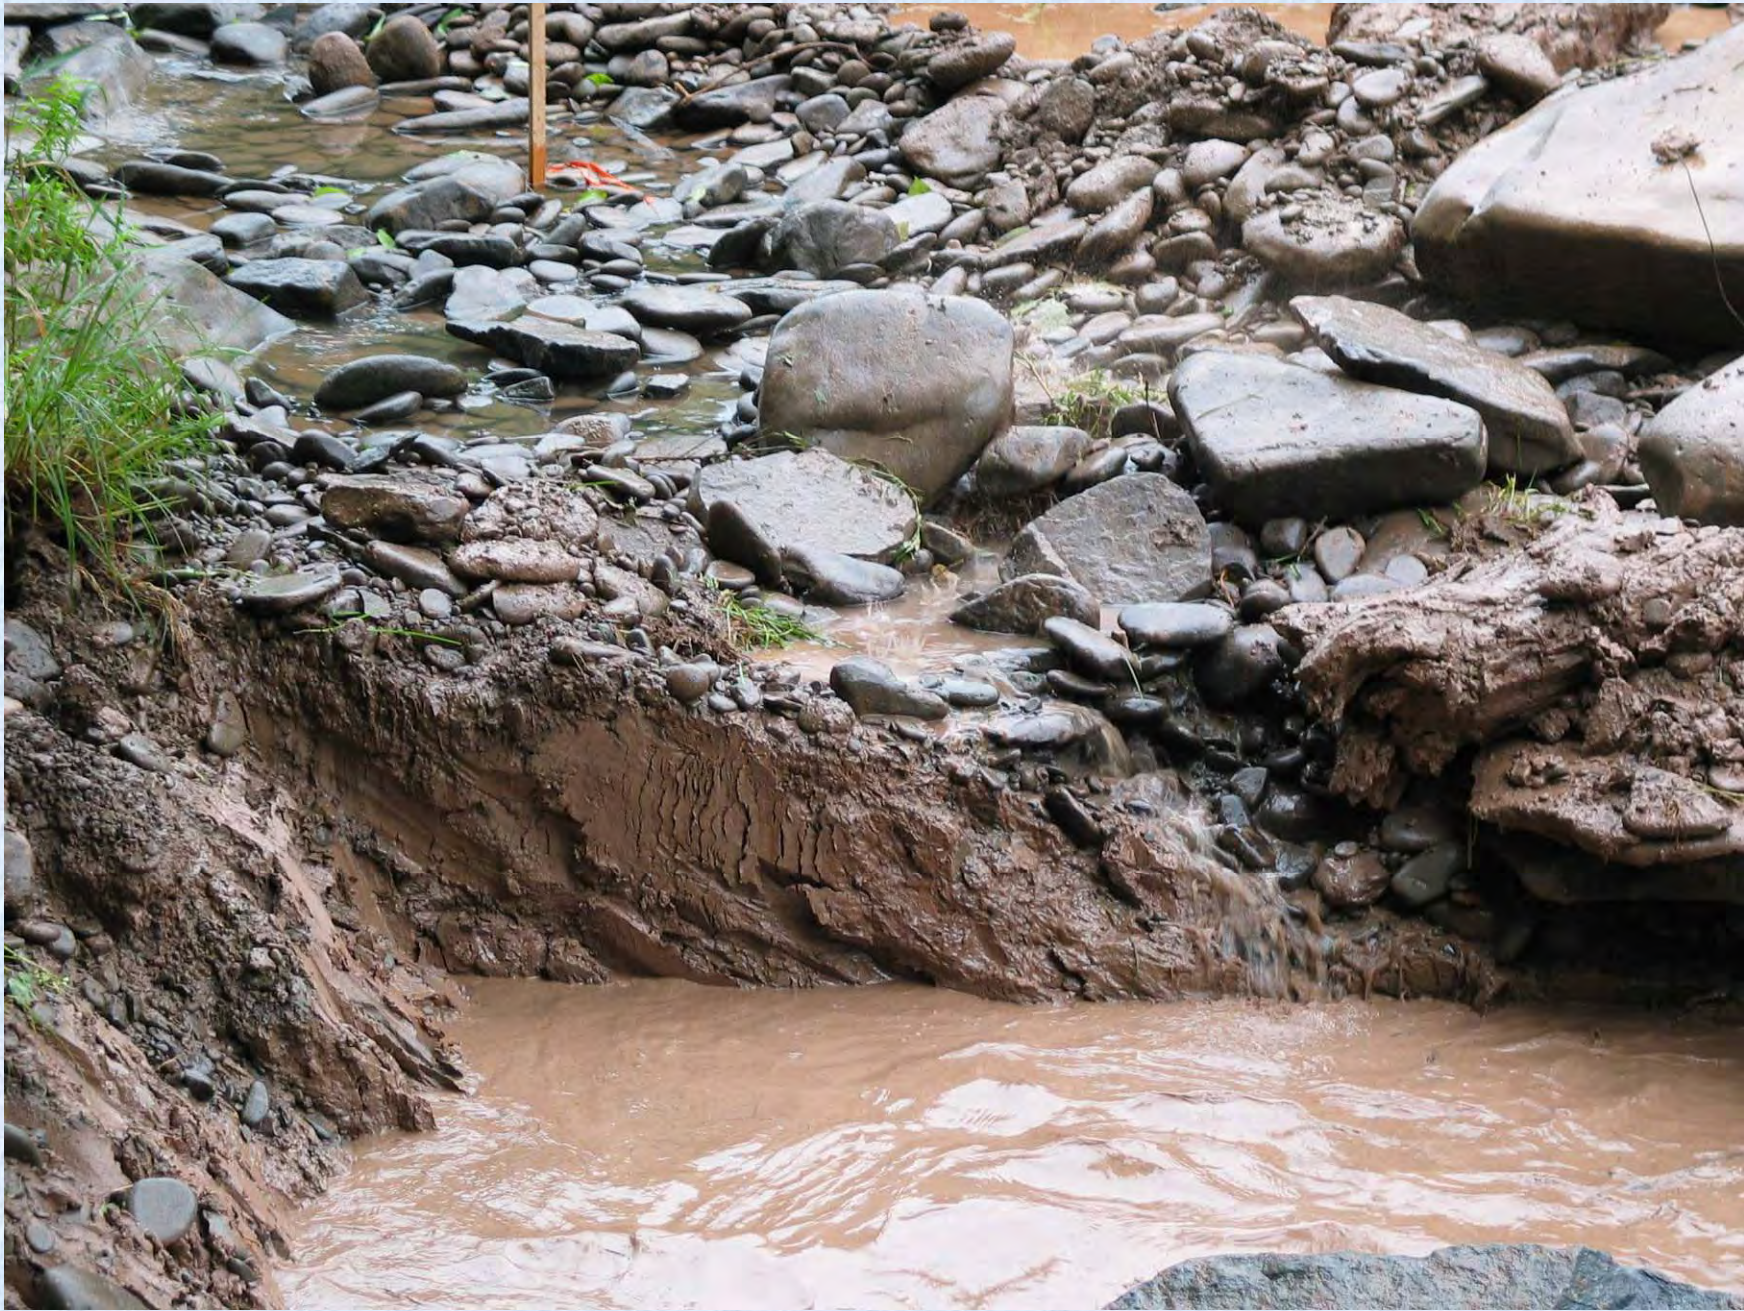
Glacial lake clay substrate in south channel

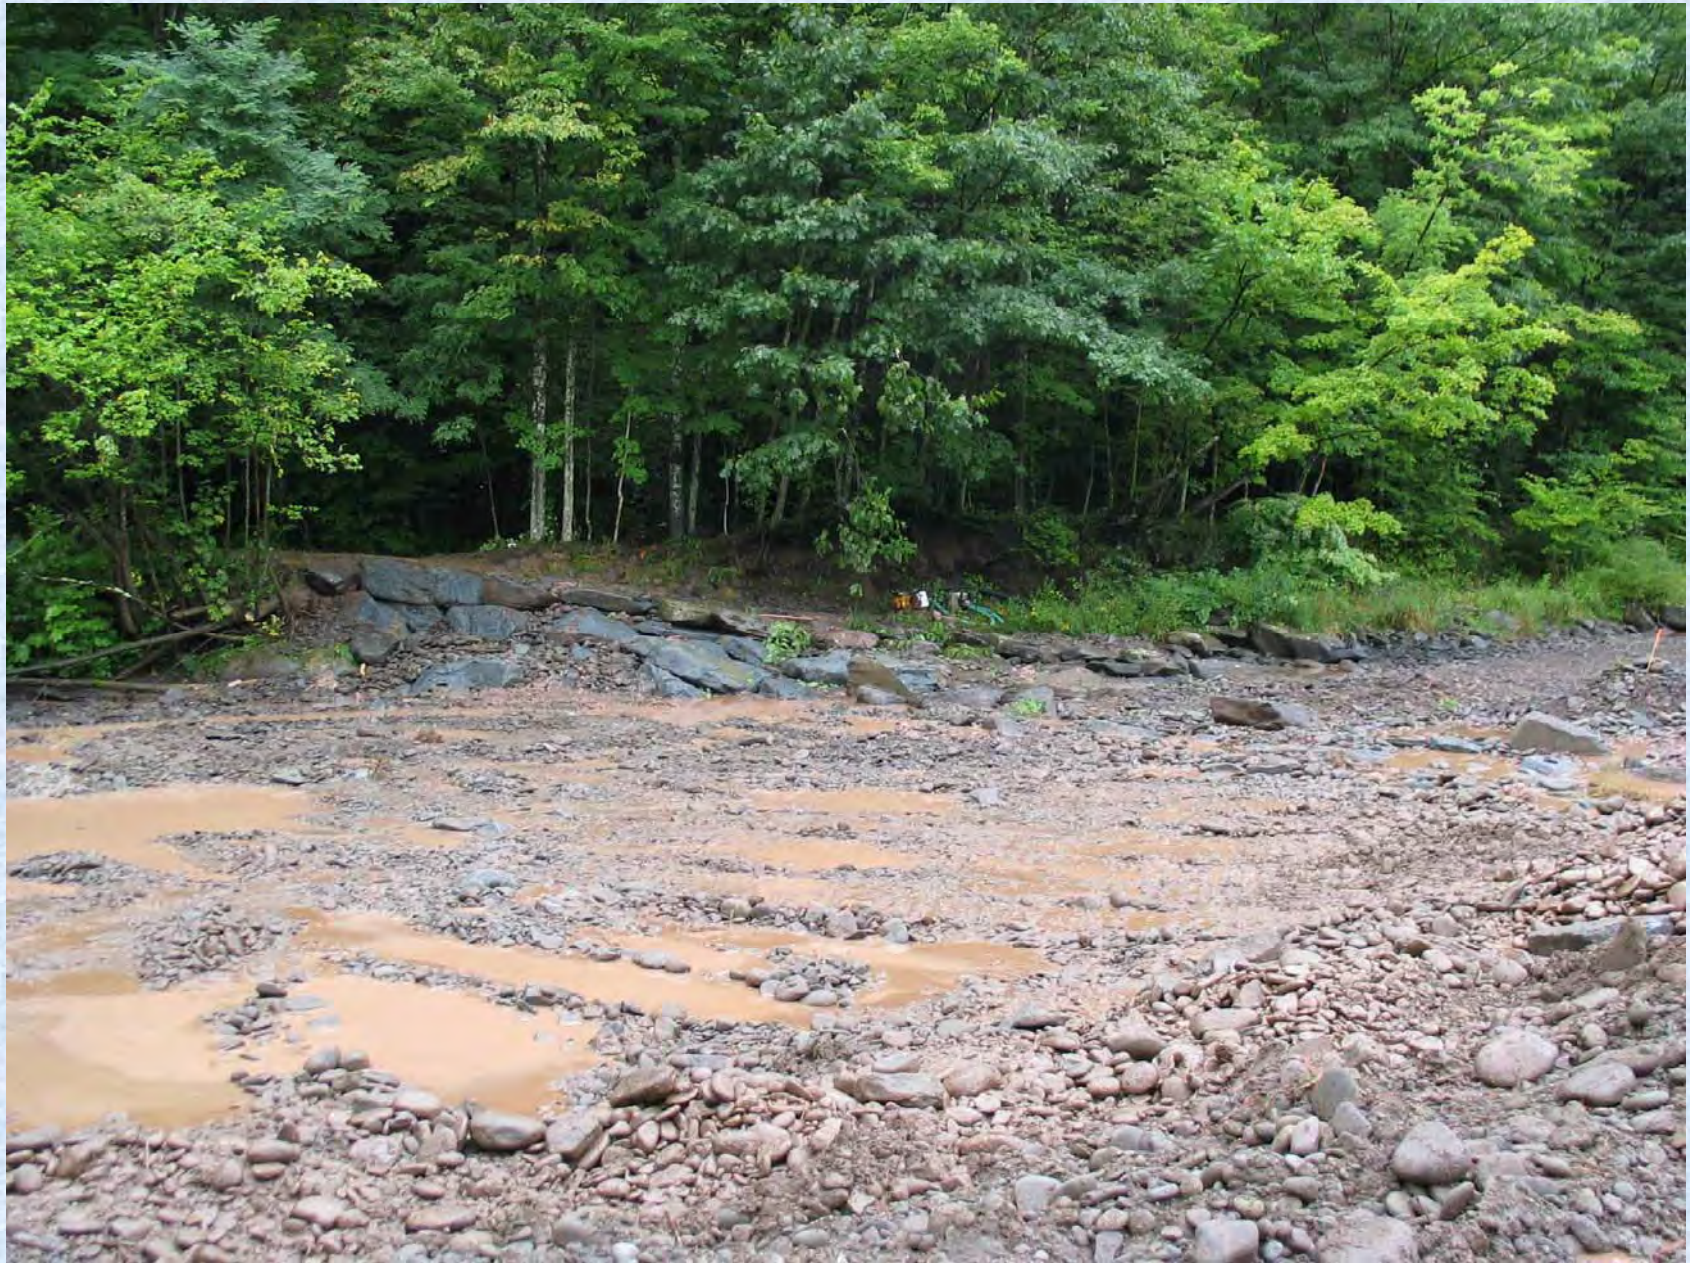
Completed US weir/vane

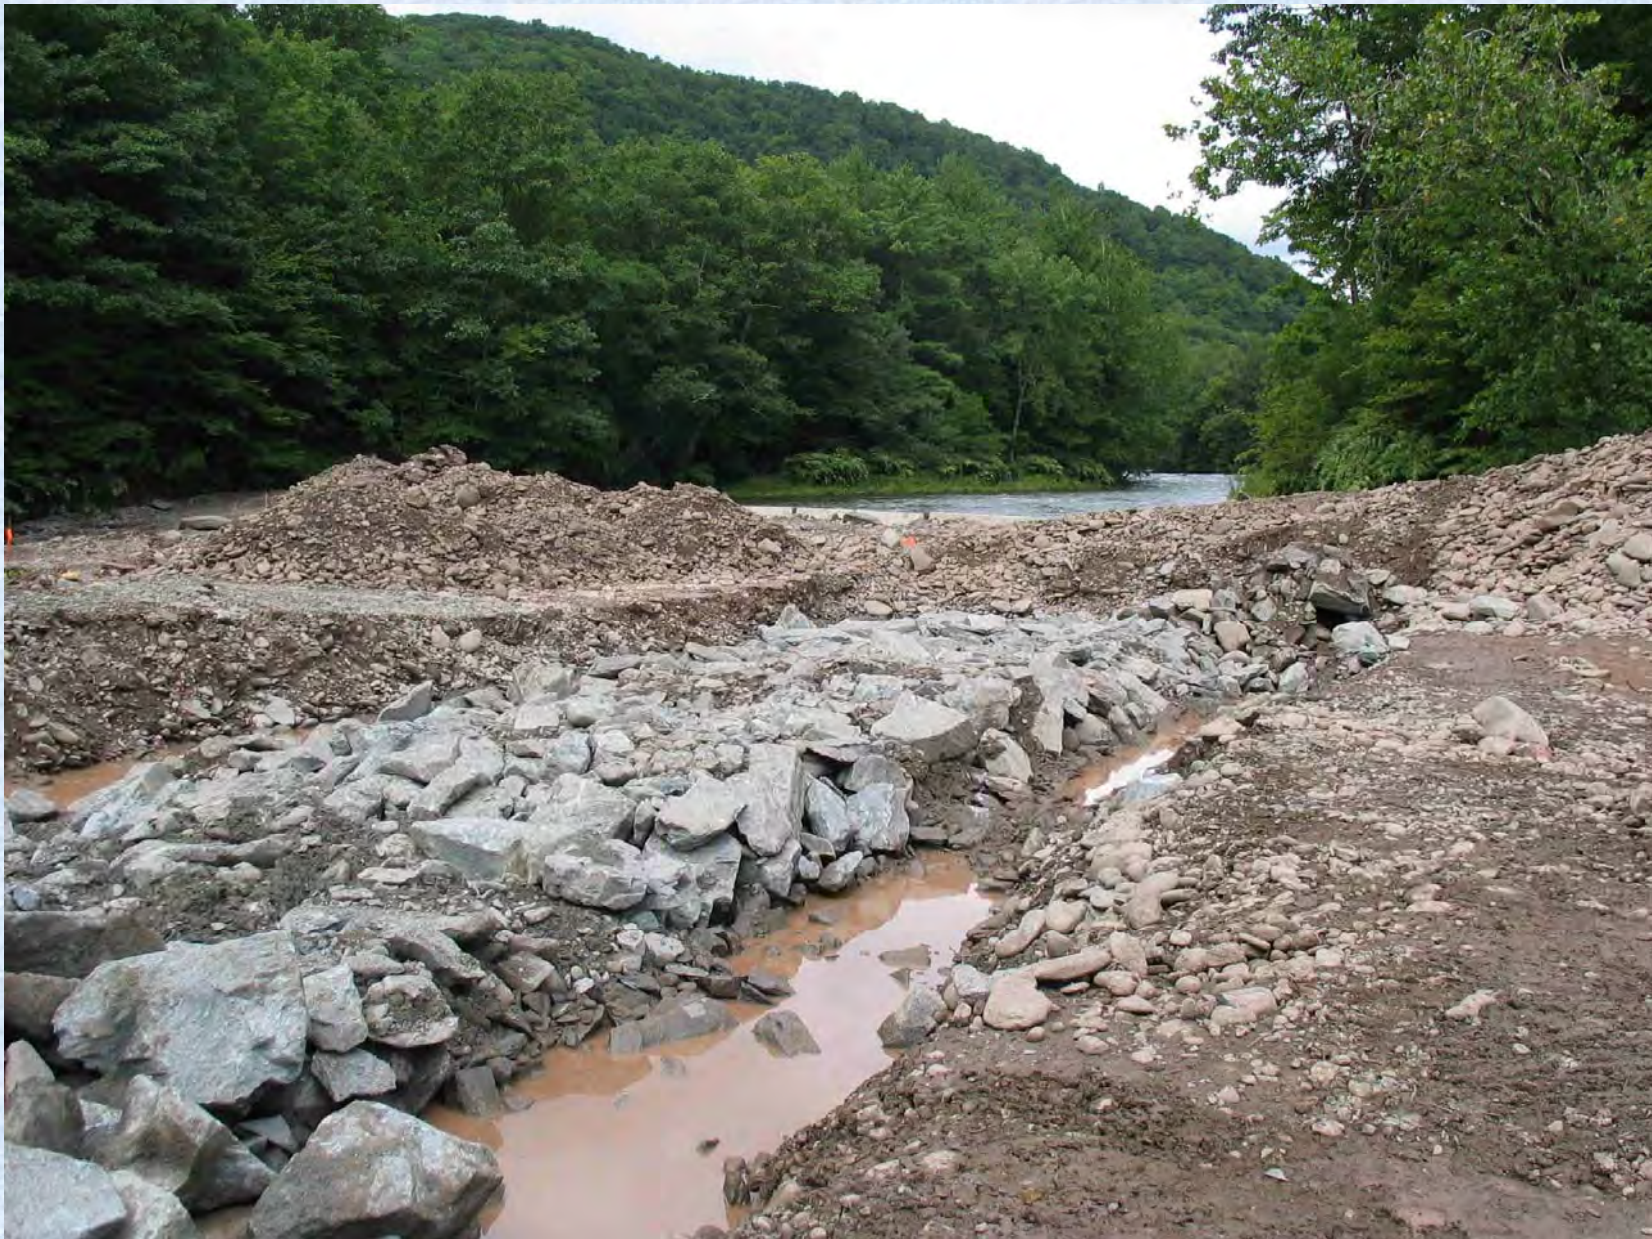
Installing channel blocks (buried rip rap) in flood plain
