Esopus Creek Stream Restoration Project

Demonstrating multi-objective stream restoration and monitoring as part of the Esopus Creek Stream Management Plan

Project Construction

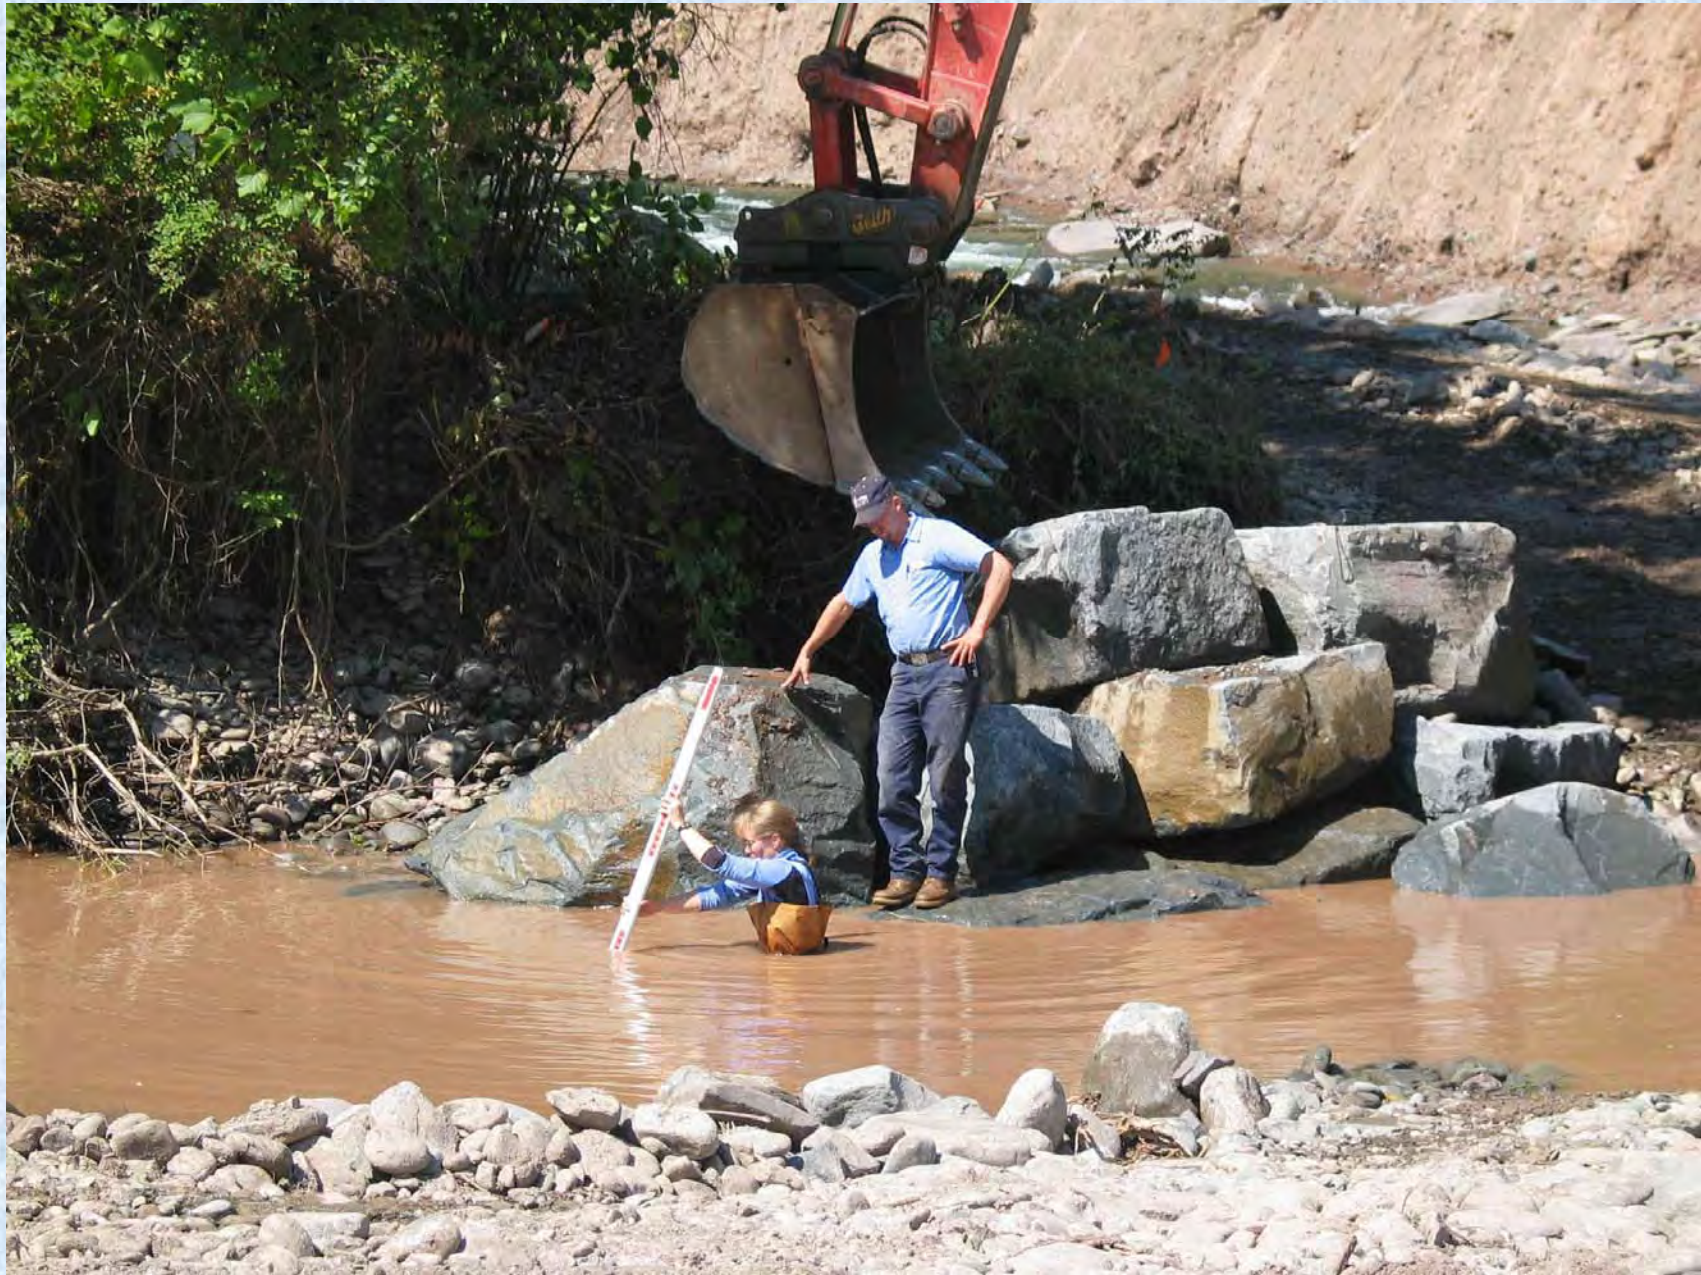
Constructing DS boulder weir in Esopus yooahoo

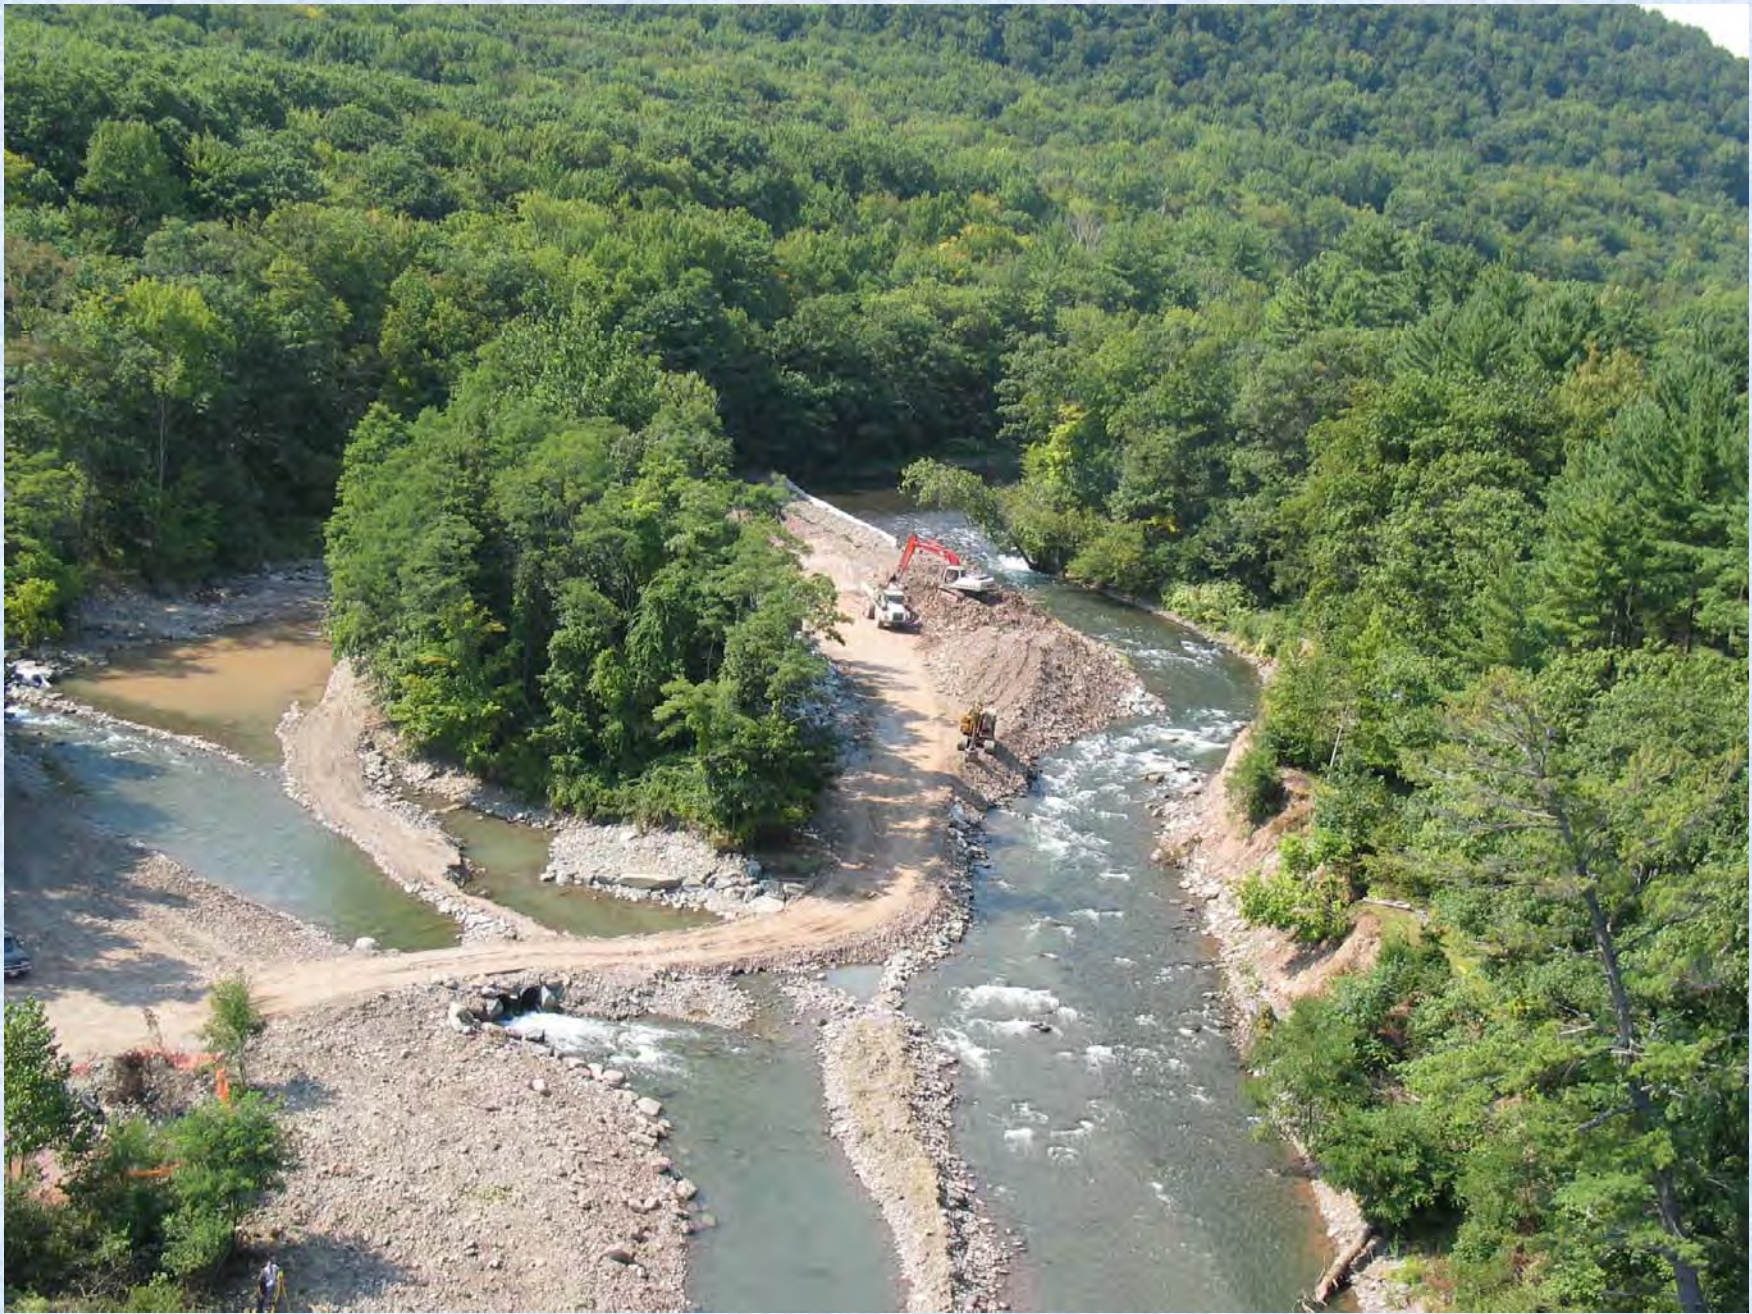
Project construction dewatering

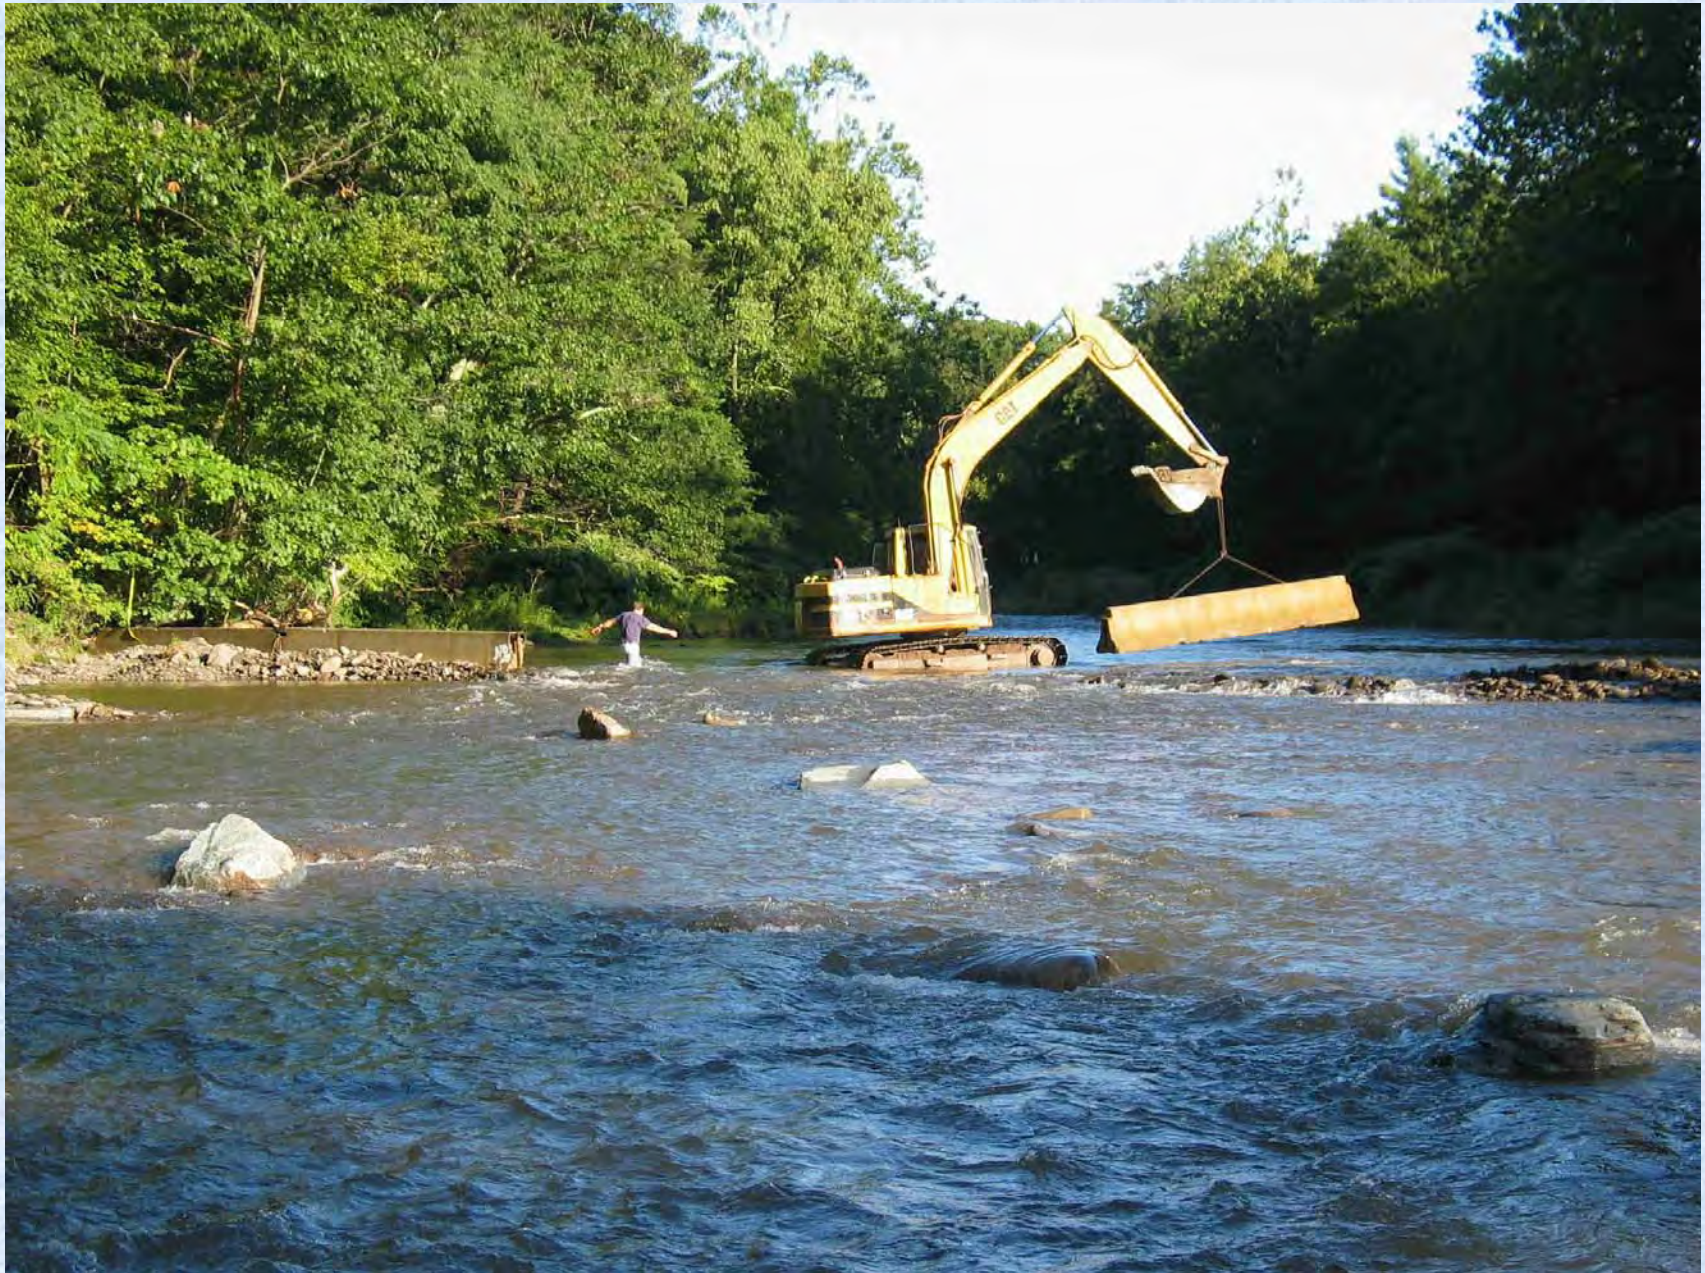
Opening up the south channel

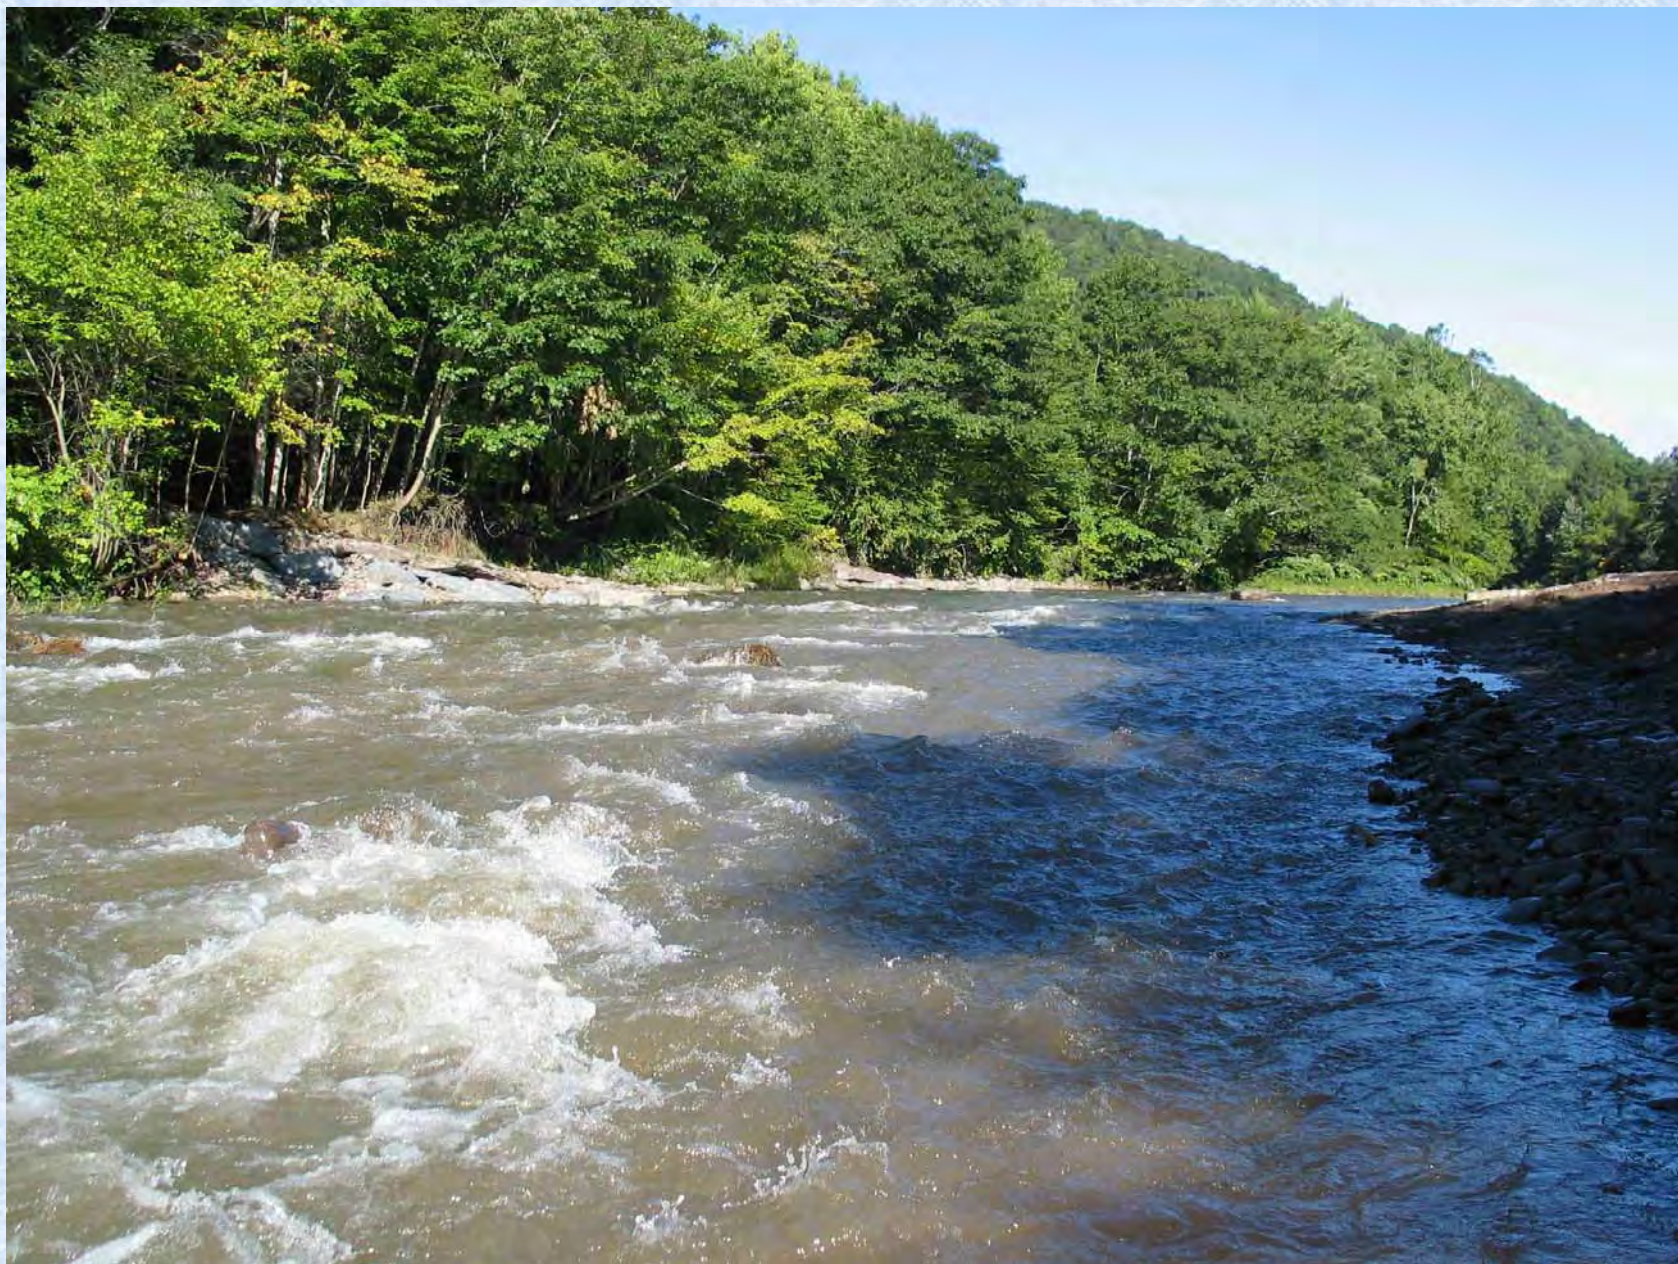
First flush of Esopus Creek in new south channel

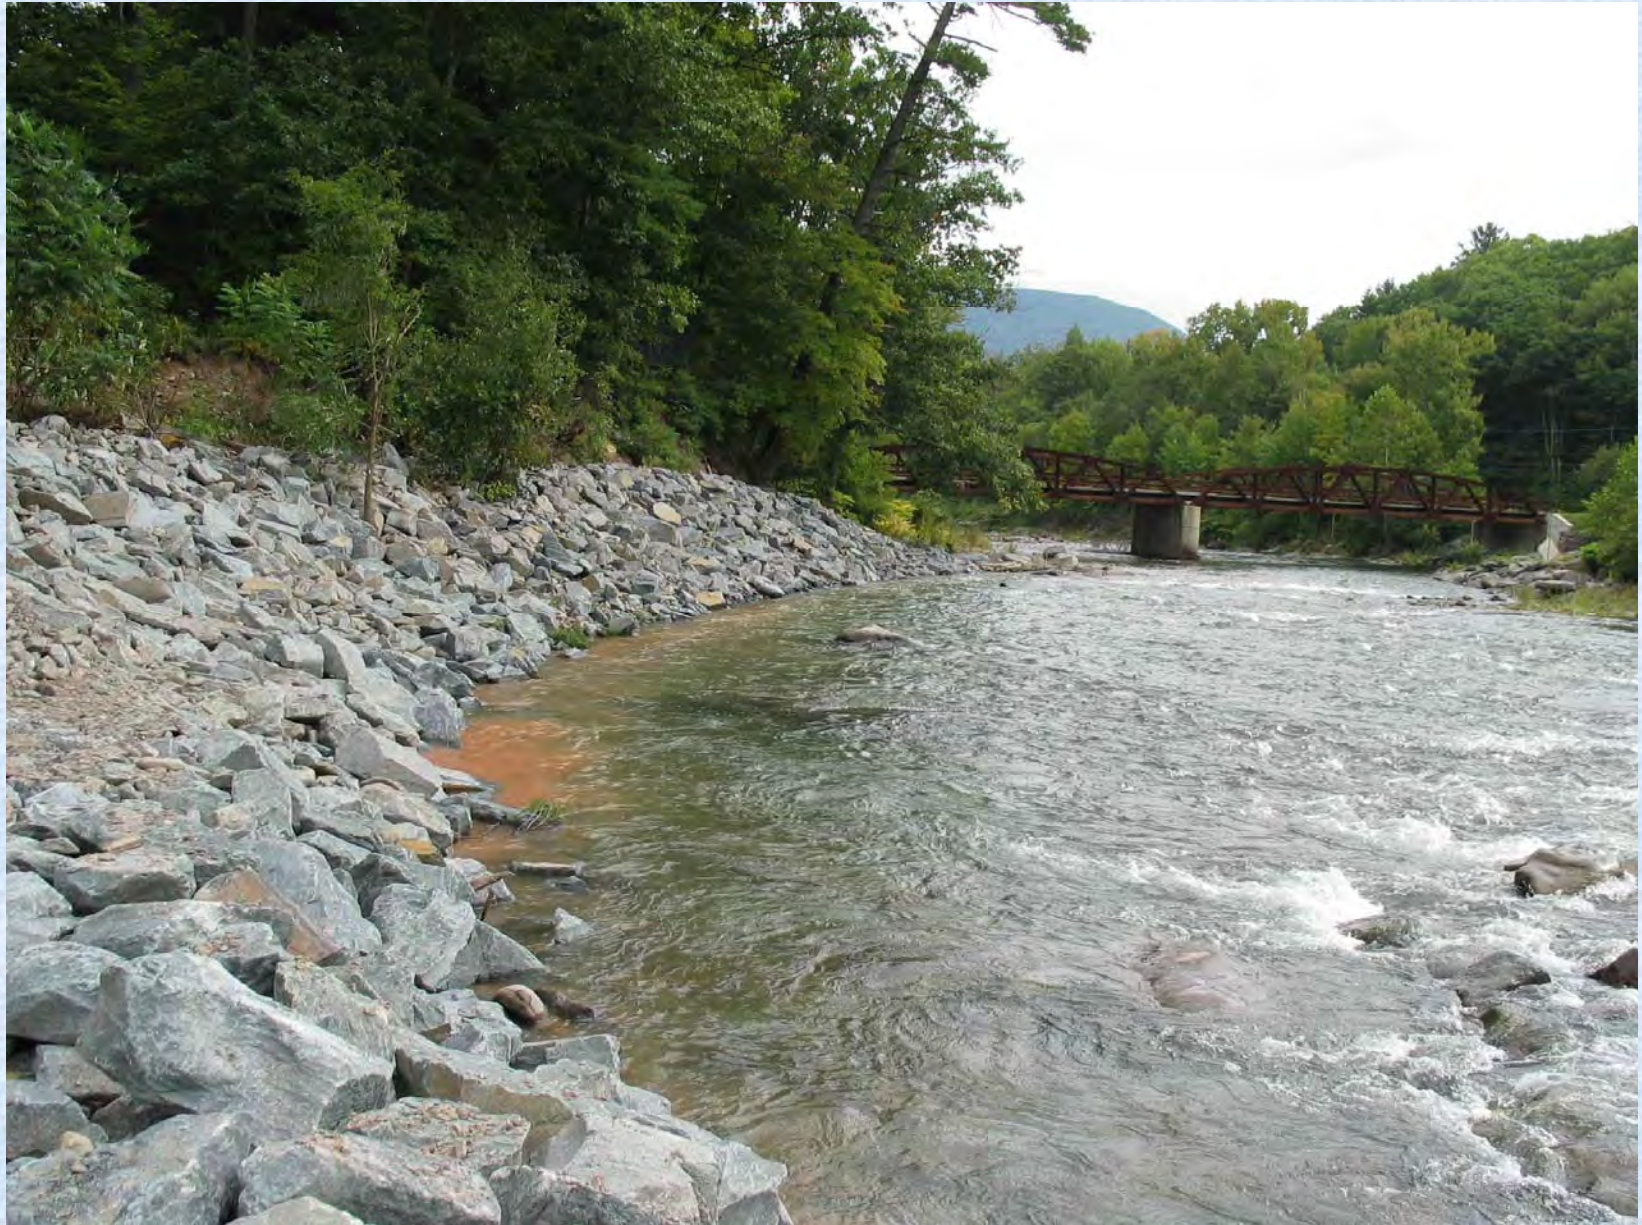
Stream bank armoring with graded rip rap

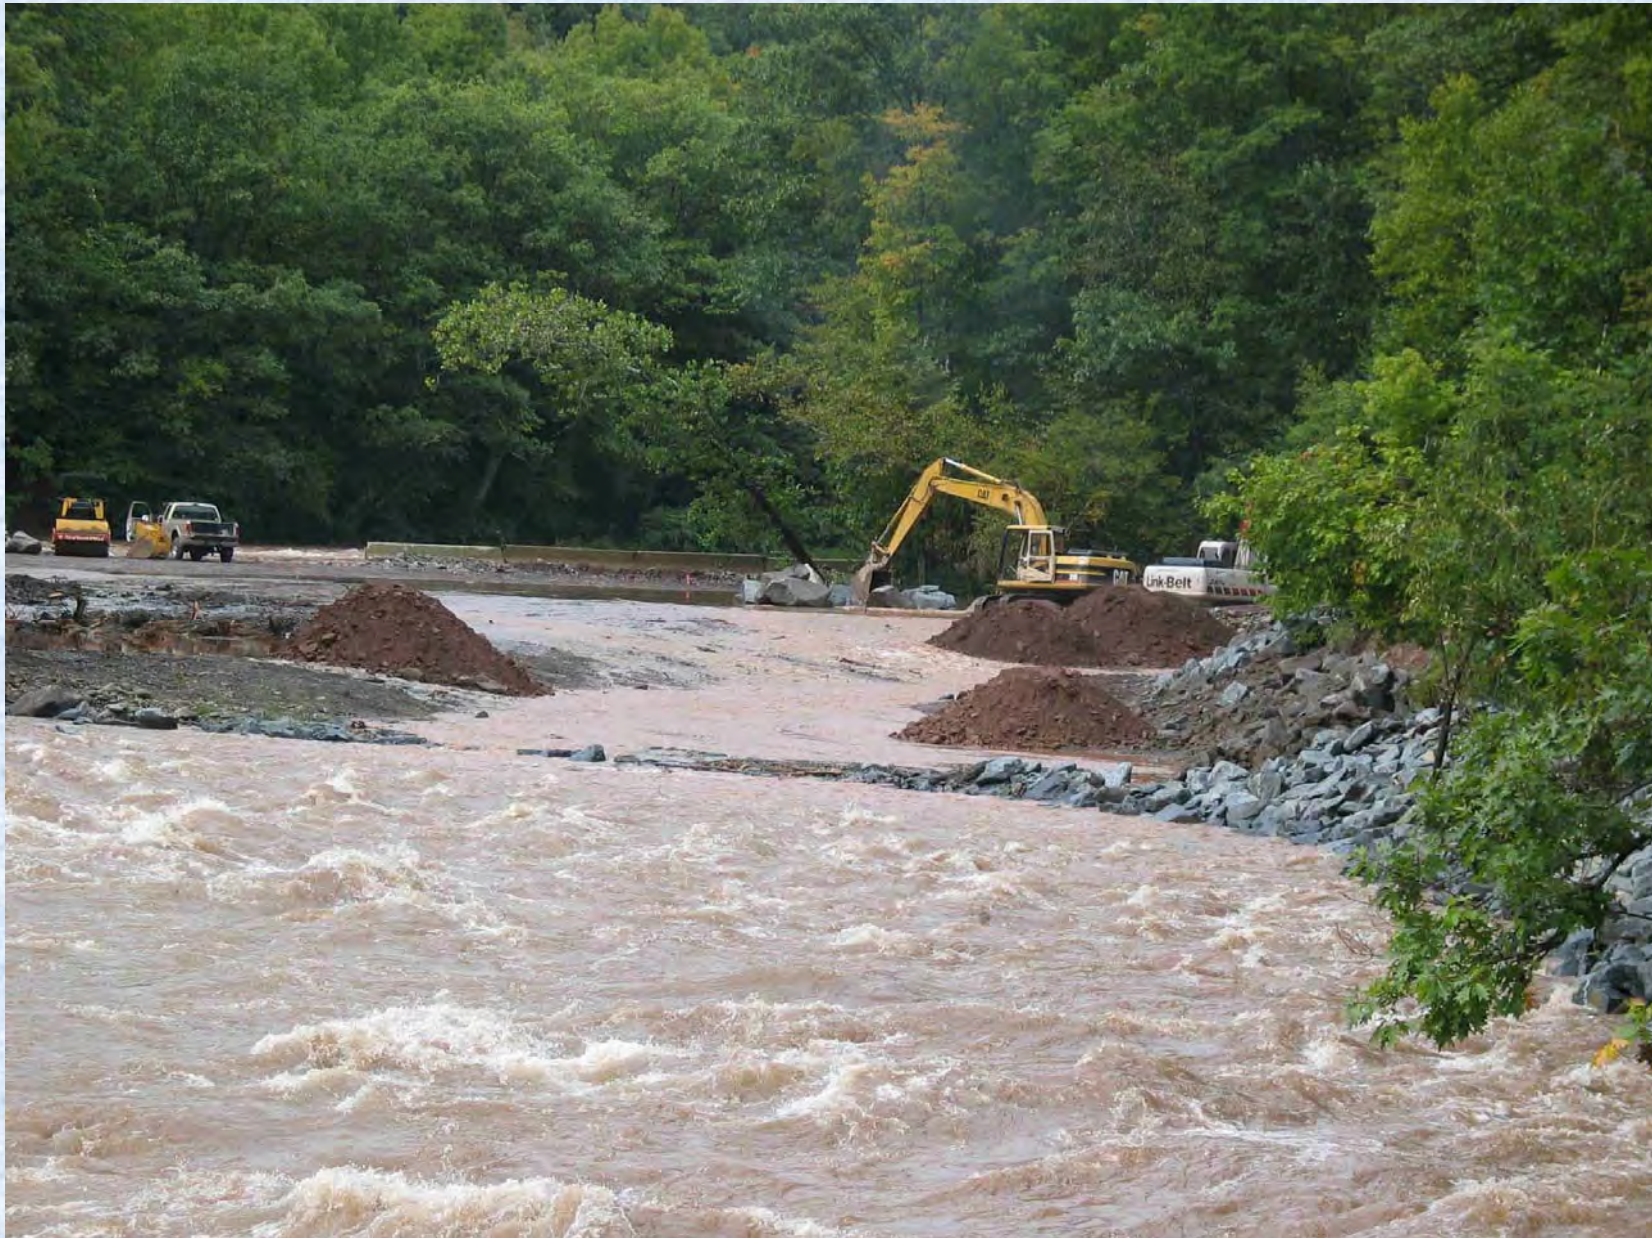
Flood flows over partially constructed floodplain

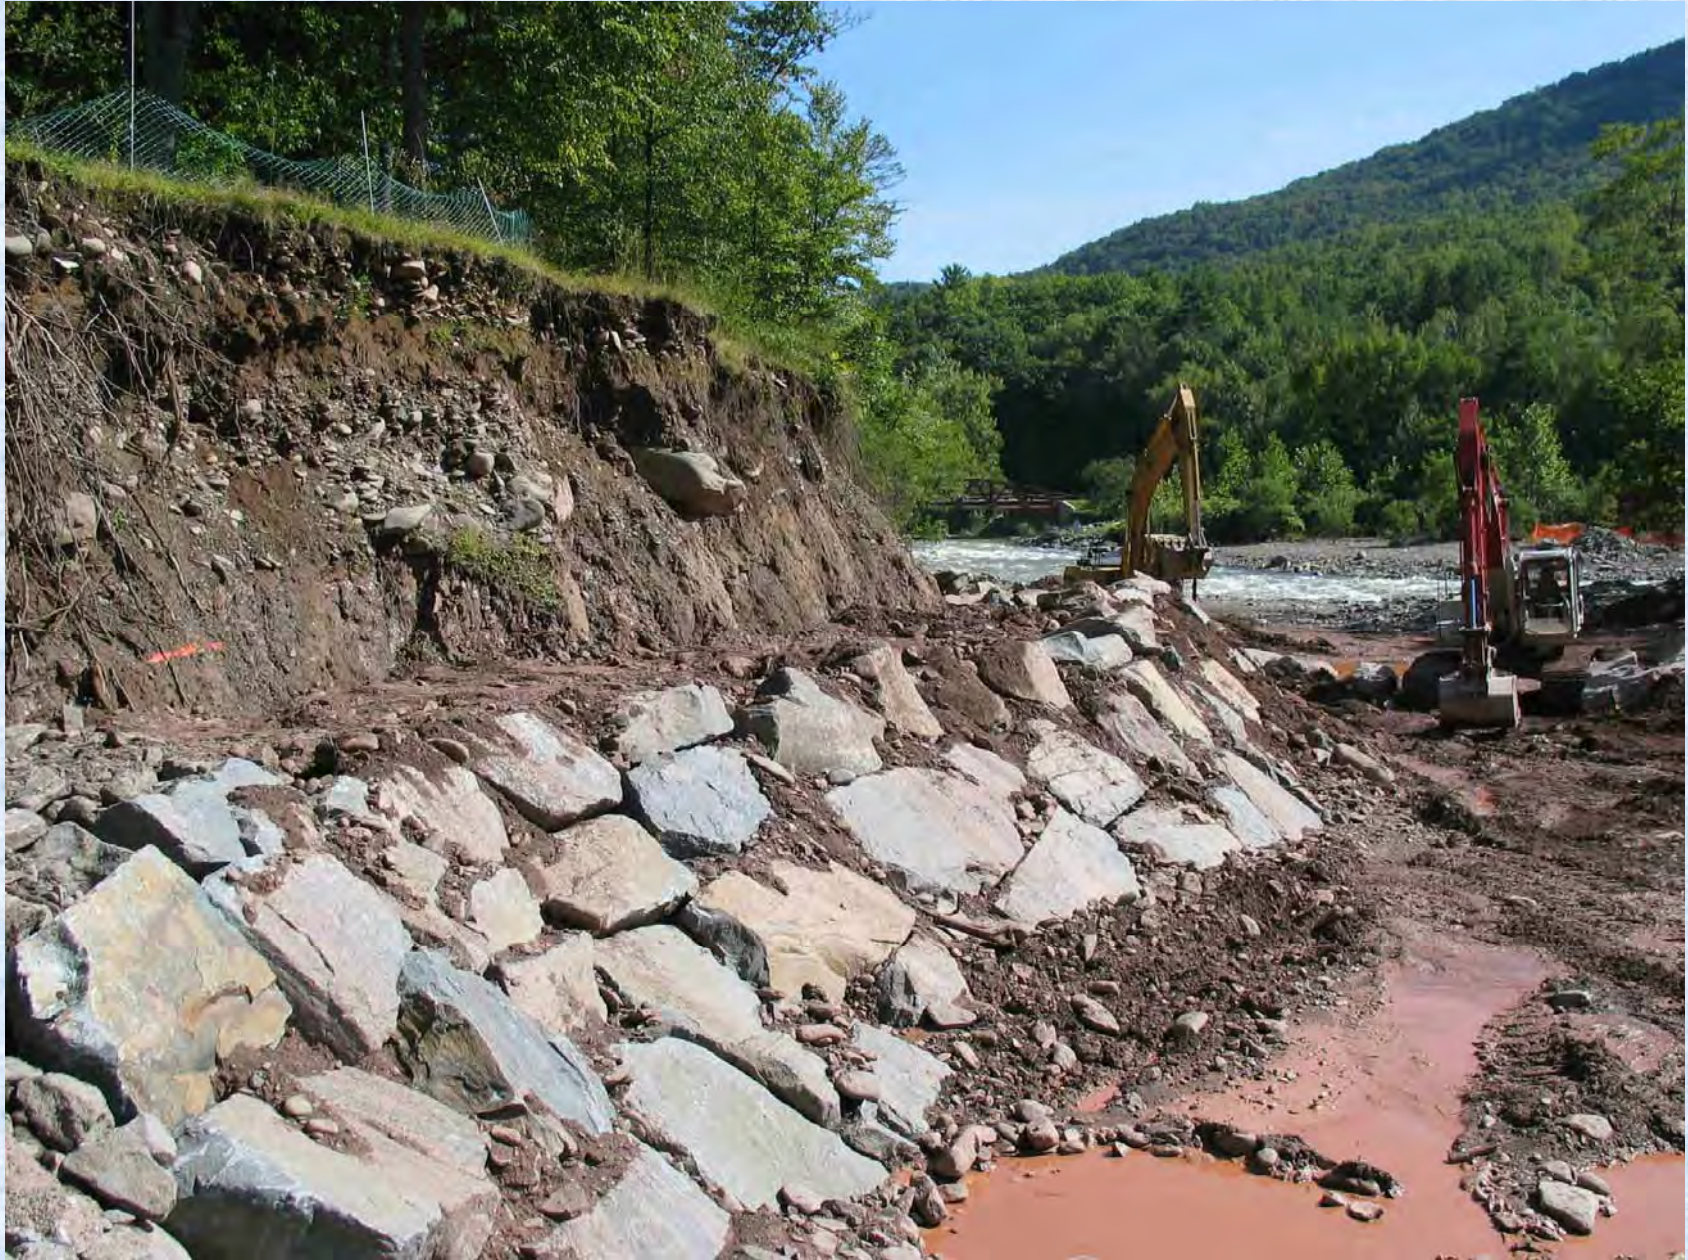
NRCS designed and installed “paved” rip rap

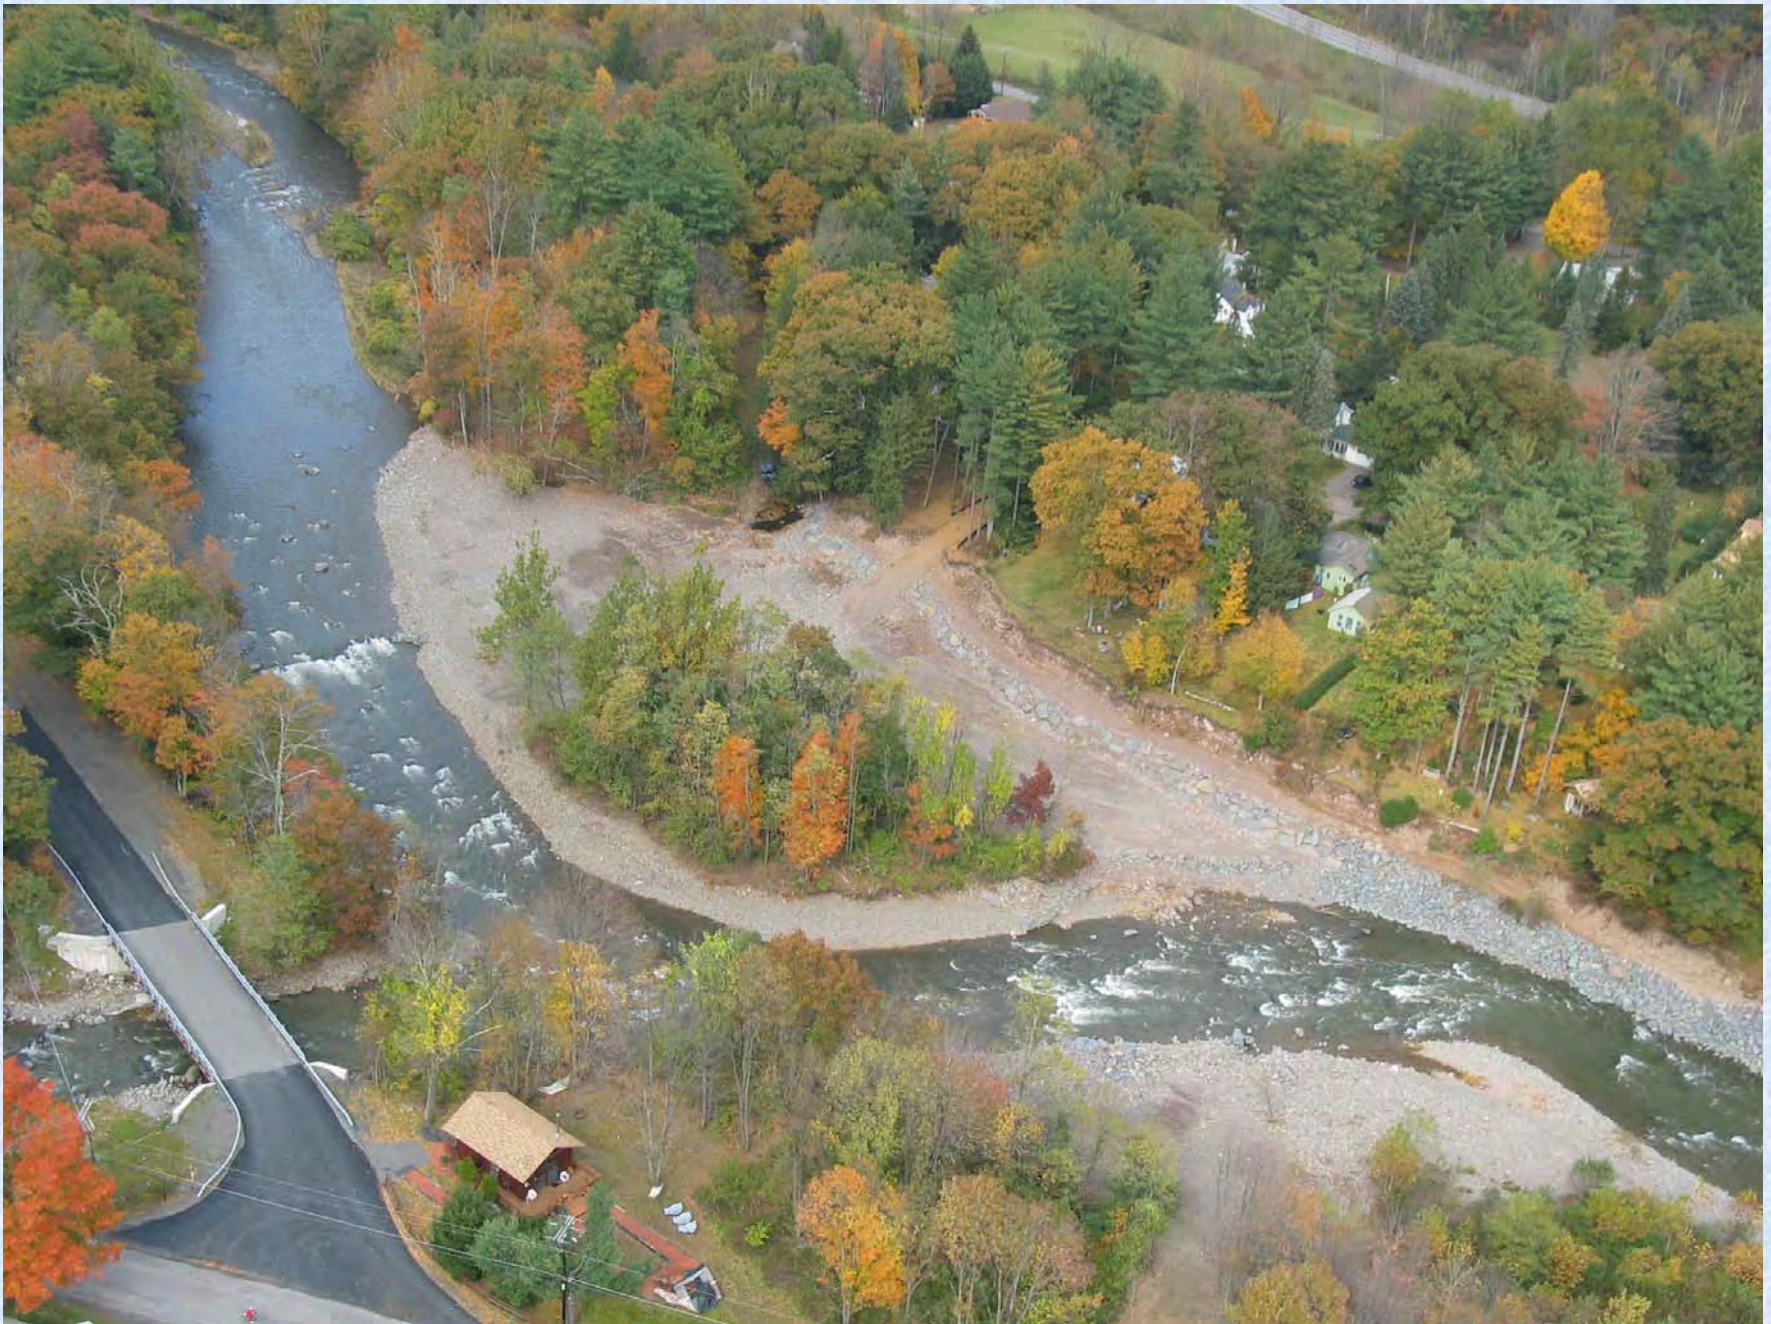
Completed channel work

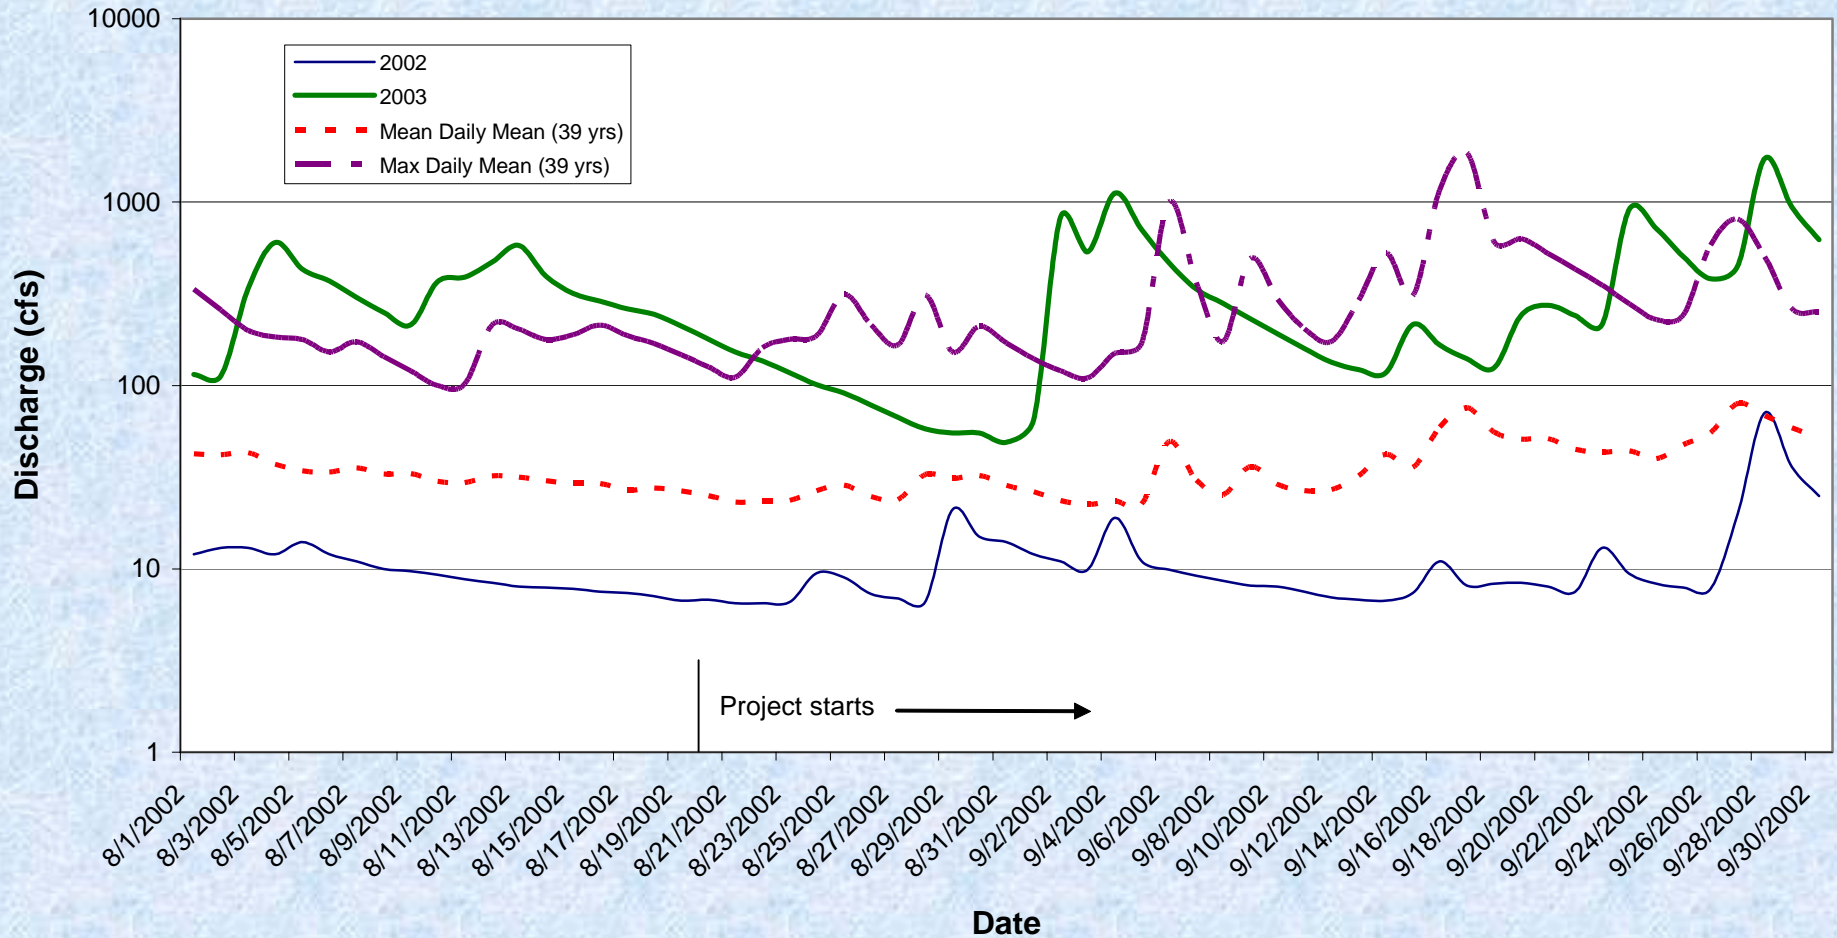
Comparison of Mean Daily Discharges at the Esopus Creek at Allaben, NY Gage during August-September

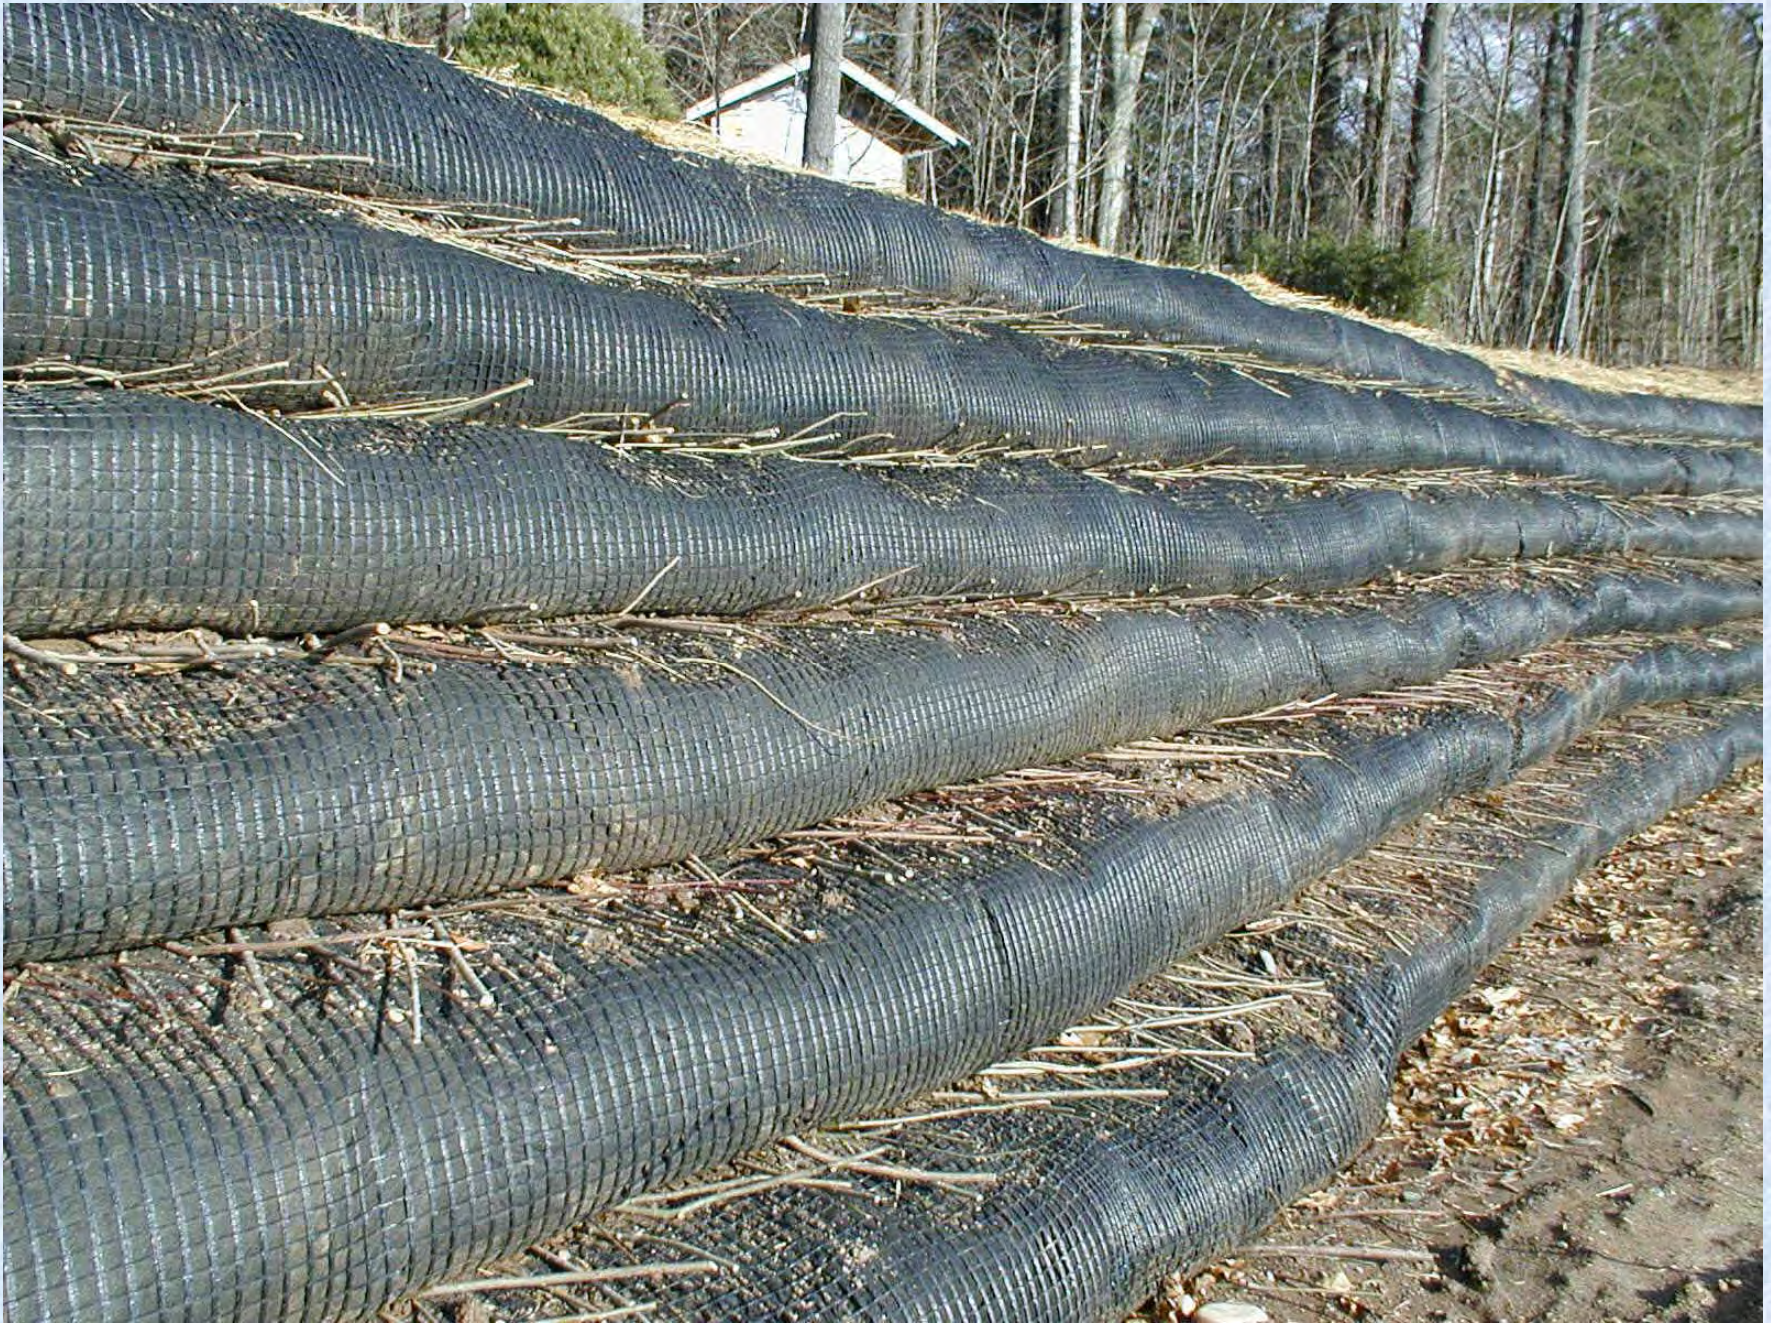
Vegetated Reinforced Soil Slope
