Esopus Creek Stream Restoration Project

Demonstrating multi-objective stream restoration and monitoring as part of the Esopus Creek Stream Management Plan

Project Construction

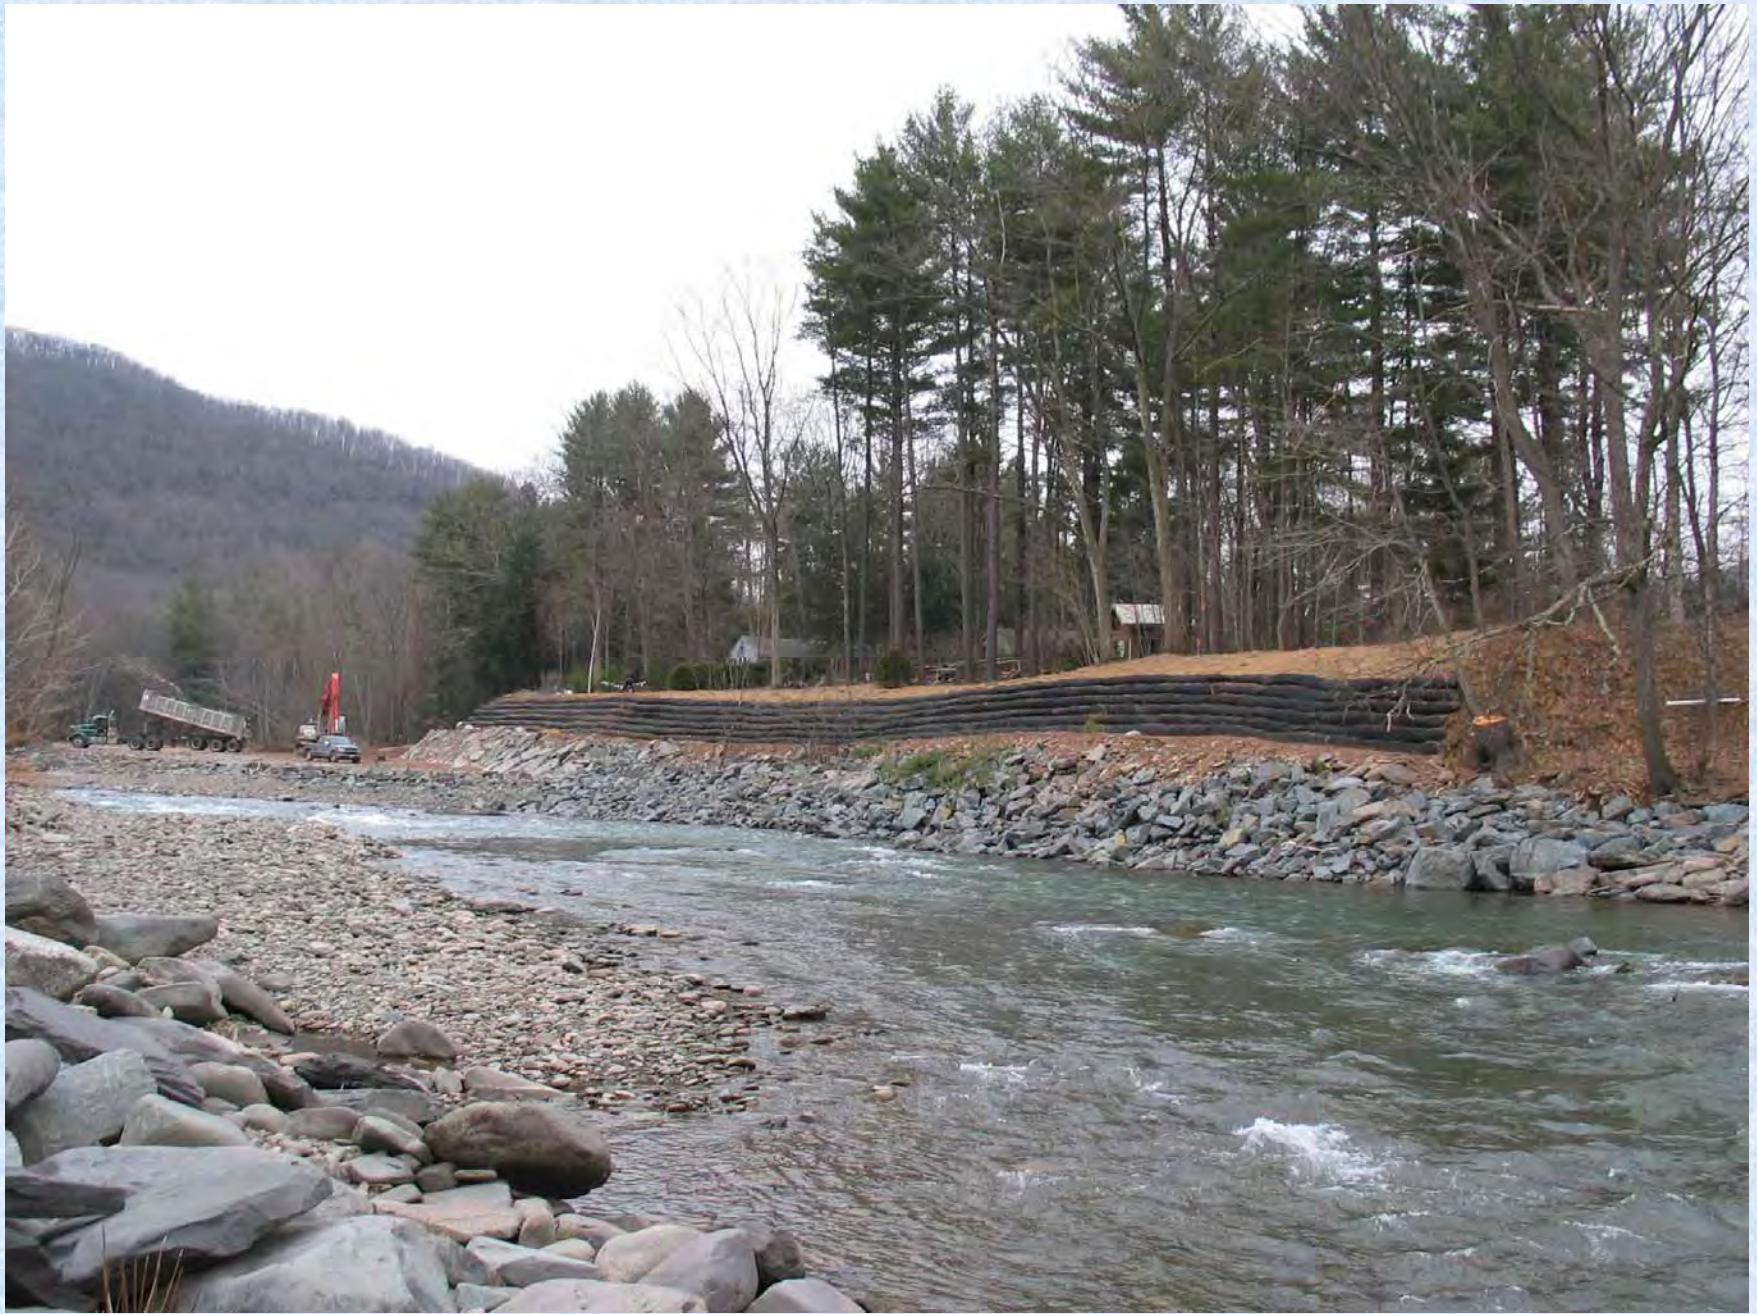
Vegetated Reinforced Soil Slope

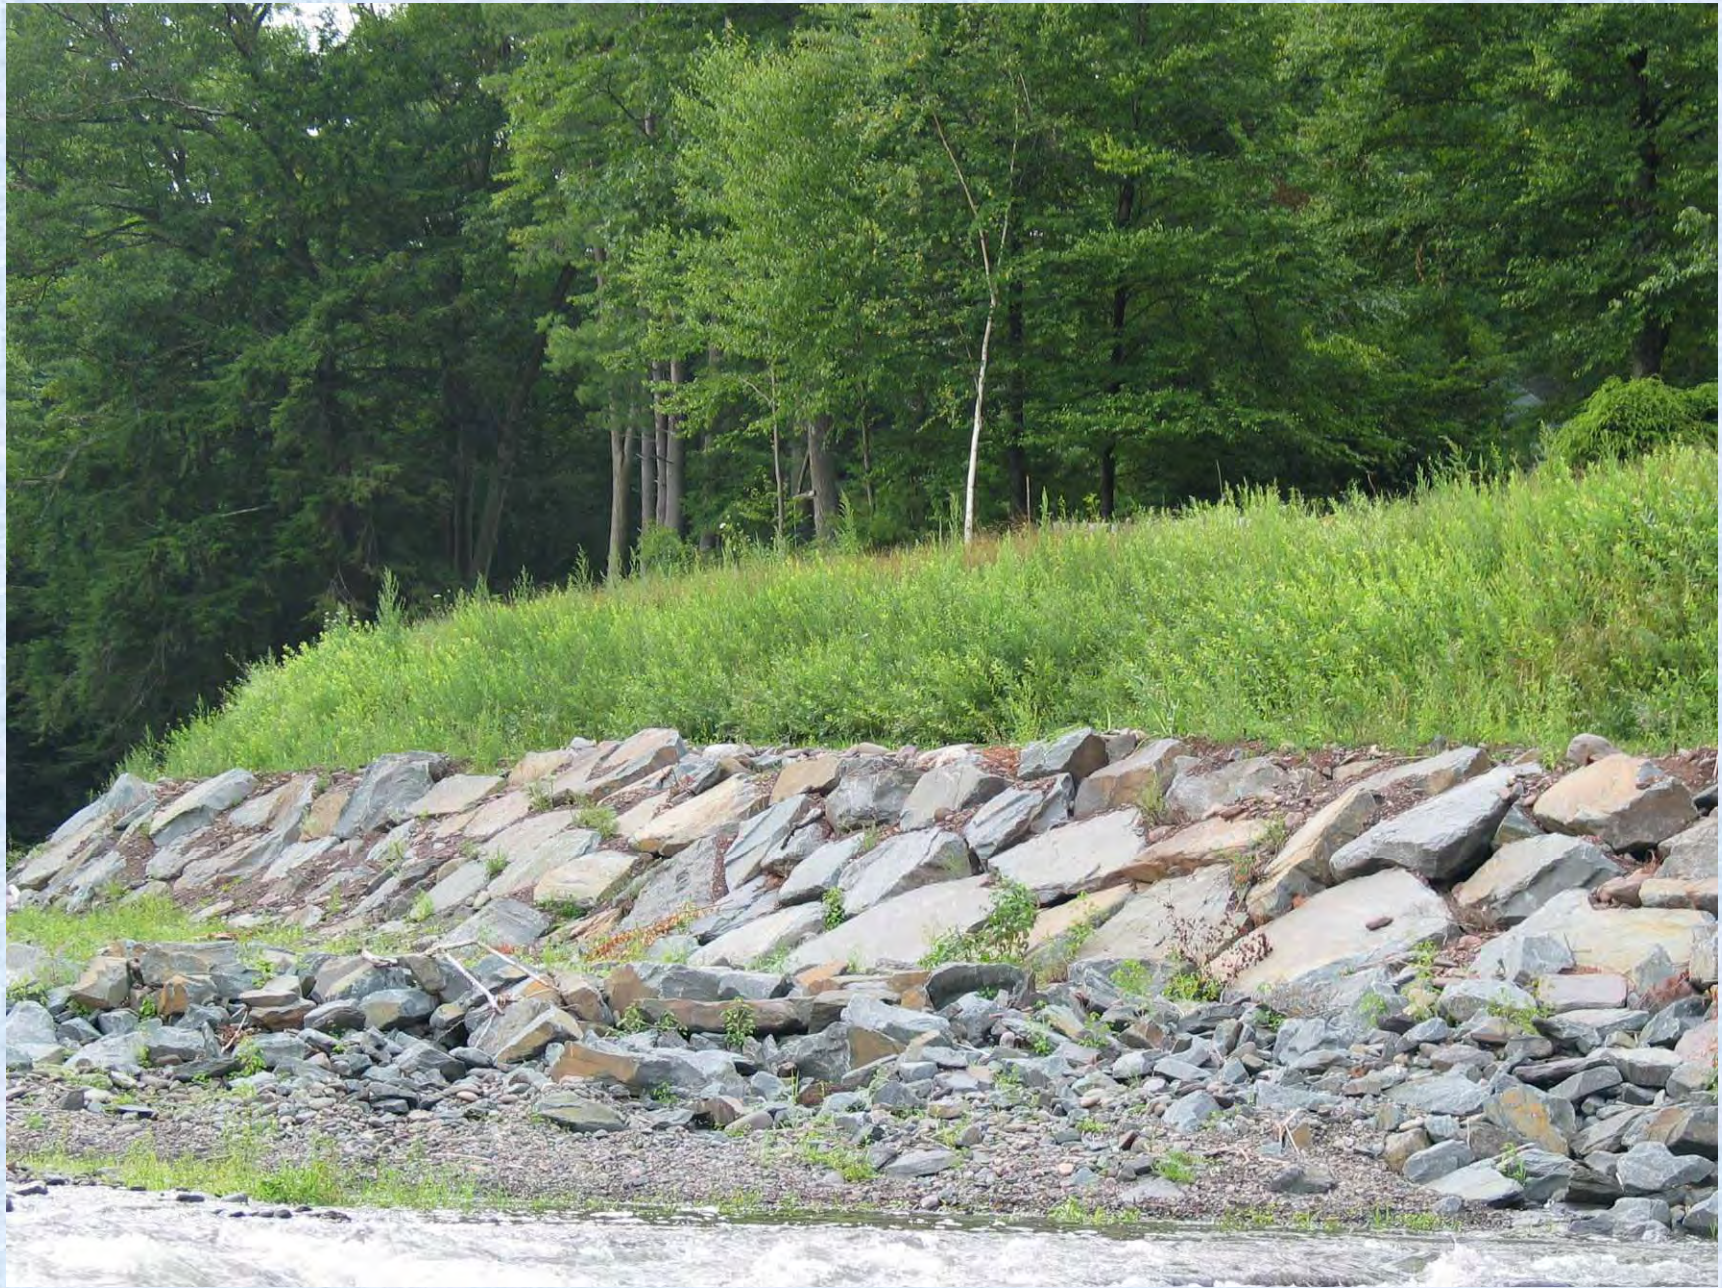
Vegetated Reinforced Soil Slope – first growing season

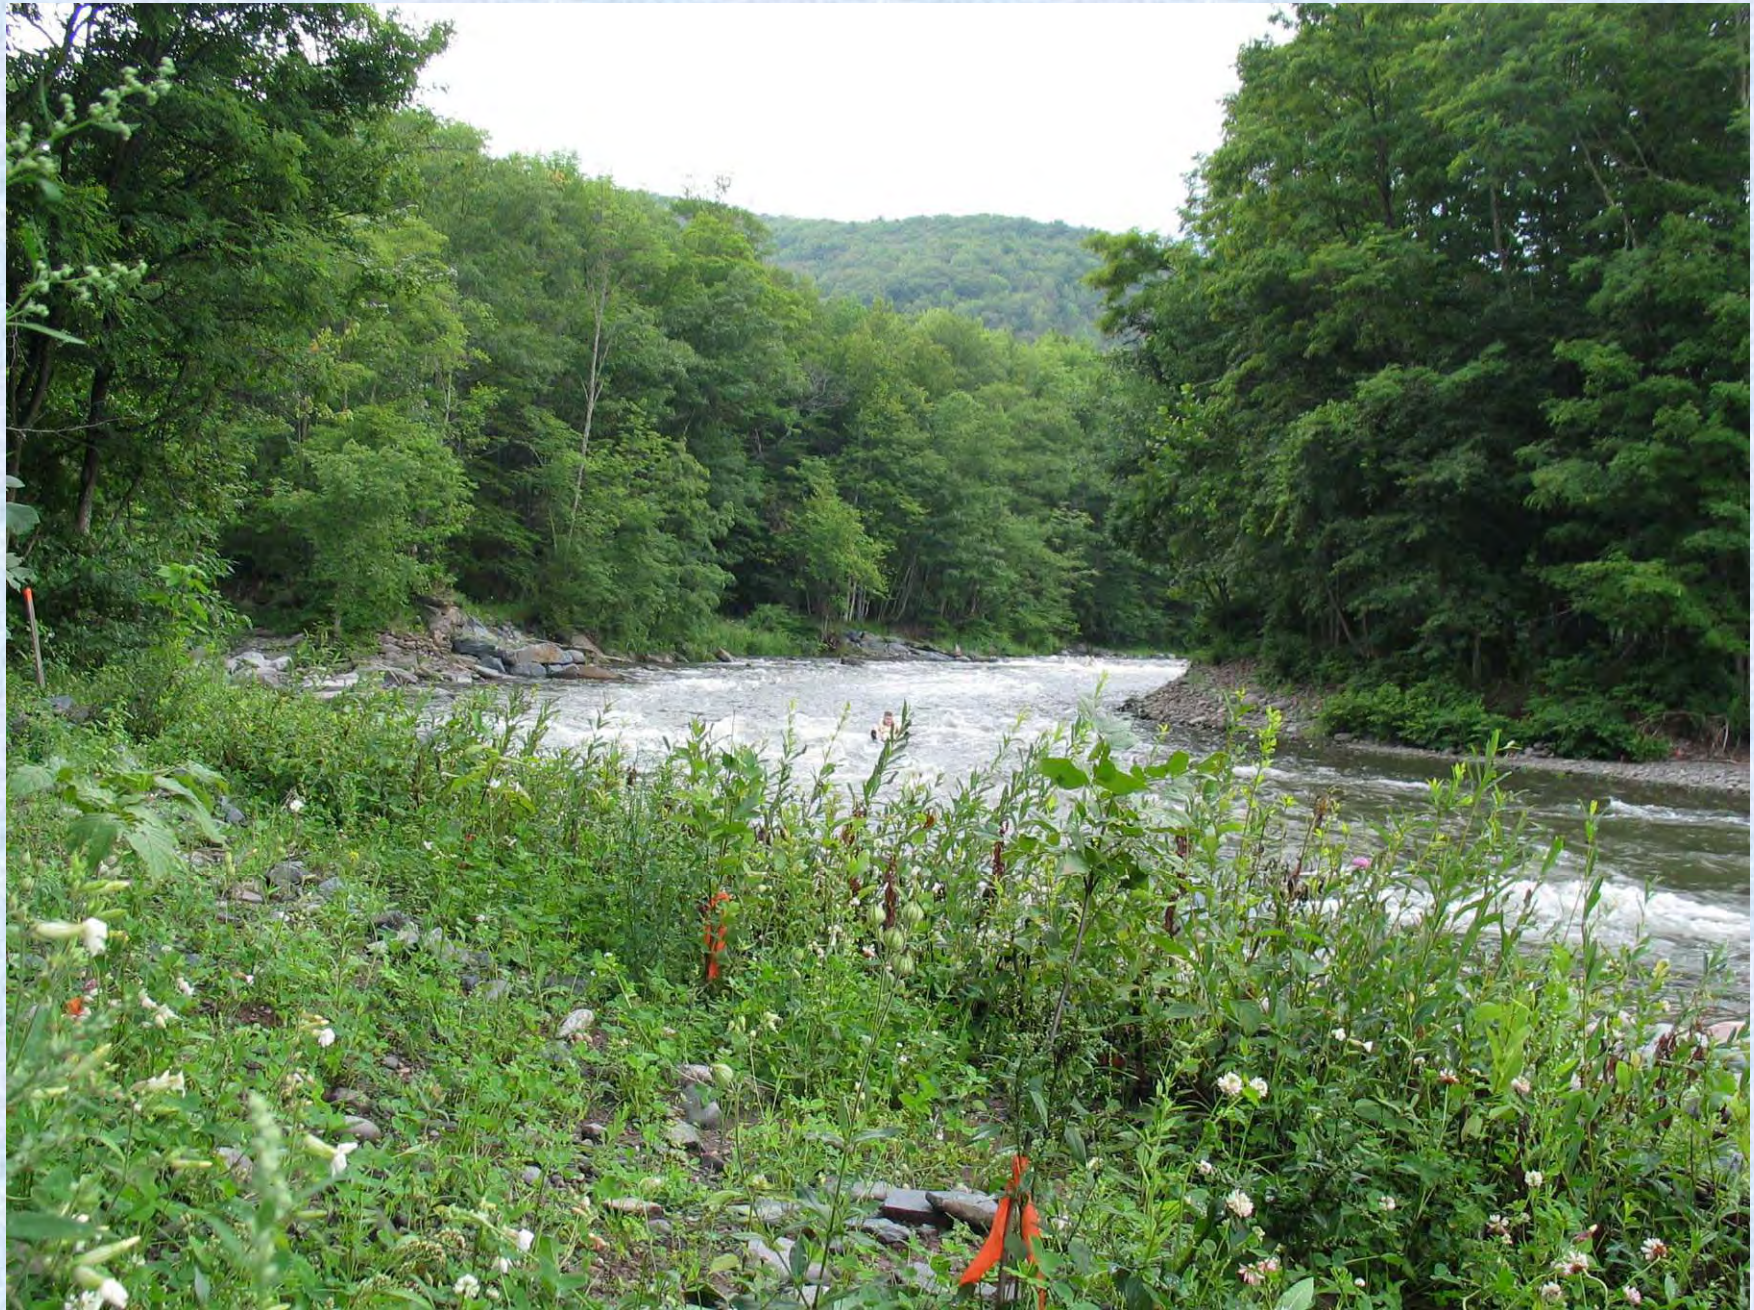
Willow fascines – first growing season

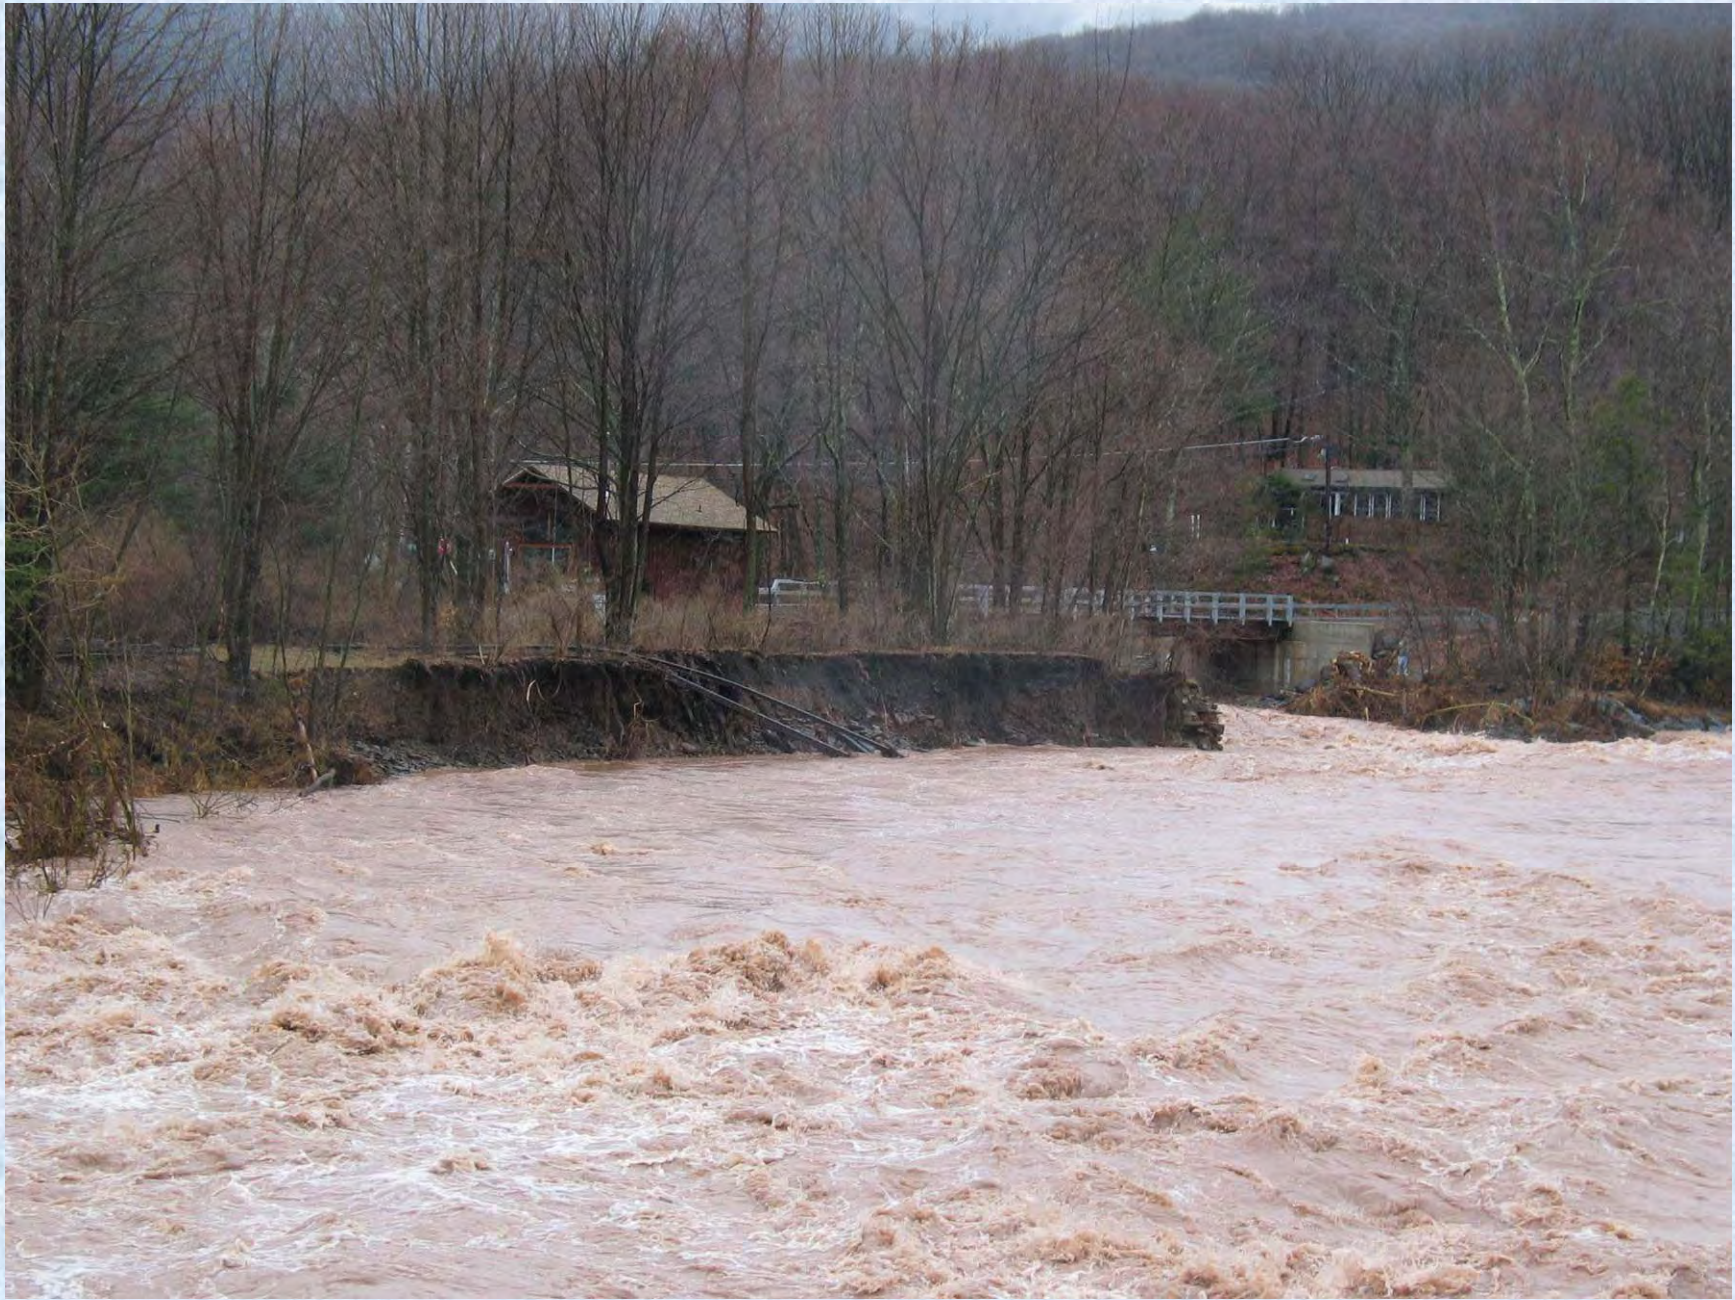
Stream bank and bed erosion

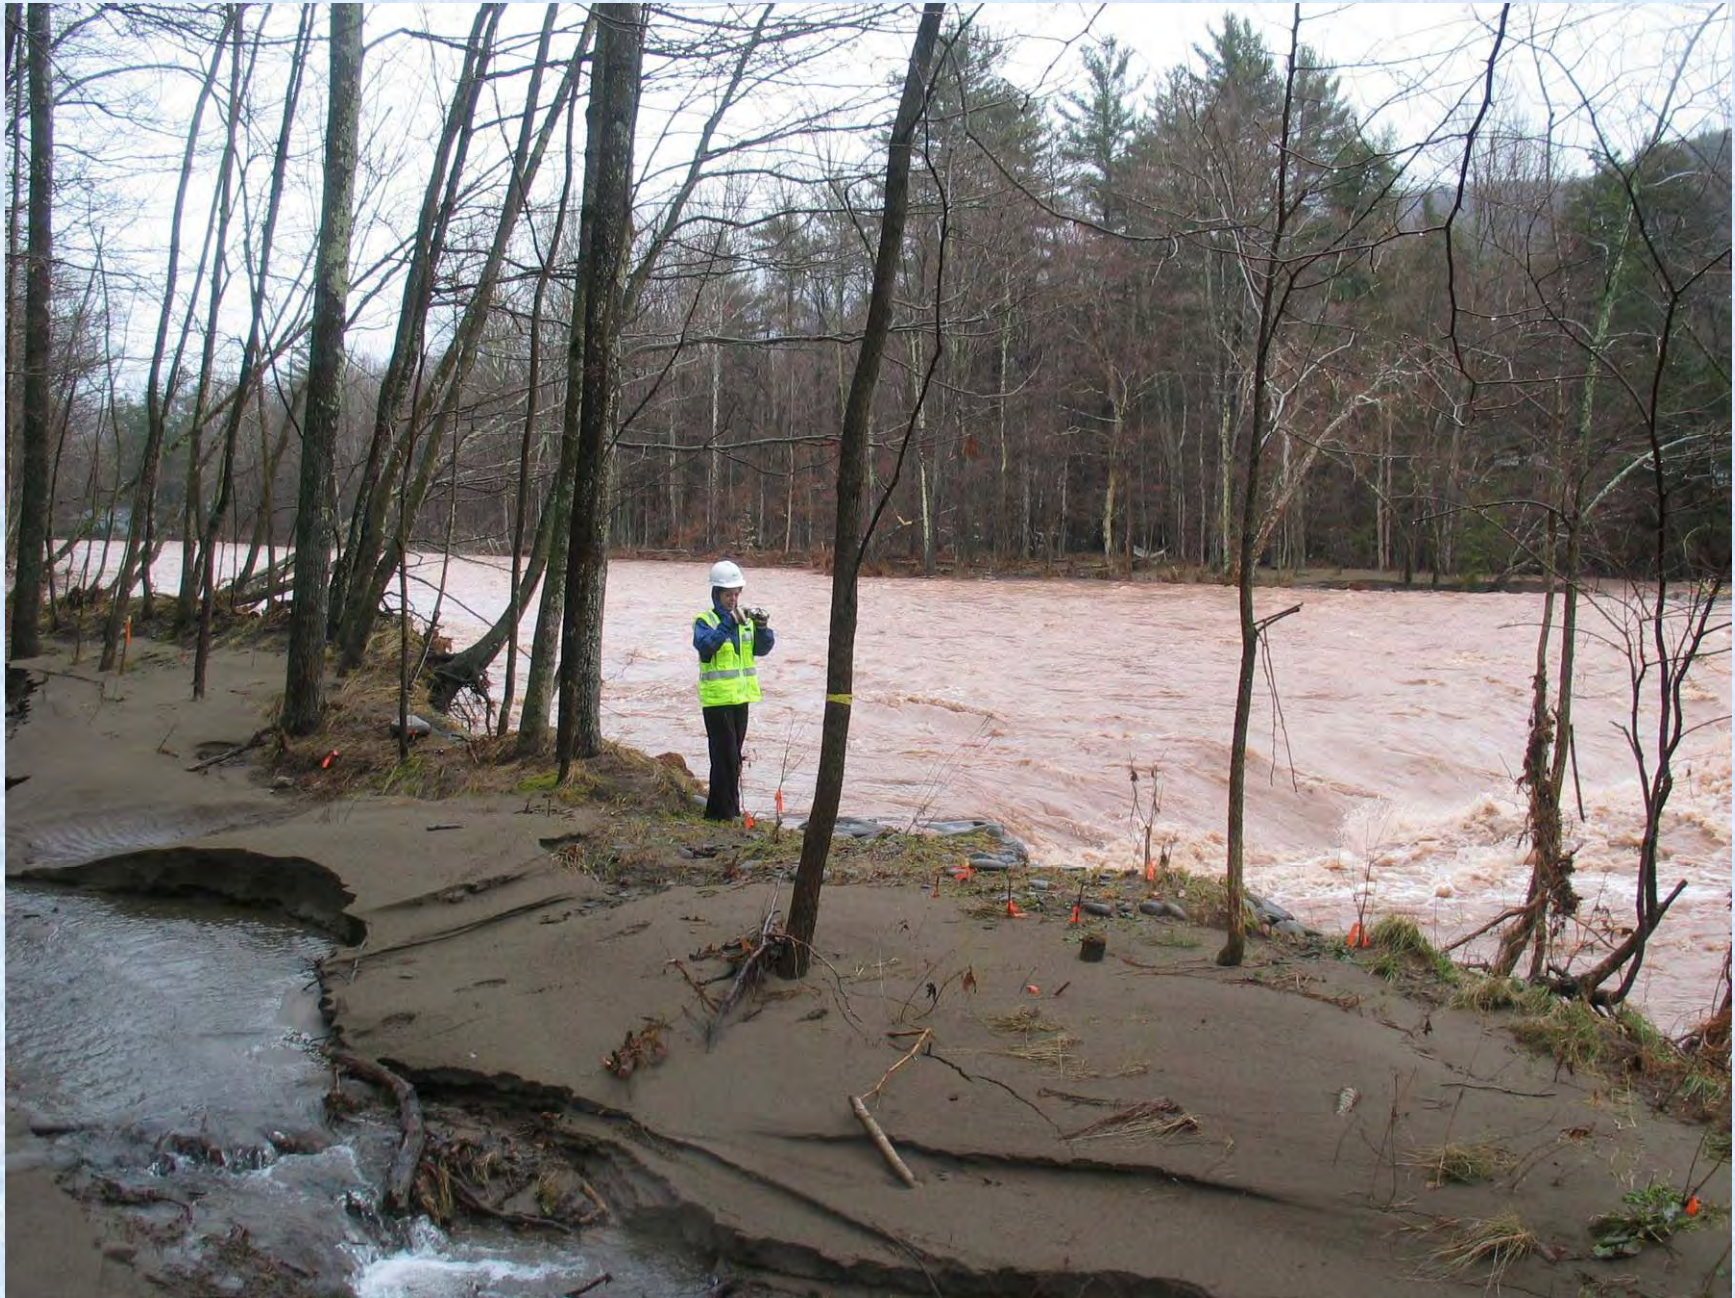
Floodplain deposition

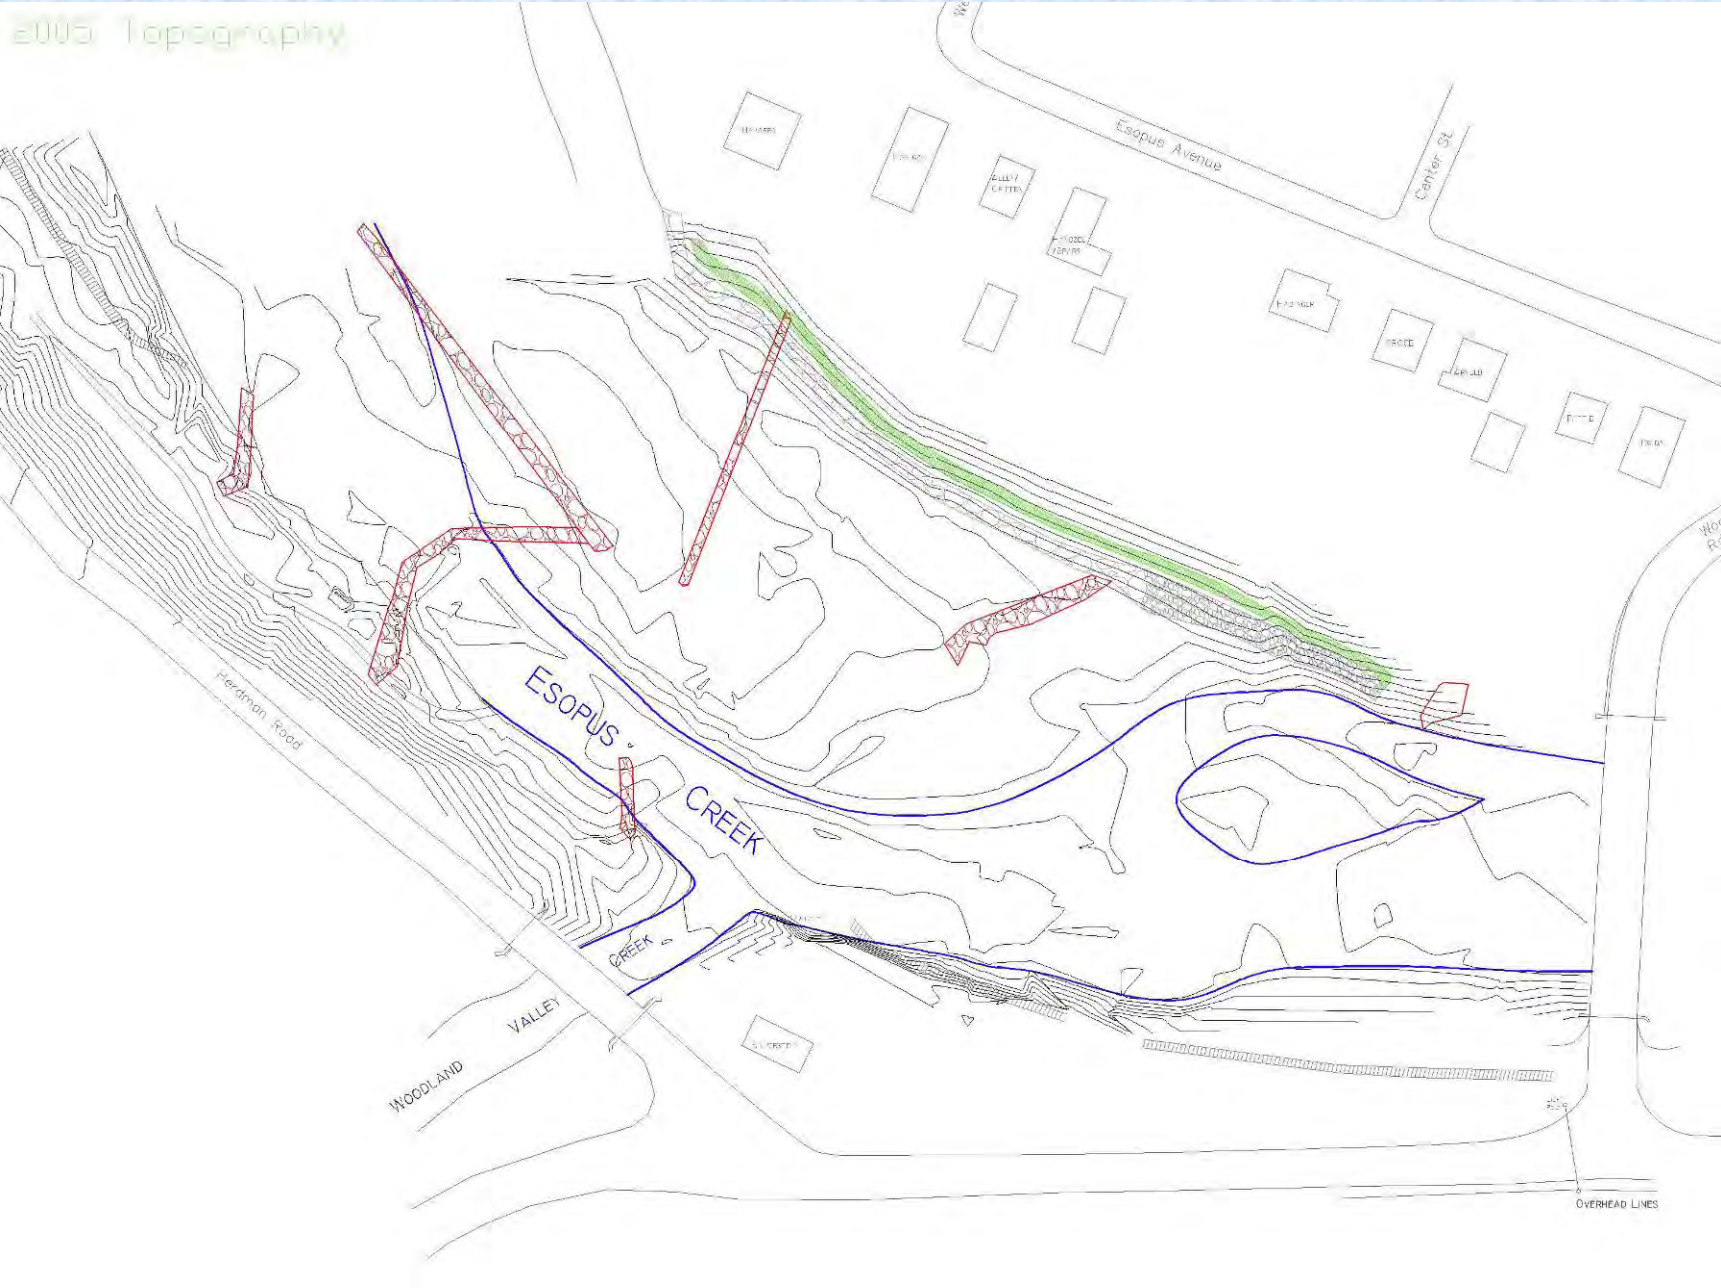
Post-Construction As-Built Survey

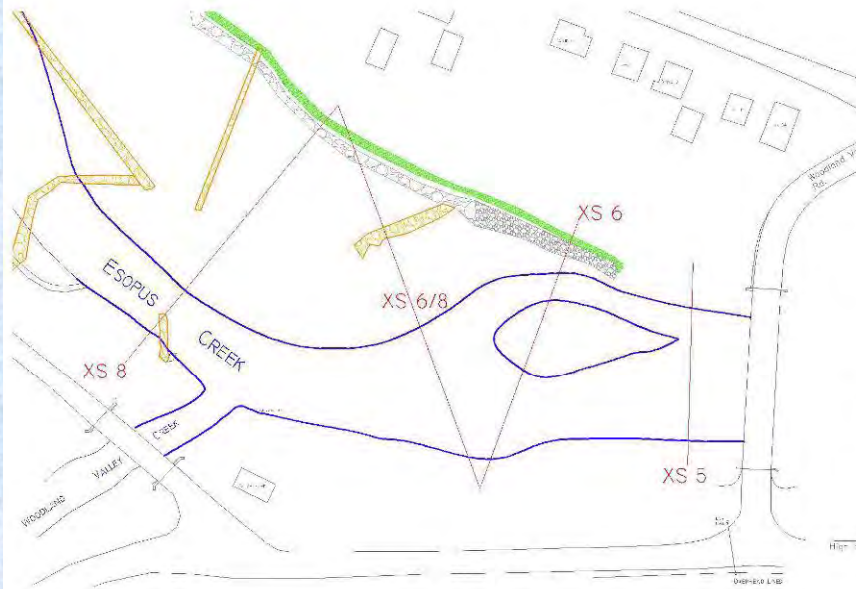
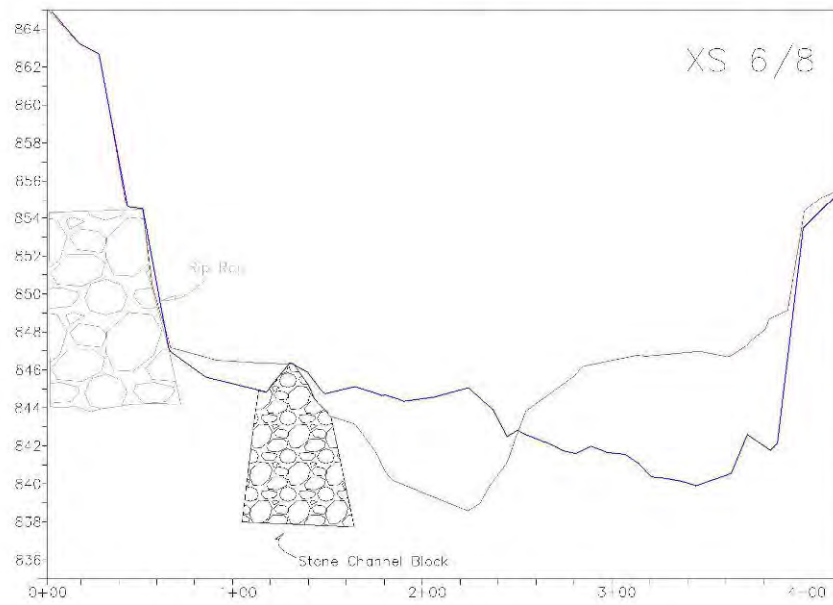
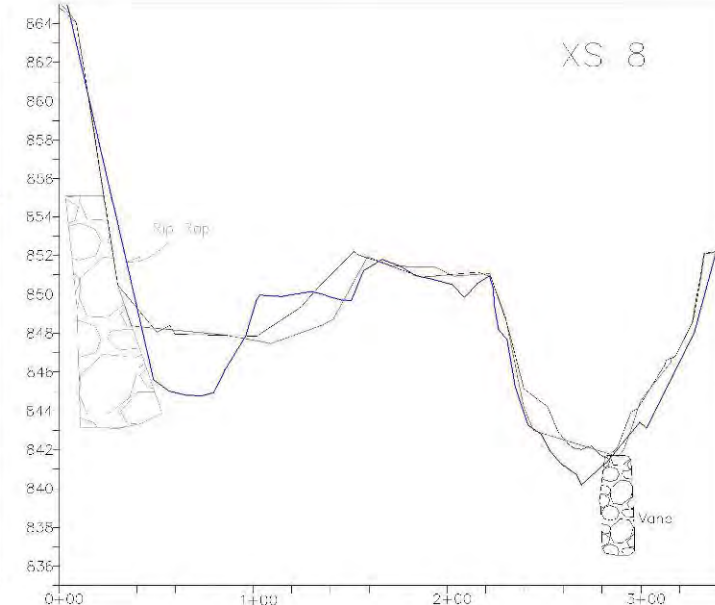
Post-Flood Hydraulic Geometry Changes
