# Upper Neversink River

*Stream Management Plan*

This plan was adopted by the Towns of Denning and Neversink in February 2013.

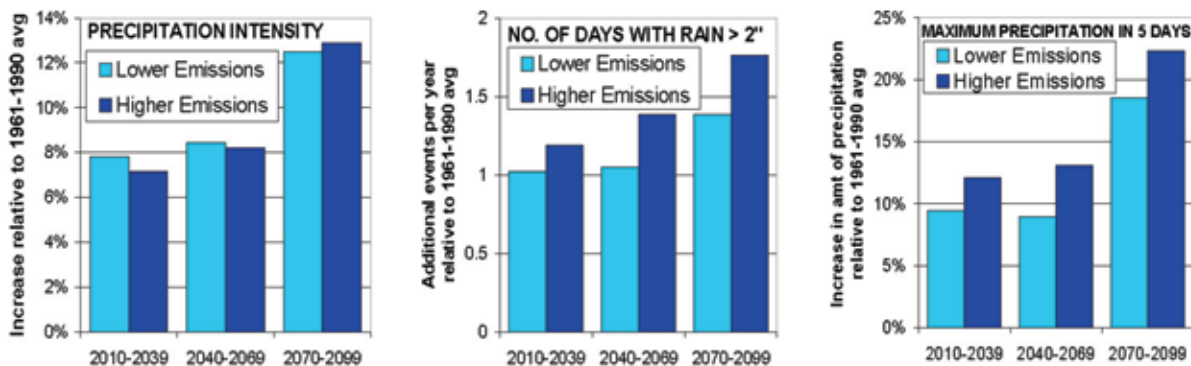
*Projected increases in three indices of extreme precipitation: (1) precipitation intensity, (2) number of days per year with more than two inches of rain, and (3) maximum amount of precipitation to fall during a five day period each year (Frumhoff et al., 2006)*

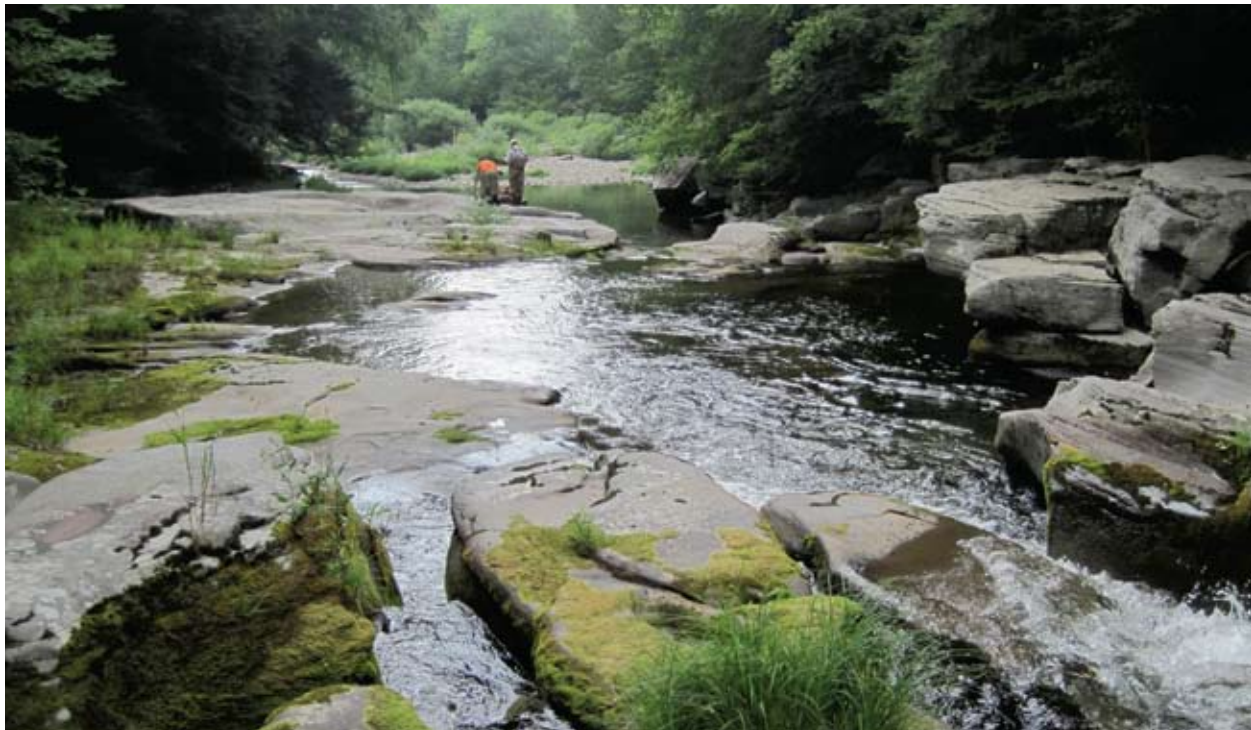
*Bedrock reach along the West Branch Neversink River*

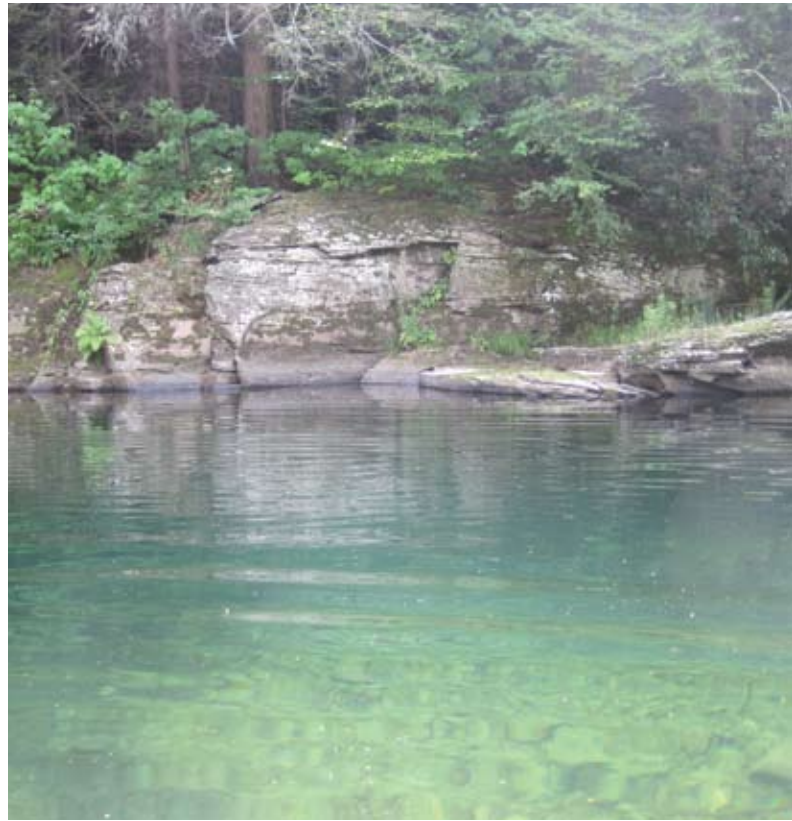
*Bedrock planform control along the West Branch Neversink River*

Most of the stream valleys draining the Southern Escarpment are oriented NE-SW, bisecting the two predominant bedrock fracture orientations. This orientation is principally based on pre-glacial erosion of the landscape, which was controlled by the fractured, very gently southwest dipping bedrock. The orientation of stream valleys is important, influencing the microclimate, average depth of snowpack and local hydrological regime in many ways.

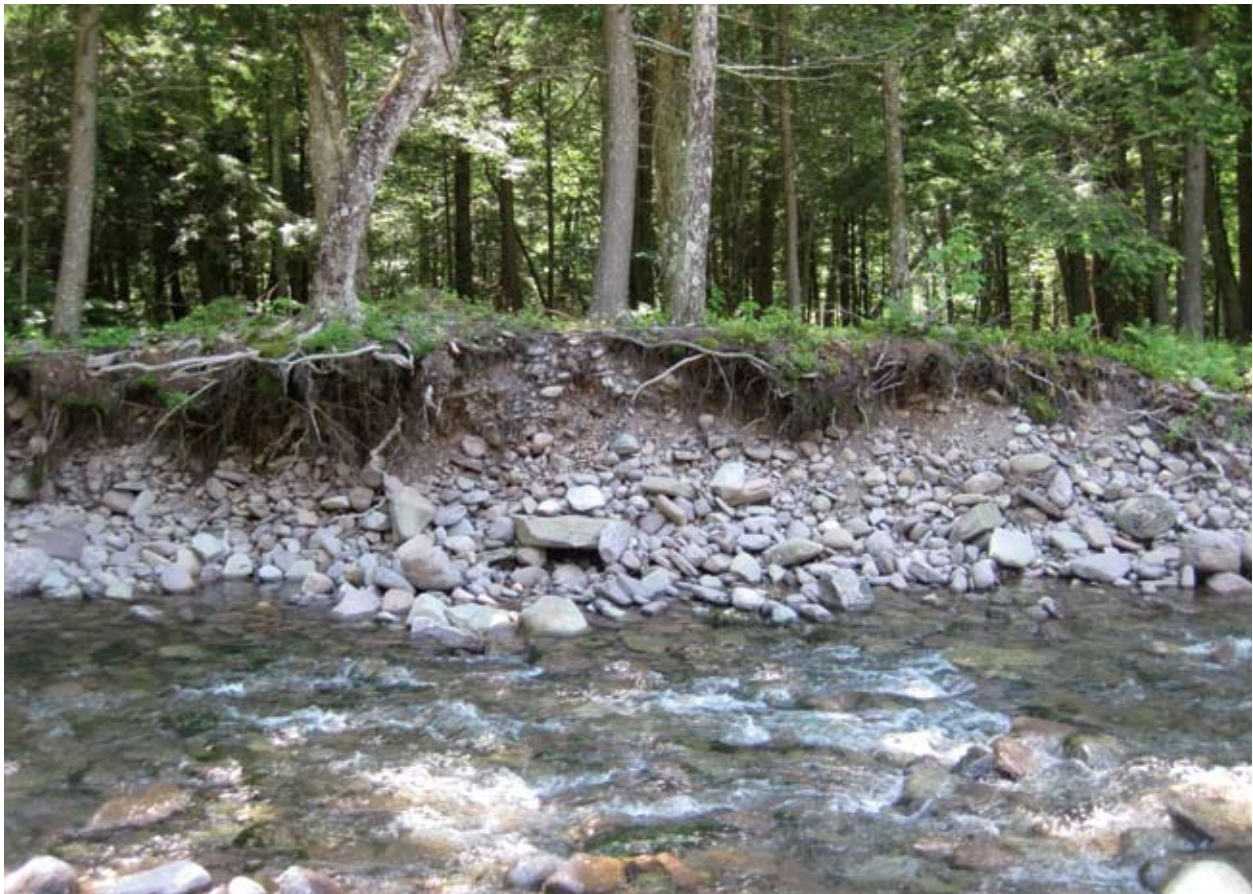
*Alluvial (stream-deposited) material exposed in an eroding bank*

Following deglaciation, streams became the acting geomorphic agent in the valley bottoms, re-working much of the glacial sediment into Holocene alluvium. Much of the active stream corridor is floored with this alluvial material typically ranging in sediment size from sand to boulders (*pictured below*).

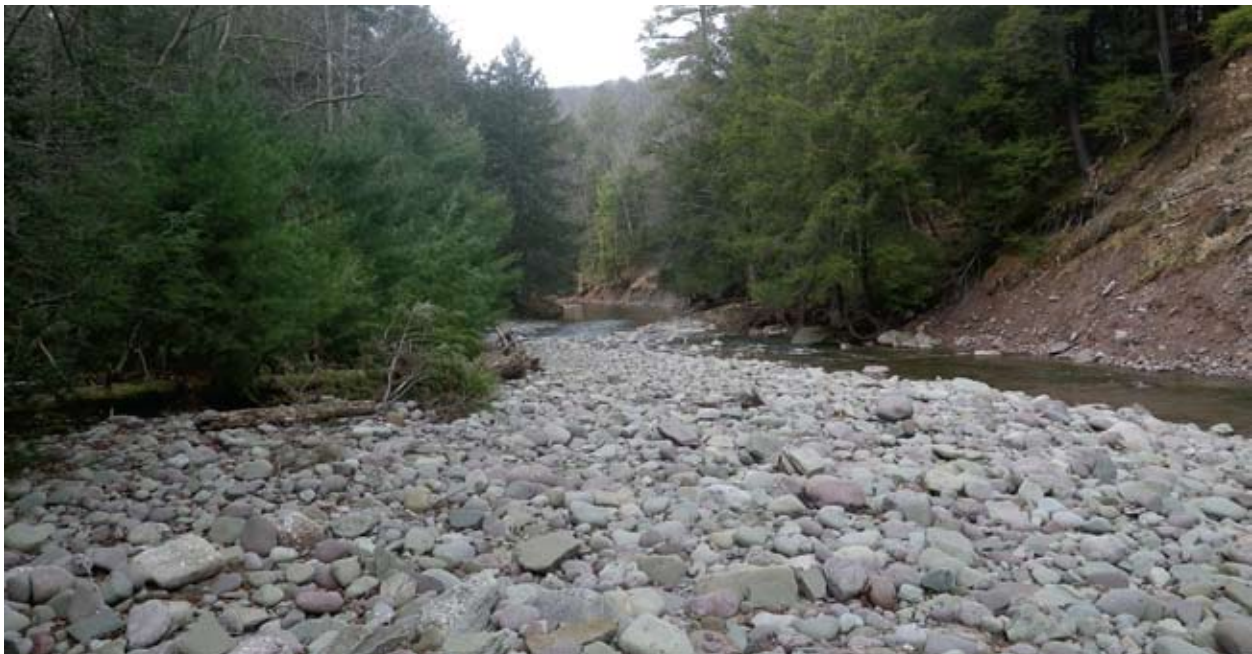
*Example of imbricated Catskill stream sediment*

Imbricated streambeds are thus generally more stable or "locked up", and all other things being equal, generally require a larger flow to mobilize the bed material than nonimbricated beds. However this same platy shape can also, under the right conditions, act like an airplane wing and be lifted by the streamflow more readily than would a spherical particle of similar weight. Once this occurs for even a few particles, the imbrication is compromised and significant portions of the streambed become mobile.

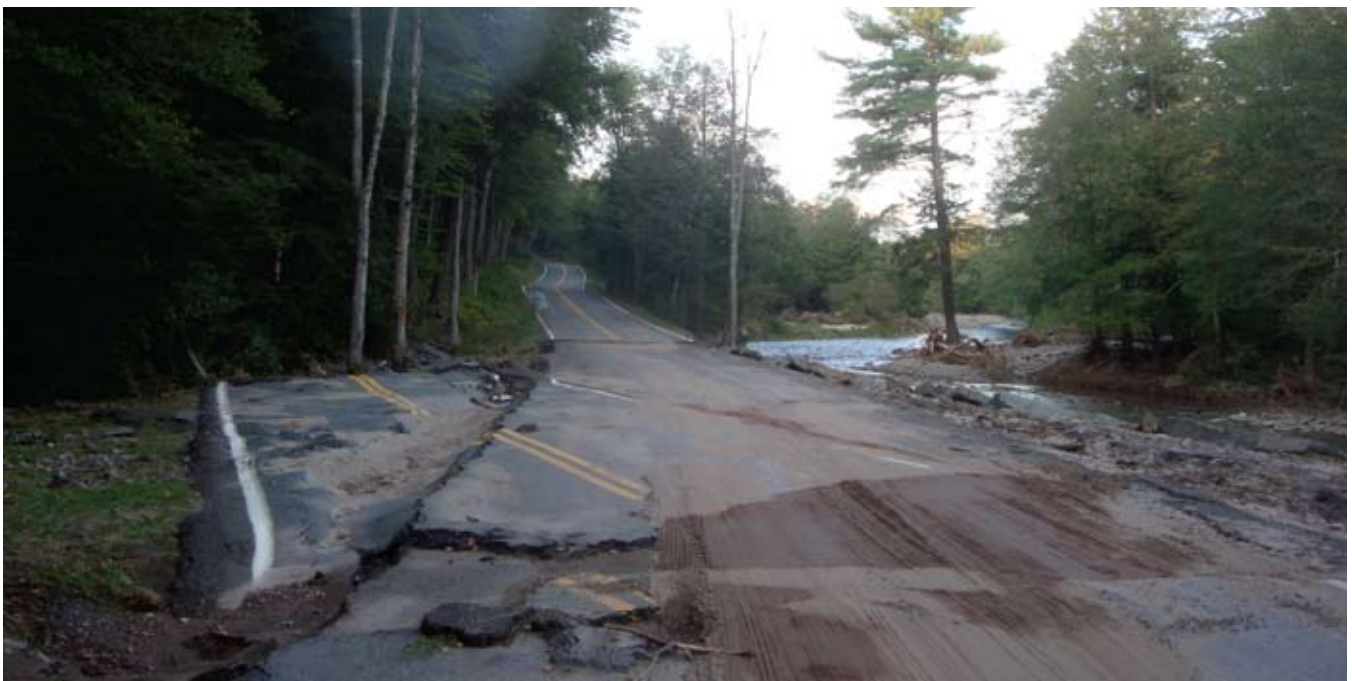
*Floods cause repeated damage to County Road 47; this photo August 2011.*

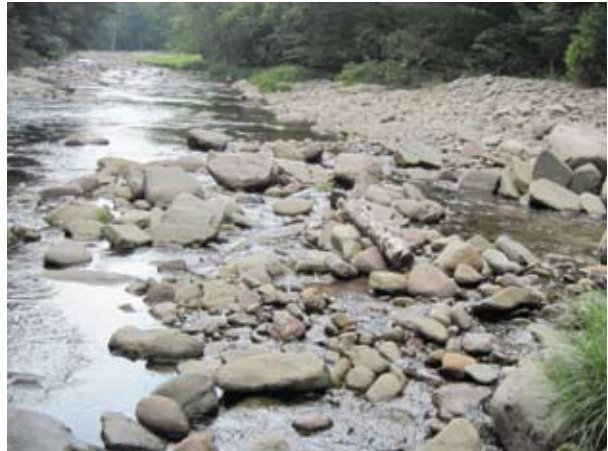
*Cobble delta bar in main channel at confluence (A224)*

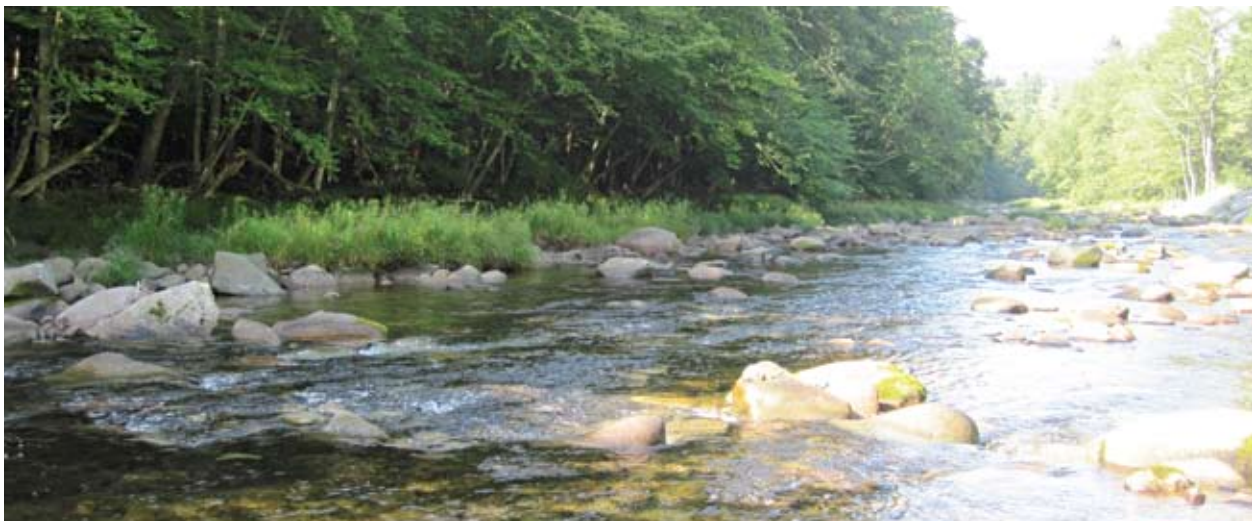
*Cobble bankfull bench (A228)*

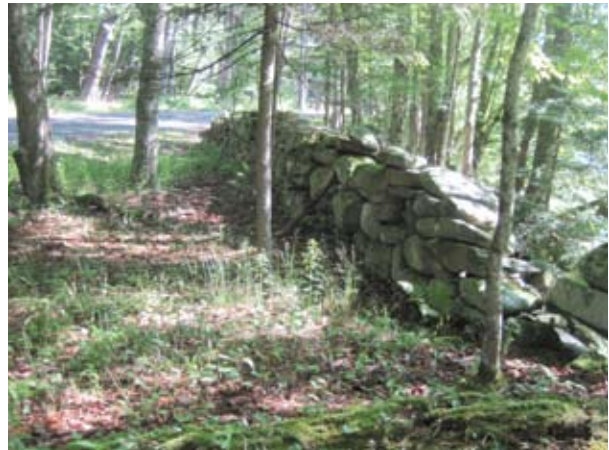
*Actively maintained berm on right floodplain (A237)*

At Station 13900 a 115-foot stone berm was observed in the thick forested riparian buffer between a flood chute in the right floodplain and Frost Valley Road. The berm appeared to be actively maintained as evidenced by recently placed stones. Some scour was observed on the right bank at the downstream end of the berm indicating that the flood chute conveys flow during high flow events. (A237 and A235) A headcut was observed in the main channel near at large boulder at Station 13800 that has caused a minor drop in stream grade at this location.

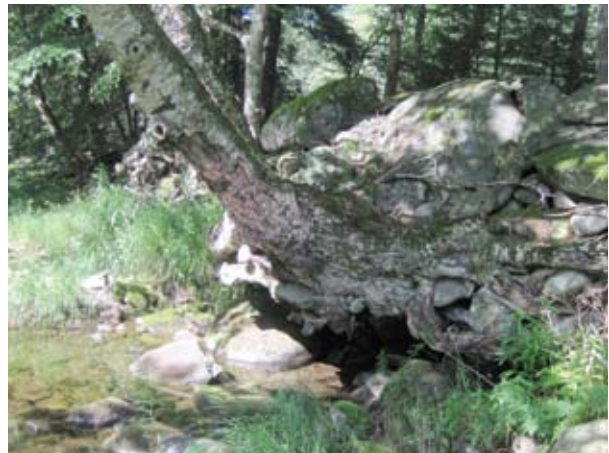
*Scour on right bank downstream of berm (A235)*

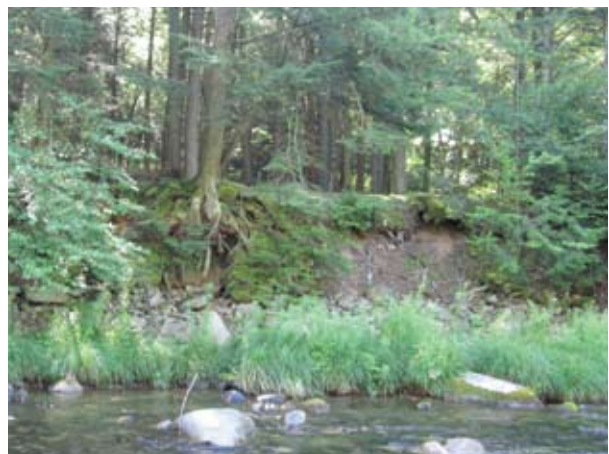
*Erosion on left bank (A242)*

The riparian buffer has the potential to be improved along the right bank between Station 13550 and Station 12910. An eroding bank segment was observed on the left bank extending 340 feet from Station 13540 to Station 13200 (BEMS NWB4\_13200). This bank failure site was documented as active; while there is hardening at the toe, hydraulic erosion and fluvial entrainment are causing scour at the crown of the bank exposing glacial till. The 50-foot length of the eroding segment from 13450 to 13400 was documented as a fine sediment source although it is not a significant source of turbidity. In addition, an unnamed tributary conveying flow from the right valley wall (and former location of Prothero sawmill) was observed joining the main channel across from the bank failure site near Station 13400. It is possible that the additional sediment and flow conveyed by this tributary is contributing to this bank erosion. (A242) Due to the active erosion at the tip of the bank failure and the ongoing contribution from the tributary, recommendations for this site include *assisted restoration* to improve bank stability.

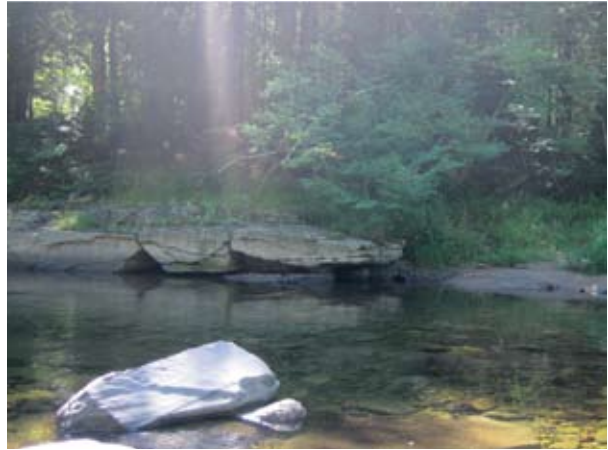
*Bedrock grade and planform control (A253)*

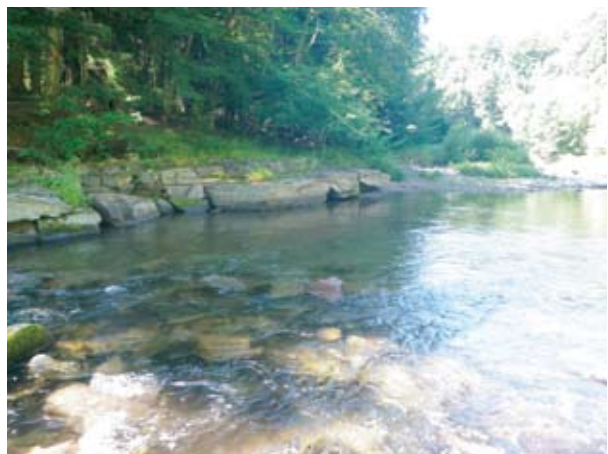
*Placed quarry rock forming grade control (P7290125)*

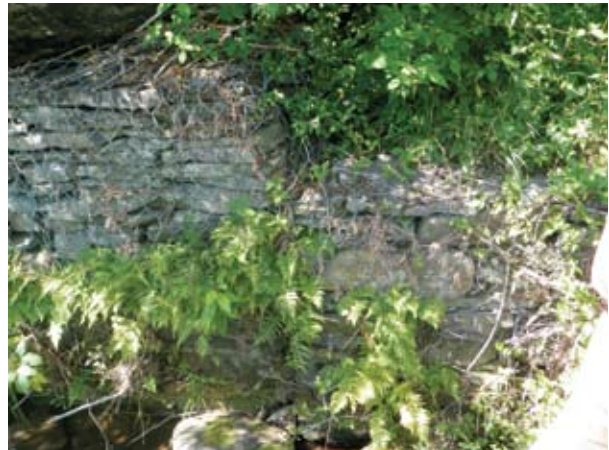
*Stone gabion revetment on right bank (P7190130)*

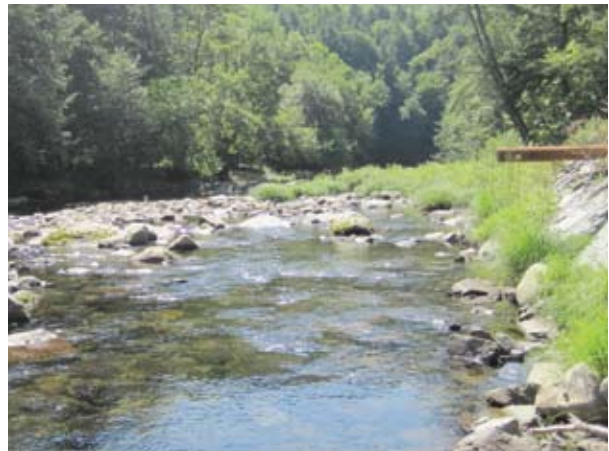
*Piped outfall conveying flow from Frost Valley Road (A263)*

A piped outfall was observed at the end of this revetment near Station 12360 conveying flow from Frost Valley Road to the main channel. The outfall is constructed of a 2-foot diameter smooth steel pipe with 3 feet of outfall and good outfall protection. (A263) It is recommended that the water quality impacts of this outfall be investigated to better understand and possibly mitigate the water quality implications of this conveyance.

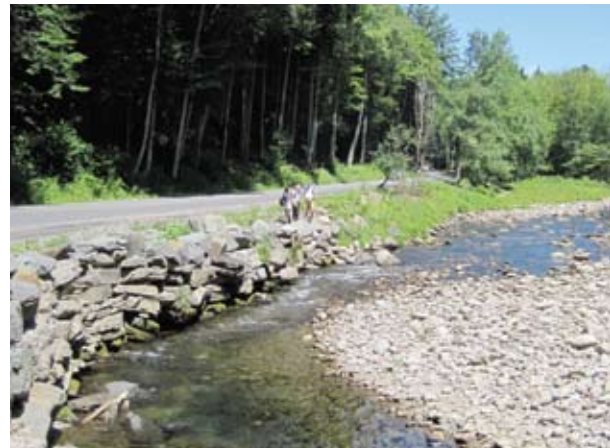
*Stacked rock revetment protecting Frost Valley Road (A280)*

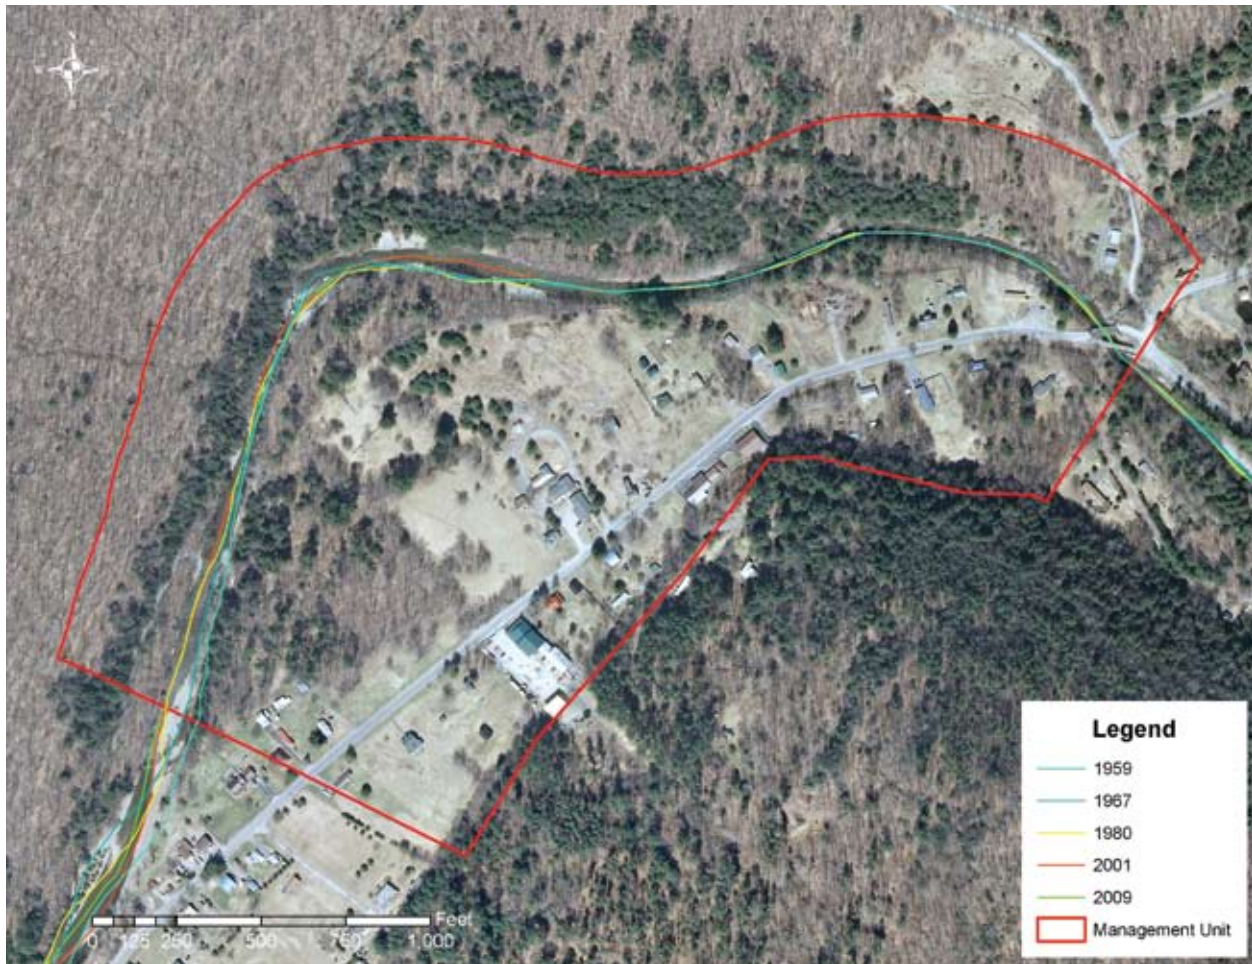
*Historical channel alignments from five selected years (Figure 3)*

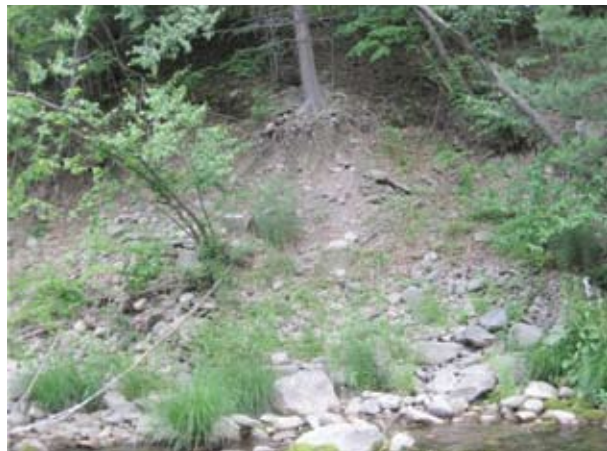
*Stabilizing slope failure on right bank (A334)*

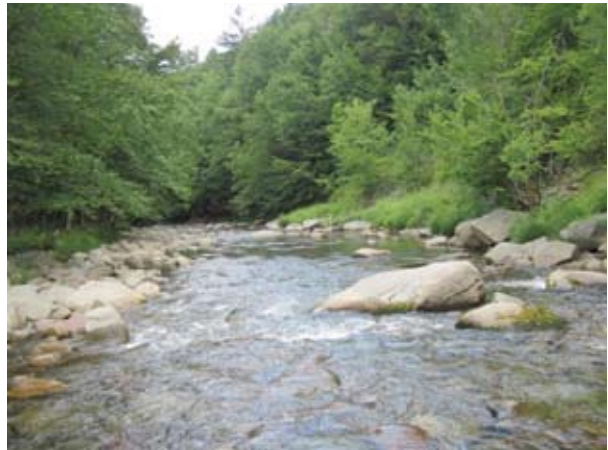
*Large boulders contributing to bank stabilization (A337)*

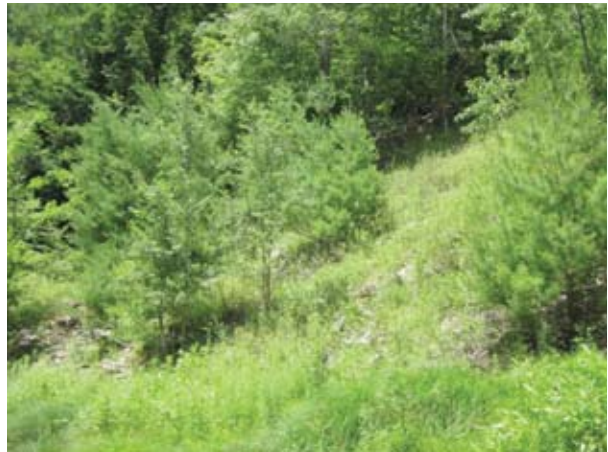
*Re-vegetated slope failure (A344)*

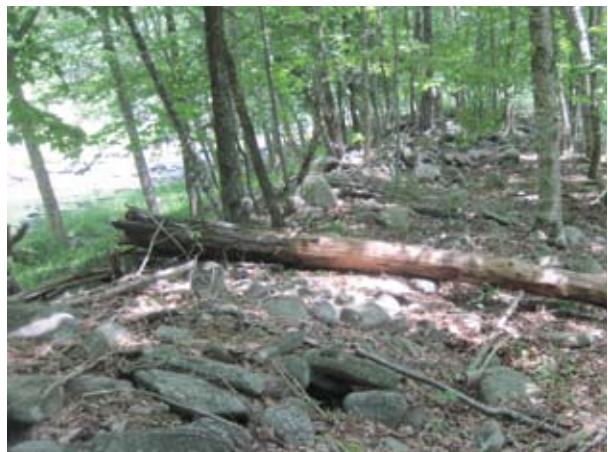
*Berm along left bank (B288)*

In order to protect infrastructure, several attempts have been made to prevent the stream from connecting to its left floodplain during large events. A berm begins along the left bank behind the town hall at Station 8700 and continues until Station 8475. (B288) This berm mainly consists of cobbles, but also has large placed boulders interspersed. Near Station 8490 the berm transitions to a more

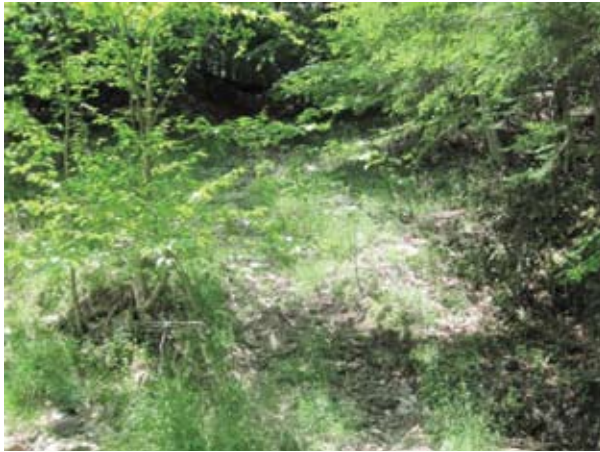
*Slope failure due to upland drainage (A358)*

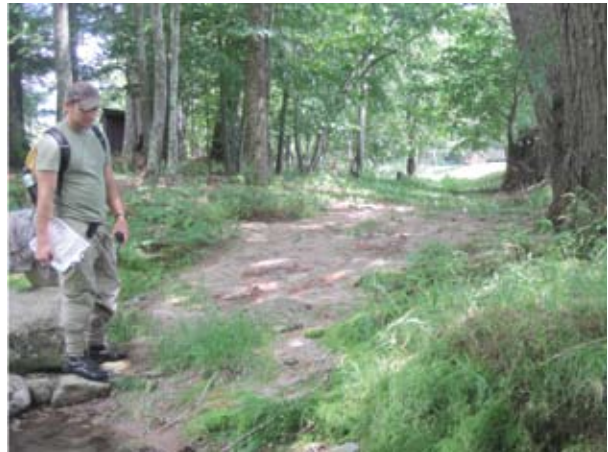
*Access path along left bank (B301)*

piles of tree trunks were documented significantly above the wetted channel width. (A371) Along the left bank, an access path has been mowed from the floodplain all the way down to the stream, removing all woody riparian vegetation at Station 7500. (B301) Removing significant amounts of vegetation from the riparian zone can reduce bank stability and lead to erosion. An intact riparian buffer including woody vegetation can strengthen the stream bank and slow erosive forces of higher flows during flood events, reducing the need for the installation of revetments and berms.

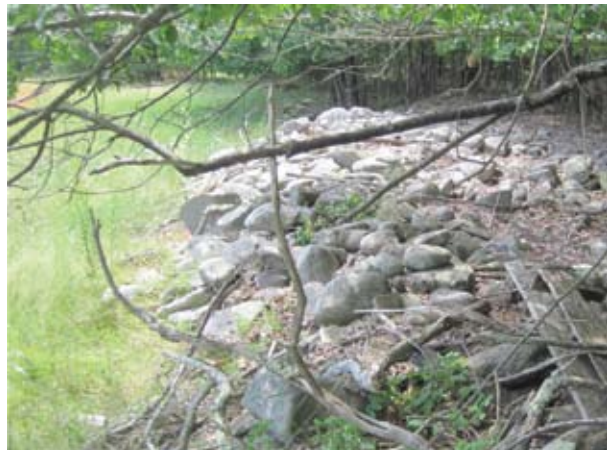
*Berm along left bank (B304)*

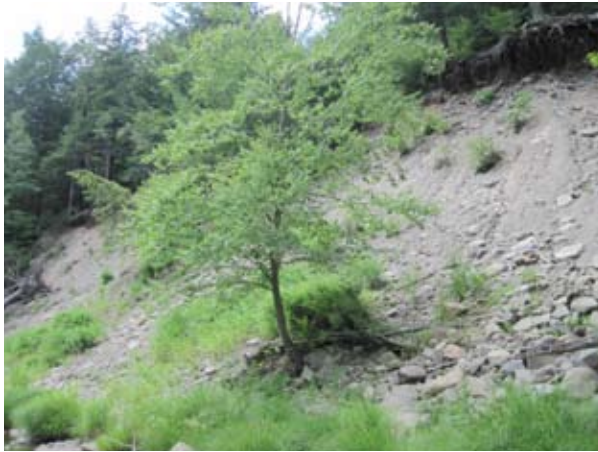
*Severe slope failure on right bank (A384)*

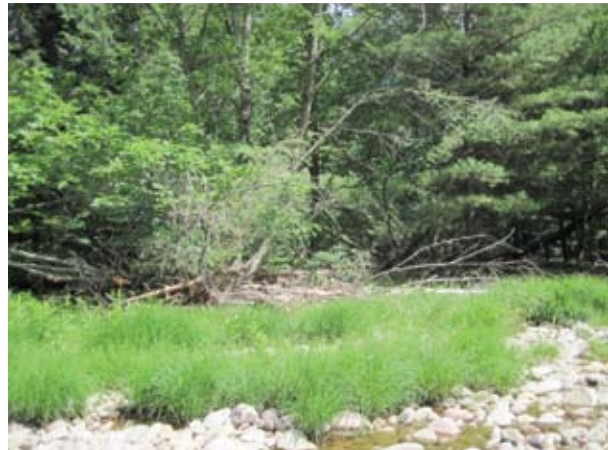
*Obstructions along left bank (A416)*

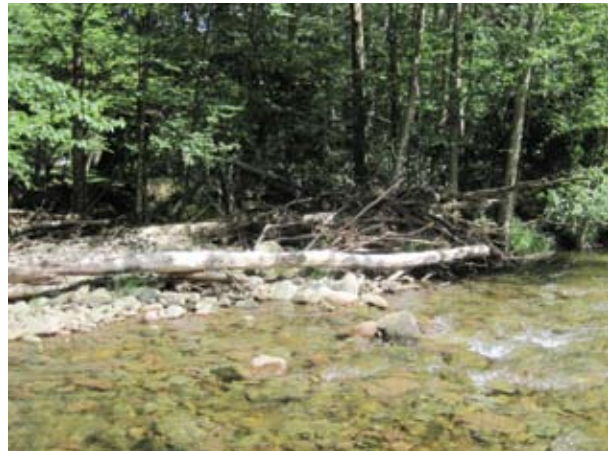
*Obstructions along left bank (A418)*

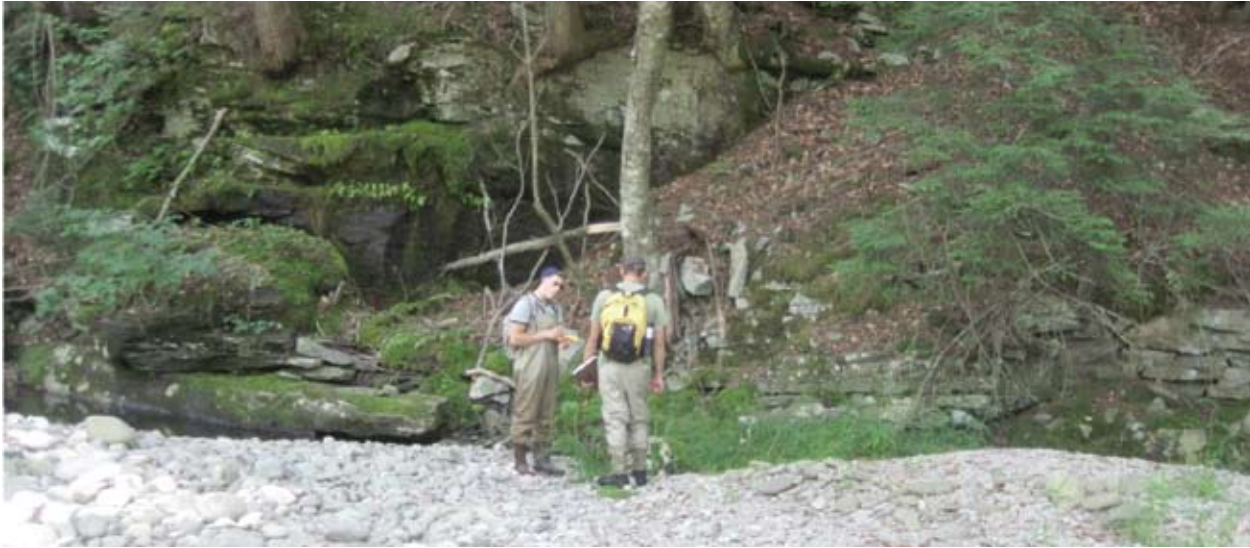
*Bedrock along right valley wall (B328)*

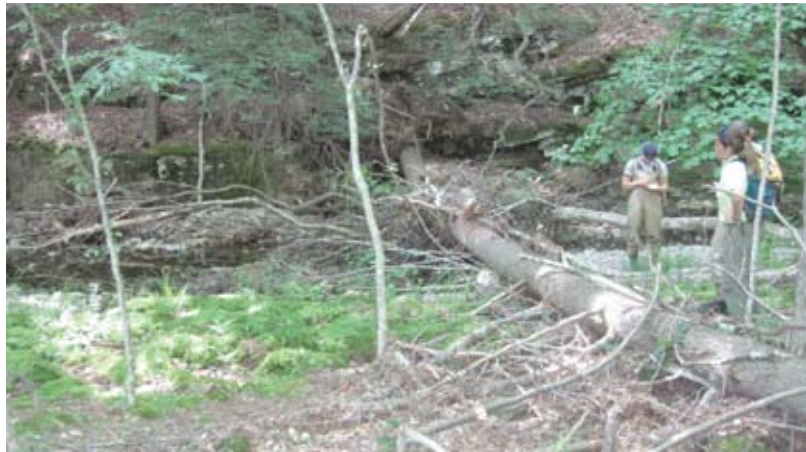
*Large obstructions in side channel (B332)*

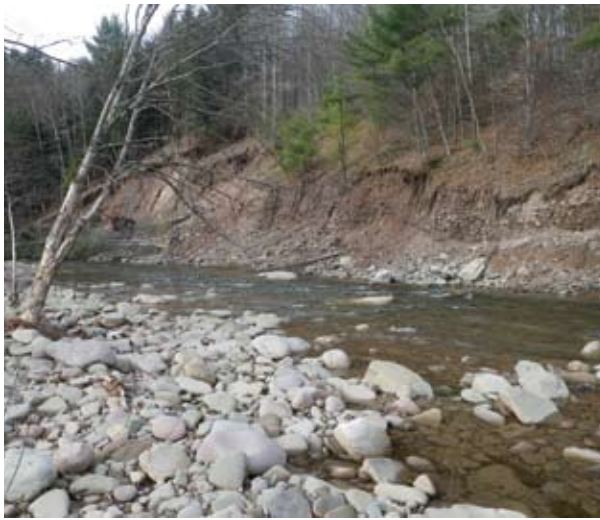
*Slope failure on the right bank across from cobble point bar. (IMG1744)*

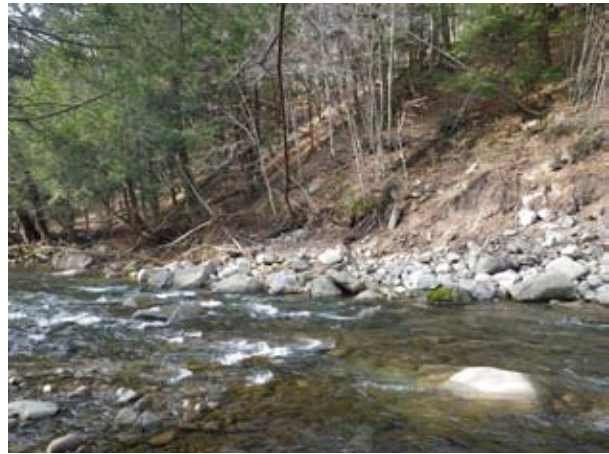
*Stabilizing slope failure on the right bank. (IMG1751)*

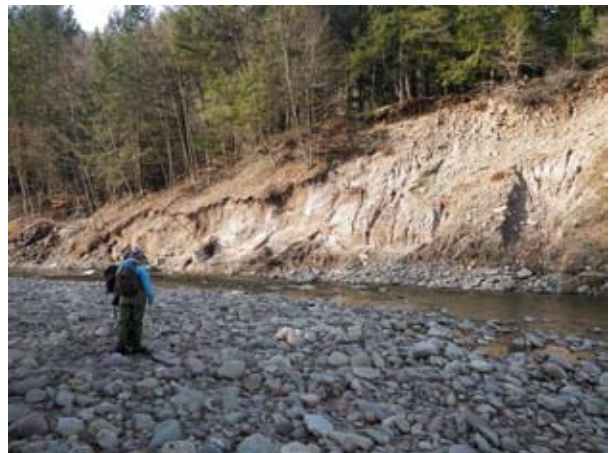
*Slope failure with exposed glacial till on the right bank. (IMG1756)*

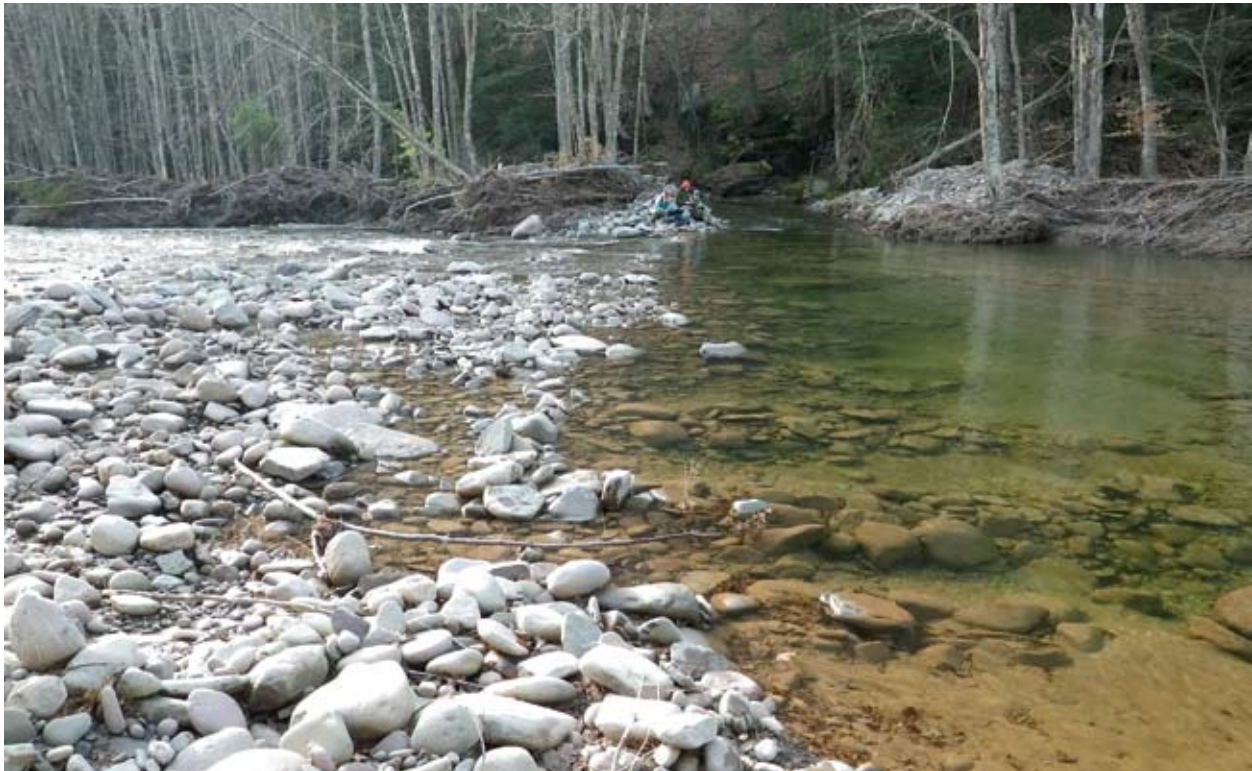
*Berm in the main channel diverting flow into a previously dry side channel. (IMGP1760)*

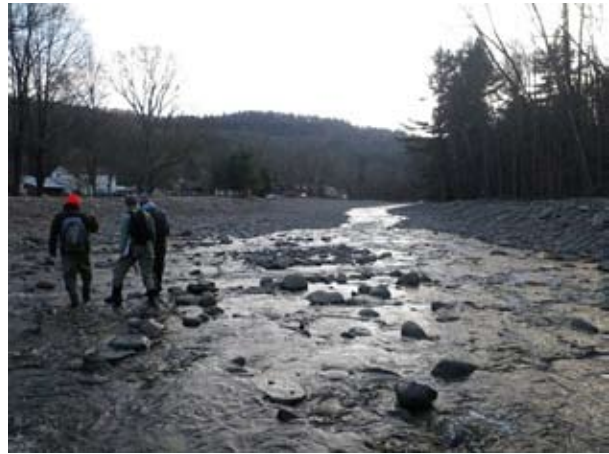
*Appropriately sized main channel. Flow is diverted by a berm upstream. (IMGP1769)*

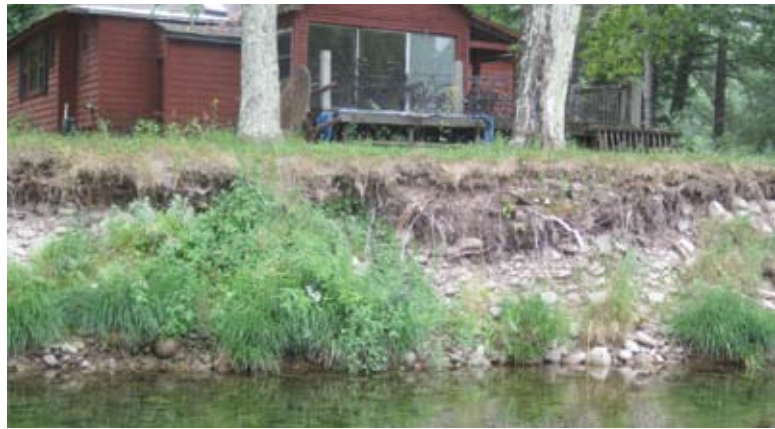
Erosion on left bank (B406)

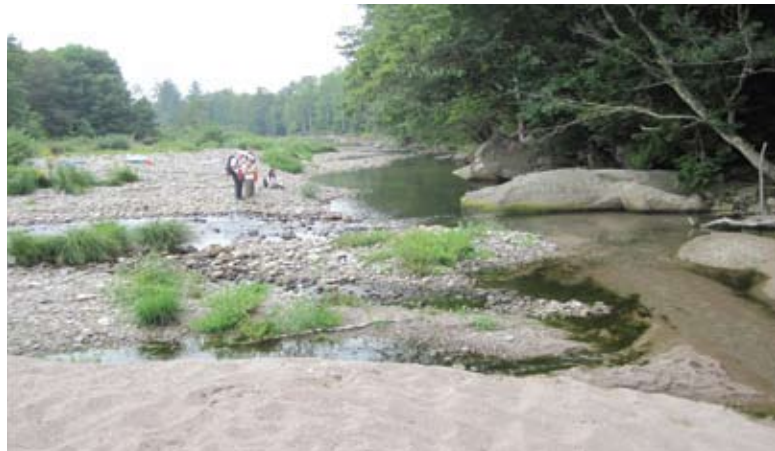
Downstream view of convergence (A076)

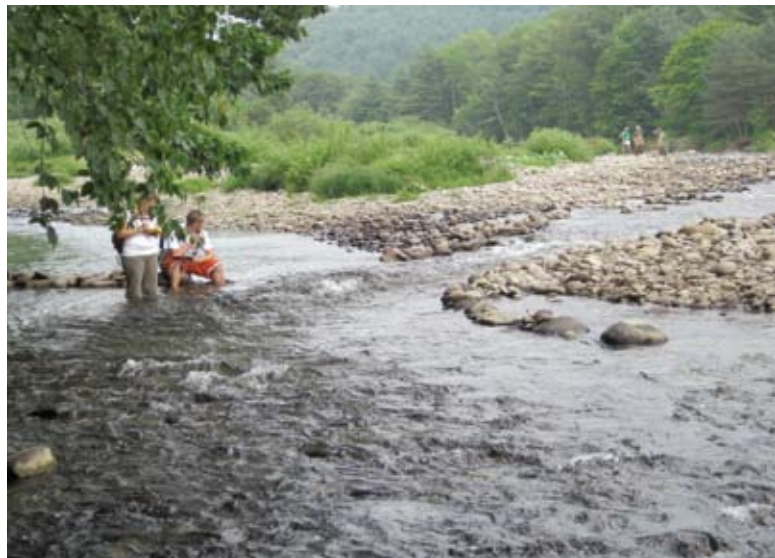
Looking upstream at convergence and cobble center bar (A080)

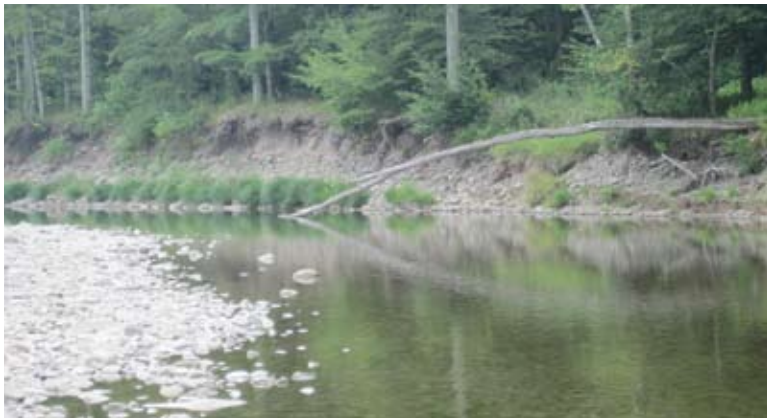
*Erosion and fine sediment on right bank (A84)*

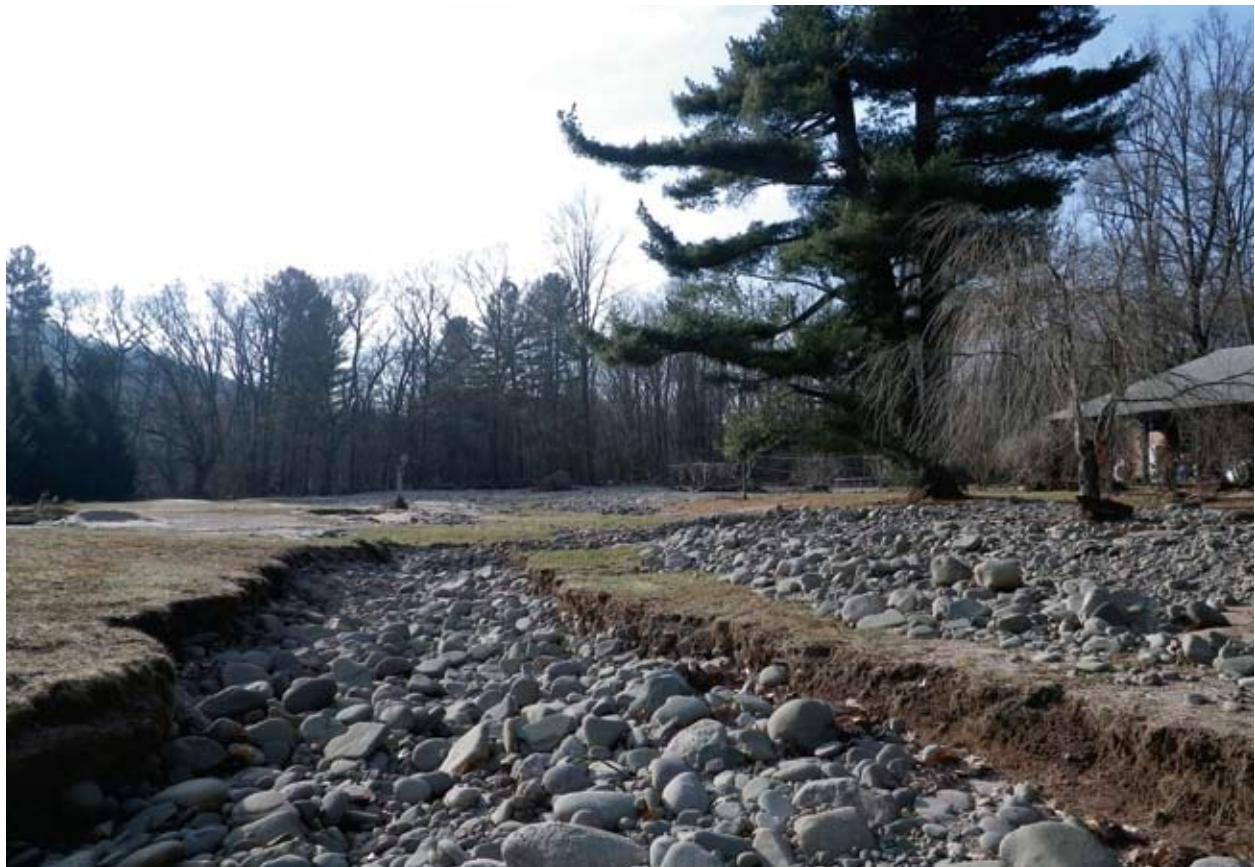
*Flood chute that caused severe damage to structures in the left flood plain near Station 27800. (IMGP2327)*

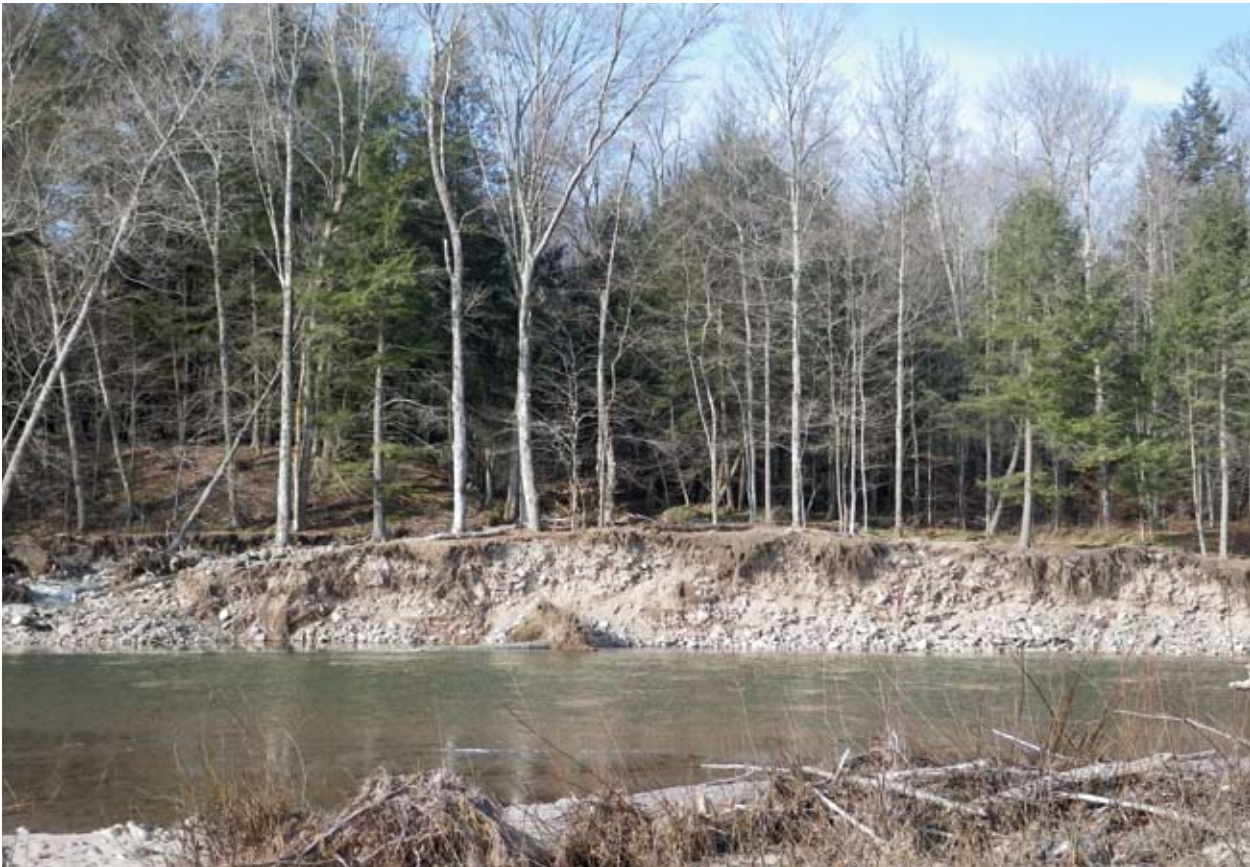
*Eroding bank segment on the right bank near Station 27100. (IMGP2329)*
