Hudson River Estuary Watershed Assessment & Outreach Project

2007 Watershed Report Card for the Rondout Creek

A Hudson Basin River Watch Watershed Assessment & Outreach Project

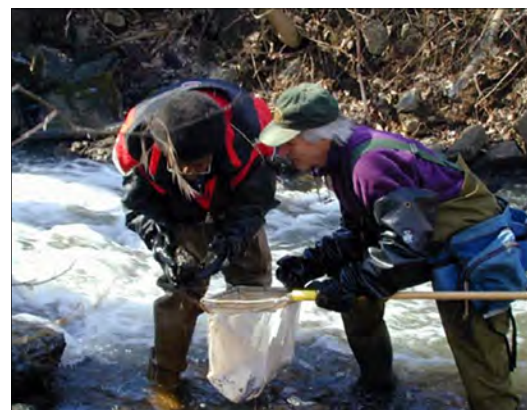
The NYS DEC Stream Biomonitoring Unit's (DEC SBU) methodology was used for all sample collection and analysis tasks. These methods involve collecting, sorting and analyzing a sample of benthic macroinvertebrates - stream bottom-dwelling organisms with no backbone that are visible to the naked eye. These organisms vary in their sensitivity to water quality impacts. DEC SBU's methods use the presence or absence, relative abundance, and diversity of species to obtain an overall water quality score called the Biological Assessment Profile (BAP). BAP is scored 0-10, with 10 indicating the best water quality. The DEC SBU also uses four narrative descriptions of water quality based on the BAP score as illustrated in the graph below:

It's important to note that the term "slightly impacted" can be misleading if it's taken out of context. Sites with water quality at only 5.1 on the BAP scale, or almost "moderately impacted", can be described as only "slightly impacted".

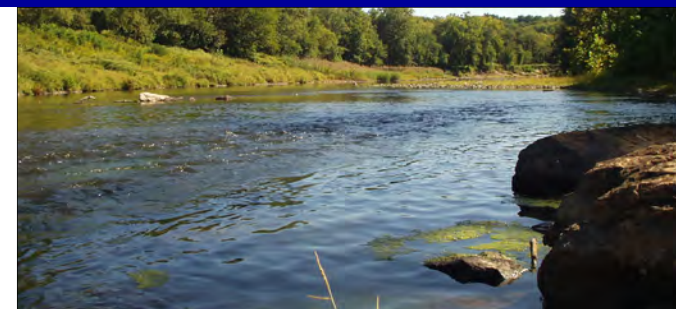
Rondout Creek Site RN14, in the Town of Rosendale

Station RN14, Rondout Creek, is just downstream of the Rosendale sewage treatment plant, in the Town of Rosendale. The BAP score of 6.20 fell into the slightly impacted category. The ISD indicated a community structure affected by non-point source nutrient additions.

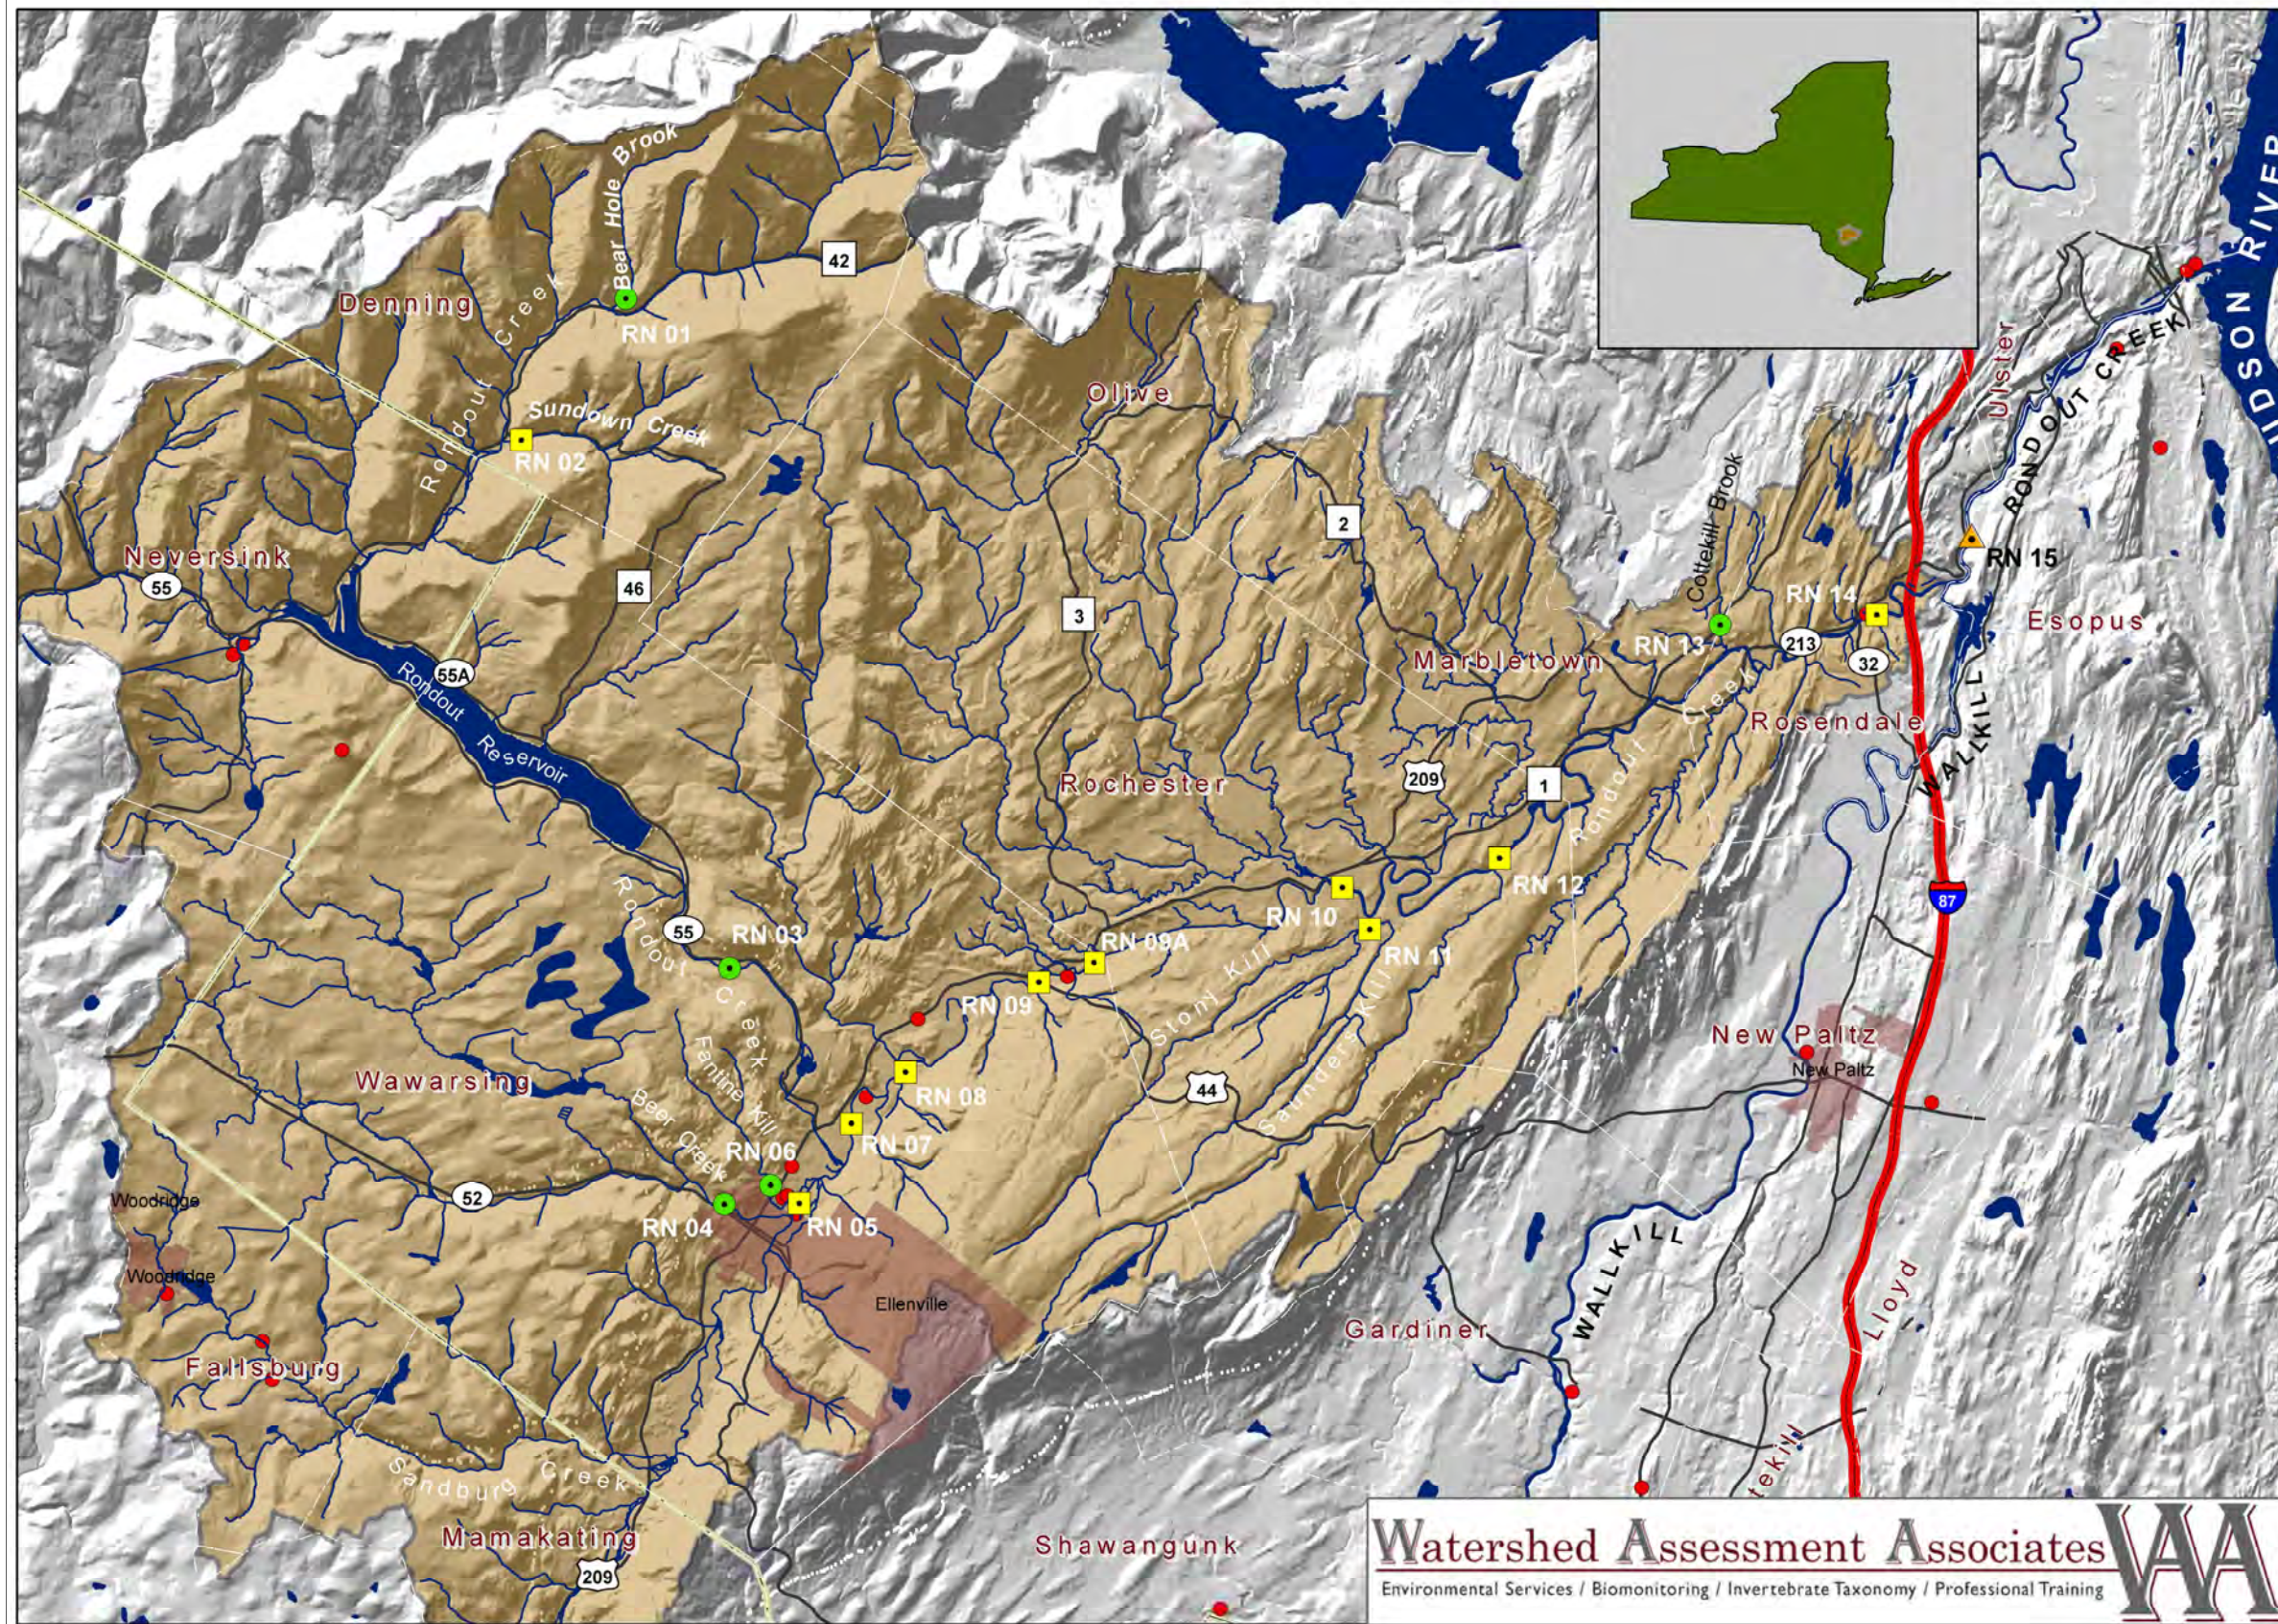
Figure 1
Rondout Creek
2007 Biomonitoring Study
Base Map

In September and October 2007, Hudson Basin River Watch (HBRW) sampled 16 sites in the Rondout Creek Watershed. The Rondout Creek Watershed Council, the NY State Dept. of Environmental Conservation (NYSDEC), and the NY City Dept. of Environmental Protection provided input in site selection. HBRW collected stream bottom macro-invertebrate samples and measured basic physical and chemical parameters at each site. HBRW evaluated the data to assess water quality conditions and impacts using NYSDEC methods. A map depicting the sampling locations and impact results is on pages 2-3 of this report card.

Water quality was non-impacted at 5 sites, slightly impacted at 10 sites and moderately impacted at one site. Of the 5 non-impacted sites, only one was on the Rondout Creek, the first site below the Rondout Reservoir. The other 4 non-impacted sites were tributaries draining relatively undeveloped areas. "Non-point source nutrient additions" was the most common source of impact, appearing in 12 sites. "Sewage effluent and/or animal wastes" appeared in 3 sites, and "Complex sources" (municipal and industrial inputs) appeared in 3 sites. The one moderately impacted site is located downstream from the confluence with the Wallkill River and is also affected by large changes in flow from a hydroelectric dam. More information on methods, terminology, and data interpretation is on page 4.
