Local Flood Analysis

Hamlets of Roxbury and Grand Gorge
Town of Roxbury, Delaware County, New York
February 2020

Prepared for:
Delaware County Soil and
Water Conservation District
44 West Street, Suite 1
Walton, New York 13865

Prepared by:
MILONE & MACBROOM, INC.
231 Main Street, Suite 102
New Paltz, New York 12561
(845) 633-8153
www.mminc.com

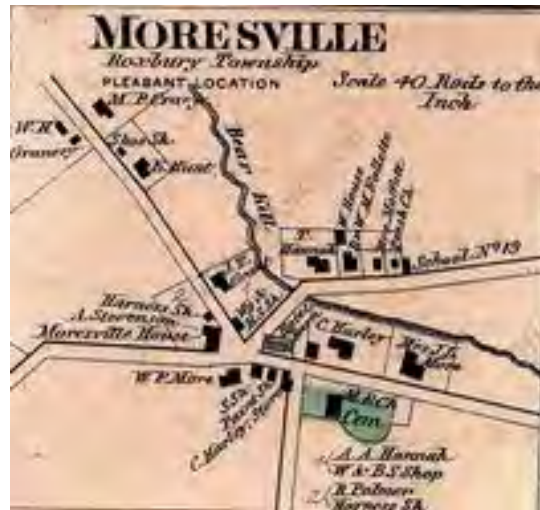
Figure 2-6
Historic Map – Hamlet of Grand Gorge, New York

Grand Gorge was originally named Moersville after the More family, the first family to settle what is now the town of Roxbury in 1786. A historic map from 1869 (Figure 2-6) illustrates the Bear Kill as it flows through the hamlet with an alignment much like how it is seen today.

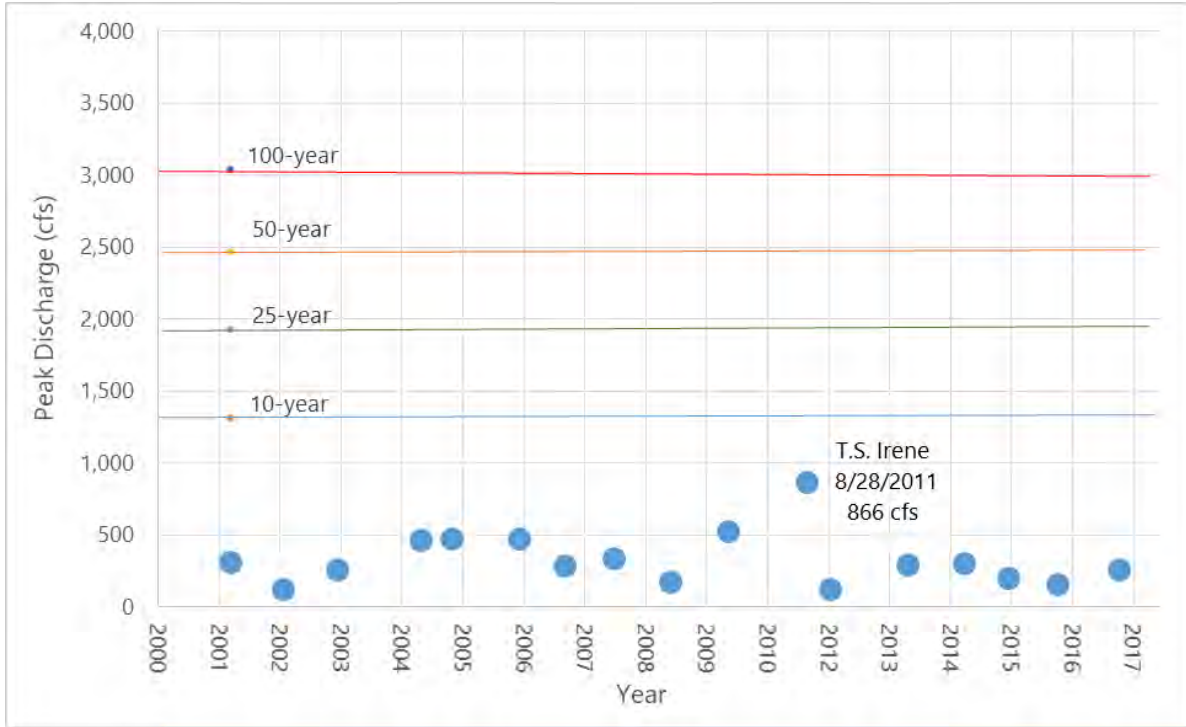
Figure 3-1
Annual Peak Discharge at USGS Gauge #01413088 in Roxbury, New York, Compared to FEMA
Discharges from Delaware County FIS, Effective June 2016

Similarly, the Bear Kill in the hamlet of Grand Gorge was said to not have caused severe flood damage during Tropical Storm Irene. Comparison of annual peak discharges at the Schoharie gauge is depicted in Figure 3-2. During Tropical Storm Irene, flows on the Bear Kill gauge reached a peak discharge of 2,000 cubic feet per second (cfs), almost equivalent to a 10-year event. During witness meetings, recollection of the 1996 flood evoked a larger response than Tropical Storm Irene. The 1996 storm event was described as having caused substantial flood damage to properties in the hamlet. Throughout the LFA process, there was also mention of seasonal ice jams leading to flooding of a few properties along the Bear Kill reach. Beaver dams also were pointed out as issues for the hamlet although they are often preemptively removed by the town in order to prevent the dams from bursting and causing property damage downstream.

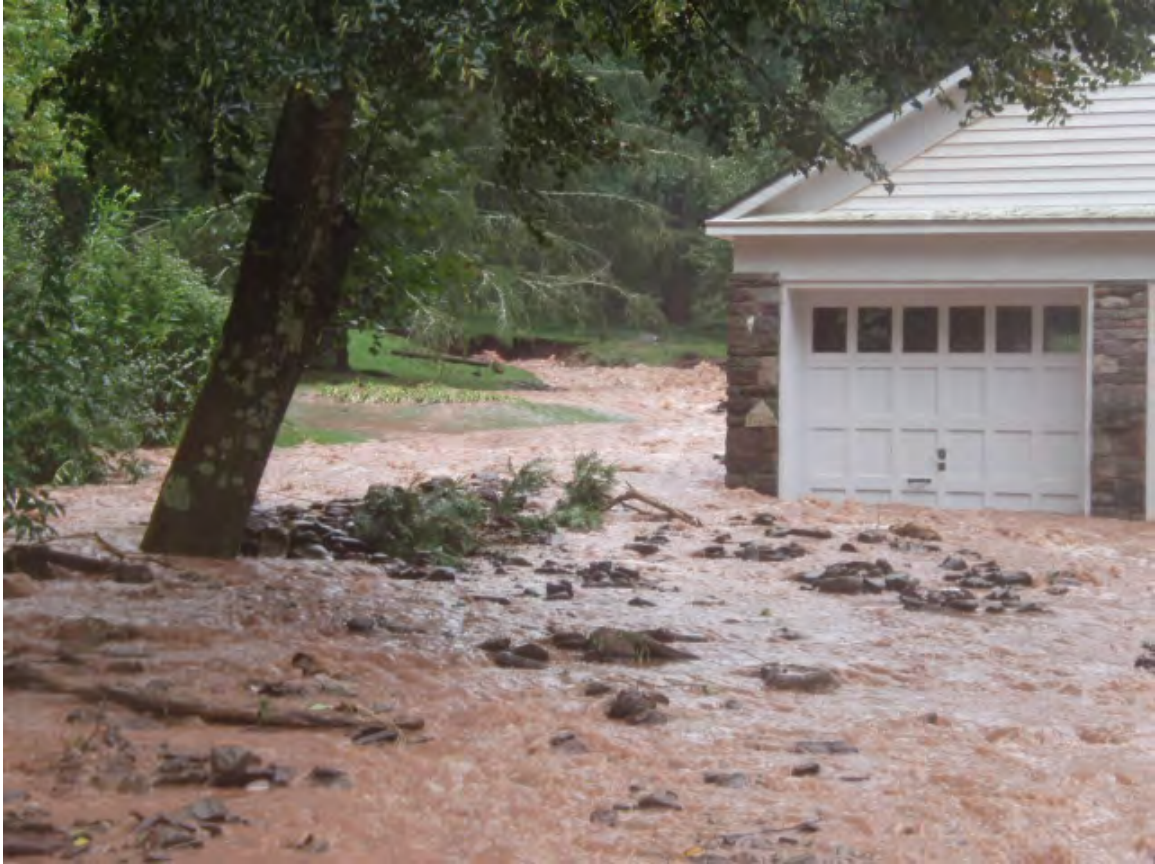
Figure 3-3
Looking Upstream, Vega Mountain Stream near Vega Mountain Road Crossing
during Tropical Storm Irene

During community meetings, the watercourse was described as a persistent flooding issue within the hamlet even during minor storm events. Flooding is only exacerbated during large rainstorms, resulting in widespread inundation at the heart of the hamlet. The following series of photos captured by the public during Tropical Storm Irene illustrates the flood extent due to the large volume of water coming from Vega Mountain Stream. Additional details about this tributary to the EBDR are discussed in Sections 4.6 and 6.0 of this report.

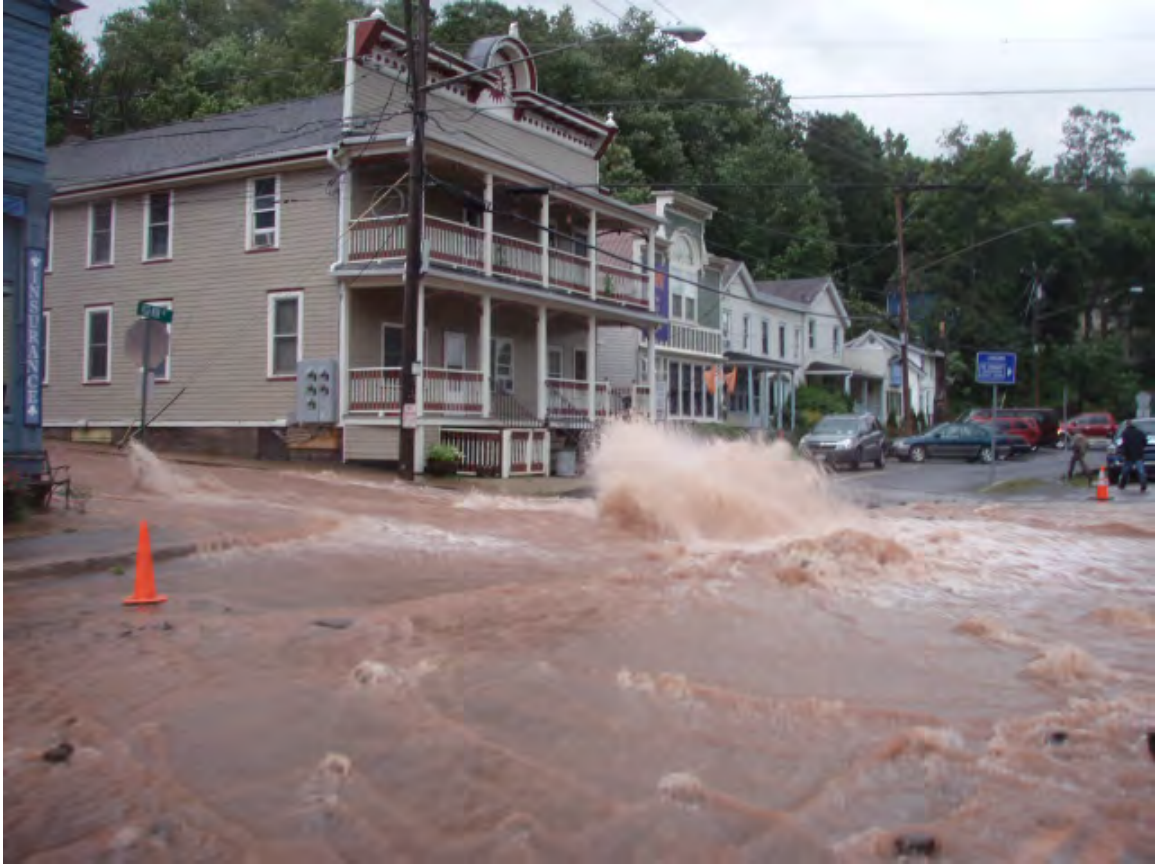
Figure 3-4
High-Velocity Floodwaters Traveling Down Vega Mountain Road toward NYS Route 30;
Energy Dissipation Causes a Hydraulic Jump at Intersection

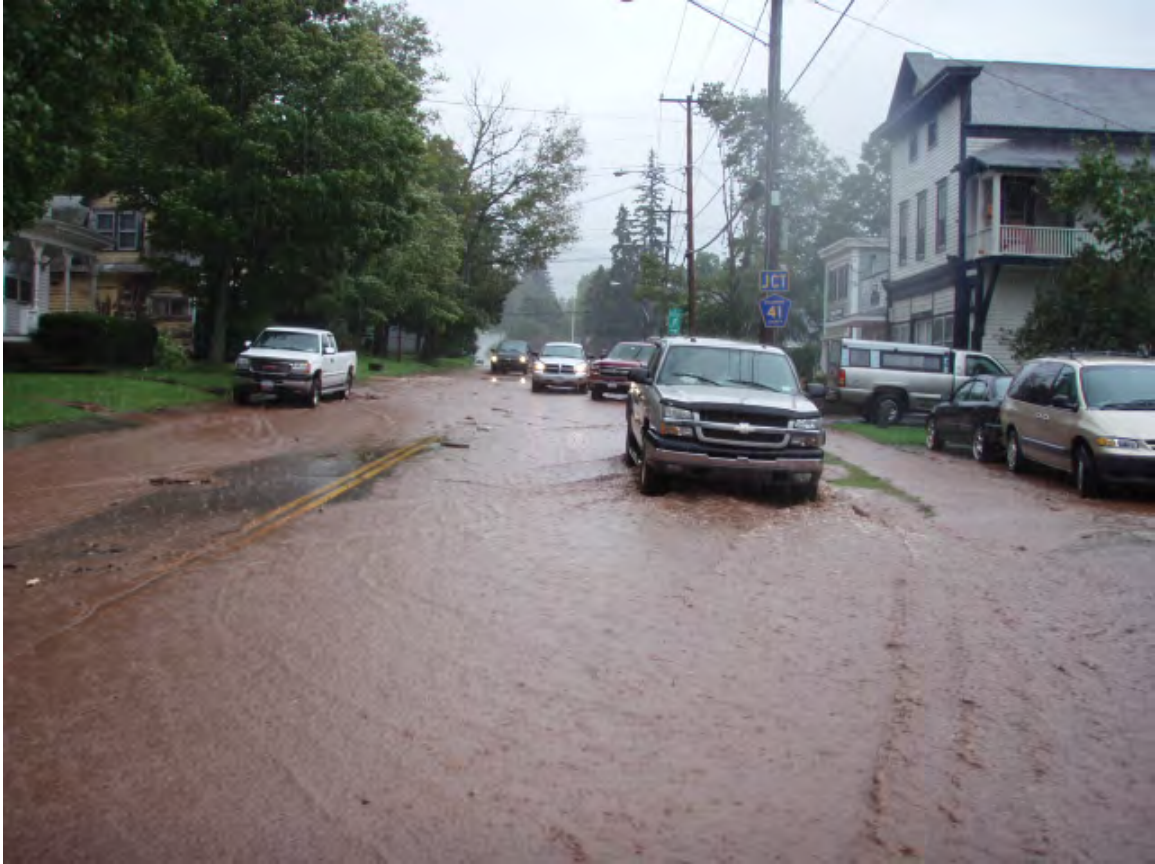
Figure 3-5
(Facing South on NYS Route 30 near Roxbury Fire Department Building)
Vega Mountain Stream Floodwaters Traveling across the Backyards of Homes North of
Route 30 and Flooding Main Street

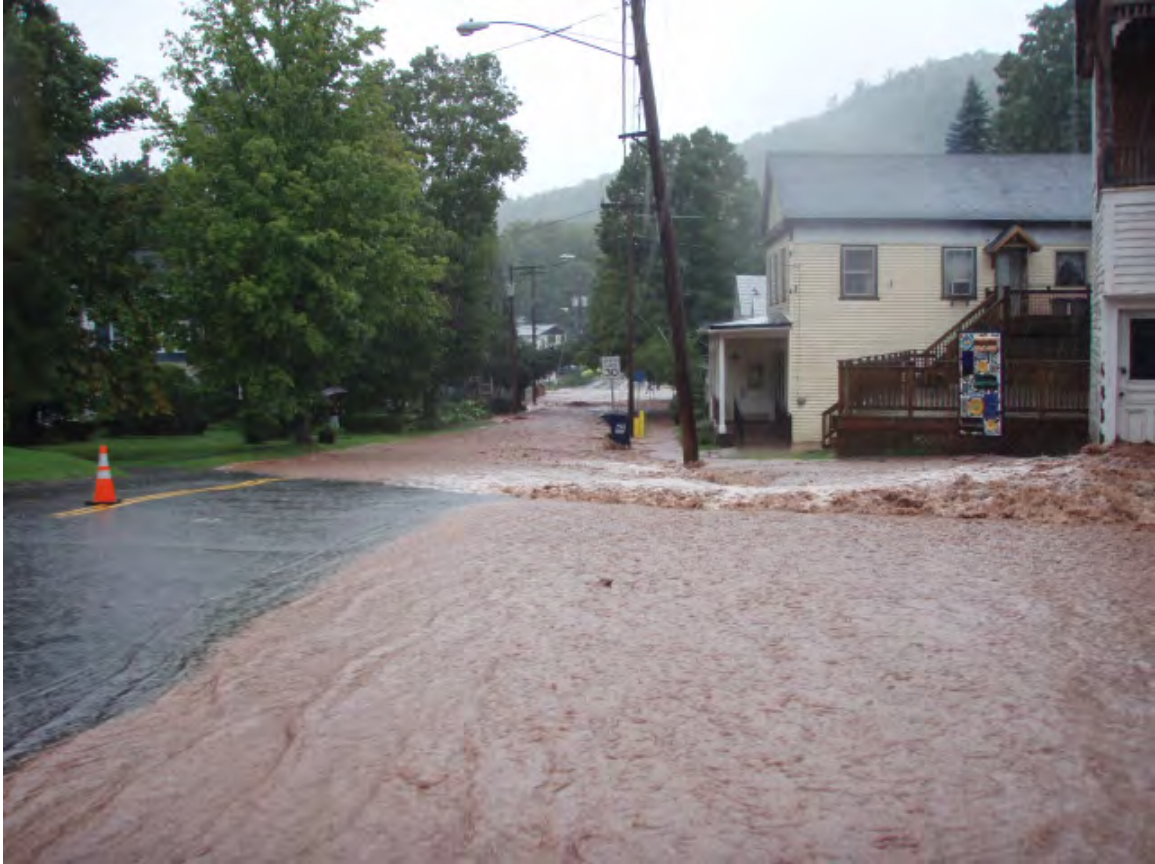
**Figure 3-6
(Facing West, Down Bridge Street Bridge) In Typical Fashion, Vega Mountain Stream
Floodwaters Flowing down Bridge Street Bridge toward the EBDR**

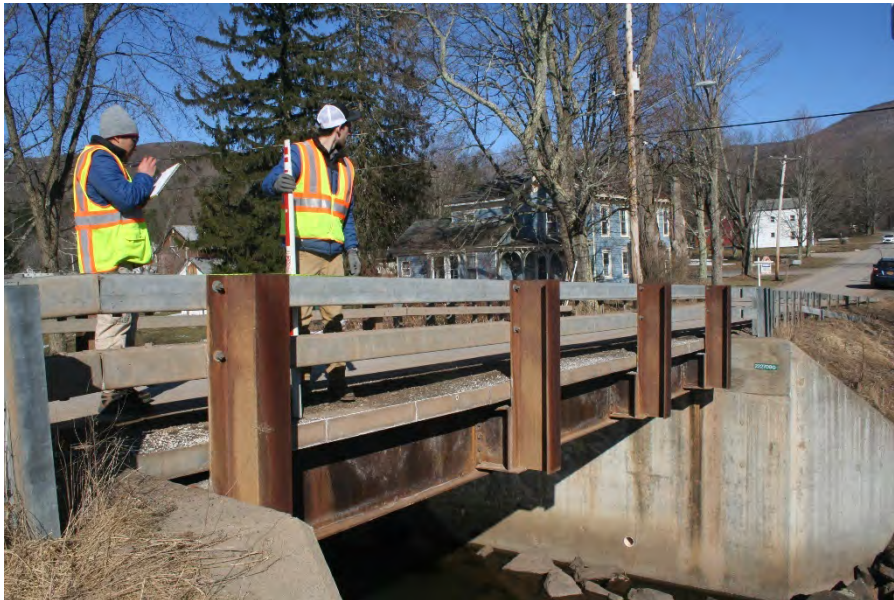
Figure 4-3
North Montgomery Road Bridge over EBDR

The North Montgomery Hollow Road bridge is not a high priority for immediate replacement. However, when the bridge is due for a regularly scheduled replacement, the new bridge should be adequately sized so that the 100-year flood can safely pass without overtopping the adjacent roadway. Recommendations are discussed in Section 6.0.

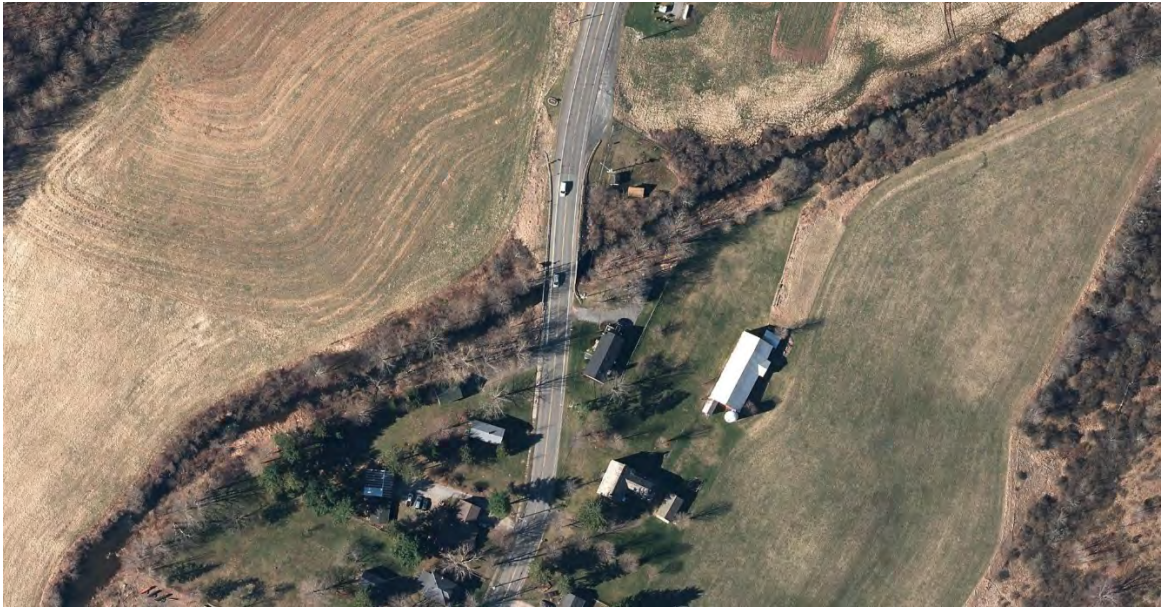
Figure 4-4
NYS Route 30 Bridge in Roxbury, New York, over EBDR

NYS Route 30 (Figure 4-4) runs from north to south through the hamlet of Roxbury and is a central road for means of transportation in and out of town. No reports of the roadway overtopping have been received at this location. Hydraulic modeling indicates that the structure can safely pass the 10-year flood. Flows are constricted by the bridge abutments and road embankment during the 25- and 50-year storms, resulting in backwaters extending 2,000 feet upstream to flood nearby fields. Potential for flooding on the roadway to the north during the 100-year storm was also shown.

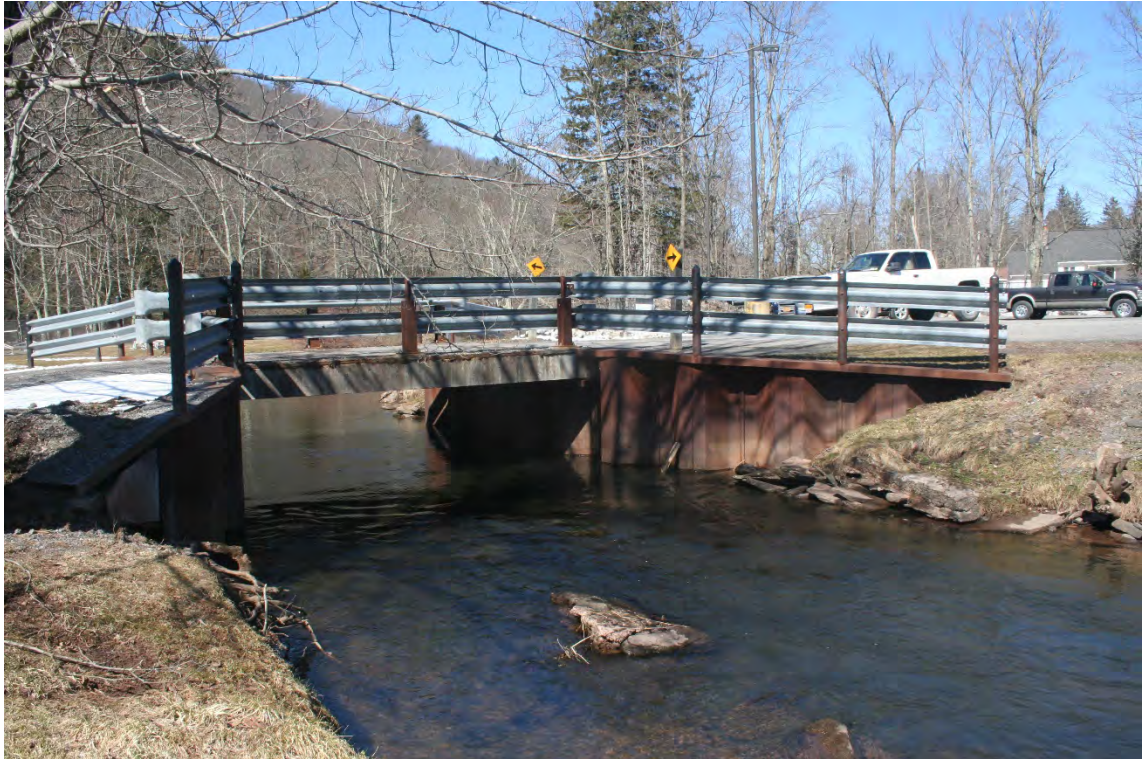
Figure 4-5
Bridge Behind Roxbury School over EBDR

higher-magnitude, lower-frequency events when conveyance is entirely overland flow and the bridge is no longer a constriction.

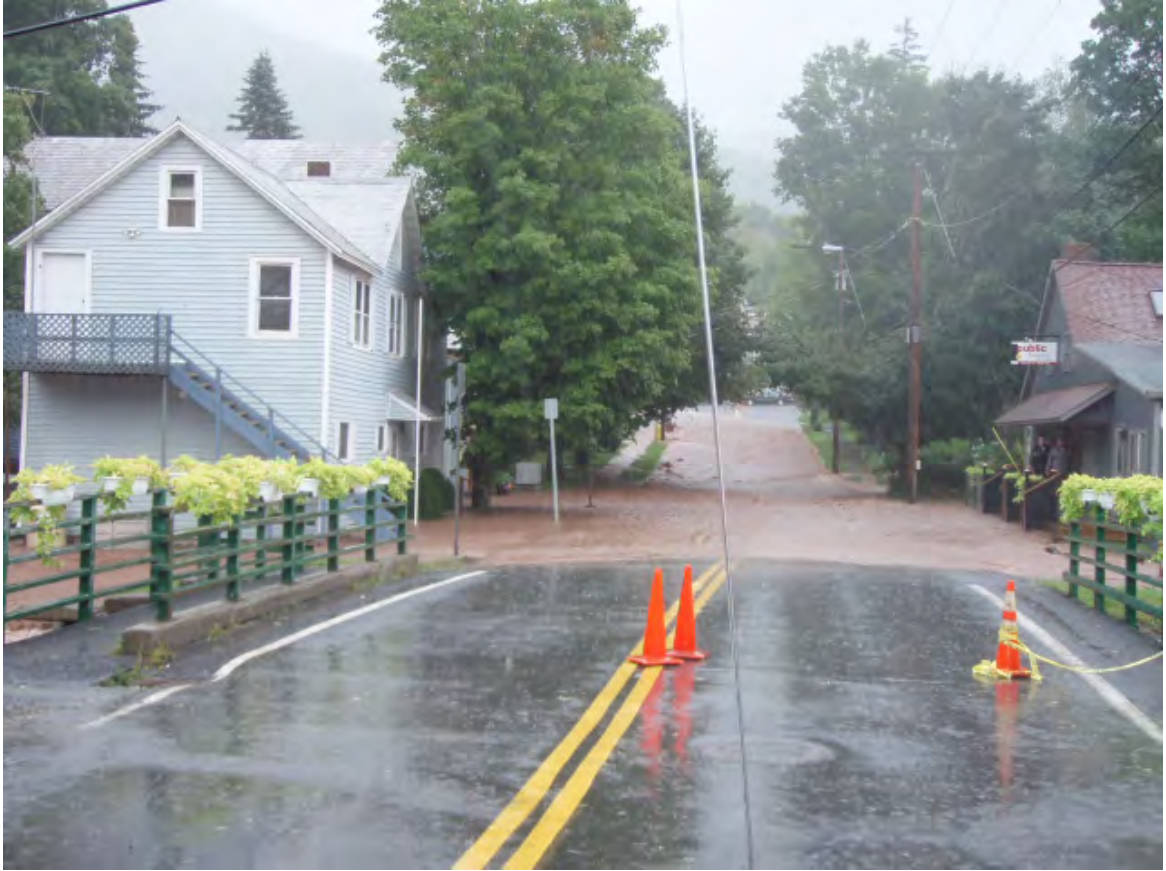
Figure 4-6
Bridge Street Bridge over EBDR during Tropical Storm Irene

County Route 41 (more commonly referred to as the Bridge Street bridge) crosses the EBDR near the Roxbury Hotel. The structure has a horizontal span of 38 feet with an average 10.5-foot vertical opening. The channel banks upstream and downstream of the bridge have been lined with large boulders, portions of which were seen to begin sloughing. During Tropical Storm Irene, water on the EBDR reportedly reached the low chord and also flanked the bridge to its left (Figure 4-6). Water backed up at the bridge resulting in flooding of the adjacent roadway and nearby homes, reportedly with over a foot of water. Water spilling out of Vega Mountain Stream and flowing down Vega Mountain Road across Main Street and down Bridge Street also contributed to flooding in this area.

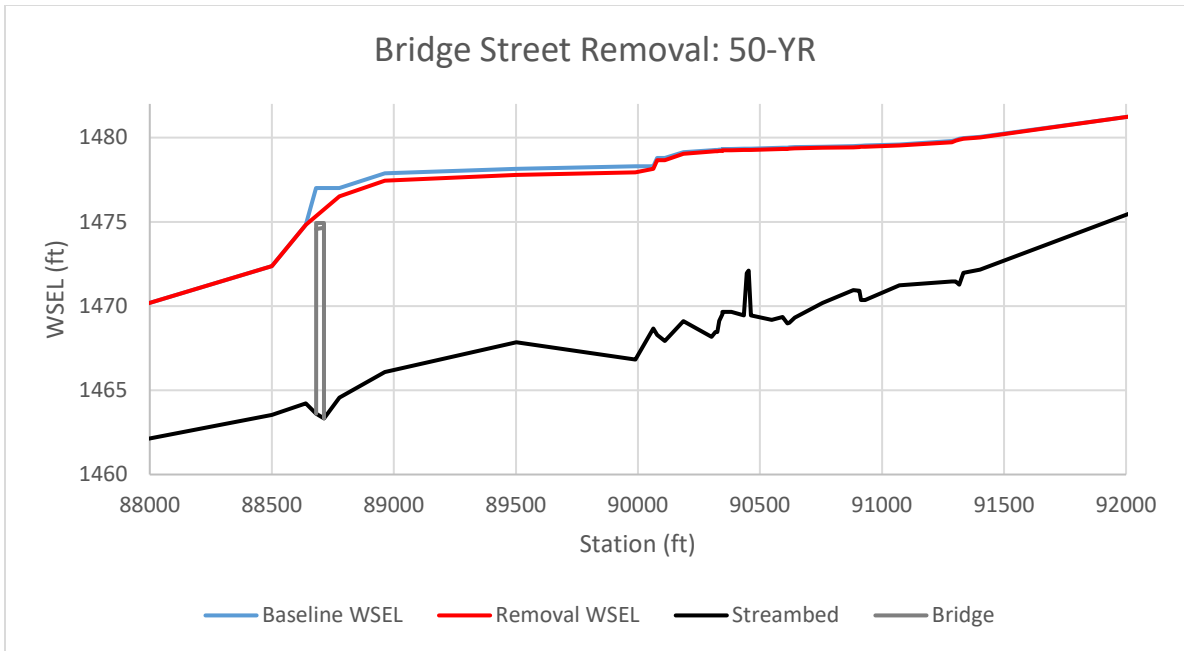
Figure 4-8
Longitudinal Profile – 50-Year Flood
Bridge Street Bridge over EBDR

Lesser flood mitigation benefits are seen for the 25-, 50-, and 100-year recurrence intervals. This is because the existing bridge gets significantly flanked to its left at these stages, and the majority of the flow conveyance occurs on the left overbank. Removal of the existing structure is not enough to offset for the undersized channel and embankment encroaching on floodwaters upstream of the structure. Resulting water surface elevations from the bridge removal can be seen in longitudinal profile form in Figures 4-8 and 4-9 for the 50- and 100-year storm events, respectively. In order to optimize flood mitigation benefits at this crossing, enhancement of the floodplain upstream and downstream of the bridge, along with replacing the bridge with a larger structure, is advisable.

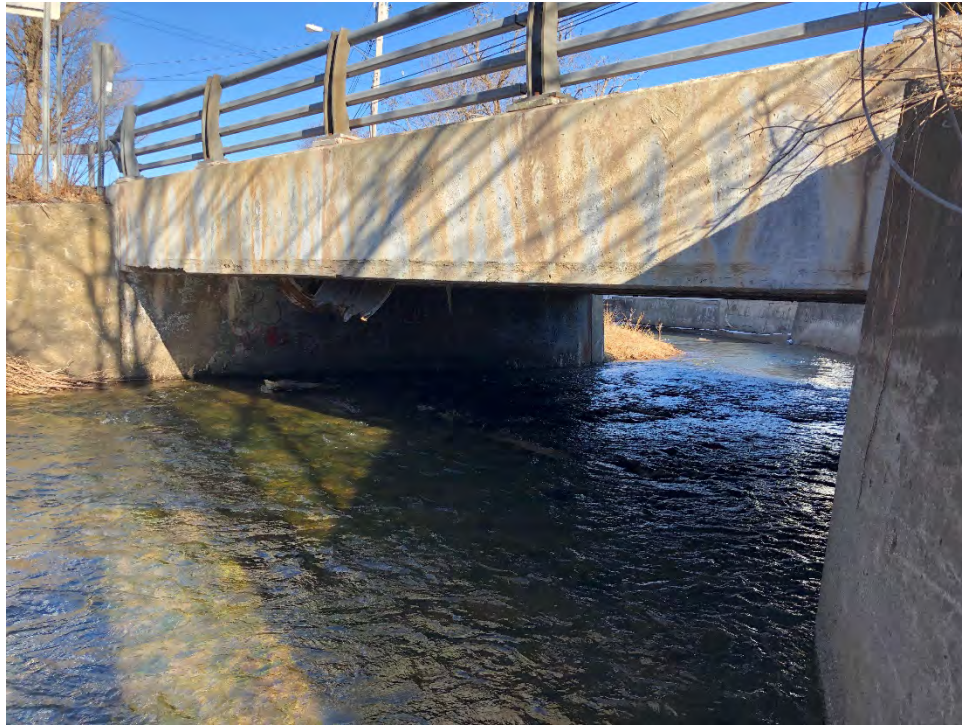
Figure 4-10
NYS Route 30 Bridge over the Bear Kill in Grand Gorge

Visually, the Route 30 bridge appears to be in poor condition. Defoliating steel concrete forms under the superstructure, and spalling concrete, were observed in the field. For the next replacement bridge, it is recommended that a full hydrologic and hydraulic study be conducted to adequately size the new replacement structure to comply with NYSDOT design standards.

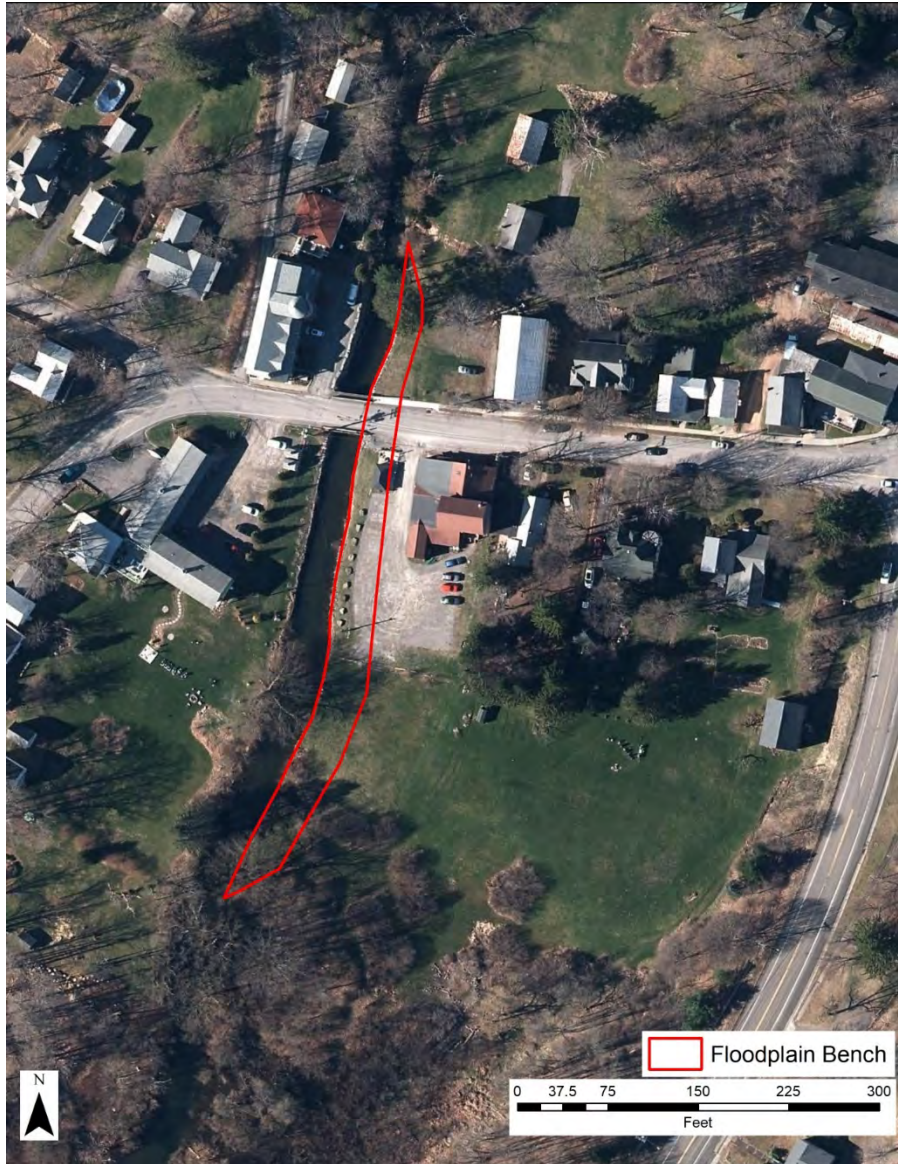
Figure 4-12
Floodplain Bench Enhancement along the EBDR at the Bridge Street Bridge,
Hamlet of Roxbury

Floodplain enhancement scenarios were evaluated along the EBDR at the Bridge Street bridge in Roxbury and along the Bear Kill in Grand Gorge. These scenarios are depicted on Figure 4-12 and Figure 4-13. Detailed descriptions of each scenario follow.

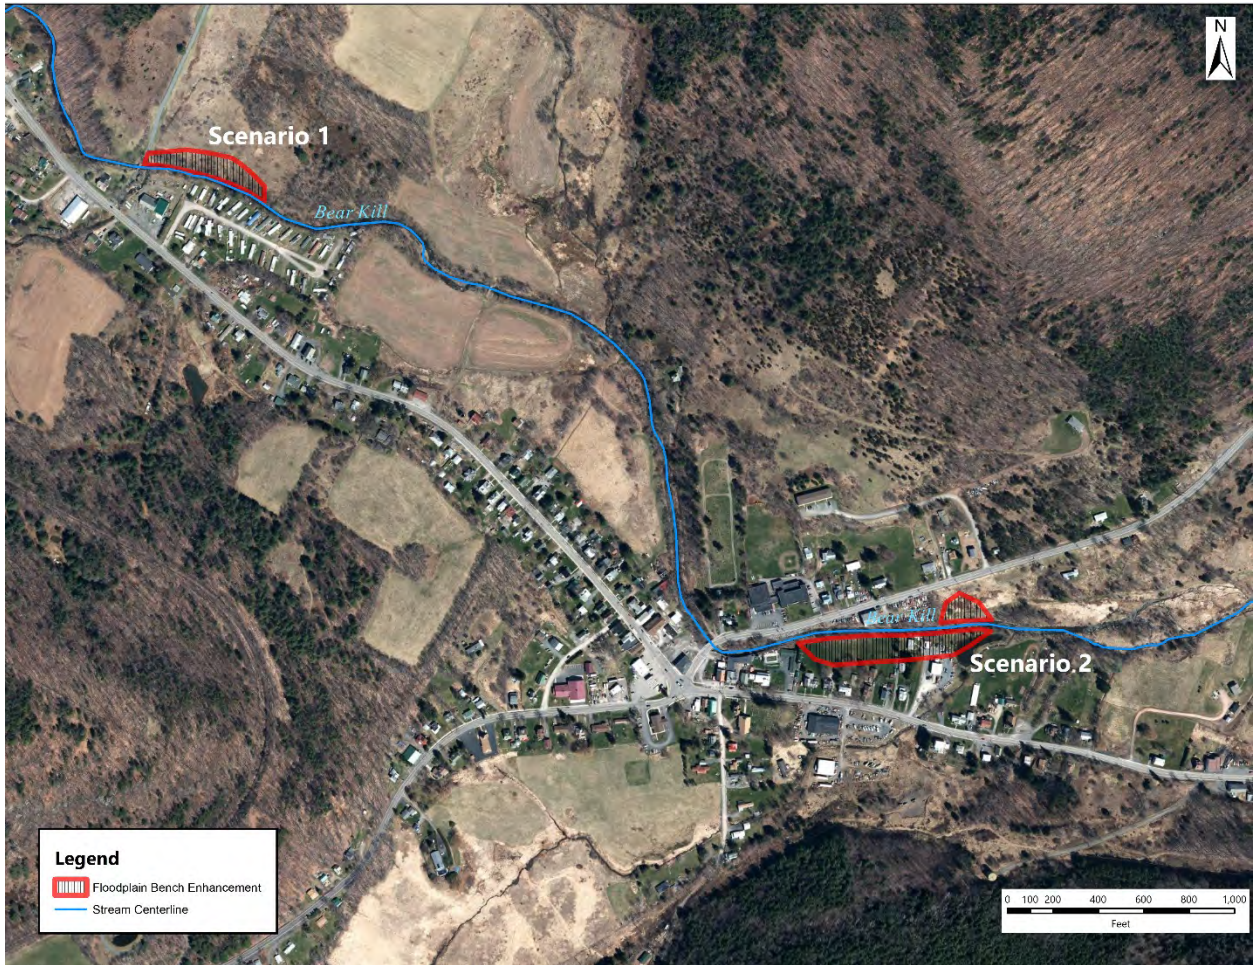
Figure 4-13
Areas of Floodplain Bench Enhancement along the Bear Kill,
Hamlet of Grand Gorge

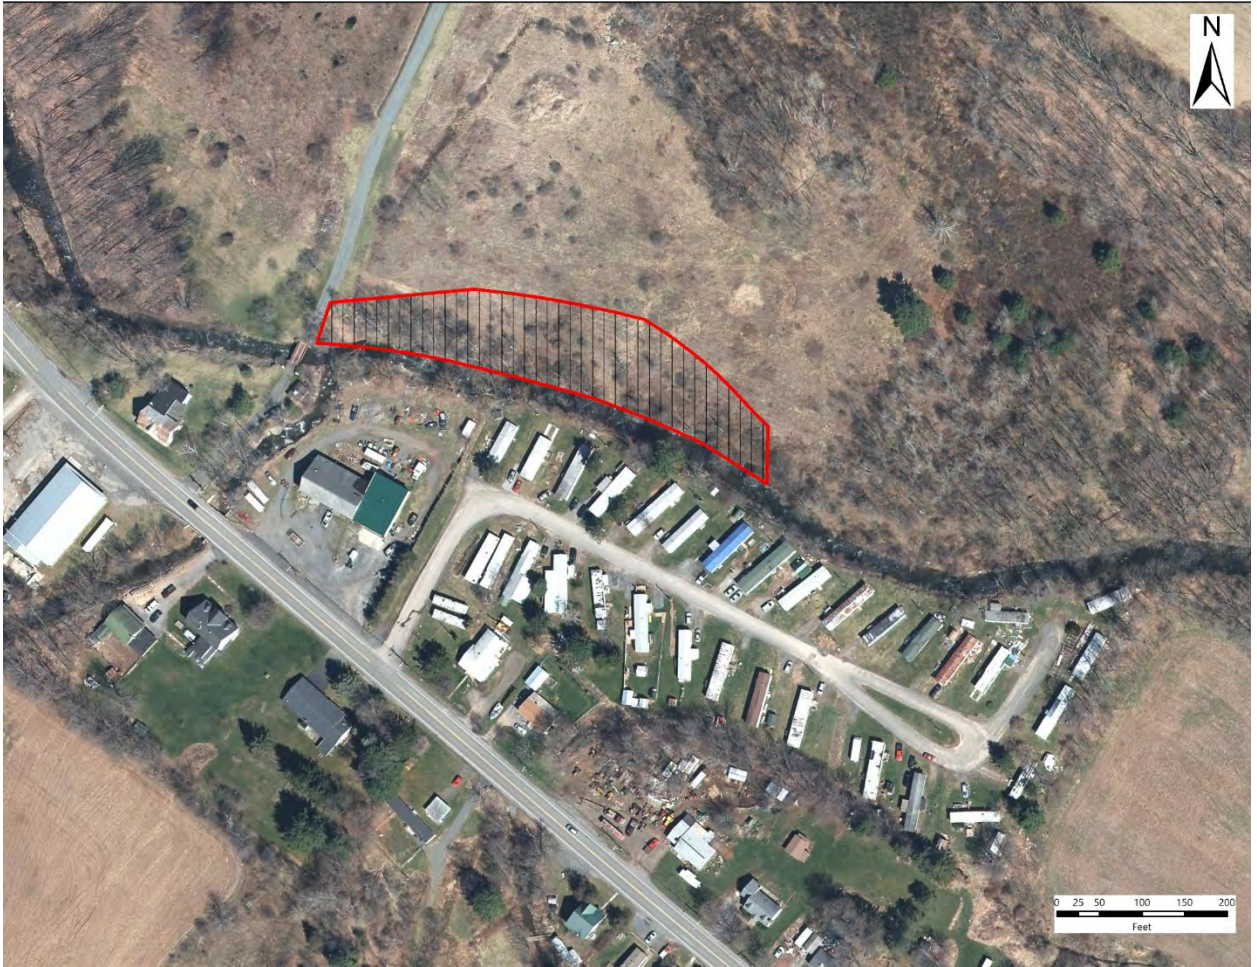
Figure 4-20
Floodplain Bench Enhancement Scenario 1 along Bear Kill, Hamlet of Grand Gorge

Scenario 1 considers a floodplain bench enhancement along the right bank of the Bear Kill (Figure 4-20) and aims to alleviate flooding of mobile homes located in Park Lane, which the FAC depicted as a potential area of concern. The property is located off northbound NYS Route 23 below the confluence of Jump Brook with the Bear Kill and is at a low grade in relation to the surrounding terrain. Existing conditions modeling indicates that floodwaters break over the right bank during the 25-year discharge, resulting in flooding of mobile homes. The proposed mitigation scenario would require excavation of the opposite bank in order to allow the floodplain bench to become activated during the 10-year storm. The floodplain configuration that proved to be the most effective called for a 550-foot-long, 100-foot-maximum-width design.

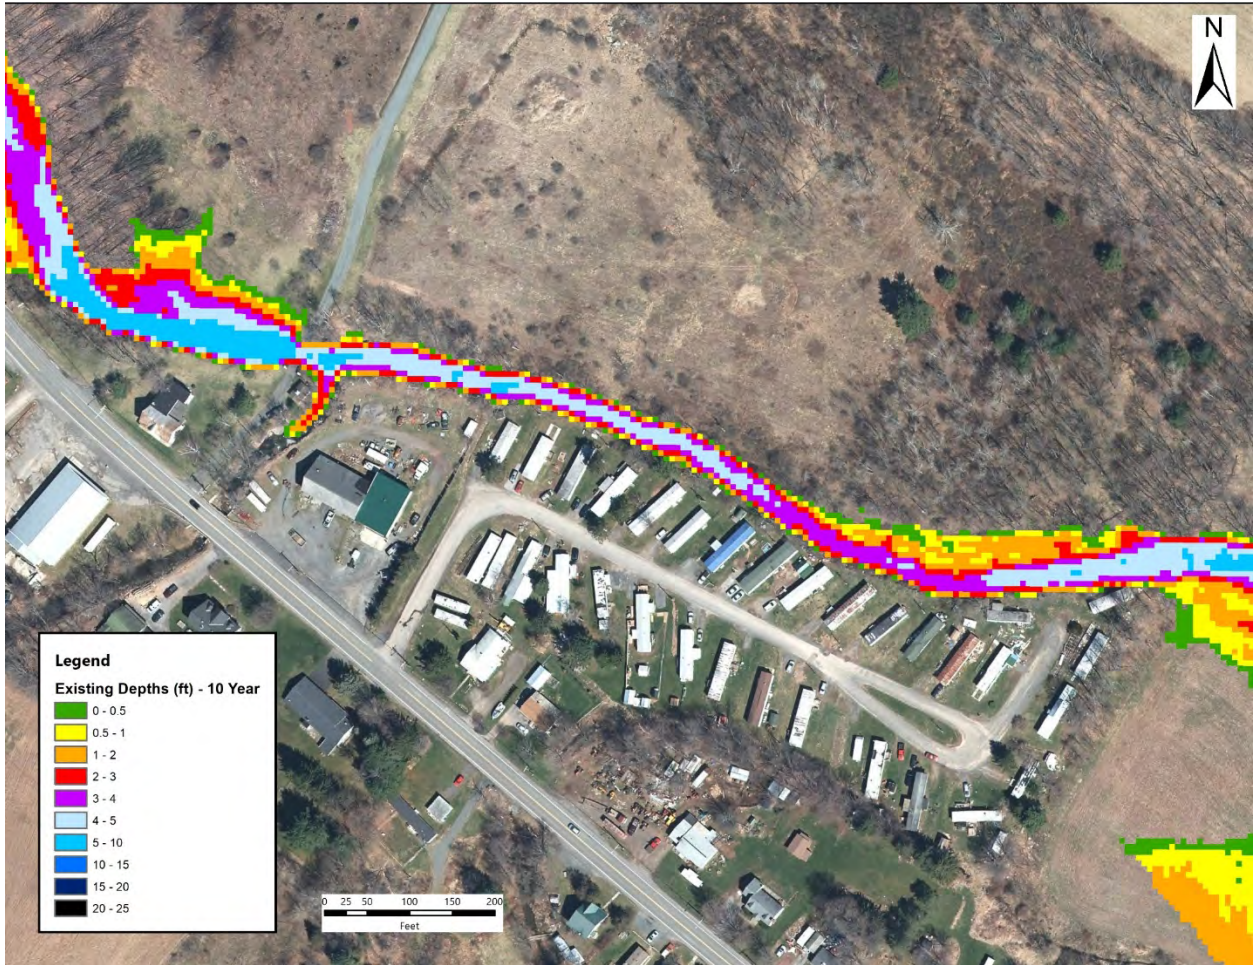
Figure 4-21
Depth Grid Mapping at Park Lane Homes – 10-Year Flood
Existing Conditions

Flood inundation mapping for the 10-year flood event under existing conditions is depicted on Figure 4-21. Flood inundation mapping for the 10-year flood event under floodplain enhancement Scenario 1 is depicted on Figure 4-22. Mapping for the 50-year flood event is depicted on Figures 4-23 and 4-24. Mapping for the 100-year flood event is depicted on Figures 4-25 and 4-26.

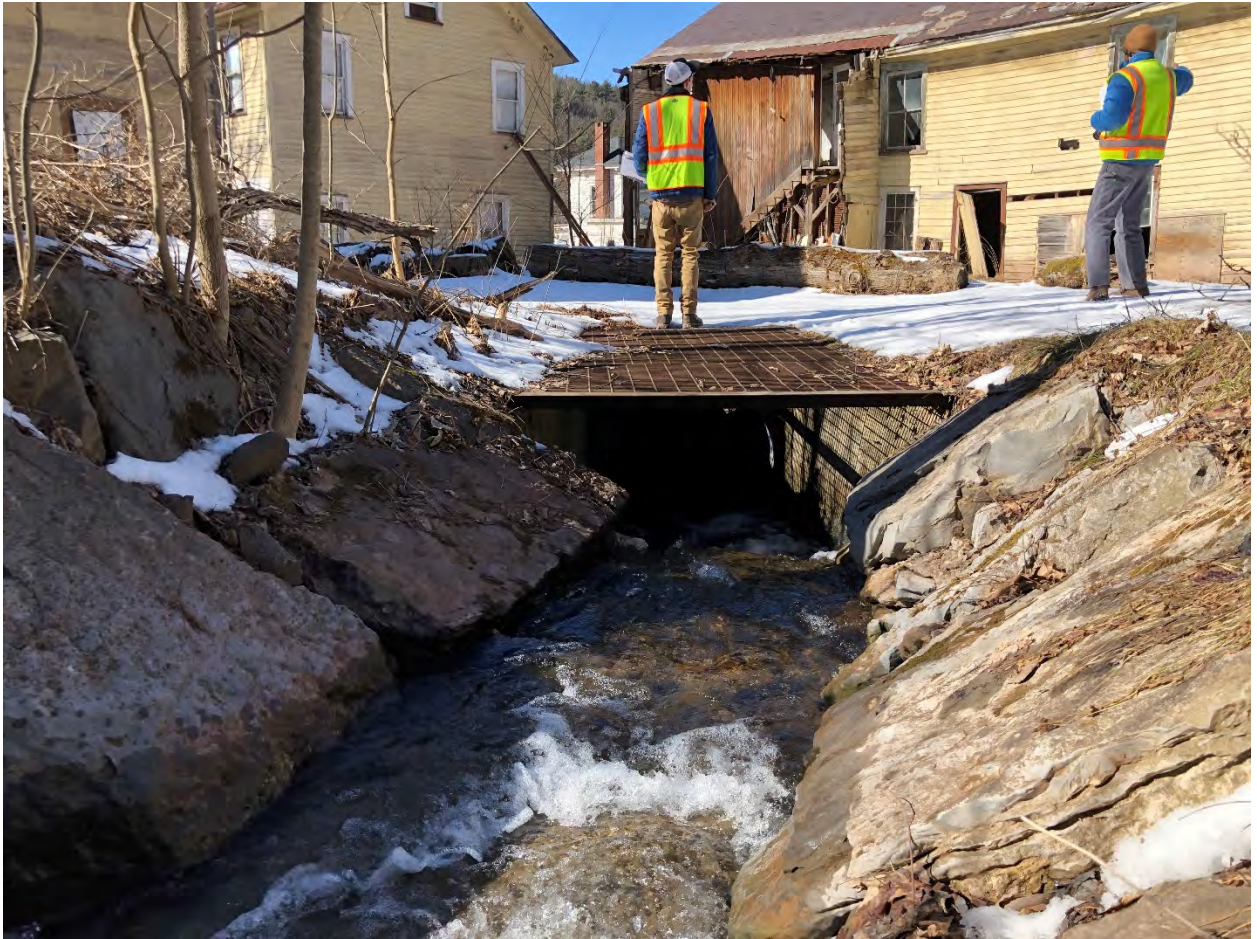
Figure 4-33
Inlet Structure to Pipe Flowing under NYS Route 30, Vega Mountain Stream

In past floods, the culvert and channel upstream have been susceptible to debris jams, further limiting the capacity of the structure and allowing floodwater to overtop the structure. On these occasions, floodwaters traveled through the backyards of homes located to the east of NYS Route 30, across NYS Route 30, through the backyards on the west side of NYS Route 30, where they eventually reached the EBDR.

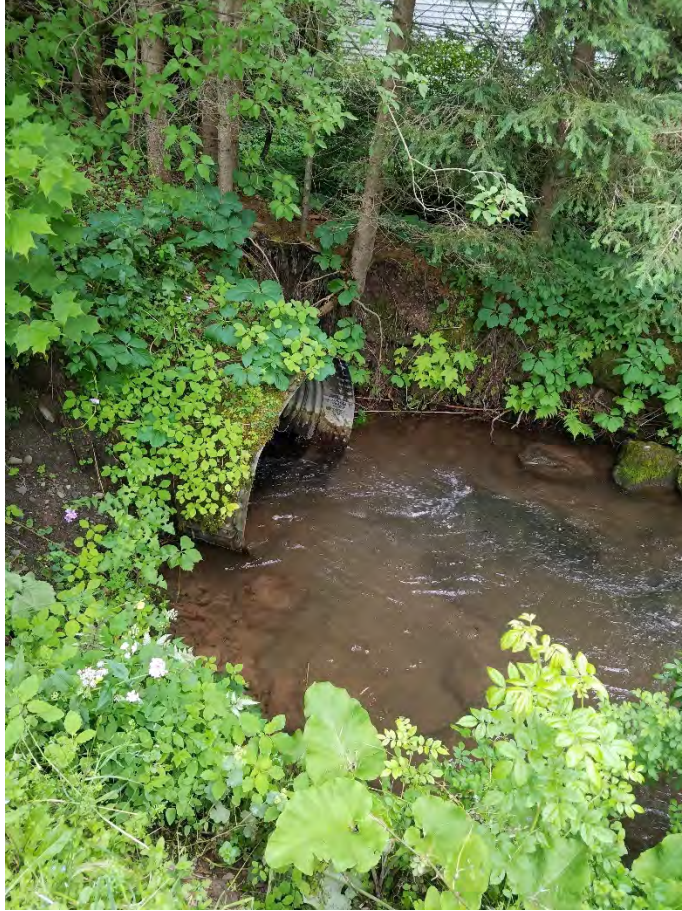
Figure 4-34
Outlet Culvert of Pipe System under NYS Route 30

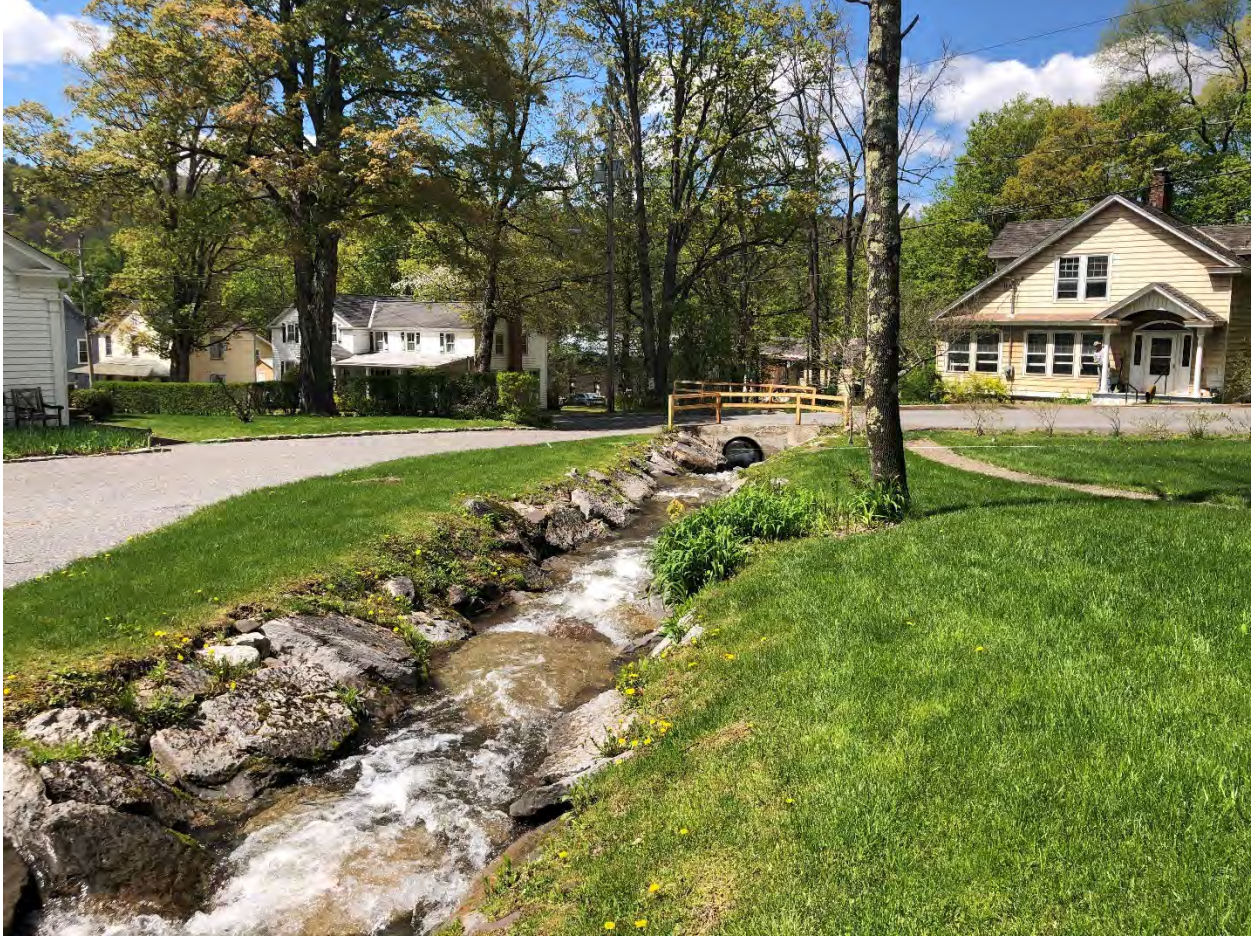
Figure 4-35
Culvert Carrying Vega Mountain Road (Looking Downstream)

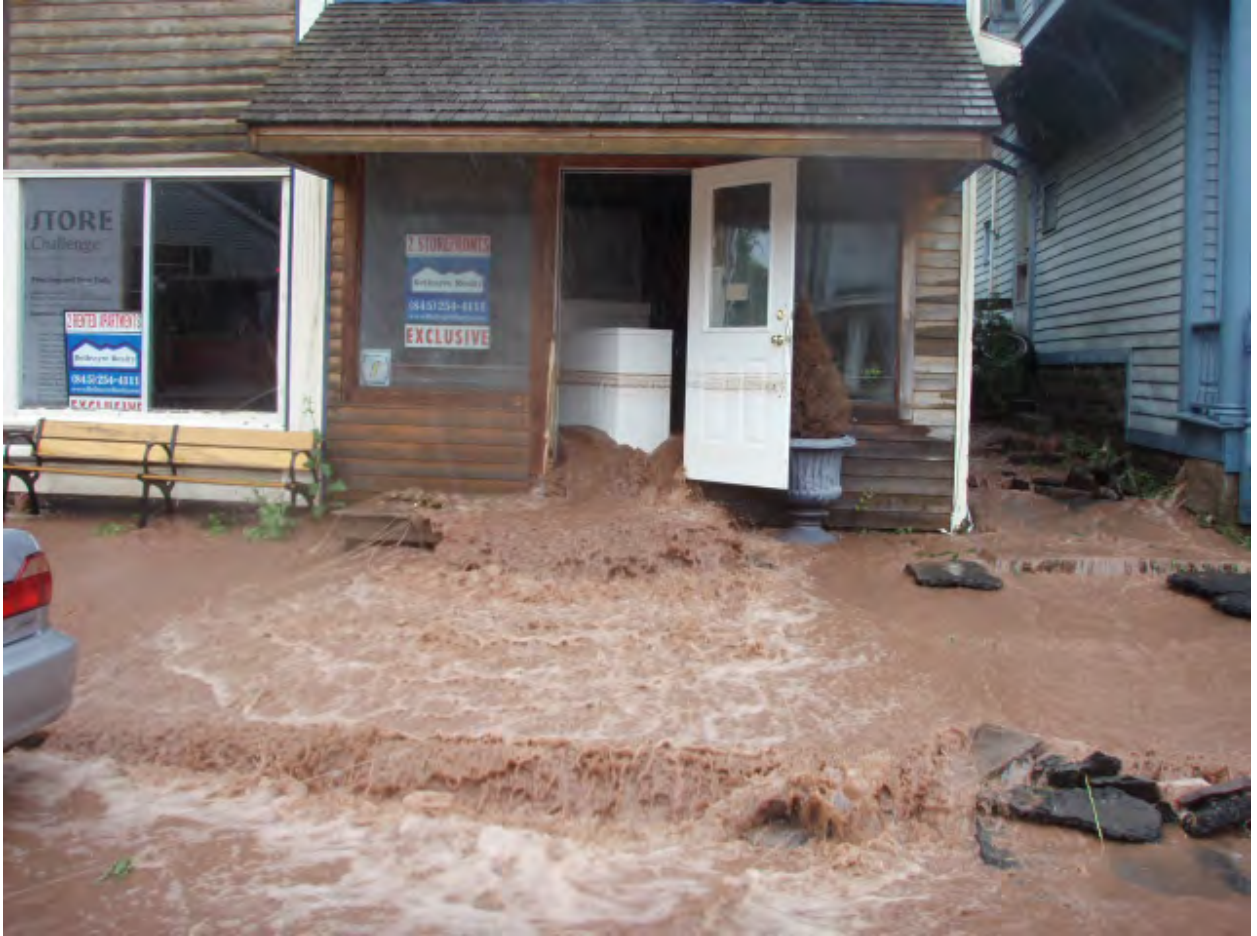
Figure 4-36
Floodwaters from Vega Mountain Stream Flowing Through a Building that is Located on the Northern Corner of the Vega Mountain Road /NYS Route 30 Intersection

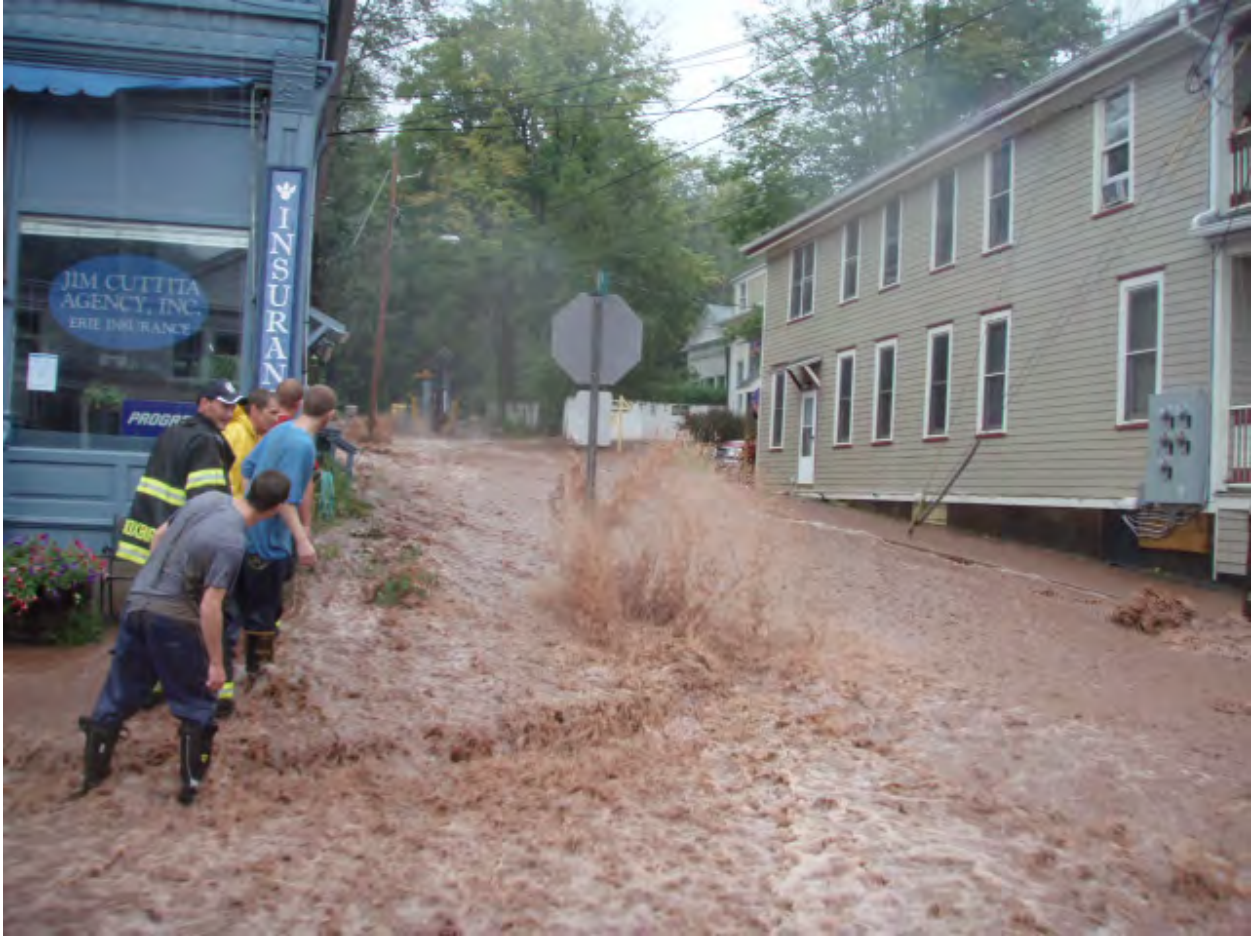
Figure 4-37
Floodwaters from Vega Mountain Stream Flowing Down Vega Mountain Road During Tropical Storm Irene
