Local Flood Analysis

Hamlets of Roxbury and Grand Gorge
Town of Roxbury, Delaware County, New York
February 2020

Prepared for:
Delaware County Soil and
Water Conservation District
44 West Street, Suite 1
Walton, New York 13865

Prepared by:
MILONE & MACBROOM, INC.
231 Main Street, Suite 102
New Paltz, New York 12561
(845) 633-8153
www.mminc.com

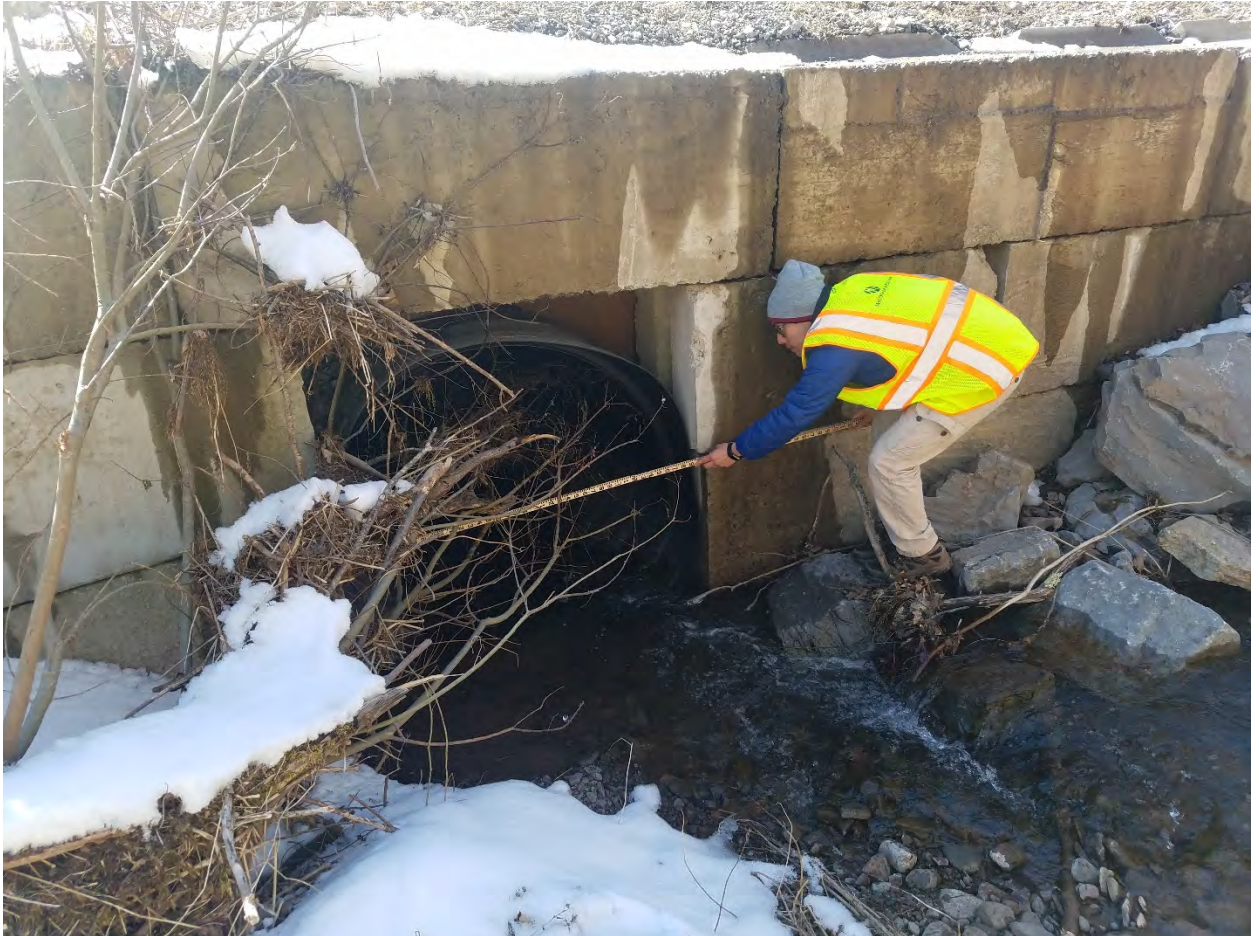
Figure 4-38
Inlet of the Johnson Road Culvert carrying Vega Mountain Stream

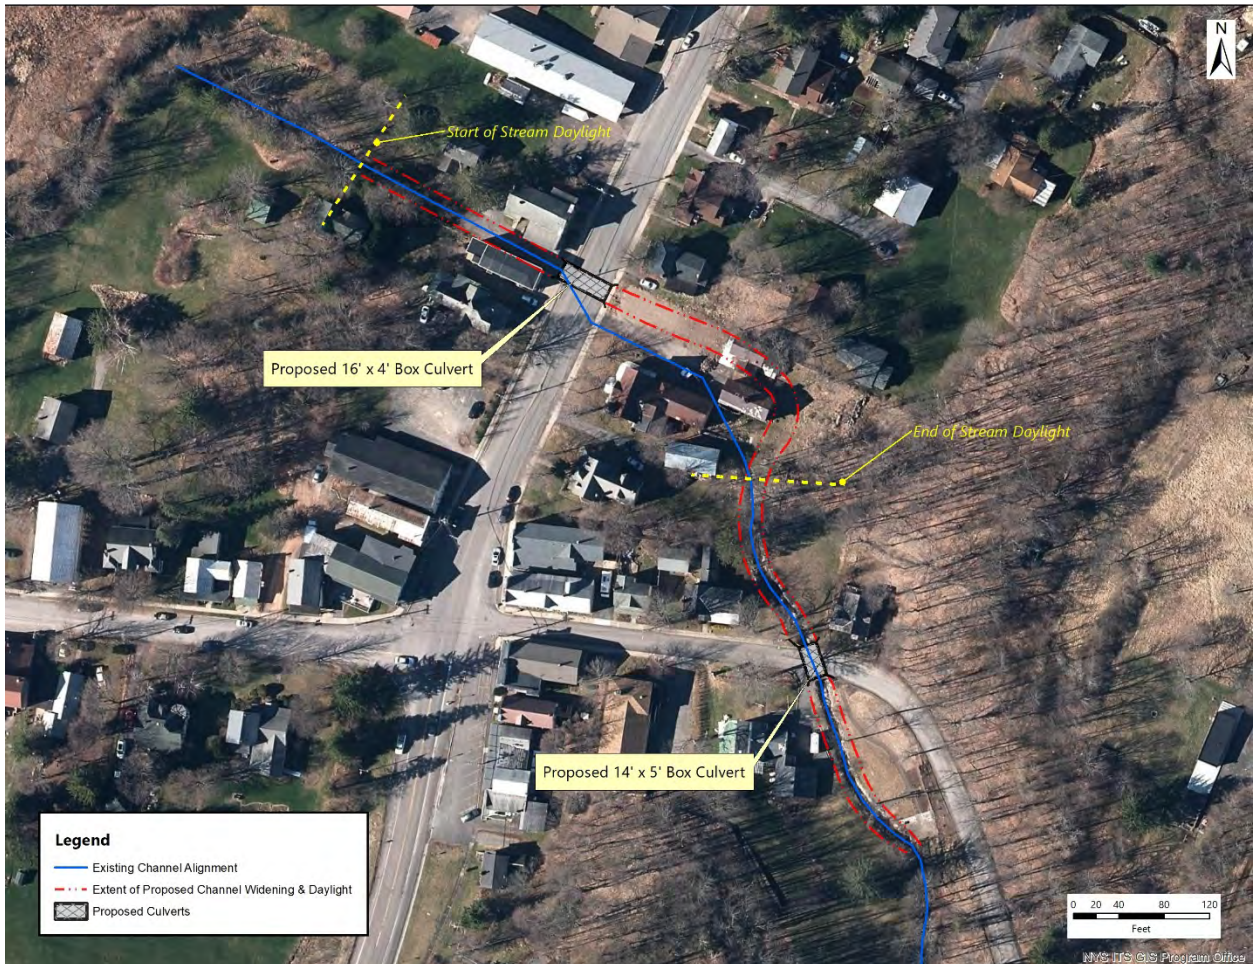
Figure 4-39
Conceptual Alignment of Vega Mountain Stream and Culvert Improvements

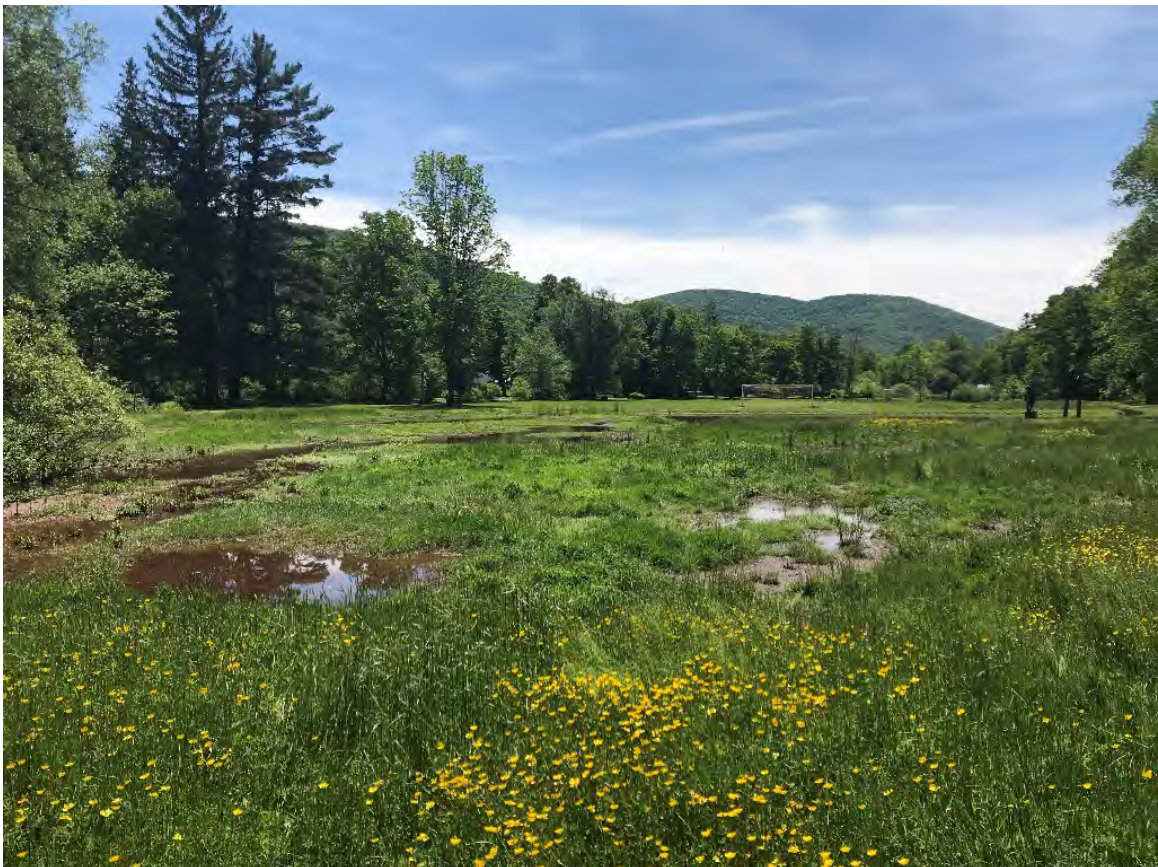
Figure 4-40
Water Poned at Kirkside Park during a Sunny Day, Summer 2019

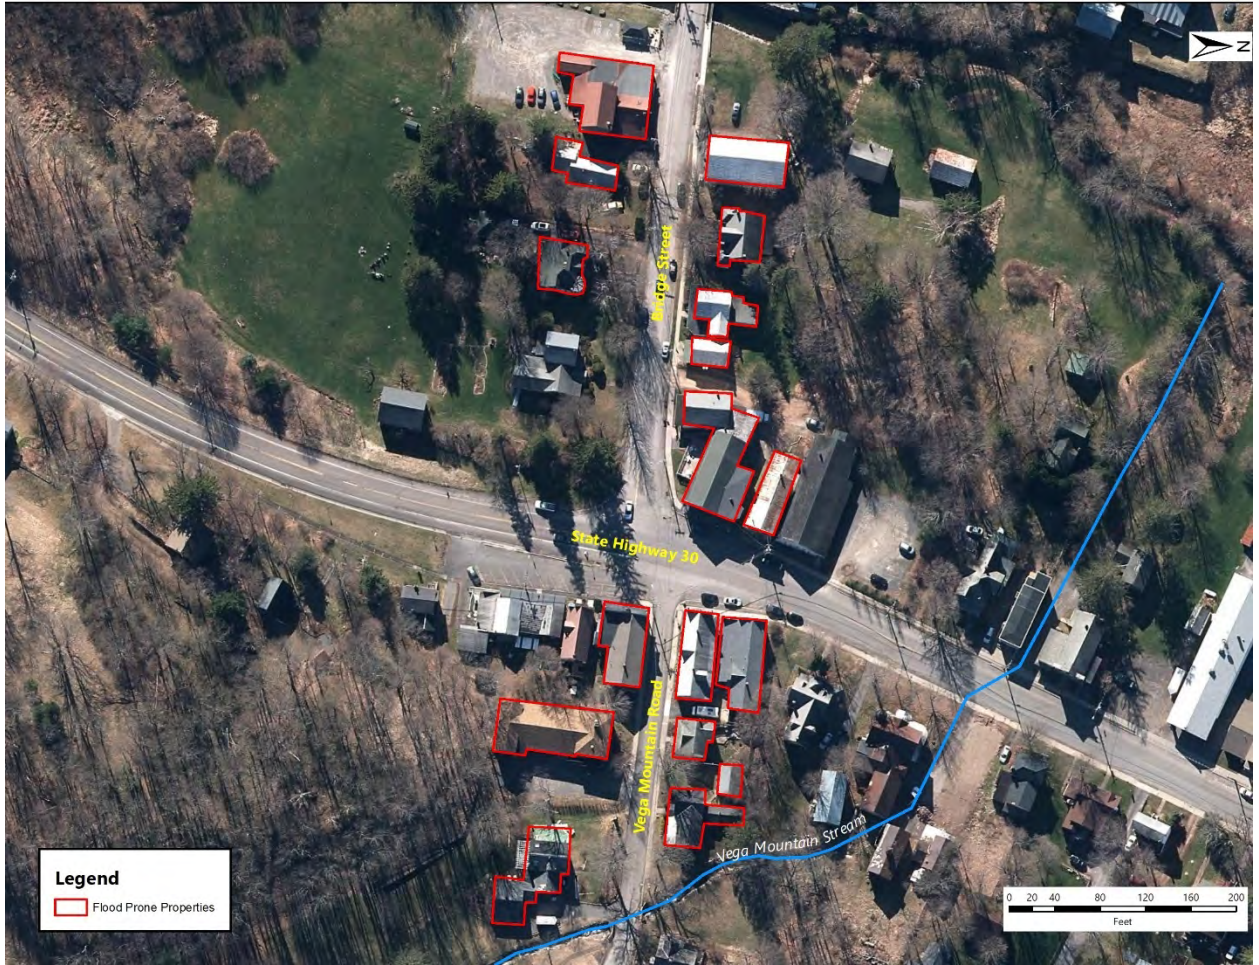
Figure 5-1
Structures (Highlighted Red) Described during Public Meetings as Experiencing Recurring Flood Damage from Vega Mountain Stream
