Chestnut Creek Local Flood Analysis

Hamlet of Grahamsville, New York

SLR #141.14282.00009

December 2022

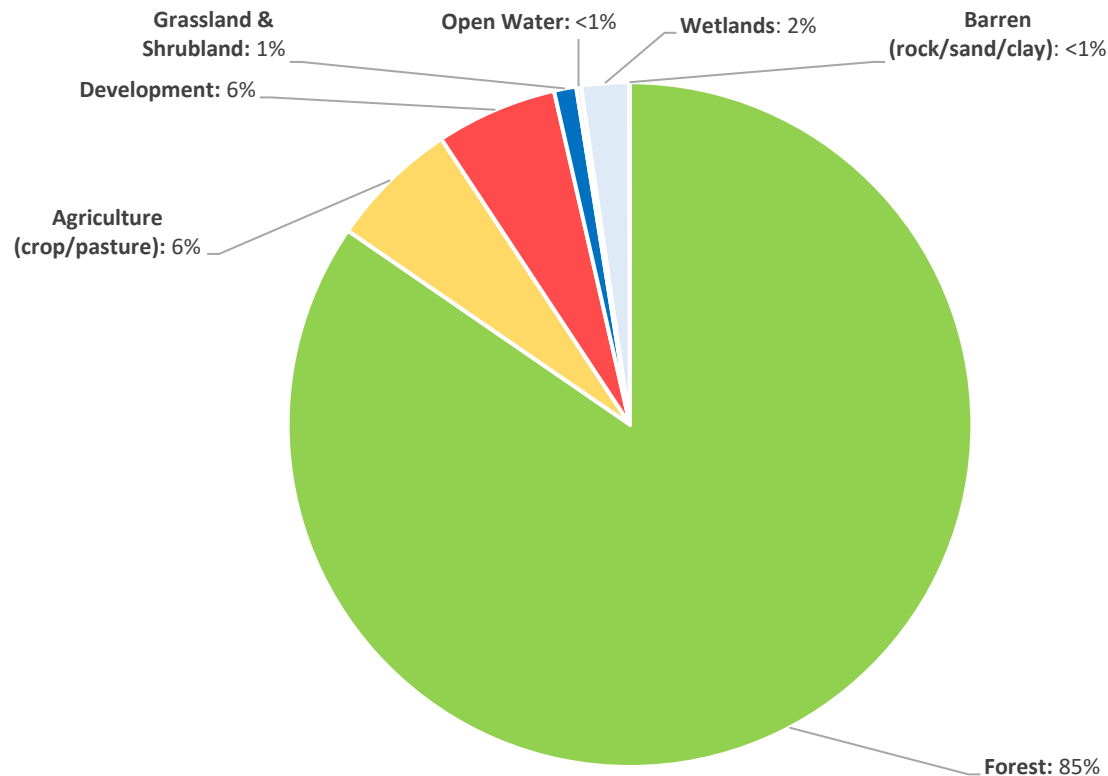
Figure 2-5: Land Cover within the Chestnut Creek Watershed

Forested land makes up 85 percent of the Chestnut Creek watershed. Developed land makes up 6 percent. Agricultural land makes up 6 percent. Wetlands make up 2 percent of the watershed. The remaining 1 percent of land cover consists of grassland and shrubland, open water, and barren land (Figure 2-5).

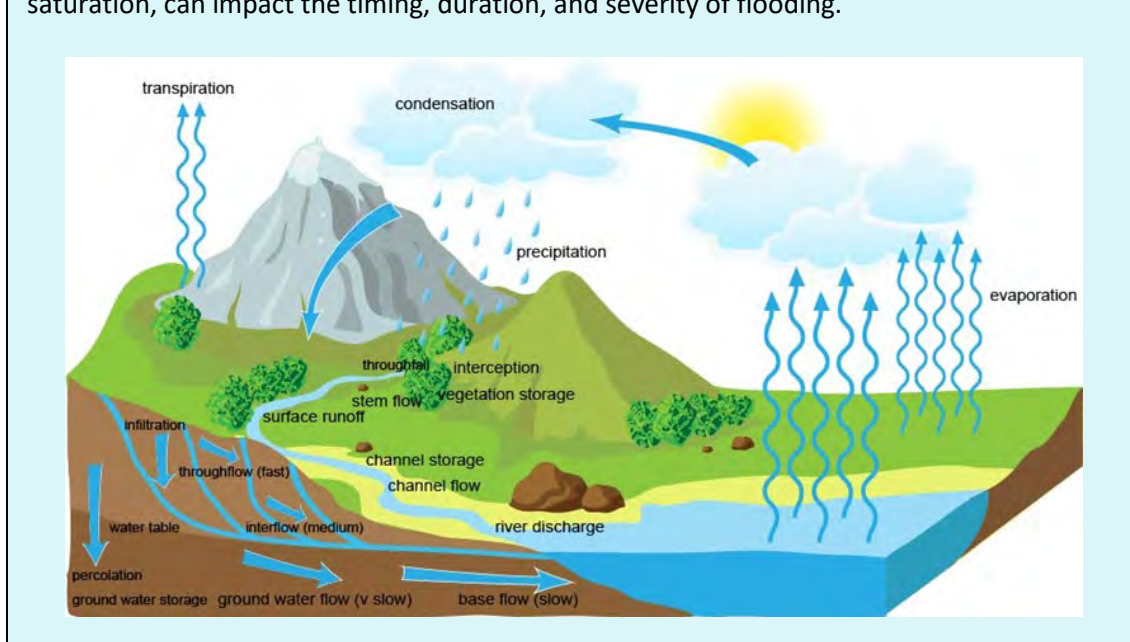
Figure 2-7: Diagram of Simplified Hydrologic Cycle

Along with the location, duration, and intensity of a storm, the flooding that may result from a rainfall event can vary widely depending on the unique hydrology of each basin. Characteristics of local topography, soils, vegetation cover and type, bedrock geology, land use and cover, river hydraulics and floodplain storage, ponding, wetland, and reservoir storage, combined with antecedent conditions in the watershed such as snowpack or soil saturation, can impact the timing, duration, and severity of flooding.

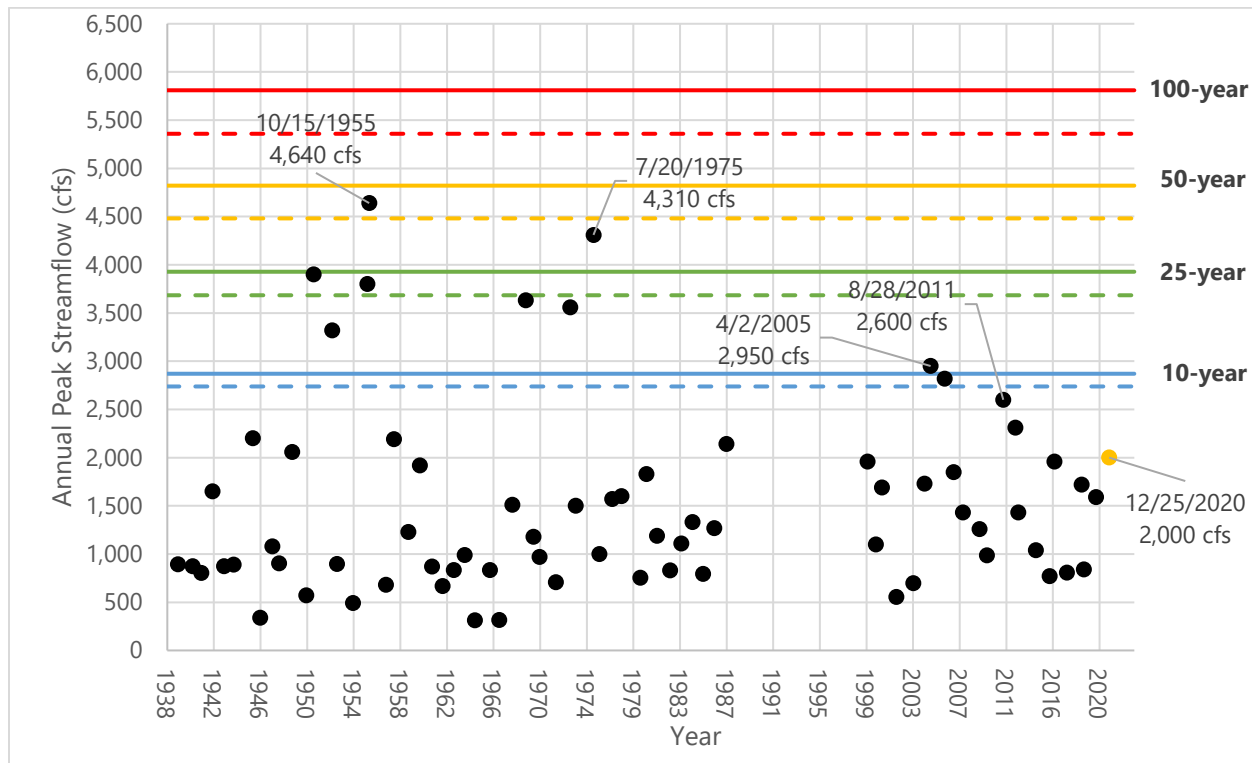
Figure 3-1: Hydrograph of annual peak flows as recorded by USGS Gauge 01365500 on Chestnut Creek in Grahamsville, New York (1938 – 1987; 1998 – Current)

Annual peak-flow data on Chestnut Creek provide a useful view into past flood events. A hydrograph with annual peak flows measured at gauge 01365500 for the 2020 water year is illustrated in Figure 3-1. The hydrographs were updated with the recent flood event that took place in December 2020. Published and updated flood recurrence information was superimposed on the hydrographs. The FEMA FIS 10-, 25-, 50-, and 100-year peak discharges are denoted by solid lines while the updated gauge analysis peak flows are denoted by dashed lines. The events that resulted in the largest magnitude flows on Chestnut Creek include a storm in October 1955, which exceeded a 50-year event, and an event in January 1975, which was close to a 50-year flood event. The August 2011 Tropical Storm Irene event, which caused widespread flooding across the Catskill region, reached a peak of 2,600 cubic feet per second (cfs) on Chestnut Creek, or almost a 10-year flood event. Within the past two decades, the largest recorded storm was the April 2005 flood that was above a 10-year storm event.

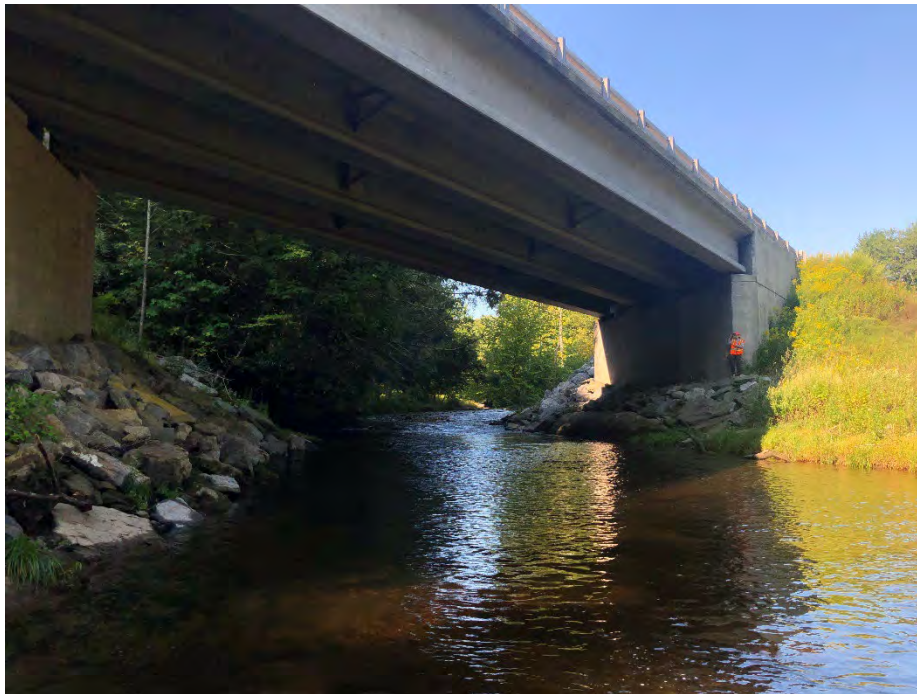
Figure 4-2: Downstream outlet opening of the State Route 55 bridge

The NYS Route 55 bridge (BIN 1027070) crosses over Chestnut Creek at STA 0+50 near the downstream limits of the LFA project reach. The structure is an open deck steel girder bridge built in 2010 that is owned by the NYC Department of Water Supply, Gas and Electricity (Figure 4-2). The structure spans 73 feet wide and has a vertical opening of approximately 24 feet. There were no problems reported by the public at this crossing at the time of this analysis. The NYSDOT bridge inspection report for the State Route 55 bridge, dated April 2020, did not identify any problems with the structure.

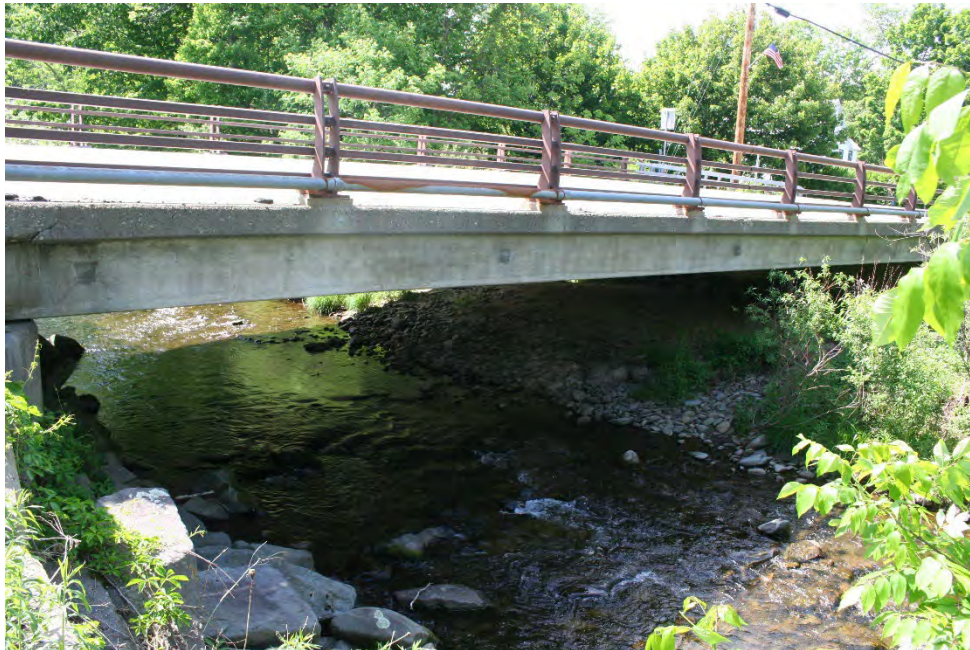
Figure 4-3: Looking upstream at the outlet of the NYS Route 42 bridge over Chestnut Creek

New York State Route 42 is a north-south state highway that branches off Main Street (State Route 55) in downtown Grahamsville. The structure carrying NYS Route 42 over Chestnut Creek at STA 50+73 is a single-span concrete box beam bridge built in 1998 (Figure 4-3). The bridge measures approximately 64 feet wide and has a vertical opening of roughly 9.5 feet. According to the NYSDOT bridge inspection report from April 2020, the structure was determined to be in overall good condition with no listed action items.

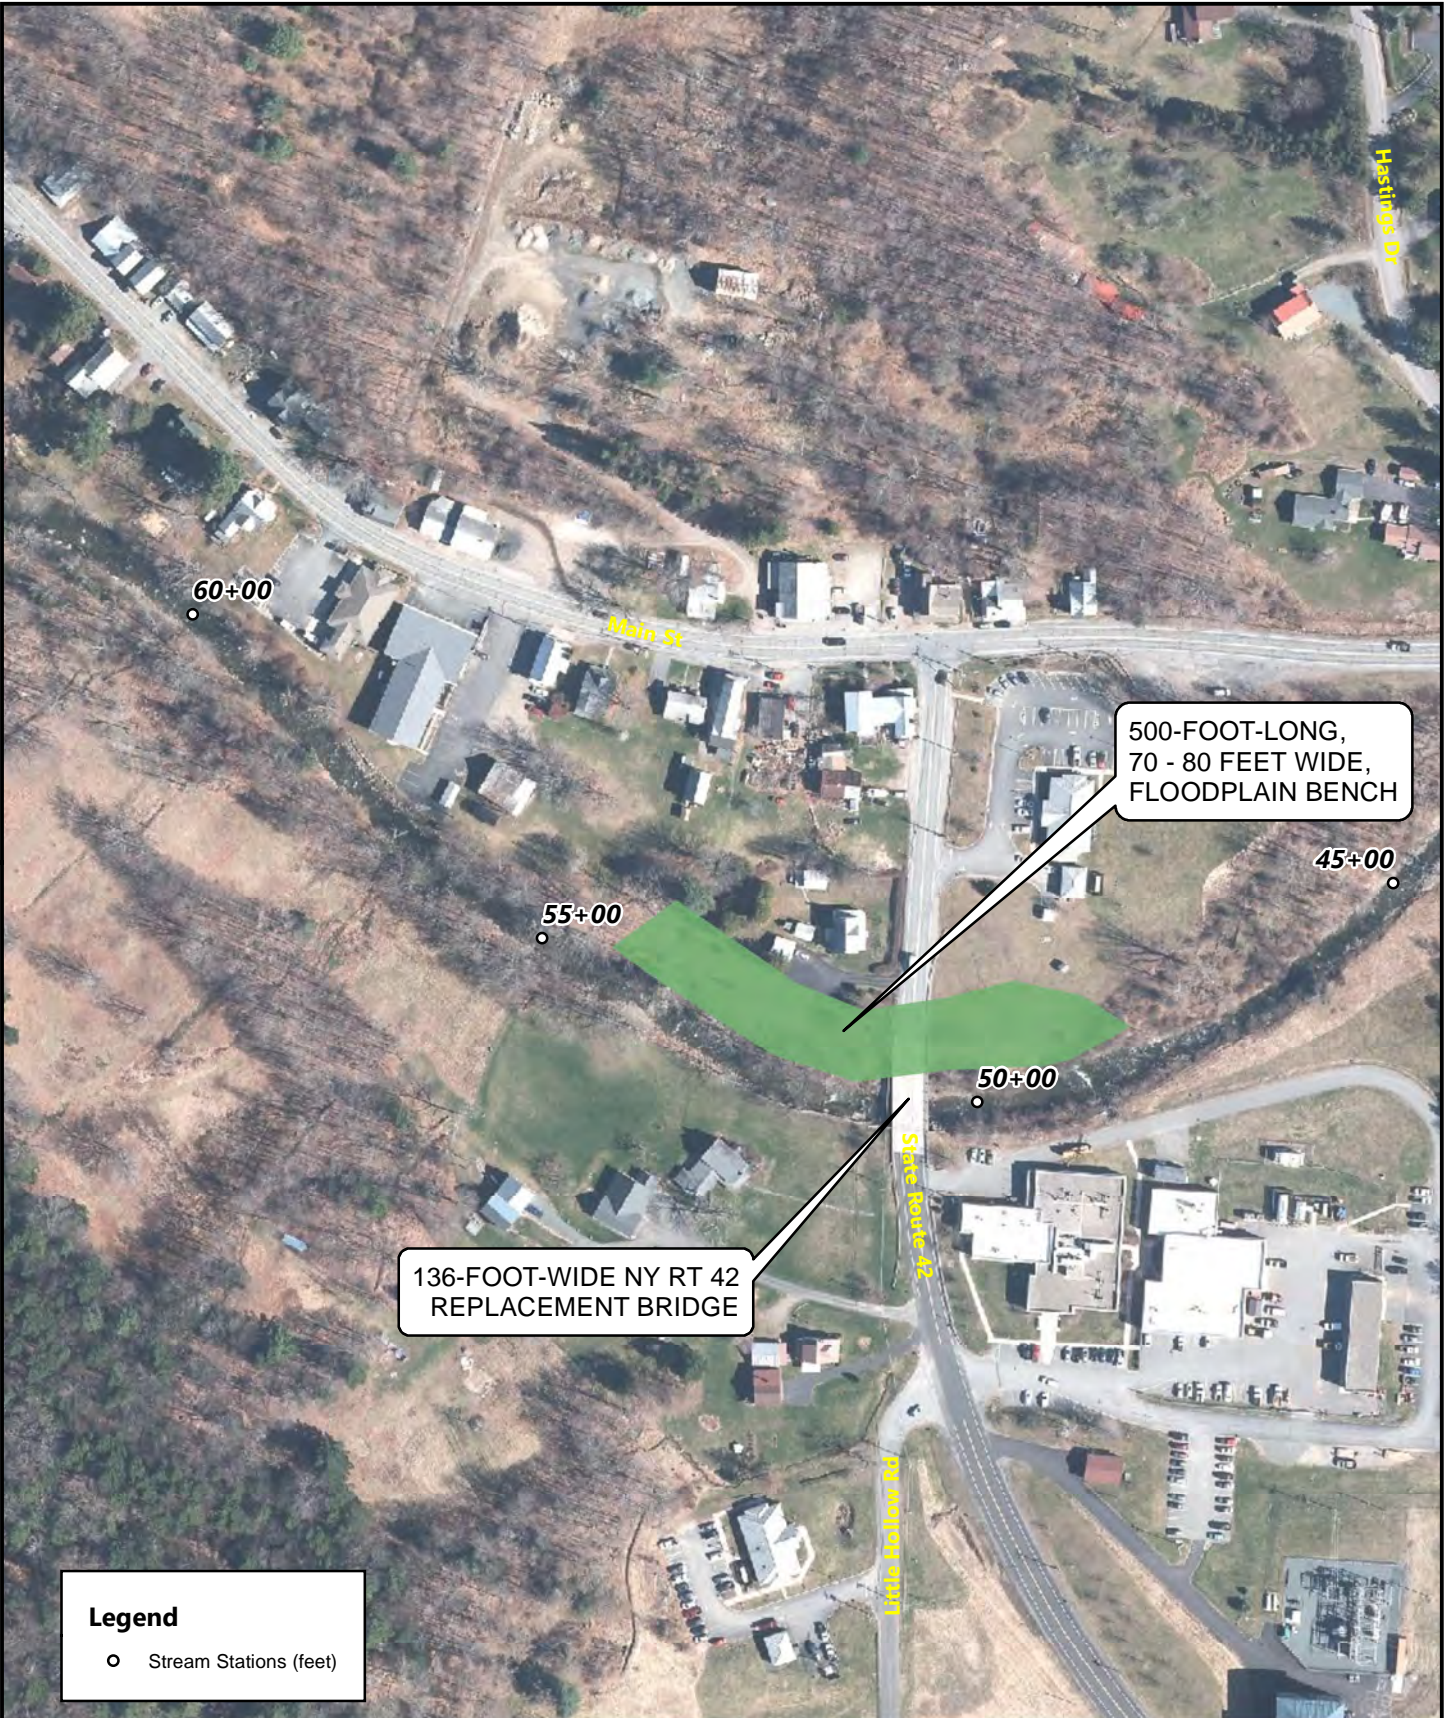
FIG. 4-4A

500-FOOT-LONG,
70 - 80 FEET WIDE,
FLOODPLAIN BENCH

The scenario described above would reduce flooding of Main Street and building across all flood storm events, most notably in the lower-frequency but higher-magnitude floods. In the 50-year event, reductions in upstream water surface elevations would range from 1.2 to 3.0 feet below existing conditions. Water surface elevations would be lowered between 1.3 to 2.7 feet in the proposed conditions 100-year storm event. The resulting reductions in water surface elevations is suggested to remove about half a dozen homes from the current inundation extents of the 50- and 100-year storm events. Flood depth mapping for the 10-year storm event is depicted in Figure 4-4 (existing conditions) and Figure 4-5 (proposed conditions). Mapping for the 50-year storm is illustrated in Figure 4-6 (existing conditions) and Figure 4-7 (proposed conditions). Lastly, the 100-year storm is illustrated in Figure 4-8 (existing conditions) and Figure 4-9 (proposed conditions).

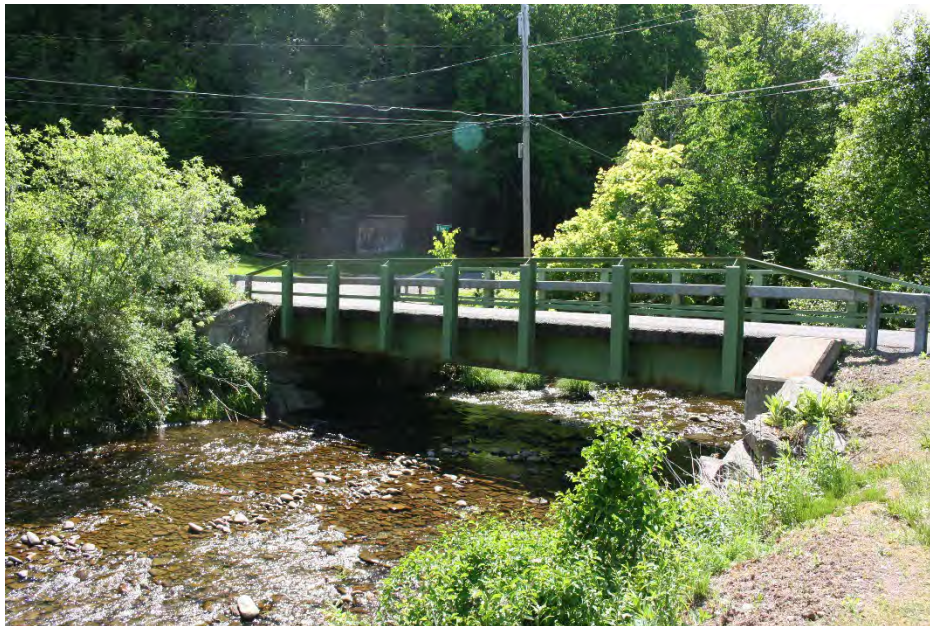
Figure 4-12: Looking upstream at the inlet of the River Road bridge over Chestnut Creek

The River Road bridge (BIN 3357080) over Chestnut Creek at STA 67+74 is a single-span steel girder bridge approximately 43 feet wide with a 6.5-foot-high opening (Figure 4-12). According to the bridge inspection report dated June 2008, the bridge was built in 1996 and exhibits minor structural wear at its deck and slight erosion along the bank protection measures abutting the structure. River Road branches off State Route 55 and runs southwest across the Chestnut Creek valley floor. The left (northeast) approach is at grade with the natural floodplain for most of its length and ramps slightly upward as it approaches the left bridge abutment. River Road is a dead-end access road to about half a dozen homes located southeast of the creek along River Road and Gillette Road.

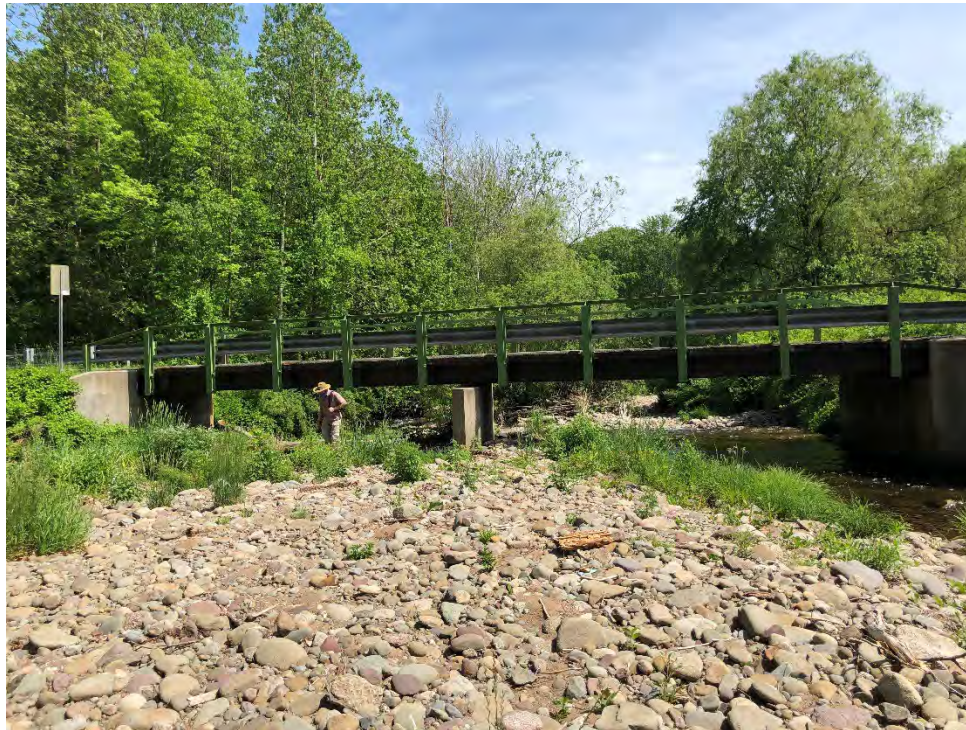
The structure carrying Davis Lane over Chestnut Creek at STA 90+00 is a county-owned bridge (BIN 3357040) built in 1993. The steel girder bridge spans 57 feet wide, approximately 6.5 feet high, and has a center pier underneath (Figure 4-13). According to the NYSDOT bridge inspection report dated March 2020, the road crossing exhibits structural deficiencies and received an overall inspection score of 'poor.' At about 20 feet downstream of the bridge face, there is a grouted angular rock weir structure that has been installed to protect a utility sewer main that runs under Chestnut Creek. The hard weir structure limits the downstream vertical adjustment of the natural stream bottom and might be contributing to sediment transport instabilities and the development of a lateral sediment bar upstream of the bridge. In the event of an overtopping flood on Davis Lane, a 0.5-mile detour via Fairground Road is available to residents that live southwest across Chestnut Creek.

Figure 4-13: Looking downstream at the Davis Lane bridge inlet over Chestnut Creek. A prominent lateral sediment bar is located immediately upstream of the bridge.

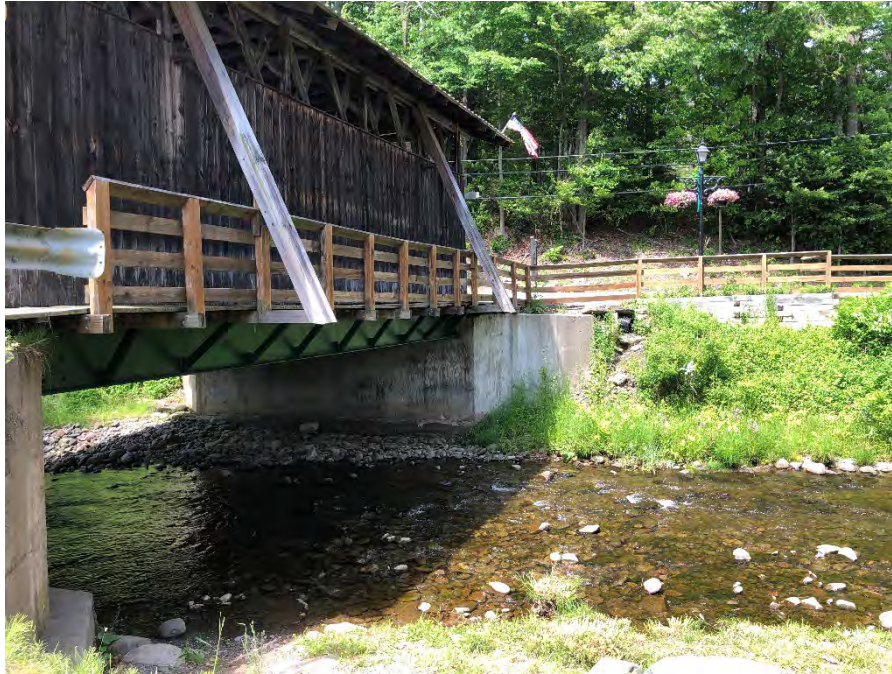
Figure 4-14: Looking upstream at the Fairground Road covered bridge outlet over Chestnut Creek

The Fairground Road covered bridge (BIN 5524660) passes over Chestnut Creek at STA 101+00 (Figure 4-14). The road connects State Route 55 on the north to the Grahamsville Fairgrounds and a few homes located across Chestnut Creek to the south. The town-owned structure is a steel girder open-bottom bridge built in 1976 that spans 36.5 feet wide and is approximately 9.0 feet high. As of the NYDOT inspection dated March 2020, this structure received an overall rating of 'good,' with no action items listed. However, the report describes multiple sightings of spalling and undermining near the abutment interfaces with the wingwalls. In the event that the bridge becomes unsafe for vehicular passage, a 0.5-mile detour is available via Davis Lane for emergency ingress and egress.

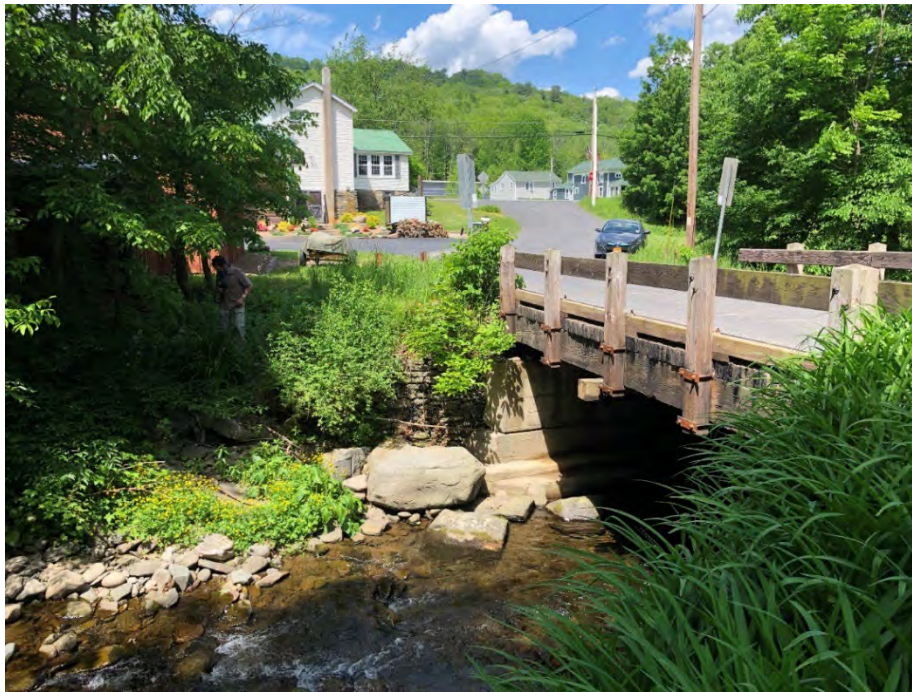
Figure 4-15: Looking downstream at the Hilltop Road bridge inlet over Chestnut Creek

members do not yet need extensive reconditioning. There may be some minor substructure undermining.” However, the structure was not flagged as being in ‘poor’ status.

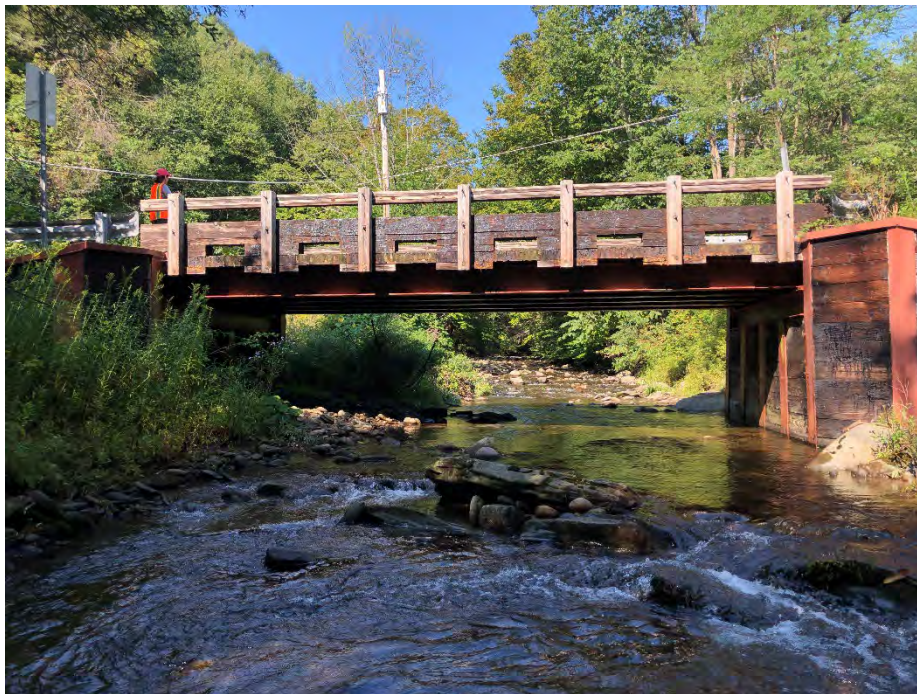
Figure 4-16: Looking upstream at the Clark Road bridge

The structure carrying Clark Road over Chestnut Creek at STA 152+75 is a single-span, open-bottom steel girder bridge built in 1995 (Figure 4-16). The county-owned bridge (BIN 3357090) measures 30 feet wide and has a vertical opening of approximately 7 feet. As of the August 2020 bridge inspection report, this bridge is listed as being in overall good condition without mention of any significant wear or structural deficiencies requiring further investigation. Clark Road is a dead-end road branching off NYS Route 55 that serves about four homes to the south and is the only route available for residents and emergency responders across the creek.

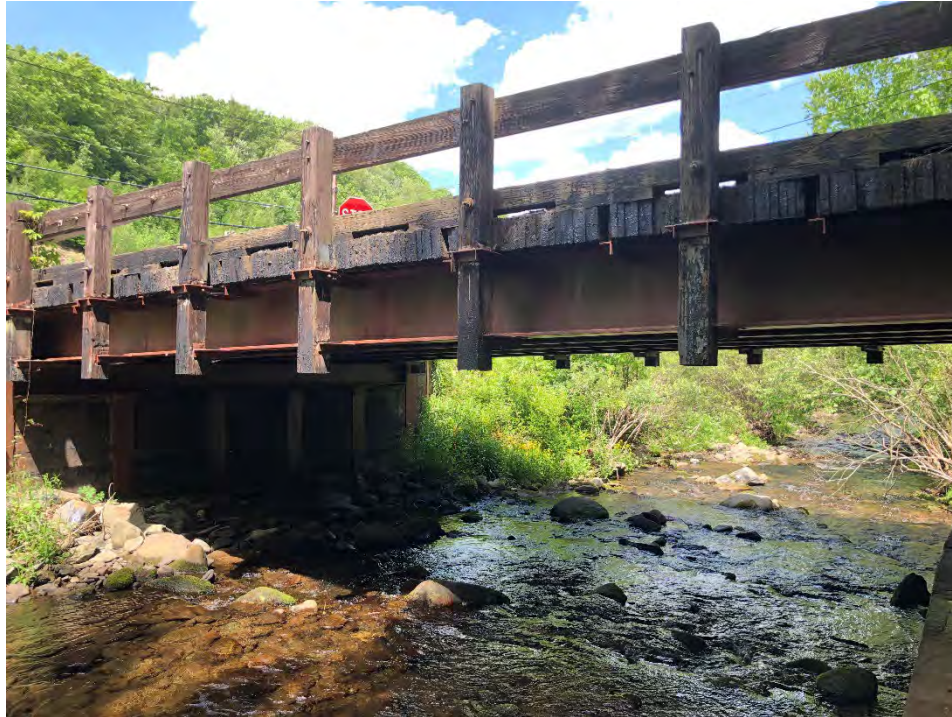
Figure 4-17: Looking downstream at Kelly Road bridge inlet over Chestnut Creek

Kelly Road branches off to the south of NYS Route 55 and crosses over Chestnut Creek at STA 175+21 (BIN 3229170). The structure carrying Kelly Road is a single-span timber steel girder bridge that measures approximately 29 feet wide and has an open bottom that is about 12 feet high at its deepest point (Figure 4-17). This bridge is the sole means of access to the subdivision of homes located to the south of Chestnut Creek. An informal detour may be available for emergency access or evacuation via a privately owned driveway bridge that crosses the creek at STA 163+35. According to the NYSDOT bridge inspection report dated April 2020, the 1979 structure was identified to be in overall good condition and shows no issues requiring immediate action.

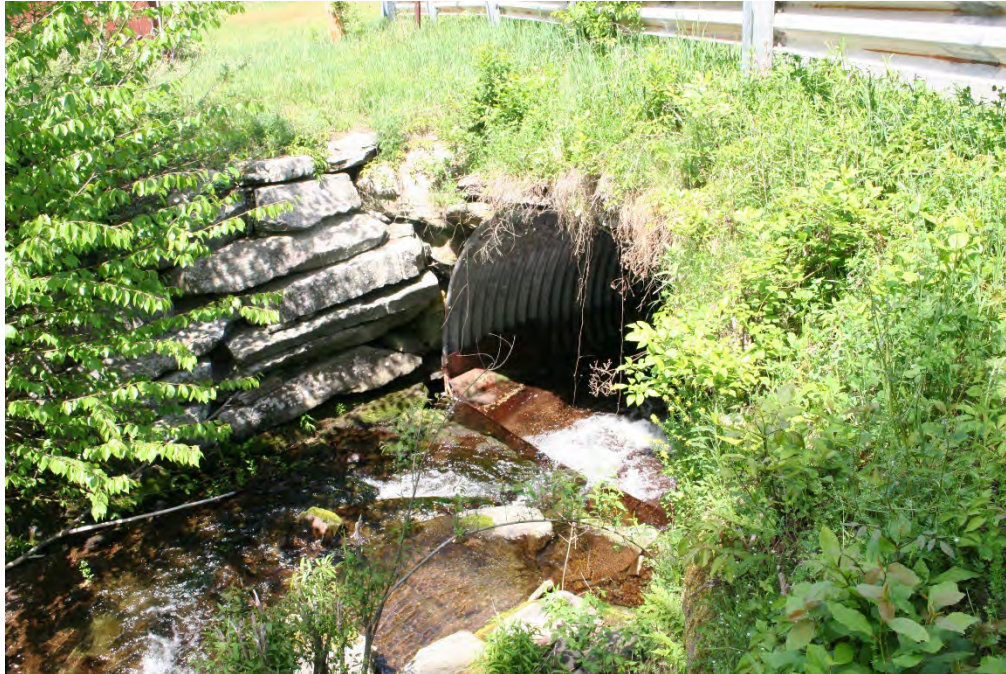
Slater Road crosses over Chestnut Creek at STA 211+23 and is the upstream most crossing within the LFA study reach. The roadway is carried by a corrugated metal arch culvert with a 14-foot span and 9.8-foot rise abutted with stacked stoned wingwalls (Figure 4-18). Reports from town officials indicate that the stacked stone wingwalls at the inlet have begun deterioration and pose a threat to the overall performance of the culvert in the event of a collapsing failure. During field site visits, inlet and outlet drops were observed at this crossing, including a 2-foot-deep scour pool at the downstream end. These features are indicative of stream channel instabilities resulting from an undersized stream crossing and present passage problems for aquatic organisms. Based on aerial imagery, the crossing serves roughly seven to eight homes to the south of Chestnut Creek, and an informal seasonal detour may be available via Thunder Hill Road in the event of a roadway washout.

Figure 4-18: Looking downstream at Slater Road culvert over Chestnut Creek. The stacked stone wall and culvert inlet drop are also illustrated.

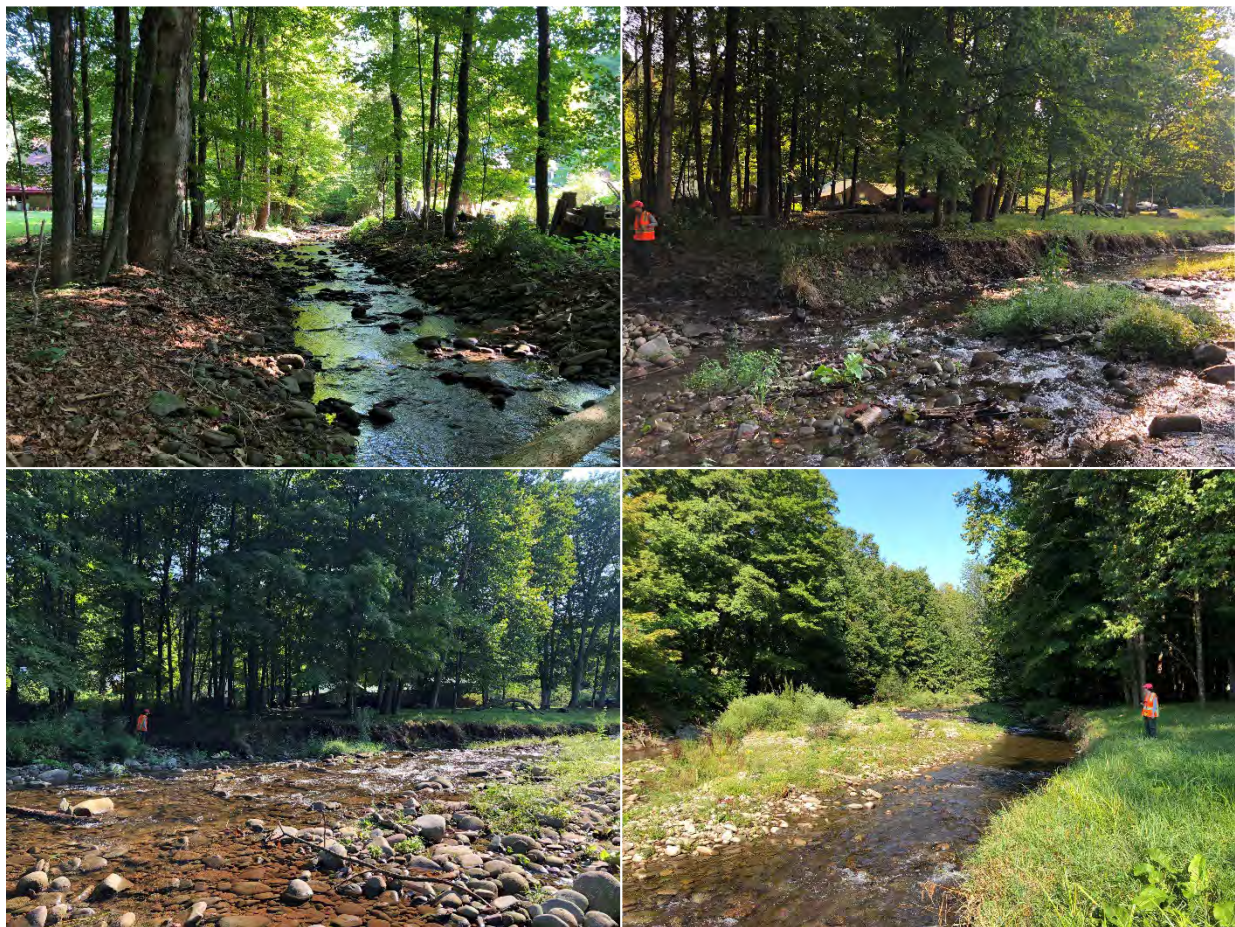
Bullet Brook meets Chestnut Creek near STA 92+81 and has a drainage area of 1.64 square miles. Reports of flooding and erosion near the confluence with Chestnut Creek were mentioned during the public outreach portion of the study. A field visit was conducted in summer 2022 to document current site conditions and any potential sources of channel instability. Figure 4-19 illustrates a series of photographs taken while walking the confluence area.

Figure 4-19: (Top Left) Bullet Brook tributary near confluence looking upstream. (Top Right) Looking downstream at eroding bank on Chestnut Creek. (Bottom Left) Large sediment buildup upstream of confluence area. (Bottom Right) Mid-channel sediment bar downstream of confluence area.

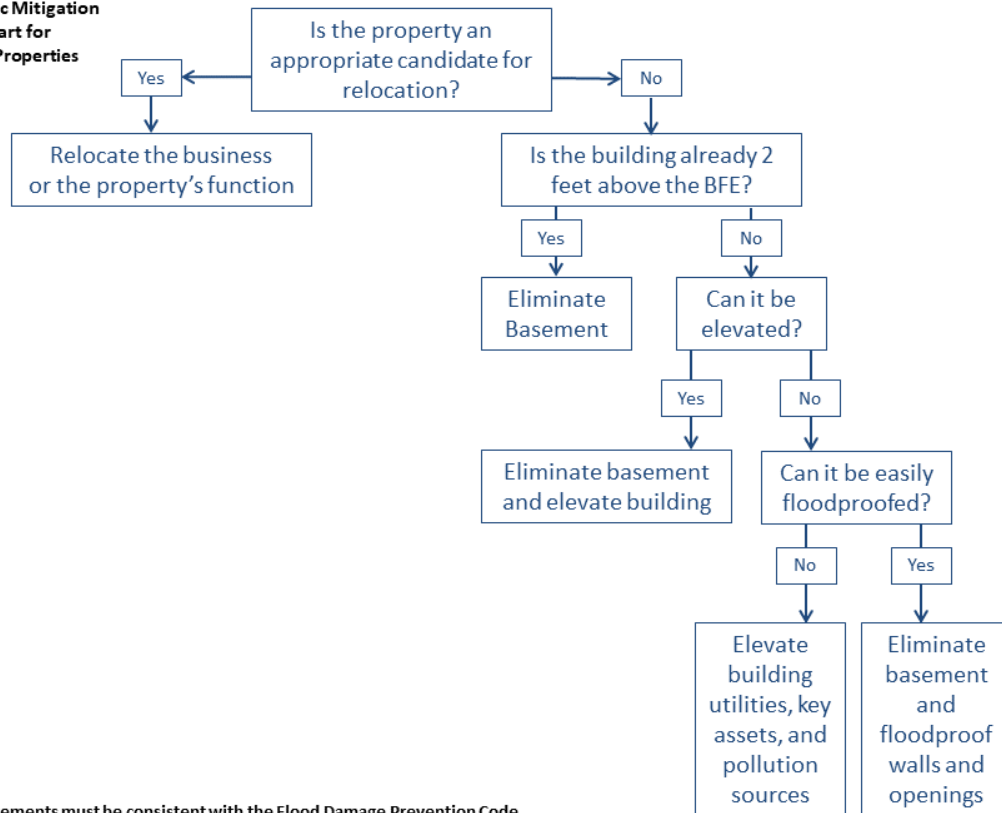
**Property-Specific Mitigation
Decision Flowchart for
Nonresidential Properties**

Note: All improvements must be consistent with the Flood Damage Prevention Code. Consult the Town of Neversink Code Enforcement Officer in all cases

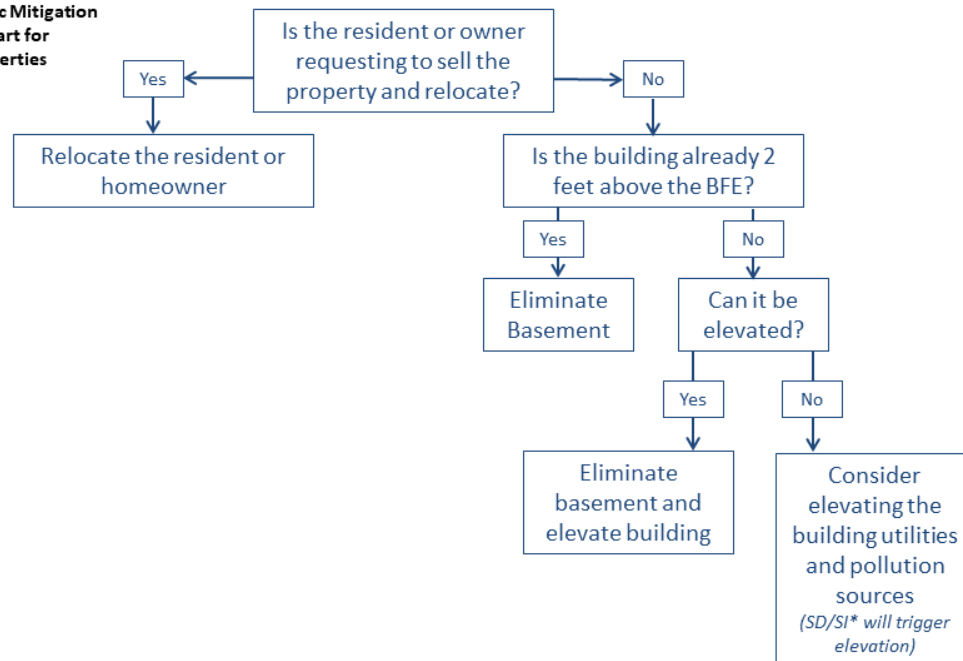
**Property-Specific Mitigation
Decision Flowchart for
Residential Properties**

*Substantial Damage/Substantial Improvement
 Note: All improvements must be consistent with the Flood Damage Prevention Code.
 Consult the Town of Neversink Code Enforcement Officer in all cases

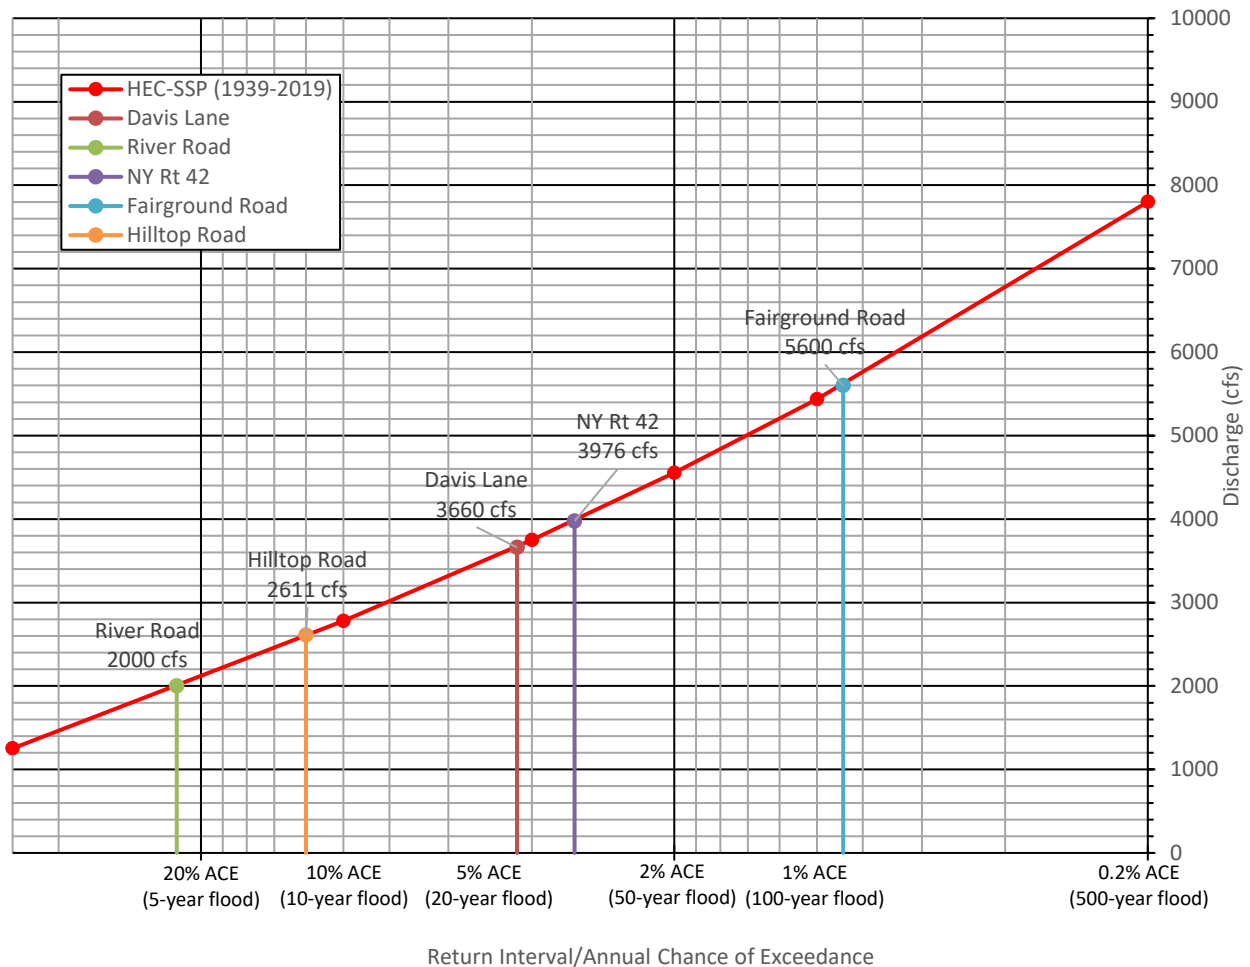
Crossing	Threshold Flow at Crossing (cfs)	Corresponding Flow Reading at Gauge (cfs)
River Road	1,333	2,000
Hilltop Road	1,439	2,611
Davis Lane	2,730	3,660
NYS Route 42	2,455	3,976
Fairground Road	3,359	5,600

Figure 4-23: Flood-Frequency Curve created from USGS Stream Gauge Analysis on Chestnut Creek. Community members can expect flooding at the specified crossings when the flow reading at the USGS gauge approaches the indicated discharge amounts.
