HAMLET OF PINE HILL LOCAL FLOOD ANALYSIS

Town of Shandaken, New York

SLR #142.14615.00030

November 2022

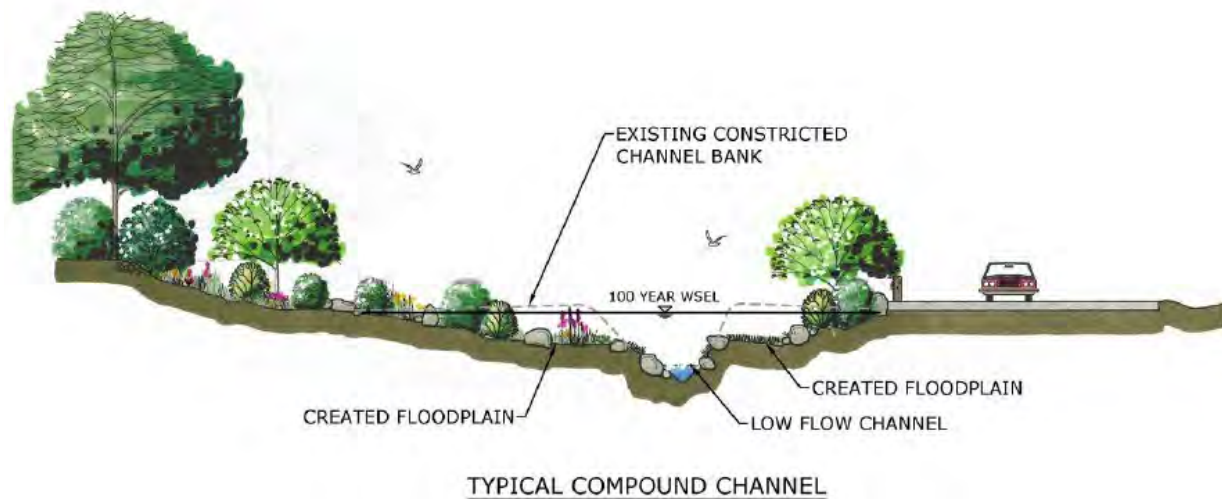
Figure 1-1: Cross Section of River Channel with Floodplains

Pine Hill and the LFA area are high in the Esopus Creek watershed. **This headwater region is characterized by relatively steep slopes and deep valleys that transition to gentler slopes and wider valleys further**

downstream. The fast-moving water picks up sediment that is then deposited further downstream as the water slows in the flatter regions. Areas like Pine Hill are therefore expected to see a trend of erosion over time.

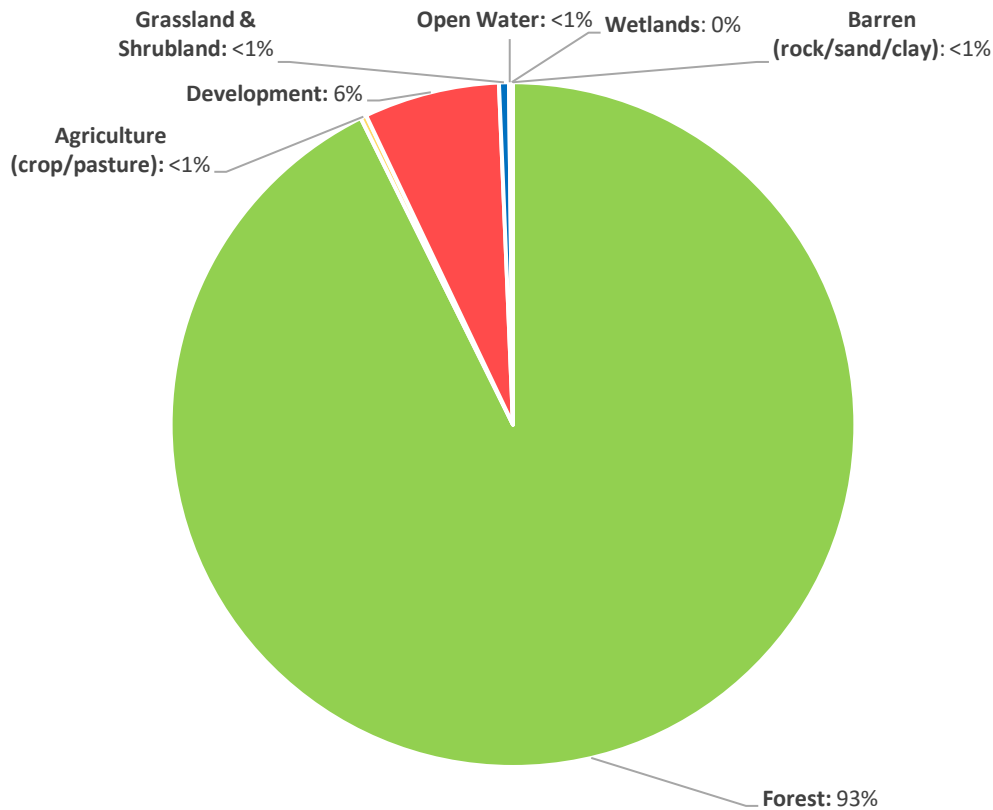
Figure 2-4: Land Cover within the Birch Creek Watershed

Forested land makes up 93 percent of the Birch Creek watershed. Developed land makes up 6 percent. The remaining 1 percent of land cover consists of agricultural land, grassland and shrubland, open water, wetlands, and barren land (Figure 2-4). A portion of Belleayre Mountain Ski Center is located in the northeast corner of the watershed. The ski center artificially makes snow and utilizes several ponds in the watershed to produce the snow.

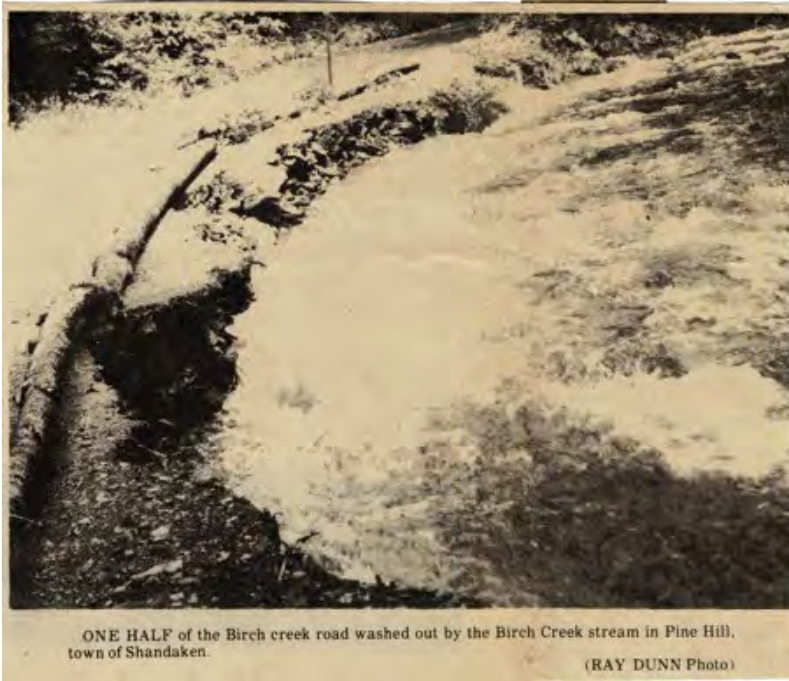
Figure 3-2: A photo depicting flood damage within the hamlet of Pine Hill on Birch Creek Road during the July 1973 event. Photo Source: Catskill Mountain News

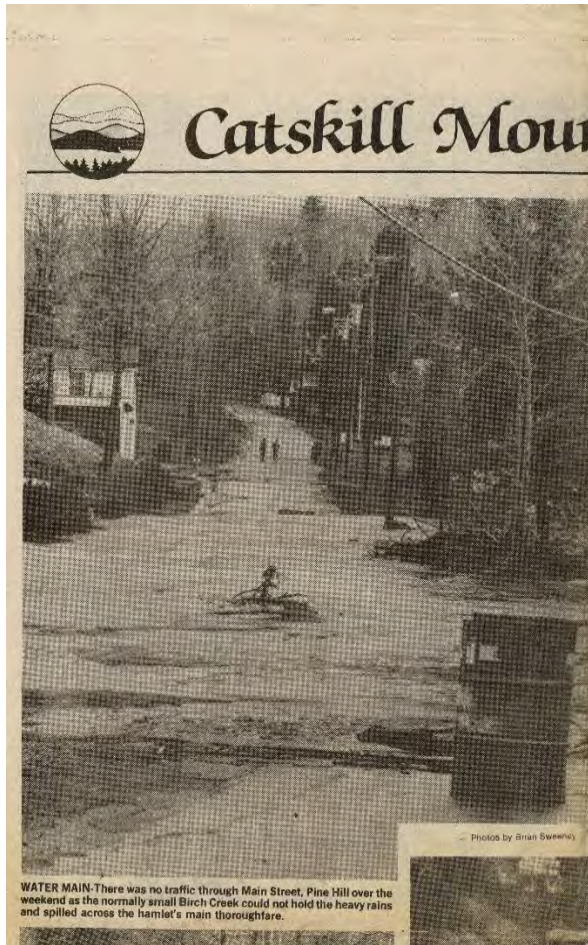
Figure 3-3: A photo depicting flooding across Main Street (left) and flood damage within the hamlet of Pine Hill on Upper Main Street bridge during the April 1987 event (below). Photo Source: Catskill Mountain News (left) and Daily Freeman (below)

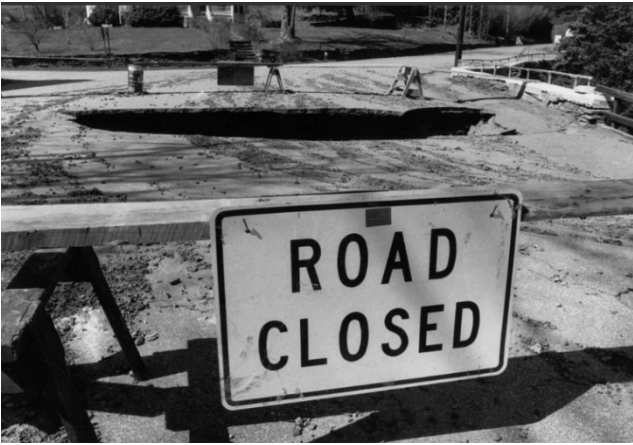
Figure 3-4: A photo depicting flood damage within the hamlet of Pine Hill during the April 1987 event. Photo Source: Aaron Bennett, NYCDEP

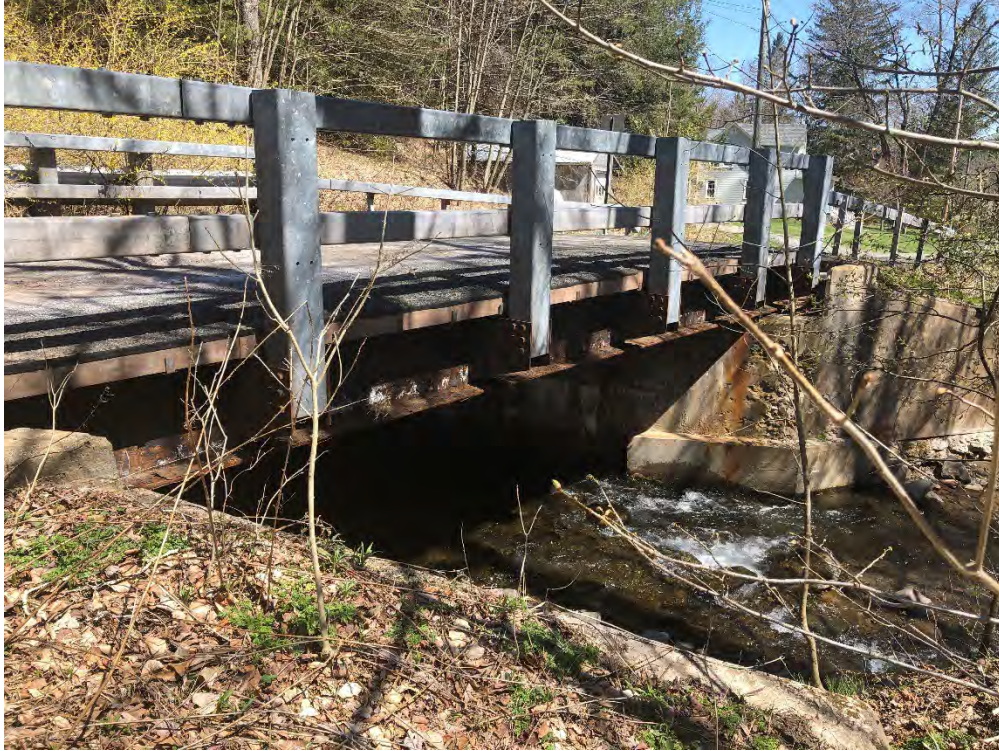
Figure 4-3: Outlet of county bridge over Alton Creek

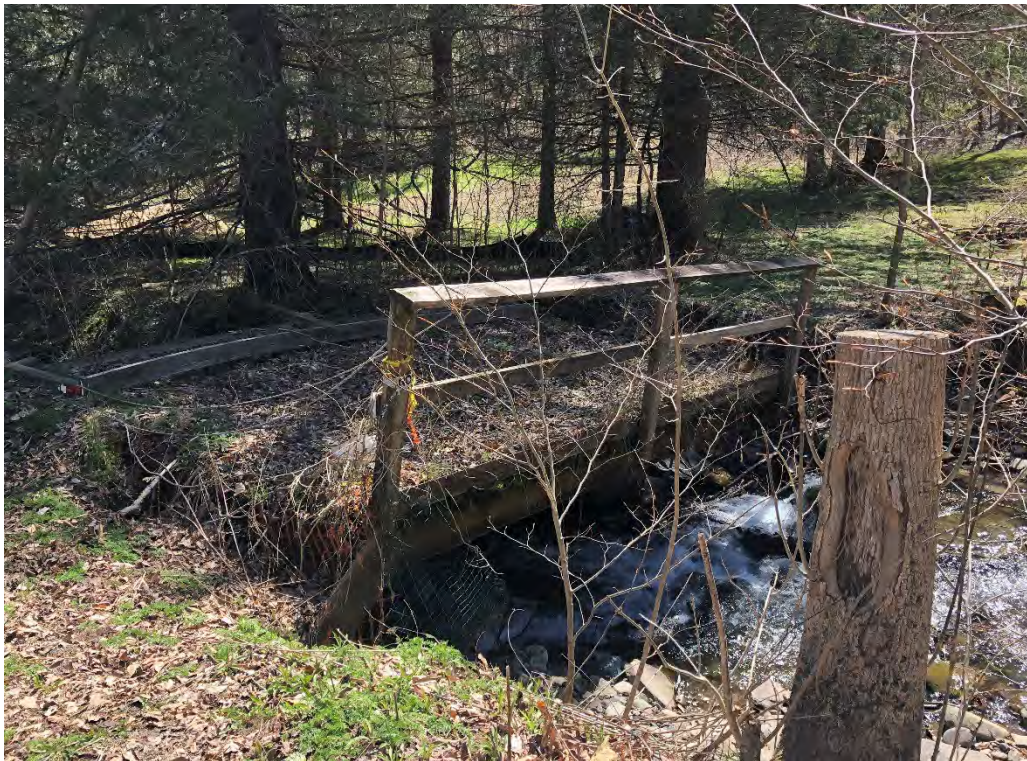
At river station 32+20, an abandoned private driveway crosses Alton Creek. The wood and metal structure sits on top of concrete abutments. The abutments are undercut, and the surface is no longer connected to either bank. The crossing overtops during flows less than the 10-year flood event, and it creates backwater flooding. This structure is a medium priority due to the risk of flooding Bonnie View Avenue. It is recommended for removal.

Figure 4-9: Overgrown private driveway bridge over Alton Creek

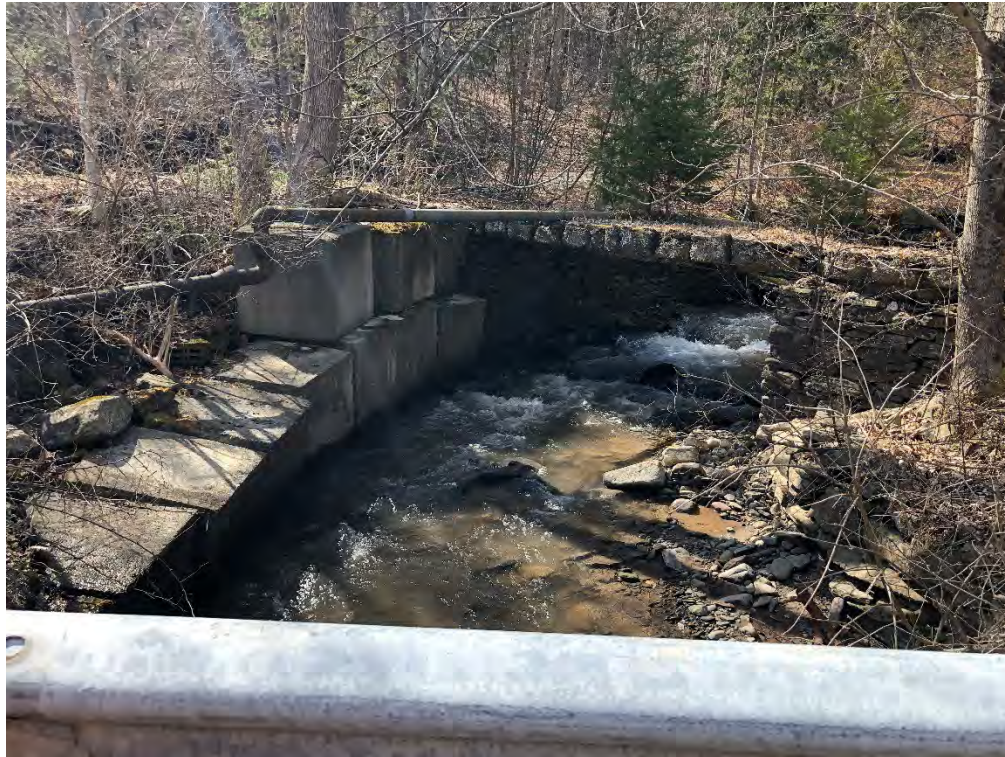
Figure 4-10: Looking upstream at stone crossing with disconnected pipe

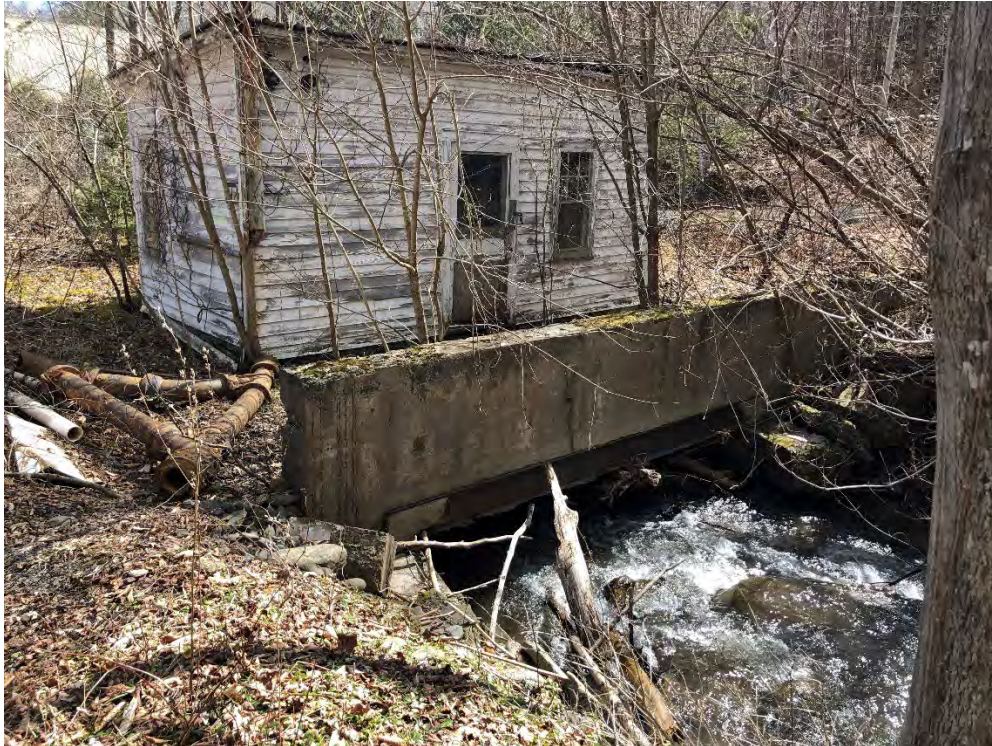
Figure 4-11: Shed over Alton Creek

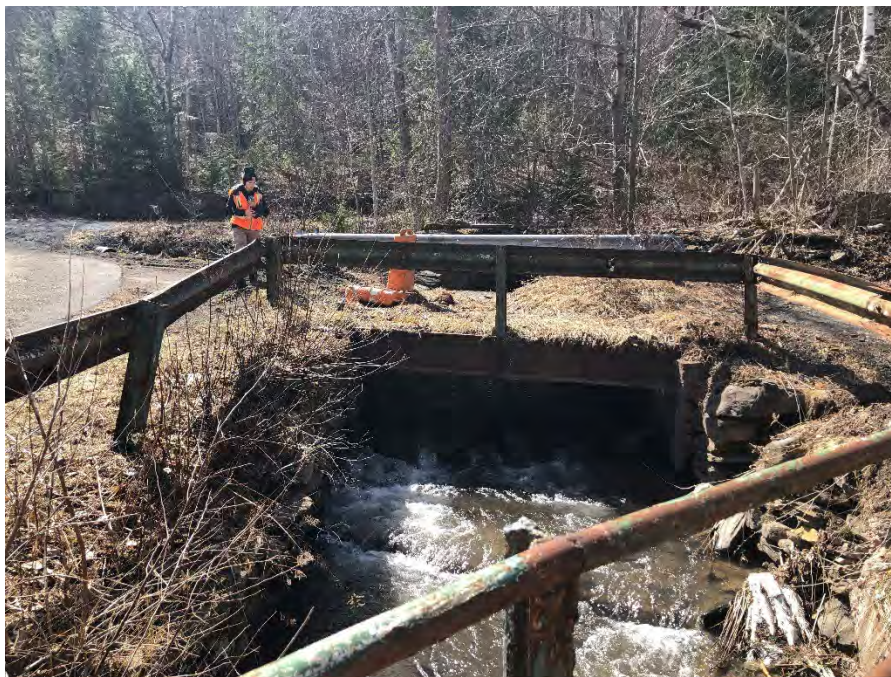
Figure 4-12: Looking upstream at the most upstream Bonnie View Avenue at Station Road crossing over Alton Creek

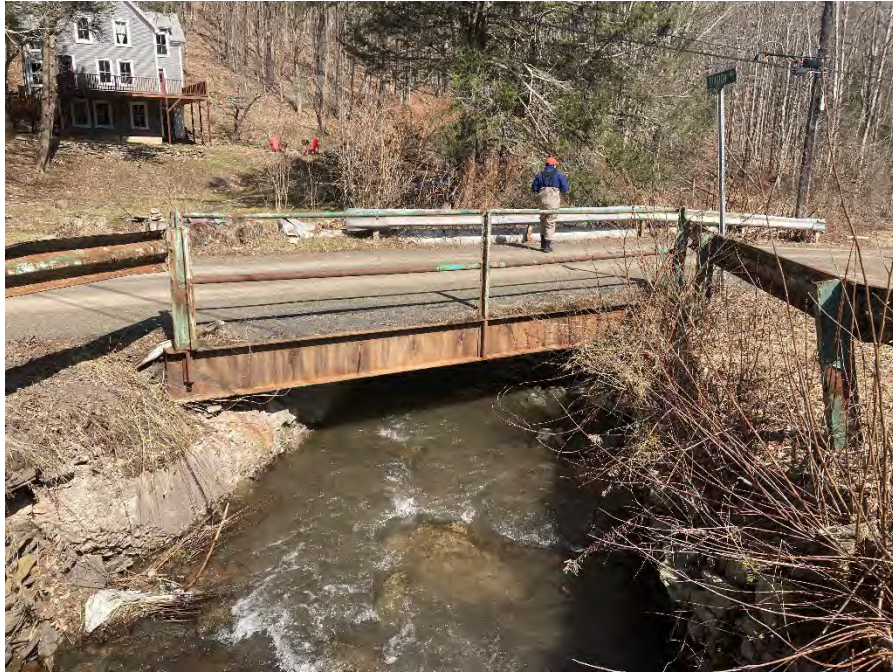
Figure 4-13: Looking downstream at the inlet of the most downstream Bonnie View Avenue at Station Road crossing over Alton Creek

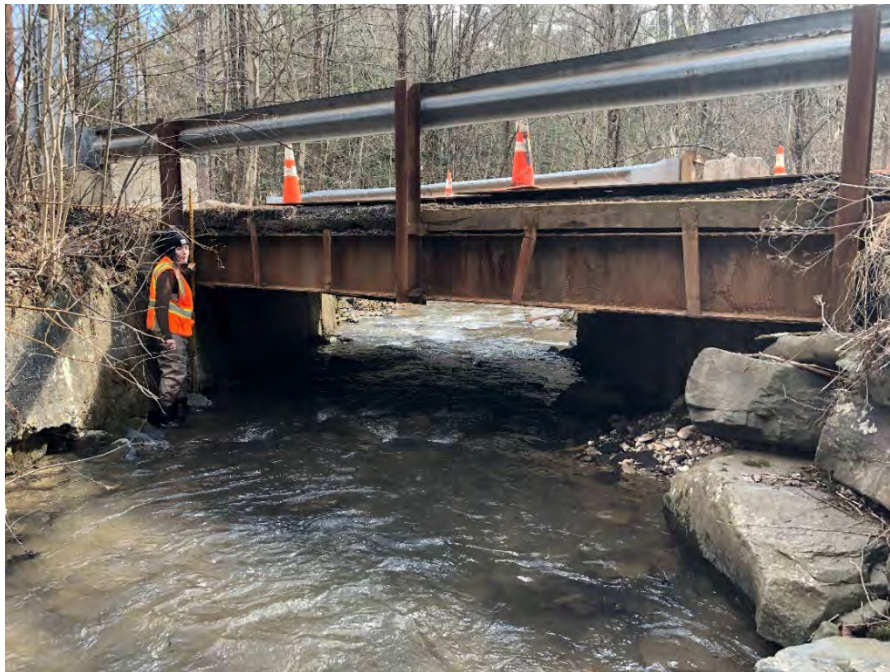
The current bridge passes the 10-year flood event without overtopping, but with backwater flooding, according to the HEC-RAS model. Overtopping of the bridge and flooding of Bonnie View Avenue may prevent passage and reduce access to some houses and the water treatment facility, a critical facility that must be accessible. There is a detour available via Mill Street and Station Road. However, the route is not passable by large vehicles such as fire trucks due to the rail bridge on Mill Street. Additionally, the route requires passage of two other floodprone locations - the Mill Street crossing (Project Area 3) and the intersection of Station Road and Bonnie View Avenue (Project Area 1). Based on the flood risk and poor structural condition, the bridge is a high priority for replacement. A full hydraulic and hydrological analysis is recommended to properly size the replacement bridge. Based on the HEC-RAS model, a 50-foot-span bridge, with the channel adjustments discussed below, can pass the current and future 50-year flows without overtopping.

Figure 4-19: Looking downstream at the Bonnie View Avenue culvert inlet over Alton Creek

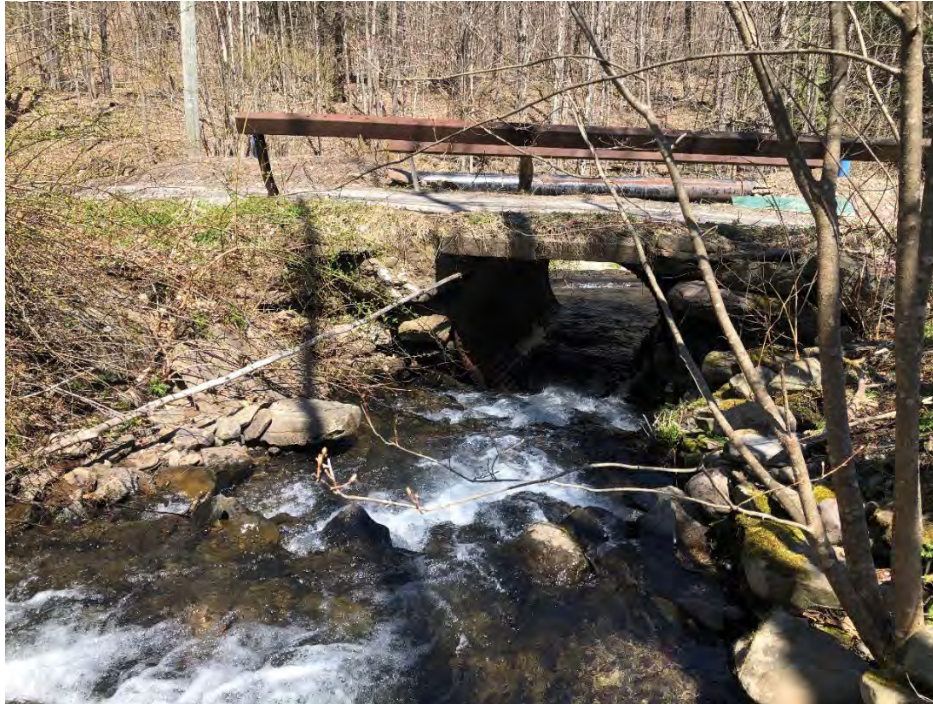
Figure 4-20: Inlet of culvert crossing Alton Creek

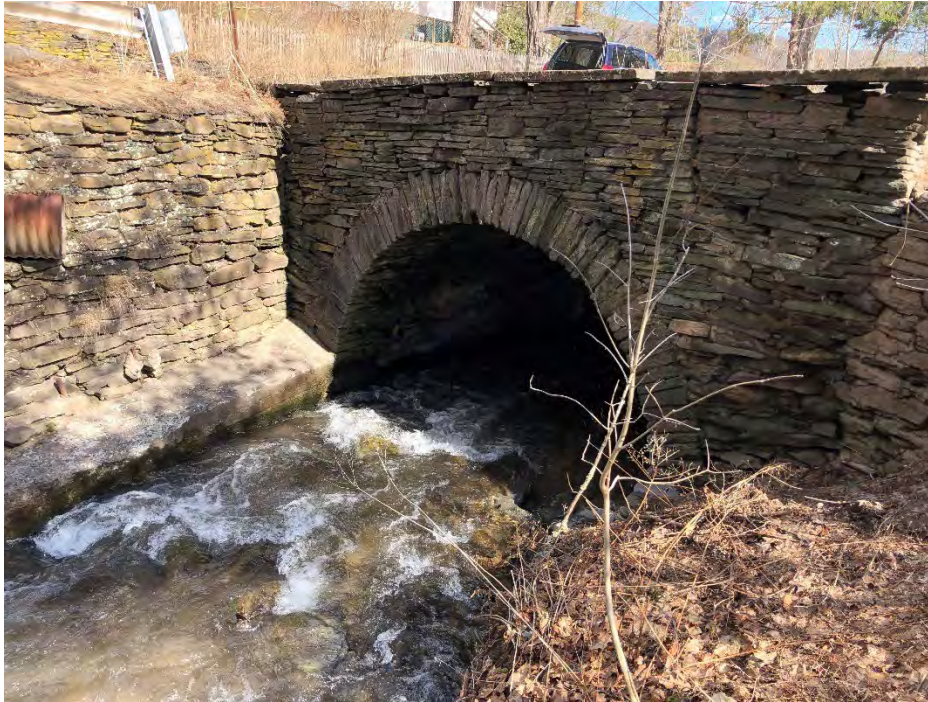
The existing culvert's capacity is sufficient to pass a 10-year flood event without overtopping. However, backwater flooding does occur. A detour is possible via Bonnie View Avenue and Station Road. However this detour is not passable by large vehicles such as fire trucks and includes two other floodprone areas – Project Areas 1 and 2. The flood risk at this crossing makes it a medium priority for replacement. Channel widening is also recommended in this area. A full hydraulic and hydrological assessment of the crossing, including any changes to the channel, is recommended to properly size the replacement structure. In concert with the channel changes recommended below, a 35-foot-span bridge will reduce backwater flooding and has the capacity to pass a current 100-year flood and future 50-year flood.

Figure 4-21: Looking downstream at the inlet of the Mill Street culvert over Alton Creek

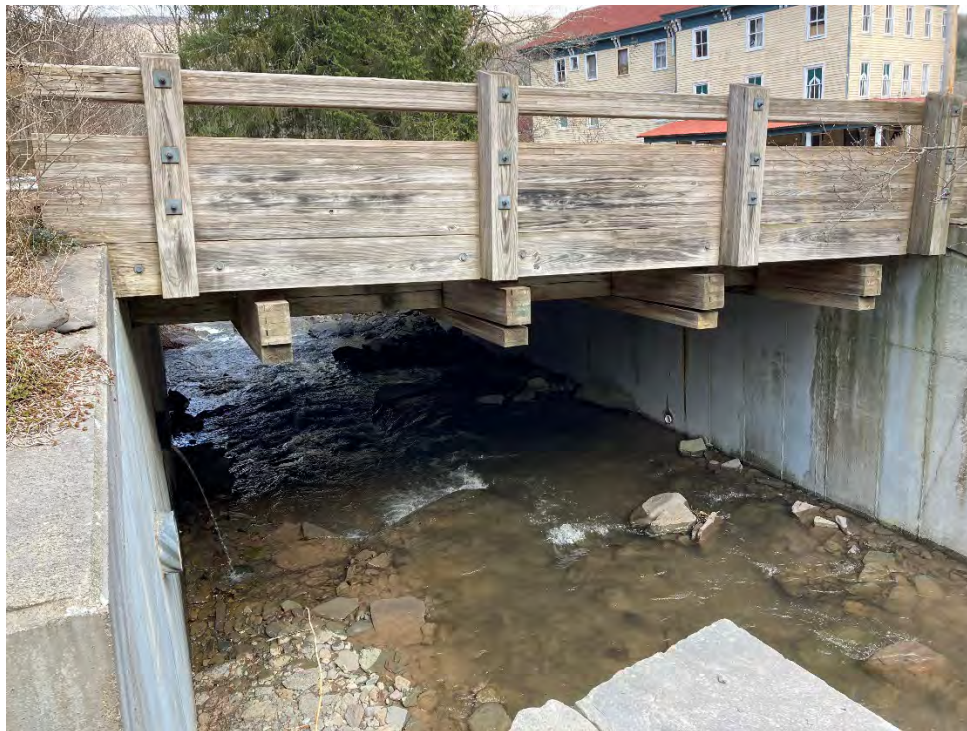
A replacement design should also include channel widening as described below. A full hydraulic and hydrological assessment is recommended to properly size a new bridge. This assessment should also include the channel changes. Based on a HEC-RAS model with an increased channel width, a bridge with a span of 35 feet has the capacity to pass the 100-year current and future flood event without overtopping and reduced backwater flooding.

Figure 4-27: Looking downstream at the inlet of the upper Main Street crossing over Alton Creek

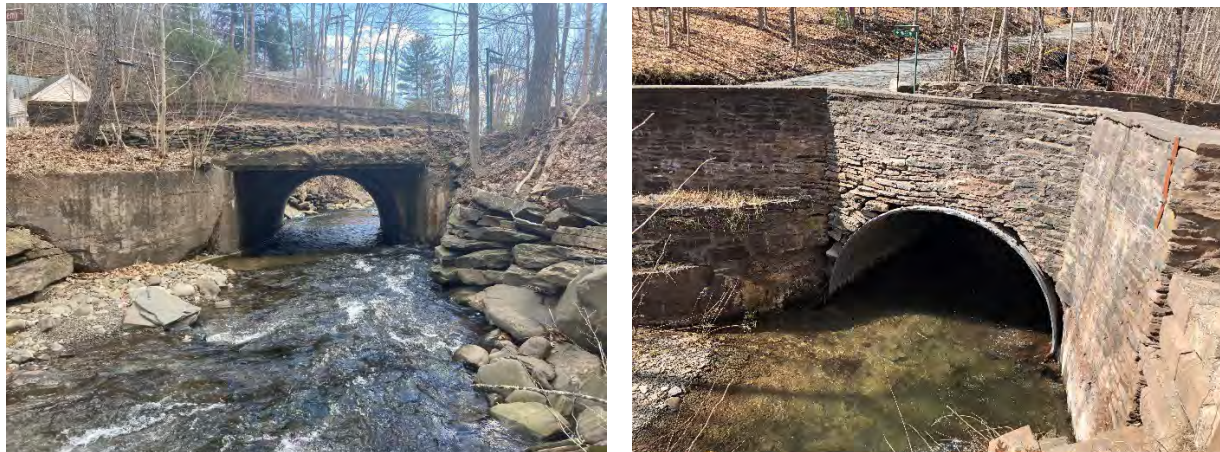
Due to the low capacity of the culvert and the impact of subsequent flooding, this culvert is a medium priority for replacement. The replacement structure is recommended to have a span of 35 feet, which covers the active channel width of 29 feet and passes a current and future 50-year flood event without overtopping. The new crossing should have an open bottom with a constant slope as recommended by the NYSDEC to support aquatic organism passage.

Figure 4-28: Inlet (left) and outlet (right) of Academy Street crossing over Birch Creek

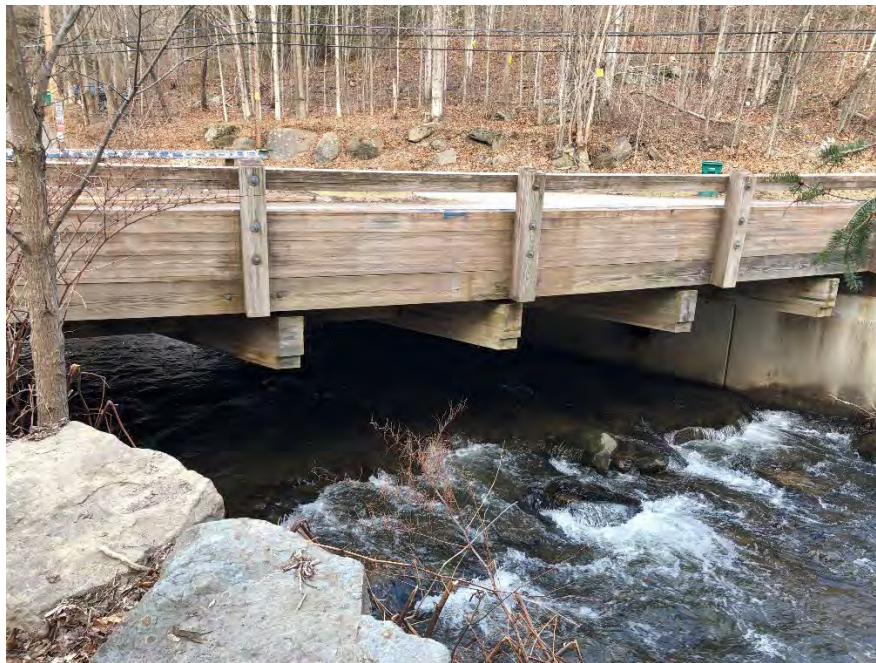
Replacement of this crossing is most effective if done in concert with channel and floodplain adjustments. A full hydraulic and hydrological study should be done to include the channel and floodplain changes to properly resize the crossing. With the channel widening and floodplain creation recommended in this study, the bridge span is recommended to be 60 feet to reduce backwater flooding. The increase in span only slightly reduces the risk of overtopping. Further widening of the bridge and floodplain will require the removal of one or both houses at the outlet.

Figure 4-34: Looking downstream at the lower Main Street crossing over Birch Creek

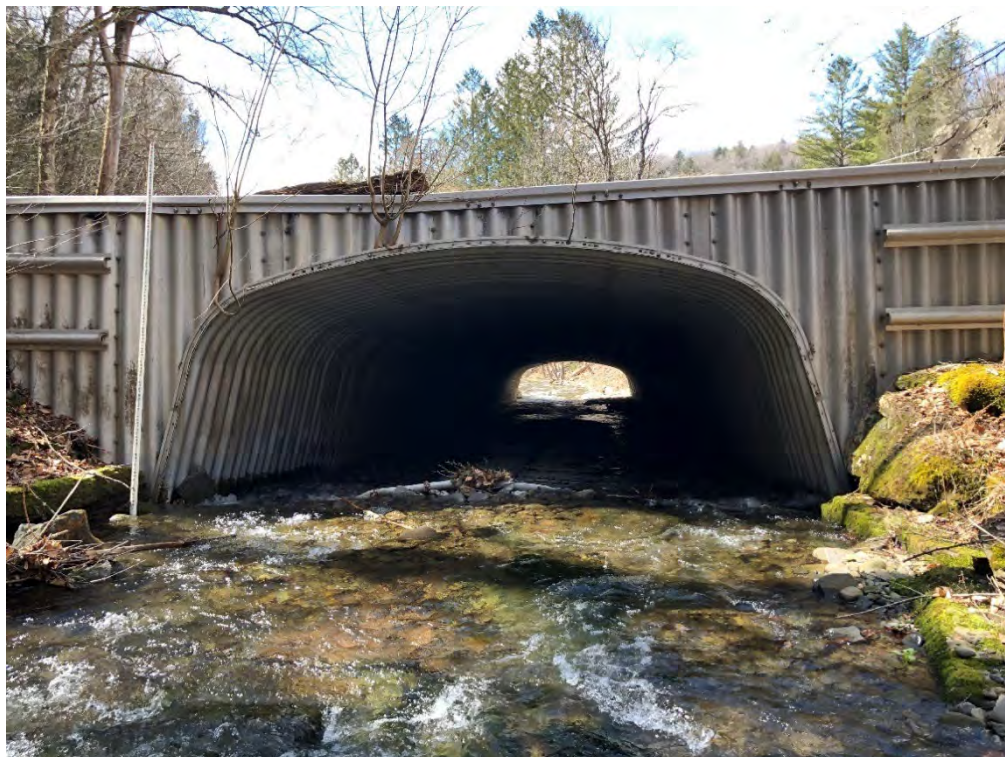
Due to the current capacity and condition of this culvert, it is a low priority for replacement. When it is due for replacement, a detailed hydraulic and hydrologic analysis is recommended to properly size a replacement structure. It is also recommended that an open bottom is used, following NYSDEC recommendations for aquatic organism passage. The HY-8 model used in this study shows that expanding the span to 25 feet, matching the active channel width, as an open-bottom bridge gives a capacity of 1,628 cfs. This is sufficient capacity for the current 100-year flood event and the 50-year future flood event.

Figure 4-40: Looking downstream at Birch Creek Road culvert over Birch Creek

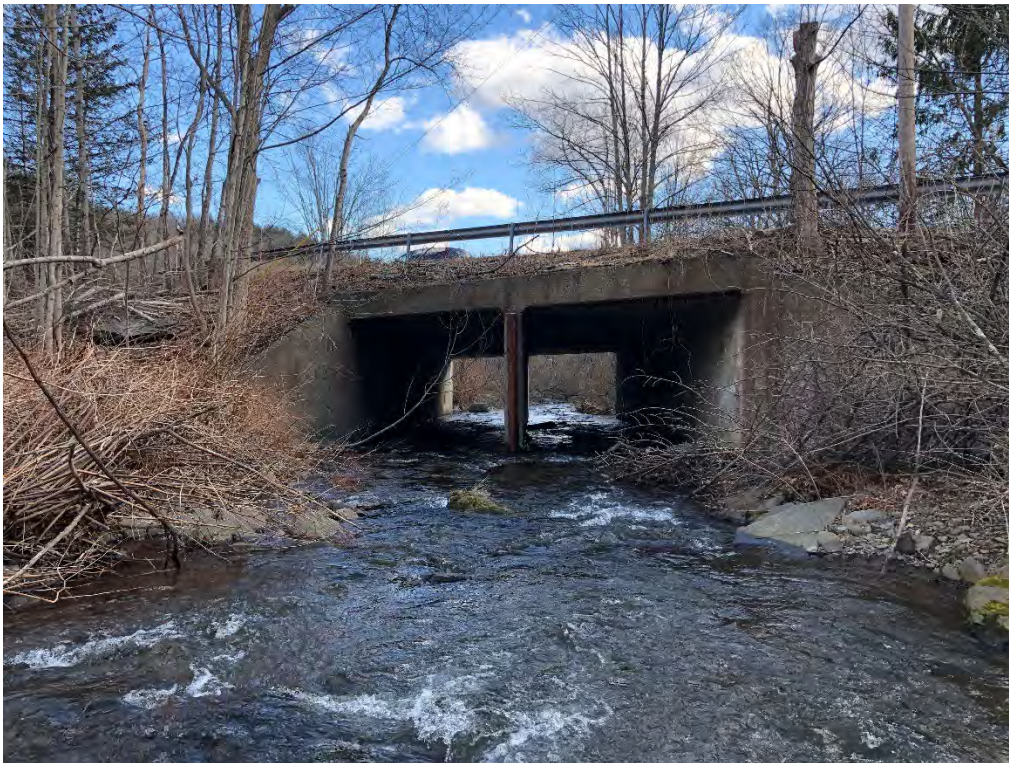
The Elm Street crossing over Birch Creek at river station 151+40 is two open-bottom concrete box culverts, each with a 12-foot span. A one-dimensional HEC-RAS model of Birch Creek shows that the existing capacity of the crossing is sufficient to pass the 50-year flood event without overtopping the road. However, backwater flooding begins at flows greater than the 10-year flood event. Due to the limited reach of this flooding in an undeveloped area, this crossing is determined to be a low priority for replacement.

Figure 4-41: Looking downstream at the Elm Street culvert over Birch Creek

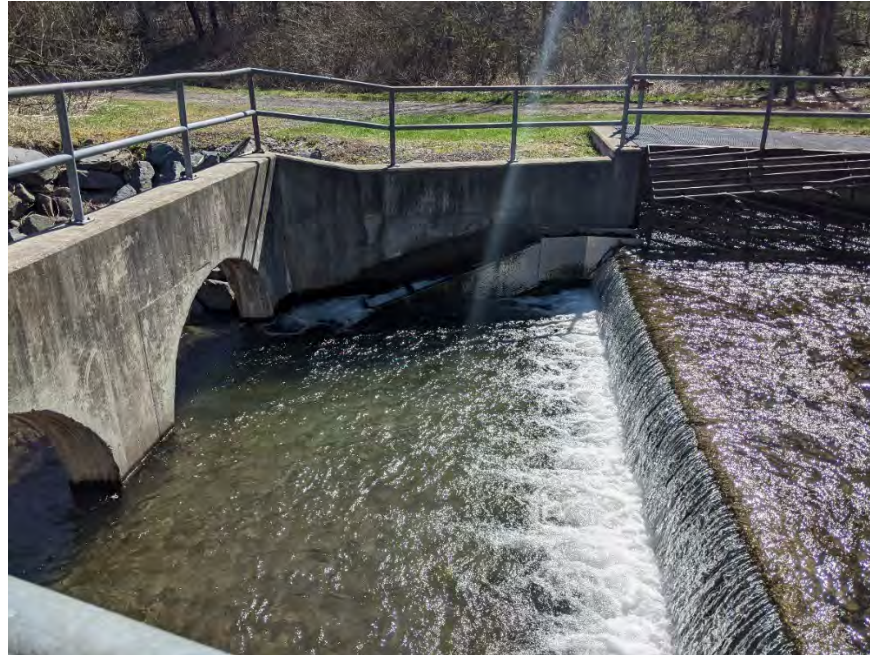
The dam is necessary for the intake of the Belleayre Lake. There is a fish passage structure along the right bank to support aquatic organism passage. It is unclear if the culvert structure is critical for the stabilization of the dam. This structure is a low priority for replacement if replacement is allowable.

Figure 4-42: Dam, old road crossing, and intake for Belleayre Day Use Area

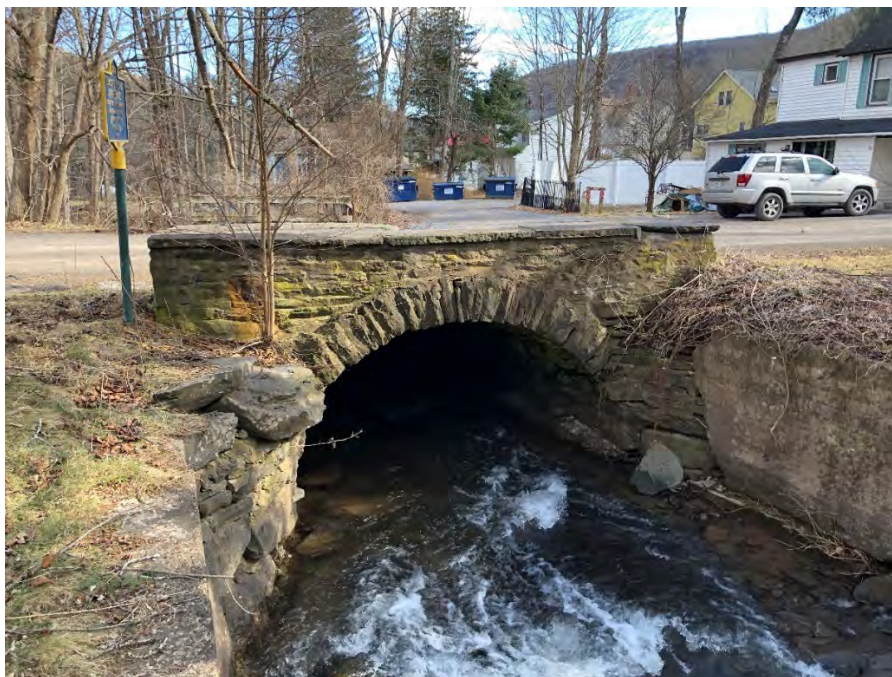
Elm Street crosses Alton Creek at river station 5+50. The historic stone arch has a span of 10 feet. The active channel width in this section of Alton Creek is 22 feet. The undersized channel overtops in a 10-year flood event. The backwater floods the upstream region. Given the limited flooded area and alternative routes available if the road is flooded, this culvert is a low priority for replacement at this time.

Figure 4-43: Historic Elm Street stone arch over Alton Creek

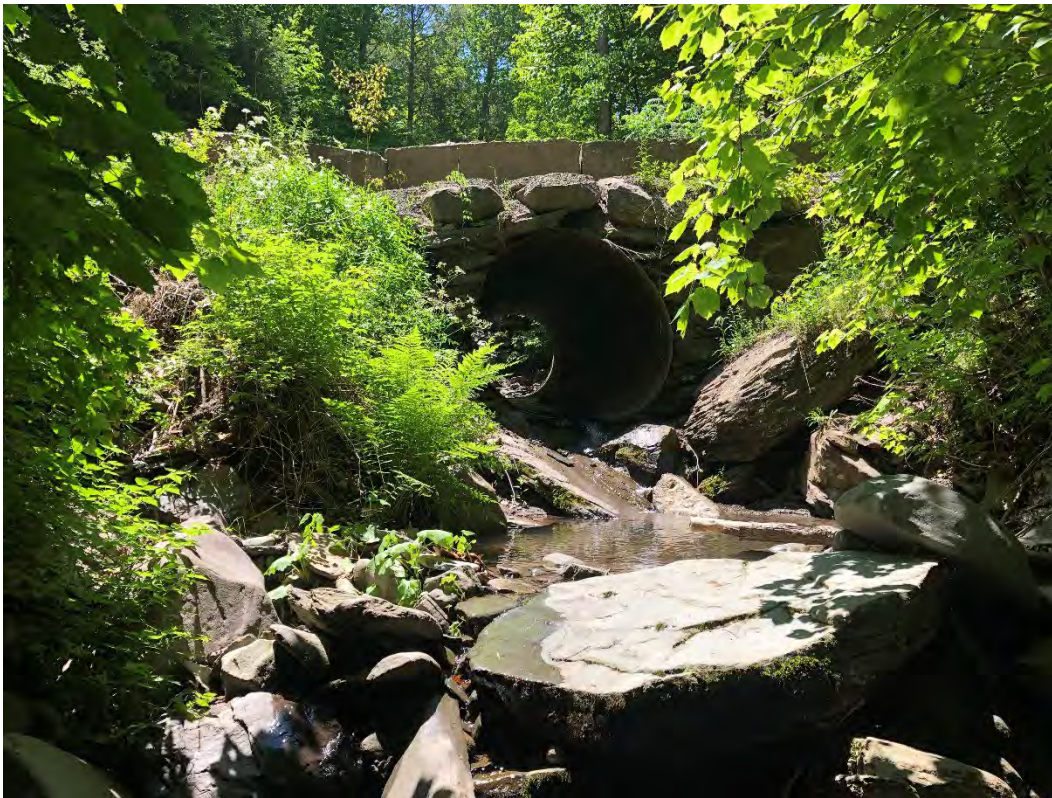
An HY-8 model of the culvert shows it passes the 50-year flood event without overtopping. The flow of the October flood was not measured, so the return period is unknown. Given the results of the model, this culvert is not recommended for replacement at this time. Further investigation in the upstream extents of Woodchuck Hollow is needed to determine and resolve the source of past flooding.

Figure 4-44: Outlet and tailwater of Station Road culvert at Woodchuck Hollow

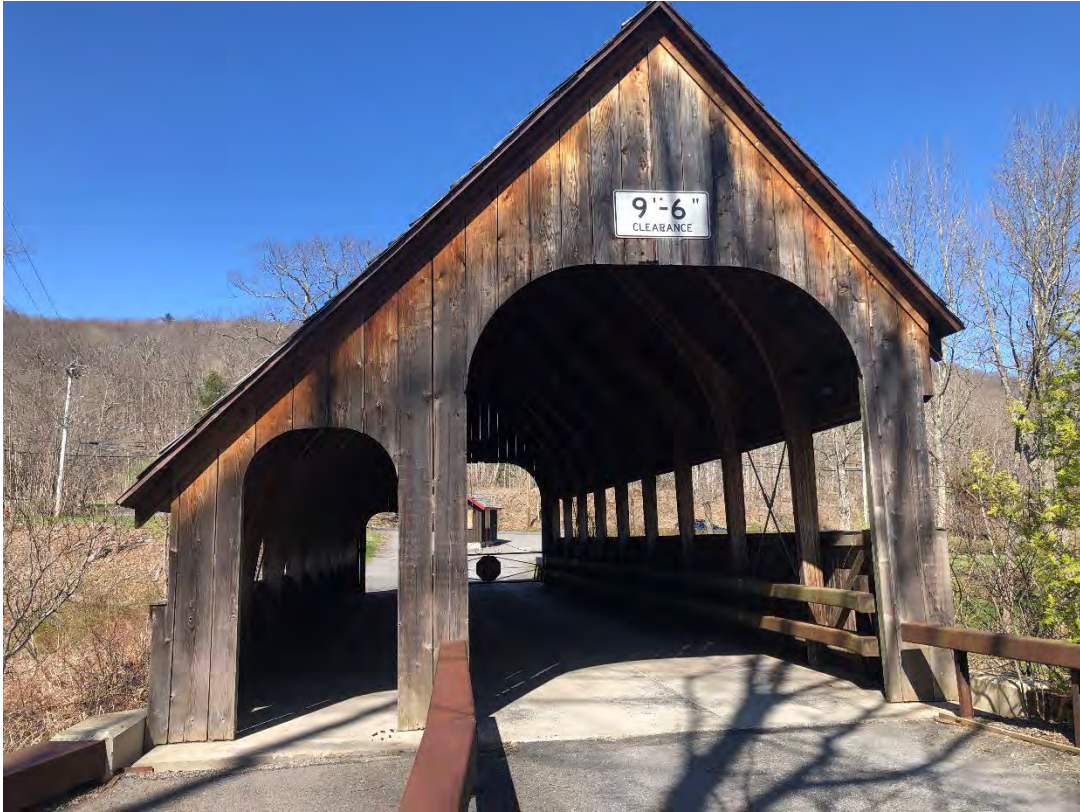
The access driveway to Belleayre Lake and Day Use Area crosses Birch Creek at river station 110+30 with a covered bridge. Birch Creek runs along the north side of the earthen dam that creates the lake. The outlet of the lake re-enters the creek upstream of the driveway bridge crossing. There are also signs of beaver lodges in the floodplain just upstream of the crossing. The HEC-RAS model shows that the crossing can pass a 100-year flood event without overtopping and that backwater flooding occurs at flows less than the 10-year flood event. The flooding is limited to the floodplain area where the beaver activity was seen. The increase in water levels is due to the beavers rather than confinements due to the bridge. This bridge is not recommended for replacement at this time.

Figure 4-45: Covered bridge over Birch Creek is the only access to Belleayre Day Use Area.

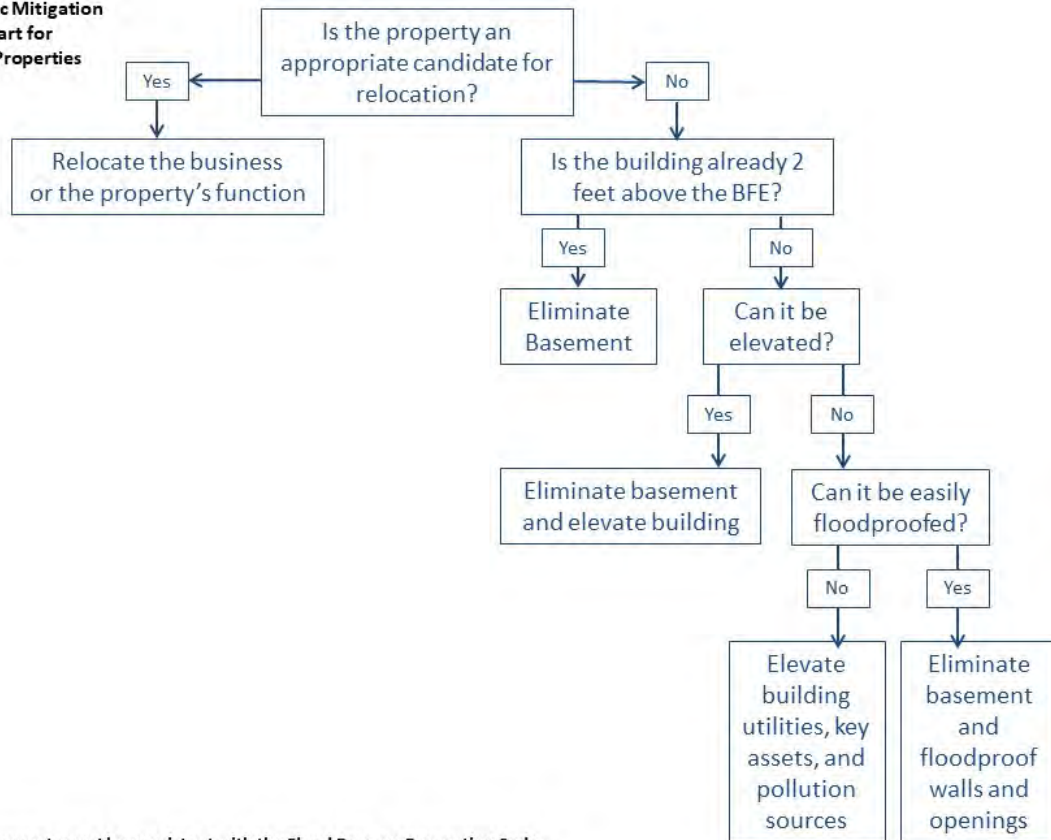
Property-Specific Mitigation Decision Flowchart for Nonresidential Properties

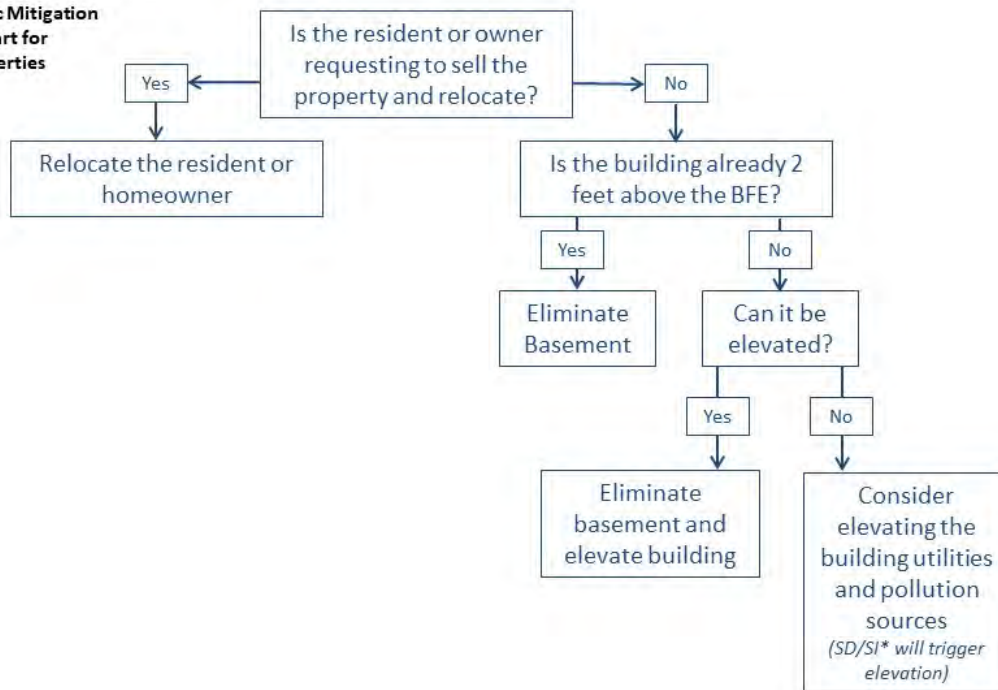
**Property-Specific Mitigation
Decision Flowchart for
Residential Properties**
