Reach 1b (Maplecrest Gage to County Bridge #3-30287-0)

Reach 1b begins at the USGS gage station in Maplecrest, and flows parallel with Big Hollow Road for approximately 8,744 feet (1.7 miles) to the county bridge below the L. MacGlashen farm (**Map VI-2**). The stream reach is located within valley zone 5 (**Figure V-11**), with an average valley slope of 2.7%. Valley morphology is characterized by steep side slopes with a narrow, confined valley floor. The drainage area contributing to the reach ranges from 2.03 mi² at the top of the reach to 5.5 mi² at the county bridge. Land cover through the reach is dominated by forest, while other land use in the reach includes limited residential development and some small scale agriculture.

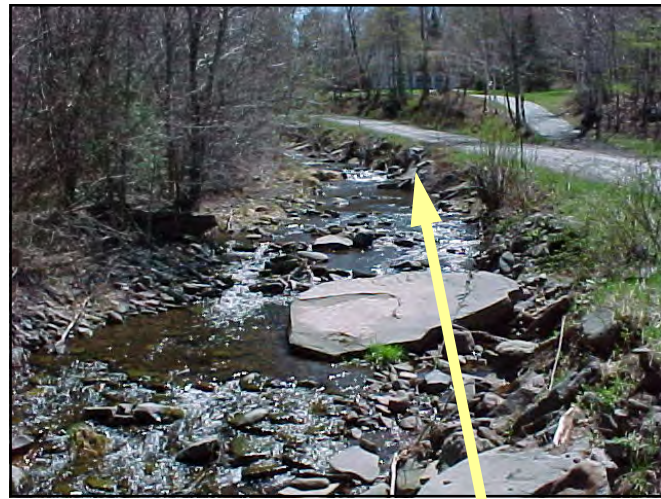
A

While the upper portion of the reach is characterized as being relatively stable, the lower portion of reach 1b was noted as having significant areas of channel erosion (**Figure VI-5b, photos A,B,D,E,F**). The erosion inventoried in 1997 was almost exclusively located in this sub-reach. Instabilities were noted in several areas, with channel aggradation and degradation observed, as well as lateral channel erosion. In August of 1999, three monitoring sections were installed in this section to determine stream type and the current state of instability.

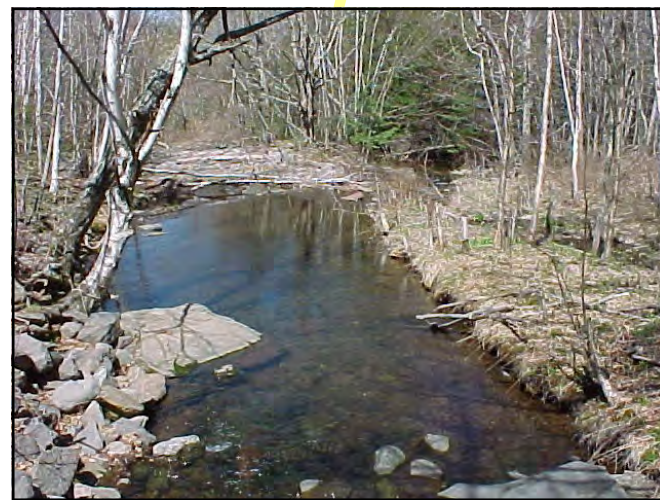
F

In September 1999, the town bridge at the L. Milton MacGlashan farm failed during the Tropical storm Floyd flood event (**Figure VI-5b, photo F**). The cause of the failure was documented as scour of the left bridge abutment, most likely the result of inadequate capacity to pass the storm flow, as well as degradation of the streambed and lateral erosion. The replacement bridge was relocated approximately 150 feet down stream, to a location where the stream planform was straight. The new bridge was built at 60 feet in length, in an area where the GCSWCD has determined the bankfull width to be approximately 35 feet. The combination of the new alignment and the lengthening of the bridge is both highly favorable to reestablishing a stable stream morphology in this reach.
