Reach 2b (Intersection CR 40/ CR 56- Hensonville Market)

Reach 2b includes the section of Batavia Kill beginning at the intersection of County Routes 40 and 56 in Maplecrest, and runs downstream to the area adjacent to the Hensonville Market. The reach is approximately 1.9 miles in length and ranges in drainage area from 11 mi² to 13.4 mi². The channel receives four unnamed seasonal tributaries through reach 2b. The stream reach is located in Valley Zone 3 and has an average valley slope of 1.3% (**Figure V-11**).

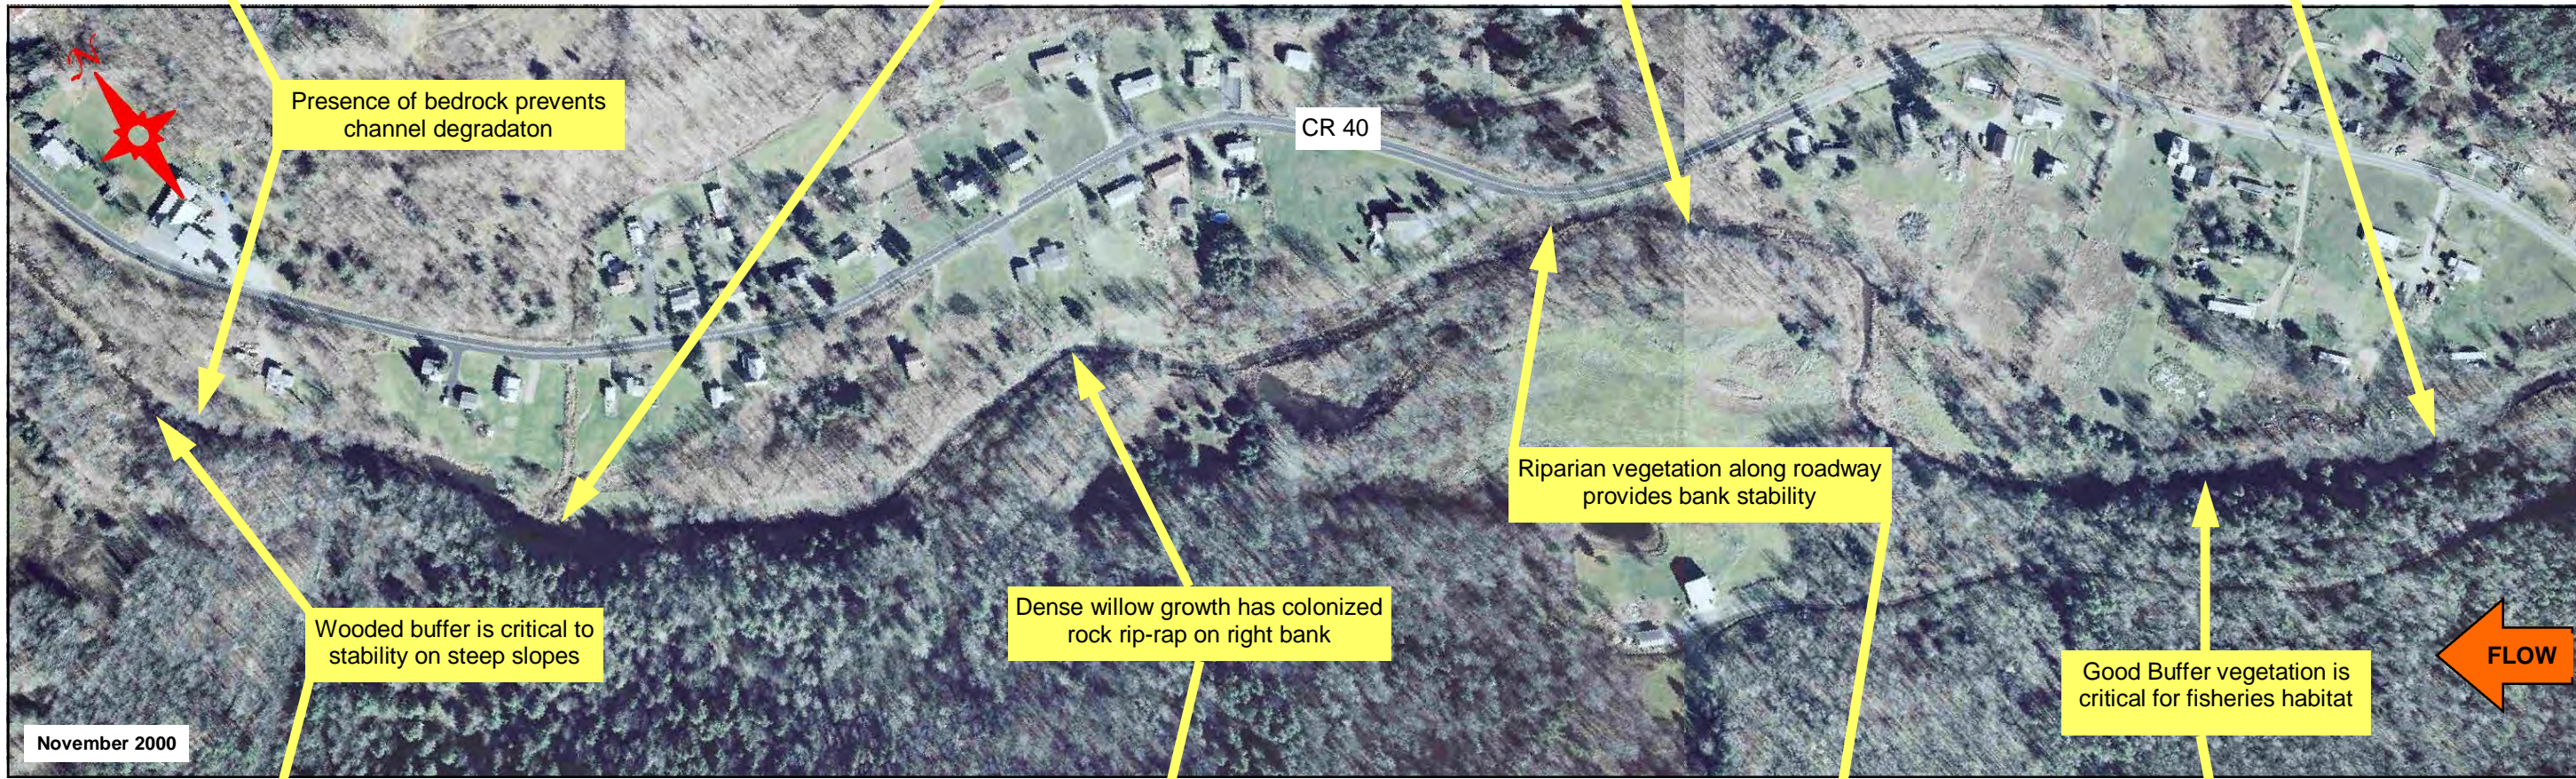
Presence of bedrock prevents channel degradation

Wooded buffer is critical to stability on steep slopes

Dense willow growth has colonized rock rip-rap on right bank

Riparian vegetation along roadway provides bank stability

Good Buffer vegetation is critical for fisheries habitat
